The Bendigo-Ophir Gold Project

A Heritage Assessment

Report Prepared for Matakani Gold Ltd
Author: Dr Naomi Woods and Claire Thorrold
Reviewed by: Dawn Cropper and Megan Lawrence

Prepared by New Zealand Heritage Properties Ltd

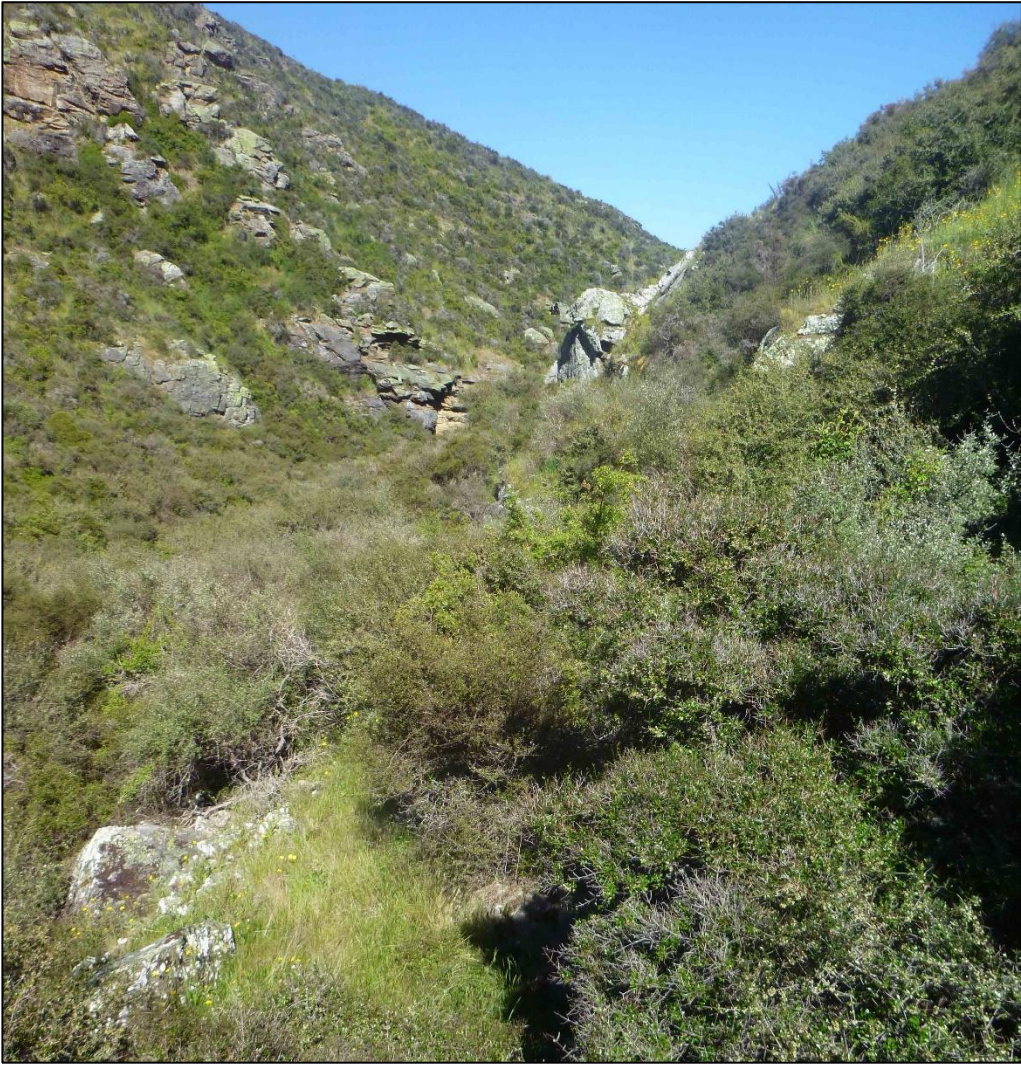
Figure 4-2. Schist outcrops within the project area (NZHP 2018).

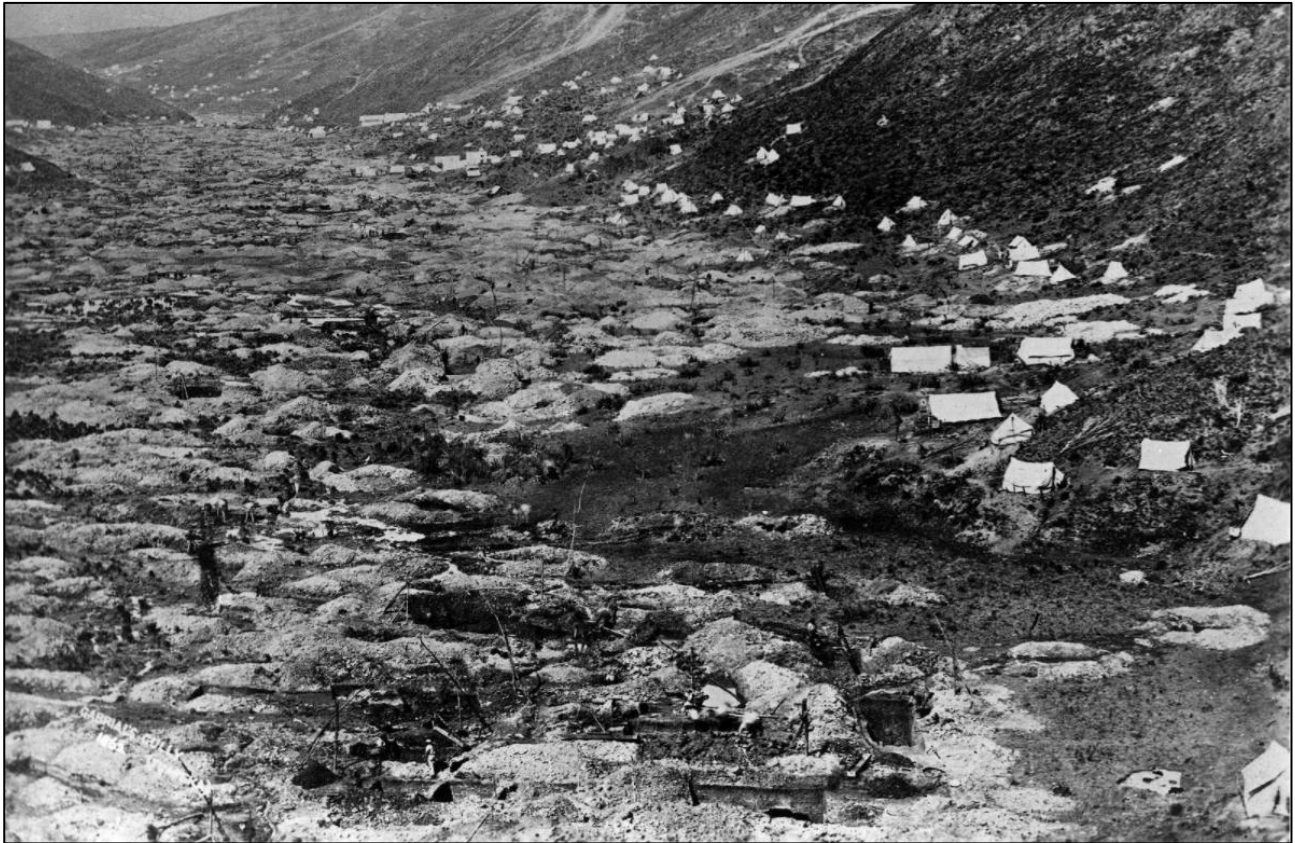
Figure 5-5 A view of Gabriels Gully in 1862, showing a pitted landscape with various mound and pothole features (Gore, 1862). Also note the frequency of tent sites.

pitted landscapes with scattered mound and pothole features (Figure 5-5). Hamel (2001) states that the miners lived in tents associated with low sod or stone walls, sod chimneys and bunks of manuka poles. Shopkeepers also followed the miners, setting up tents near the gold workings. These activities are demonstrated in an 1862 photograph of Gabriels Gully (Figure 5-5). Many of these early river workings have likely been destroyed by flooding or subsequent sluicing and dredging, this includes working in the Clutha gorges. As for evidence for the Serpentine fields only a small section of this area has been surveyed (Hamel, 2001). Chinese goldminers arrived in Otago from 1865, mostly working on small claims and in the creation of water races (McIntyre, 2007).

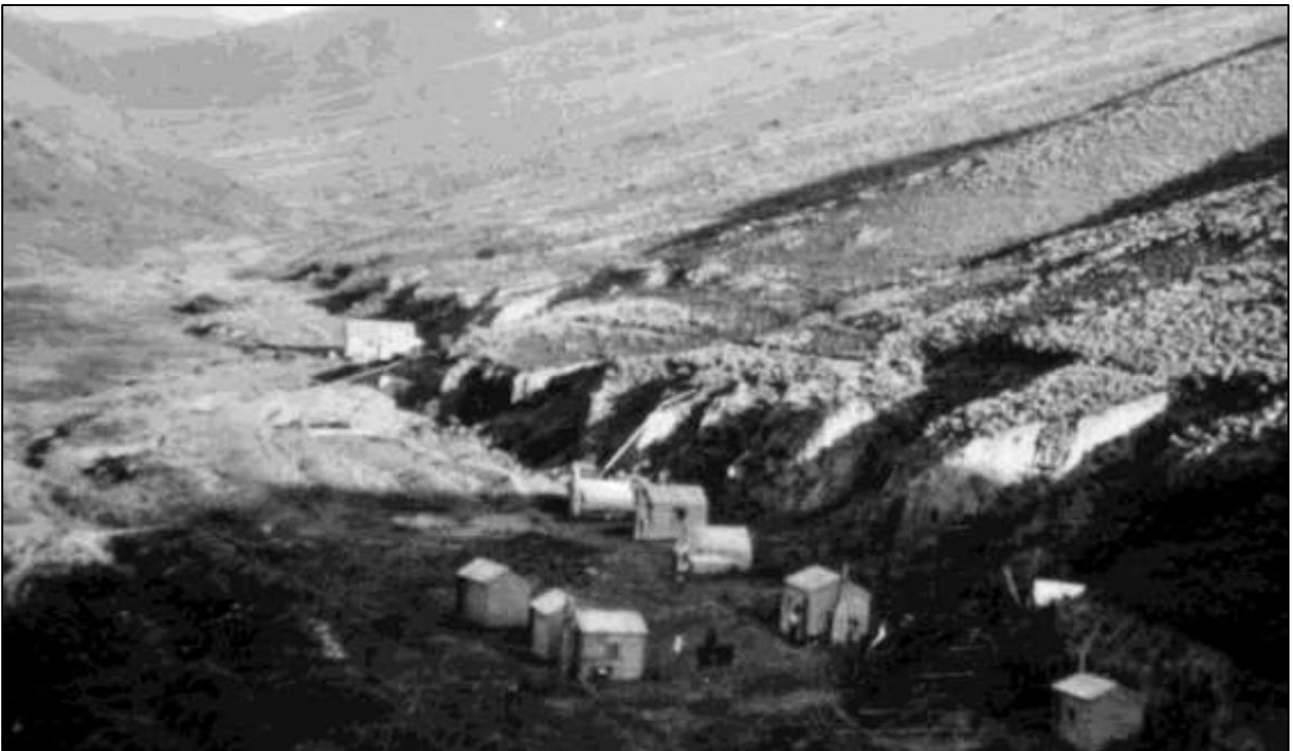
Figure 5-8. Miners' huts and manager's house at the Bendigo Rise and Shine Mine in 1933 ('Quartz Mining in Otago - Unemployed Strike it Rich' New Zealand Free Lance, 28 March 1934 in Carpenter, 2013b: Figure 8).

The initial SRF records machine foundations, tailings, a reservoir or dam, and a revetted roadway leading downstream on the true right. This site has been subject to more recent mining activity disturbance such as drill holes undertaken in the 1980s through to the 2000s. However, the site was walked over and appeared in good condition aside from heavy vegetation. The revetted roadway or tramway was re-identified during the site survey (POI 203). The southeast extent of the tramway was heavily vegetated, and it was not possible to completely view its full extent as identified in the 1980 survey. Aerial imagery shows the road running for 291m along the Rise and Shine Creek (Figure 7-47). The tramway revetment was built using schist stones, occasionally incorporating or built around larger in situ natural schist outcrops (Figure 7-45). Historic photographs of this area show 1930s buildings (Figure 5-7 and Figure 5-8), however no remains of these buildings were identified during the survey.

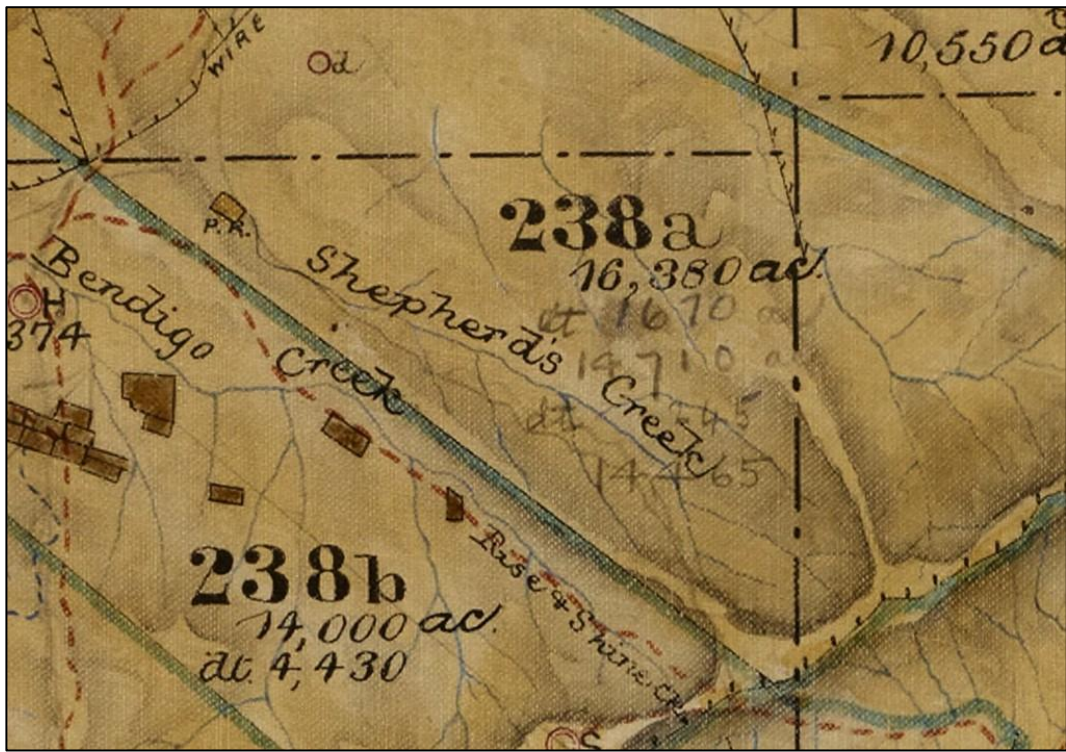
Figure 5-10. Detail of 1897 map showing Shepherds Creek (H.T.W., 1897).

An 1898 map shows McLean’s area of Pre-Emptive Rights along Shepherds Creek (containing sites G41/4 and G41/5 as discussed in Section 5.3.2) and one water race (**G41/6**) passing just to the south but no other features, including **G41/790** and **G41/792** (Figure 5-10). A geological plan drawn in 1907 records pockets of old workings on either side of Shepherds Creek, but these stop just west of the junction with Jean Creek (Figure 5-11). No evidence was found of later twentieth century mining along the portion of this creek within the project area; however, the lower reaches were the location of a relatively successful dredging operation (Hamel, 1993).

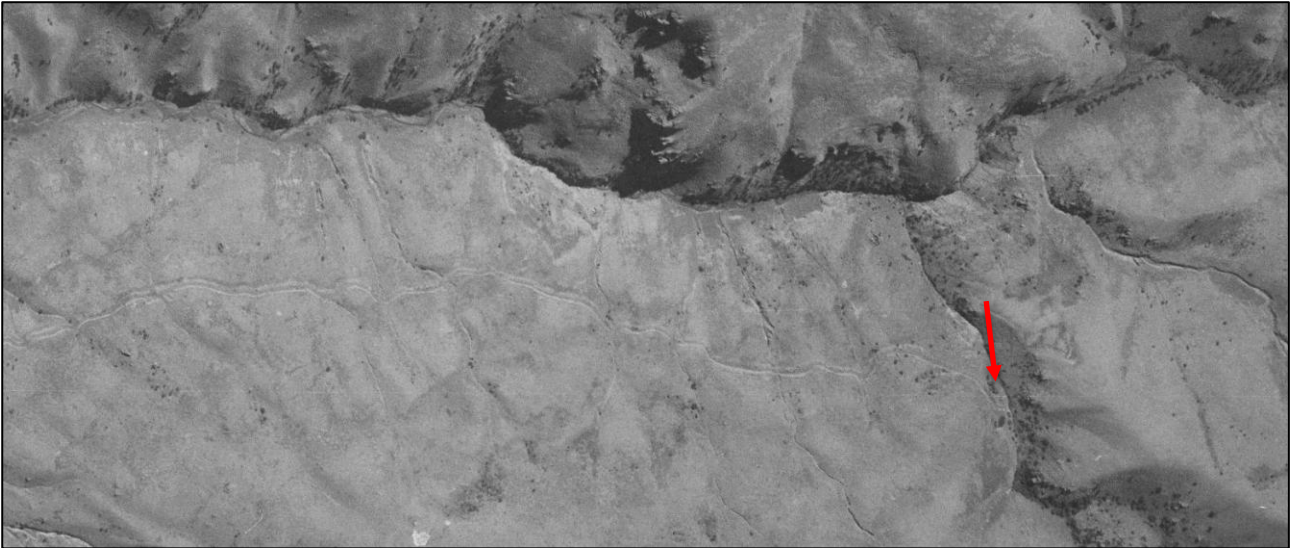
Figure 5-13. Aerial photograph from 1958 showing the Matakanui-Bendigo Road (Retrolens, 2021). Note that following the main stone revetment (red arrow) the wide road is no longer visible.

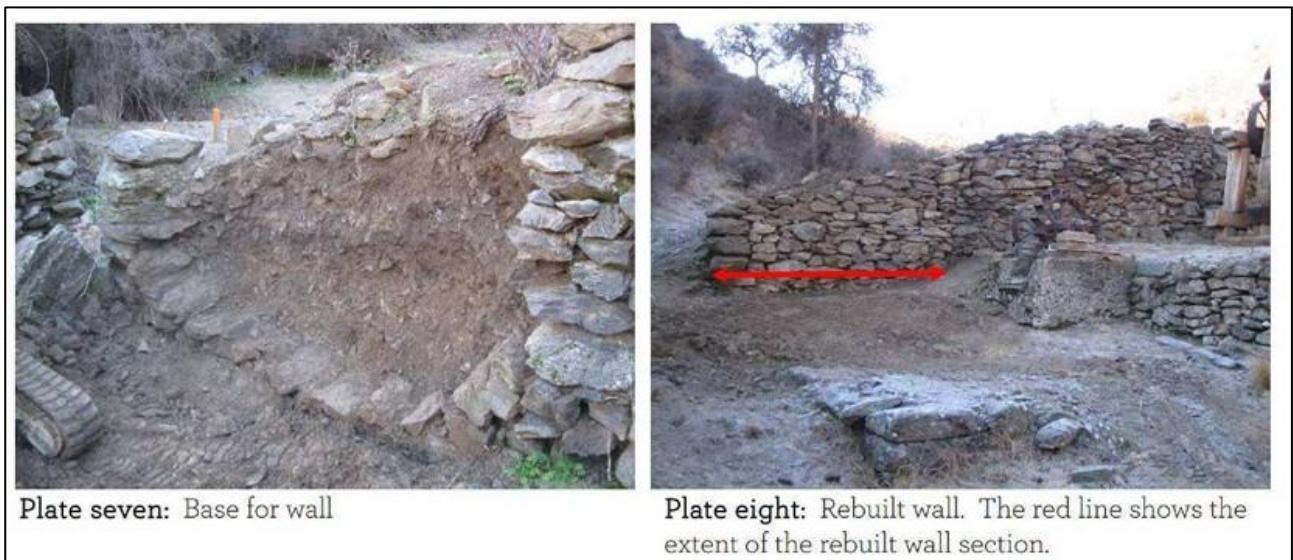
Plate seven: Base for wall

Plate eight: Rebuilt wall. The red line shows the extent of the rebuilt wall section.

Later in 2005 restoration works were undertaken on the battery under Archaeological Authority 2006/054, including the installation of a replacement Pelton wheel and replacement of rotten timbers, but this authority was not relevant for the portion of the site that falls within the current project area. In 2010 more restoration works occurred here under the same authority, this time on the stone walls surrounding the battery (Middlemiss, 2011).

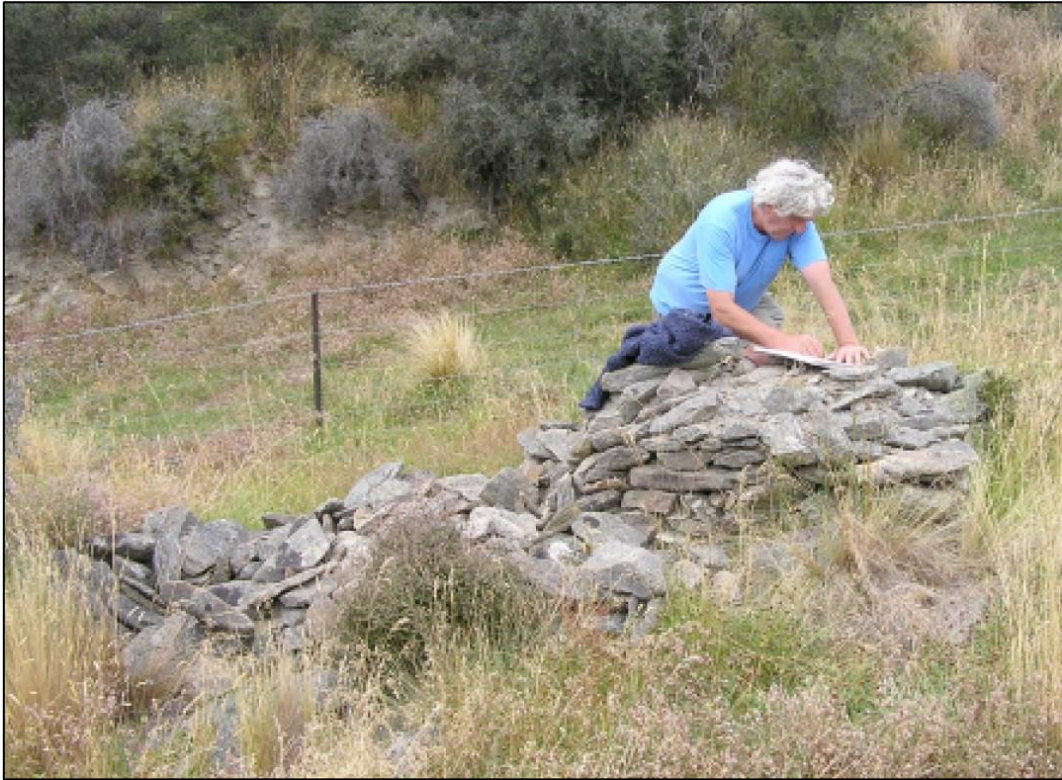
Figure 6-13. Site G41/265 looking east in 2005 (Nichol & Wright, 2006).

Stone huts G41/265, G41/266 and G41/267 were first recorded by Jacomb and Easdale in 1980 and are discussed together due to their close proximity. Sketch maps were drawn of each structure (Figure 6-9, Figure 6-10 and Figure 6-11), with one (G41/265) noted to have been partially disturbed by a modern fence line, with schist stones from the walls pushed aside to clear a path for this feature. Jill Hamel revisited all three stone huts in 1990 and noted that G41/266 and G41/267 were being rapidly enveloped by matagouri scrub (Figure 6-12). Nichol and Wright relocated all three huts during their 2005 survey, noting that the structures remained in a stable condition but that the vegetation was continuing to take over (Figure 6-13 and Figure 6-14), especially for site G41/267 which could not be photographed clearly due to the heavy scrub (Nichol & Wright, 2006).

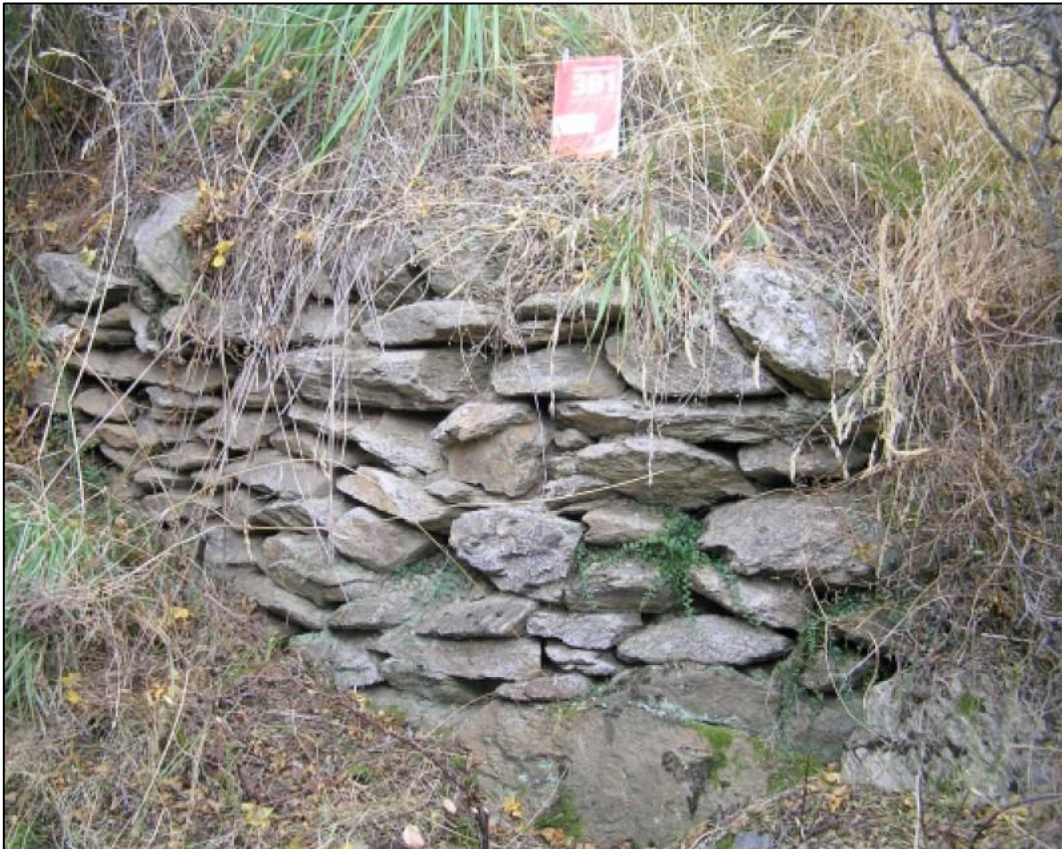
Figure 6-14. Rear wall of site G41/266 in 2005 (Nichol & Wright, 2006).

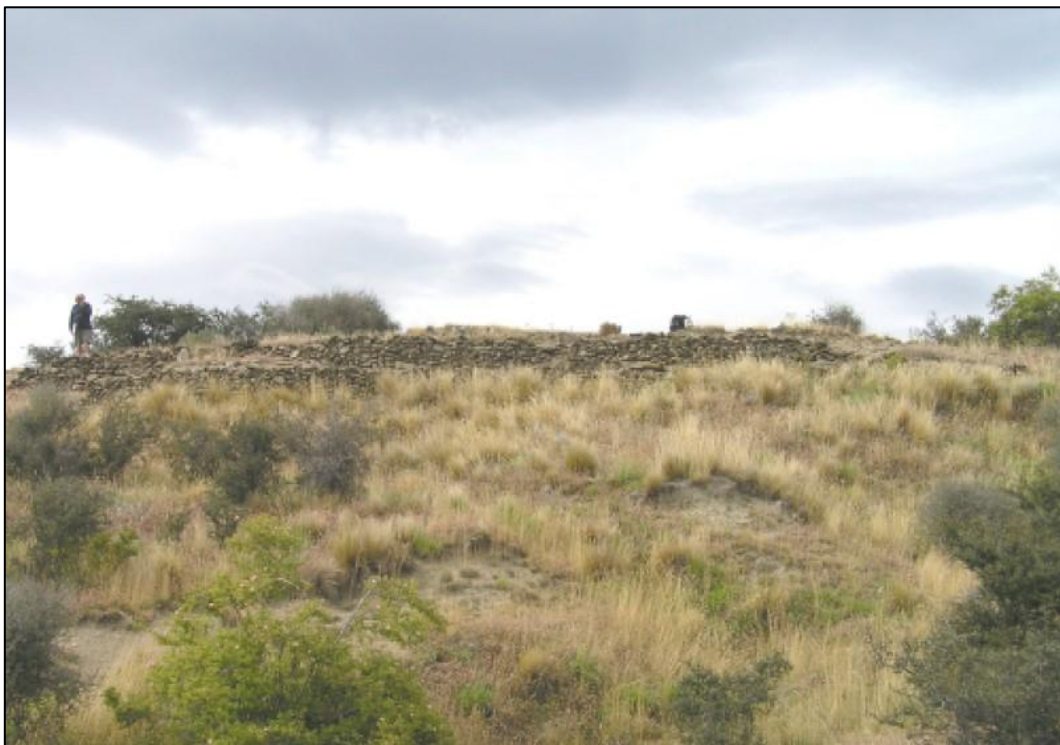
Figure 6-16. Site G41/269 in 2005, looking southeast (Nichol & Wright, 2006).

Jacomb and Easdale recorded a stone-faced dam within the larger area of workings (G41/264) in 1980 and drew a sketch map (Figure 6-15). This site was recorded as part of the wider gold workings complex by Hamel in 1990, when it was noted as being in a similar condition as recorded by Jacomb and Easdale (Hamel, 1993). The GPS coordinates were updated as part of Nichol and Wright's (2006) survey, and the dam photographed (Figure 6-16).

The dam recorded as G41/269 (Figure 7-38 and Figure 7-39) was revisited during the November 2017 and both 2018 surveys and during a 2025 site visit with HNZPT. The stone revetted dam face was in good condition and the site was as described in the SRF (Figure 6-16). The dam is clearly visible in 1950s aerials and LiDAR imagery as shown in Figure 7-39.

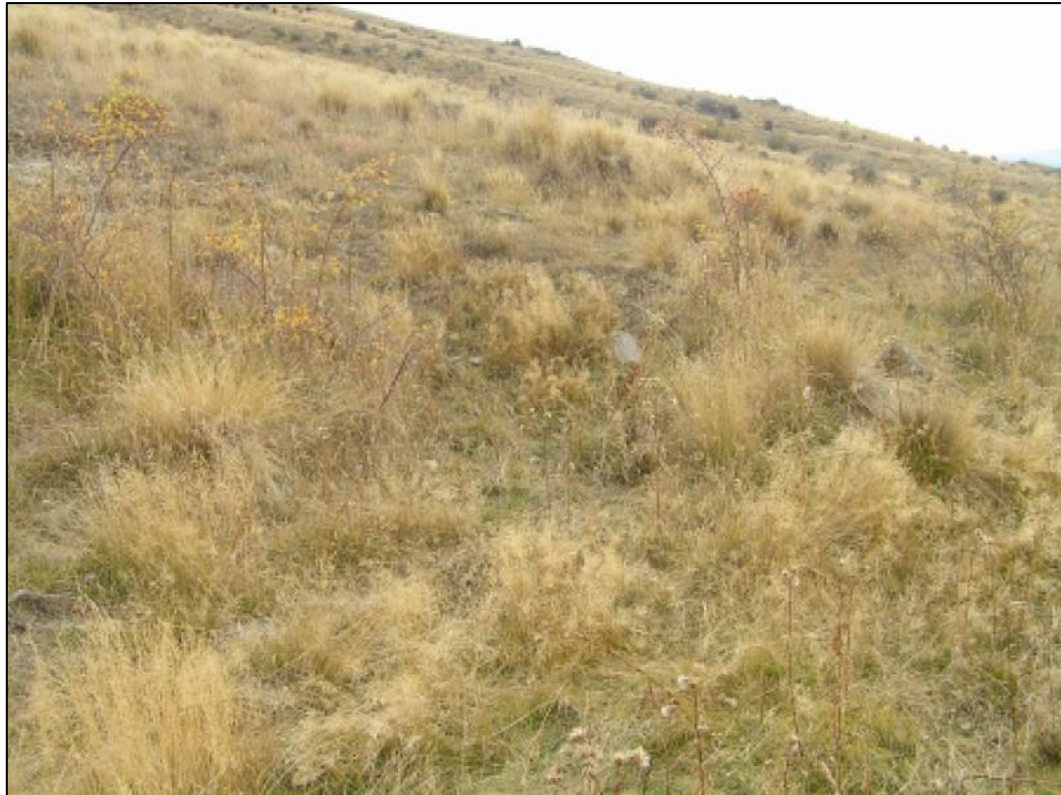
Figure 6-18. Looking west at site G41/273 (stones just visible in centre of image) (Nichol & Wright, 2006).

only the fireplace and an outline of low rubble visible. A sketch map was drawn for the site (Figure 6-17). The hut was revisited by Nichol and Wright in 2005 and found to be in the same condition as previously described, but almost entirely hidden by vegetation (Nichol & Wright, 2006) (Figure 6-18).

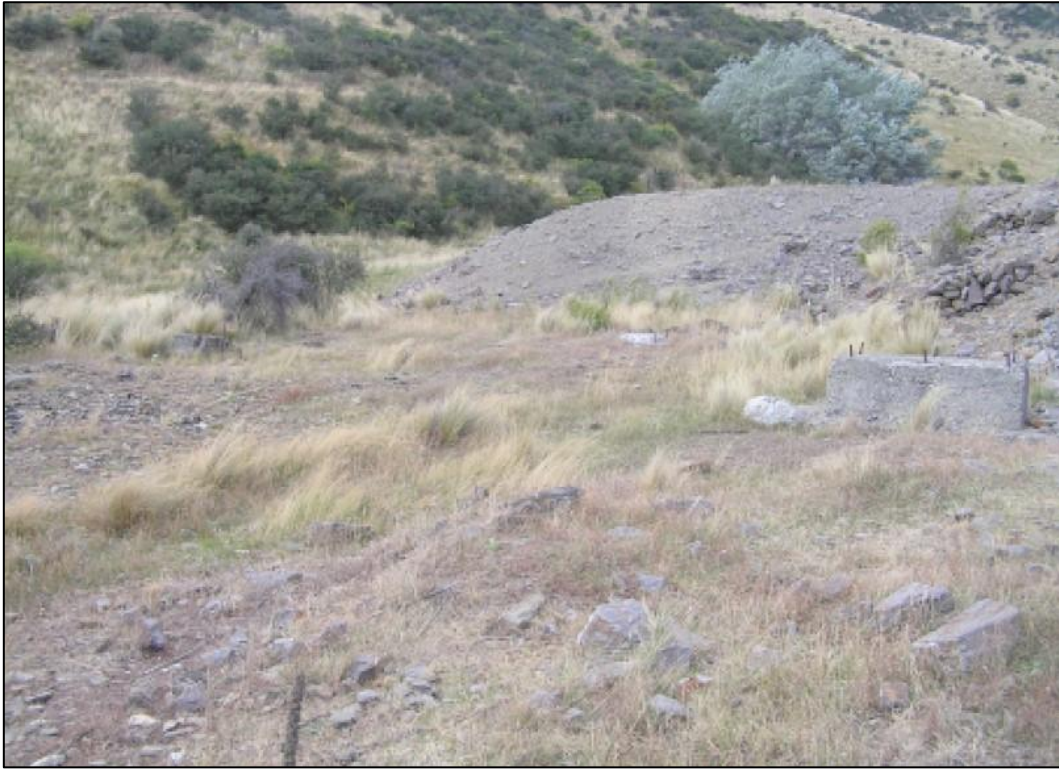
Figure 6-22. Looking east over G41/277 in 2005, with water race G41/586 visible at top left (Nichol & Wright, 2006).

The roadway recorded may be the southeast extent of the Eureka tramway visible in SO 2086. The northwest extent of the tramway is recorded as part of the Eureka mine and battery (G41/252 – outside the current project area). Hamel (1993) identified the tramway or roadway near the mine and battery yet it is not shown in her plan of the site (Figure 6-19). However, her plan does show the water race (G41/586) that runs above the roadway further downstream. Hamel (1993) noted a number of drives between, and another revetted platform behind, the machine foundations. Further adits and sluice faces were added to the SRF by Nichol and Wright in 2005 (Nichol & Wright, 2006), and the site photographed (Figure 6-21 and Figure 6-22).

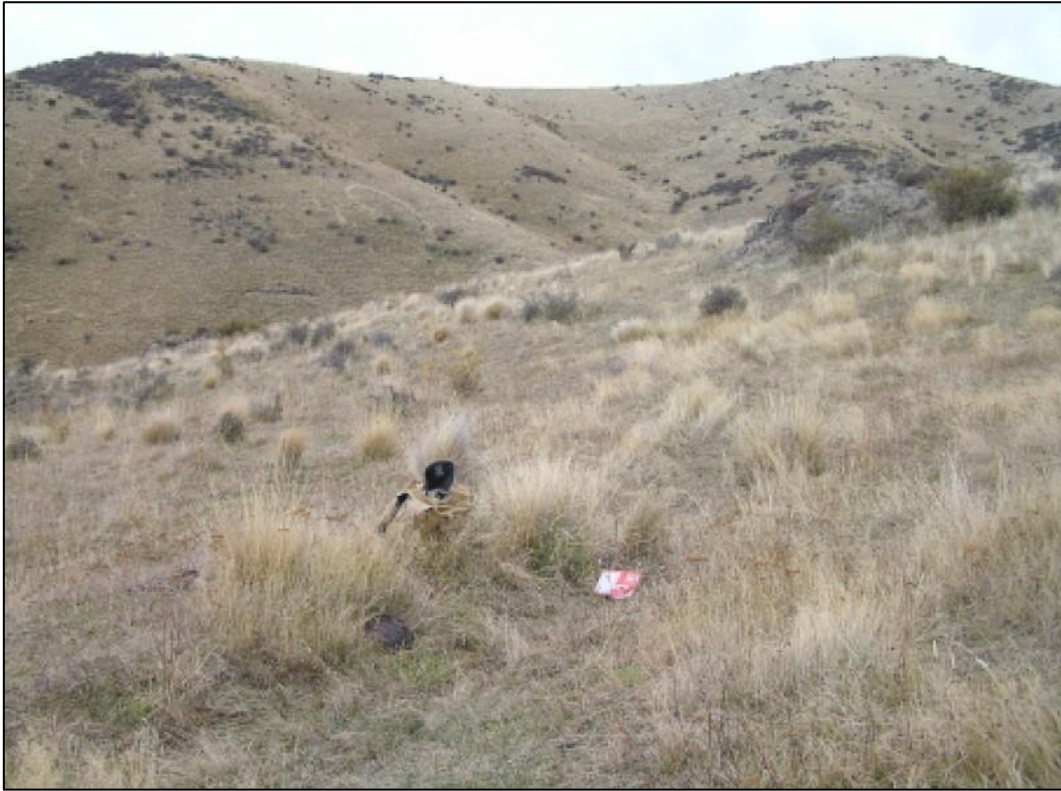
Figure 6-23. Section of G41/584 in 2005, with notebook in ditch and backpack on bank (Nichol & Wright, 2006).

The Rise and Shine water race, completed in 1865 by the Rise and Shine Syndicate, was first recorded in 2005 by Nichol and Wright (2006). They recorded the lower north-western extent of the water race on the hillsides southwest of the Rise and Shine Creek (Figure 6-23 and Figure 6-24). Briden and Schmidt (2012) revisited the site in 2011 and recorded the upper southern portion of the water race around Mount Moka, and Carpenter photographed the upper portion of the race in 2012. The full extent of the Rise and Shine Water Race is over 10km in length.

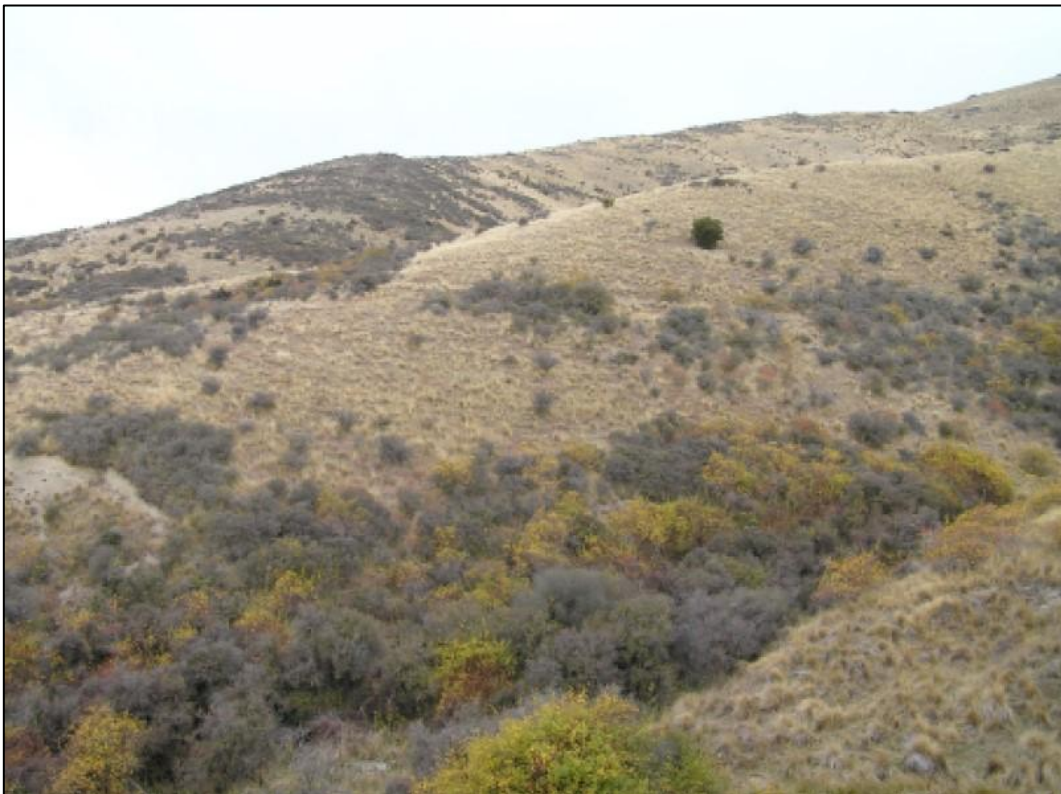
Figure 6-24. View of G41/584 on far side of valley in 2005 (Nichol & Wright, 2006).

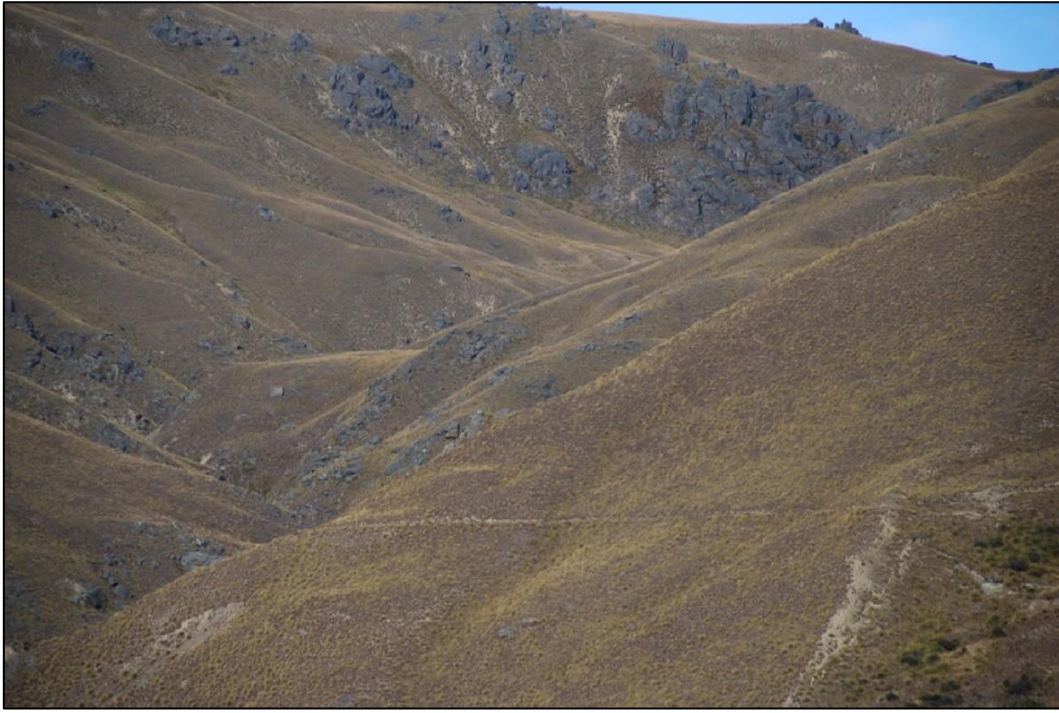
Figure 6-25. Site G41/584, close to Thompsons Saddle (Carpenter, 2012).

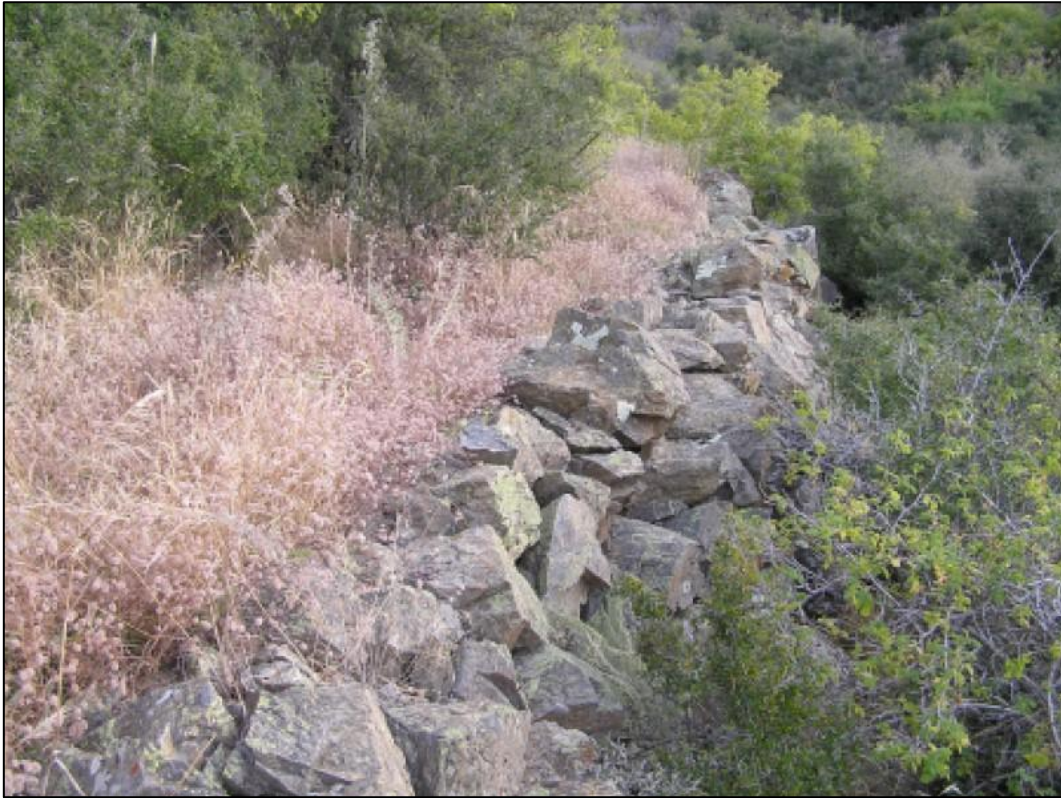
Figure 6-26. Site G41/589 in 2005 (Nichol & Wright, 2006).

Site G41/589 is a revetted path (Figure 6-26) first recorded by Nichol and Wright in 2005. The path passes on the north side of Clearwater Creek, measured approximately 2m wide and was heavily overgrown in parts (Nichol & Wright, 2006).

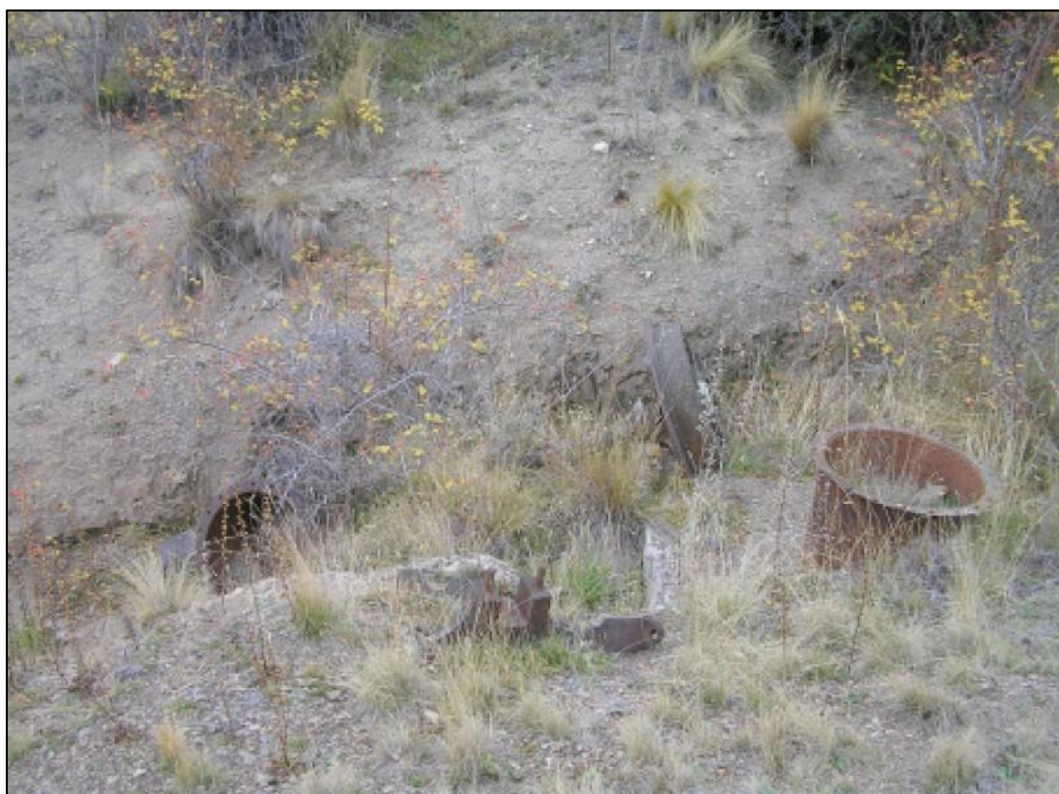
Figure 6-28. Potential turbine remains at site G41/604 in 2005 (Nichol & Wright, 2006).

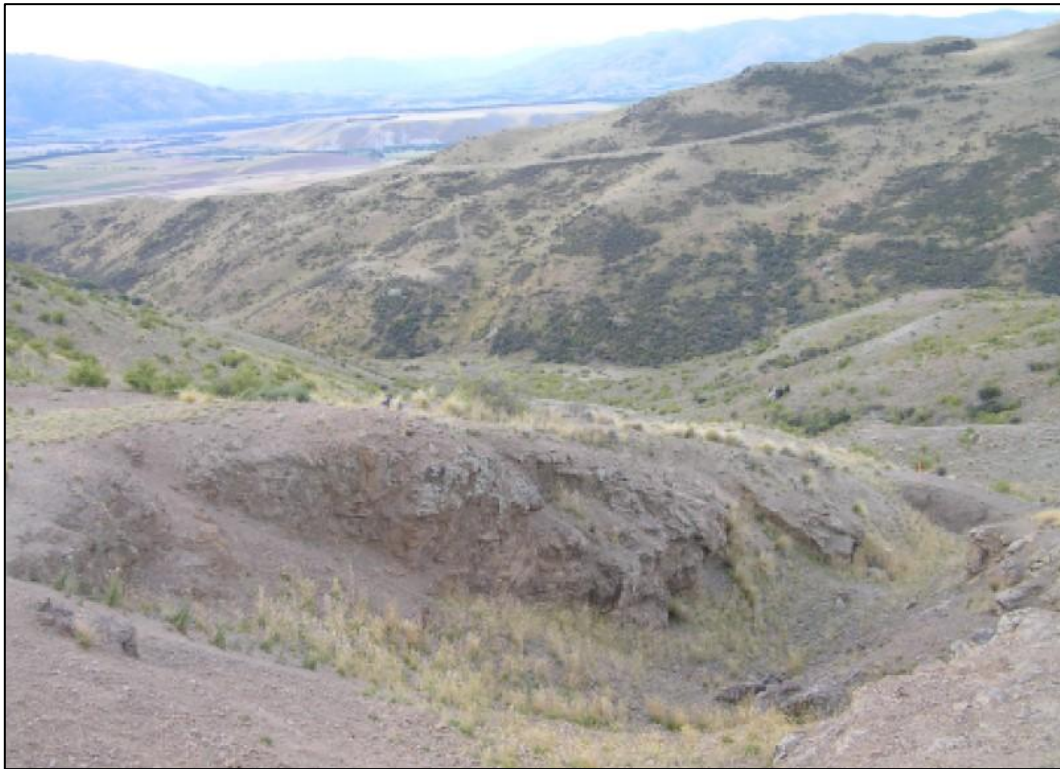
Figure 6-29. Looking north over site G41/605 in 2005 (Nichol & Wright, 2006).

Site G41/605 is a mining complex first recorded by Hamel in 1990 but first recorded on ArchSite by Nichol and Wright in 2005. Hamel (1993) recorded it as one of four drives in the Red Mine area, likely used by the Cameron Brothers in the 1910s, but did not go into detail regarding the features within other than suggesting it was merely a prospecting drive based on its small size. Nichol and Wright (2006) recorded a range of features, including a large

trench, two shafts, an adit, an area of possible sluicing and various metal items on the surface or partially buried (note: in their report the site is described as G41/597; Figure 6-29).

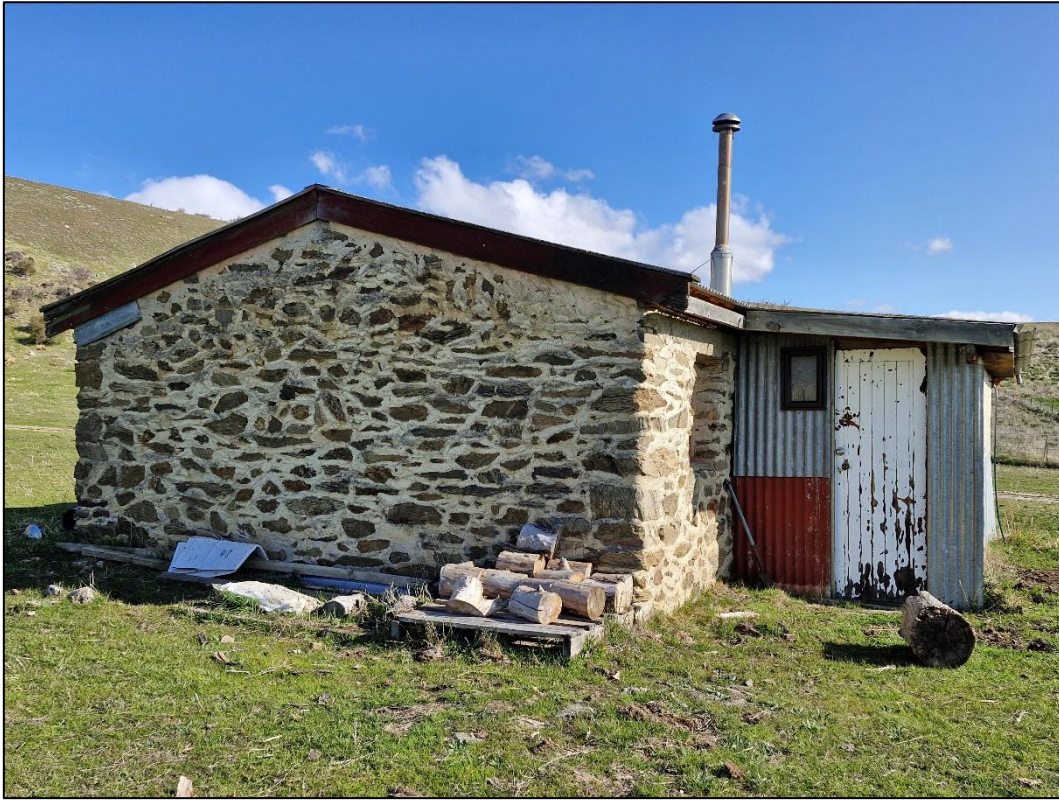
Figure 7-13. Site G41/4 in 2024, looking east.

Site G41/4 is known to locals as Rabbitier's Hut, though it was originally built as a shepherd's cottage in the mid-nineteenth century. This hut was visited in 2024 and has been modified since it was last described by Hamel (1993). Though we do not have previous photographs of this hut, the footprint can be seen to have been extended when compared with Hamel's sketch plan (Figure 6-3), with a corrugated iron lean-to added on the south elevation (Figure 7-13 and Figure 7-14). The glazing has been replaced as well as potentially the roof, the chimney brought down to roof level, and a modern flue installed. These modifications have altered heritage fabric; however, they have preserved the hut as a functioning building, one that is still in use by farm staff today.

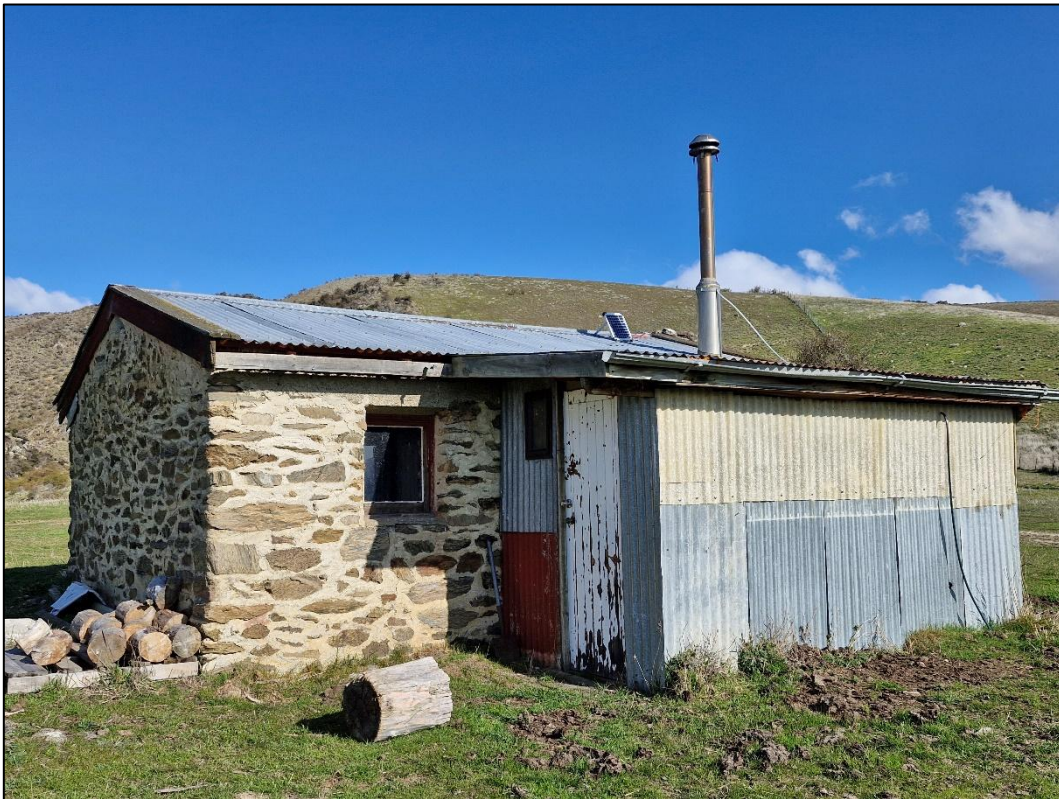
Figure 7-14. Site G41/4 in 2024, looking north.

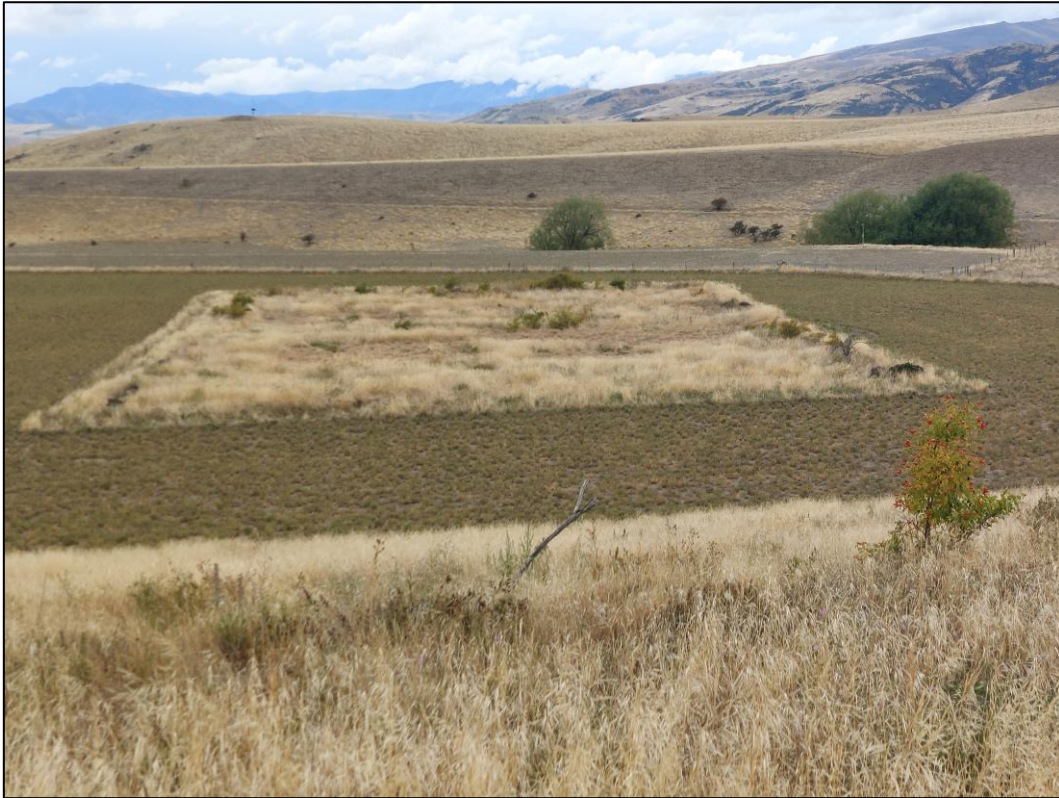
in good condition. All the features previously described by Hamel were easily identified and the walls are intact. In March 2025 long grass covered the site.

Figure 7-16. Looking southeast at Site G41/5, March 2025.

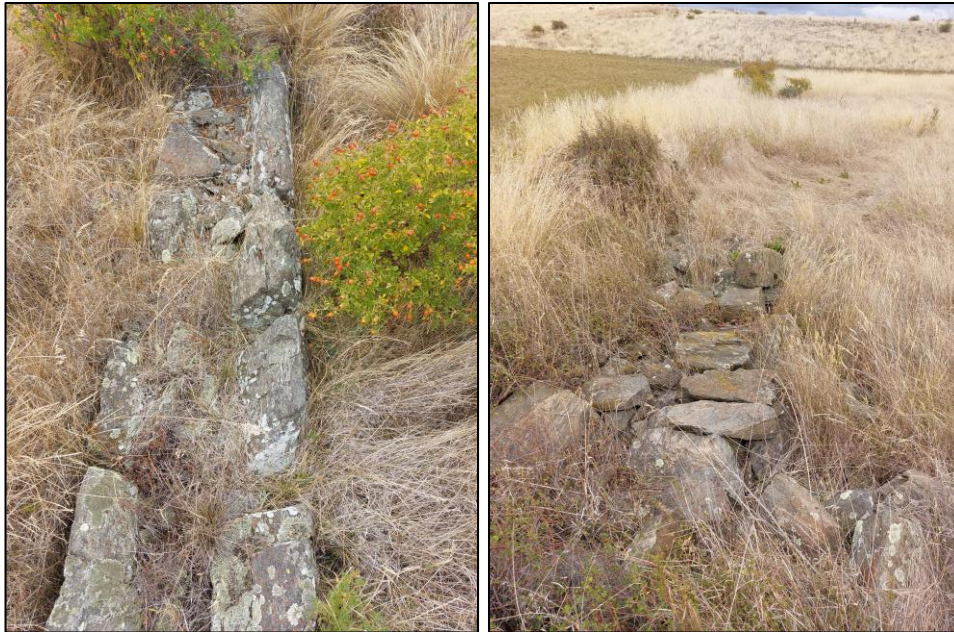
Figure 7-17. Details of stone walls at site G41/5, March 2025.

Site G41/5 was visited during the April and December 2024 surveys, with additional photographs taken in March 2025 (Figure 7-16 and Figure 7-17). The site is bounded by a modern post and wire fence to keep stock out and is

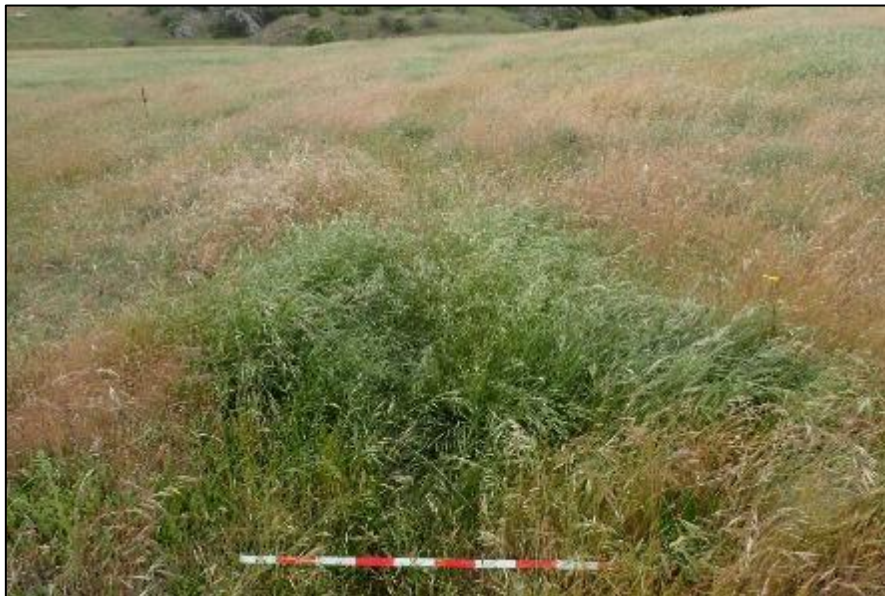
Figure 7-19. Photograph showing the G41/6 water race, looking east towards the project area.

Previously recorded site G41/6 (Figure 7-18 and Figure 7-19) is a water race that was located and recorded as POI 206 on April/May 2024 and again as POI 108 in December 2024. This race extended outside of the project area to the northwest and seemed to disappear where it has been disturbed by the modern road at the southern extent of the project area. Where visible, the race was 800mm-1m wide and 500-800mm high. The race is approximately 1055m long.

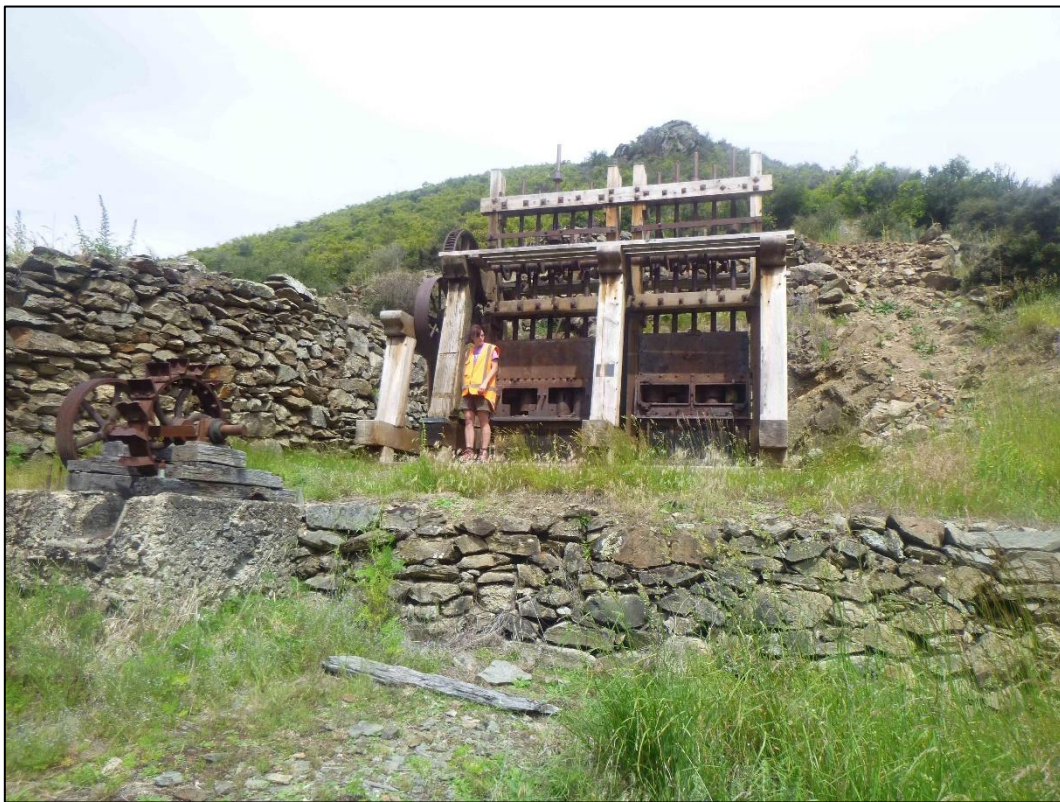
Figure 7-21 Photograph looking southeast at the Come-in-Time battery recorded as G41/251. Phoebe Scrivener is shown in front of the battery.

Site G41/251 is the Come-in-Time battery and surrounding features in use between 1880 and the early 1900s (Figure 6-4 and Figure 7-21). The current battery at the site was installed in the early twentieth century and was restored in 2005. It is enveloped by three stone walls, to which two stone tracks lead. The restoration included, removal of rotting timbers, partial reconstruction of a collapsed stone wall (the northern wall around the battery), and a pelton wheel was brought onto site to replace the lost original. Approximately 80 m up the gully a mine drive is present which has been dug out horizontally into the hillside. This is the main drive of what was known as the Red Mine (Figure 7-23). A second adit 30 m east of the first, is also recorded, and it is only this feature that sits within the current project area. Some of the schist revetments of the pathways were noted to have partially collapsed during the 2018 survey (Figure 7-24).
