The Bendigo-Ophir Gold Project

A Heritage Assessment

Report Prepared for Matakani Gold Ltd
Author: Dr Naomi Woods and Claire Thorrold
Reviewed by: Dawn Cropper and Megan Lawrence

Prepared by New Zealand Heritage Properties Ltd

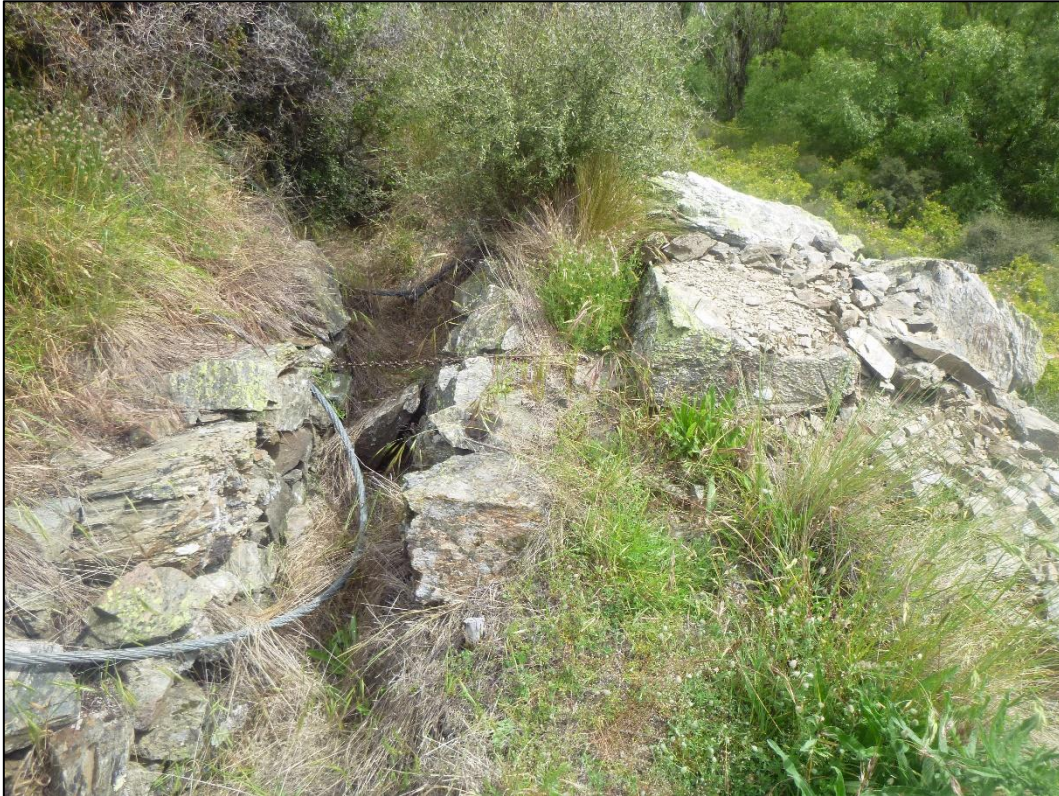
Figure 7-22 Photograph looking southwest at the schist channelling at the end of the Come-in-Time water race recorded as part of G41/251.

Site G41/251 is the Come-in-Time battery and surrounding features in use between 1880 and the early 1900s (Figure 6-4 and Figure 7-21). The current battery at the site was installed in the early twentieth century and was restored in 2005. It is enveloped by three stone walls, to which two stone tracks lead. The restoration included, removal of rotting timbers, partial reconstruction of a collapsed stone wall (the northern wall around the battery), and a pelton wheel was brought onto site to replace the lost original. Approximately 80 m up the gully a mine drive is present which has been dug out horizontally into the hillside. This is the main drive of what was known as the Red Mine (Figure 7-23). A second adit 30 m east of the first, is also recorded, and it is only this feature that sits within the current project area. Some of the schist revetments of the pathways were noted to have partially collapsed during the 2018 survey (Figure 7-24).

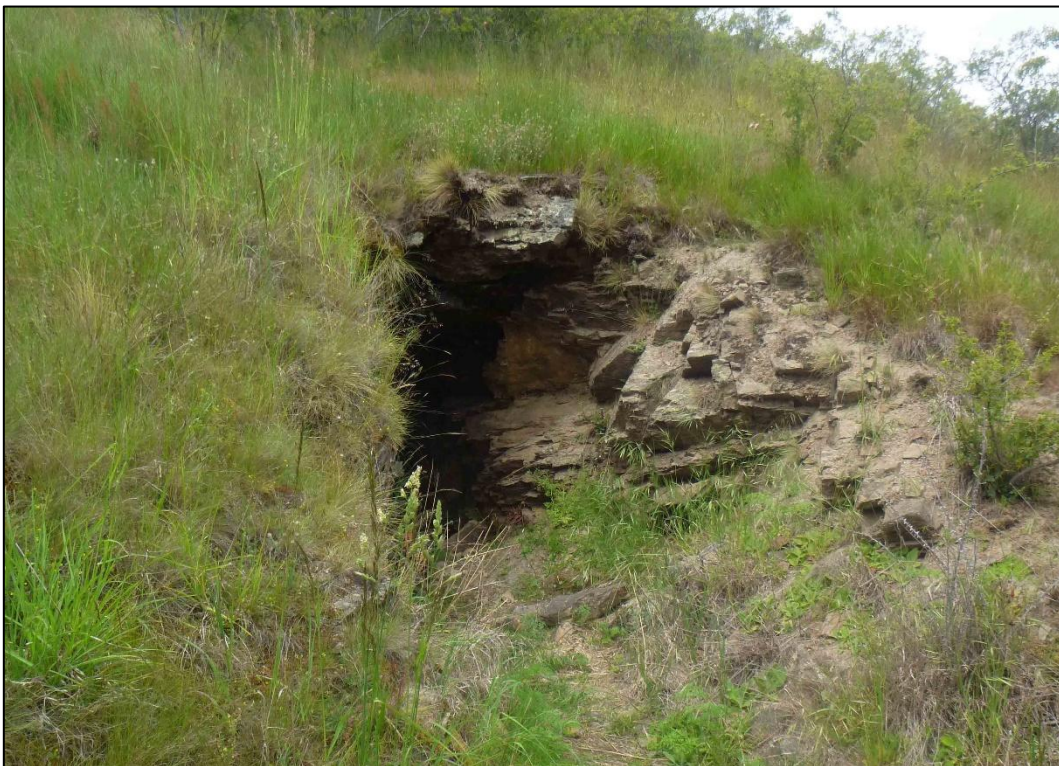
Figure 7-23 Photograph looking north at the main adit of the Red Mine recorded as part of G41/251.

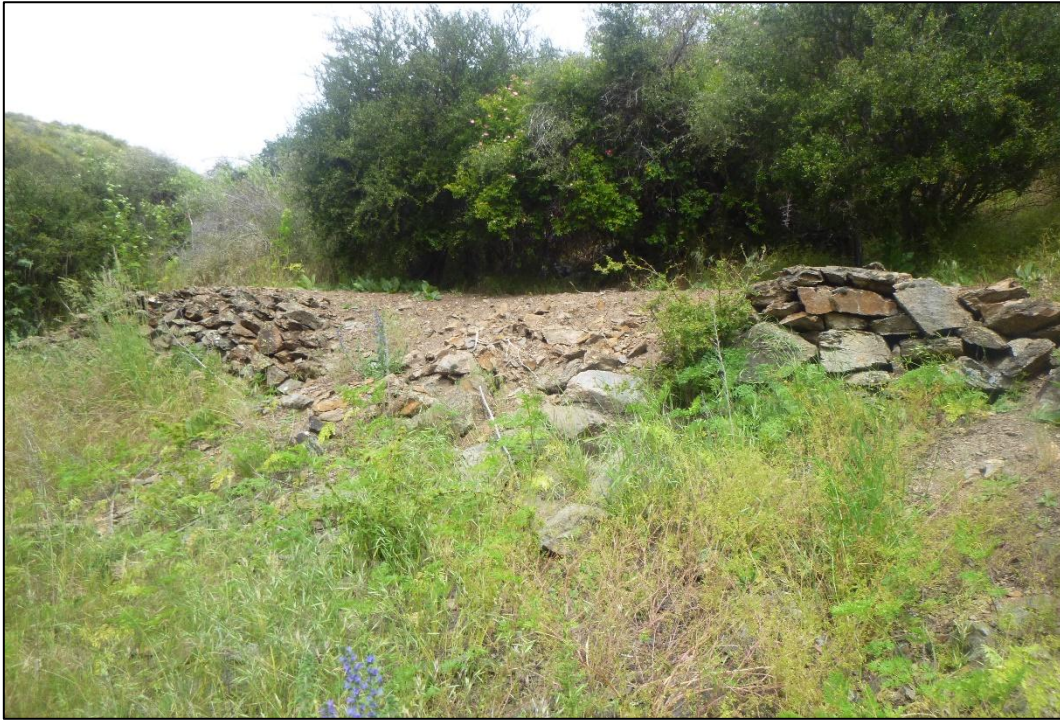
Figure 7-24 Photograph looking north at the partially collapsed stone revetment recorded as part of G41/251.

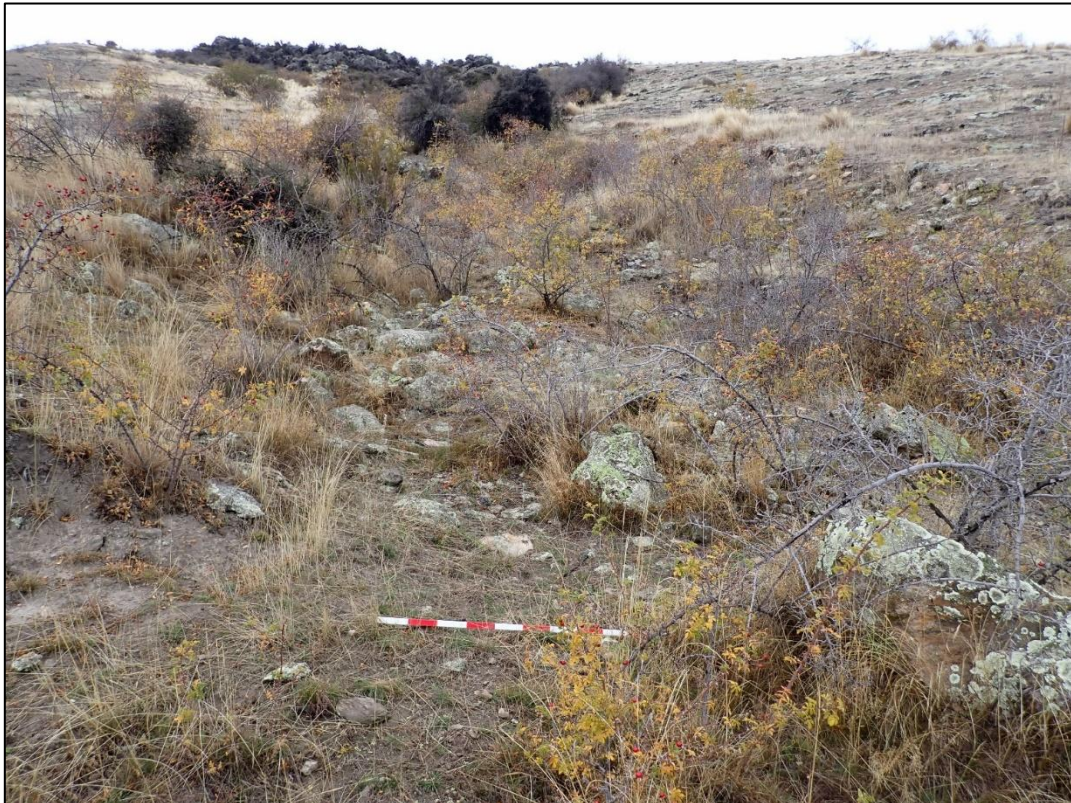
Figure 7-26. Photograph showing the tailing mound, looking southeast (NZHP, 2024).

Tailings mounds and sluice face from this site were identified in the creek bed heading northwest down the hillside during the April-May 2024 survey (Figure 7-26, Figure 7-27). The site is located approximately 75m southeast of the farmer's track of Thomson Gorge Road. The tailings mound was approximately 7m long and 2m wide, rising up approximately 1.5m from the creek bed floor. The tailings mound is partially obscured by vegetation, with the mound potentially continuing further southeast up the creek bed. The tailings are in good condition; however, the original site record also includes an earth dam which was not visible on the ground. The sluice face identified was approximately 6m wide and 2m long (Figure 7-28). The dam and obvious areas of sluicing are, however, clearly visible in the LiDAR imagery and the site extent has been updated based on a combination of pedestrian survey and LiDAR results.

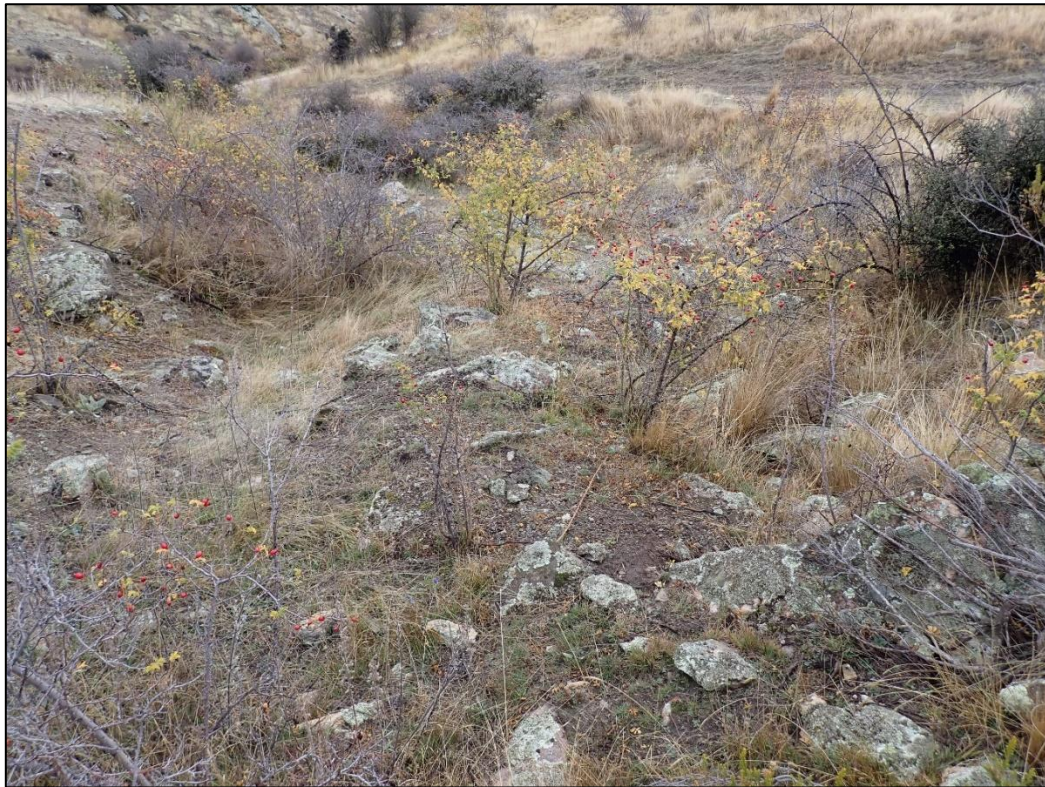
Figure 7-27. Photograph showing the tailing mound, looking northwest with the farmers track in the background (NZHP, 2024).

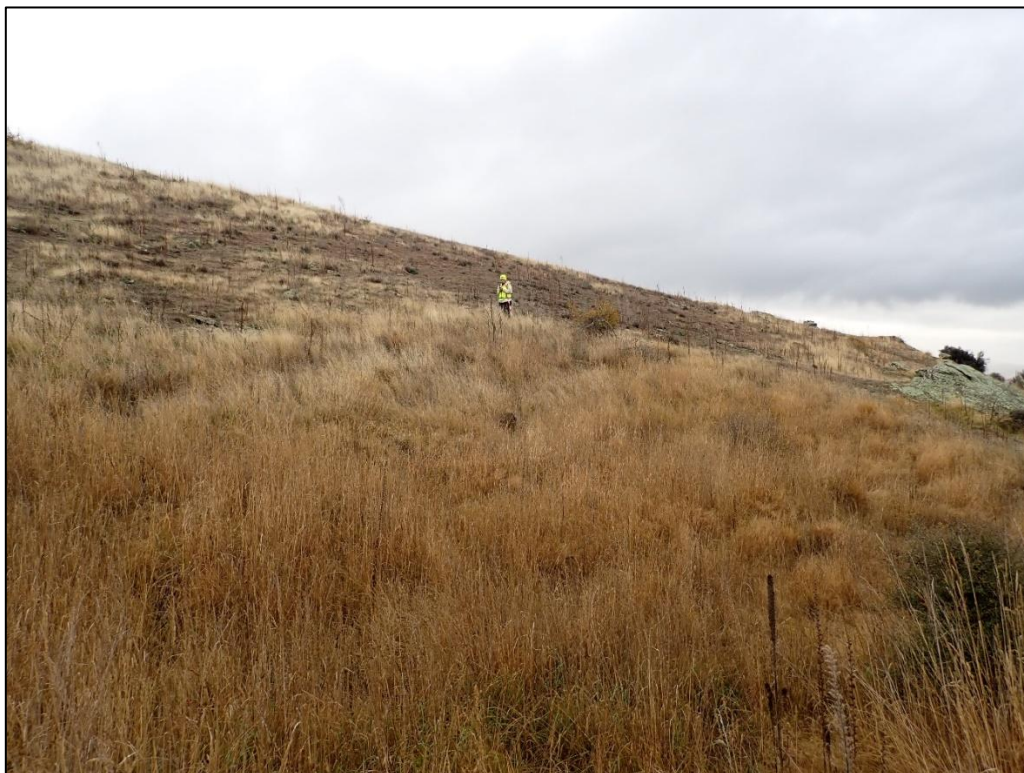
Figure 7-28. Photograph of the possible sluice face, looking west (NZHP, 2024).

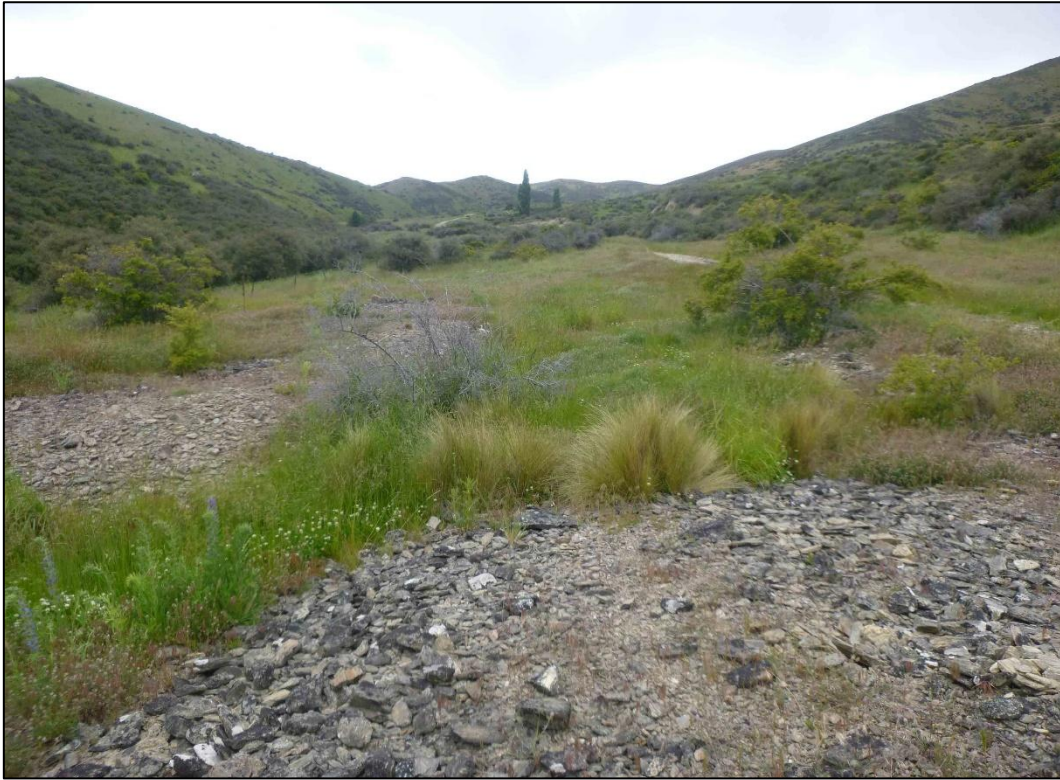
Figure 7-30 Photograph looking southeast at the tailings recorded as part of G41/264.

of the site include small tailings mounds scattered across the alluvial flats, some with revetted channelling and sluicing in the gullies run down towards the creek. Later additions to the SRF by Nichol and Wright (2006) included two dams, barrel hoops, a collapsed adit, tailings and sluicing areas. There have been modern mining works undertaken throughout this site including root raking, drill holes, trenching and pitting from the mid-1980s through into the twentieth century. These works have likely modified and damaged the site. In spite of this, given the extensive covering of the site, many features remain intact. The site was revisited during the 2017 and 2018 surveys and additional tailings associated with the site were identified (Figure 7-30). These tailings were located along the valley floor, immediately north of Thomson Gorge Road, spread over an area of 160m (POI 180, 257 and 258). Further aeriels and LiDAR imagery show that the site and sluicing areas extends further up the hills of the valley as shown in Hamel's (1993) plans (Figure 6-7 and Figure 6-8), with tailings identified on the ground on these slopes during the December 2018 survey.

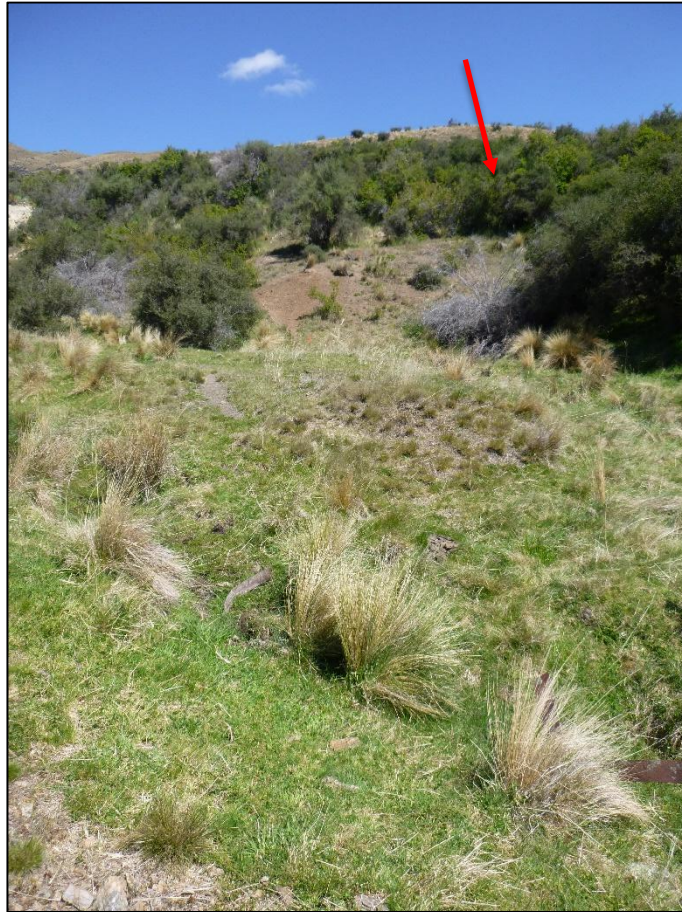
Figure 7-32. Looking south towards sites G41/266 and G41/267, with their approximate locations indicated by the red arrows.

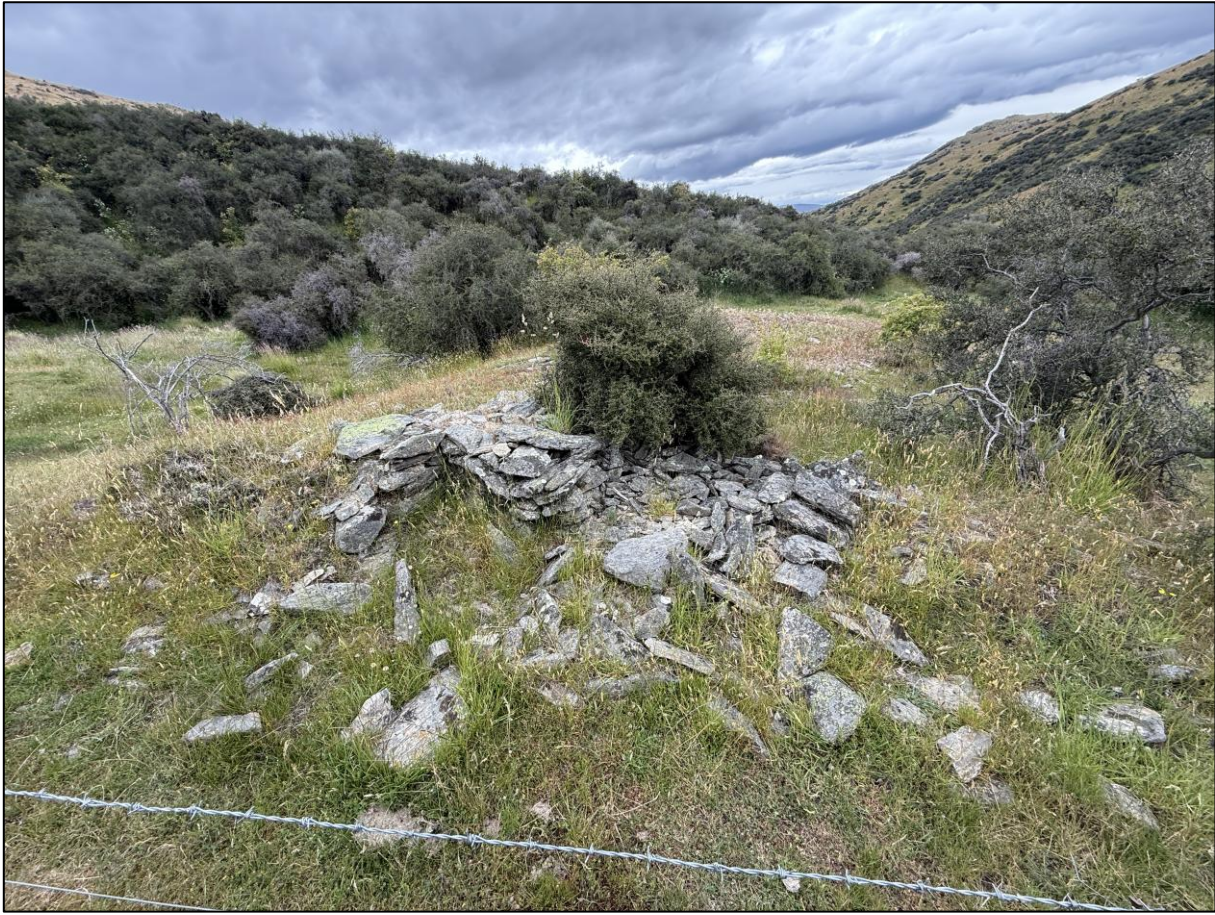
Figure 7-34. Site G41/265 looking northwest. Note modern fence in foreground.

Three previously recorded stone huts (G41/265, 266 and 267) sit within the extent of gold mining complex G41/264 and were revisited during the February 2018 survey and during a 2025 site visit with HNZPT. The location data, description and condition were found to be consistent with the SRFs for each site as recorded in 2005. Dense matagouri and briar rose made photographing sites G41/266 and G41/267 difficult (Figure 7-32), and a modern access track passed close to each; however, they remain in the conditions as described in their SRFs and as shown in Hamel's 1990 photograph (Figure 6-12). Site G41/265 (Figure 7-33 and Figure 7-34) was modified by the installation of the early 1980s fence line as described in the 2005 SRF, but no further damage was noted. This hut is visible on historic aerials and the 2018 LiDAR imagery (Figure 7-35). The other two huts are less obvious, but vague surface anomalies are present in their recorded locations (Figure 7-36 and Figure 7-37).

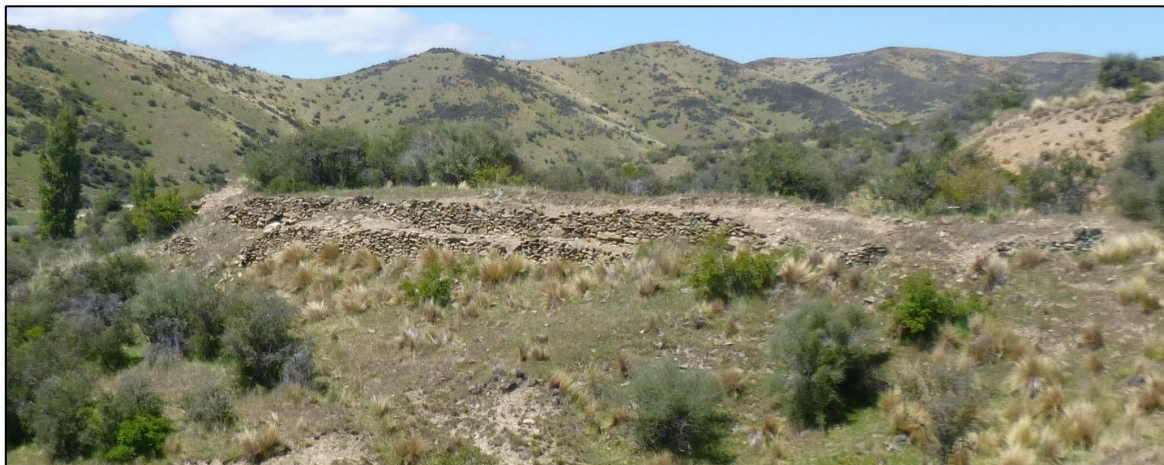
Figure 7-38. Looking south at G41/269, November 2017.

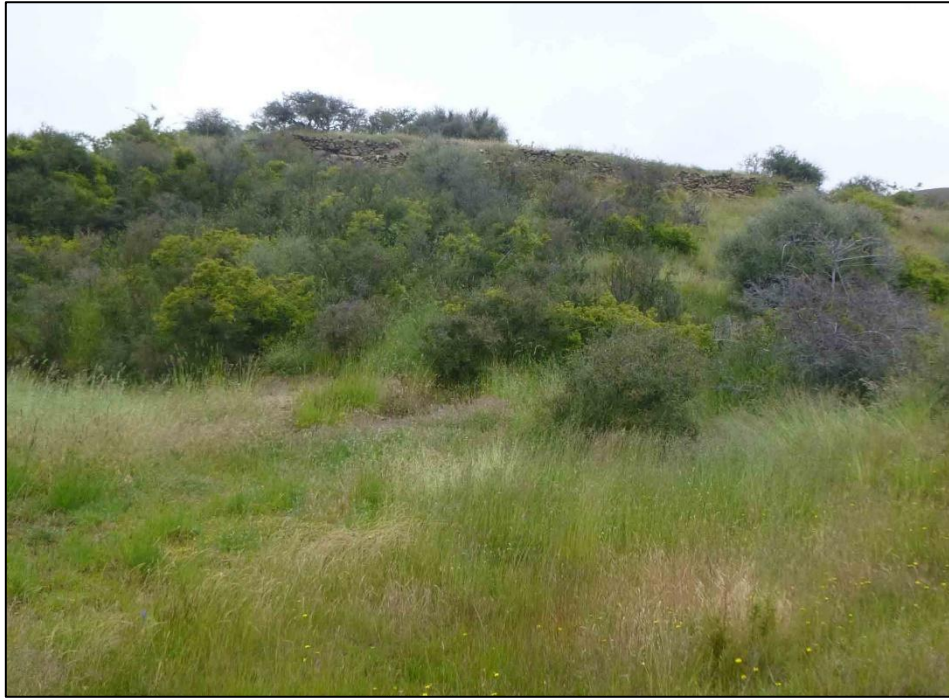
Figure 7-39. Photograph looking south at the stone revetted bank of the dam recorded as G41/269, taken December 2018.

The dam recorded as G41/269 (Figure 7-38 and Figure 7-39) was revisited during the November 2017 and both 2018 surveys and during a 2025 site visit with HNZPT. The stone revetted dam face was in good condition and the site was as described in the SRF (Figure 6-16). The dam is clearly visible in 1950s aerials and LiDAR imagery as shown in Figure 7-39.

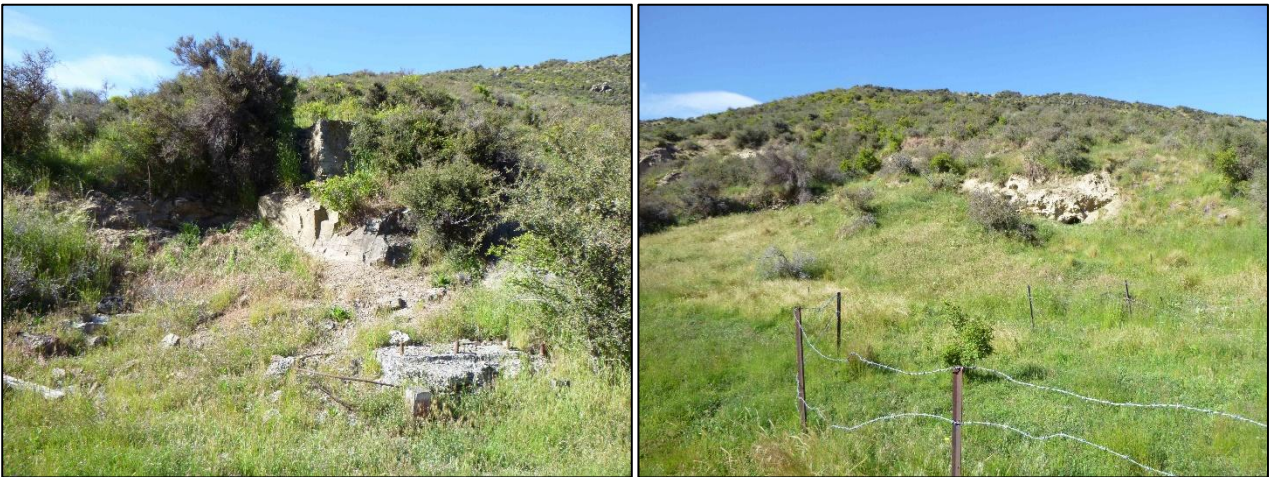
Figure 7-44 Photographs looking southwest at mine recorded as G41/277. Photographs show concrete machine foundations, adit, stone faced dam and sluice face.

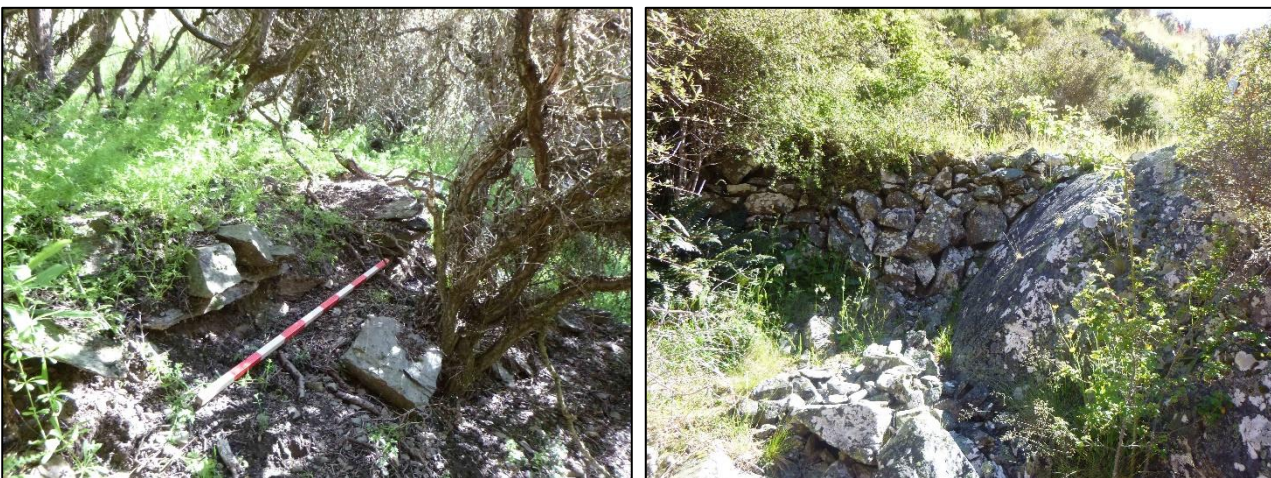
Figure 7-45 Photographs looking northwest (left) and north (right) of revetted tramway recorded as part of G41/277.

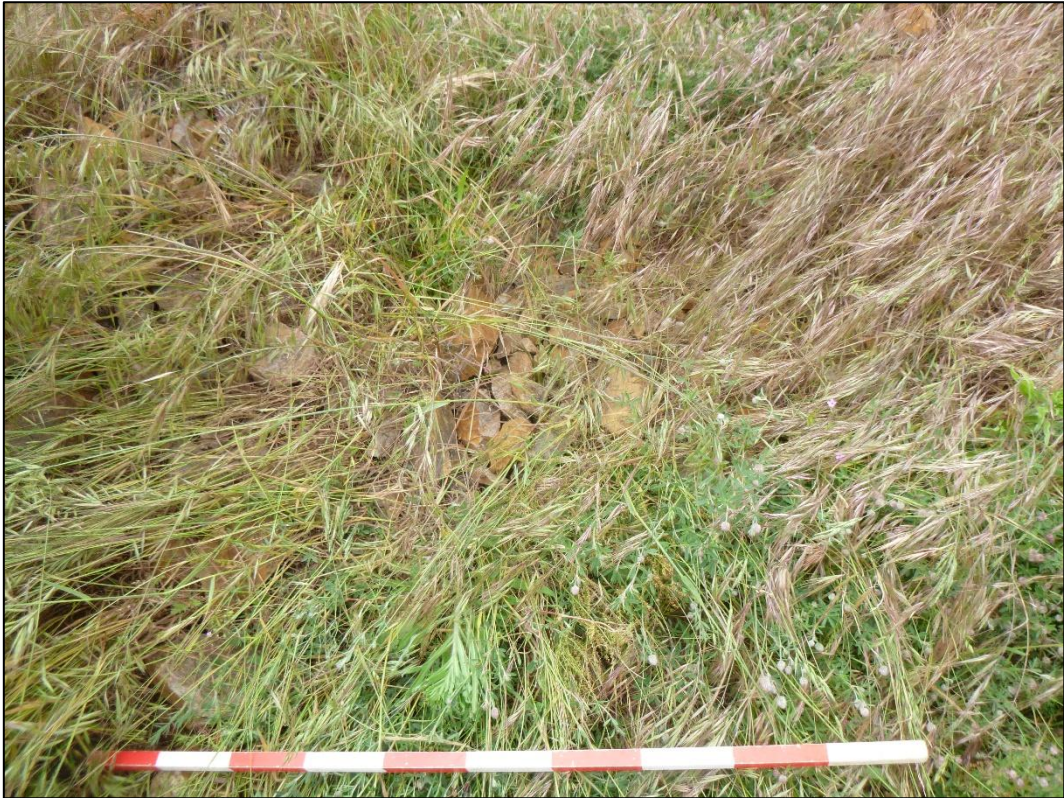
Figure 7-50 Photograph showing tailings on the slope above the Rise and Shine Creek.

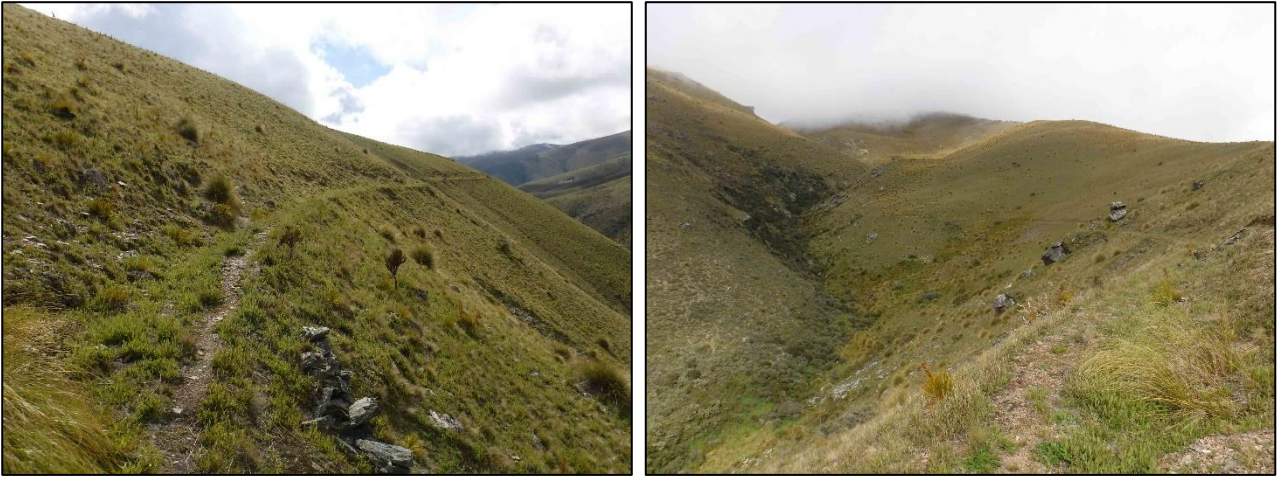
Figure 7-52 Photograph looking southeast (left) and northwest (right) at the upper extent of the water race recorded as G41/584.

Two sections of the site were revisited during the surveys. The race appeared in good condition around Mount Moka (outside of the current project area), where it is presently covered in low grass and tussock (Figure 7-52). This portion of the race is visible in survey plan SO 1204, dating to 1909 (Figure 5-14). Once over the Thomsons Saddle the race has been damaged, likely through erosion, stock trampling, vegetation growth and the formation of Thomson Gorge Road and the access road to the top of Mount Moka. However, the LiDAR images show the race dropping towards a valley which would have directed the water to the Rise and Shine Creek (Figure 7-53).

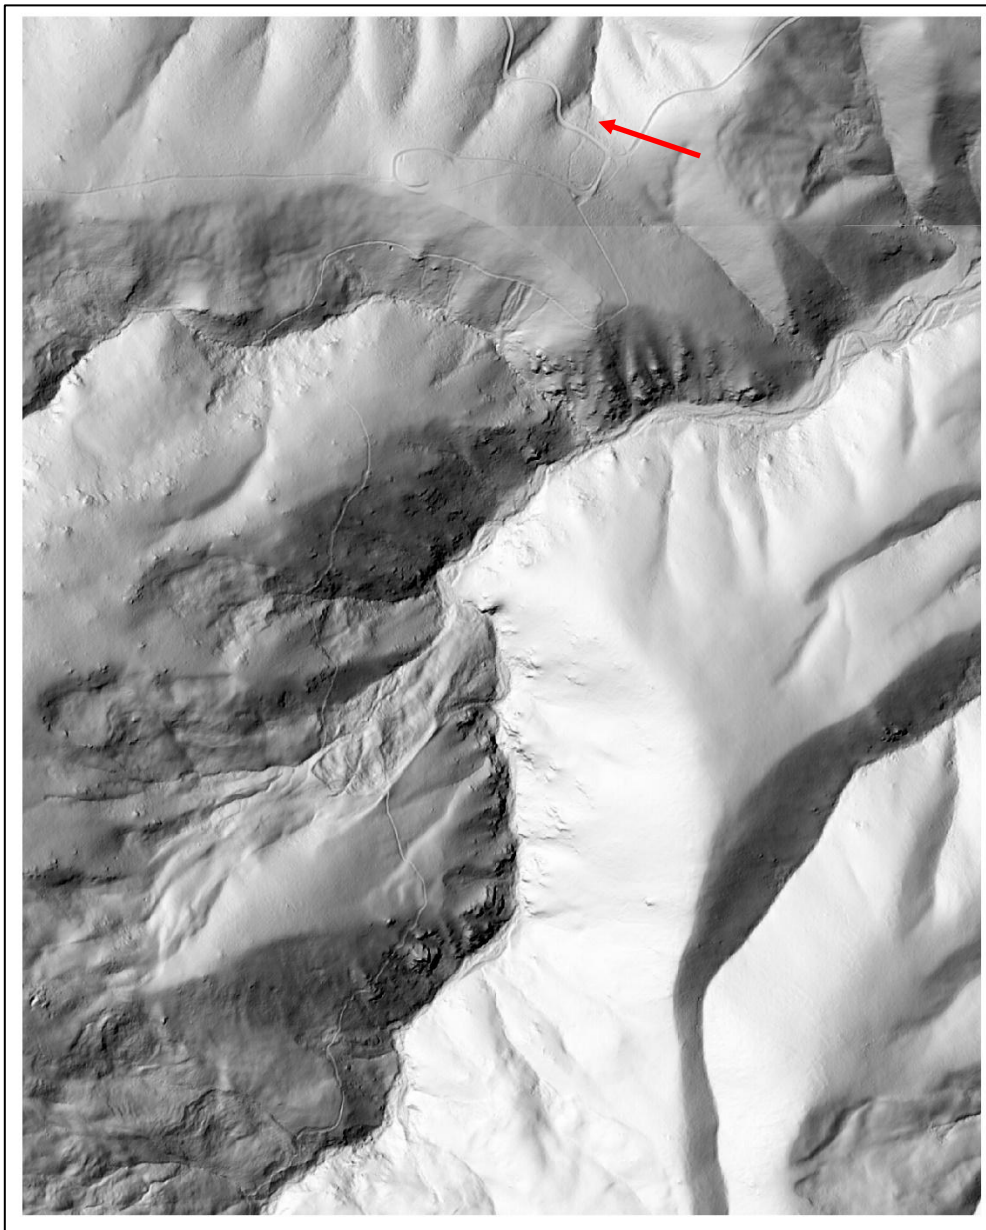
Figure 7-53. LiDAR image showing the end of the G41/584. At the top of the image the race travels around Mt Moka. The arrow shows the race dropping towards the Rise and Shine Creek.

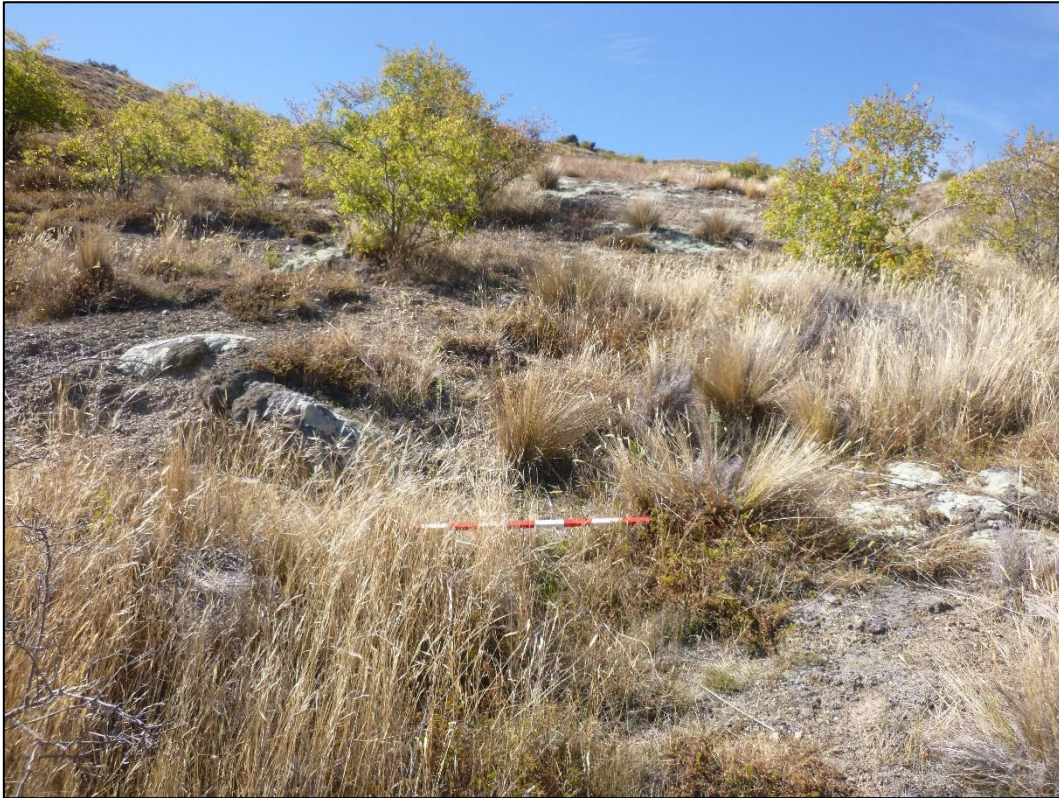
Figure 7-54. Rise and Shine water race (G41/584) within the project area, looking southeast, February 2018.

The lower section of the race recorded by Nichol and Wright (2006) was followed further east, and it extended approximately 80m further than initially recorded, extending into the current project area. The race was heavily overgrown yet, unlike the extent around Mt Moka, this section of the race still had a noticeable channel (Figure 7-54). The full extent of the race identified by Nichol and Wright (2006) was not walked over; however, it is visible in aerial photographs and LiDAR of the area. Certain sections of the race run through modern root rake areas. While there was likely some damage to the site as a result of this work, LiDAR imagery still shows the race largely intact even when running through root rake areas.

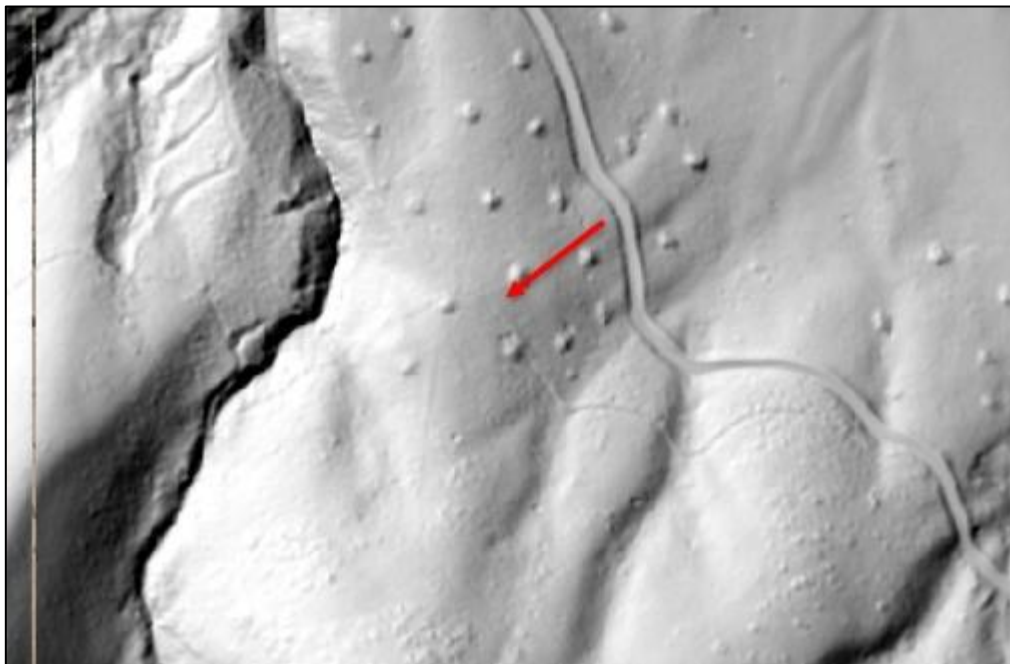
Figure 7-55. LiDAR image showing the part of the lower extent of G41/584 running through modern root rake areas (red arrow).

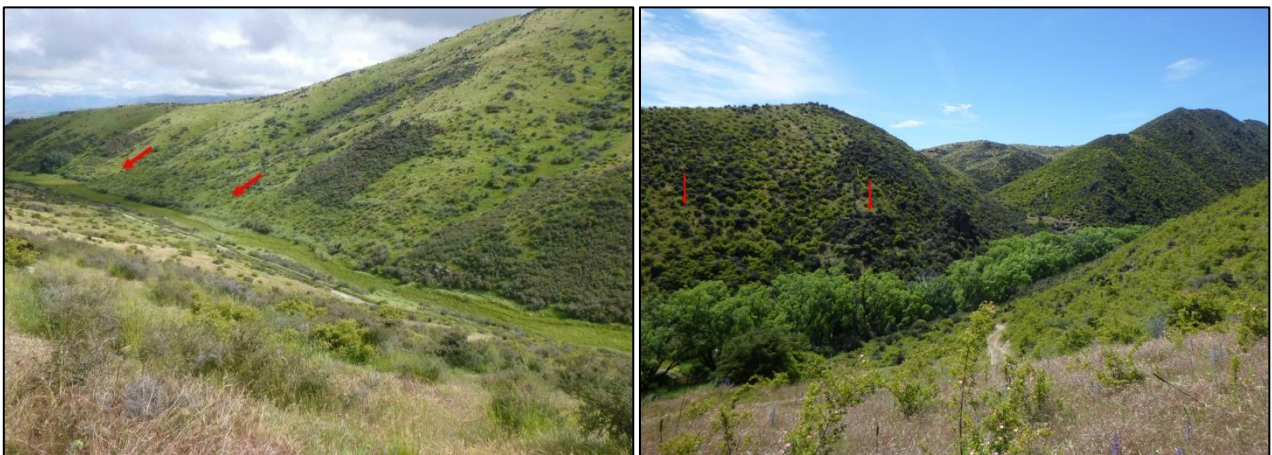
Figure 7-59 Left: photograph looking north at the Come-in-Time water race. Right: photograph looking northeast at the water race. Both photographs taken December 2018.

observations. Modern mining has occurred in and around the water race, in particular late 1980s drill holes along the section leading to Shepherds Creek. While some damage has occurred to this race, the 2018 LiDAR data still shows the race at these locations. The southern extent of the Come-in-Time water race was sighted during the December 2018 survey (Figure 7-59).

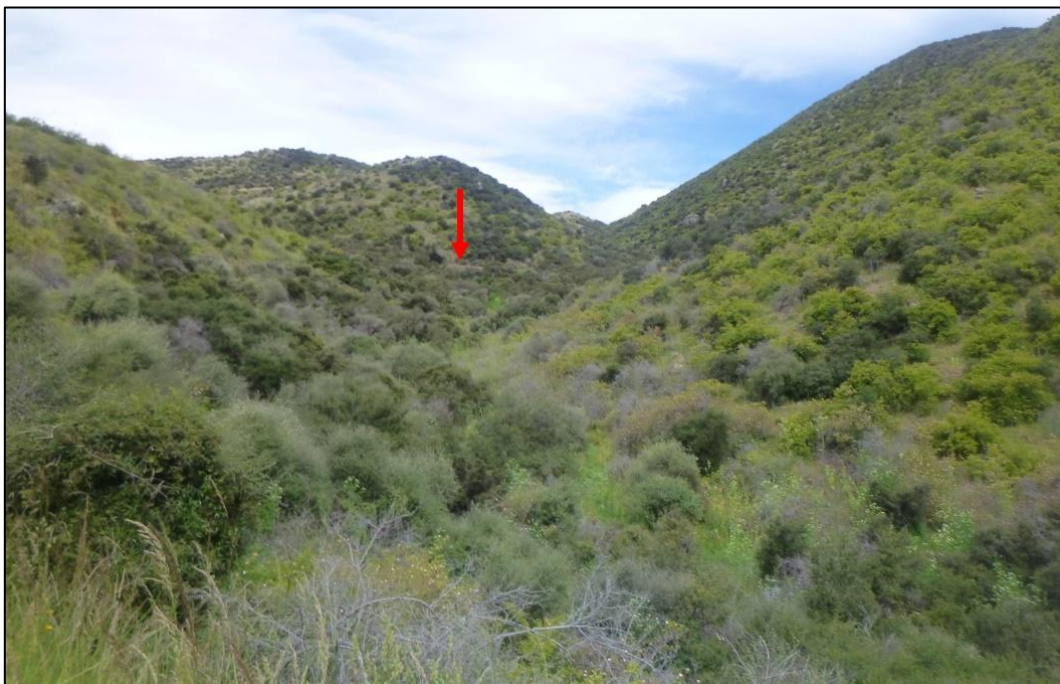
Figure 7-61. Photograph looking northeast at the revetted road recorded as G41/589 (red arrow).

A revetted road (G41/589) ran up behind the Come-in-Time Battery. The road was not revisited during any of the surveys as overgrown vegetation prevented access. However, the road was sighted from the Come-in-Time battery (G41/251) (Figure 7-61) and is visible in 1958 aerial photographs as shown in Figure 7-62. The road is also visible in the 2018 LiDAR data, as is a possible extension to the road heading north that falls within the Come-in-Time pit footprint. This may be a continuation of the road without stone revetments. This extension was not identified by Nichol & Wright (2006) when they recorded the site in 2005. As the extension was not visible in the historic aerial images, nor was it possible to view it during the pedestrian survey due to the vegetation, this has been identified as a point of interest.

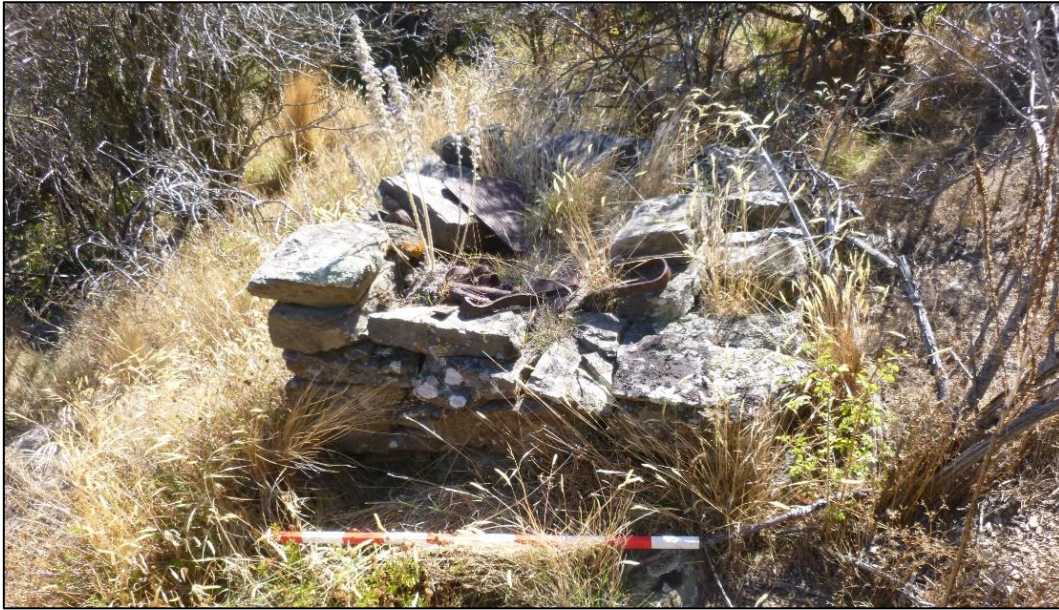
Figure 7-64. Stacked stone chimney or forge remains with metal artefacts on top (G41/604), photographed February 2018.

The turbine and battery (G41/604, Figure 7-64 and Figure 7-65) was revisited, relocated and reported on during the November 2017, February 2018 and December 2018 surveys. Intact features noted at this time included a stacked stone chimney and forge shown in Figure 7-64. Part of the Come-in-Time water race (G41/586) that passes through site G41/604 had been previously modified during construction of a late-twentieth century access route, activity which potentially modified site G41/604 further, but overall, the site was in fair condition.

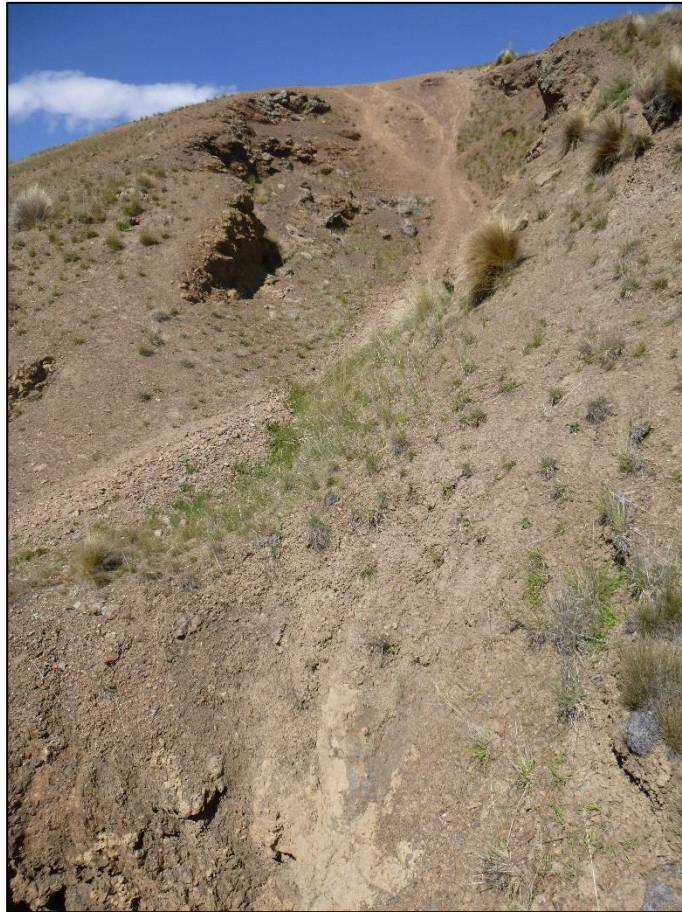
Figure 7-68. Looking southeast at G41/605, towards Thompsons Gorge Road (at top of ridge), showing motorcycle tracks, November 2017.

Site G41/605 was modified during construction of a late-twentieth century access route, and the top of G41/605 has been modified through use by mountain bikes and motorcycles (Figure 7-68), but overall, the site was in fair condition.

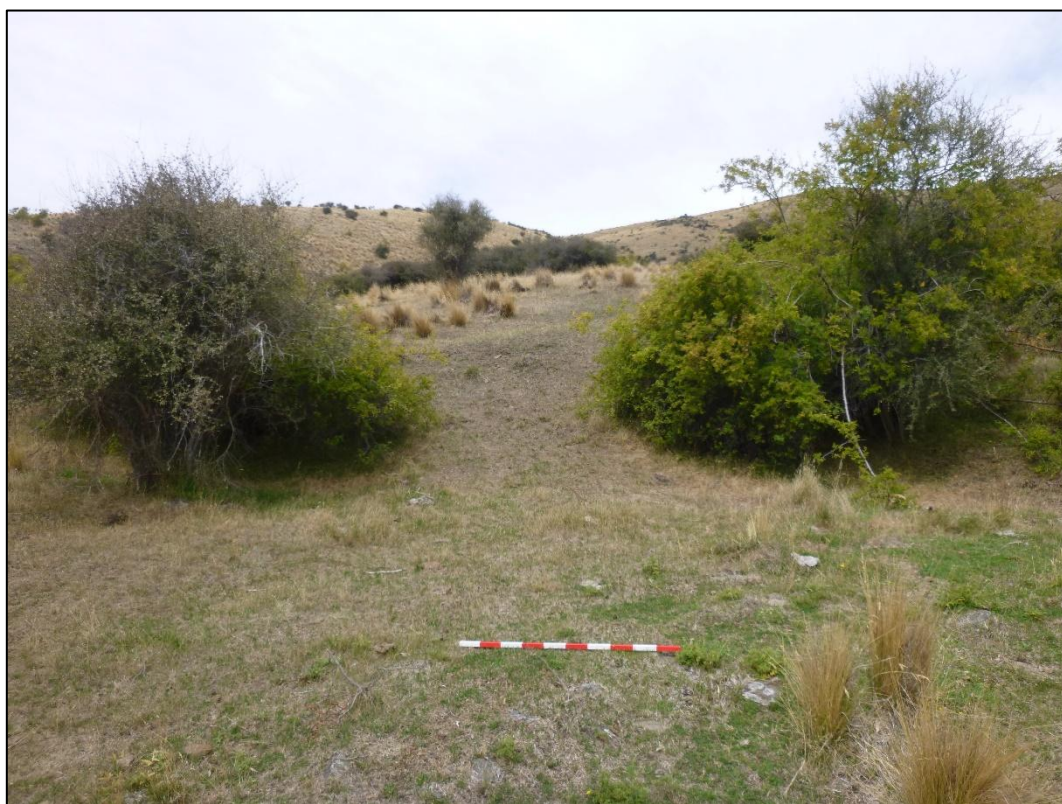
Figure 7-70. G41/658 hut terrace, looking north.

A previously unrecorded hut terrace with potentially associated prospecting pit was identified during the February 2018 survey and was recorded as site G41/658 on ArchSite. An earth bank lined the southwest side of the terrace, thought to have once acted as a wall for a structure as seen elsewhere in the Rise and Shine Valley (e.g., G41/270) which measures approximately 7.5 by 4m and is bordered by introduced rose and oleria bushes (Figure 7-70). Highly fragmented artefacts were noted on the surface, including ceramics, bottle glass and a matchbox, indicative of domestic occupation. A prospecting pit was located approximately 10m downslope from the terrace; however, it is unclear if this is contemporaneous. The terrace, bank and pit were in good condition, and the presence of surface artefacts suggests subsurface remains may be present in the area.

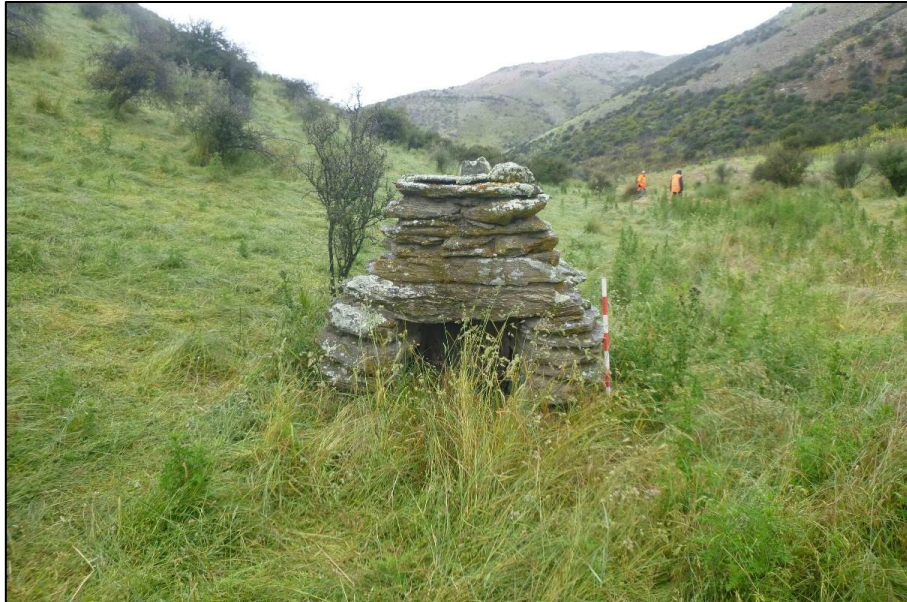
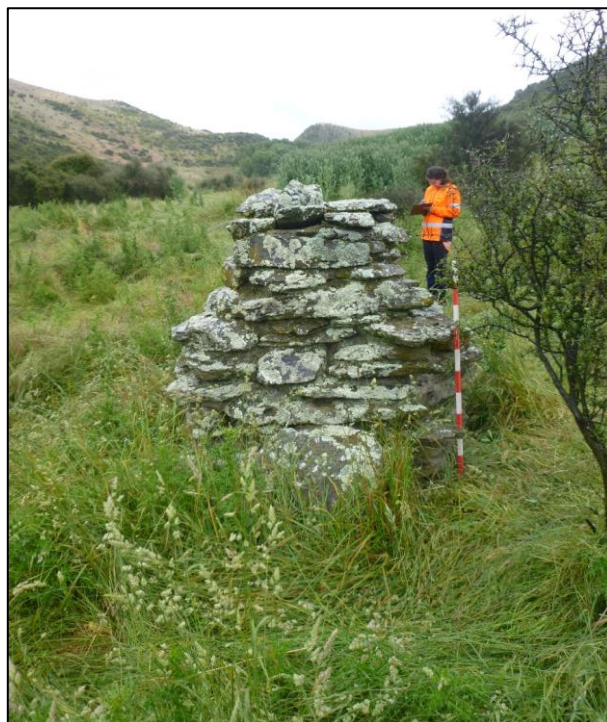
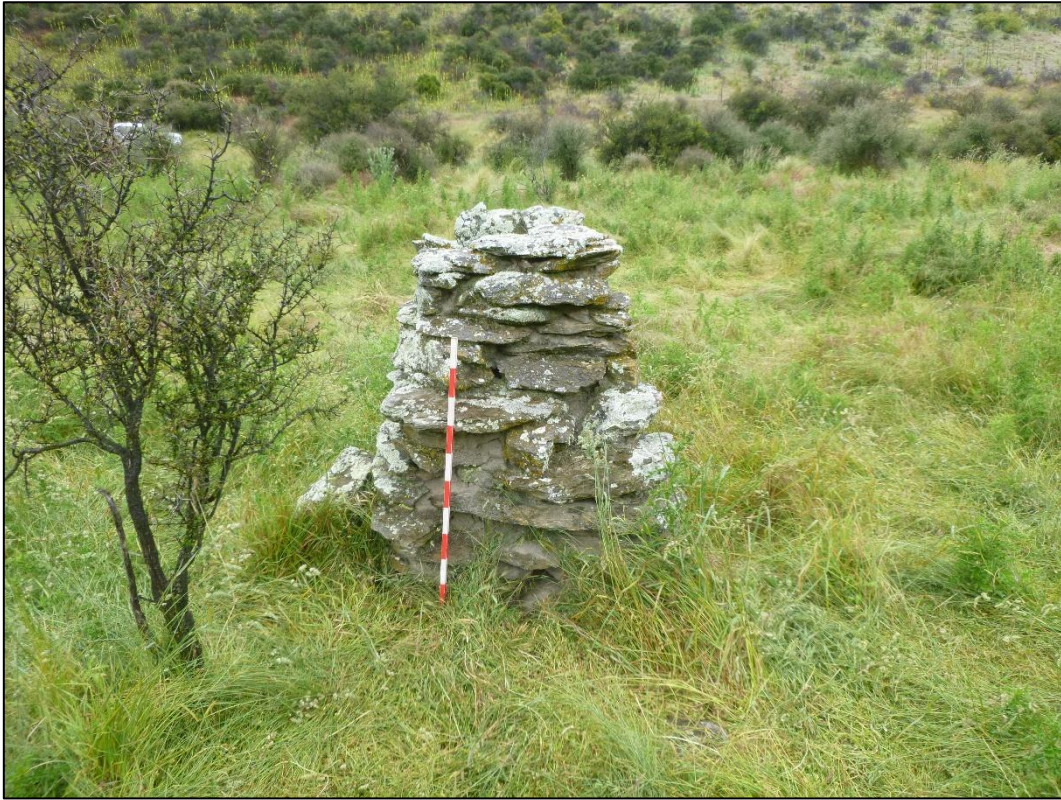
This hut or tent site with a stacked schist chimney was first recorded during the December 2018 survey located 30 m north of Shepherds Creek and was revisited in August 2022. Only the stacked chimney remains visible on the ground surface (Figure 7-71 to Figure 7-73). The chimney measured 1.2 m by 2 m and stood 1.9 m high. There was no obvious hut or tent platform surrounding the chimney. The site was overgrown in grass and no surface artefacts or associated features were identified surrounding the chimney. It is not clear if the site was used by musterers or miners in the area, but the Shepherds Creek valley has a known history of both activities during the nineteenth century (Woods & Thorrold, 2025).

Figure 7-71. Photograph looking southeast at chimney recorded as G41/678, December 2018.

Figure 7-72. Photograph looking northwest at chimney recorded as G41/678. Megan Lawrence is shown in the background of the chimney.

Figure 7-73. Photograph looking southwest at chimney recorded as G41/678.
