The Bendigo-Ophir Gold Project

A Heritage Assessment

Report Prepared for Matakani Gold Ltd
Author: Dr Naomi Woods and Claire Thorrold
Reviewed by: Dawn Cropper and Megan Lawrence

Prepared by New Zealand Heritage Properties Ltd

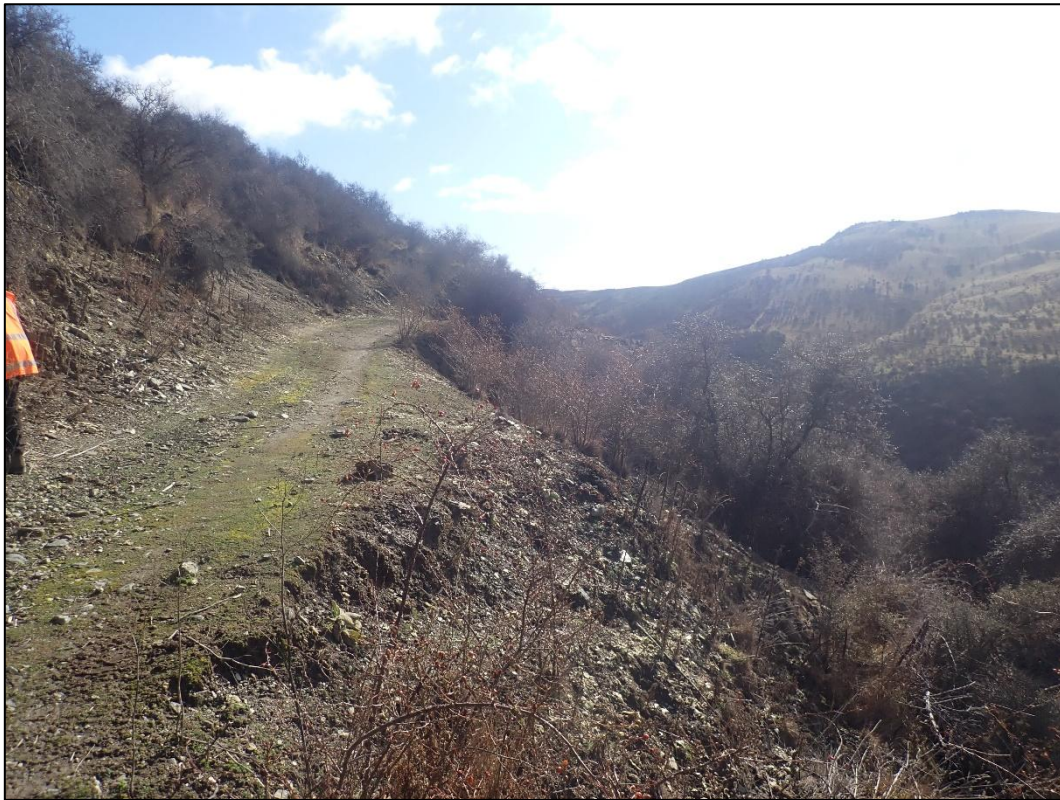
Figure 7-76. Photograph looking northwest at main vehicle track currently used.

The Matakanui-Bendigo Road was surveyed in 1898 and its development continued into the early twentieth century. Sections of the road were surveyed by NZHP archaeologists in December 2018 and August 2021, and revisited in December 2025. For the majority of the surveyed route through the project area, the main road is wide enough to allow for vehicular traffic (Figure 7-76). Within the project area nine culverts and four sections of stone

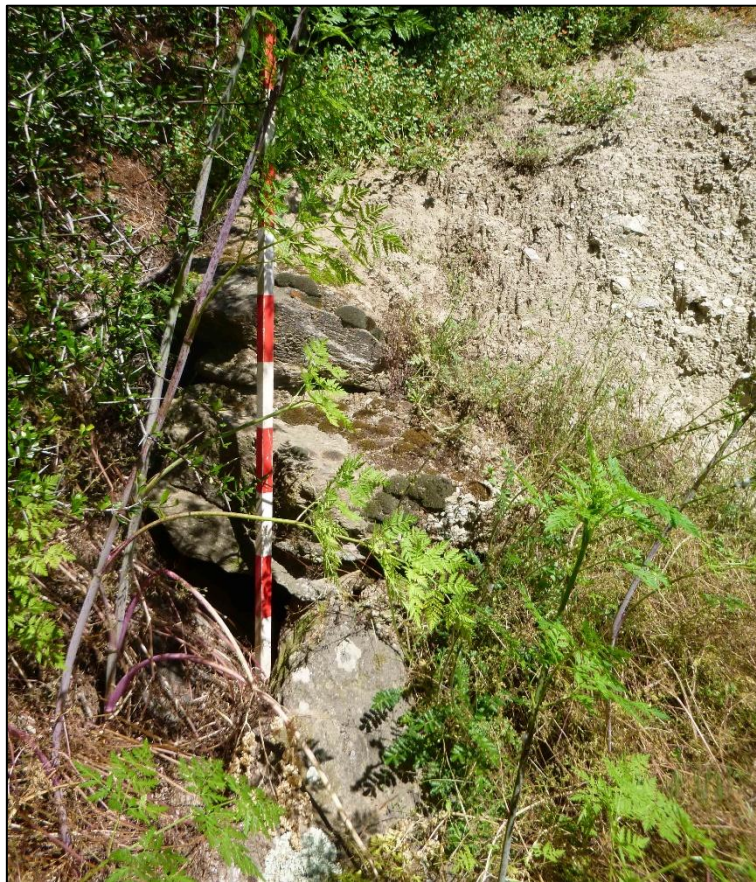
Figure 7-78. Photograph looking east at collapsed stacked schist culvert (POI 146), December 2018.

A stacked schist culvert (POI 146) and a stacked schist revetment (POI 241 and 242) were identified on the hill south of Shepherds Creek in December 2018. The culvert at POI 146 was partially collapsed and stood 0.7m high and was exposed for a width of 0.4m (Figure 7-78). The schist revetment stood up to 1.4m high and ran for 22m (Figure 7-79). Culverts POI 800 and 803 featured larger revetments of stacked schist stone forming an embankment on the downhill, northern side of the road (Figure 7-80 and Figure 7-81). Only the culvert opening of POI 808 was visible (Figure 7-82).

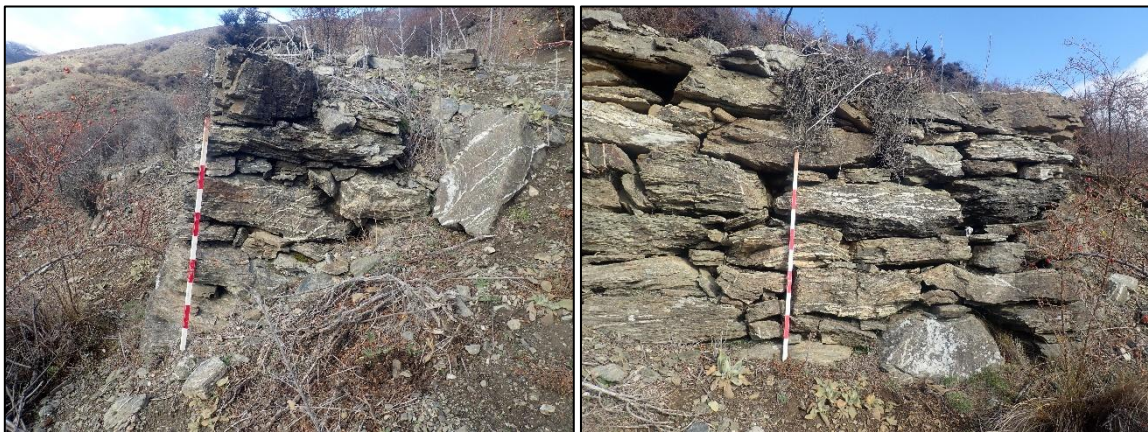
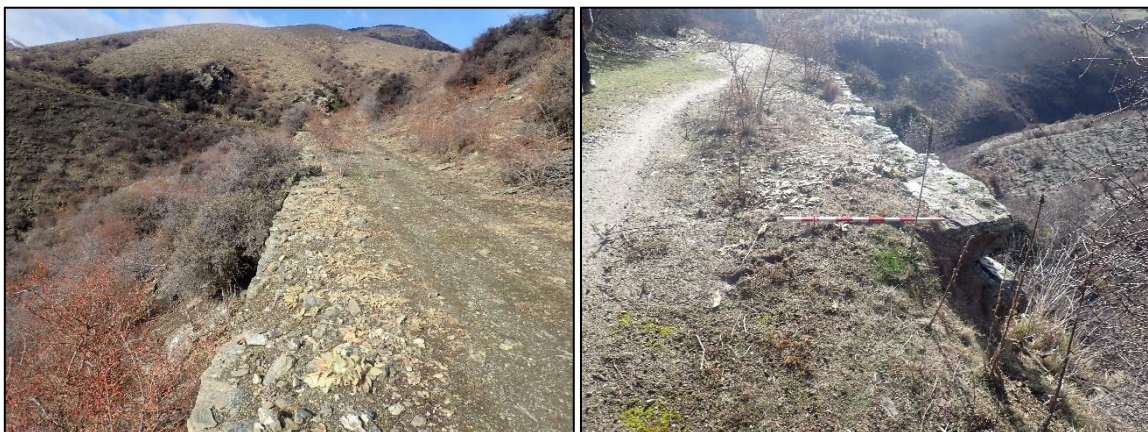
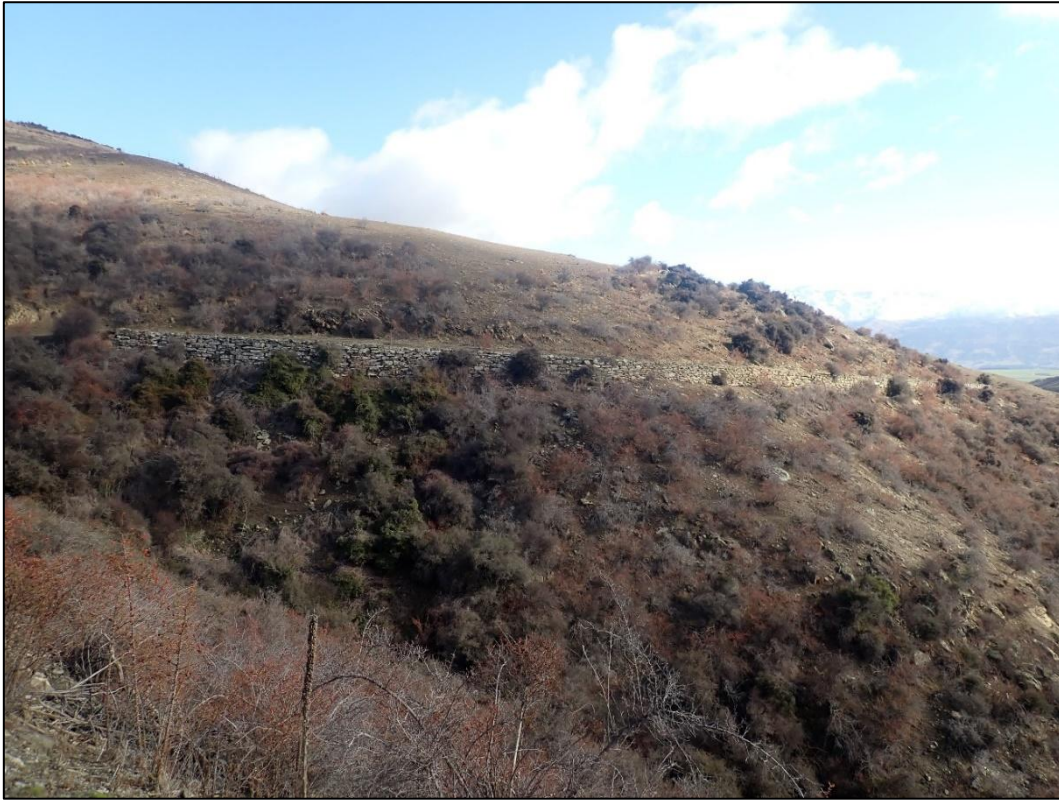
POI 810 marks a large stone revetment (Figure 7-84 and Figure 7-85). This battered wall was 140m long and ranged in height from approximately 0.5 to 3m. The top of the revetment runs 0.5 to 1m back from the road edge. The northeast end the revetment was 1.2 wide. One other feature associated with the track was identified nearby; on the southern (uphill) side of the road a drill scar was visible (Figure 7-86). It is likely that this is the result of construction and maintenance of the road, to clear a wide enough path through natural outcrops, possibly providing stone for the nearby culverts or revetments.

Figure 7-83. Photographs of stacked schist revetment (POI 810) looking southeast and southwest at the northwest end of the wall.

Figure 7-84. Photographs of stacked schist revetment (POI 810) southeast along the extent of the wall (left) and north (right) at the southeast end of the wall.

Figure 7-85. Photograph looking west at full extent of the stacked schist revetment (POI 810).

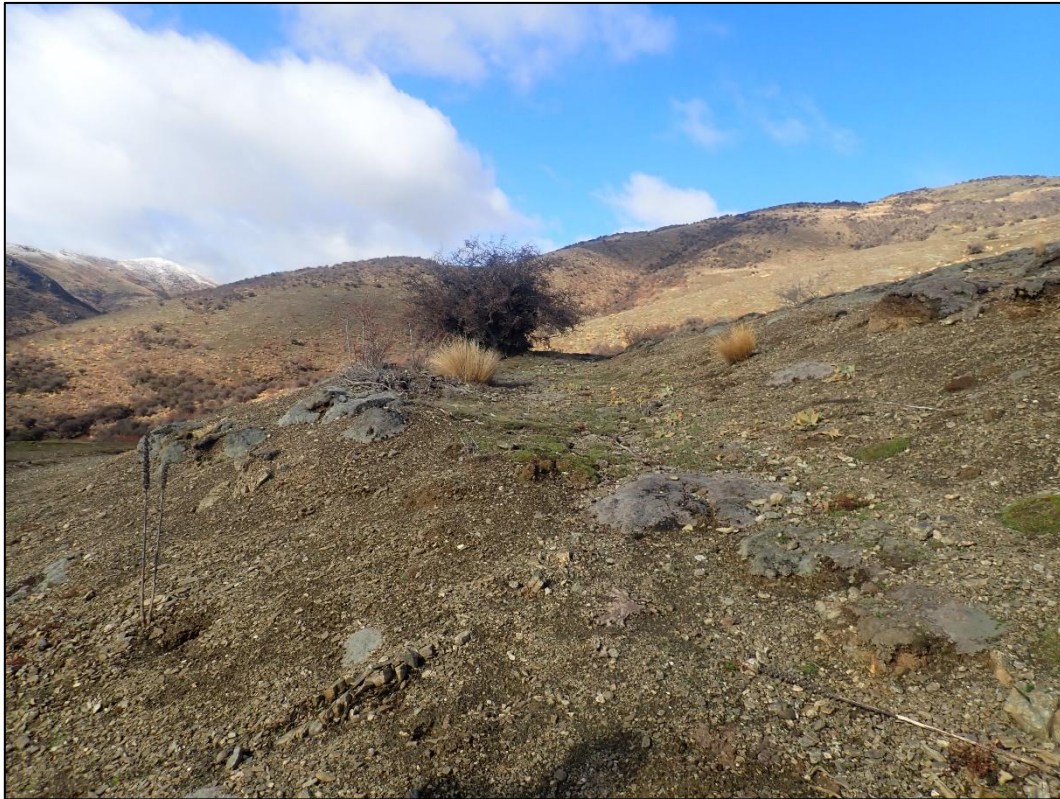
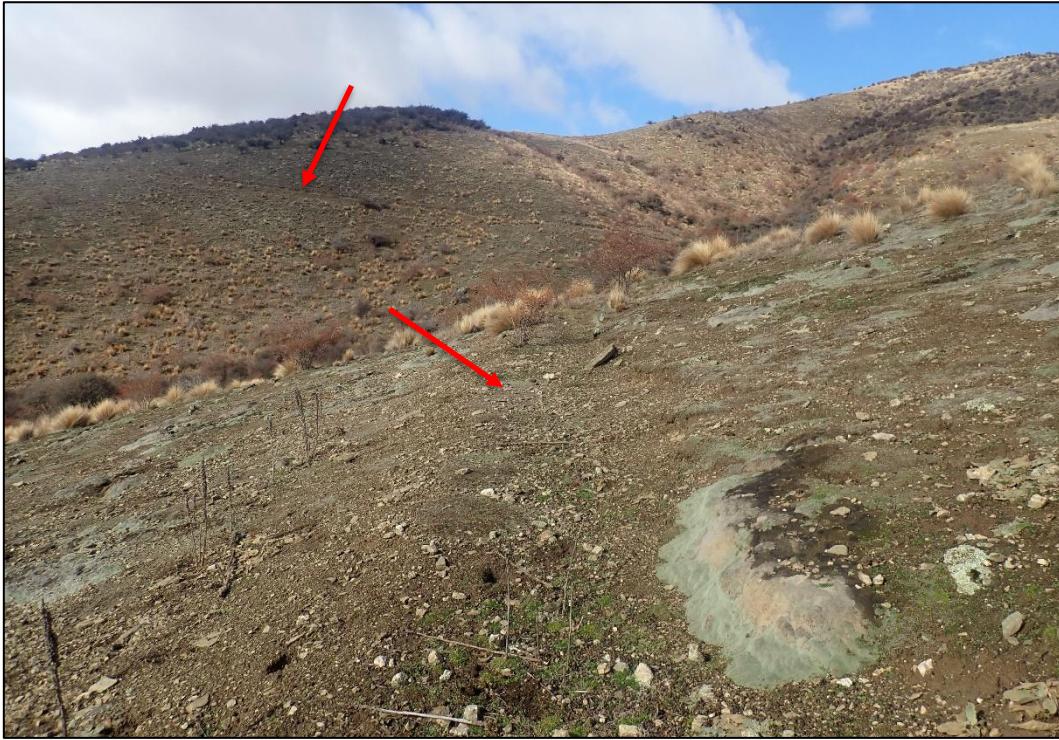
Close to the northern extent of the main project area, the track presently used as the access up the Shepherds Creek Valley veers to the northeast away from the 1898 alignment. However, a narrow track was identified during the survey and is visible in the LiDAR which follows the 1898 proposed road alignment. This formation, approximately 1.5m wide and too variable and steep in gradient to form a water race, may be associated with a pre-1900 track. However, this track has been identified by Bruce Jolly (pers. comms.) of Ardgour Station, to be one he installed 15-20 years ago. If an earlier track was present, it would have been heavily modified at this time.

Figure 7-8788. Photograph looking southeast at the narrow track following the 1898 proposed road alignment.

Figure 7-89. Photograph looking southeast at the narrow track following the 1898 proposed road alignment continuing over the next spur beyond the proposed works area.

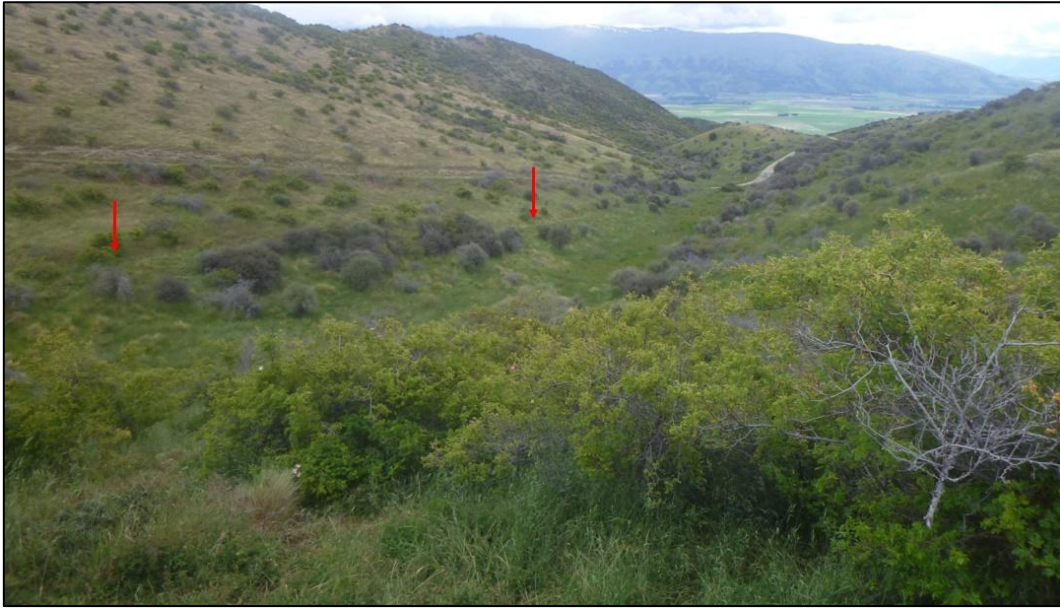
Figure 7-91. Photograph looking west at possible pre-1900 track (red arrows).

A possible pre-1900 track was identified northwest of the Rise and Shine Mine and Battery (G41/277) in December 2018. The track was approximately 3m wide and runs northeast-southwest adjacent to Thomson Gorge Road (Figure 7-91 and Figure 7-92). The track is possibly an earlier alignment of Thomson Gorge Road through this valley used by miners and farmers in the area.

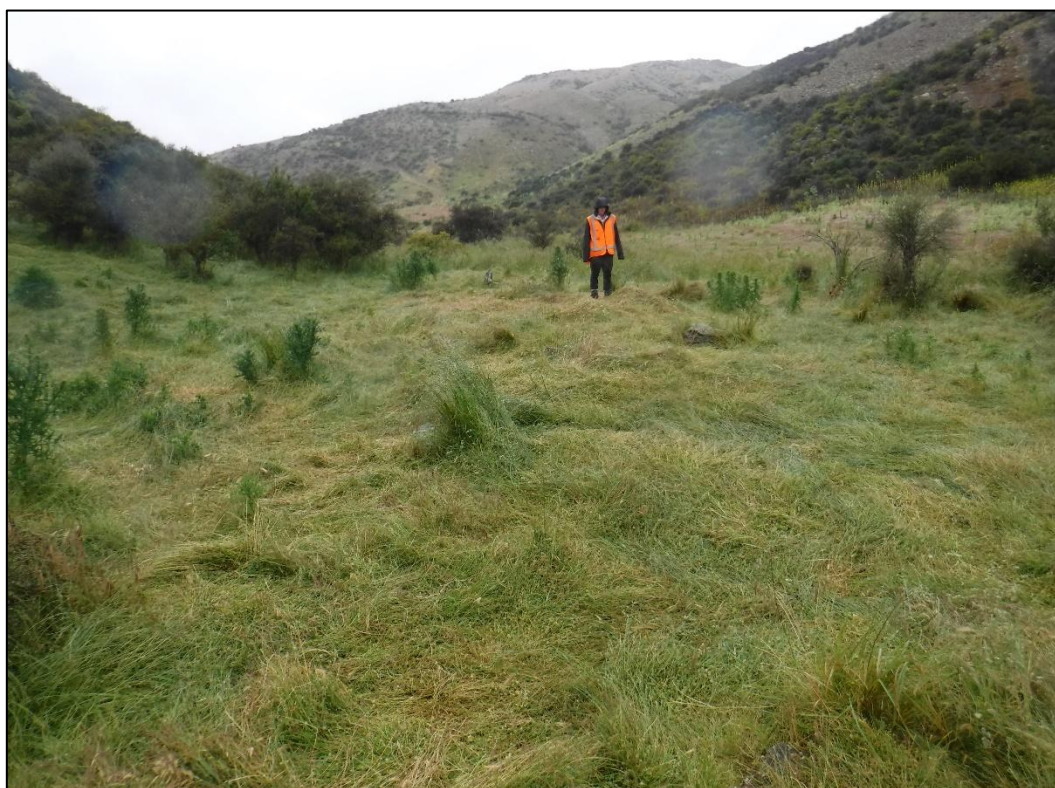
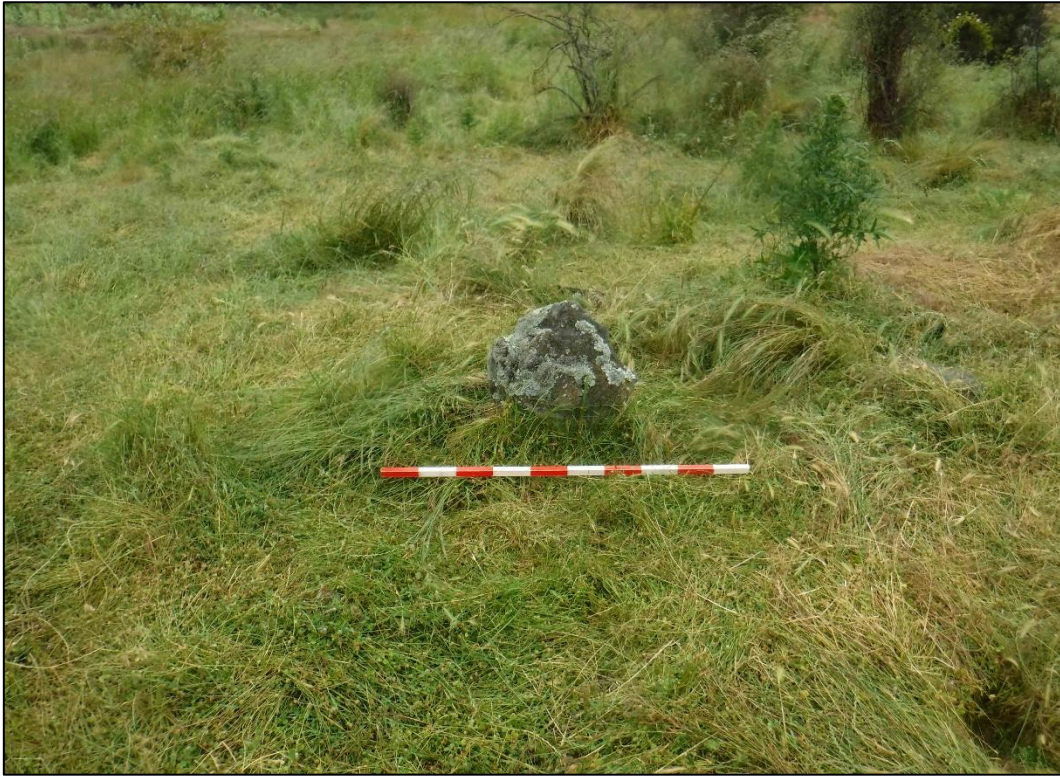
Two possible hut or tent sites were recorded in December 2018, approximately 25m southeast of hut or tent site G41/678 in the Shepherds Creek valley. These were two raised grassed areas which included a number of schist stones that may have once belonged to a structure (Figure 7-94 and Figure 7-95). The thick grass at the time made it difficult to identify distinct extents of the areas; however, the raised platform area closest to G41/678 was approximately 8 m by 3 m, and the next raised area approximately 5 m from the first was approximately 5 by 6 m. Due to their proximity, these two platforms have been recorded as one site, and are thought to relate to the small scale mining that took place in this valley during the nineteenth century.

Figure 7-94 Photograph looking southeast at raised platform and schist areas. Phoebe Scrivener stands on the south-eastern most raised platform.

Figure 7-95 Photograph looking south at raised platform and schist area.

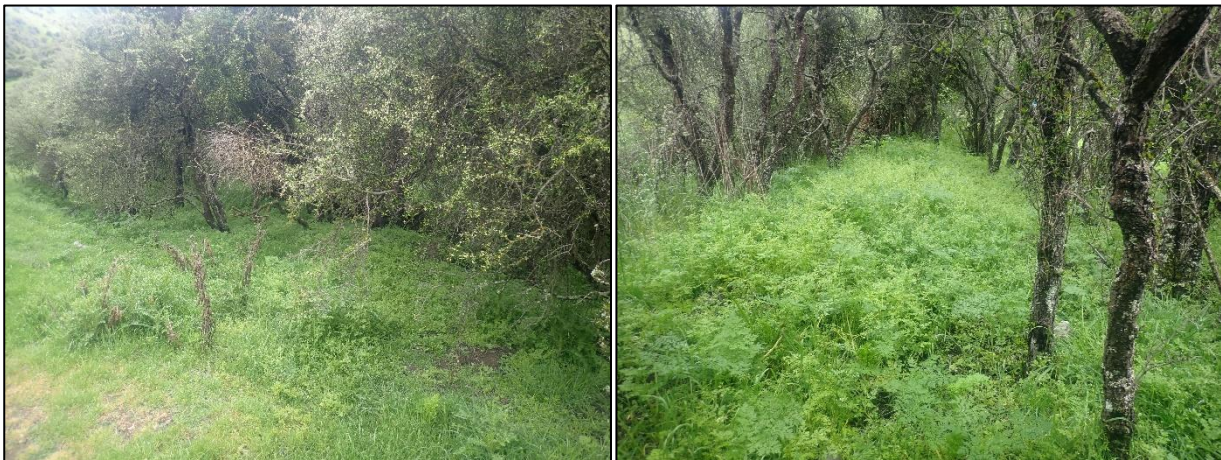
Figure 7-97. Photographs showing mound alongside Shepherds Creek (POI 815), November 2021.

A mound further up the Shepherds Creek valley (Figure 7-97) is also possibly associated with historic mining, in particular the diversion of the creek, and potential campsite remains were identified in the vicinity during the August 2021 survey. This subsequent November 2021 survey also showed that recent drilling access tracks had been installed close to POI 815 but had not impacted the feature or exposed any archaeology.

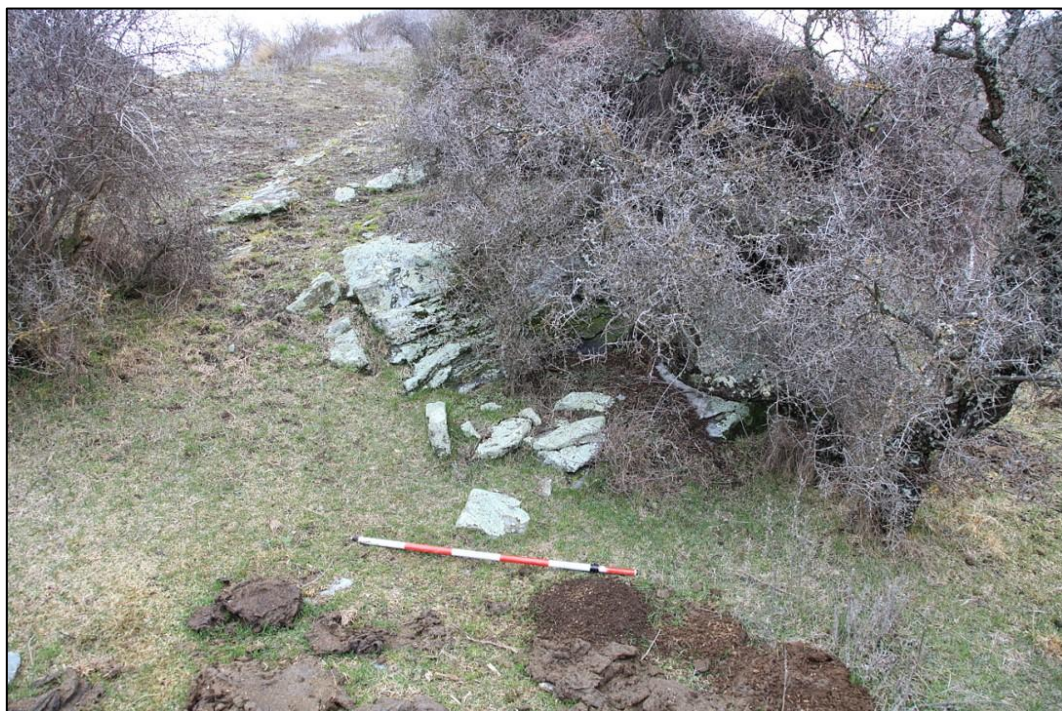
Figure 7-99. G41.786 looking south, August 2022.

A potential campsite with remnant of fire (Figure 7-99) was recorded in August 2022 close to the junction of Shepherds and Jean Creek. Vegetation and terrain made this site difficult to record in any detail and as such the extent should be treated with some caution; however, a small, terraced area is visible in LiDAR imagery of this location (Figure 7-100). This is close to the southeastern-most “old workings” shown in the 1907 geological plan (Figure 5-11) and may therefore relate to the small-scale mining that took place in this valley during the nineteenth century.

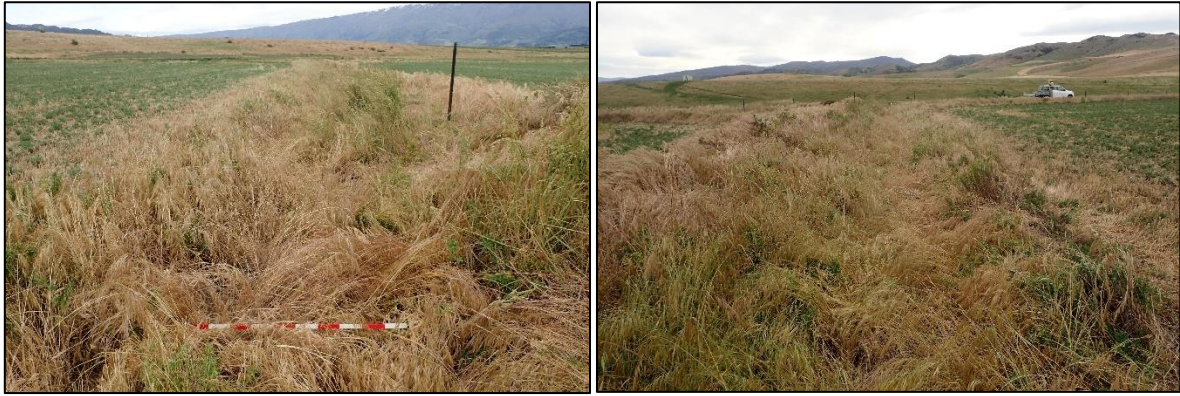
Figure 7-110. Photographs of the water race, left photograph facing west, and right photograph facing east towards the project area.

Two previously unrecorded water races were identified during the December 2024 survey and a site visit in September 2025. Water race G41/790 is located in the flat paddock area to the north of Shepherds Creek valley. The full length of the water race is approximately 1200m, although a modern road seems to have cut the race in the project area. Disturbances to the race as a result of this road include the edge of the race being cut down, and the race being filled in. The race measures 1.4m wide and 800mm deep, with notable raised mounds on the side of the race.

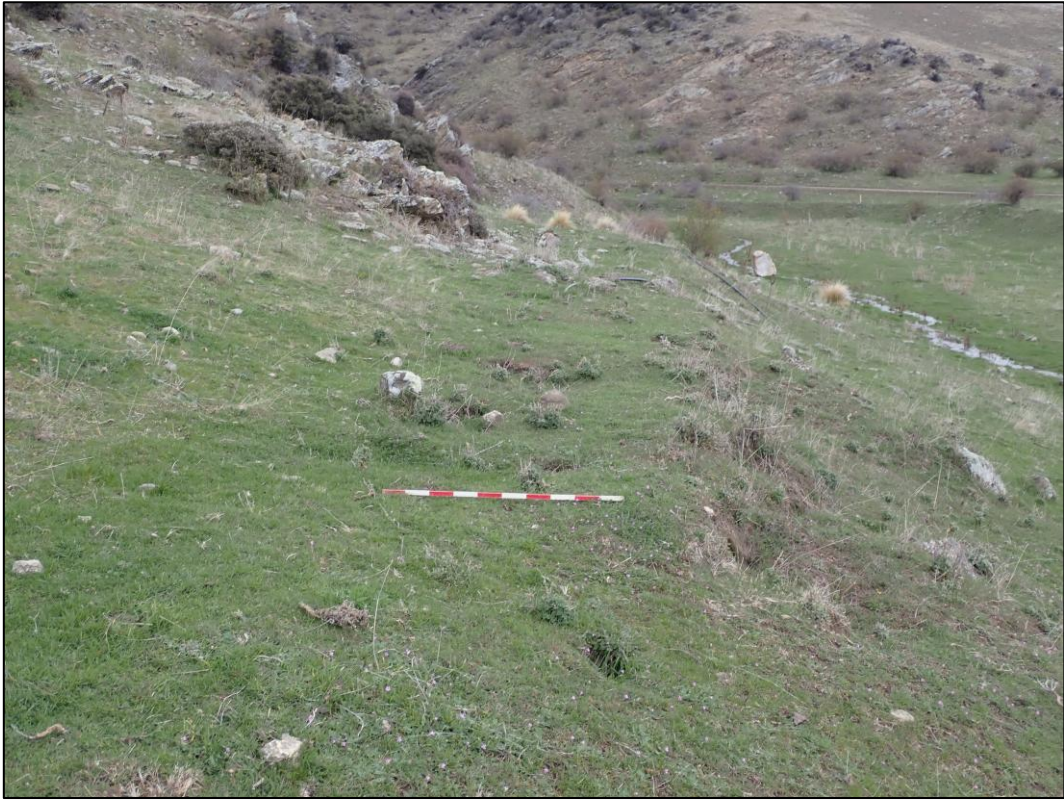
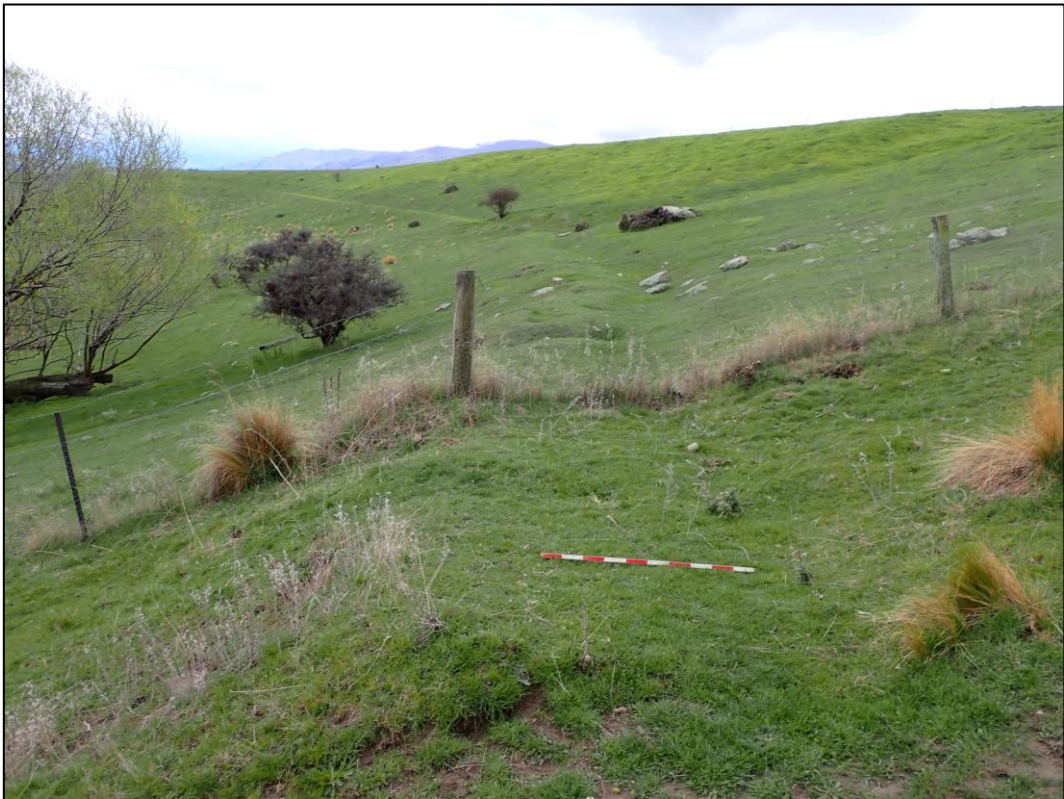
Water race G41/792 is located on the slope on the east bank of Shepherds Creek. The full length of the water race, visible in LiDAR and aerial imagery, is approximately 1600m, although a modern farm track and fence line have cut the race in the project area. Disturbances to the race as a result of this include the edge of the race being cut down, and the race being filled in. The race measures 1.5m wide, with notable raised mounds on the side of the race.

Figure 7-112. Photograph of the water race looking south, September 2025.

Figure 7-113. Looking north along water race, September 2025.

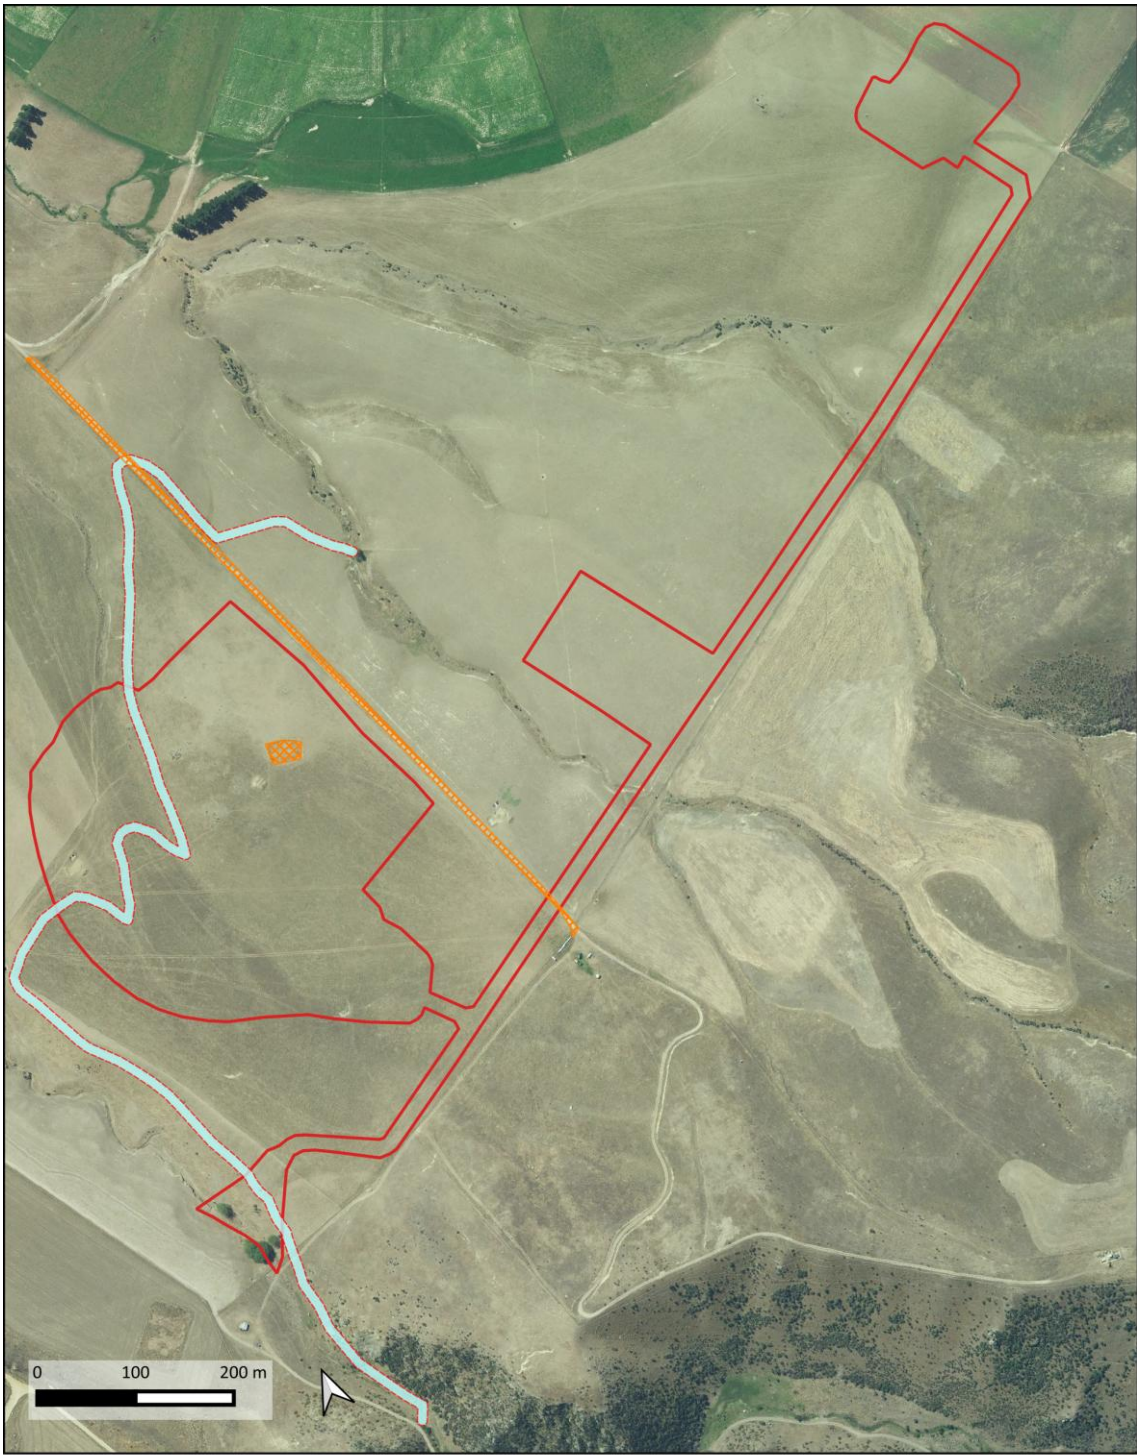
Figure 7-114. Map showing extent of recorded water race G41/792 with relevant portion of project area outlined in red and areas of known modern disturbance shown.

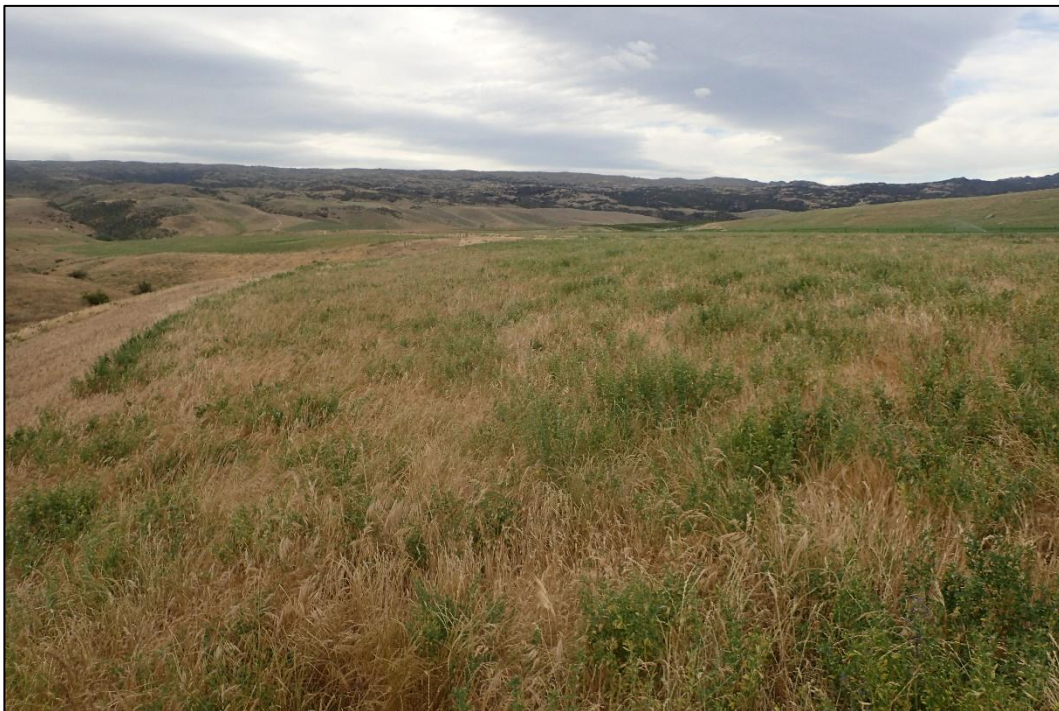
Figure 7-116. Looking south from northern tip of project area towards location of POI 46.

Four potential water races were identified in historic aerials and LiDAR running southeast-northwest through the project area. These features were unable to be located during the pedestrian surveys (Figure 7-116 and Figure 7-117). It is possible that these features are stock tracks that are shallow enough to be totally obscured by the spring vegetation growth, alternatively these could be water races that have been so heavily eroded that there are no longer decipherable mounds on either side. This area has long been subject to heavy stock traffic and ploughing, making both possibilities feasible. Removal of turf and topsoil in the location of these features would quickly show the presence or absence of historic water races.

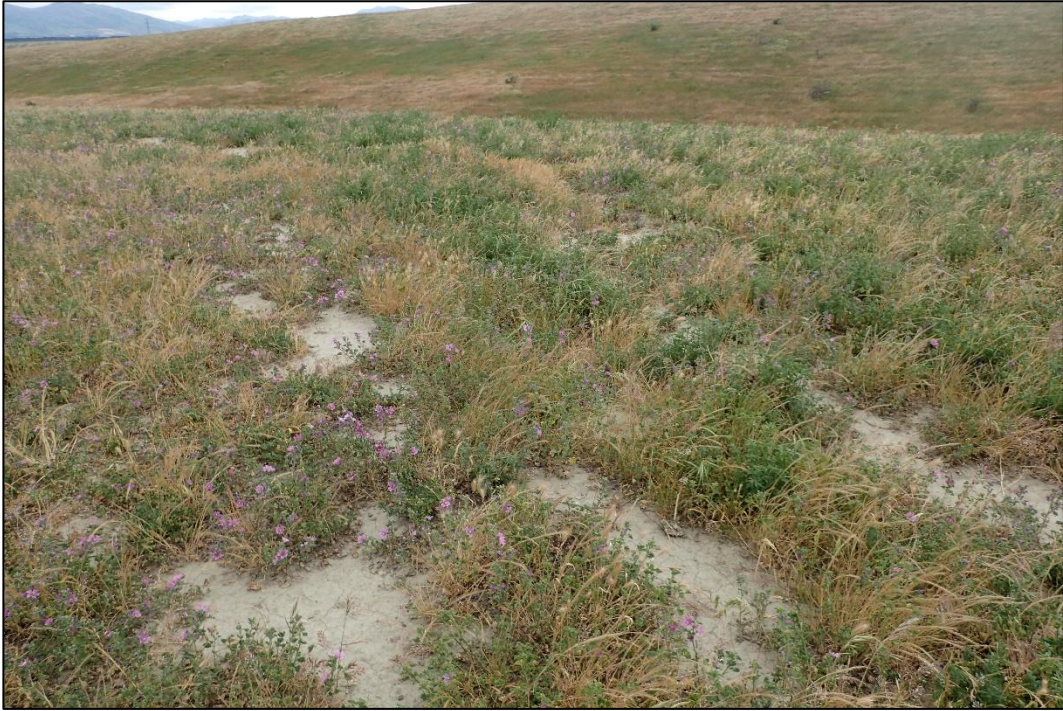
Figure 7-117. Facing northwest at location of potential fork of POI 47.

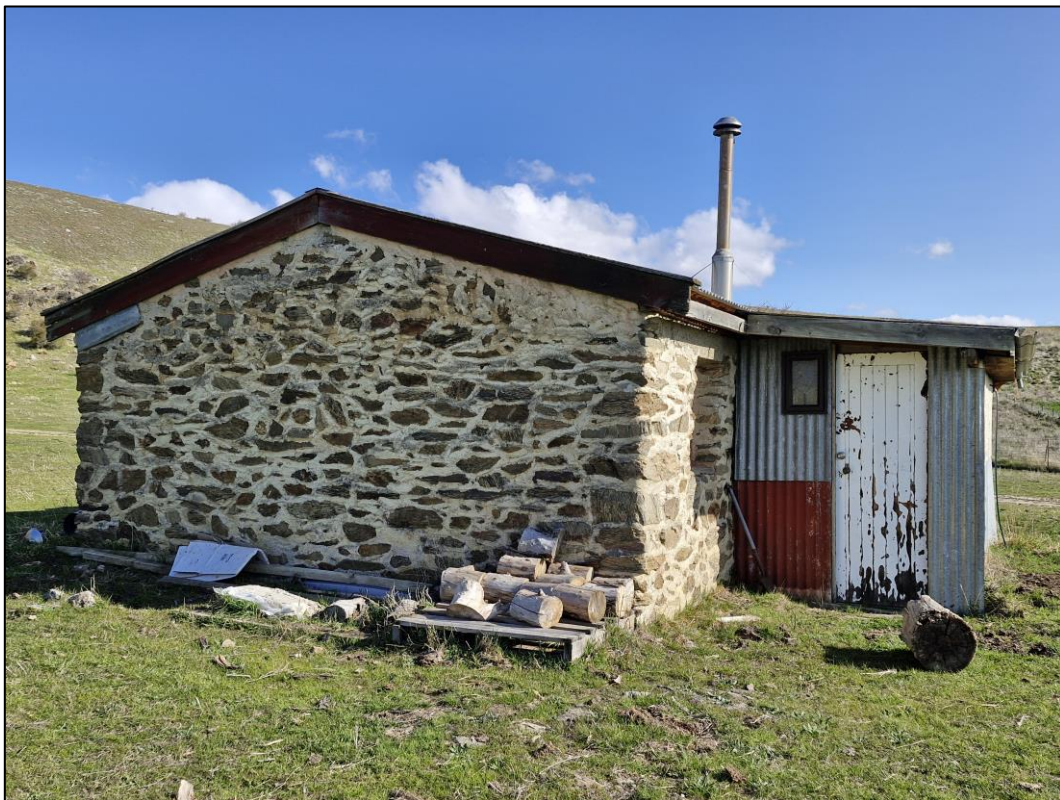
Figure 3. Site G41/4 in 2024, looking east.

Value	Assessment
Condition	Good: G41/4 is in good condition despite some modern modifications and is still in use.
Rarity or Uniqueness	Medium: Though hut sites are common, huts associated with this phase of pastoral activity in the area are less so.
Contextual Value	High: This hut is associated with the earliest pastoral occupation of the project area as part of what would become the Morven Hills Station.
Information Potential	Medium: Potential research questions able to be considered through archaeological investigations of this hut include: <ul style="list-style-type: none"> • How have the twentieth and twenty-first century modifications altered the heritage fabric of the hut? • How much heritage fabric survives in this hut? • Are there any key similarities or differences between this and huts associated with goldminers?
Amenity Value	Medium-High: This site is a prominent feature of the landscape and holds significant potential for public interpretation and education.

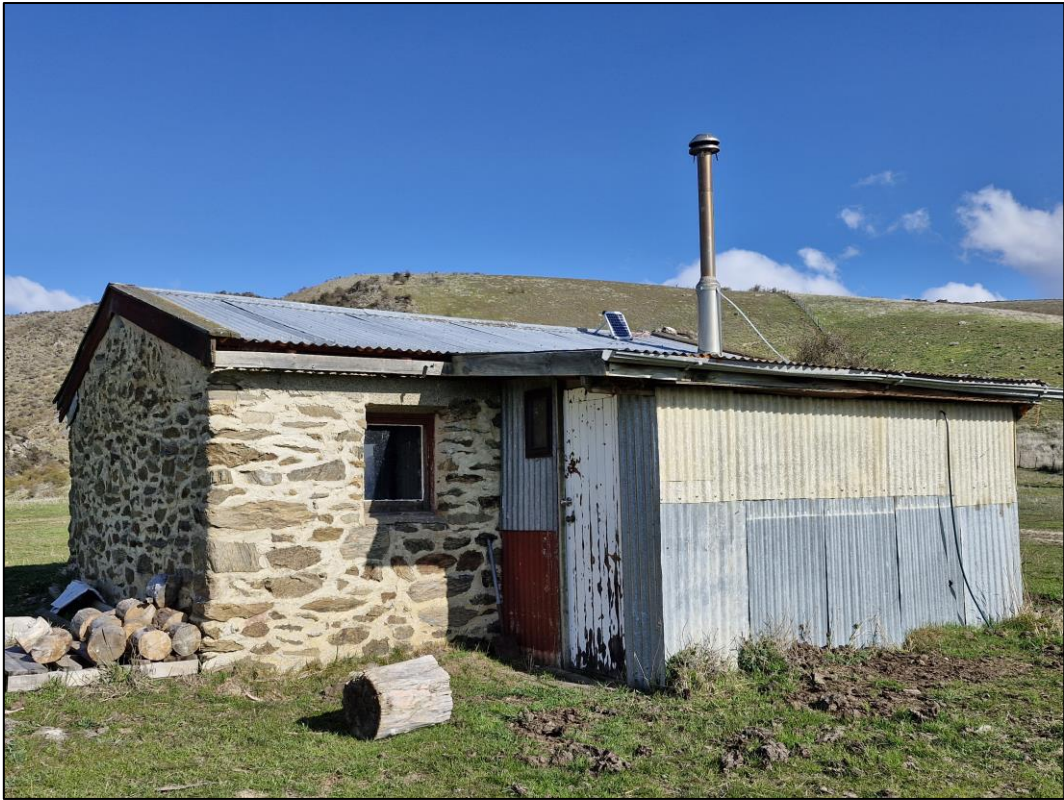
Figure 4. Site G41/4 in 2024, looking north.

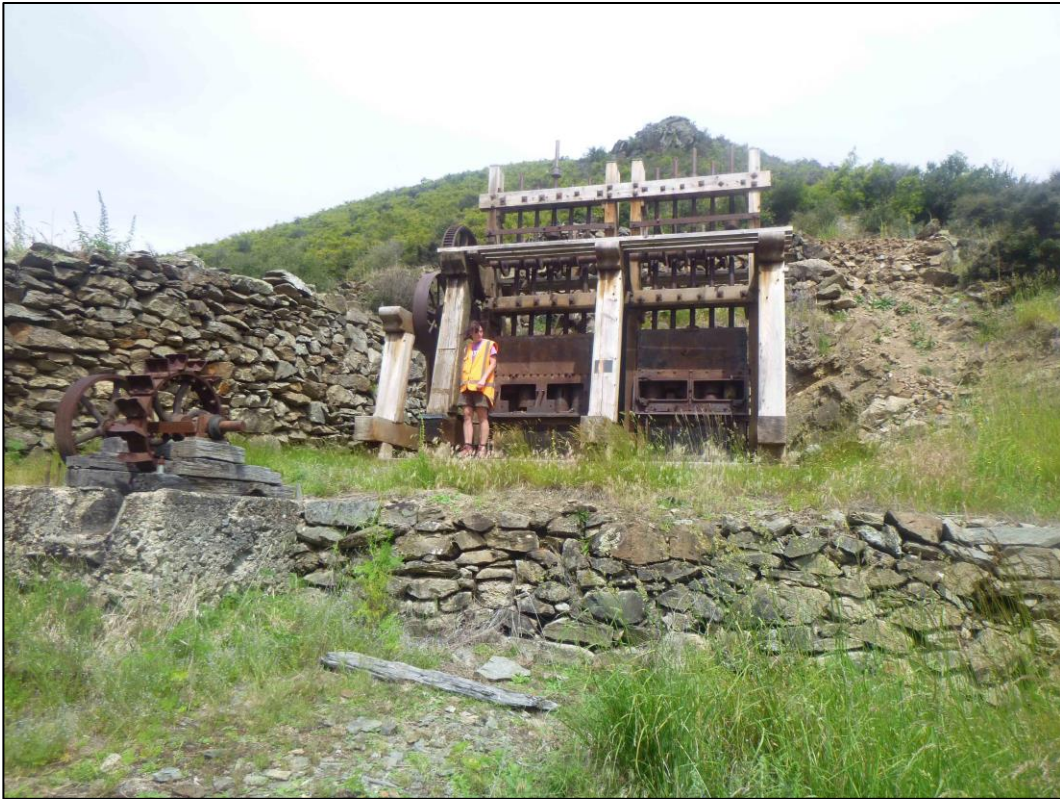
Figure 1 Photograph looking southeast at the Come in Time Battery recorded as G41/251. Photograph taken by Megan Lawrence on 18/12/18.

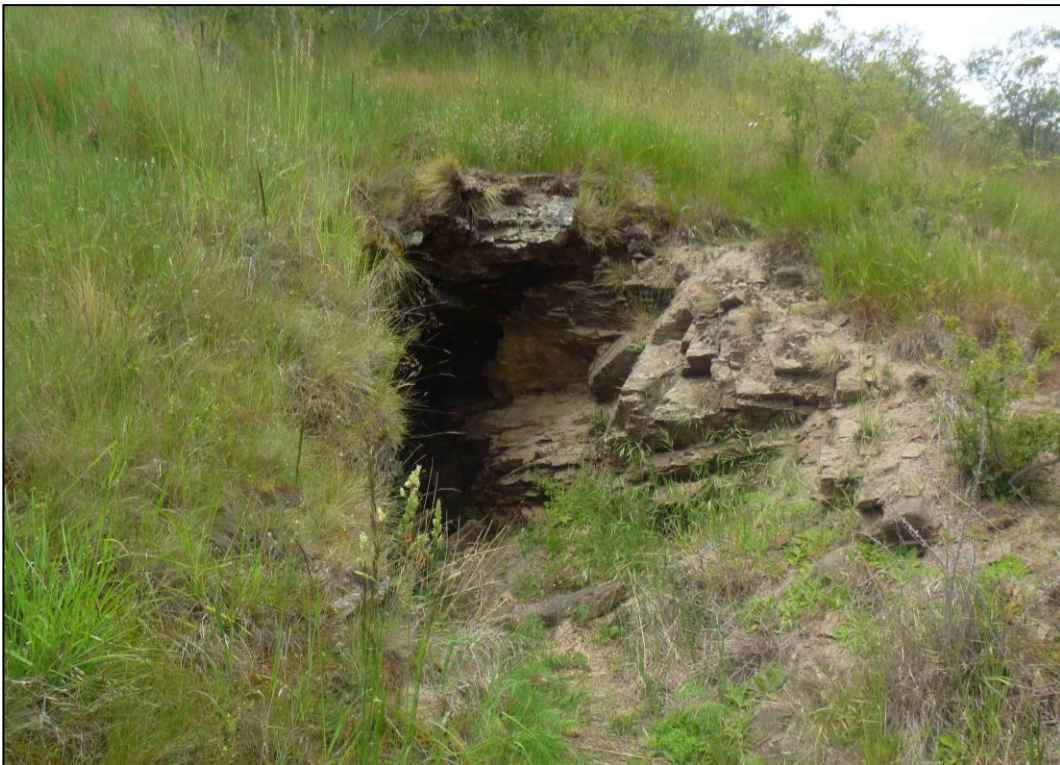
Figure 2 Photograph looking north at the main adit of the Red Mine recorded as part of G41/251. Photograph taken by Megan Lawrence on 18/12/18.

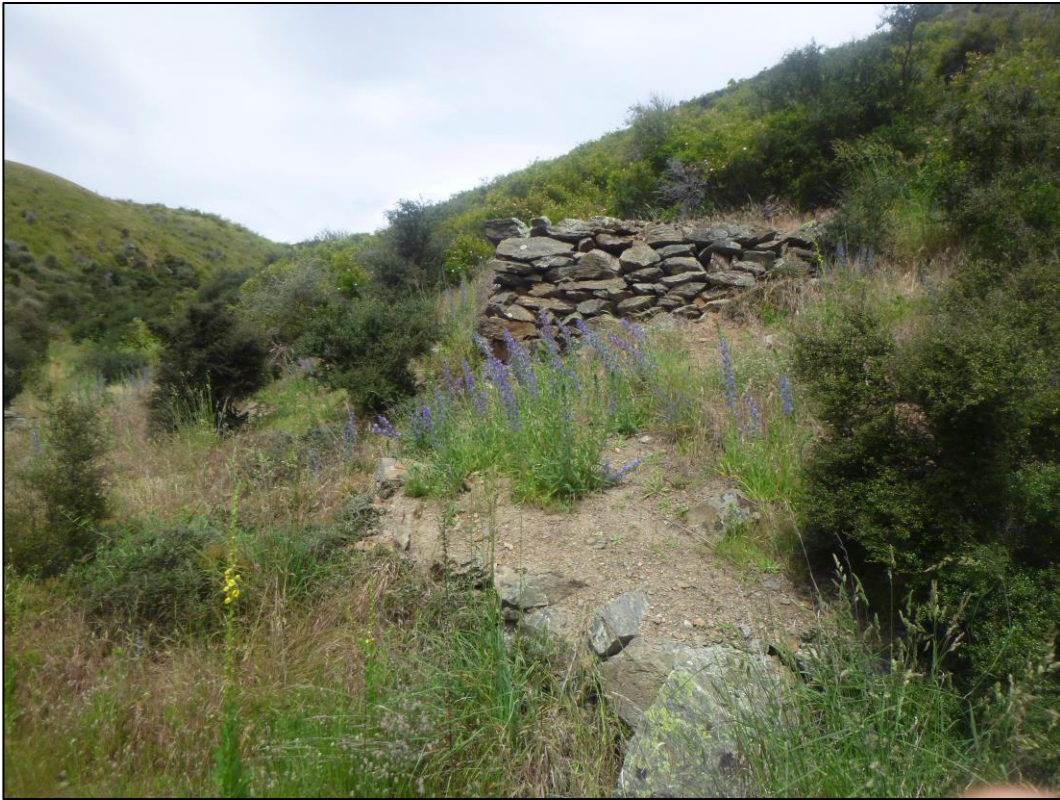
Figure 3 Photograph looking northeast at platform above the battery recorded as G41/251. Photograph taken by Megan Lawrence on 18/12/18.

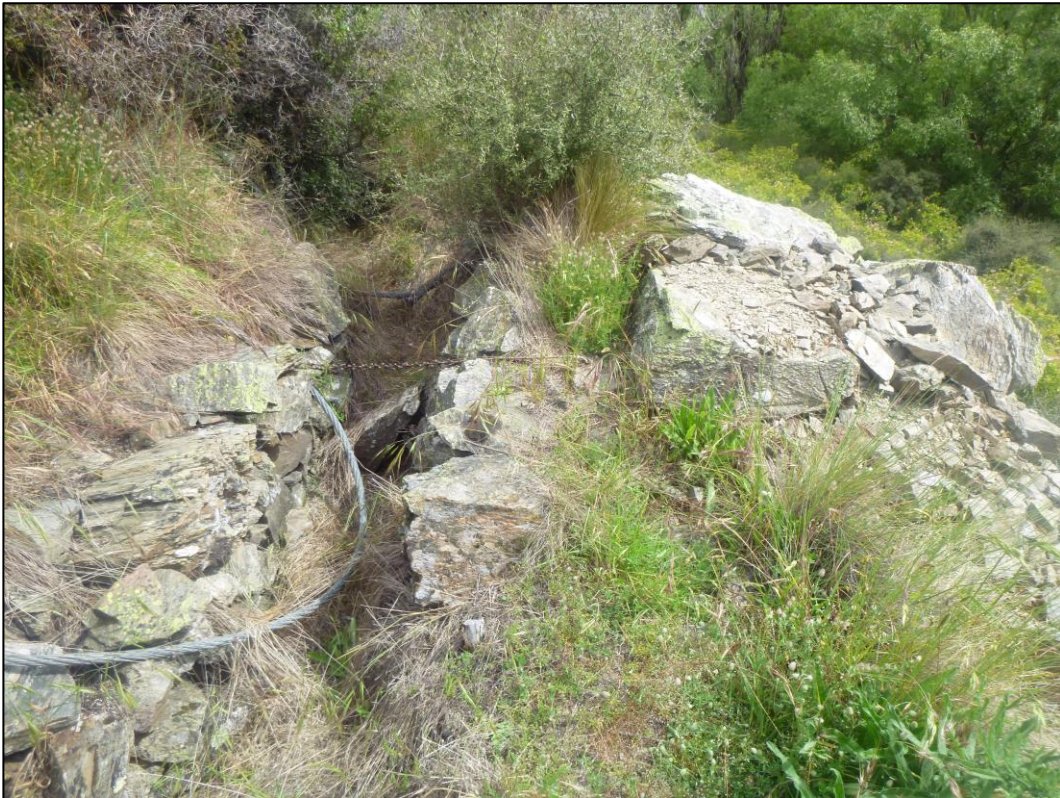
Figure 4 Photograph looking southwest at the schist channelling at the end of the Come in Time water race recorded as part of G41/251. Photograph taken by Megan Lawrence on 18/12/18.

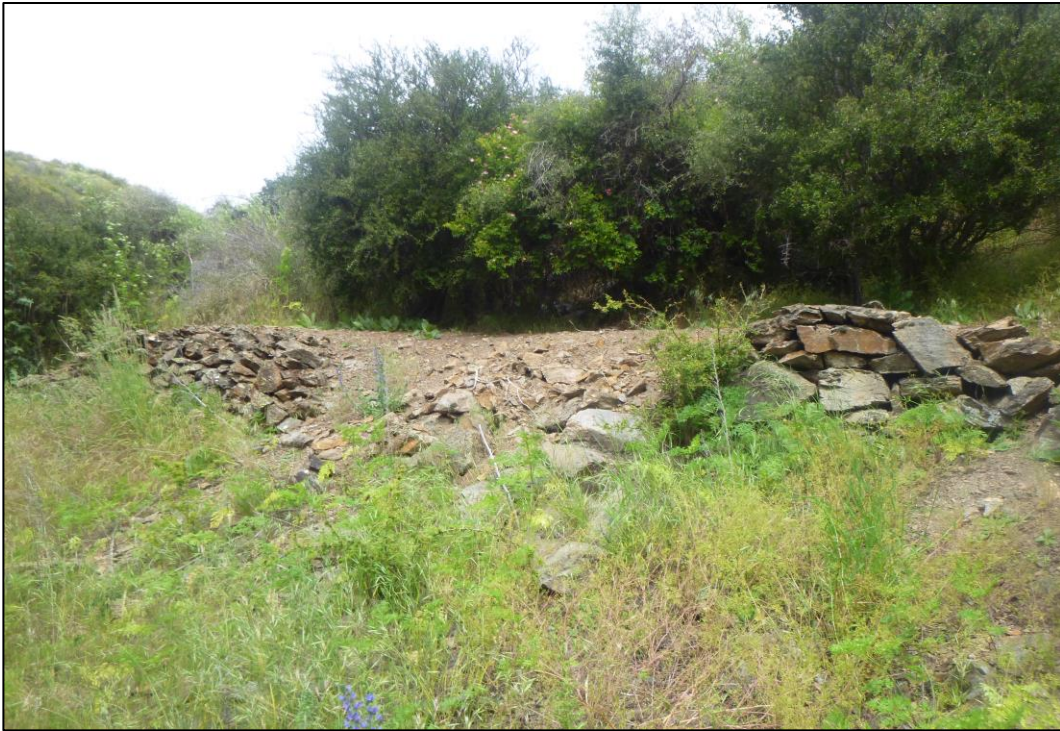
Figure 5 Photograph looking north at the partially collapsed stone revetment recorded as part of G41/251. Photograph taken by Megan Lawrence on 18/12/18.
