The Bendigo-Ophir Gold Project

A Heritage Assessment

Report Prepared for Matakani Gold Ltd
Author: Dr Naomi Woods and Claire Thorrold
Reviewed by: Dawn Cropper and Megan Lawrence

Prepared by New Zealand Heritage Properties Ltd

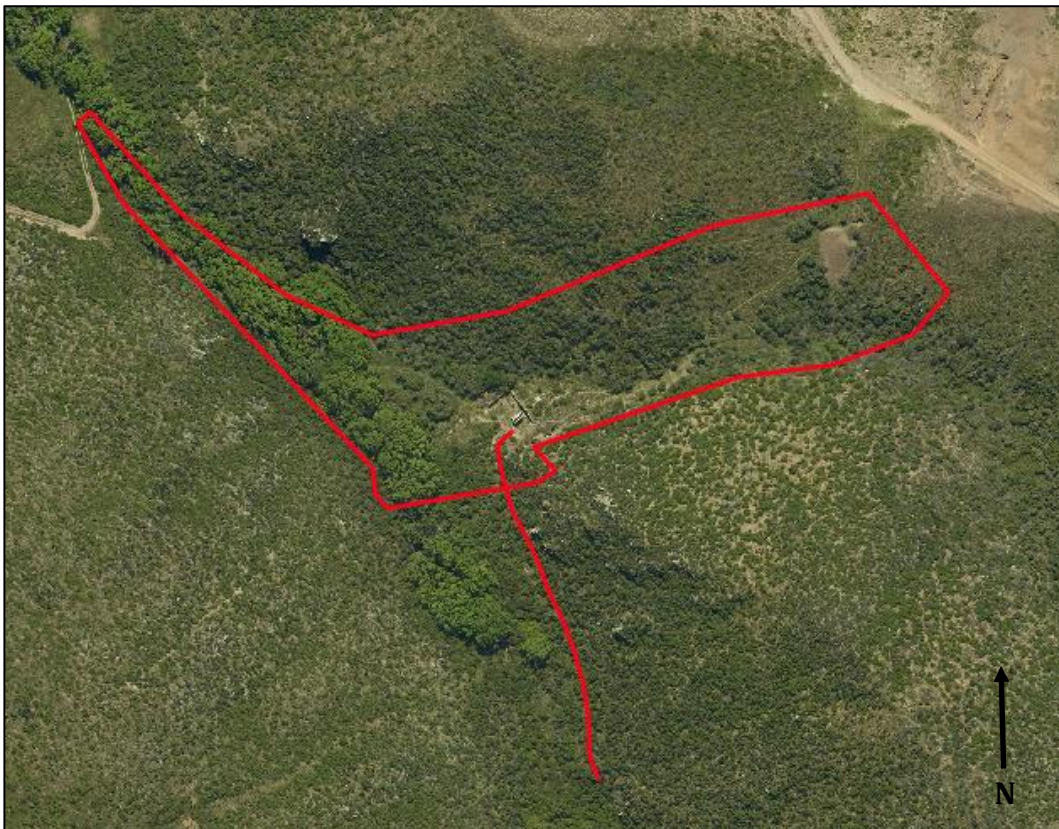
Figure 6 Approximate extent of the Come in Time battery recorded as G41/251 showing the Come in Time race head southeast towards the Rise and Shine mine and battery (G41/277). Approximate site extent based on recorded archaeological features, pedestrian survey, aerial photographs and LiDAR Data.

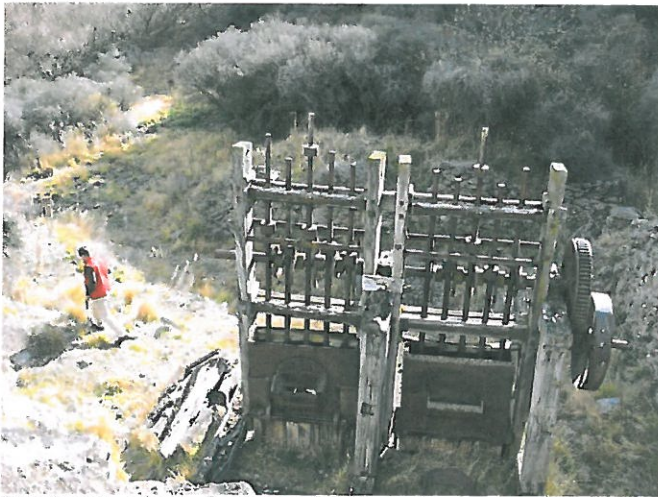
Battery site 6 June 2005 before restoration

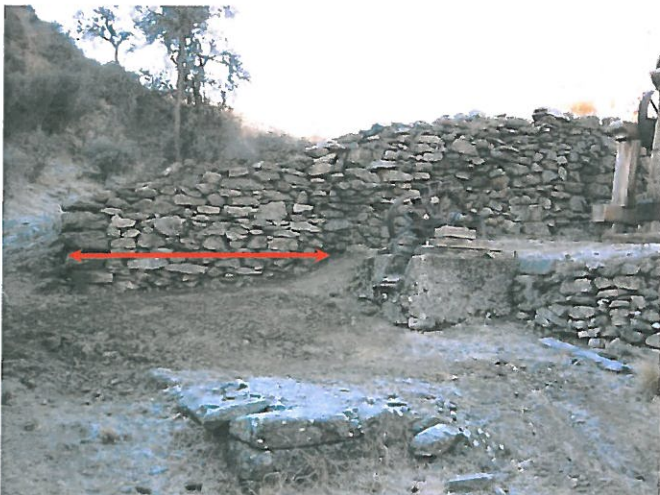
Rebuilt section of wall indicated by red arrow and borrowed pelton wheel, 30 July 2010

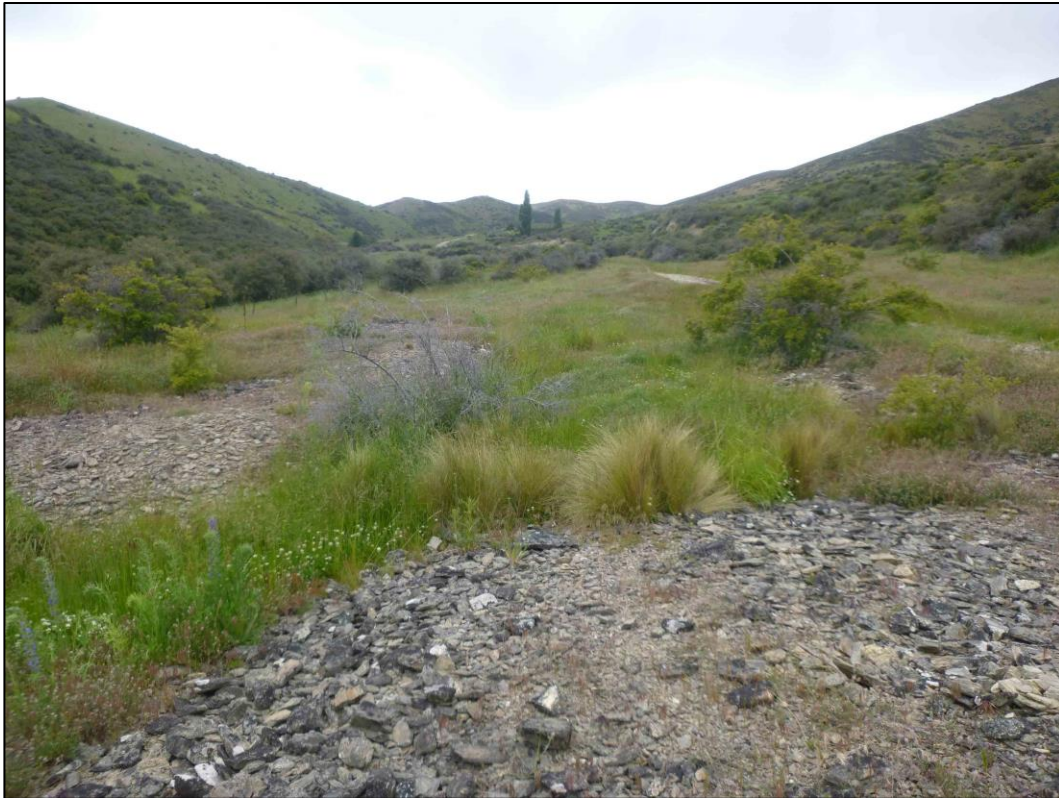
Figure 3 Photograph looking southeast at the tailings recorded as part of G41/264. Photograph taken by Phoebe Scrivener on 20/12/18.

Value	Assessment
Condition	Fair: This site has been modified by twentieth century mining and farming activity, though many visible features remain.
Rarity or Uniqueness	Medium: This is a common site type in Otago, with multiple comparable examples located in the local area (eg. Site F41/104, G41/301, G41/554, G41/745) but this is a good example of a mid to late nineteenth century alluvial gold mining complex that can be associated with a known mining syndicate (Rise and Shine) and is relatively intact.
Contextual Value	High: The site has contextual value when considered as a physical record of the Rise and Shine company's workings, but also as a component of the larger, interconnected mining landscape.
Information Potential	Medium: Potential research questions able to be considered through archaeological investigations of this site include: <ul style="list-style-type: none"> • Is it possible to identify specific mining methods and any changes in these through time and/or space? • Is there any evidence of distinctly Swedish mining practices? • How did the mining landscape develop over time? Are phases discernible?

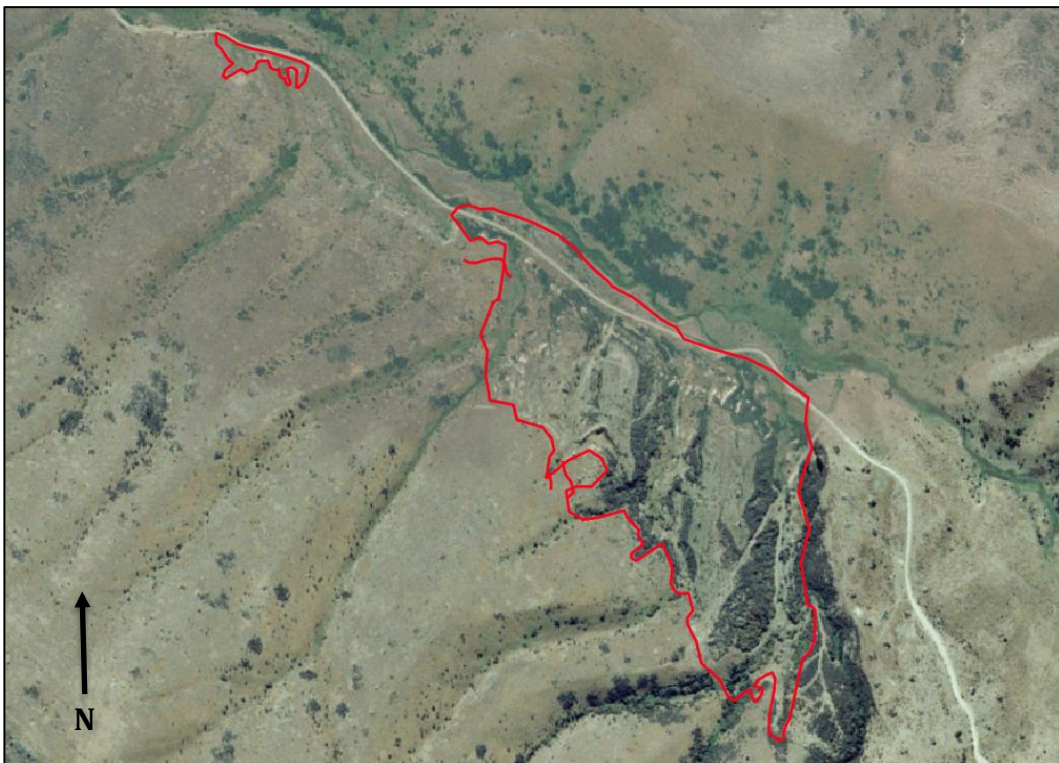
Figure 4 Aerial photograph showing the approximate extent of gold workings recorded as G41/564. Thomsons Gorge Road is shown running through the northern extent of the site. Approximate site extent based on recorded archaeological features, pedestrian survey, aerial photographs and LiDAR.

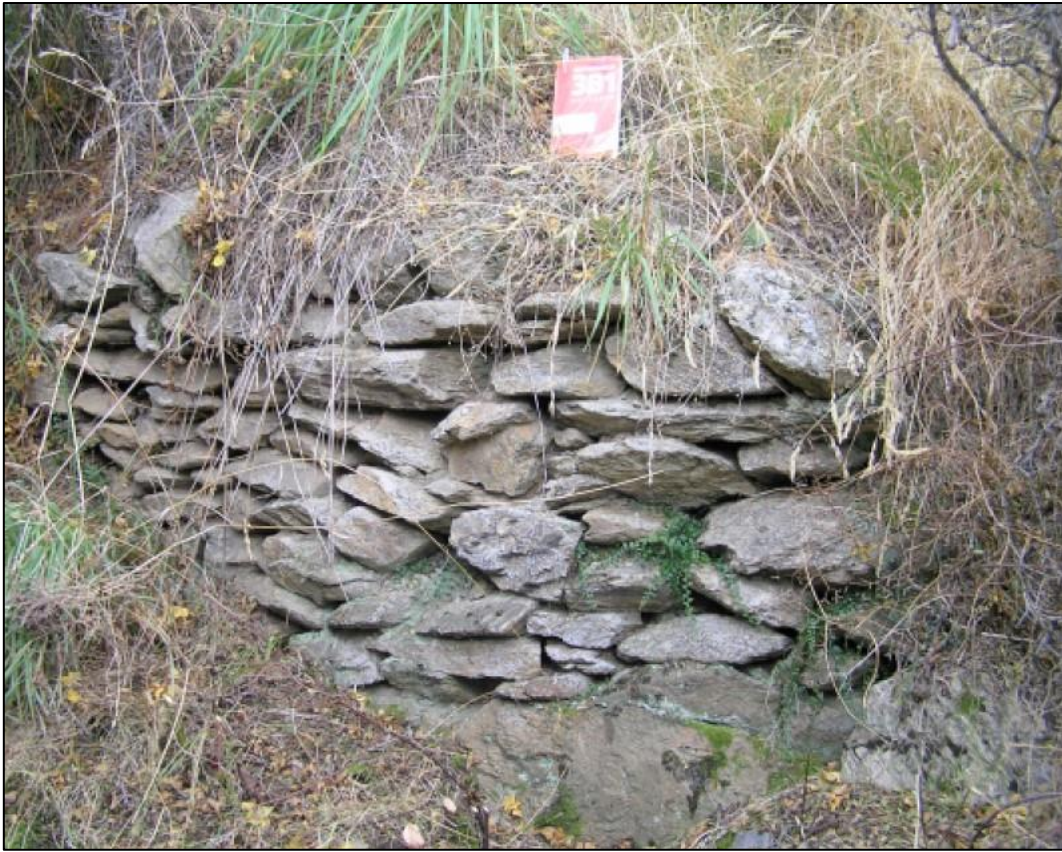
Figure 2. Site G41/266 rear wall in 2005 (Nichol & Wright, 2006).

Value	Assessment
Condition	Fair: These huts survive as partial ruins; however, the remaining portions are in good condition.
Rarity or Uniqueness	Low: Huts such as these are a very common archaeological site type in Otago, especially those in a similar ruinous condition.

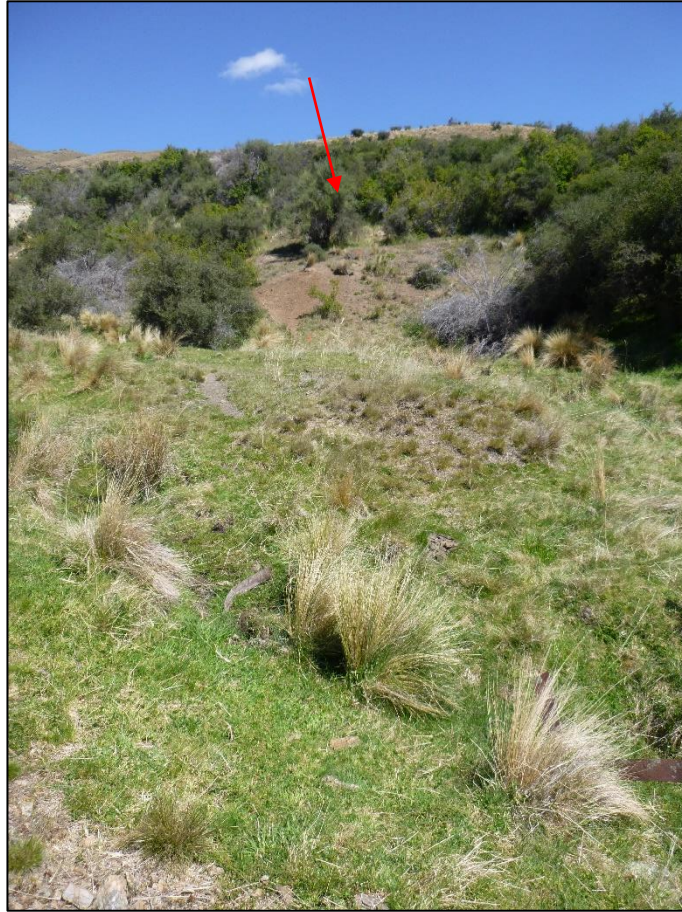
Figure 4. Looking south towards site G41/266 in 2018, with its approximate location indicated by the red arrow.

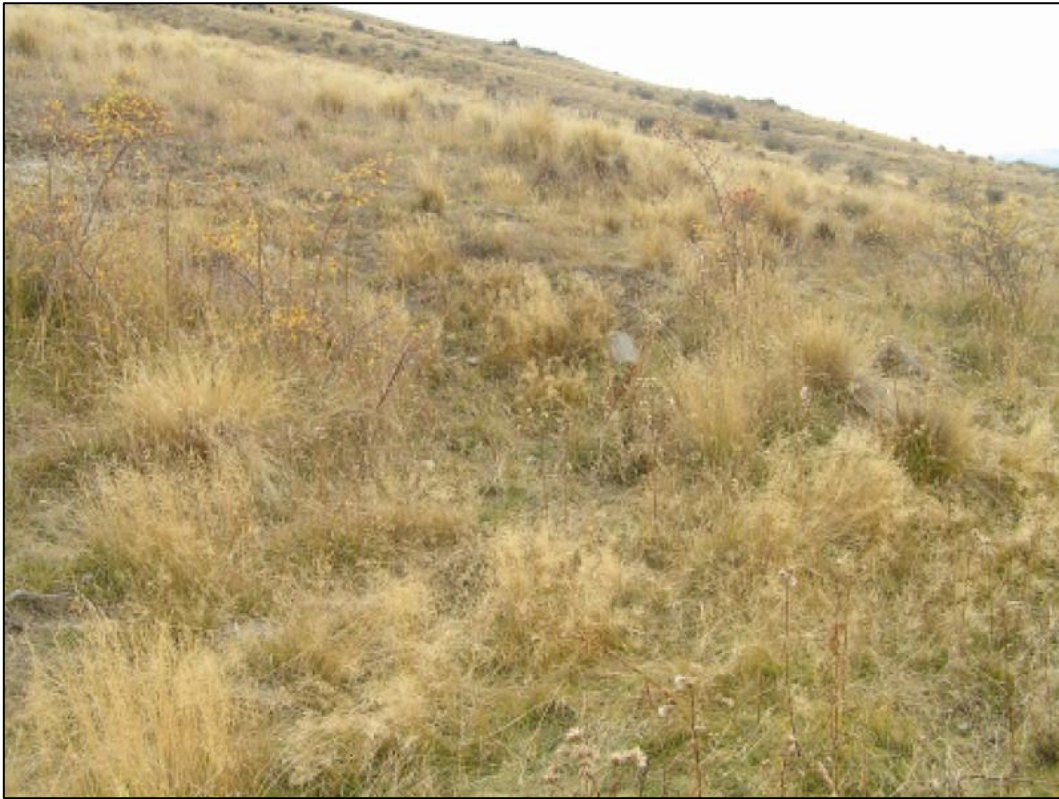
Figure 1. Looking west at site G41/273 (stones just visible in centre of image) (Nichol & Wright, 2006).

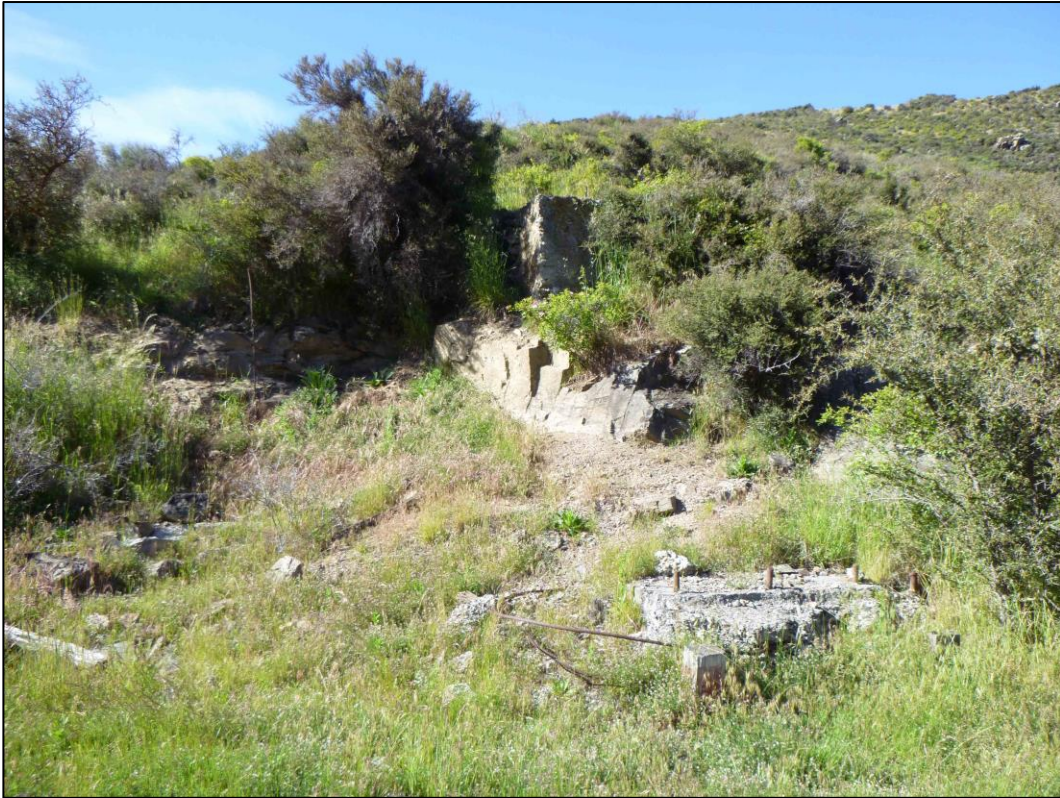
Figure 1 Photograph looking southwest at concrete machine foundations recorded as part of G41/277. Photograph taken by Megan Lawrence on 17/12/18.

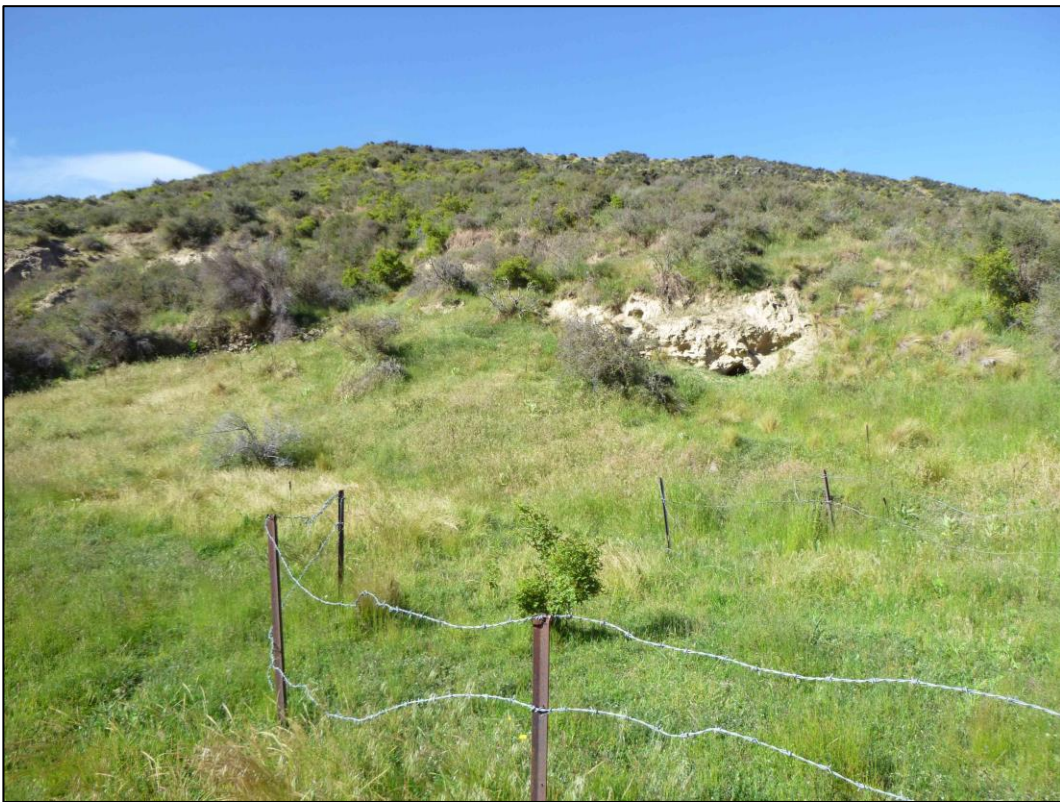
Figure 2 Photograph looking southwest at mine recorded as G41/277, showing adit, stone faced dam and sluice face. Photograph taken by Megan Lawrence on 17/12/18.

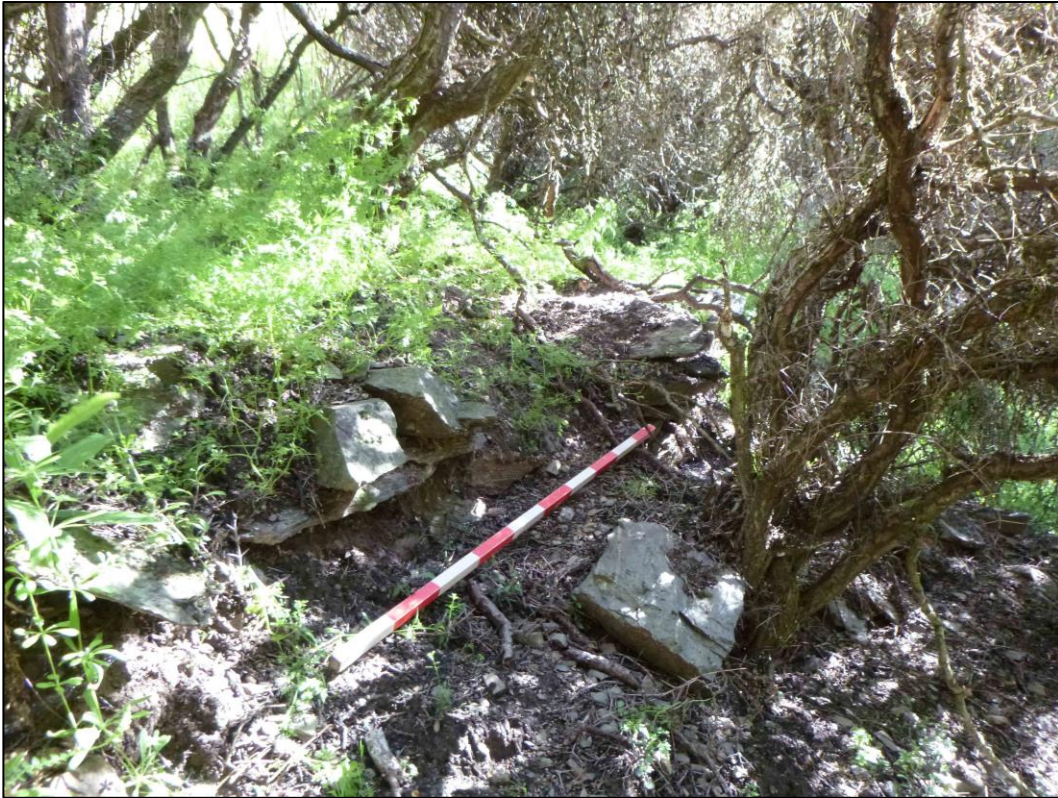
Figure 3 Photograph looking northwest of revetted tramway recorded as part of G41/277. Photograph taken by Megan Lawrence on 17/12/18.

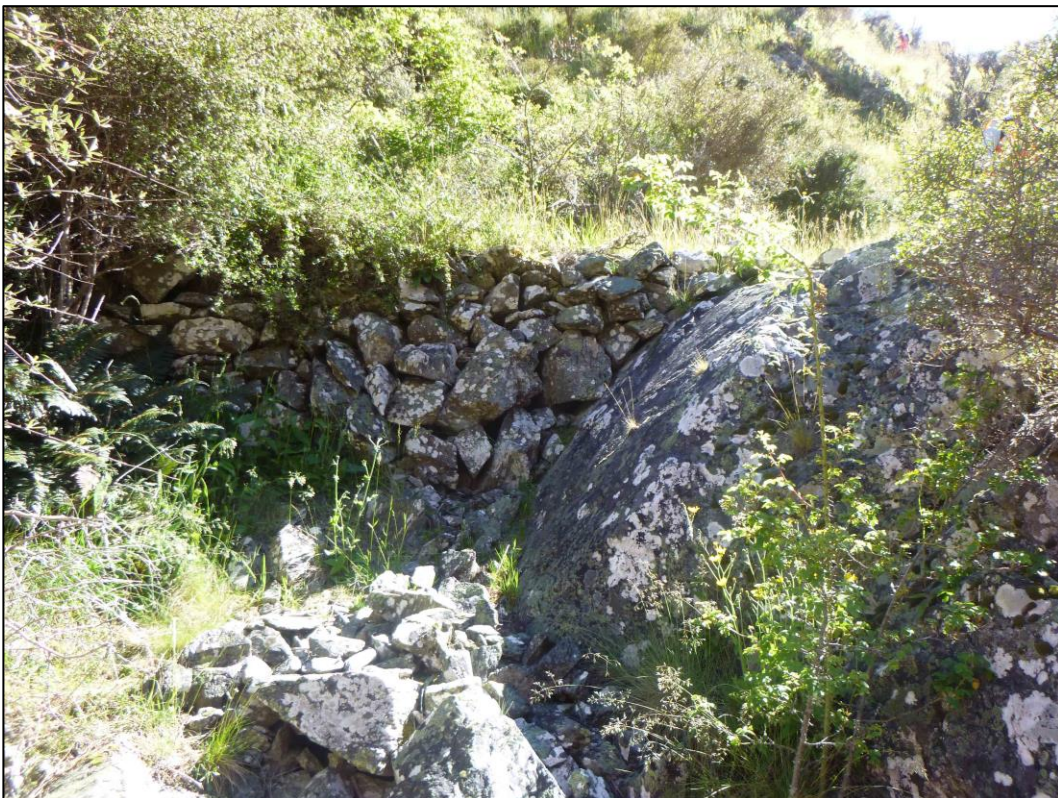
Figure 4 Photograph looking north of revetted tramway recorded as part of G41/277. Photograph taken by Megan Lawrence on 17/12/18.

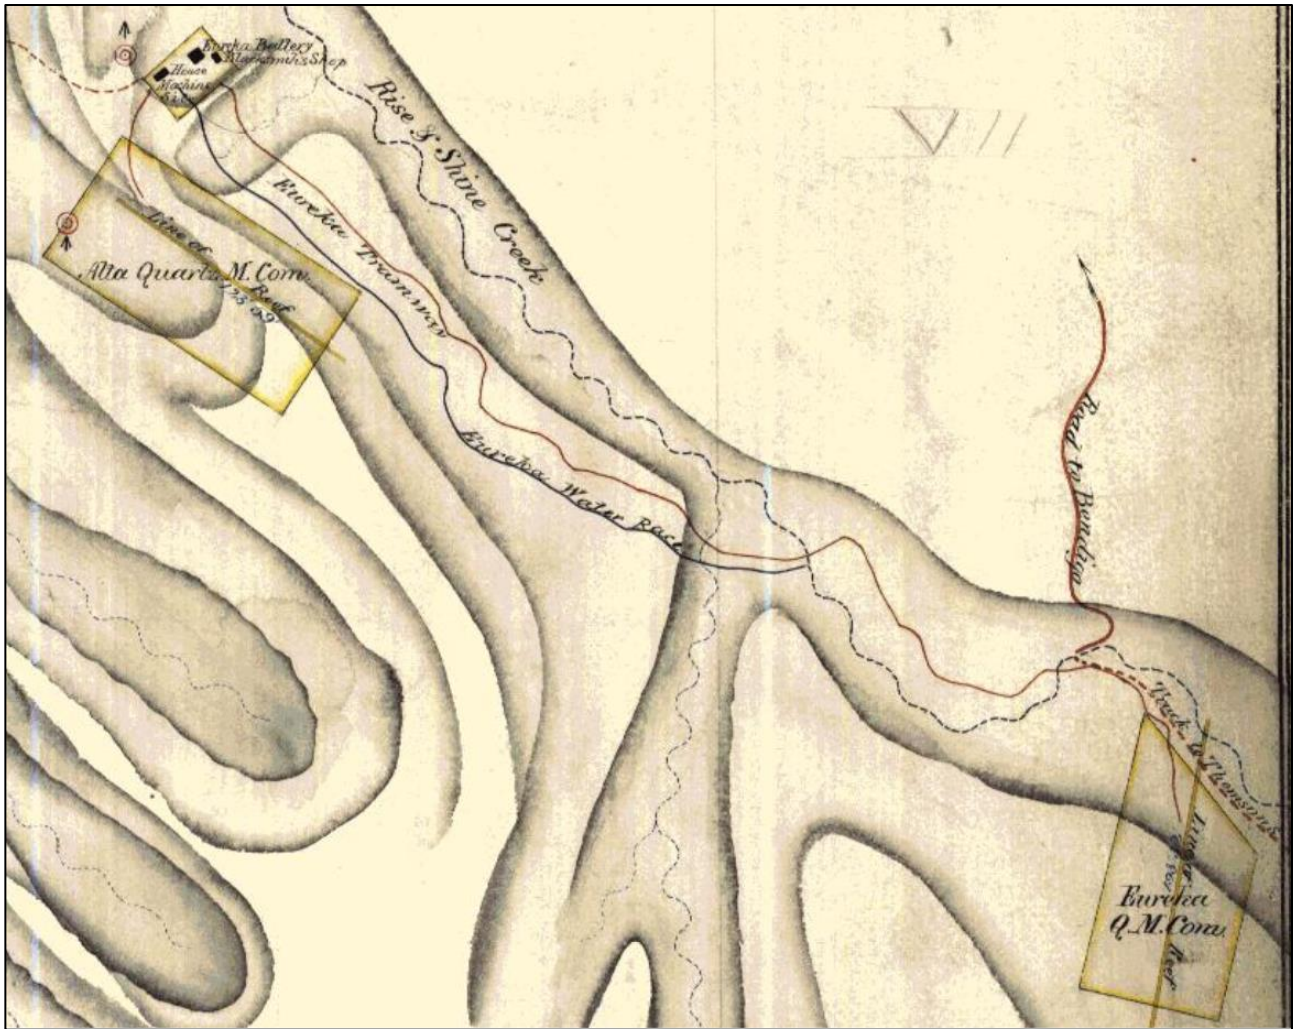
Figure 5 Survey plan SO 2086 (1876) showing the Eureka reef at the location of the Rise and Shine mine and battery site (G41/277), in relation to the Eureka mine and battery site (G41/252) and the Alta reef around the site of the Alta battery site (G41/253). The plan also shows the Eureka Water Race and the Eureka Tramway recorded as part of the Eureka Mine and battery (G41/252) (Source: QuickMaps).
