TO: Matakauui Gold Limited  
COPY TO: [REDACTED]  
FROM: [REDACTED]

Date: 16 April 2026  
Job No: 69137

**BENDIGO-OPHIR FRESHWATER STREAM ECOLOGICAL VALUATION**

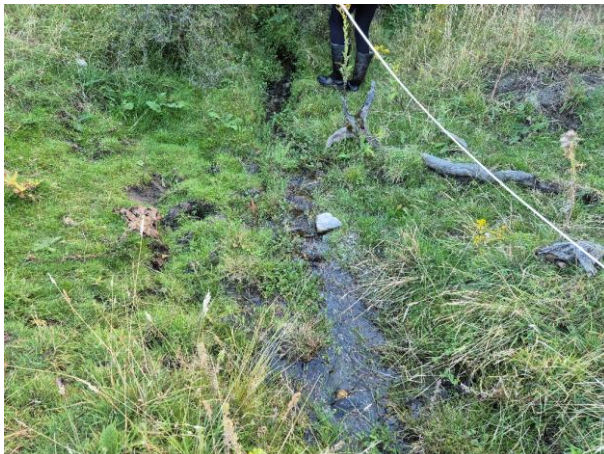
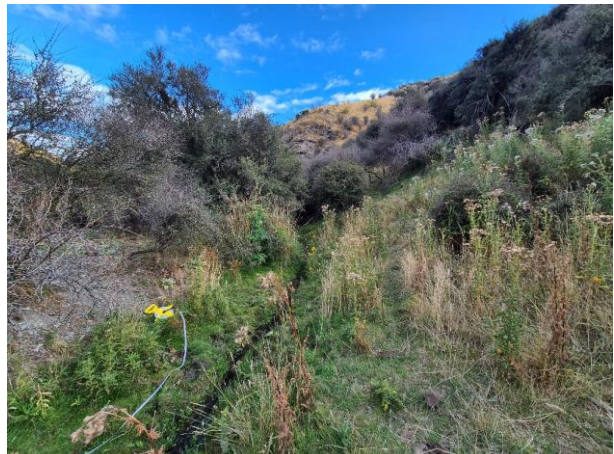
Shepherd's Creek recorded an SEV score of 0.49 within the proposed diversion reach site and 0.36 at the water take site. These relatively low scores are primarily driven by limited shading due to the pasture-dominated riparian margins and stock access, which has damaged stream banks and increased fine sediment loading, thereby reducing biogeochemical function. Riparian vegetation is dominated by pasture species, with scattered mingimingi (*Coprosma propinqua*), matagouri (*Discaria toumatou*), sweet brier (*Rosa rubiginosa*), and thistles (*Carduus* sp.).

Overall, Shepherd's Creek is a relatively natural channel with minimal modification. However high macrophyte growth and in-stream structures (such as the water take structure, road crossings) have modified approximately 30–40% of the channel. Despite this, overall bank condition is considered good, with no significant obstruction to floodplain connectivity.

Livestock pugging has widened the wetted channel, meaning that smaller flood events, which would typically be contained within the channel, are more likely to extend into the floodplain. The floodplain is predominantly vegetated with long and short grasses, with some low shrubs present. In addition to localised bank damage, it is estimated that up to 60% of the channel is affected by elevated fine sediment loading.

**Photo 1. Downstream reach of the Diversion Channel section of Shepherd’s Creek**

**Photo 2. Upstream reach of the Diversion Channel section of Shepherd’s Creek**

Based on the relatively low SEV scores recorded for Shepards Creek to be diverted, it is considered likely that the diversion channels will be capable of achieving equivalent ecological values over time. Rise and Shine Creek SEV scores indicated greater ecological values than Shepard's Creek, however ensuring the stream features, particularly shade, substrate and hydrology are appropriately implemented, it is likely the diversion channel will achieve similar ecological values but will likely take a longer time period to establish than Shepard's Creek. We note that full recovery of all ecological functions (particularly biotic components such as fish and invertebrates) cannot be assumed and will depend on post-construction conditions and timeframes. The outcome for both creeks is dependent on the diversion channels being constructed and implemented appropriately, under the guidance of a suitably qualified and experienced freshwater ecologist.

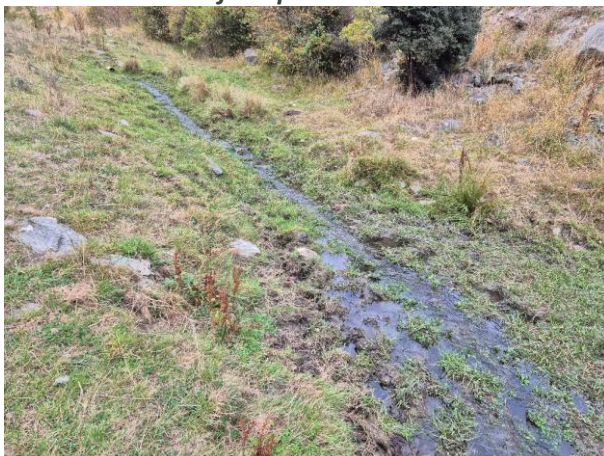
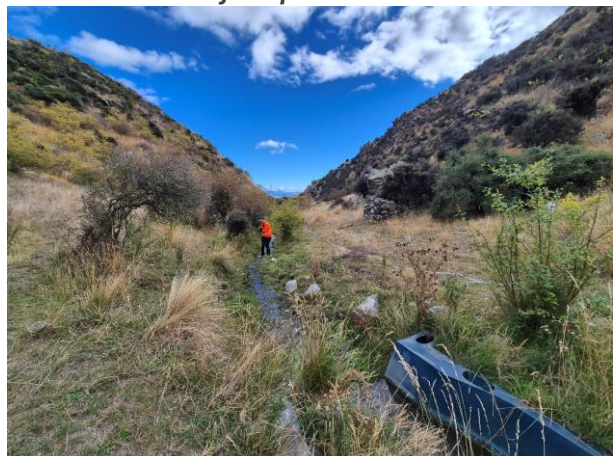
**Photo 3. Downstream reach of the water take section of Shepherd’s Creek**

**Photo 4. Upstream reach of the water take section of Shepherd’s Creek**

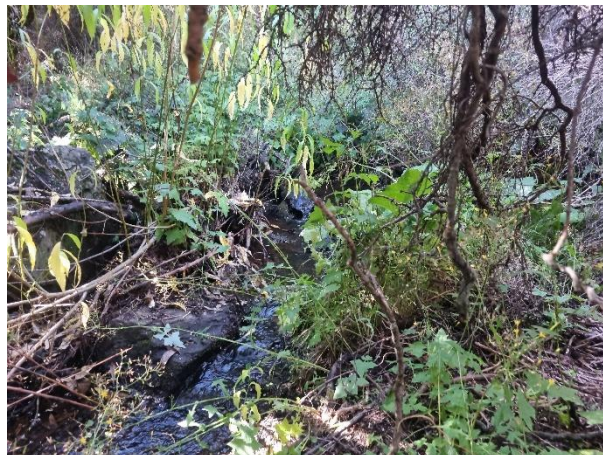
Dense indigenous vegetation covers the majority of the 20 m riparian zone, providing consistent year-round shading. However, the relatively sparse understory limits the overall filtration function of the riparian margin.

Riparian vegetation is dominated by dense matagouri, with some exotic species present. However, channel incision reduces connectivity between the stream and the floodplain.

**Photo 6. Riparian yard within Rise and Shine Creek.**

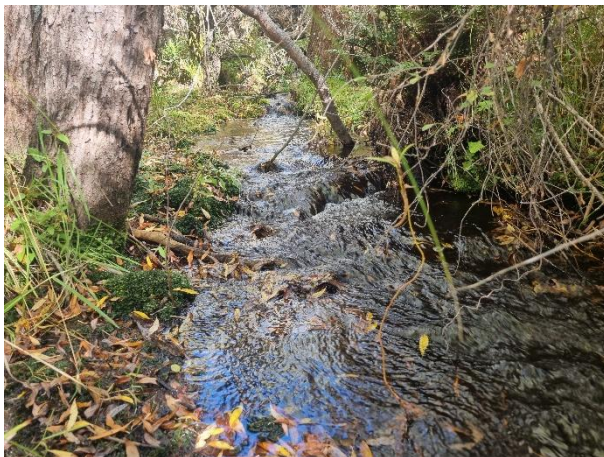
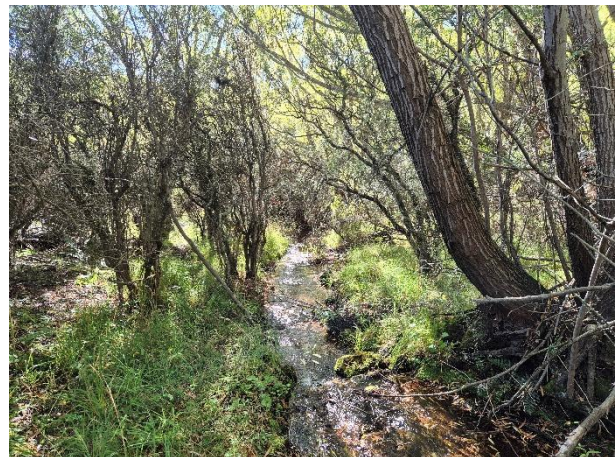
The assessed Bendigo Creek reach was located within the proposed Willow Control Area. Within this representative reach, dense willow growth has created a braided flow pattern, with multiple chutes and channels and areas of wetland habitat. The main channel was assessed over a 100 m reach.

The Bendigo Creek is predominantly soft-bottomed, with limited hard substrates present. Willow root systems are likely covering the underlying natural hard-bottomed streambed. A low-profile ford located immediately upstream of the assessed reach (i.e. where willows are absent) contains a mix of gravel sizes and some small cobbles.

This reach recorded an SEV score of 0.65 reflecting the overall natural appearance of the stream channel, despite modification from willow growth and generally undisturbed bank form.

Photo 7. Upstream reach of Bendigo Creek

Photo 8. Downstream reach of Bendigo Creek

For Bendigo Creek, a temporary decline in freshwater ecological values is expected within the Willow Control Area due to the removal of a substantial portion of the riparian zone dominated by crack willow, and the associated reduction in shading during the warmer summer months. However, the replacement of exotic, deciduous vegetation with indigenous, evergreen riparian planting is expected to provide a long-term ecological benefit to the creek and downstream receiving watercourses.
