# GREENHILL INDUSTRIAL PARK

## PRELIMINARY GEOTECHNICAL REPORT

PROJECT NO: HD3783  
GREENHILL INDUSTRIAL PARK  
CONSORTIUM  
REFERENCE: PGR 01  
21 OCTOBER 2025

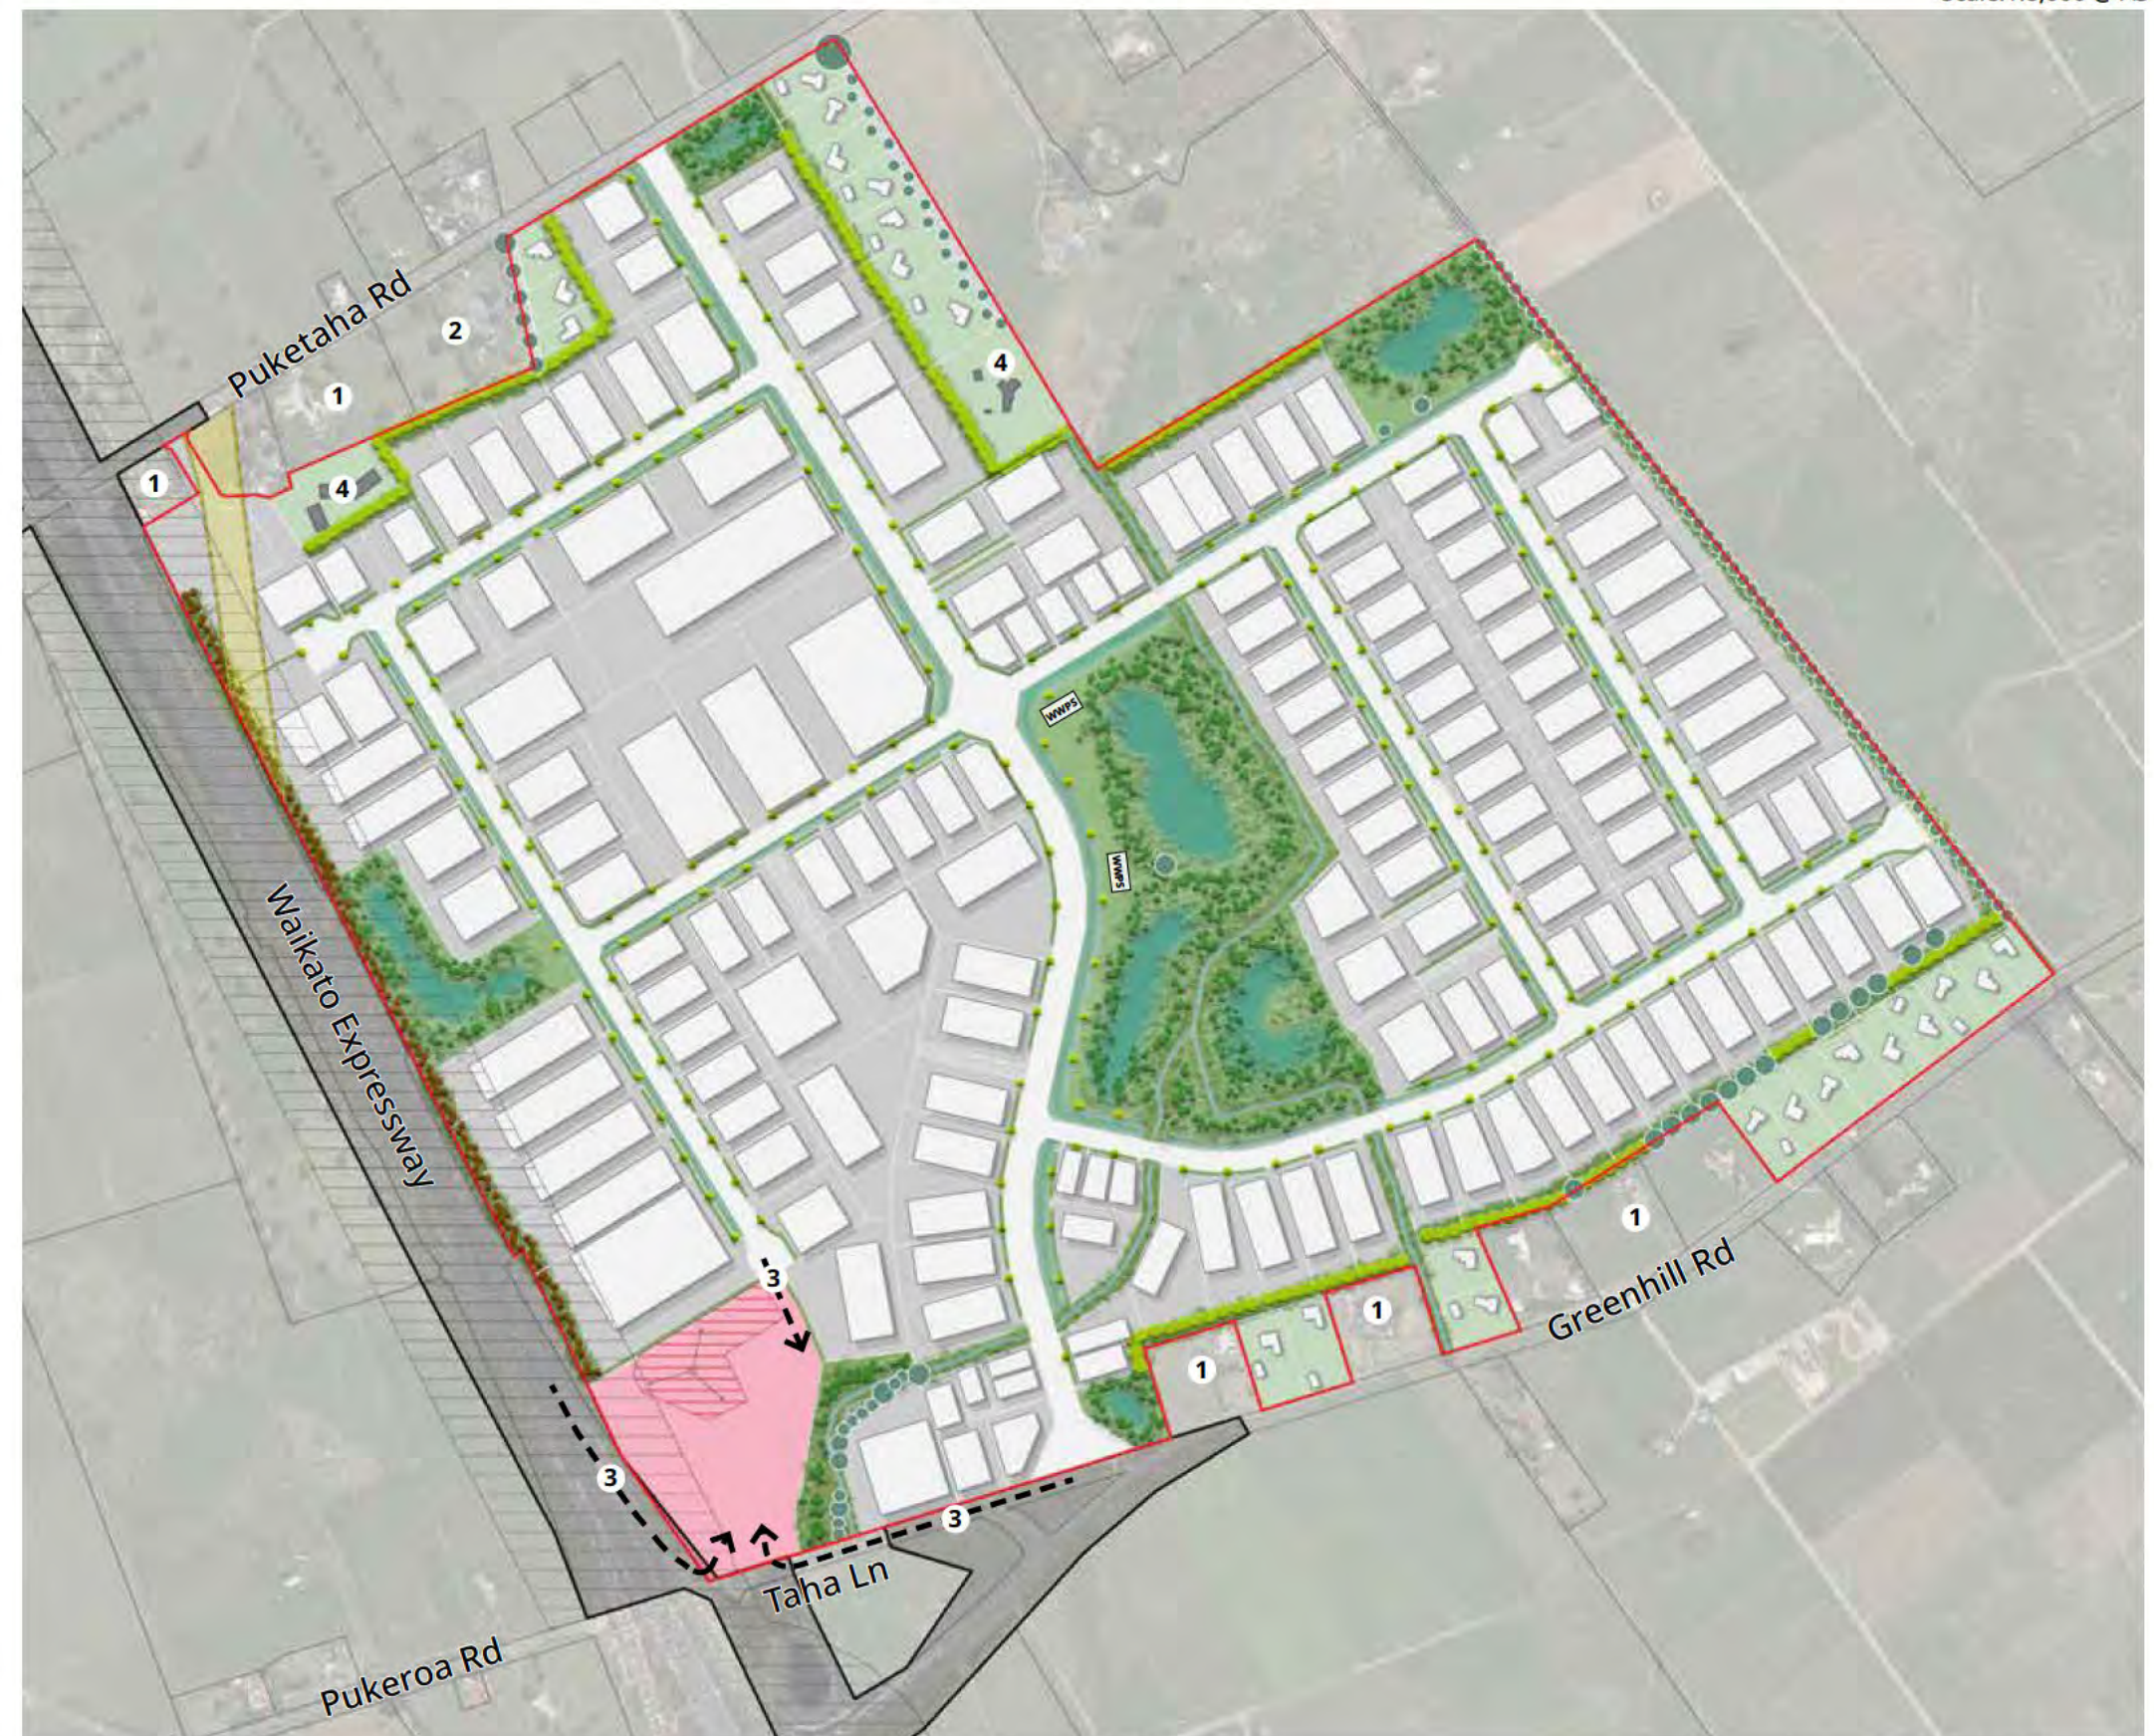
Figure 8 High-level Masterplan

The Greenhill Industrial Park Consortium plan to subdivide the site for primarily industrial use, with some residential lots connected through private roads. Road swales, landscape buffers, stormwater riparian areas, and stormwater ponds are also. We understand that the client intends to cut the elevated portion of the site down and use the material as fill across the rest of the site. High level plans are included in Appendix A.

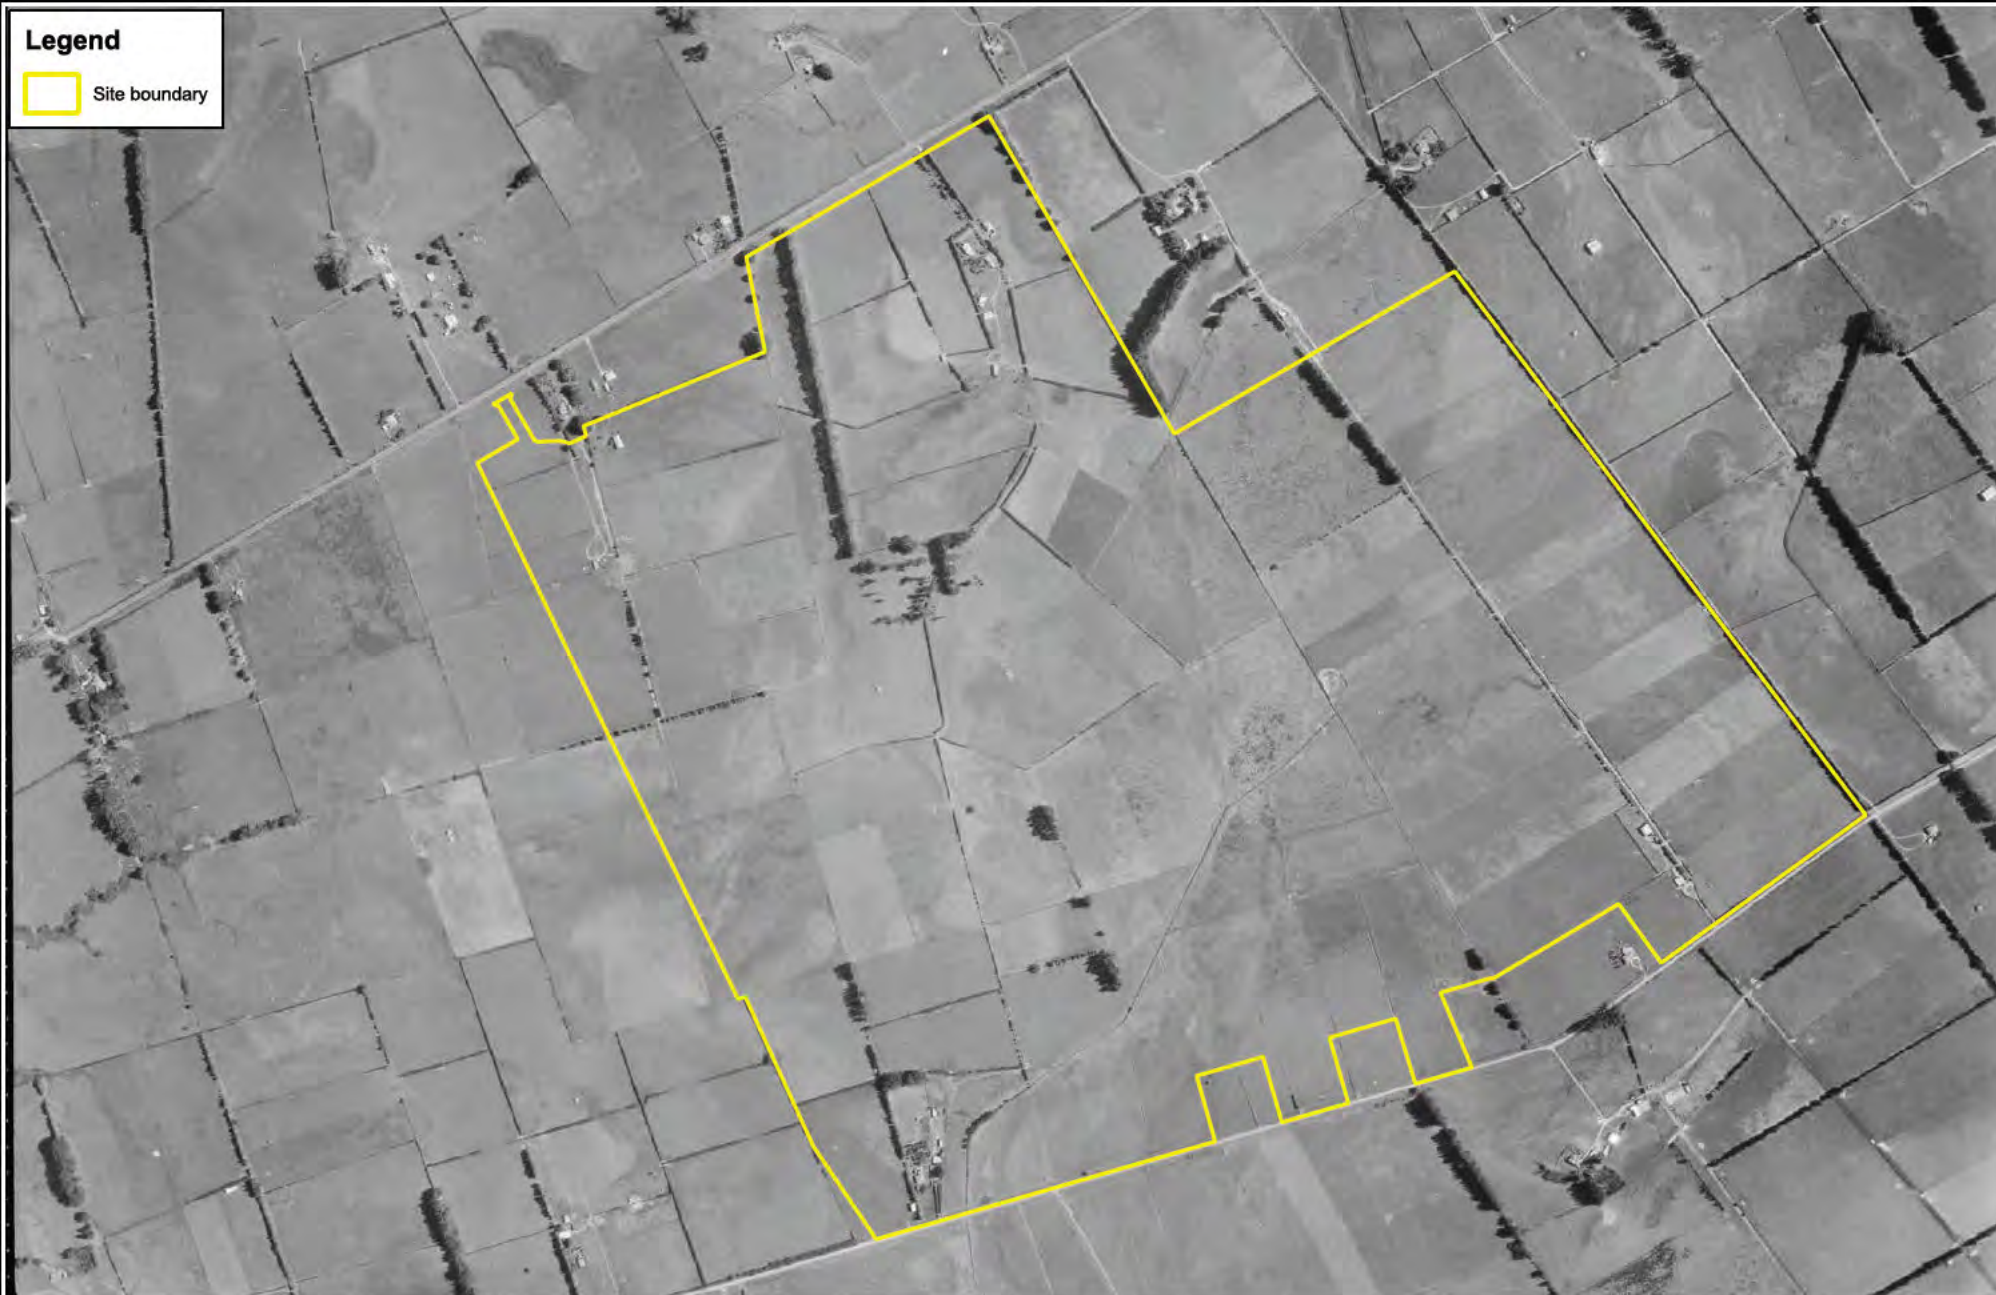
Greenhill Industrial Park  
Historic aerial images - 1963

| Date | Observations |
|---|---|
| 1963 | <ul style="list-style-type: none"><li>• The area remains largely unchanged, with continued agricultural use.</li><li>• Some minor changes in field boundaries and vegetation are visible.</li><li>• Tussocky vegetation is still visible across the central extent of the site.</li></ul> |

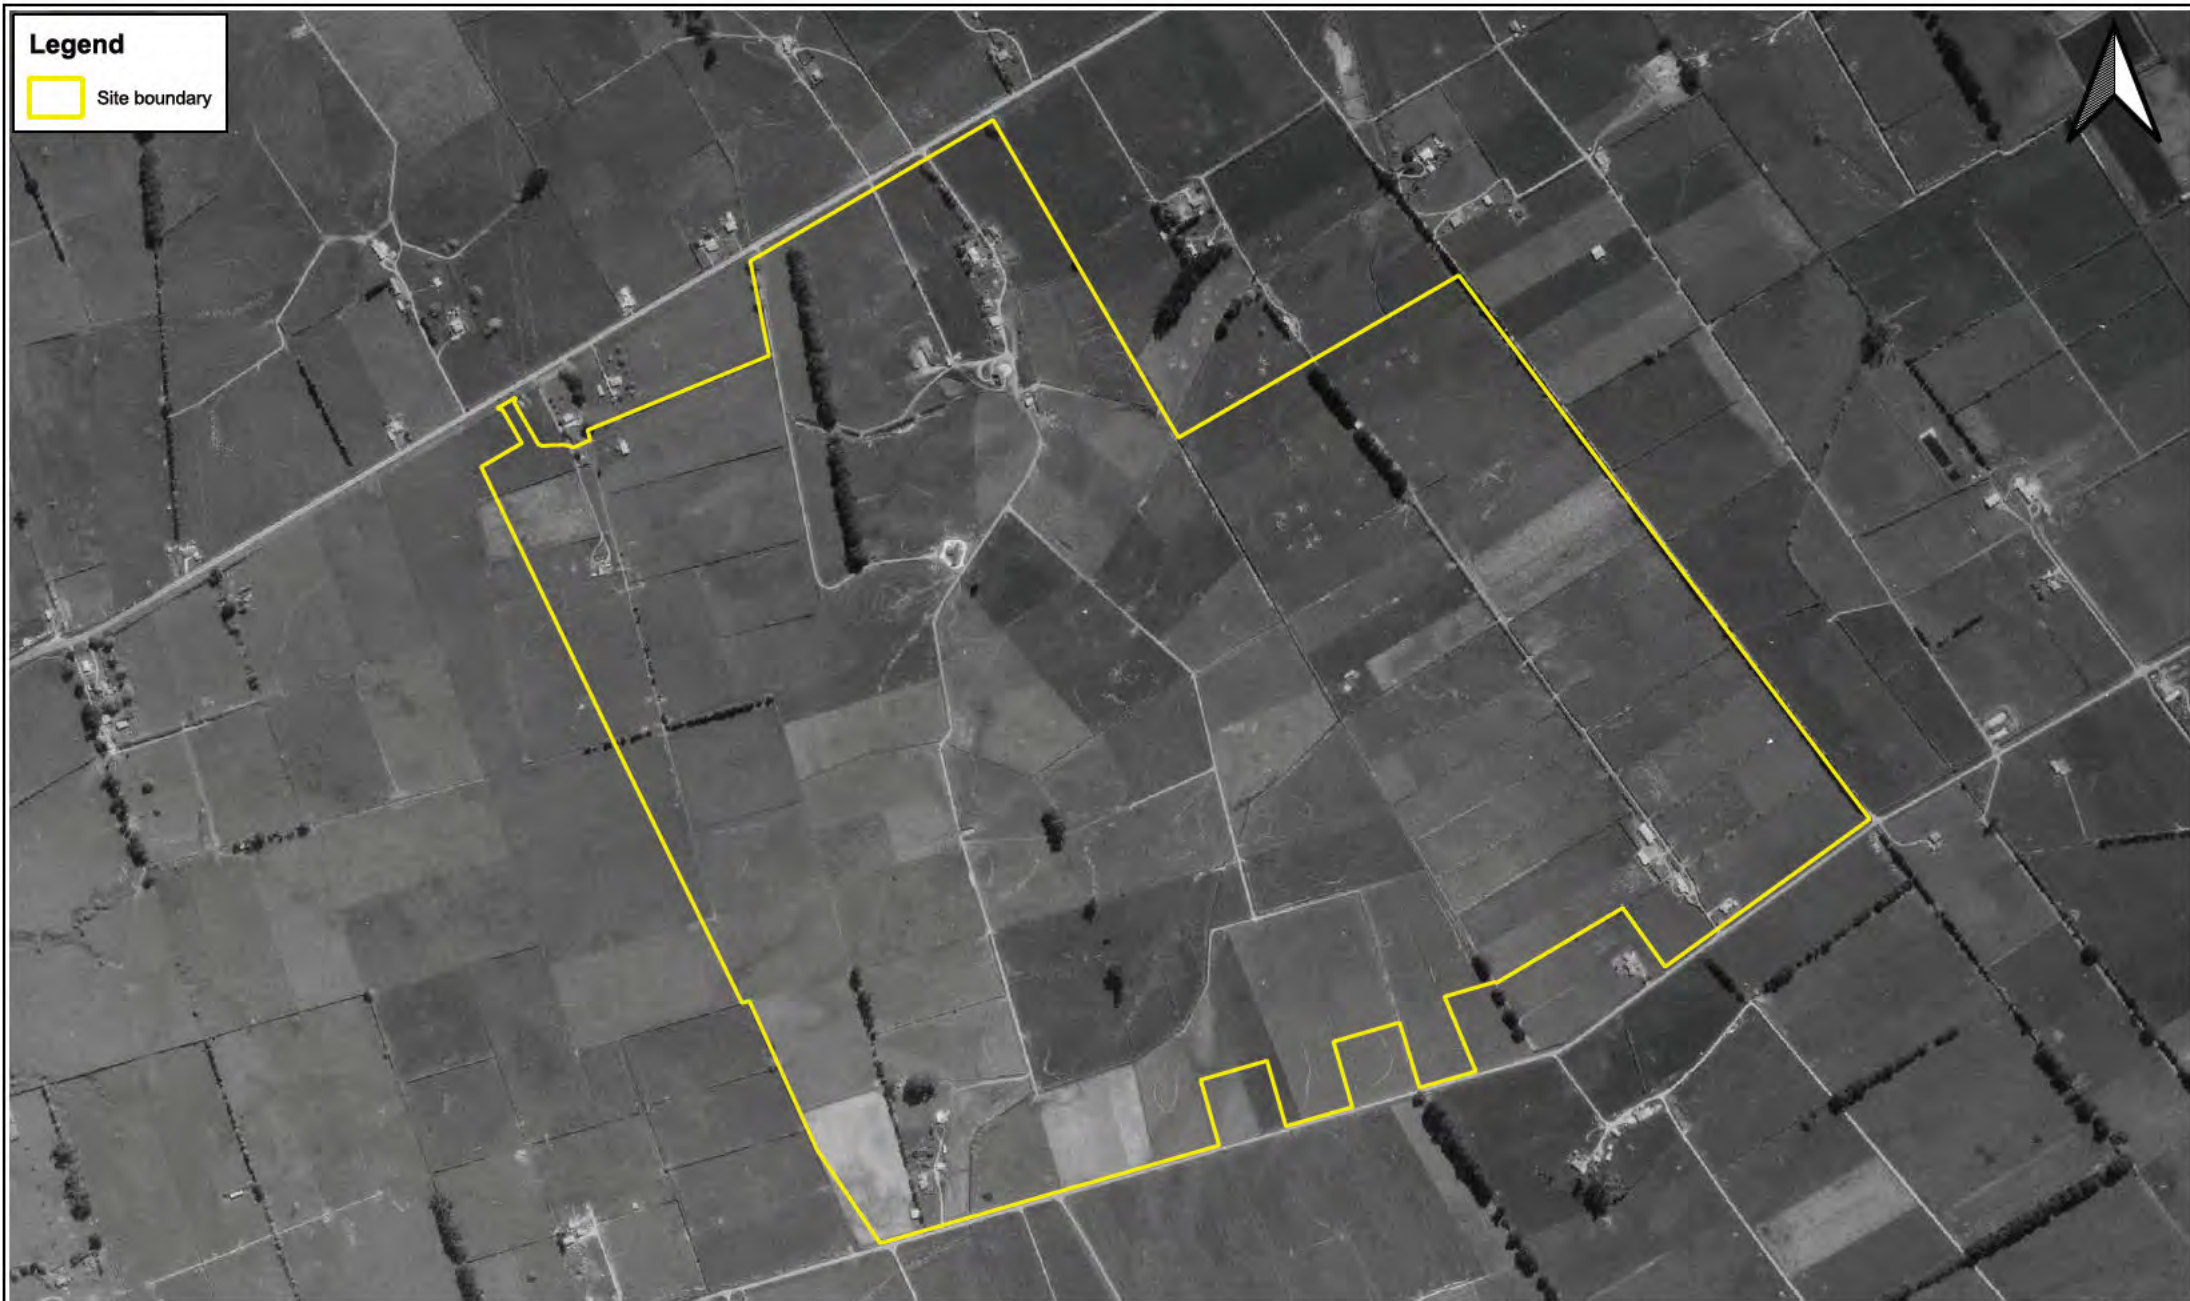
| Date | Observations |
|---|---|
| 1979 | <ul style="list-style-type: none"><li>• The site and surrounding area show gradual intensification of land use.</li><li>• More field boundaries and small structures appear, but the site itself remains undeveloped.</li><li>• Tussocky vegetation is no longer visible, potentially due to modification of the area for farming.</li></ul> |

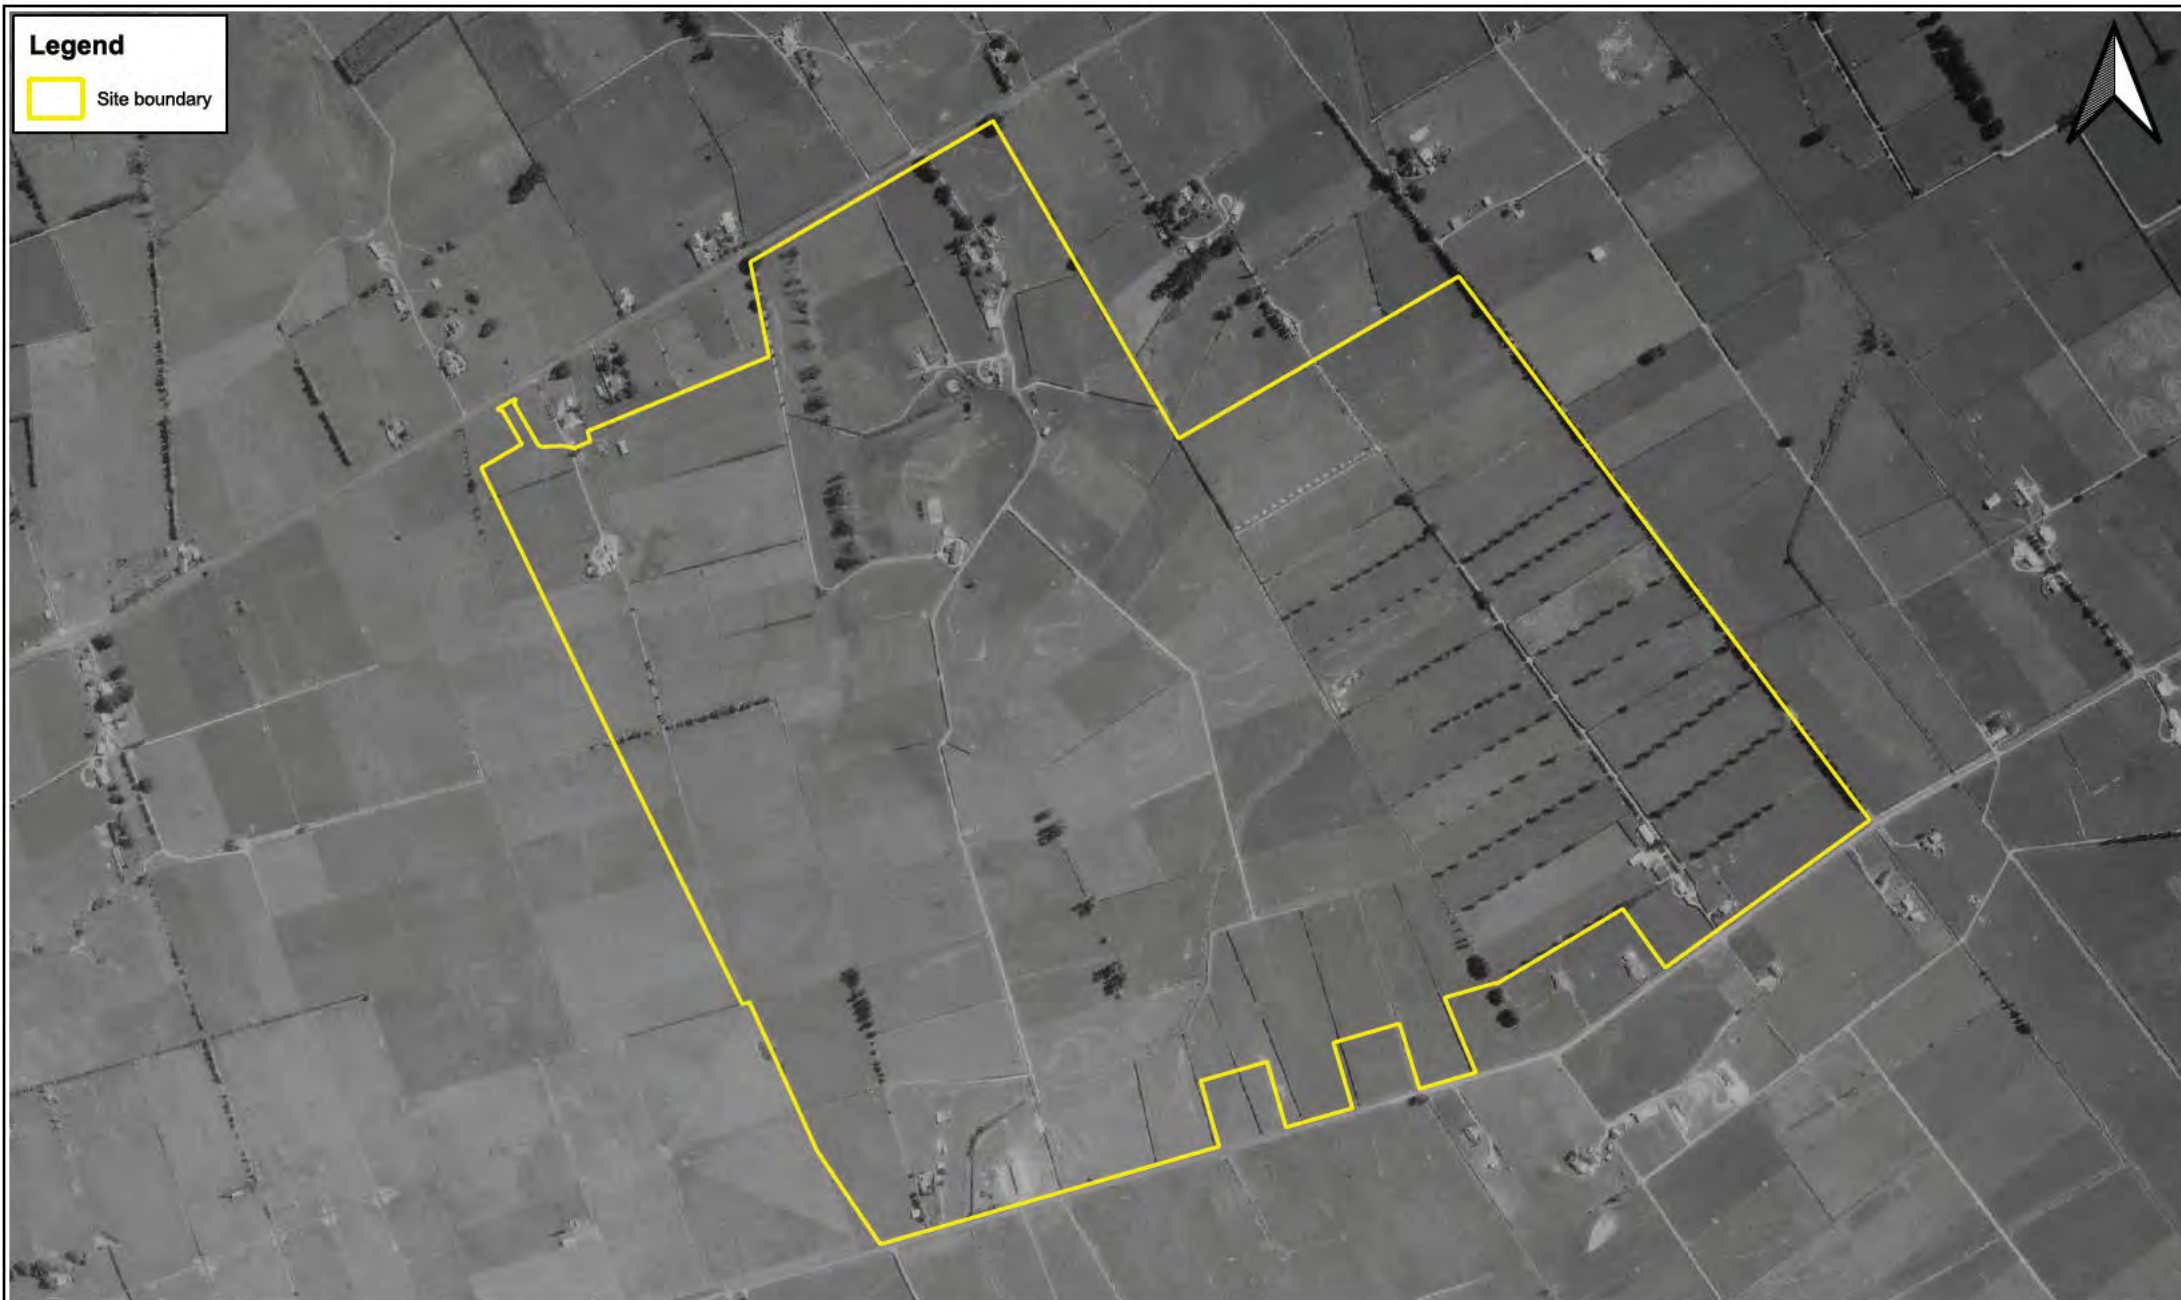
Greenhill Industrial Park  
Historic aerial images - 1991

| Date | Observations |
|---|---|
| 1991 | <ul style="list-style-type: none"><li>• There is a noticeable increase of vegetation planted within the southeast corner of the site.</li><li>• Off-site development begins to increase, with more structures visible to the north and east.</li><li>• Potential uncharacterised fill is visible within the central western area of the site*</li></ul> |

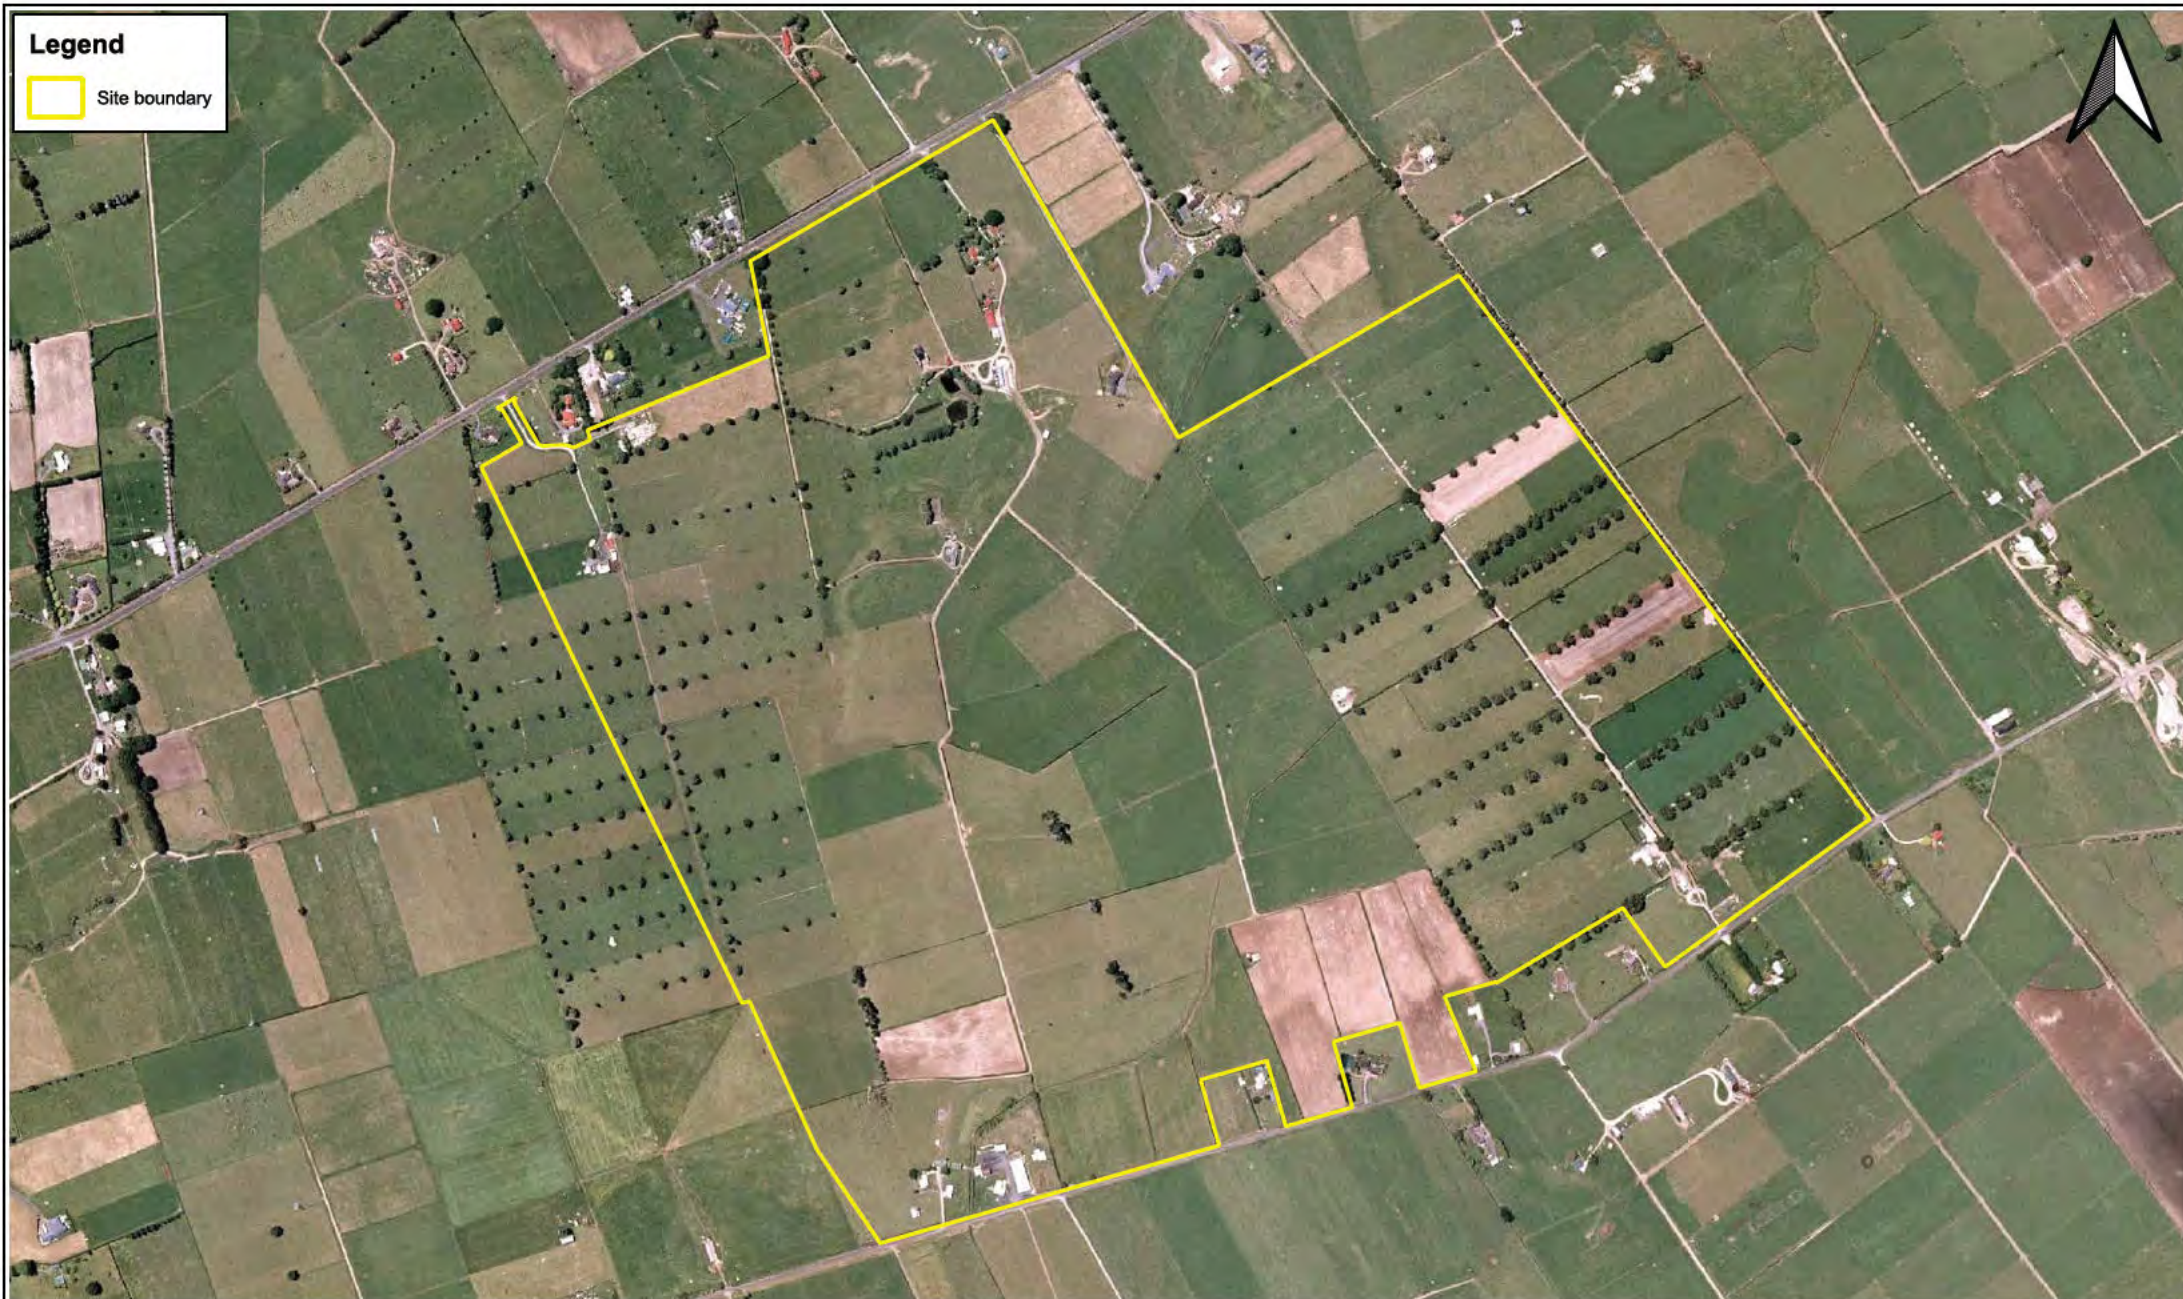
| CLIENT<br><br>Greenhill Industrial Park Consortium | | TITLE<br><br>Greenhill Industrial Park<br><br>Historic aerial images - 2008 | | | |

| Date | Observations |
|---|---|
| 2008 | <ul style="list-style-type: none"><li>• The site is still undeveloped, but surrounding areas show increased residential and rural development.</li><li>• Tree rows and shelterbelts are well established across the east and west site boundaries.</li><li>• Potential uncharacterised fill is visible onsite near the southern boundary.</li></ul> |

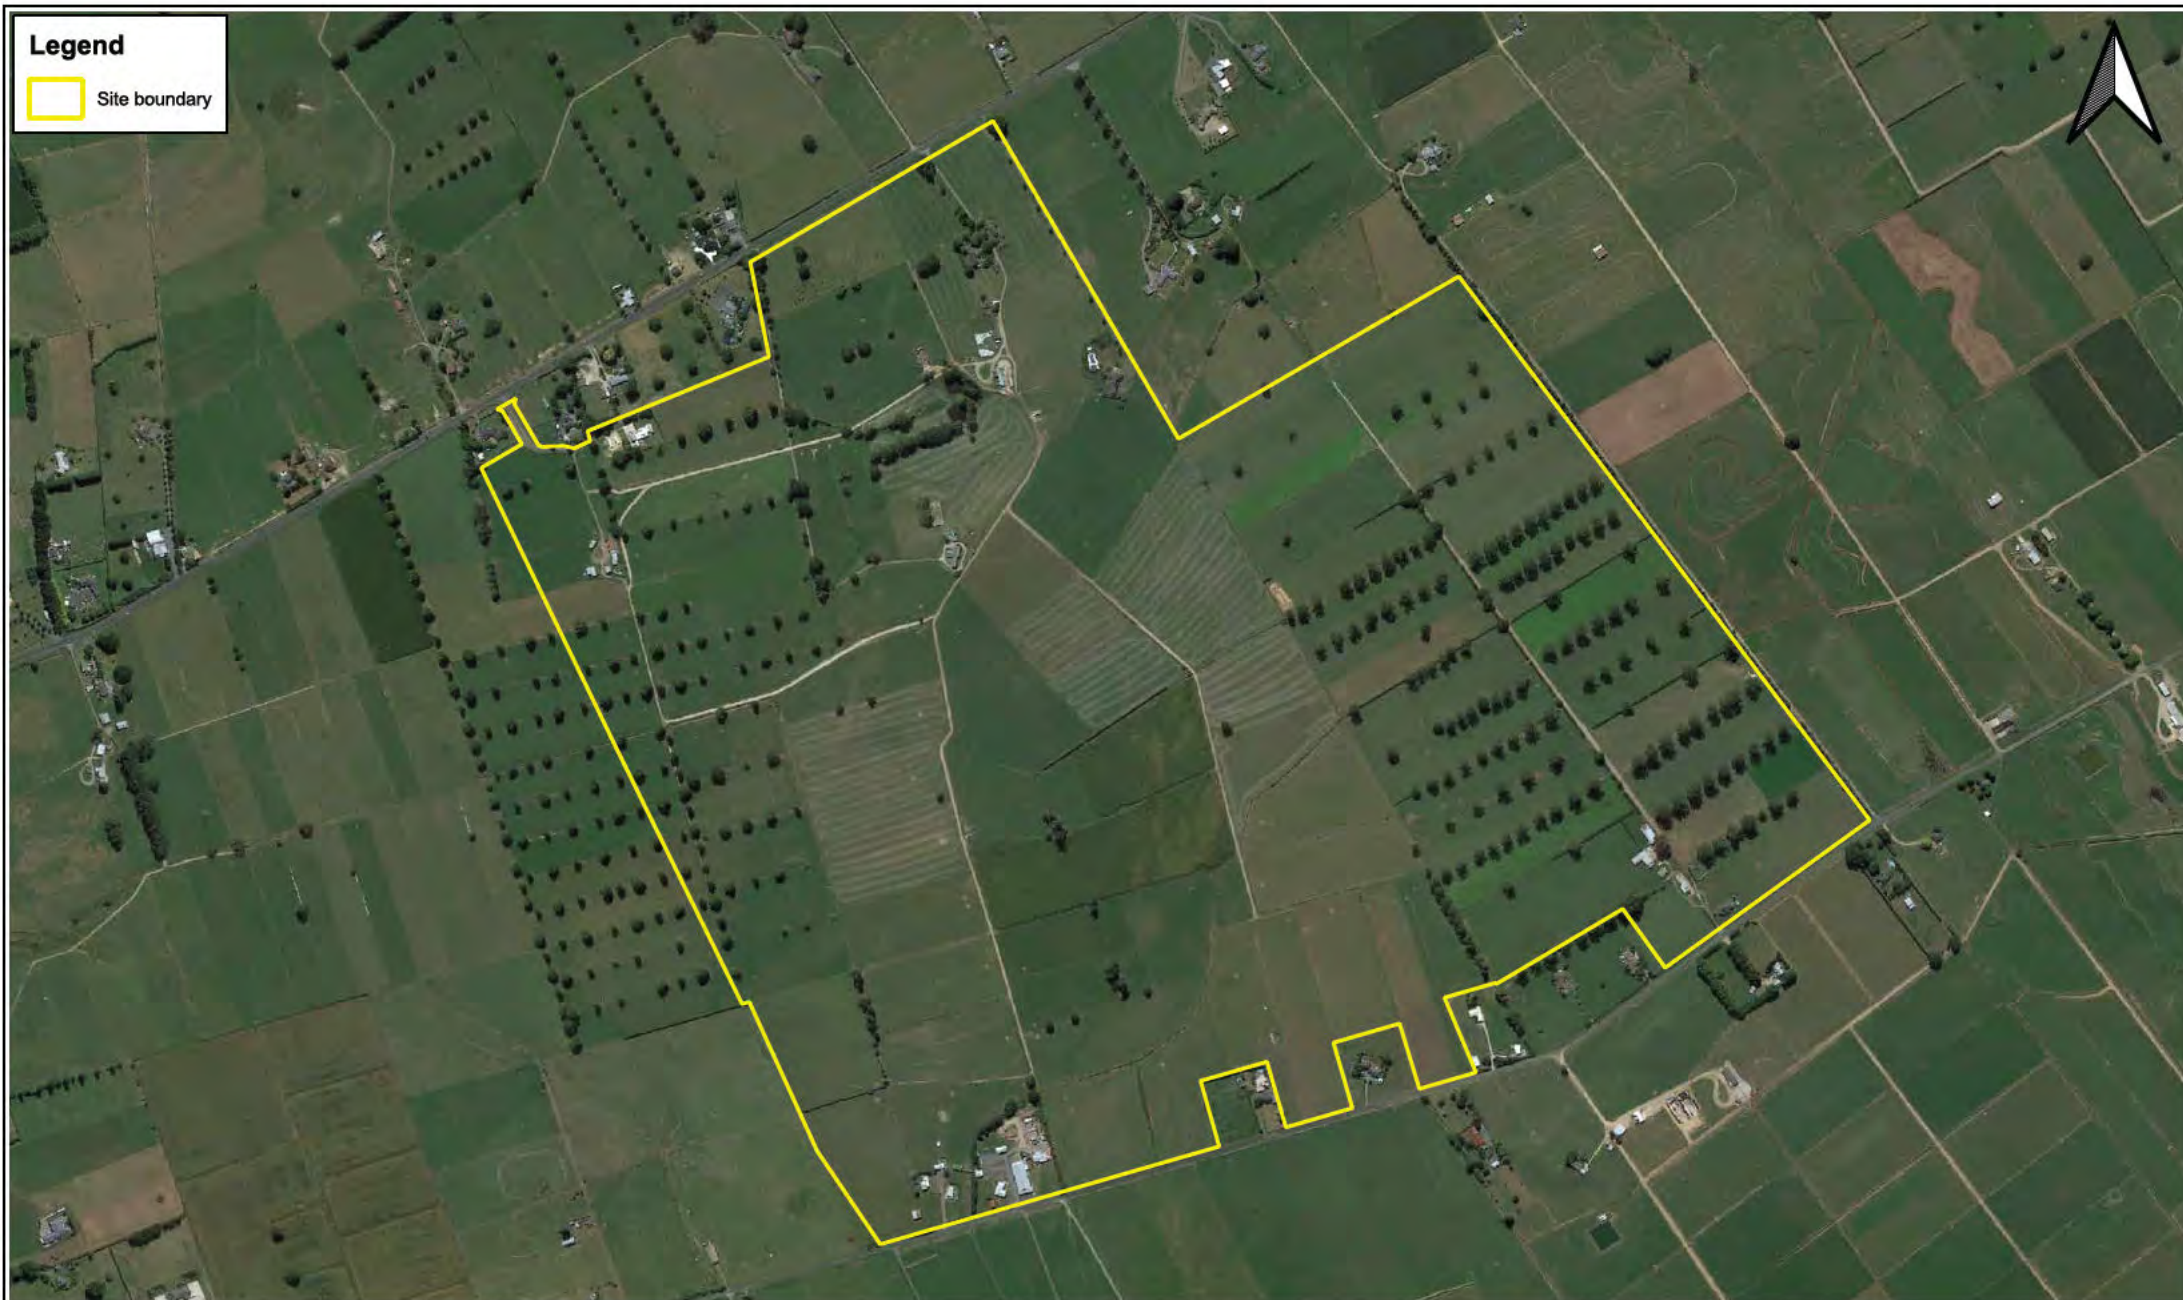
Greenhill Industrial Park  
Historic aerial images - 2016

| Date | Observations |
|---|---|
| 2016 | <ul style="list-style-type: none"><li>• The site remains largely unchanged, with continued agricultural use.</li><li>• Surrounding development continues, with more dwellings and infrastructure visible.</li></ul> |

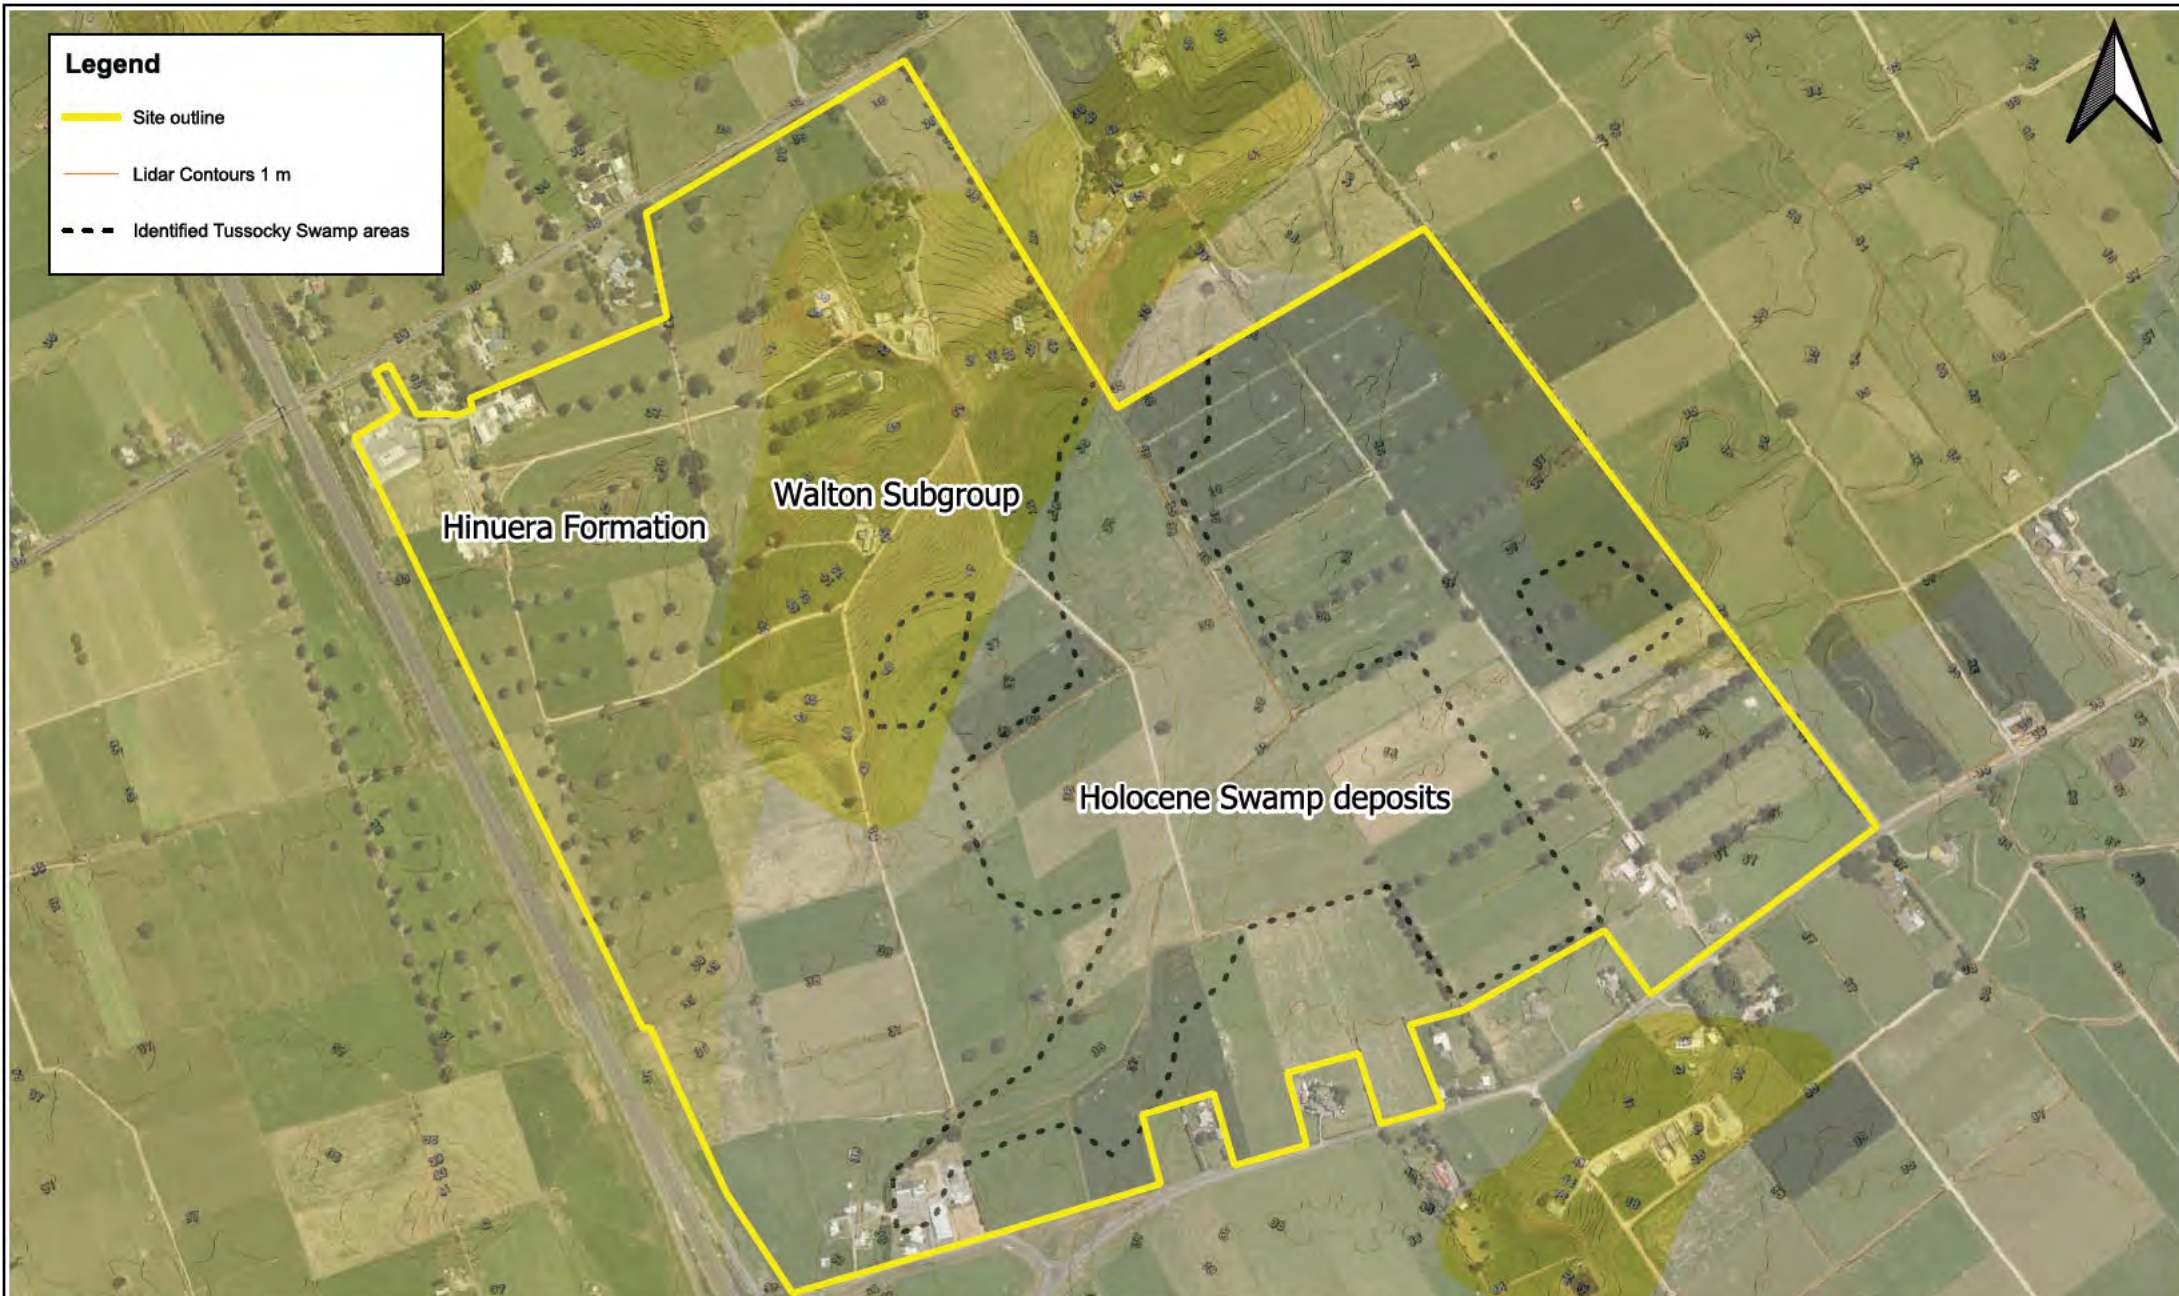
- Site outline
- Lidar Contours 1 m
- - - Identified Tussocky Swamp areas

- the East and south extents are mapped as Holocene swamp deposits
- Holocene swamp deposits are described as 'soft, dark brown to black, organic mud, muddy peat and woody peat with minor overbank sand, silt and mud'
- areas mapped as Holocene swamp deposits can also present as silt, sand and mud deposits with interbedded and/or lenses of peat. This means that the highly organic deposits can be locally limited across the mapped area. This was confirmed by some existing testing reviewed as part of the desk study
- flat areas, (RLs 36 m to 37 m) align with the Holocene swamp deposits
- a plan showing slope grades and the suspected swamp areas are provided in Appendix D
