Mill Road subdivision, Ōhoka

Archaeological assessment

Archaeological site No.	M35/1875 (Ōhoka railway station)
Site address	535 Mill Road and 290 Bradleys Road, Ōhoka (Lot 2 and 3 DP 318615, part Lot 1 DP 8301, Lot 2 DP 8301, Lot 2 DP 61732)
Client	Carter Group Ltd
Client contact	Bruce Van Duyn
Report authors	Tristan Wadsworth, Anthalina Gibson (historical background)
Reviewed by	Kirsa Webb
Nominated s45 Approved Person	Tristan Wadsworth
Report submitted to	Carter Group Ltd, Ngāi Tūāhuriri Rūnanga, Heritage New Zealand Pouhere Taonga, Environmental Protection Authority, FTA Panel Conveners and Expert Panel, Waimakariri District
Document control ID	J012274_AA_REV B

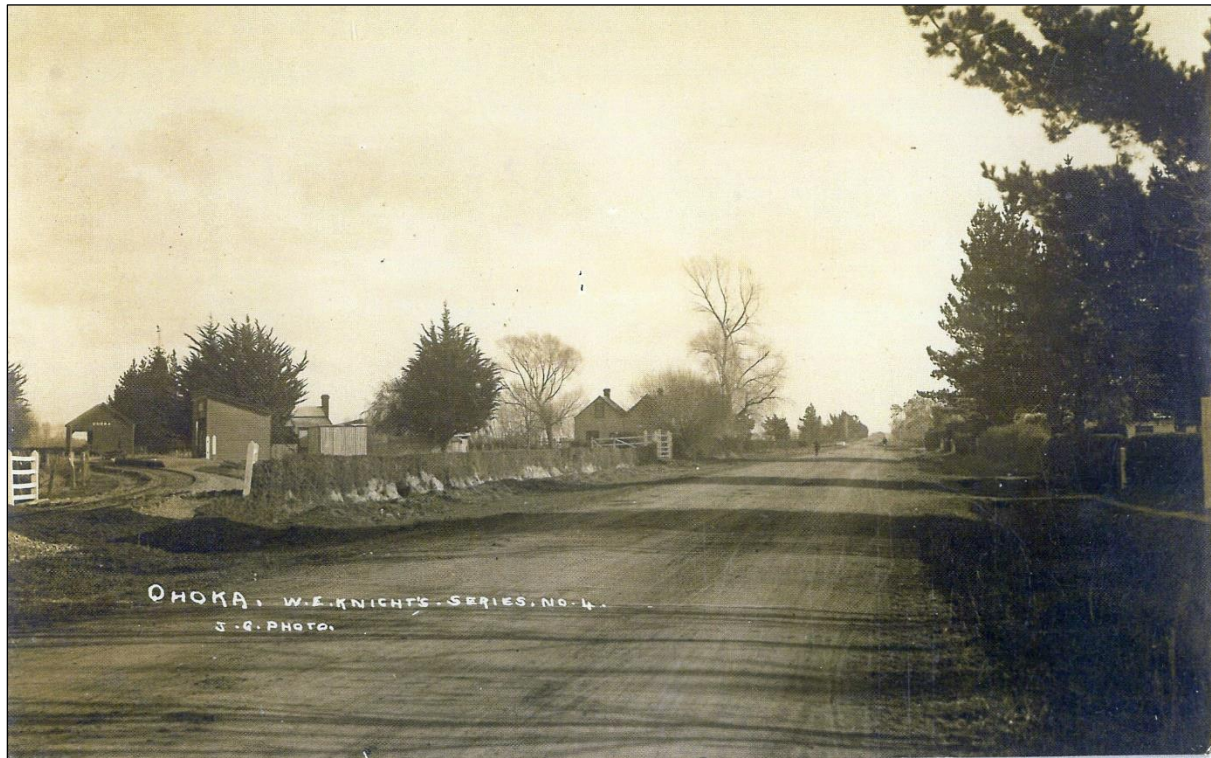
Figure 5-3. View of Mill Road looking west towards the Bradley Road intersection, with no specific date, but likely early 20th century. A two-storied dwelling is visible at the centre of the image, which was the first Methodist parsonage. Image: Knight, n.d.

A photograph from the early 1900s shows the Ohoka railway station with its sidings, associated buildings, station master's house and a two-storied double-gabled dwelling near the corner of Mill Road and Bradley Road, at what would become known as the first Methodist parsonage when it was transferred to the church in 1911, 547 Mill Road, outside the proposed area of works (see Figure 5-3; Trotter, 2017: 3-4). It is possible that this could have been Clist's dwelling.

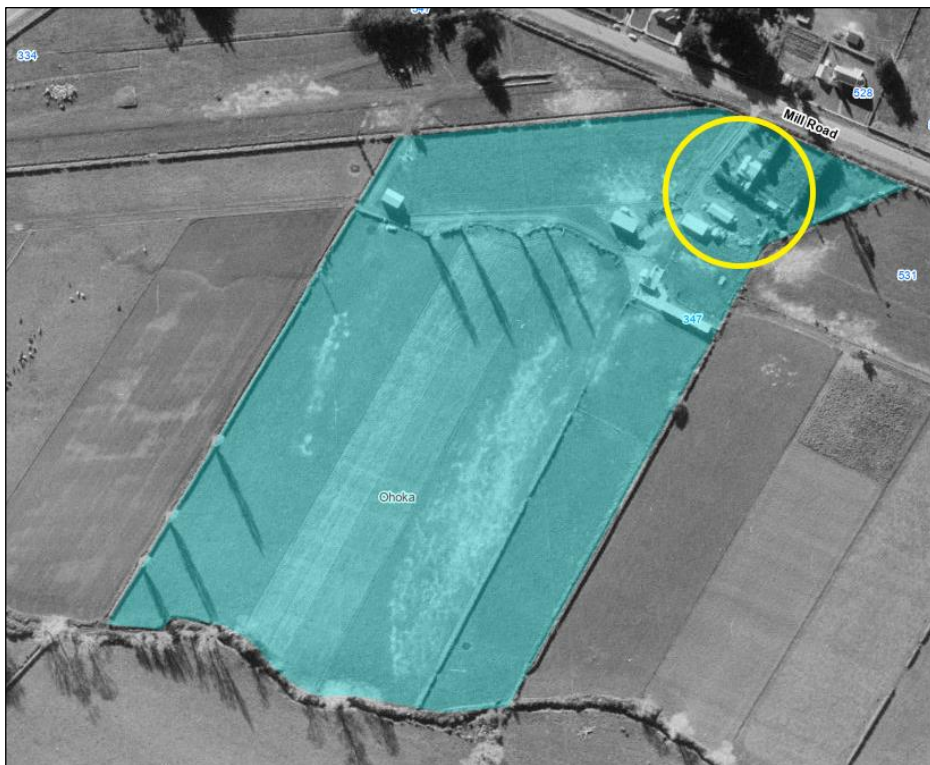
Figure 5-7. Detail from 1960 aerial imagery. Highlighted in cyan is part of Lot 2 DP 2267. The yellow circle shows the possible location of the 1888 dwelling recorded in the valuation rolls. Image: Canterbury Maps, 2025.

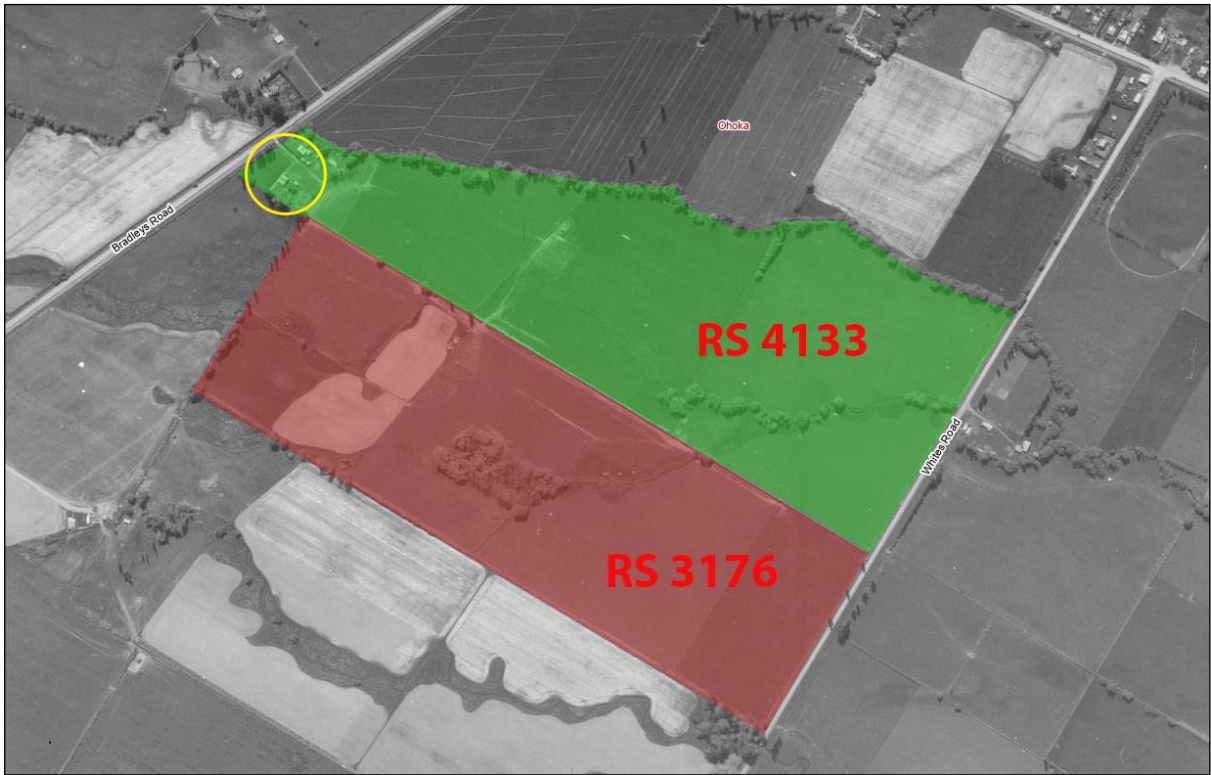
Figure 5-8. Aerial imagery from 1940. Highlighted in green is Rural Section 4133. The likely location of the pre-1900 structures is circled in yellow and remains outside the proposed area of works. Highlighted in red is Rural Section 3176 with no structures recorded on the section. Image: Canterbury Maps, 2025.

The likely location of these structures would be on Rural Section 4133. Aerial imagery from 1940 shows a dwelling and outbuildings at 290 Bradleys Road (Lot 1 DP 55849; Figure 5-8). By 1950, the dwelling had been removed and replaced with a new house (Canterbury Maps, 2025). The specific location of the dwelling is located outside the project area, but several of the outbuildings visible in the 1940s aerial are located within the project area, and these may include the pre-1900 stable or shed/dairy. The buildings within the project area had been removed by 1970, based on aerial photographs (Canterbury Maps, 2025).

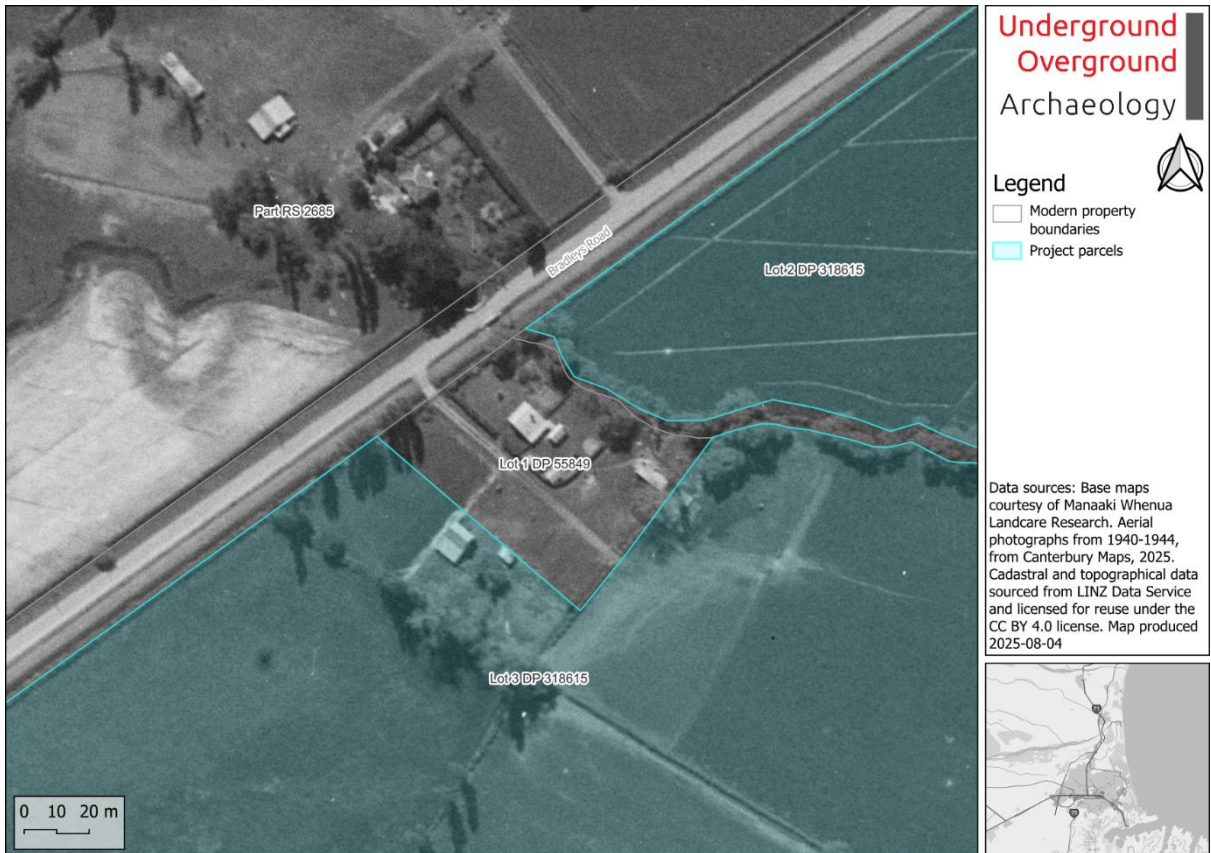
Figure 5-9. Aerial imagery from 1940 showing the extant buildings at this time in the vicinity of the modern Lot 1 DP 55849. Several of these buildings fall within the project area, and may have been built prior to 1900.

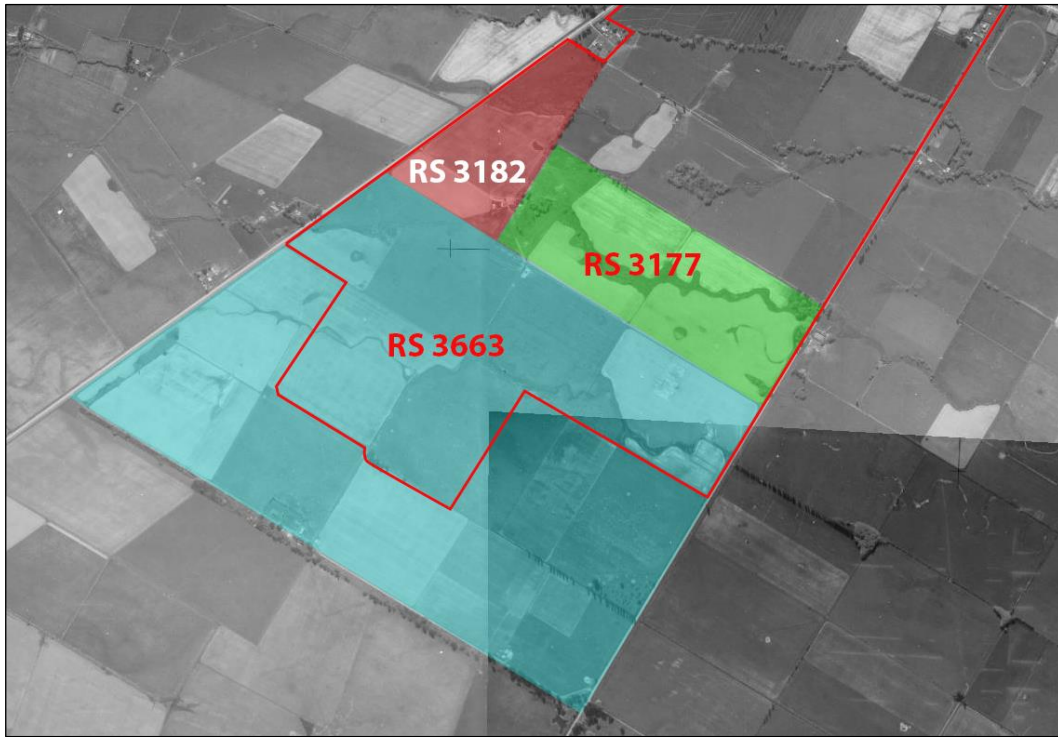
Figure 5-12. Rural Section 3177 (coloured green), 3182 (coloured red), and 3663 (coloured cyan) in aerial imagery from 1940. The red line marks the area of the proposed subdivision. Image: Canterbury Maps, 2025.

Aerial imagery from 1940 shows the relevant sections in pasture with a dwelling on Rural Section 3182 and outbuildings on part of Rural Section 3177. These may be the structures that were listed in the valuations (Figure 5-12). By 1960, the stream that runs through the sections had been deepened and straightened (see section 5.7). Further development of farming operations and outbuildings can be seen by 1970. In 1990, the dwelling was heavily modified; it is possible to see an extension and a change in the roofline. In current aerial imagery, the property has been divided into well-established paddocks with hedges as wind breaks. It is not clear from the imagery if the house was replaced entirely or renovated (Canterbury Maps, 2025).

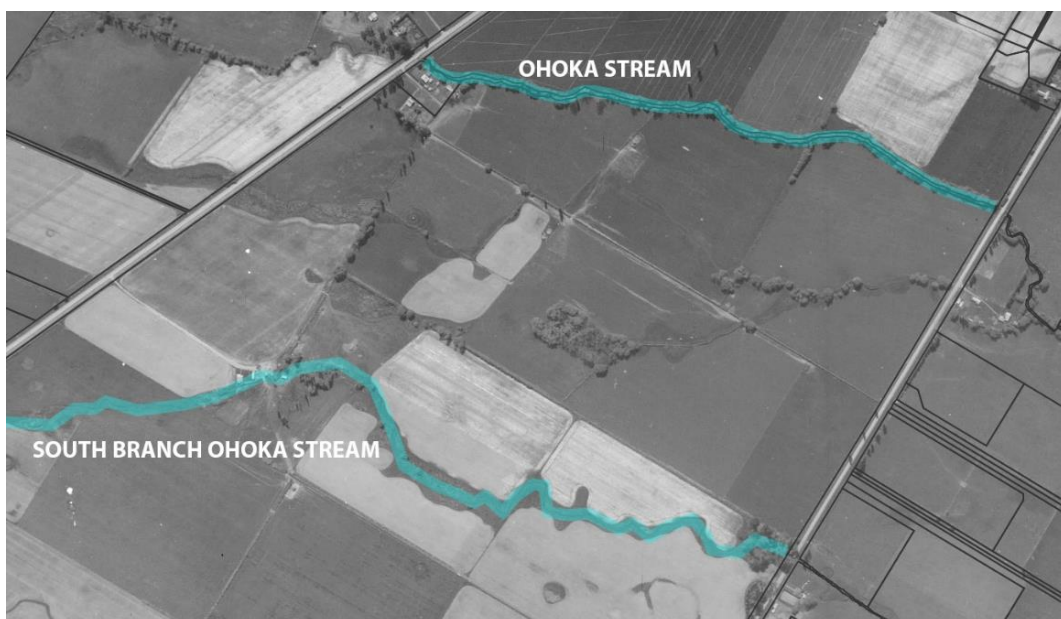
Figure 5-18. Detail from aerial imagery in 1940 showing the two branches of the Ohoka stream running through the proposed area of works. Image: Canterbury Maps, 2025.

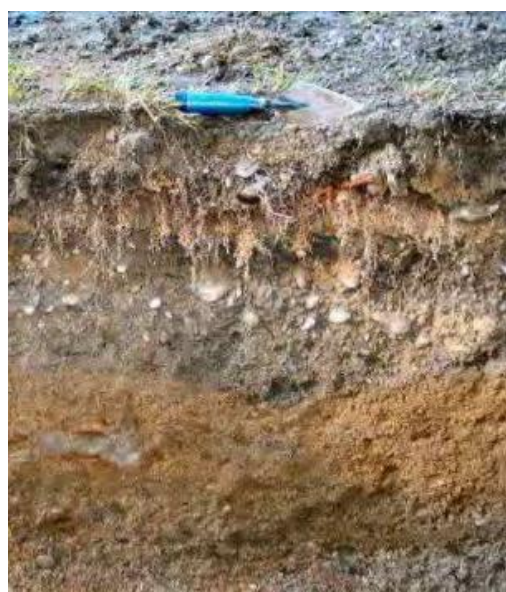
Figure 6-2. Exposed stratigraphy with ballast in centre, as exposed during works completed under archaeological authority 2016/644. Trowel included for scale. Image: Trotter, 2016: 7.

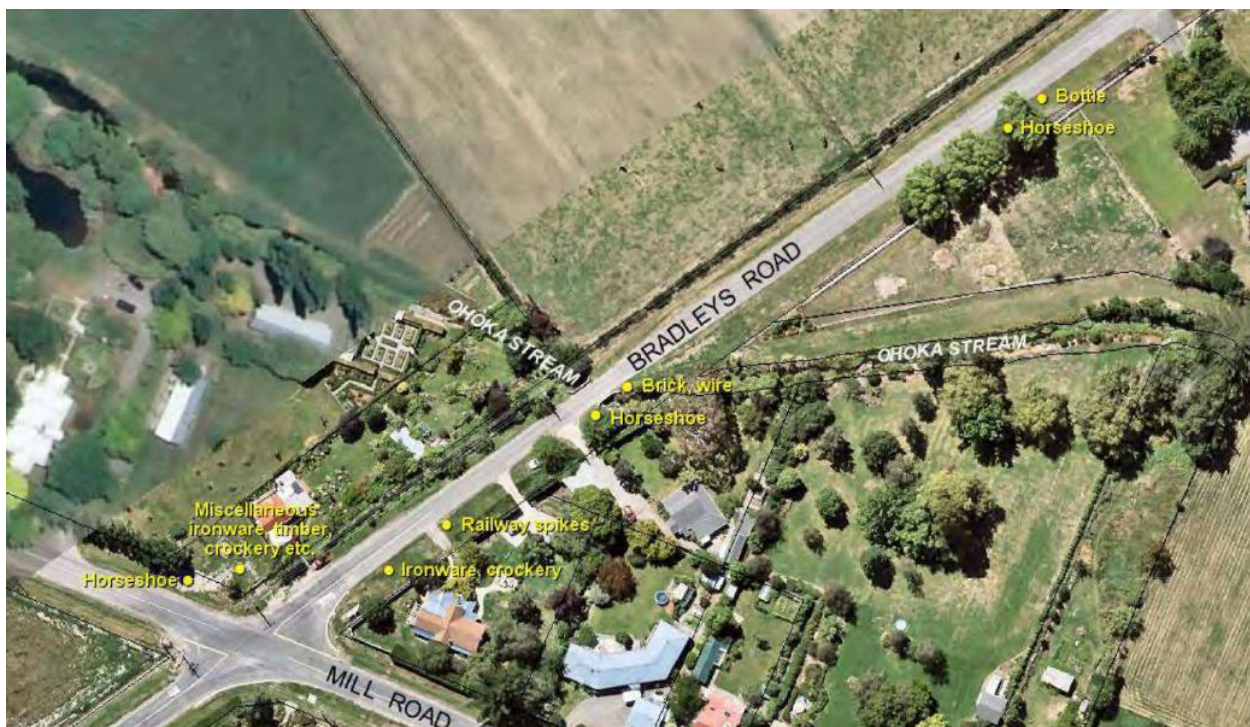
Figure 6-3. Annotated map showing the location of artefact findspots during works completed under archaeological authority 2016/911. Image: Trotter, 2017: 10.

The second set of sewer renewal works were completed under archaeological authority 2016/911. The earthworks occurred along parts of Bradleys Road, Mill Road, Whites Road, Keetly Place, and Wilson Drive. During these works scattered 19th and early 20th century artefacts were recovered along Bradleys Road, and Mill Road to the west of the Bradley Road intersection (Trotter, 2017: 9). This included numerous horseshoes, a screw augur, bricks, ceramic fragments, and further metal artefacts (Figure 6-3). The discovery of these artefacts led to the recording of the area as archaeological site M35/1893. The extent of these artefacts did not appear to continue eastward along Mill Road as no further artefacts were noted within the trench in this area.

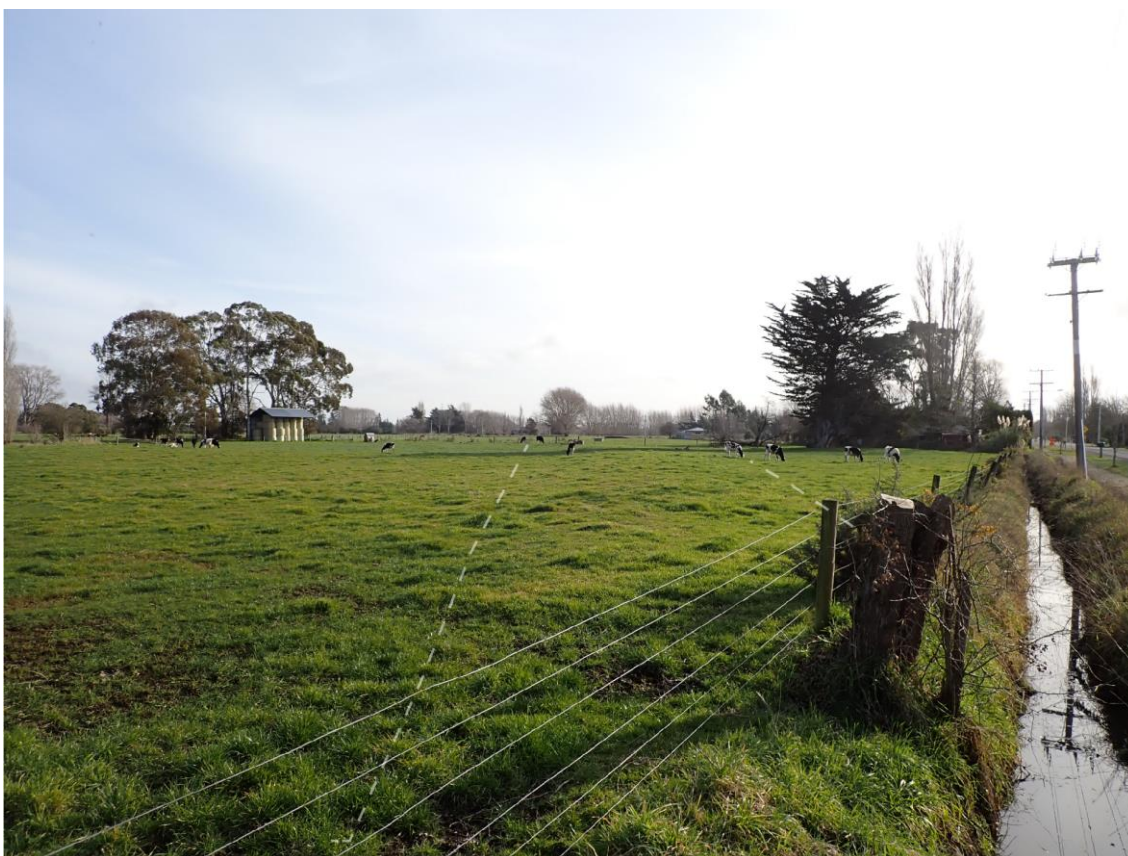
Figure 7-1. View southwest from Mill Road along railway embankment. The approximate boundaries of the embankment are shown with dashed white lines.

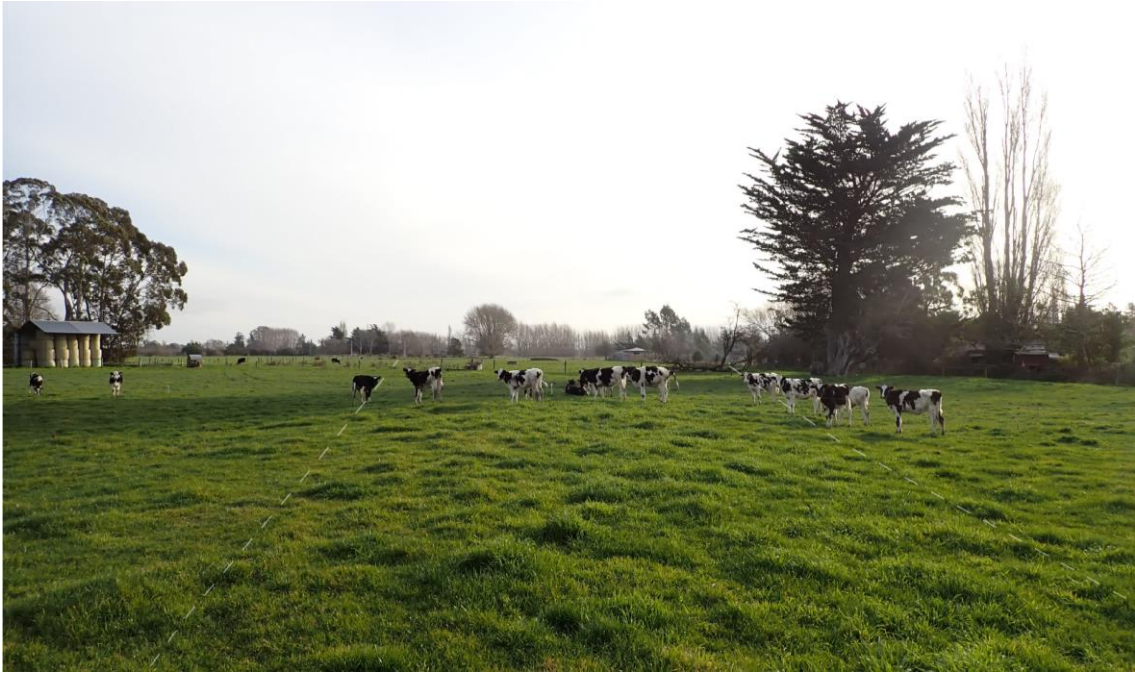
Figure 7-2. View southwest along railway embankment. The approximate boundaries of the embankment are shown with dashed white lines.

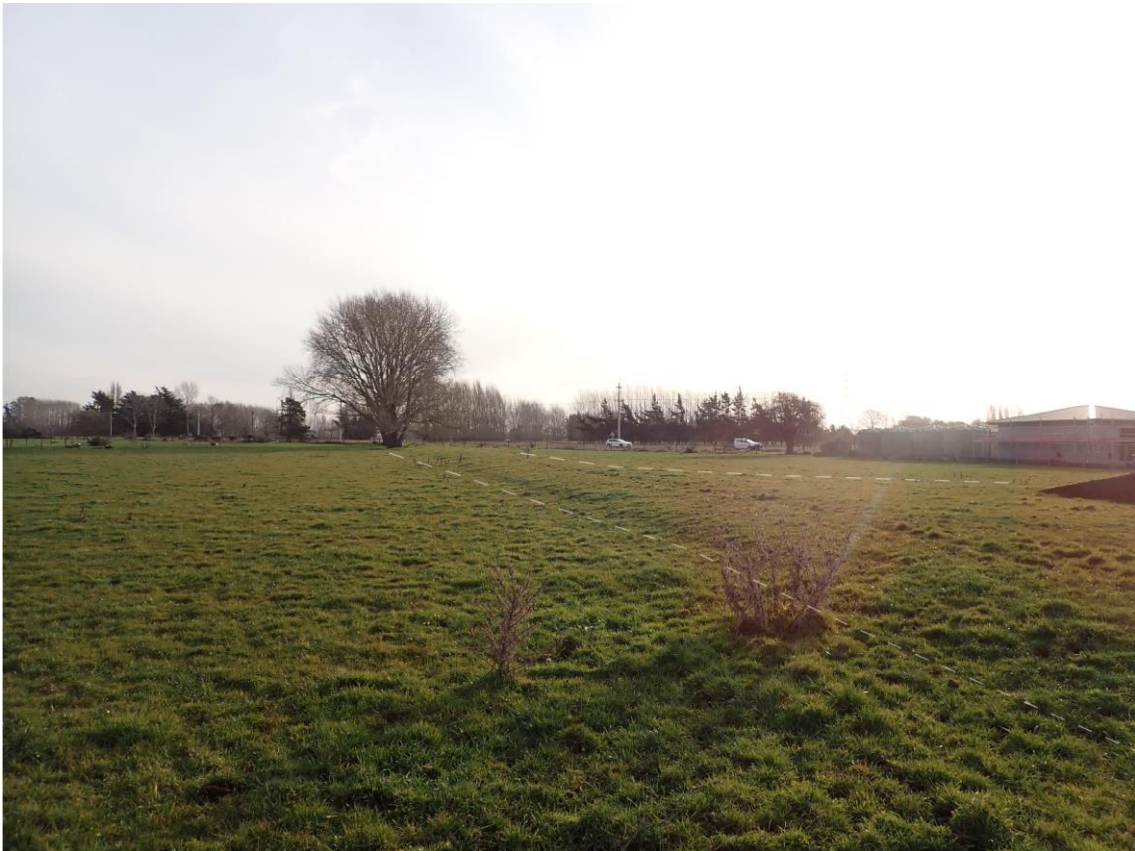
Figure 7-3. View west across railway embankment. The approximate boundaries of the embankment are shown with dashed white lines.

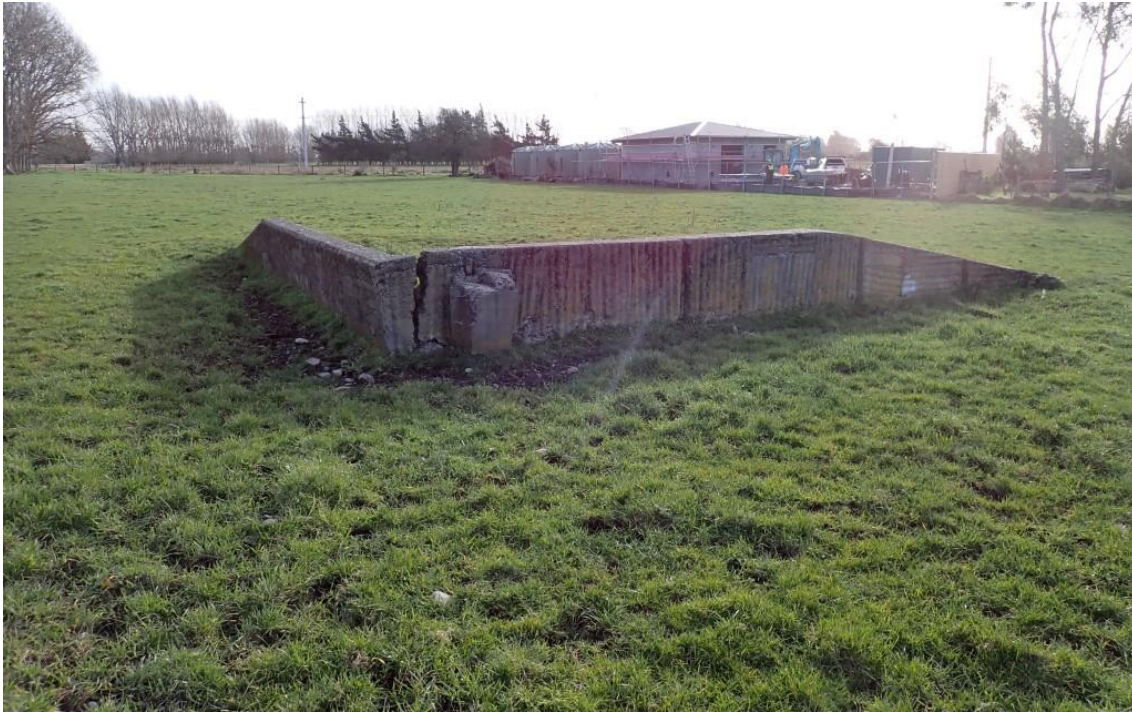
Figure 7-5. View of concrete structure within M35/1875.

The concrete was cracked vertically in places, notably near the southeast corner, and the south wall has shifted, tilting outward. The internal portion of the structure had a hollow at the centre, and landowner Peter Sherriff had informed me that the gravels within the structure (visible in earlier aerial photographs, and interpreted as forming a ramp up to access carriages and the like (Figure 7-7) had been removed by himself some decades ago. The south side of the structure bore a mark 'M 95', possibly indicating the year of construction (Figure 7-9). The structure is not shown on an 1891 plan of the railway station, which would accord with an 1895 construction (see Section 5.6 Ōhoka Railway Station and Eyreton Line; Figure 5-14). A concrete and earth loading bank was built by railway authorities at the Fernside Station in 1895, and it is possible that this represents a greater program of loading bank construction at Waimakariri stations, and the Ōhoka structure represents this (*Star*, 14/11/1895: 3; McEwan, 2019).

Prior to archaeological recording, vehicle movements in the location of the railway embankment and concrete structure should be excluded, to prevent vehicle damage to the embankment.

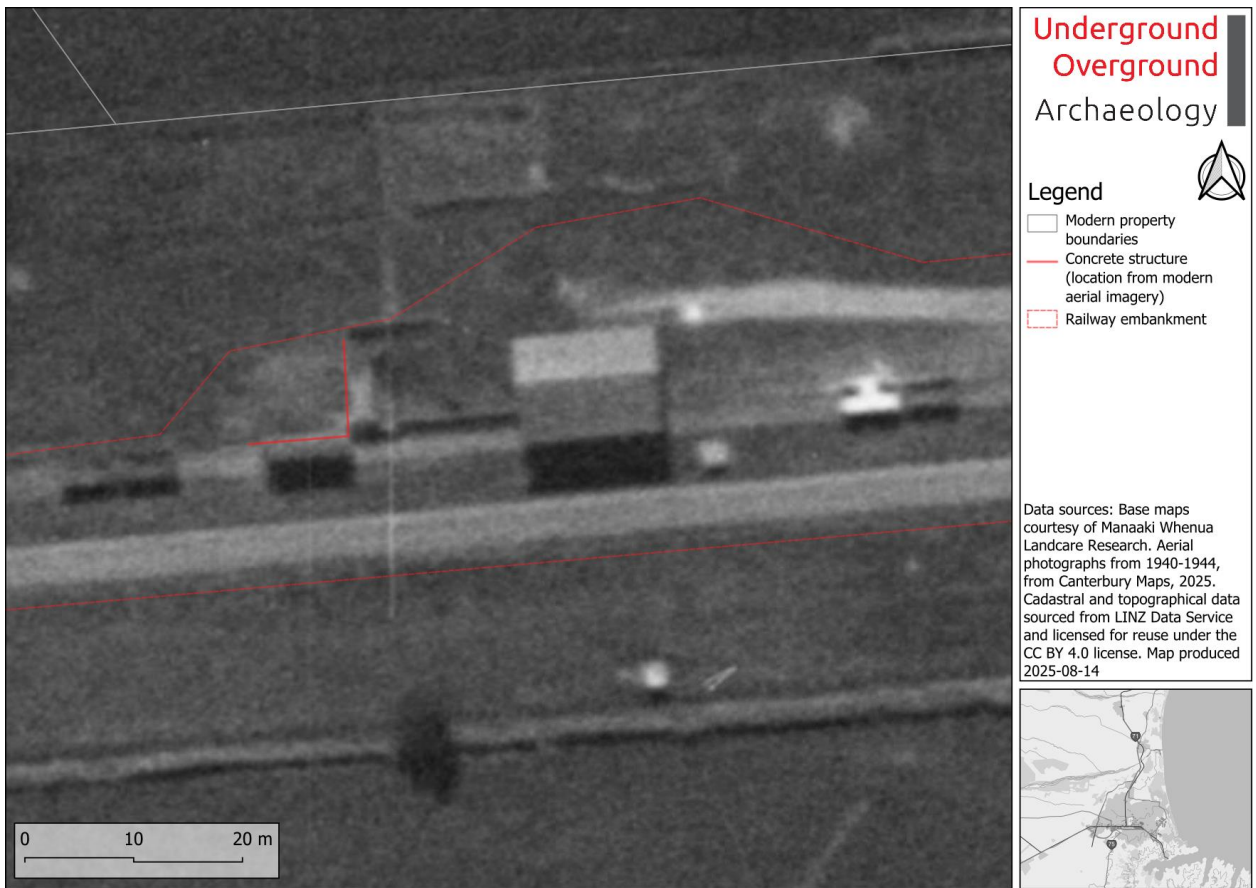
Figure 7-7. Detail of aerial imagery of Ōhoka Railway Station, 1940-1944, showing the location of the standing concrete structure in relation to dwellings.

The southeast corner of the structure had a blocky protrusion on the south east corner, likely a structural buttress (Figure 7-13). This had what appeared to be the tip of a large flat cut or beaten iron nail protruding from it, possibly originating from the formwork of the concrete, and which remained after the formwork was removed, or was intentionally part of the structure, and connecting to other, since removed parts of the structure (Figure 7-14). The 1940s aerials do appear to show a small structure in this area east of the structure (Figure 7-7).

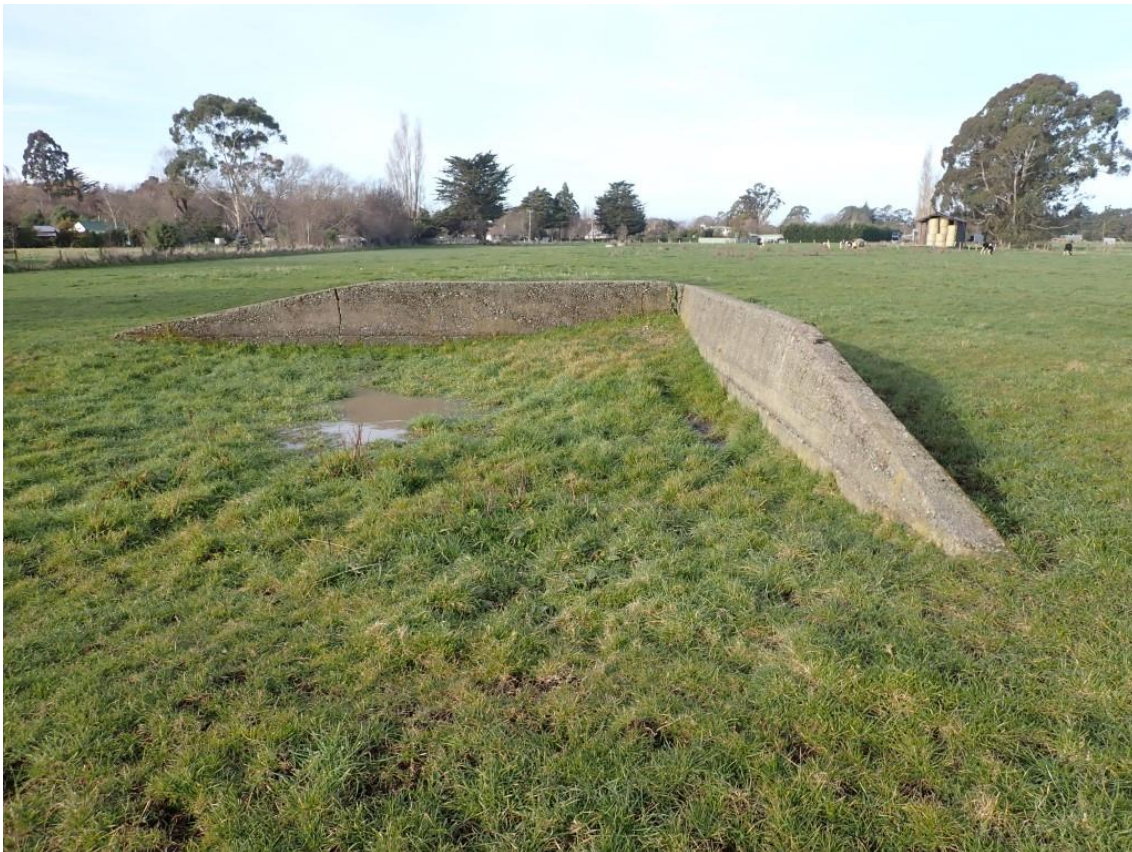
Figure 7-8. Internal view of concrete structure.

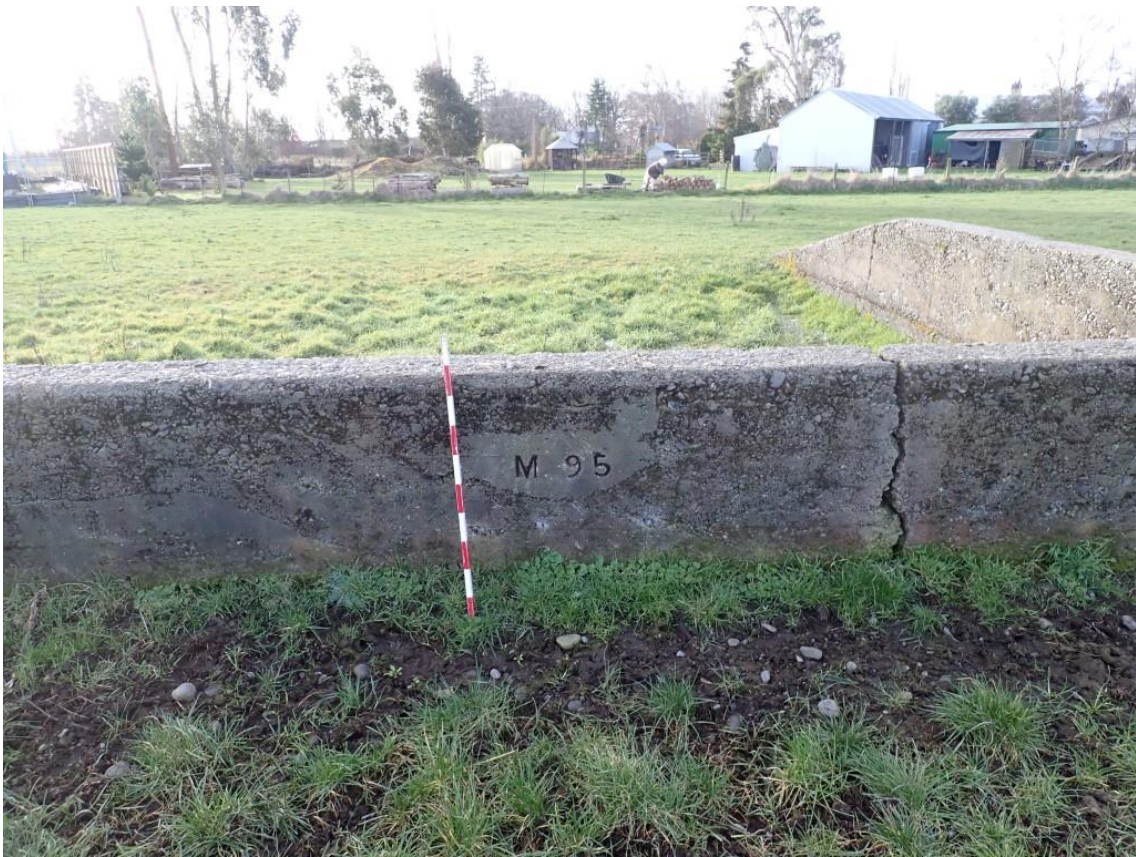
Figure 7-9. 'M 95' marking on concrete structure.

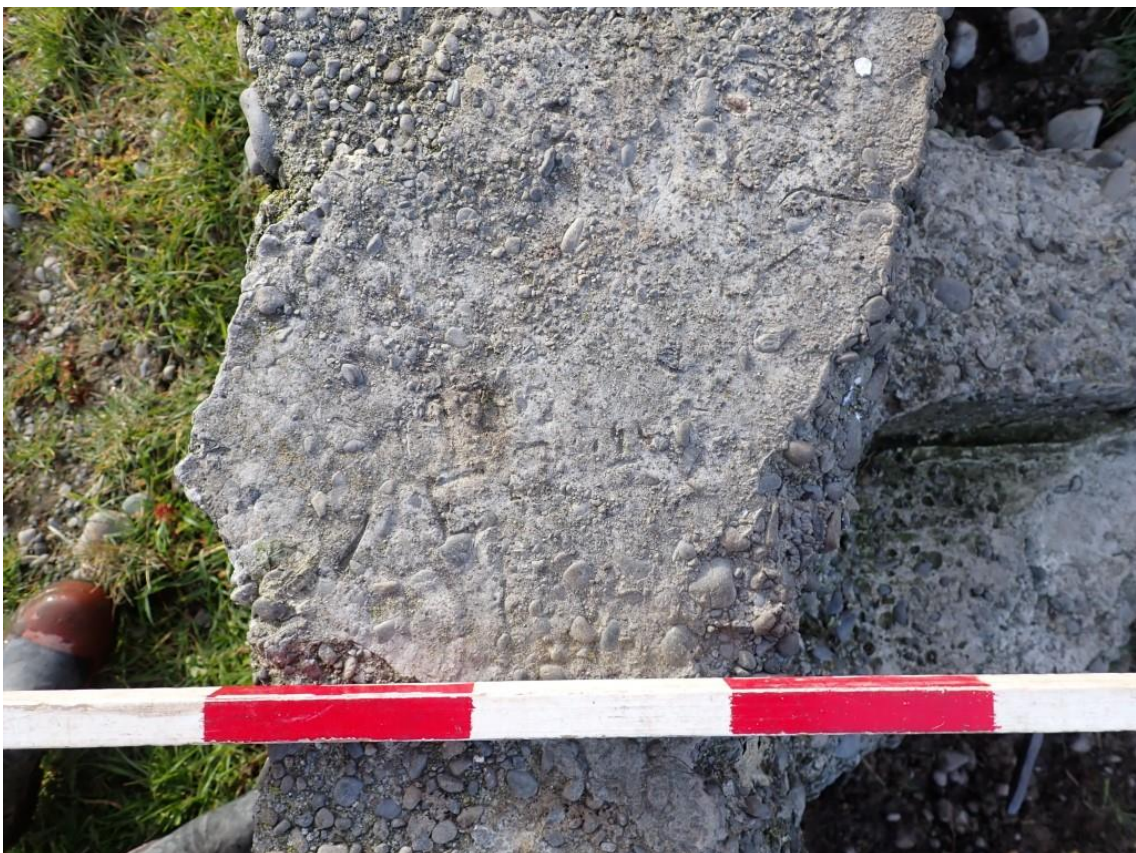
Further markings, possibly later graffiti reading '19_5 / E_ '24' were found on the top surface of the structure near the southeast corner (Figure 7-10). The east side of the structure had visible evidence of formwork/shuttering in the form of both vertical and horizontal corrugations from the use of corrugated iron as the formwork, and impressions of railway iron supports (Figure 7-11). Small fragments of the corrugated iron used as the formwork remained impressed into the concrete walls, and a misaligned in situ rail iron projected from the ground near the north end (Figure 7-12).

Figure 7-10. Possible marking/graffiti on concrete surface.

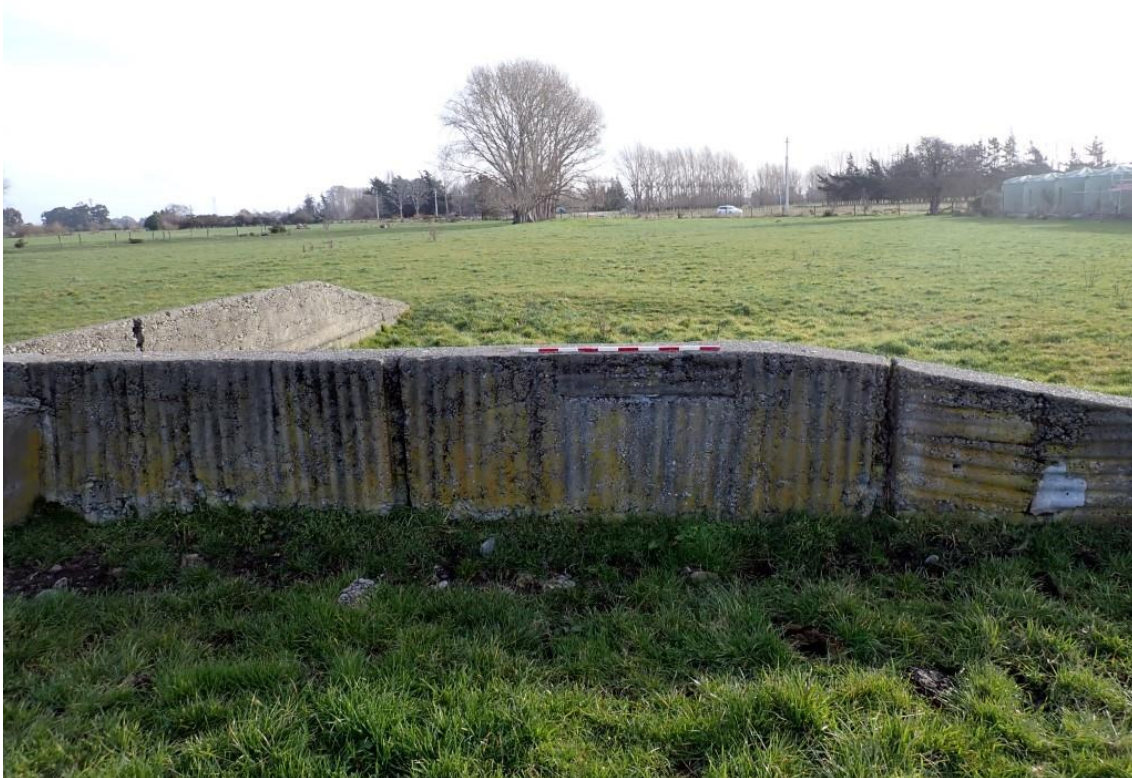
Figure 7-11. View of formwork impressions, east side.

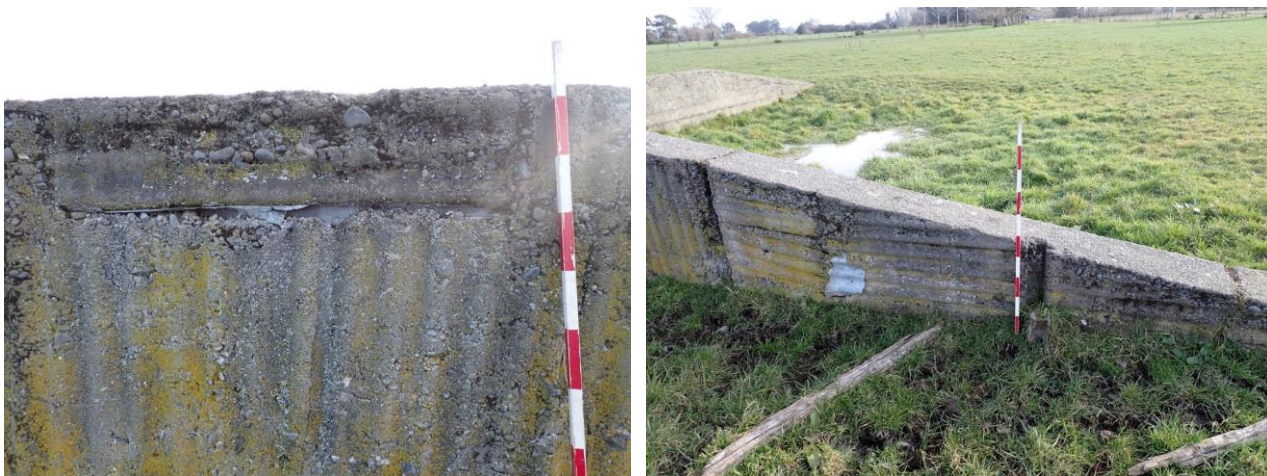
Figure 7-12. In situ corrugated iron and railway iron within northeast side.

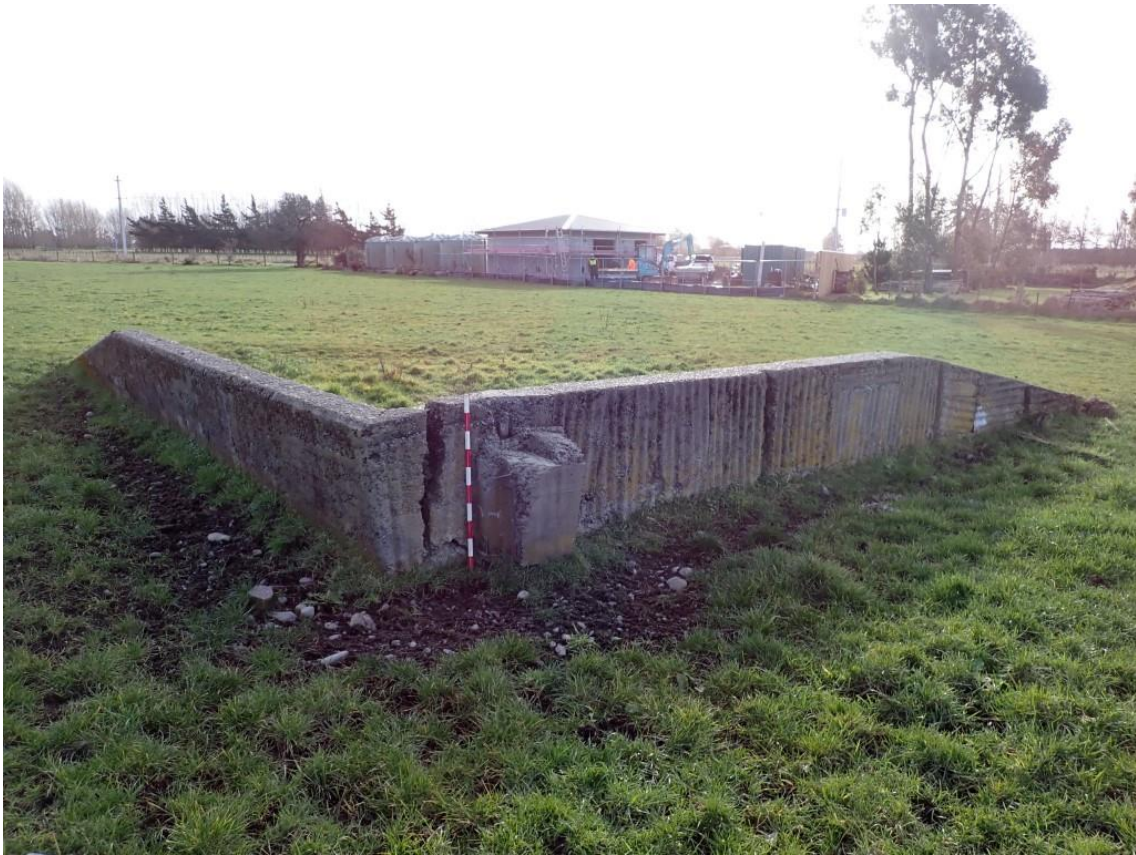
Figure 7-13. Concrete protrusion on southeast corner.

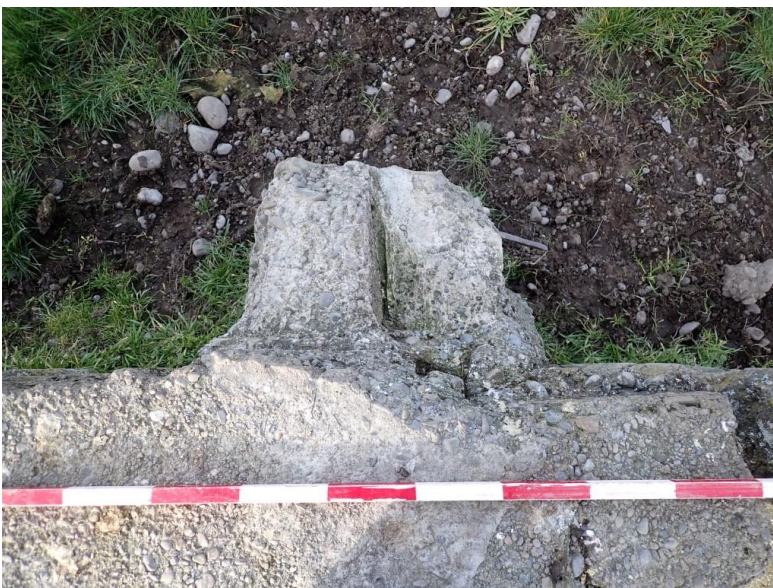
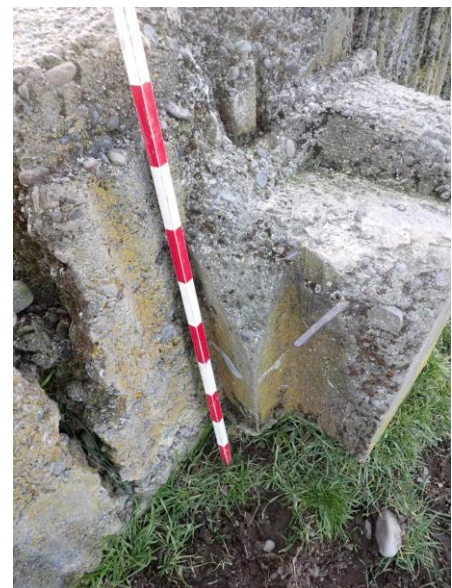
Figure 7-14. Protrusion on southeast corner of structure, showing cut iron nail projection.

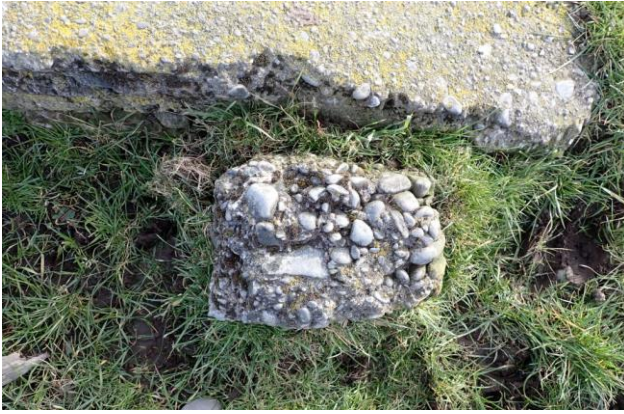
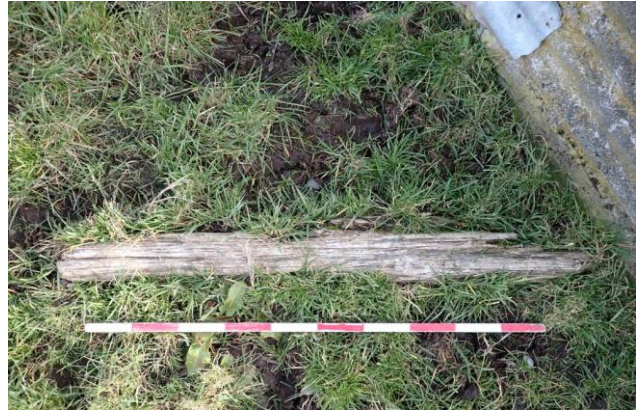
Concrete and wood fragments were encountered along the northeast of the structure, likely representing structural remains from this or another structure (Figure 7-15). Further fragments of unclear origin were found around the same area, with ceramic-like appearance yellow-brown colouration, some flat surfaces, but other pitted, slag-like surfaces (Figure 7-16). These are considered remnants of previous railway structures.

Figure 7-15. Concrete (left) and wood (right) fragments.

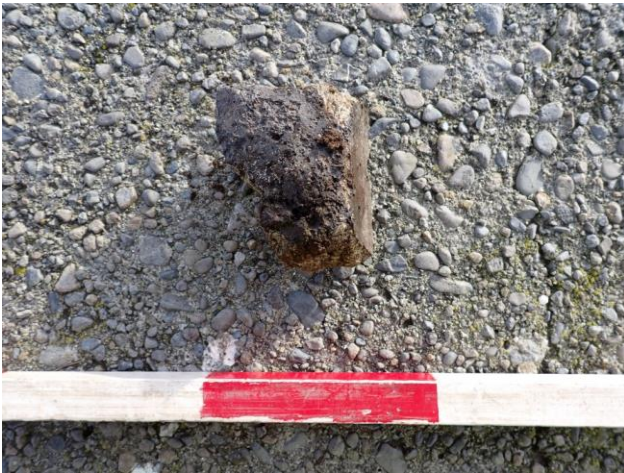
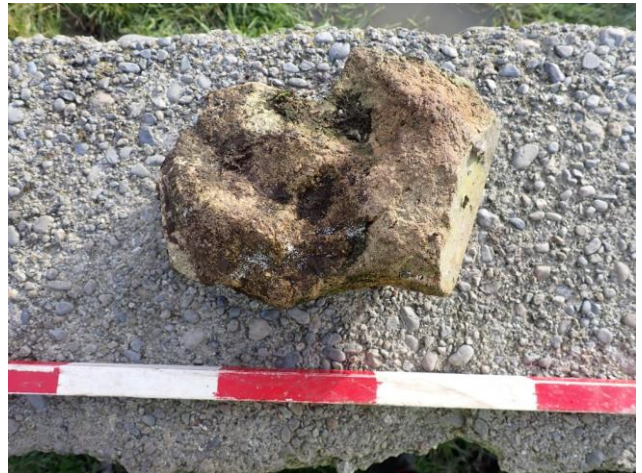
Figure 7-16. Ceramic or slag fragments.

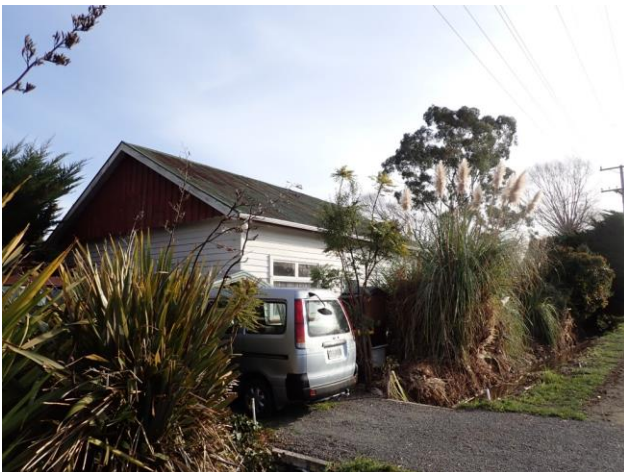
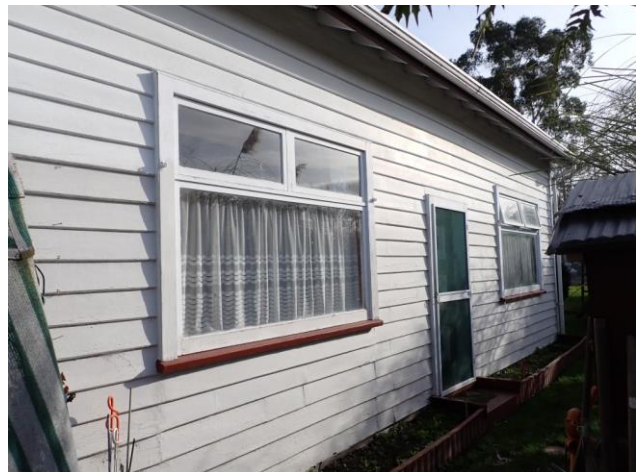
Figure 7-17. 547 Mill Road.

547 Mill Road was inspected from the street, as local knowledge had suggested the dwelling on that section was the former Ōhoka Railway Station Master’s house (Figure 7-17). Based on appearance, this dwelling is early 20th century, and it stands outside the area of the railway reserve from the time of the station’s use. The historical research has related that the likely location of the station master’s house is indicated on early survey plans and in early aerial photographs (see Section 5.6 Ōhoka Railway Station and Eyreton Line: Figure 5-14). The historical research regarding this building is unclear, though Trotter (2017) suggested it was a 19th century building significantly modified by the removal of a second storey and complete replacement of the roofline.

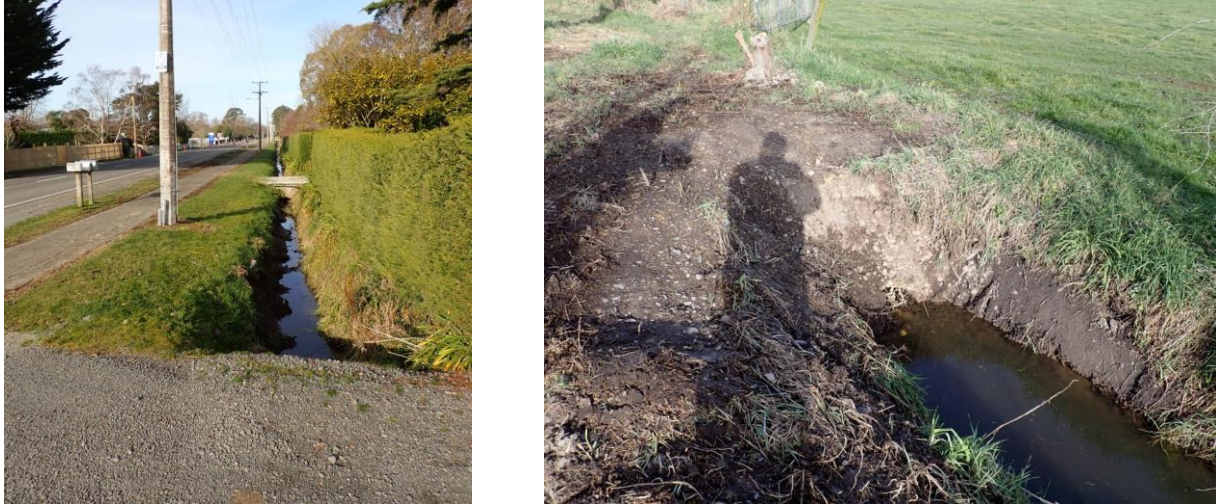
Figure 7-18. View east along the drain along the south side of Mill Road (left), and of culvert in area of embankment on Mill Road (right).

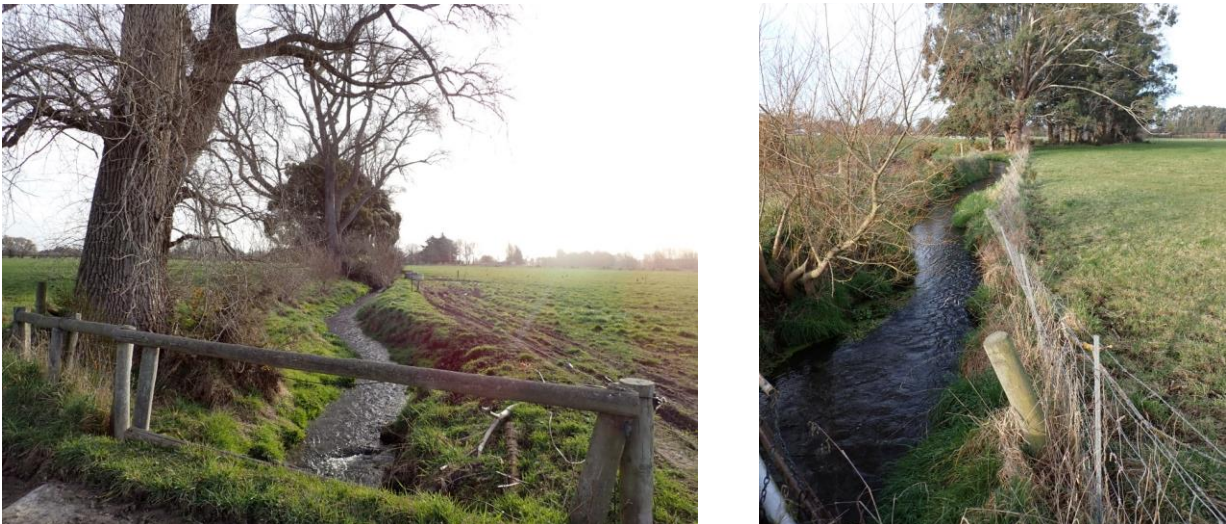
Figure 7-19. View along Ōhoka Stream from culvert, west (left), and east (right).
