Mill Road subdivision, Ōhoka

Archaeological assessment

Archaeological site No.	M35/1875 (Ōhoka railway station)
Site address	535 Mill Road and 290 Bradleys Road, Ōhoka (Lot 2 and 3 DP 318615, part Lot 1 DP 8301, Lot 2 DP 8301, Lot 2 DP 61732)
Client	Carter Group Ltd
Client contact	Bruce Van Duyn
Report authors	Tristan Wadsworth, Anthalina Gibson (historical background)
Reviewed by	Kirsa Webb
Nominated s45 Approved Person	Tristan Wadsworth
Report submitted to	Carter Group Ltd, Ngāi Tūāhuriri Rūnanga, Heritage New Zealand Pouhere Taonga, Environmental Protection Authority, FTA Panel Conveners and Expert Panel, Waimakariri District
Document control ID	J012274_AA_REV B

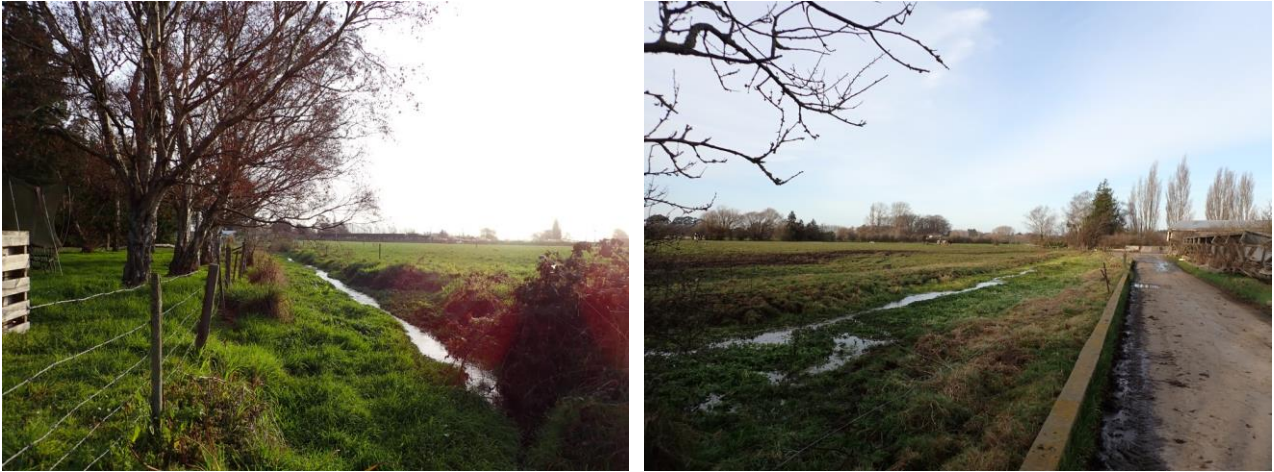
The Ōhoka South Branch stream runs across the project area toward the centre of the section, but has been significantly formalised and straightened in the mid-20th century (see 5.7 Ōhoka Stream and drainage; Canterbury Maps, 2025). The drain in this area is shallow and approximately 3 m wide, and less than 1 m deep, with gradually sloping sides, and often clear banks associated with the spoil from the excavation of these drains to replace the earlier natural alignment of the stream.

Figure 7-20. Views along Ōhoka South Branch. Left: View west from dwelling at 236 Bradleys Road; Right: view east along drain on north side of dairy buildings.

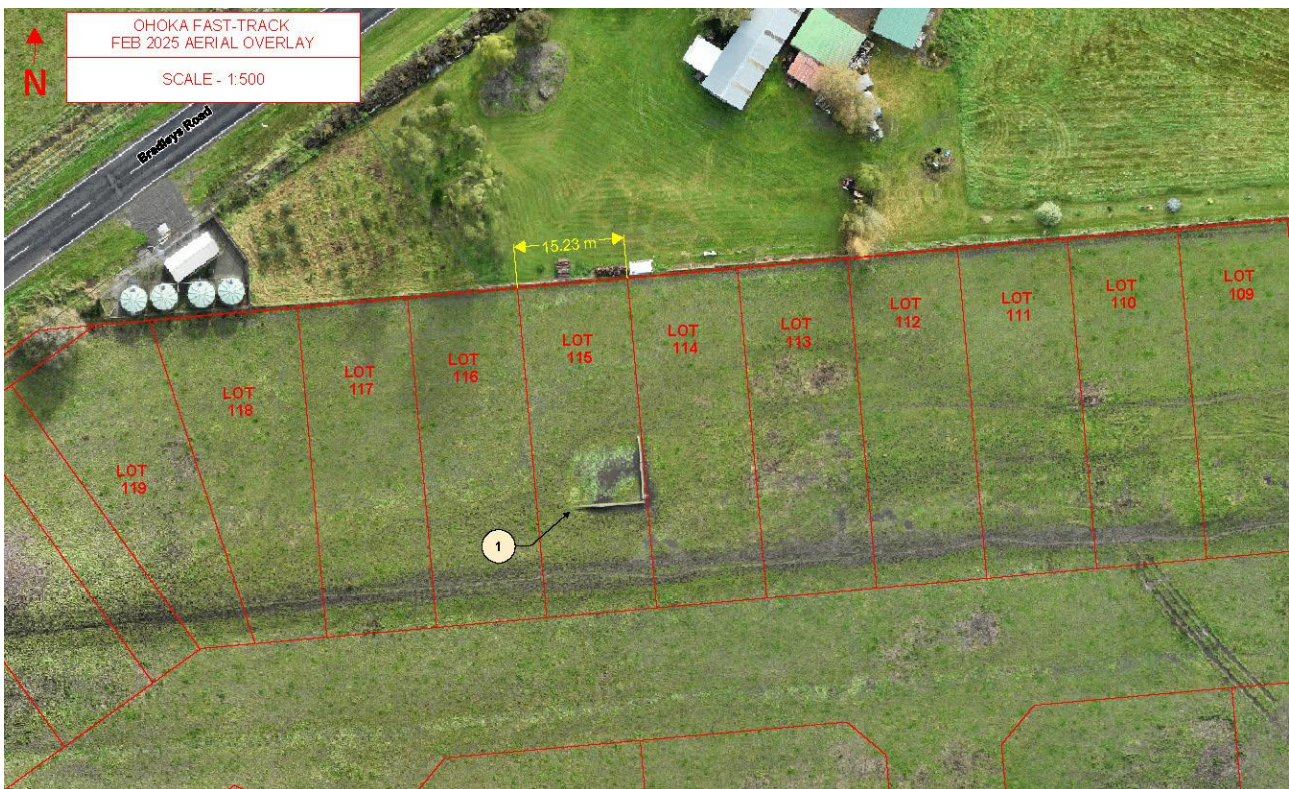
Figure 10-1. The standing concrete structure, within proposed Lot 115. Image provided by Carter Group Ltd. Note that since Feb 2025 the boundaries of the lot have been altered slightly so that the entire structure is within the parcel.

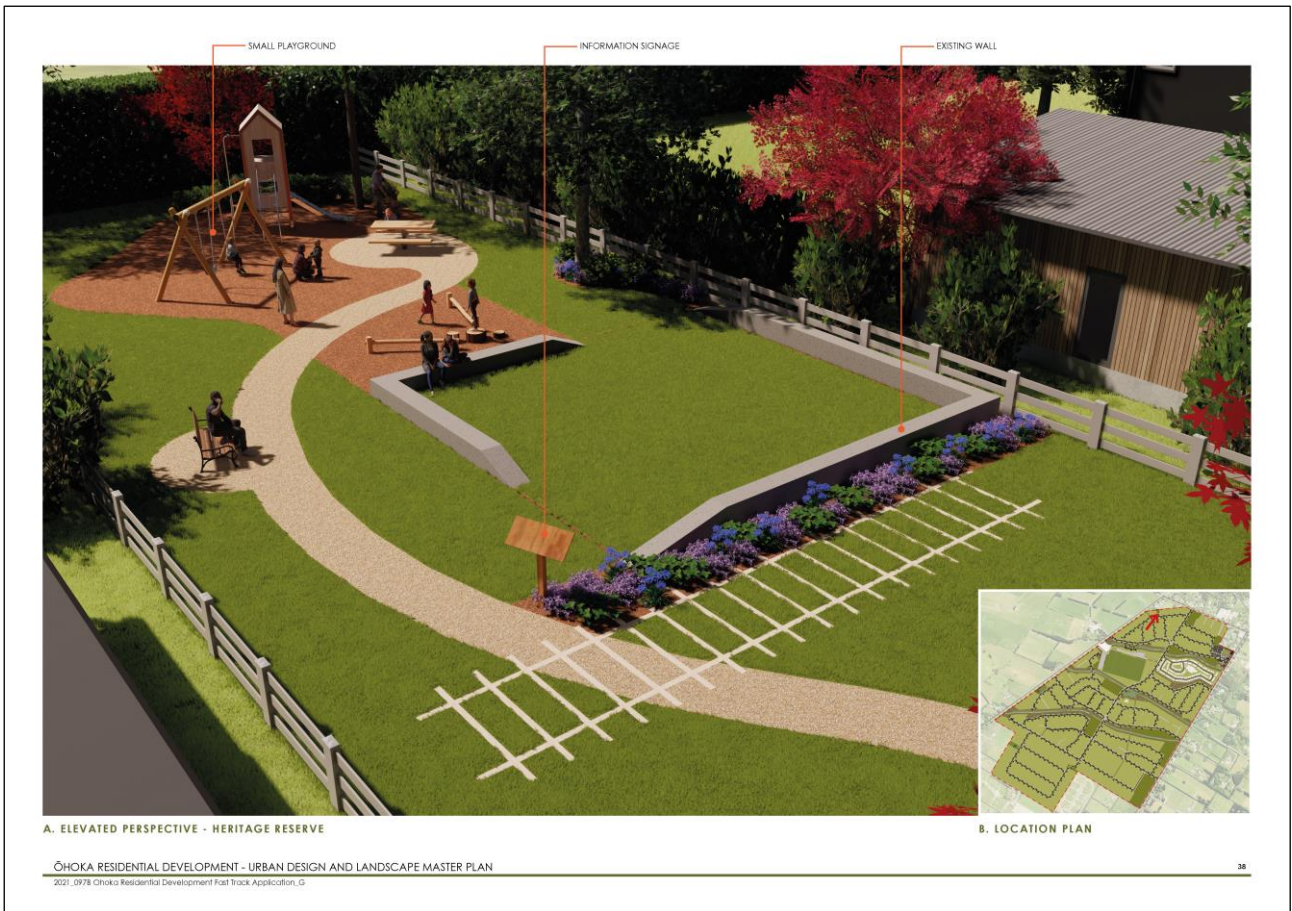
Figure 10-2. Rendered landscape plan showing the proposed heritage reserve. Image provided by Carter Group Ltd.

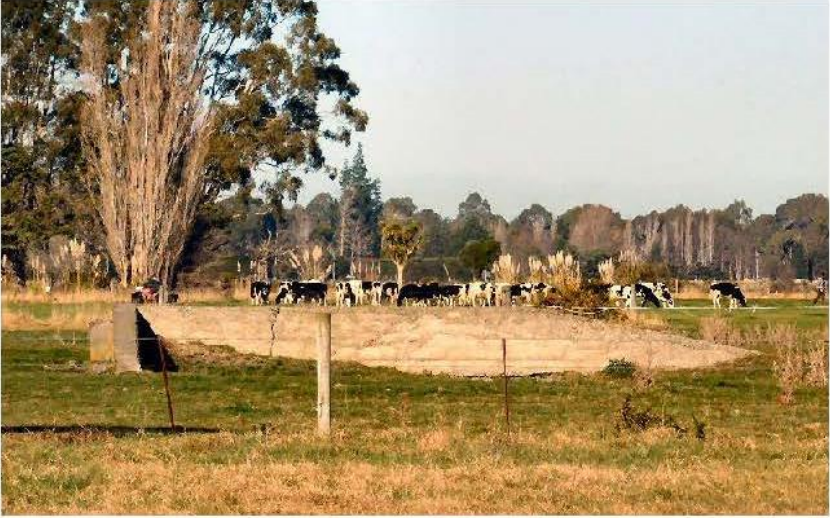
<p>Today a concrete structure that appears to be the remains of a loading ramp is all that is visible on the surface as in the above photograph, looking southwards (the cattle are standing some distance behind the structure). The station building was centred about 26 metres east of this structure.</p>

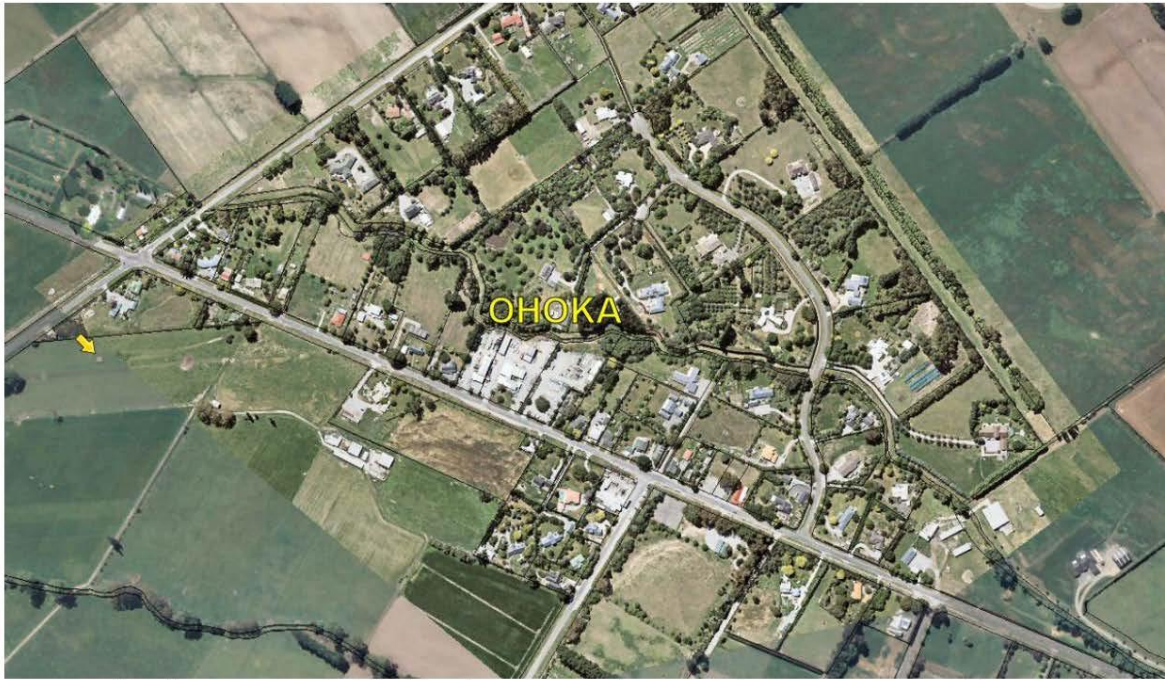
<p>List of visible archaeological features: Concrete structure as described above.</p>	
<p>Condition of site: Low concrete walls of the probable loading ramp are still extant, but the railway lines and station building have been removed. Other remains may occur beneath the surface.</p>	
<p>Associated sites: M35/1504 (Wetheral Station), M35/461 (road crossing) and M35/1625 (Eyreton Junction) are all sites on the Eyreton Branch railway line.</p>	
<p>Record submitted by: Michael Trotter, Tuahiwi, North Canterbury.</p>

The yellow arrow on the left of the above photograph points to the concrete remnant of the Station.

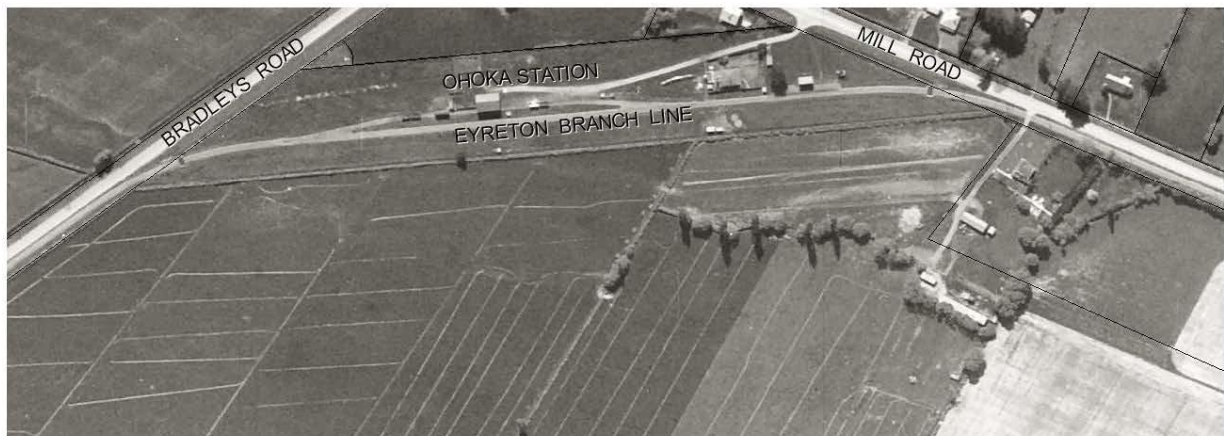
1940s aerial mapping photograph showing the Ohoka railway station.

The concrete structure is to the left of the station building.
