# Preliminary Site Investigation

**1073 Tauwhare Road, Tauwhare**

**CMW Geosciences**

**SLR Consulting New Zealand Limited**

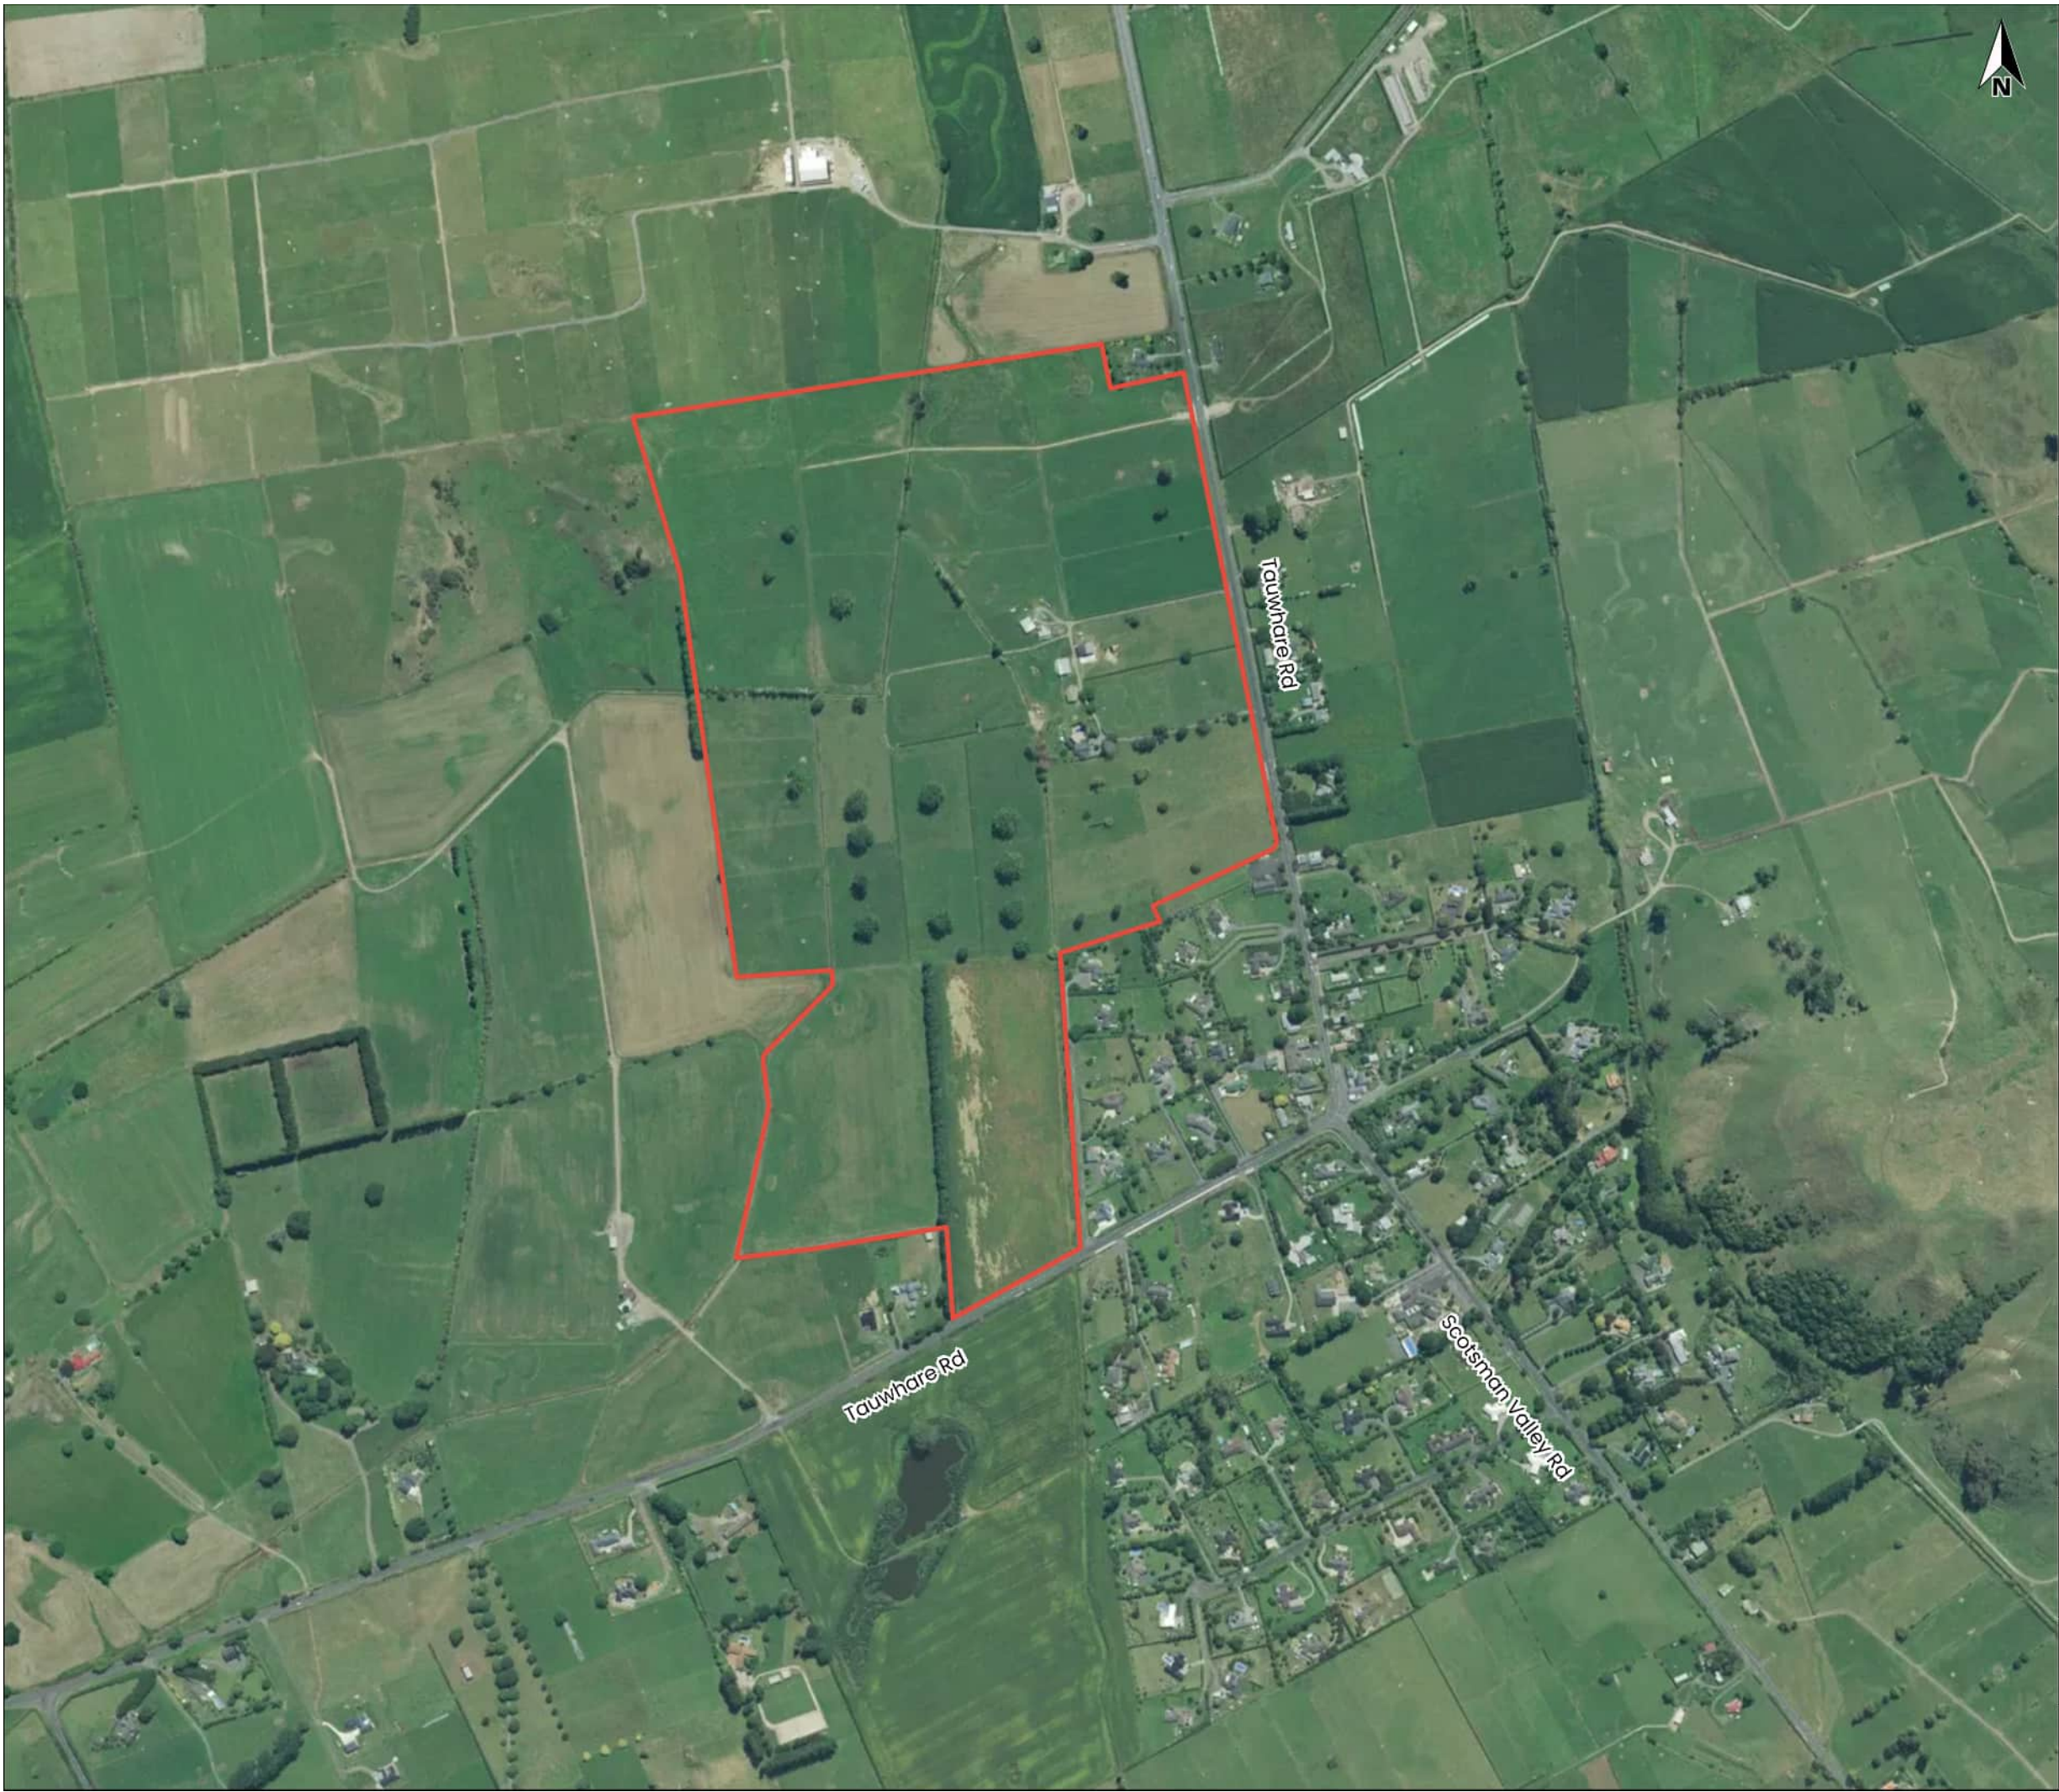
SLR Consulting New Zealand Limited (SLR) has been engaged by CMW Geosciences (the Client) to undertake a Preliminary Site Investigation (PSI) to support the construction of a proposed multi use development at 1073 Tauwhare Road, Tauwhare 3287 (the Site). The Site location and layout are presented in **Appendix A, Figure A1**.

The Site details are provided in **Table 1**. The Site location is shown in **Appendix A, Figure A1**.

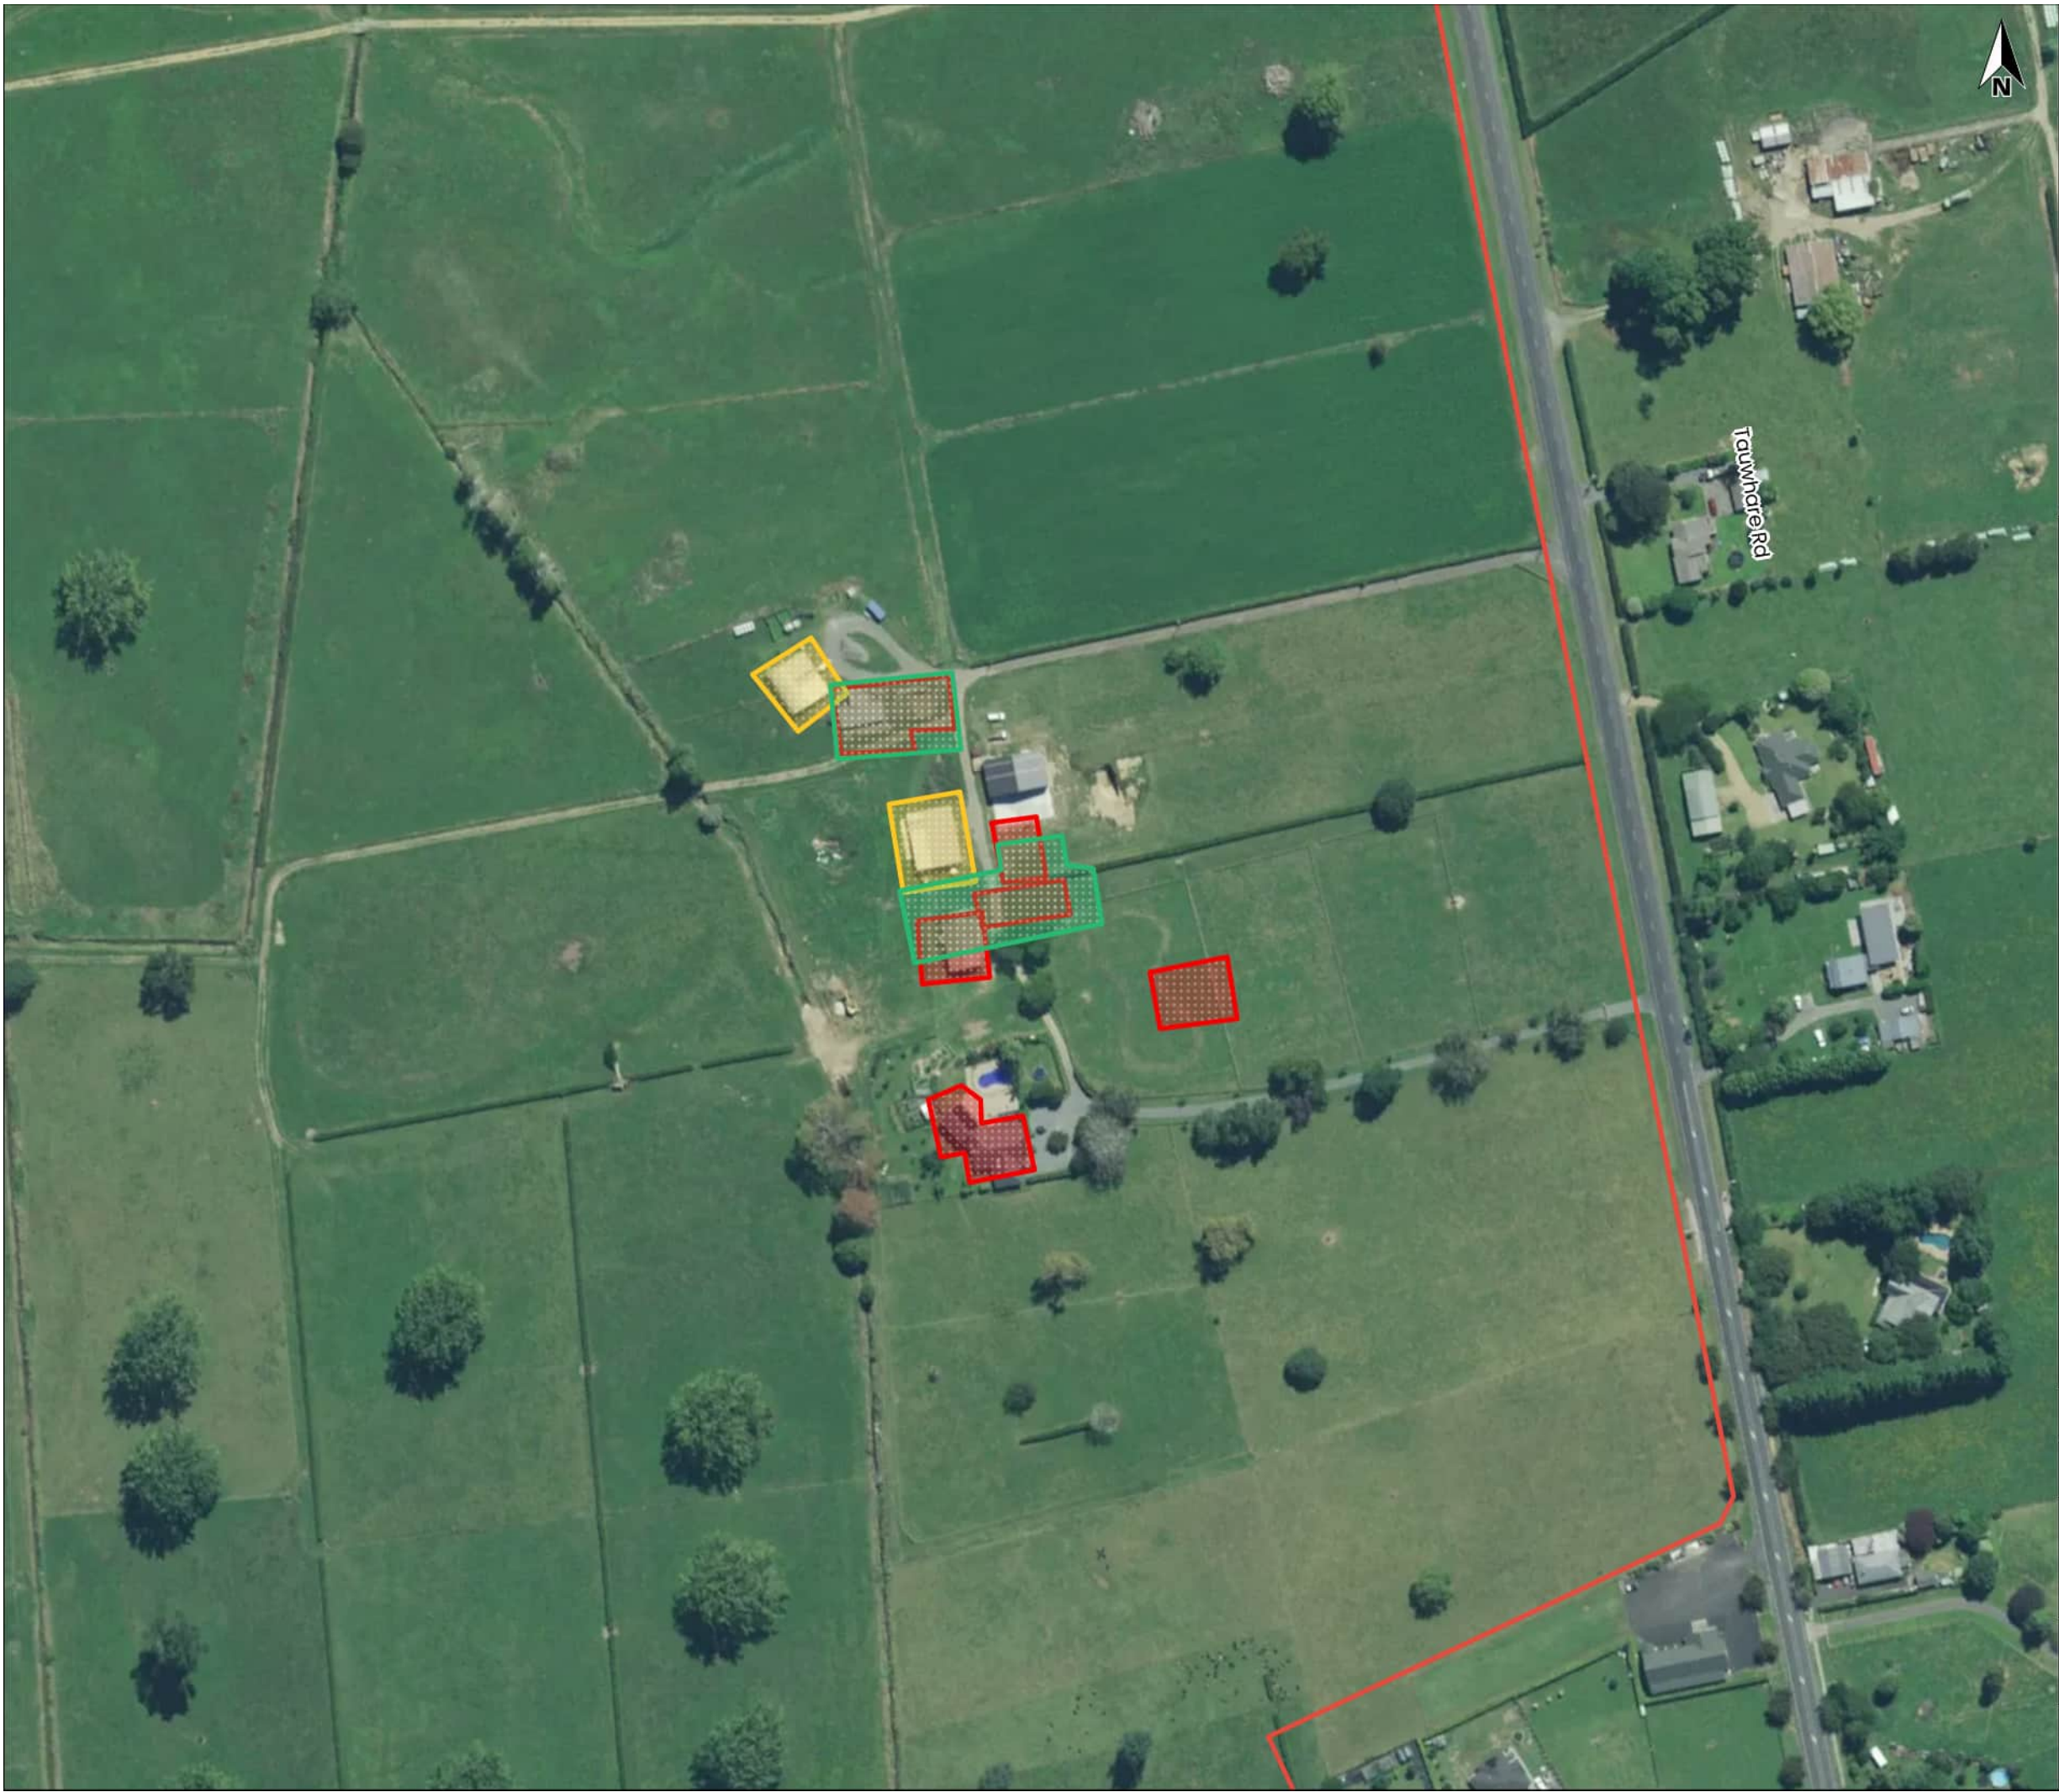
- A8: Chemical manufacture, application and bulk storage - Livestock dip or spray race operations – potentially associated with current and former stockyards (no longer present on the Site).
- A17: Chemical manufacture, application and bulk storage - Storage tanks or drums for fuel, chemicals or liquid – associated with the likely presence of fuel and chemical storage as part of current farming operations.
- E1: Mineral extraction, refining and reprocessing, storage and use - Asbestos products manufacture or disposal, including sites with buildings containing asbestos products known to be in a deteriorated condition – associated with potential asbestos containing material (ACM) that may have been used on current or former structures on the Site.

A figure showing the location of the listed potential HAIL areas for the Site is presented in **Appendix A, Figure A3**.

It is recommended that a Site walkover and if required a detailed site investigation (DSI) involving a targeted soil sampling is undertaken at the Site in support of any future land development project. This should be conducted to support the resource application. The results of Site walkover and DSI will:

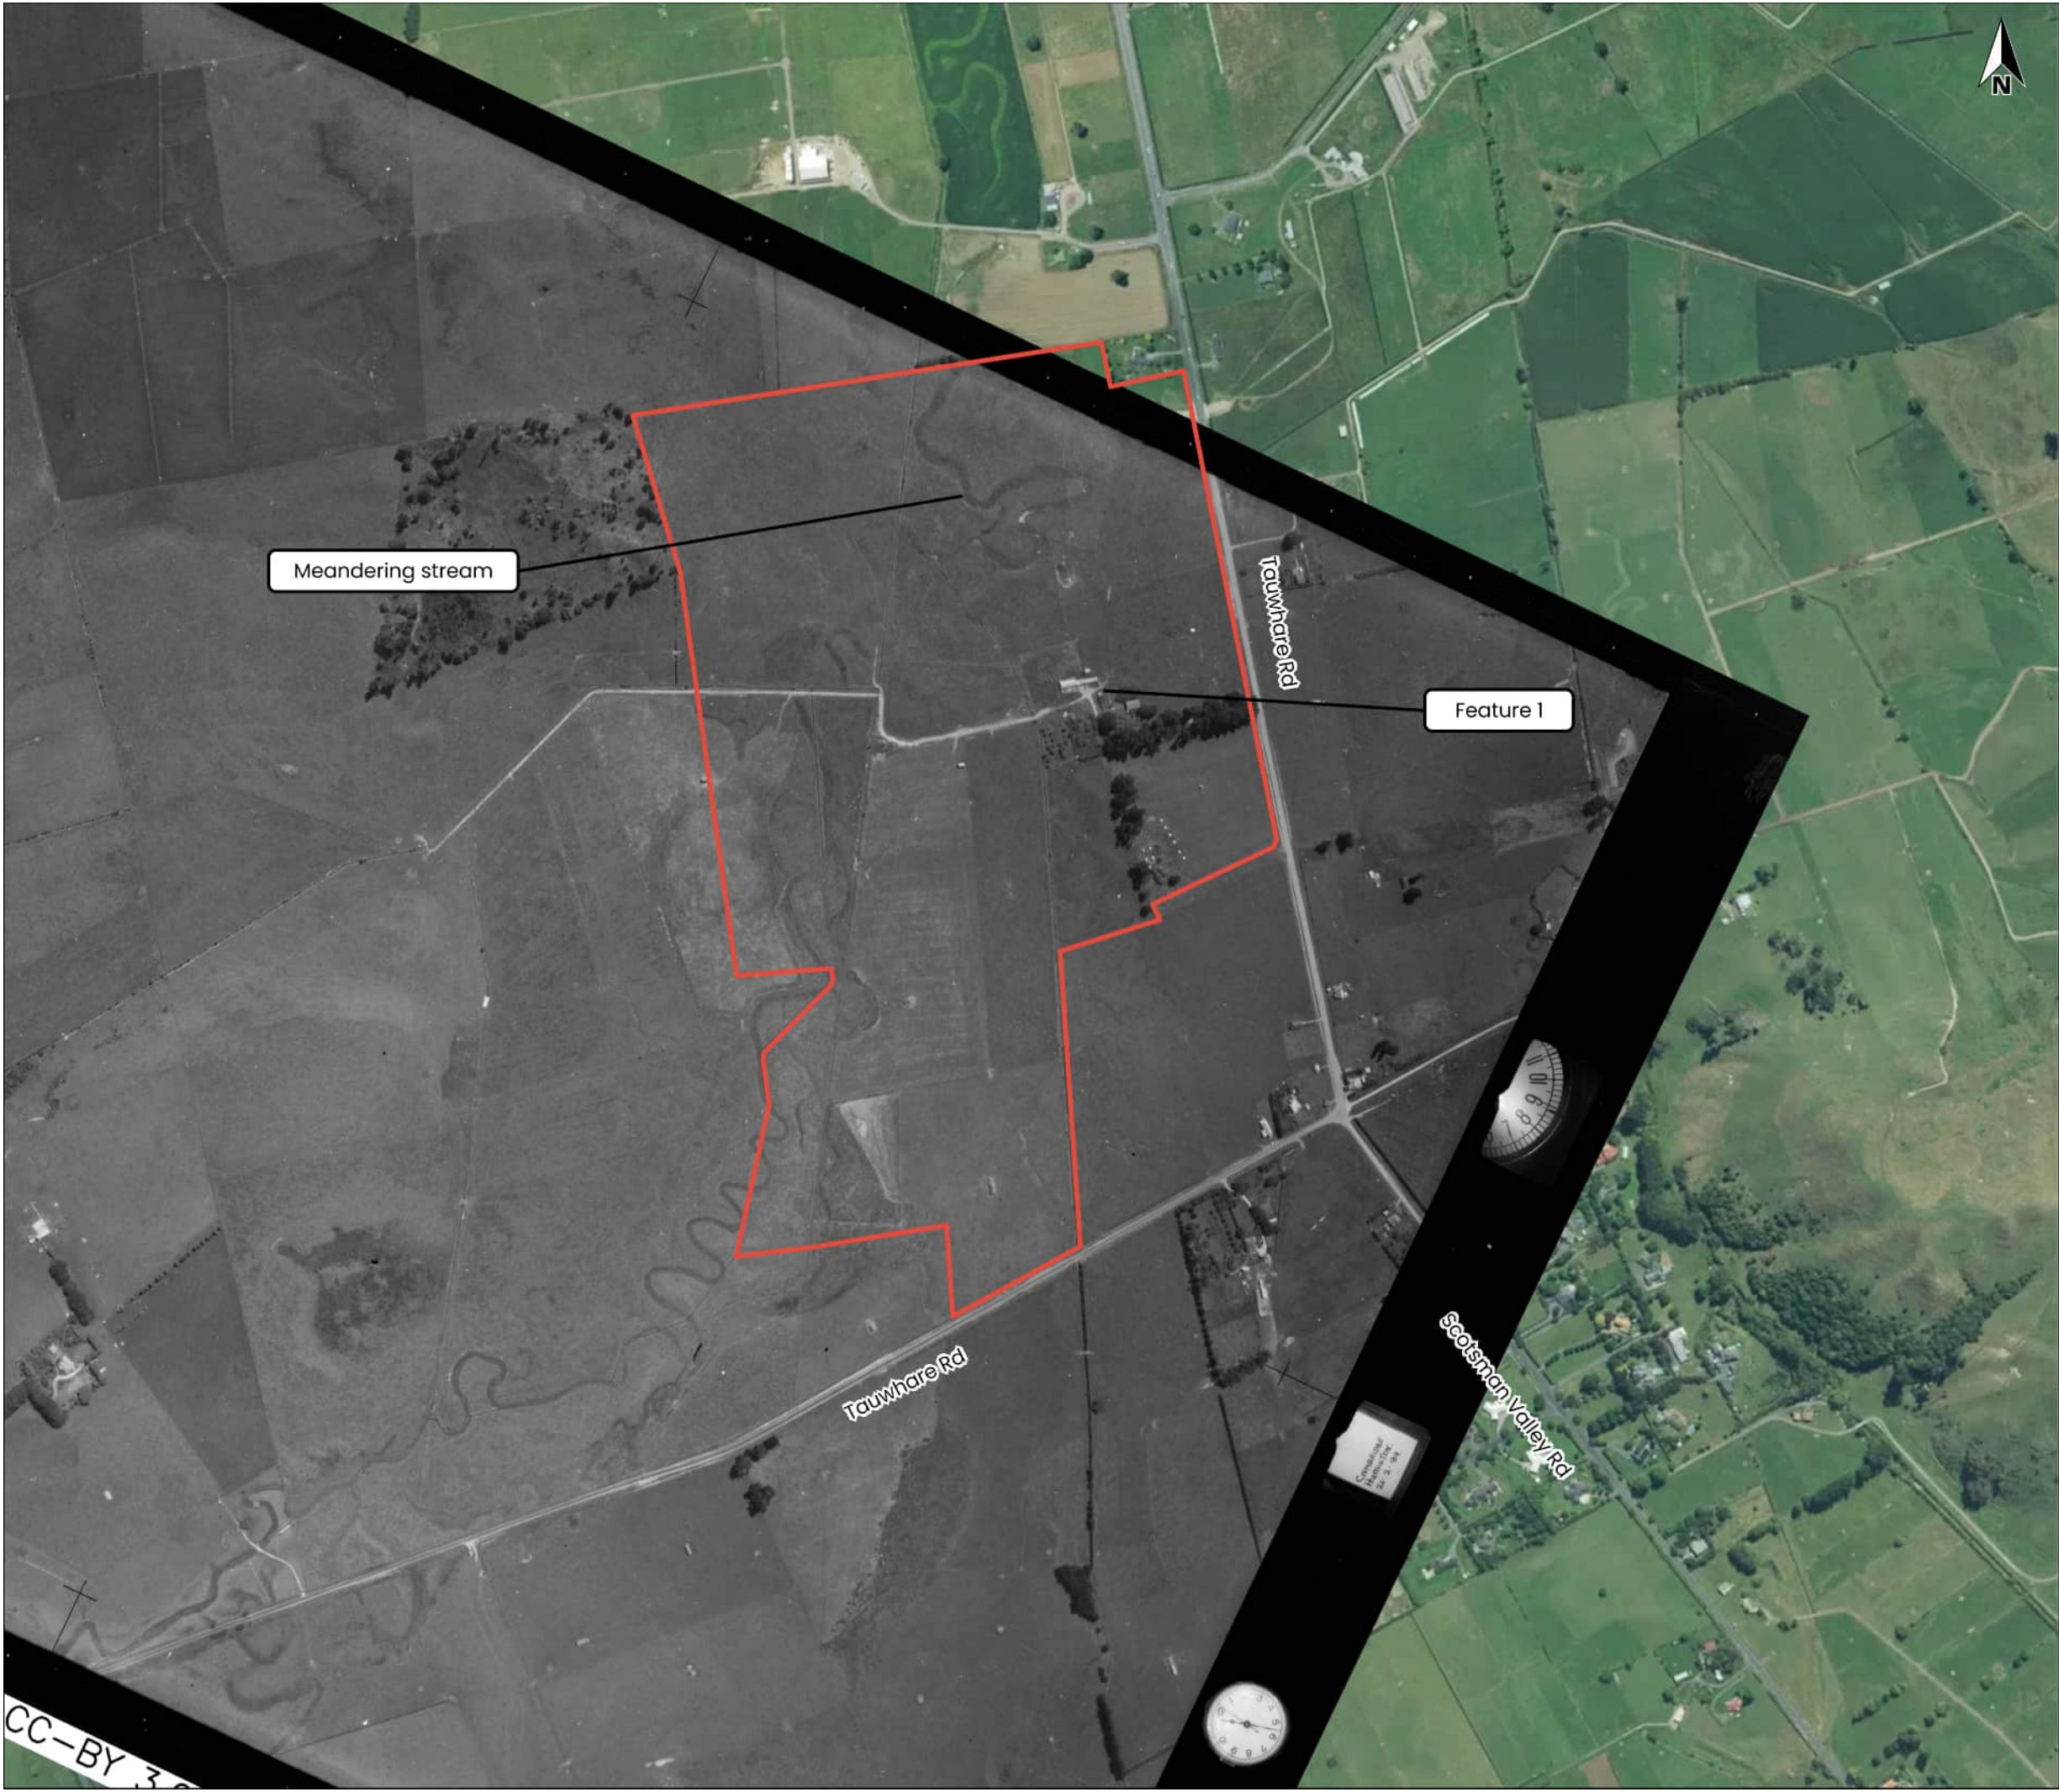
- Site Boundary
- 1939

| Year | Reference | Observations |
|---|---|---|
| 1939 | Retrolens®<br>(Black & White) | <b>The Site:</b> The land cover of the Site appears to be pasture. Tauwhare Rd and Scotsman Valley Rd are visible. A set of structures ( <i>Feature 1</i> ) are present in the central portion of the Site, one of the structures appears to be a set of stockyards, what appear to be trees associated with a home orchard are also located near the dwelling. These do not appear to be a commercial operation. A meandering stream is evident crossing part of the Site.<br><b>Off-Site:</b> The surrounding land cover is broadly rural pasture with various rural dwellings and associated ancillary farm structures. |

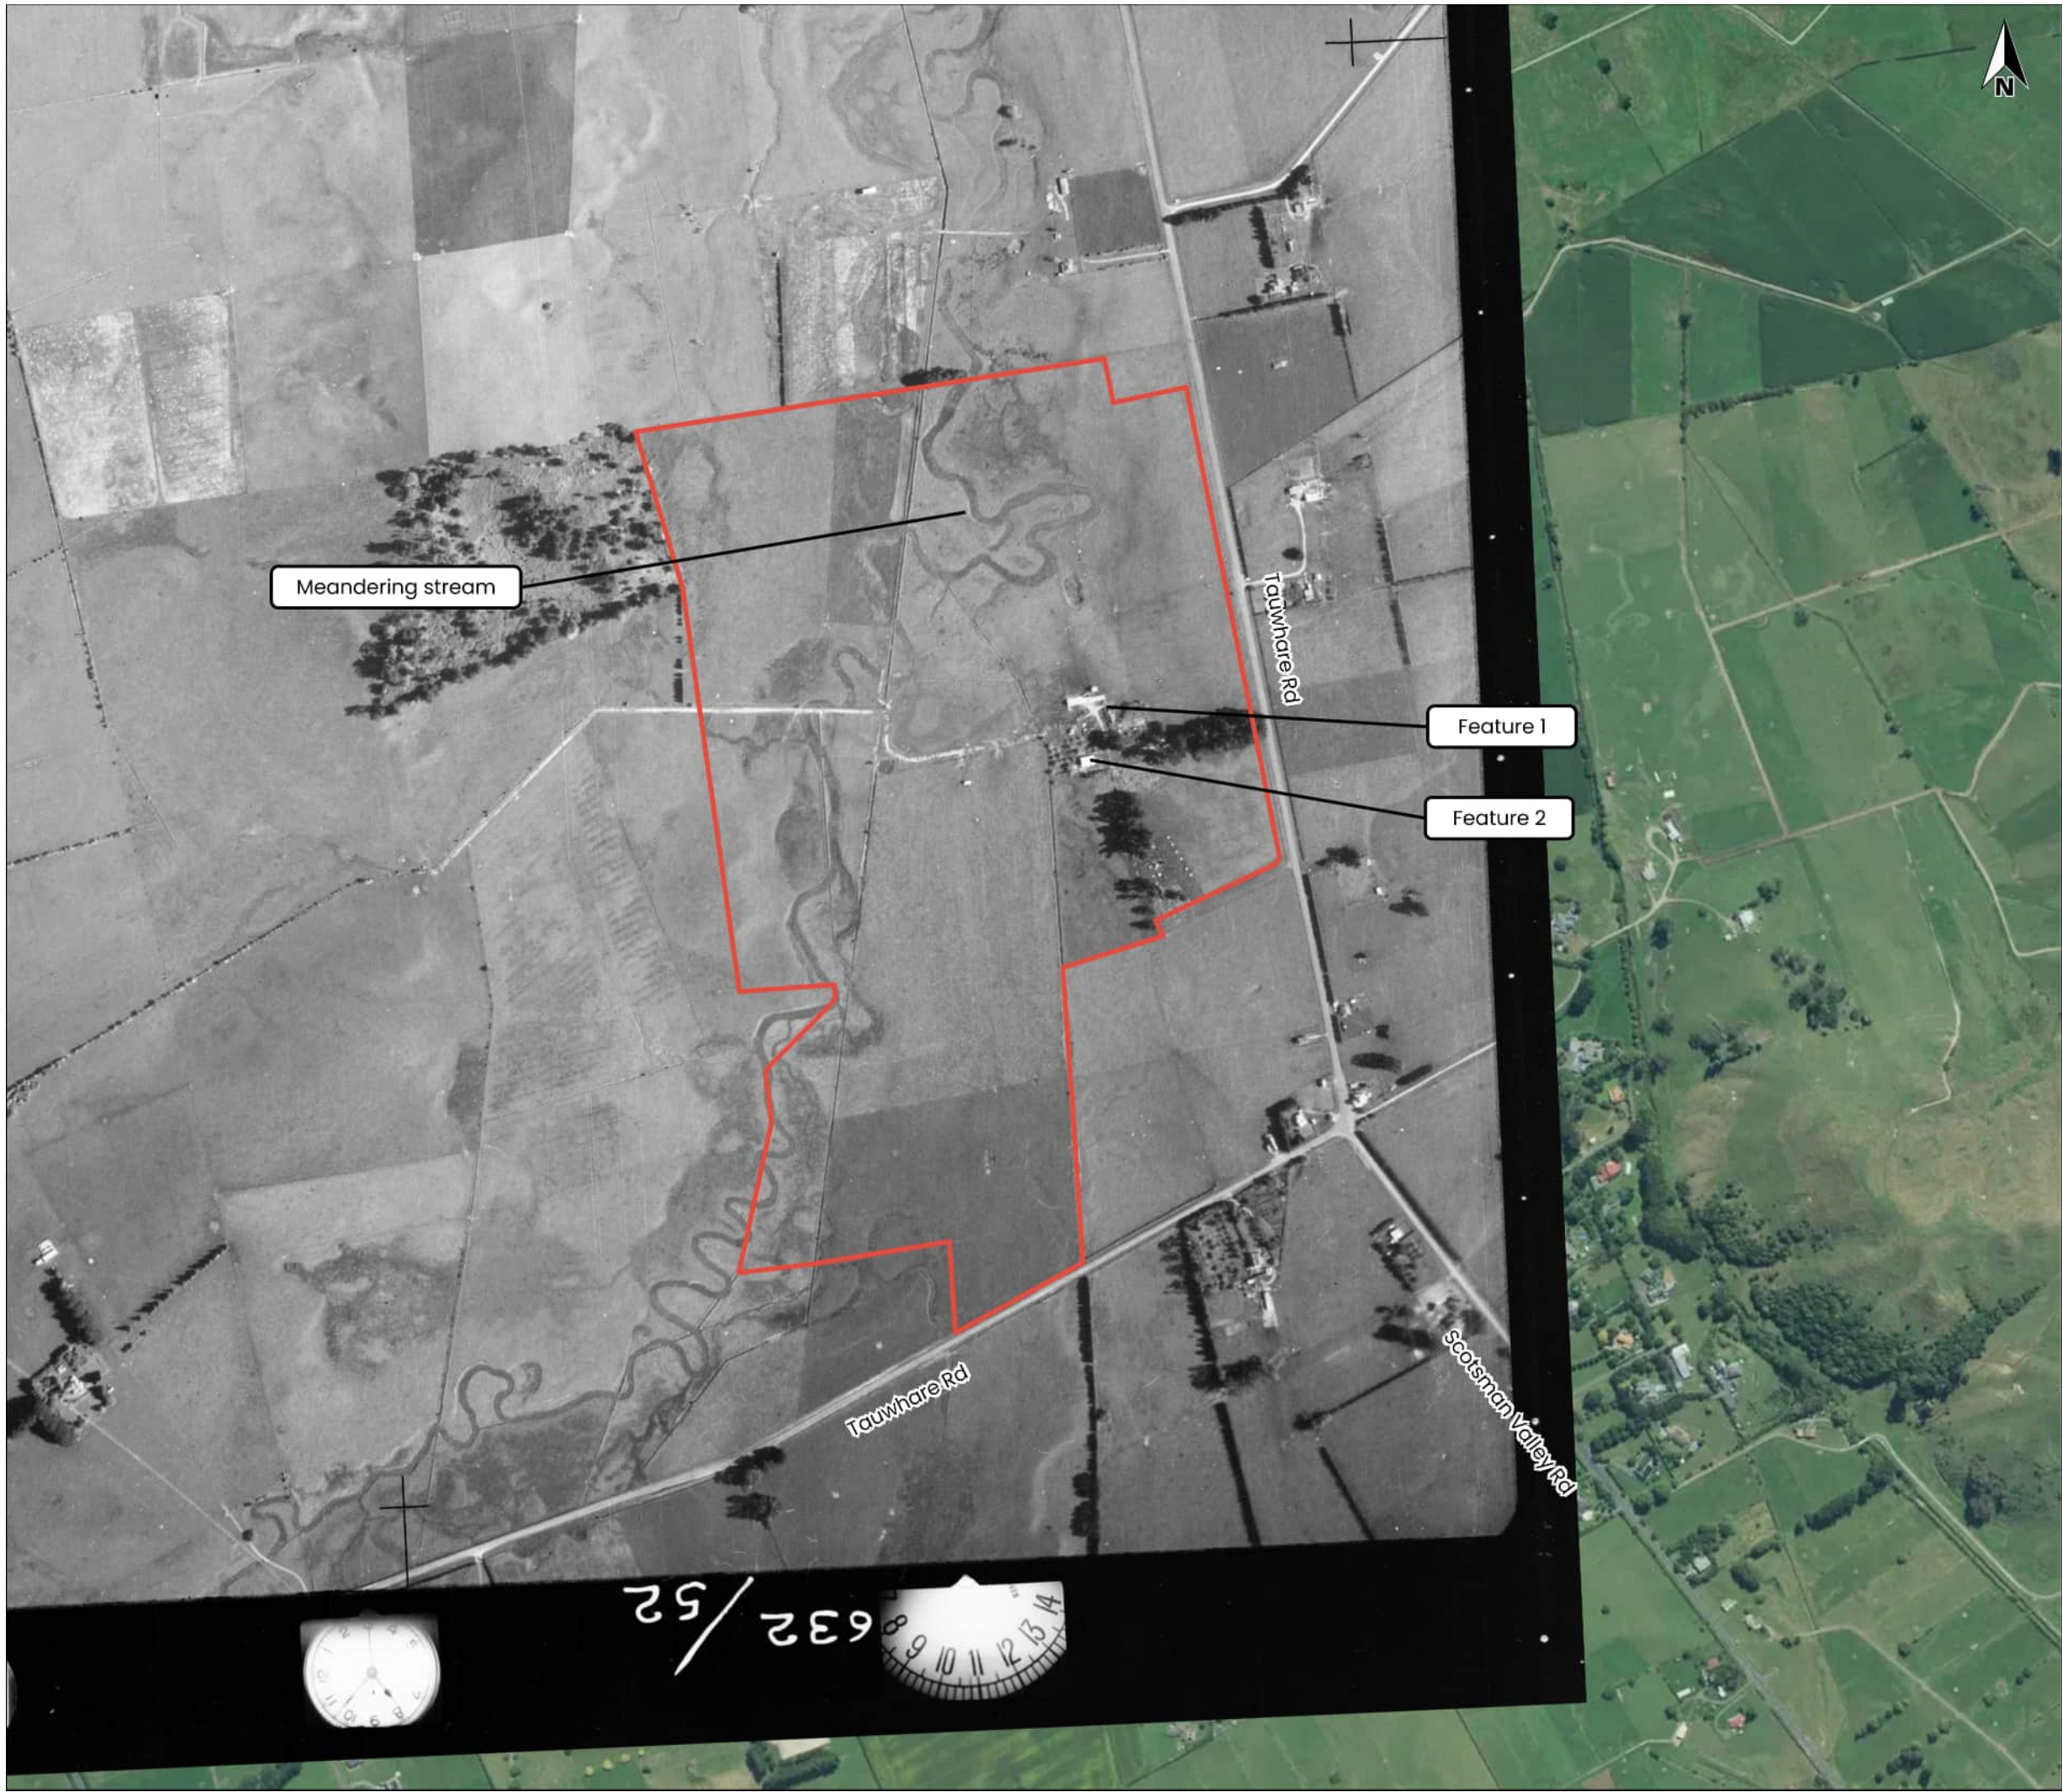
- Site Boundary
- 1946

| Year | Reference | Observations |
|---|---|---|
| 1946 | Retrolens®<br>(Black & White) | <b>The Site:</b> A structure ( <i>Feature 2</i> ), inferred to be a residential dwelling in later imagery, has been added to the south of <i>Feature 1</i> .<br><b>Off-Site:</b> No significant changes to the surrounding land cover. |

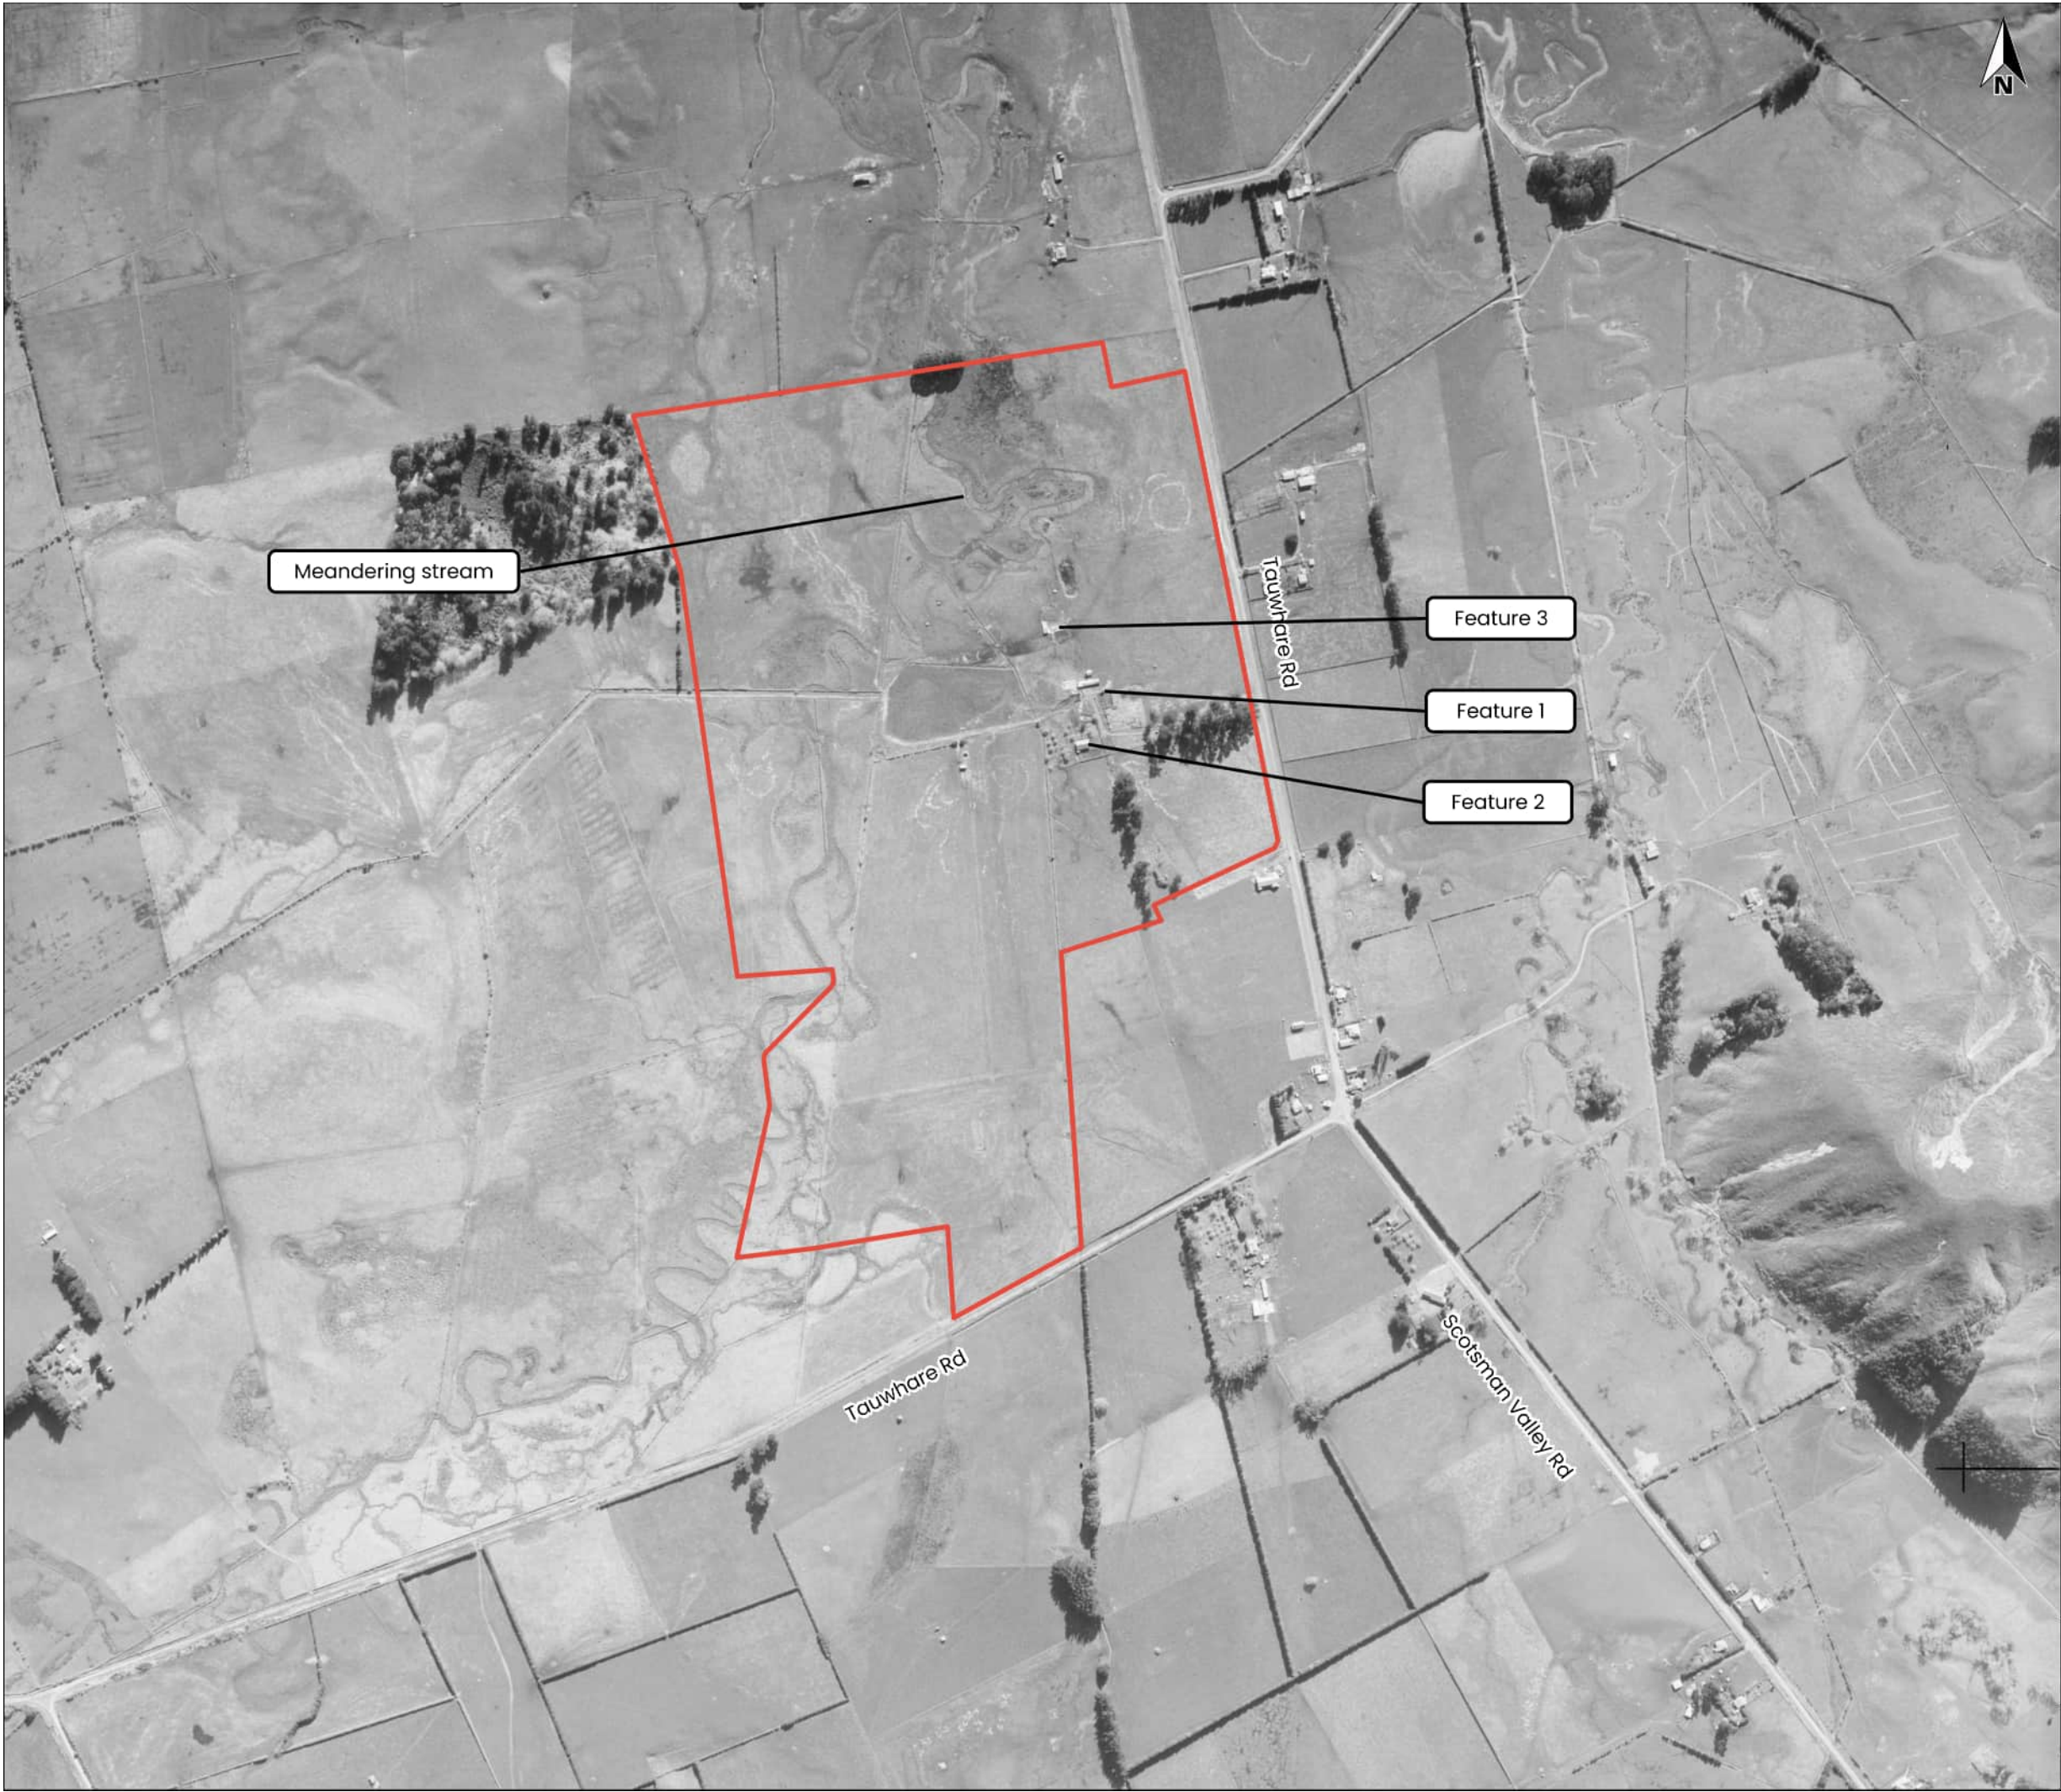
- Site Boundary
- 1953

| Year | Reference | Observations |
|---|---|---|
| 1953 | Retrolens®<br>(Black & White) | <b>The Site:</b> A structure ( <i>Feature 3</i> ) has been added that appears to be associated with another set of stockyards. The dwelling associated with <i>Feature 1</i> has been removed and the land around it cleared of vegetation.<br><b>Off-Site:</b> No significant changes to the surrounding land cover. |
