# Preliminary Site Investigation

**1073 Tauwhare Road, Tauwhare**

**CMW Geosciences**

**SLR Consulting New Zealand Limited**

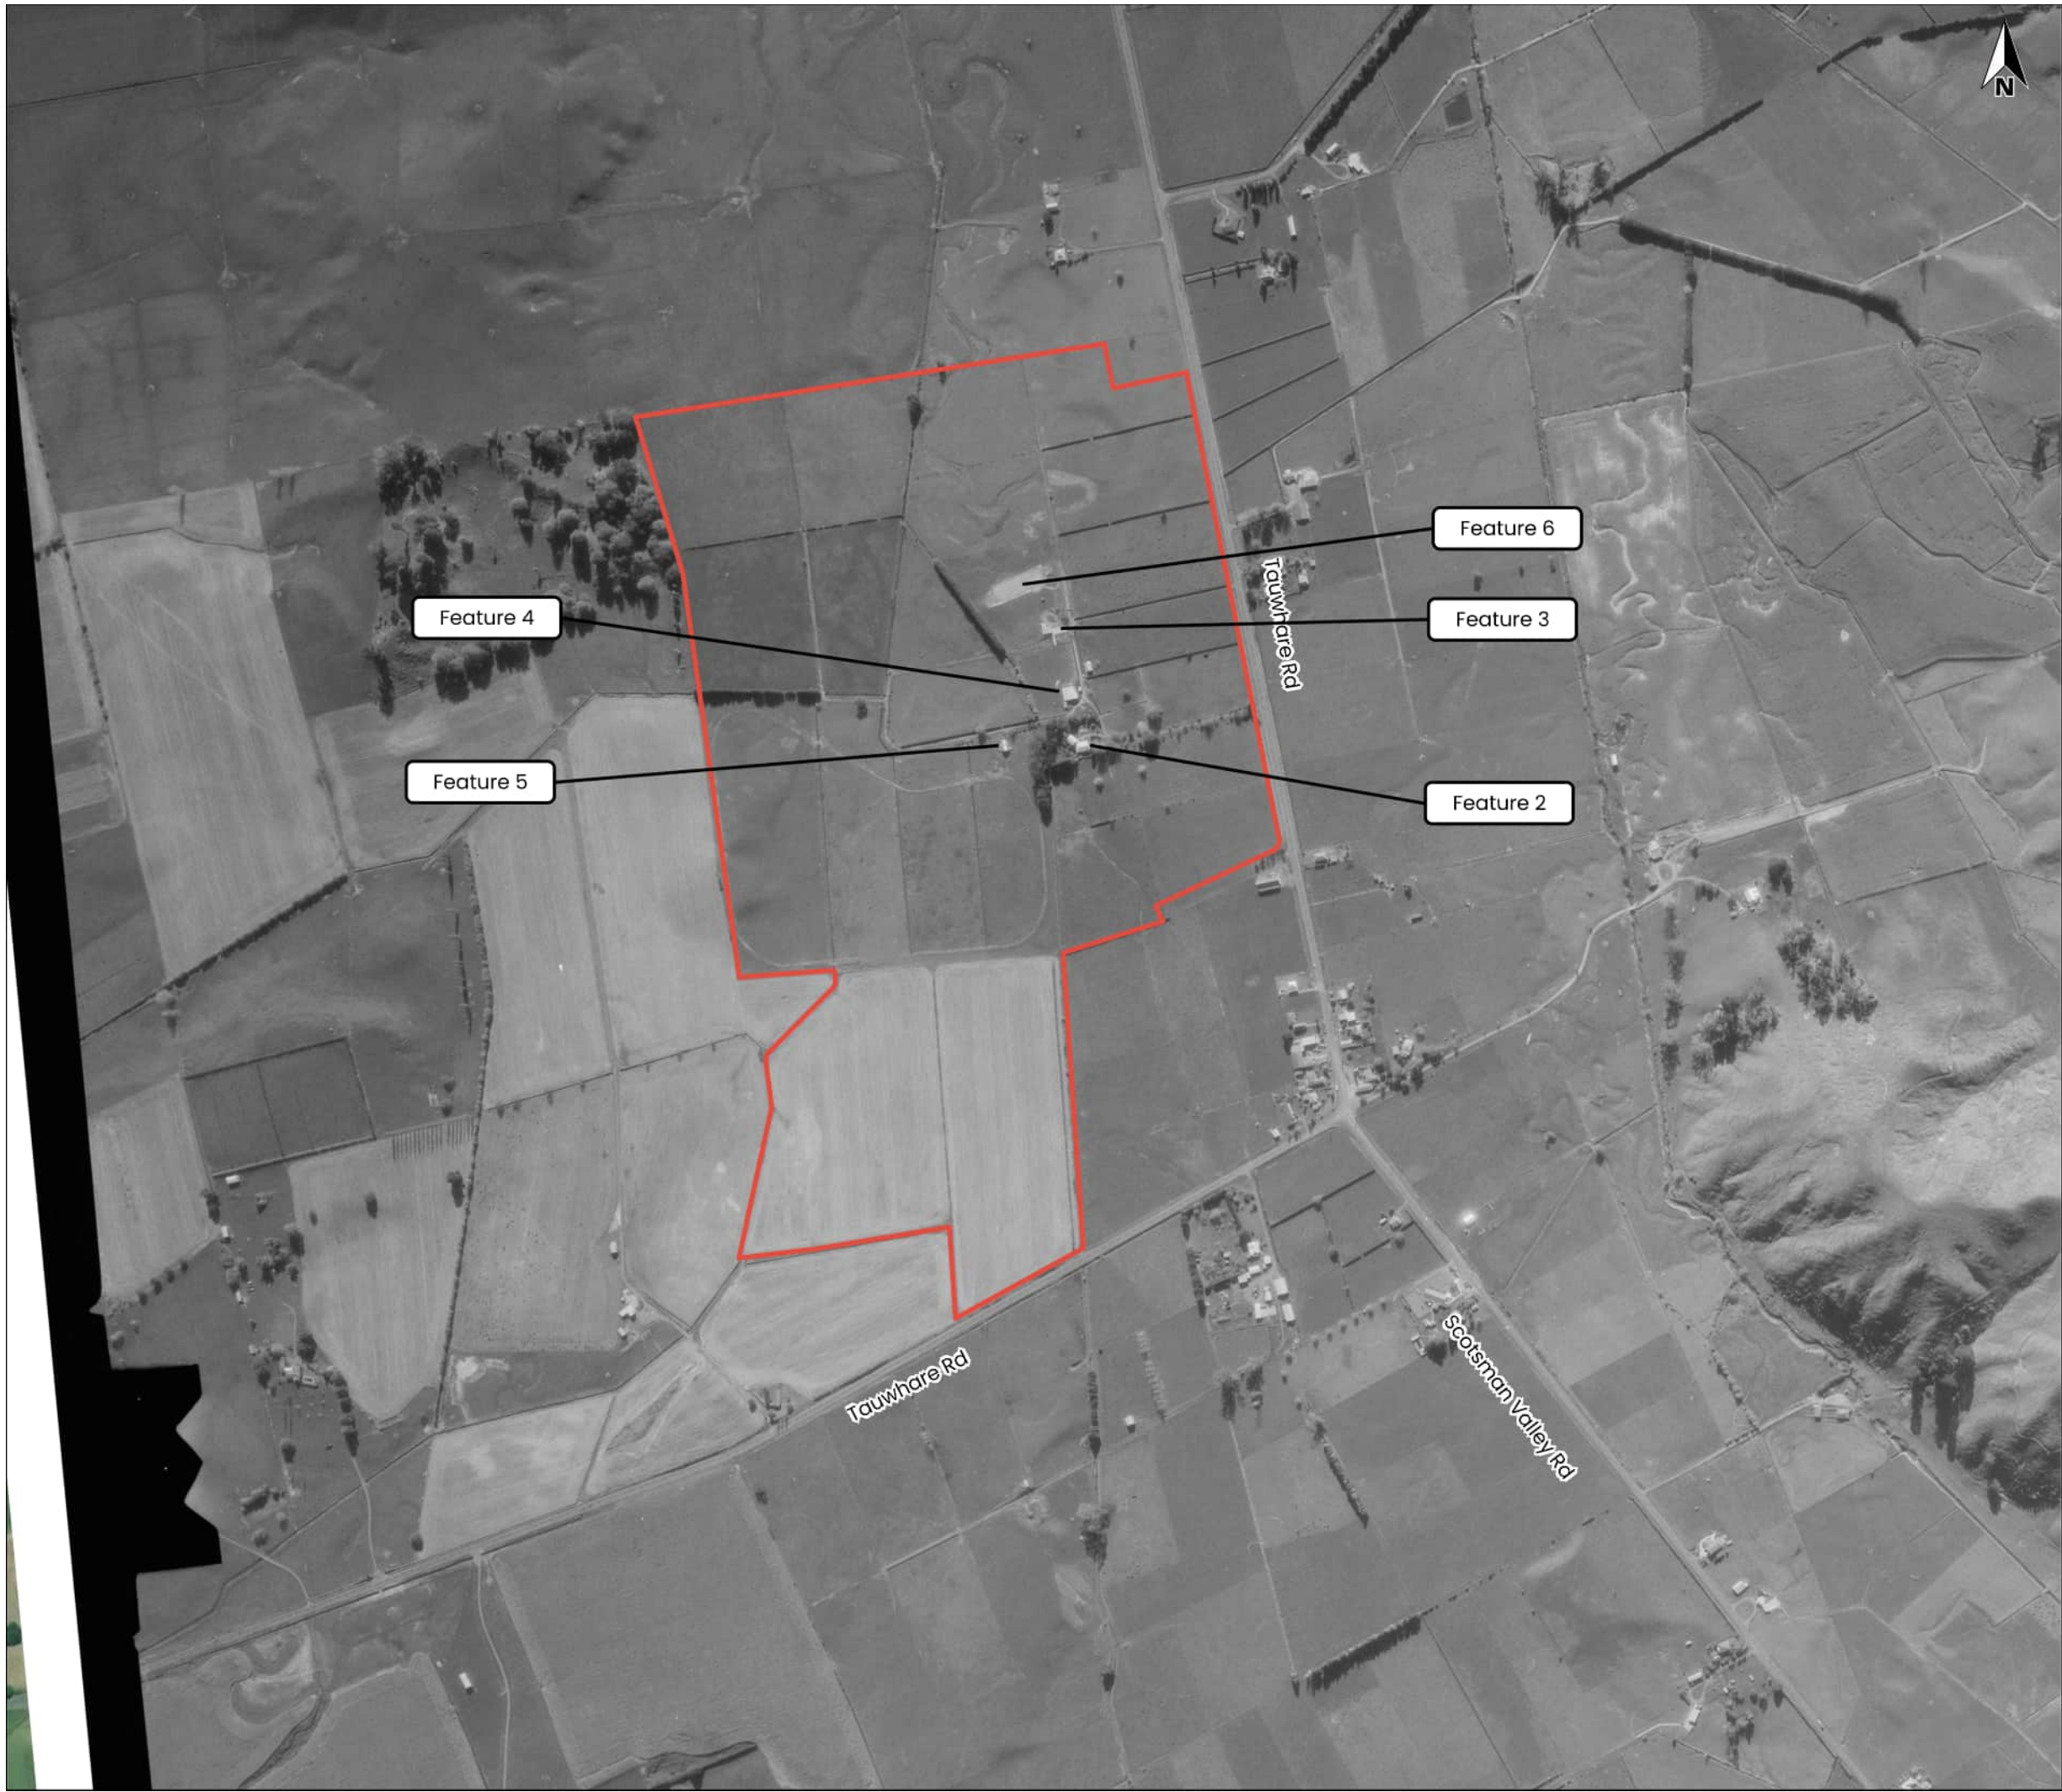
- Site Boundary
- 1986

| Year | Reference | Observations |
|---|---|---|
| 1986 | Retrolens®<br>(Black & White) | <b>The Site:</b> <i>Feature 2</i> appears to be a residential dwelling. <i>Feature 4</i> appears to be two ancillary farm sheds. An additional structure ( <i>Feature 5</i> ) has been added and appears to be a hay shed. An area of potential soil disturbance ( <i>Feature 6</i> ) is noted to the north of <i>Feature 3</i> .<br><b>Off-Site:</b> no significant changes from the previous imagery. |

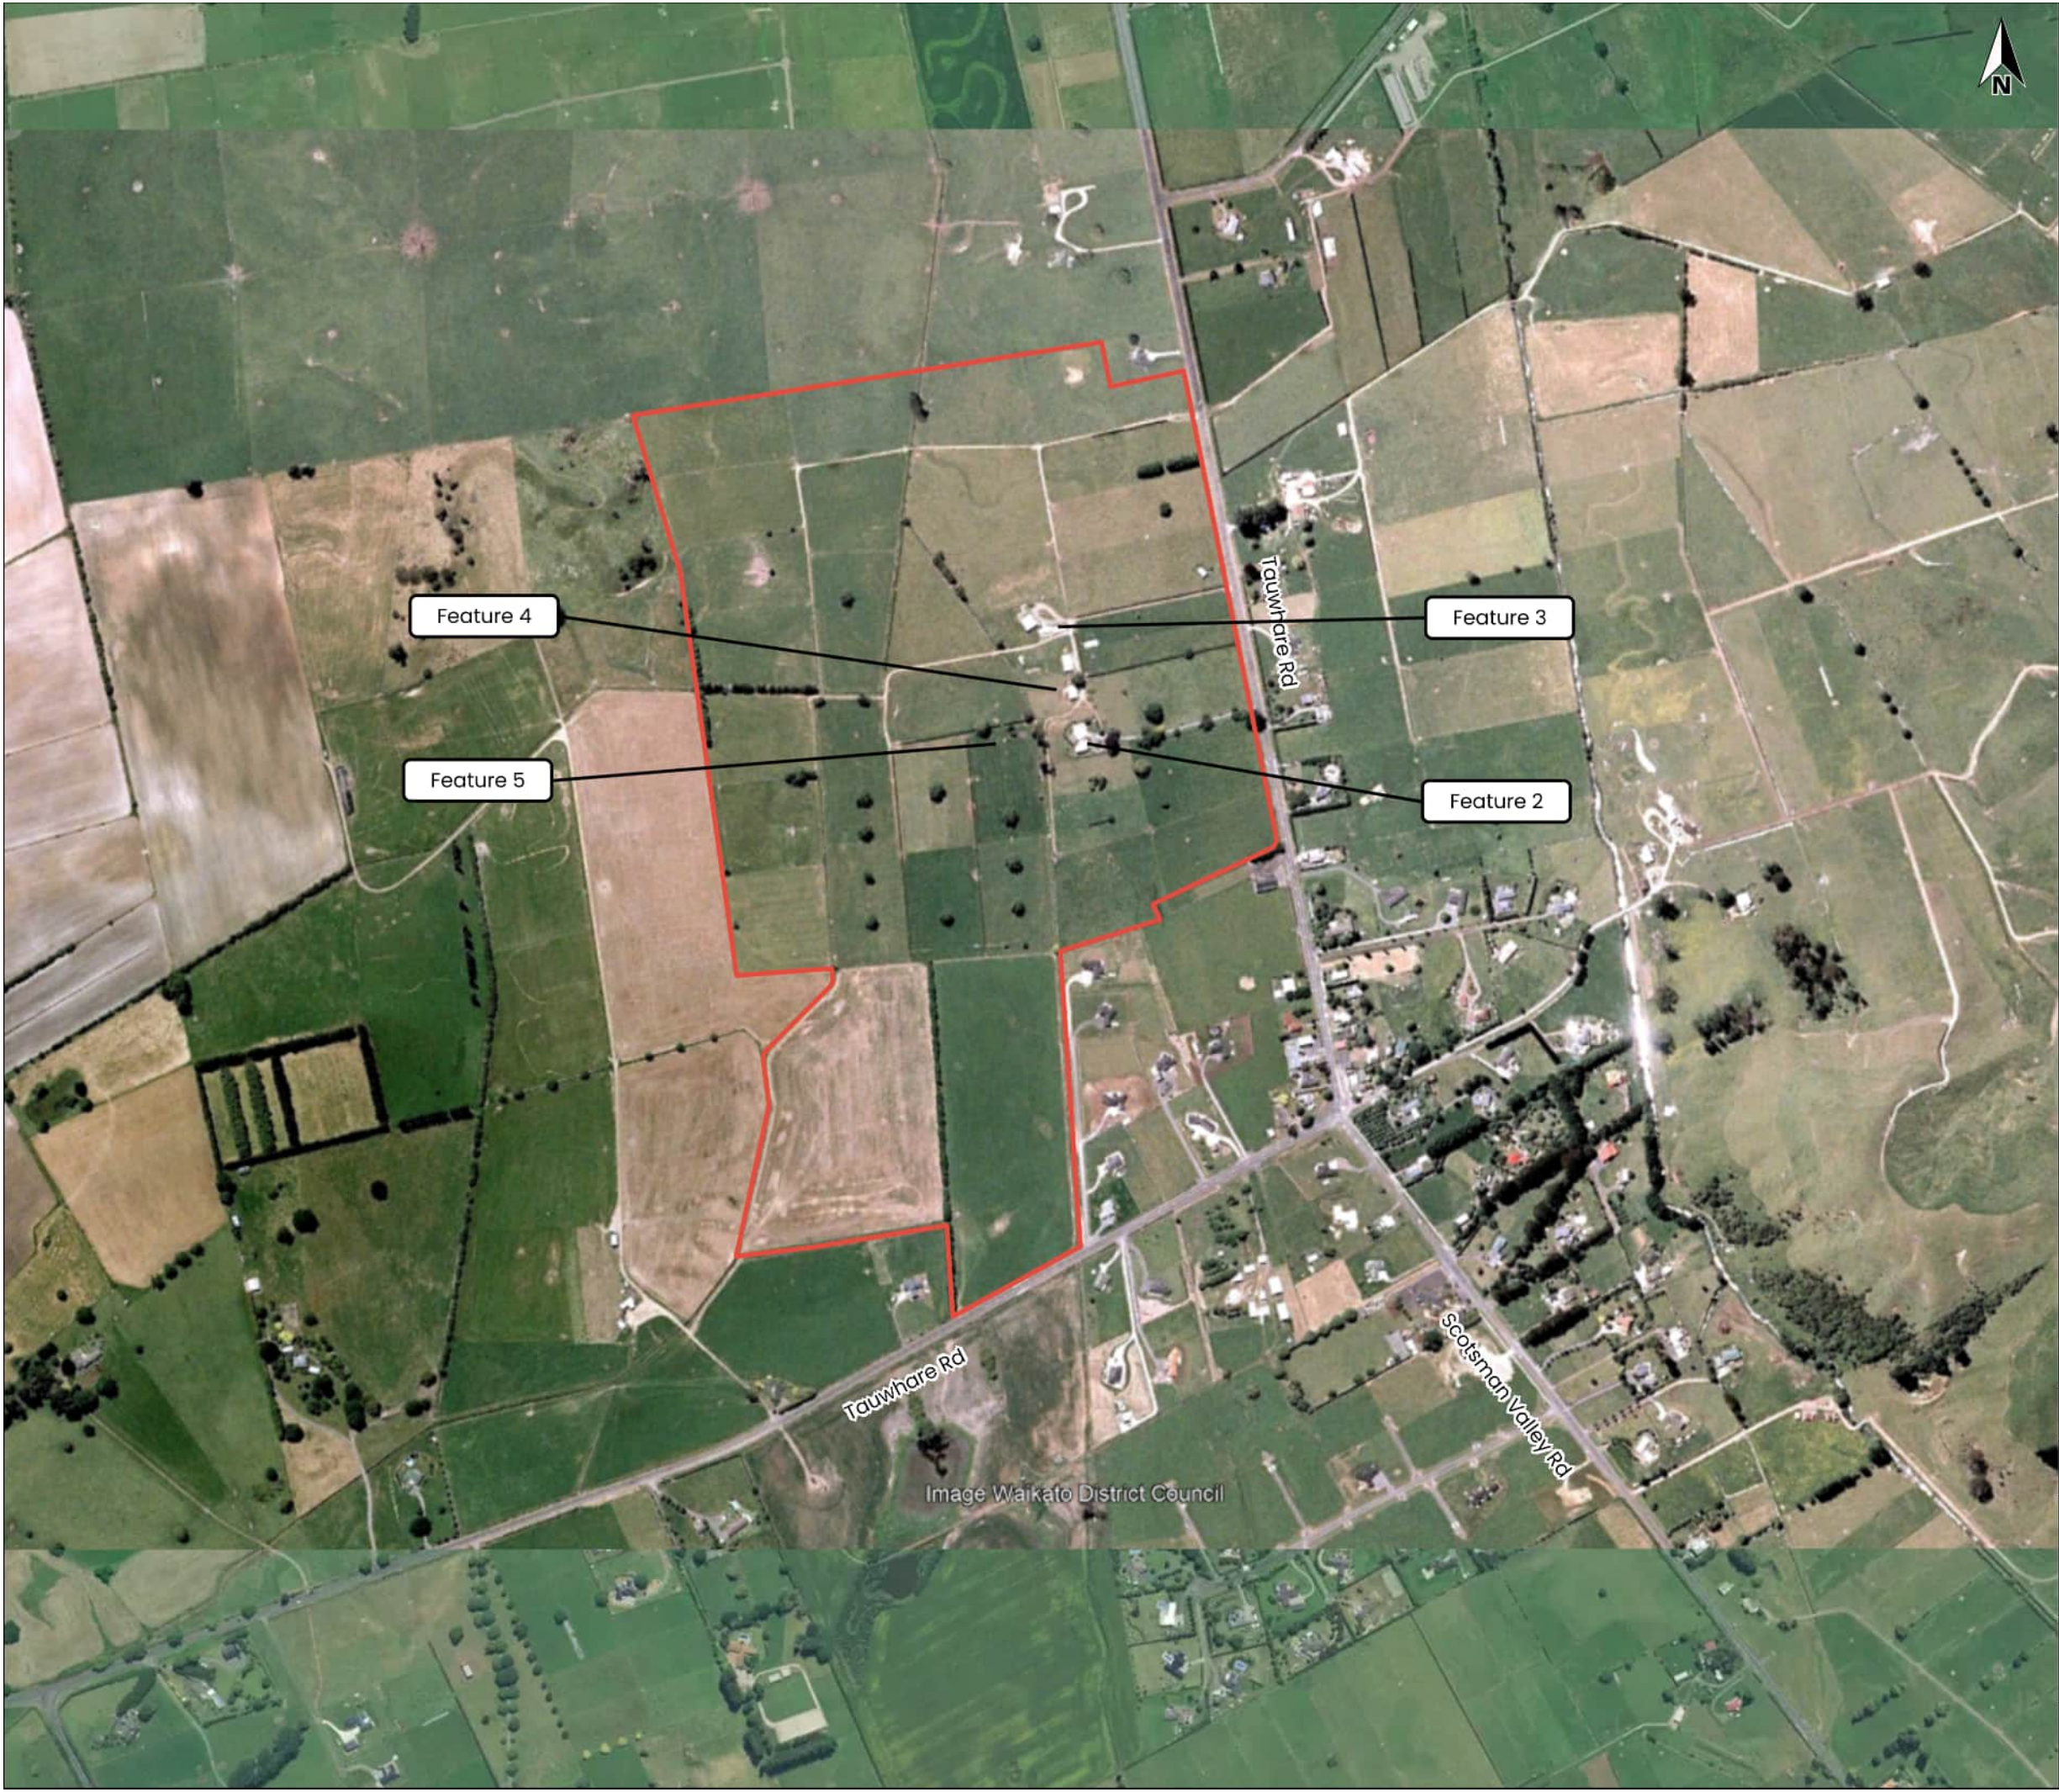
- Site Boundary
- 2008

| Year | Reference | Observations |
|---|---|---|
| 2008 | GoogleEarth™<br>(Colour) | <b>The Site:</b> <i>Feature 5</i> has been removed. A structure has been removed and another added to <i>Feature 4</i> . A structure has been added to <i>Feature 3</i> . The trees noted in the previous image are now well established.<br><b>Off-Site:</b> Significant subdivision and residential development is evident in the township of Tauwhare up to the southeastern boundary of the Site. |

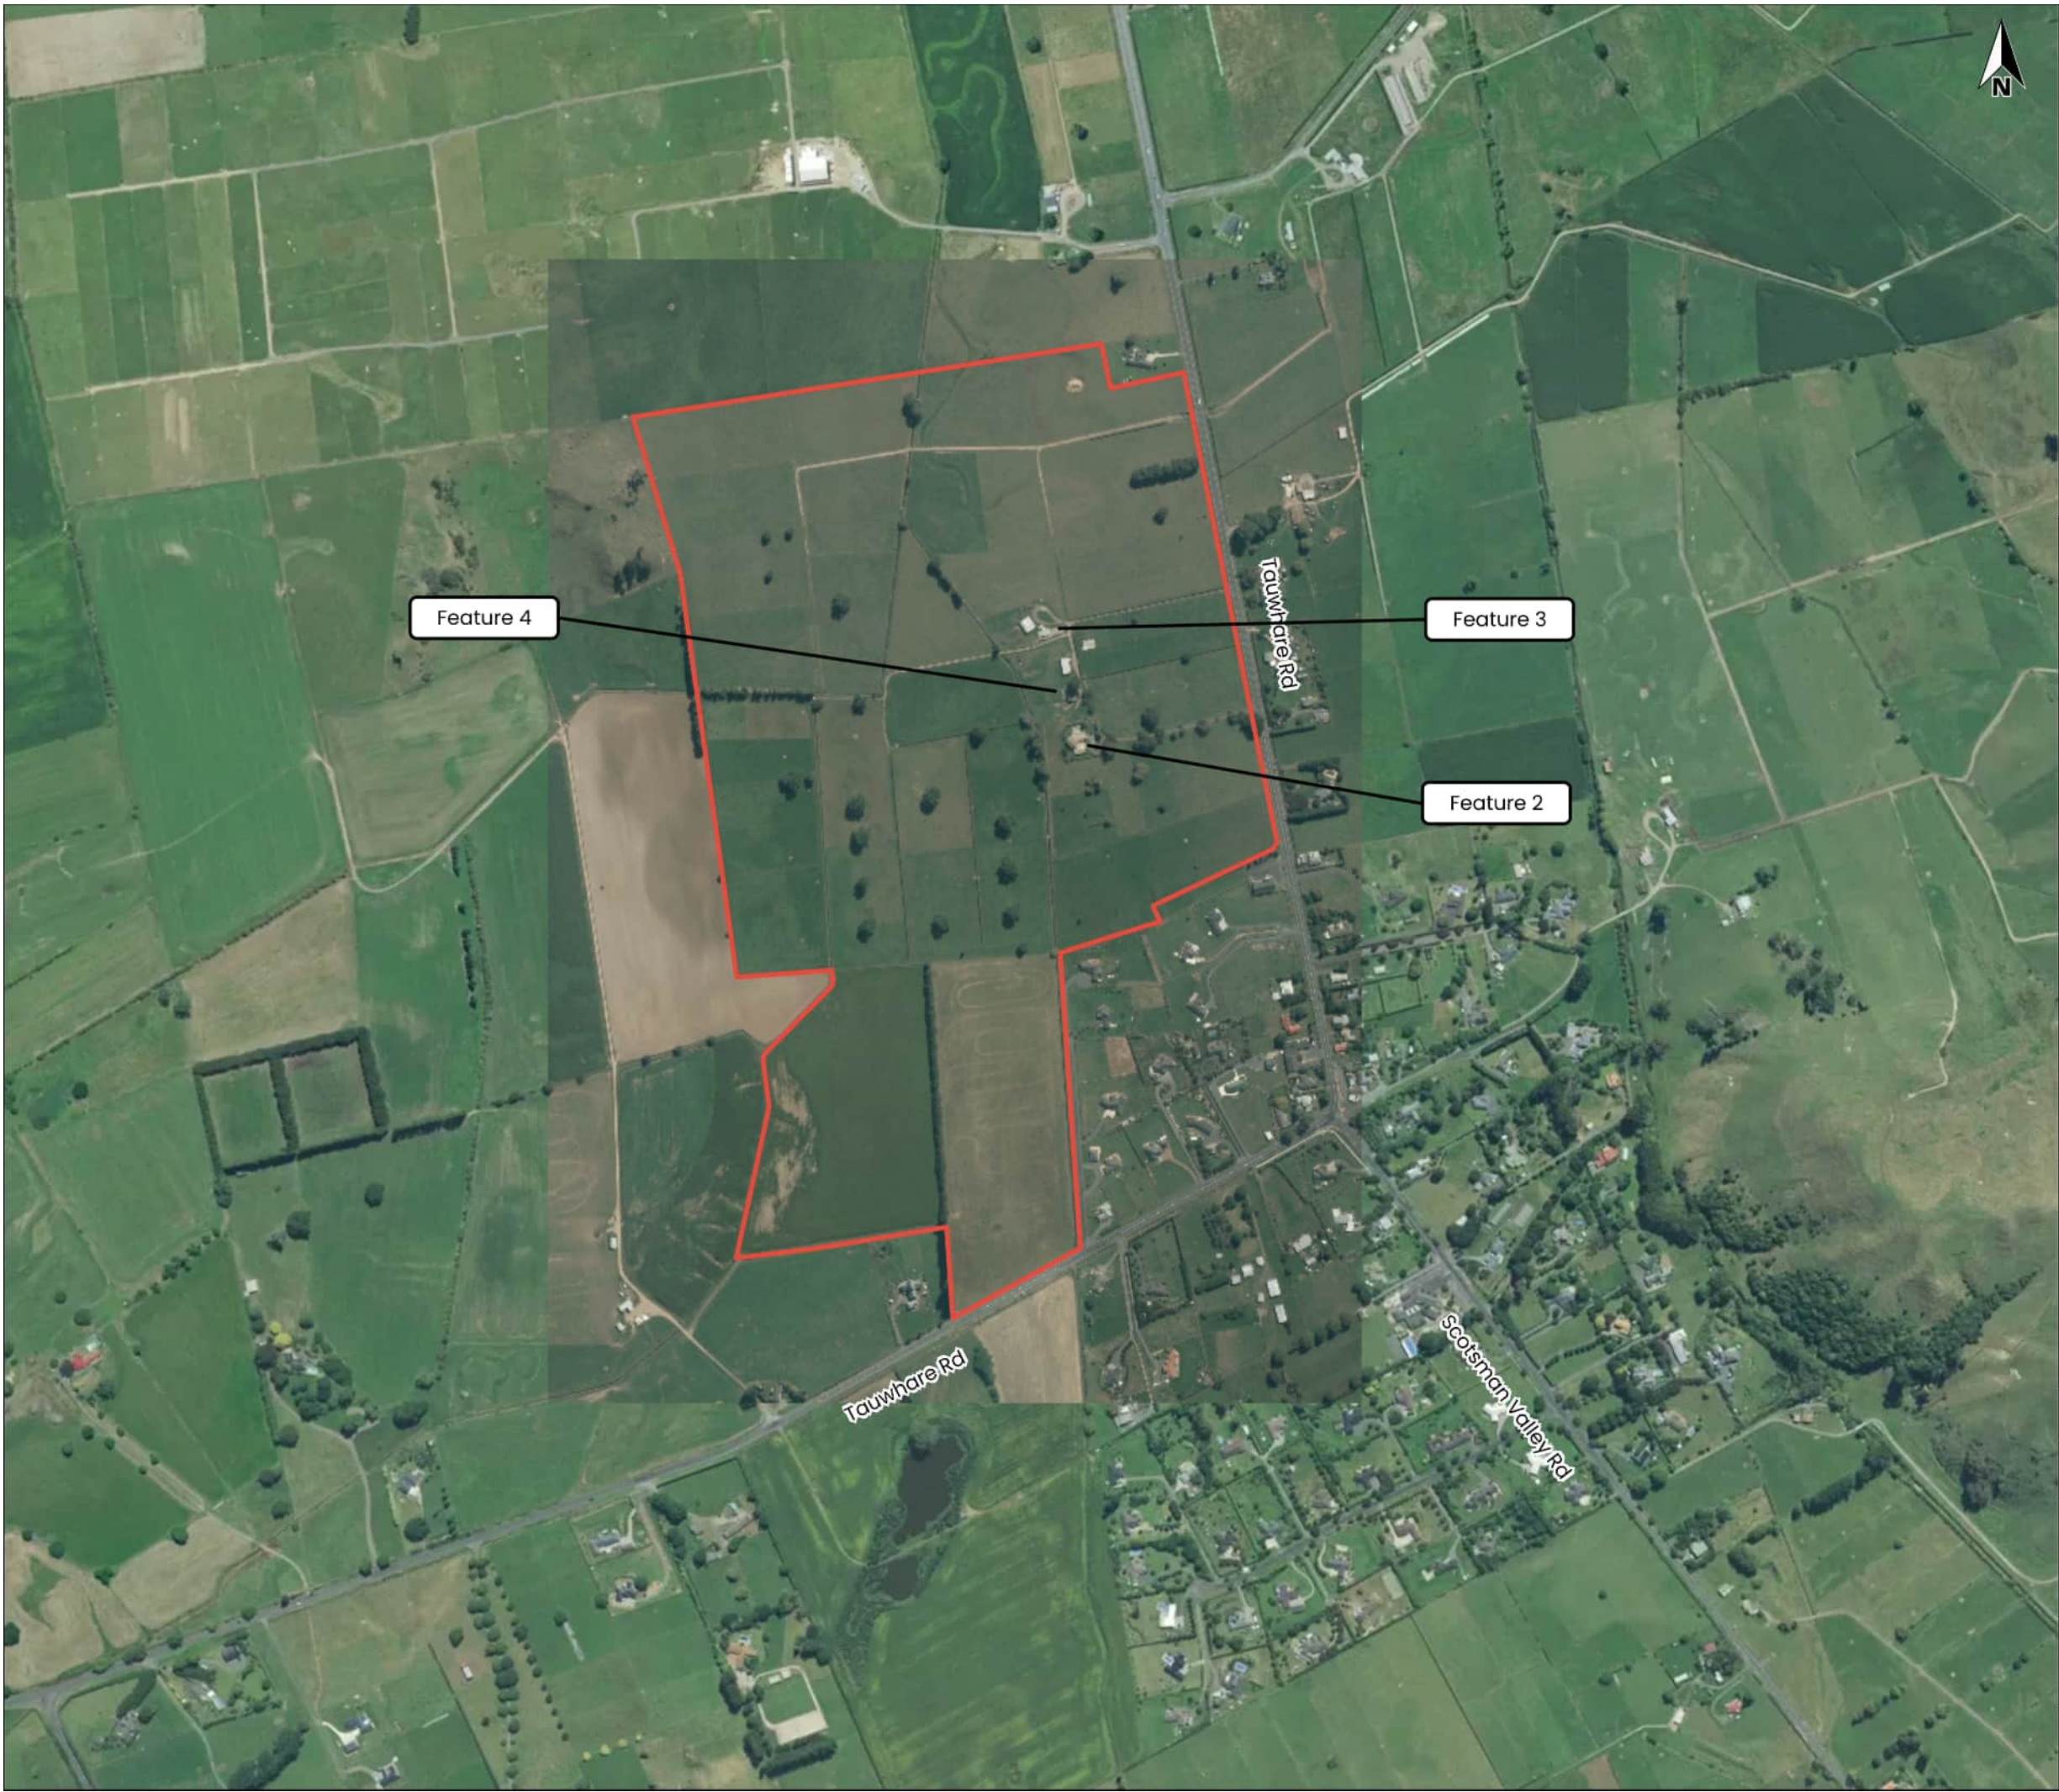
- Site Boundary
- LINZ Data Service
- Waikato 0.5m Rural Aerial Photos (2012-2013)

| Year | Reference | Observations |
|---|---|---|
| 2012-2013 | LINZ Data Service<br>(Colour) | <b>The Site:</b> no significant changes from the previous imagery.<br><b>Off-Site:</b> no significant changes from the previous imagery. |

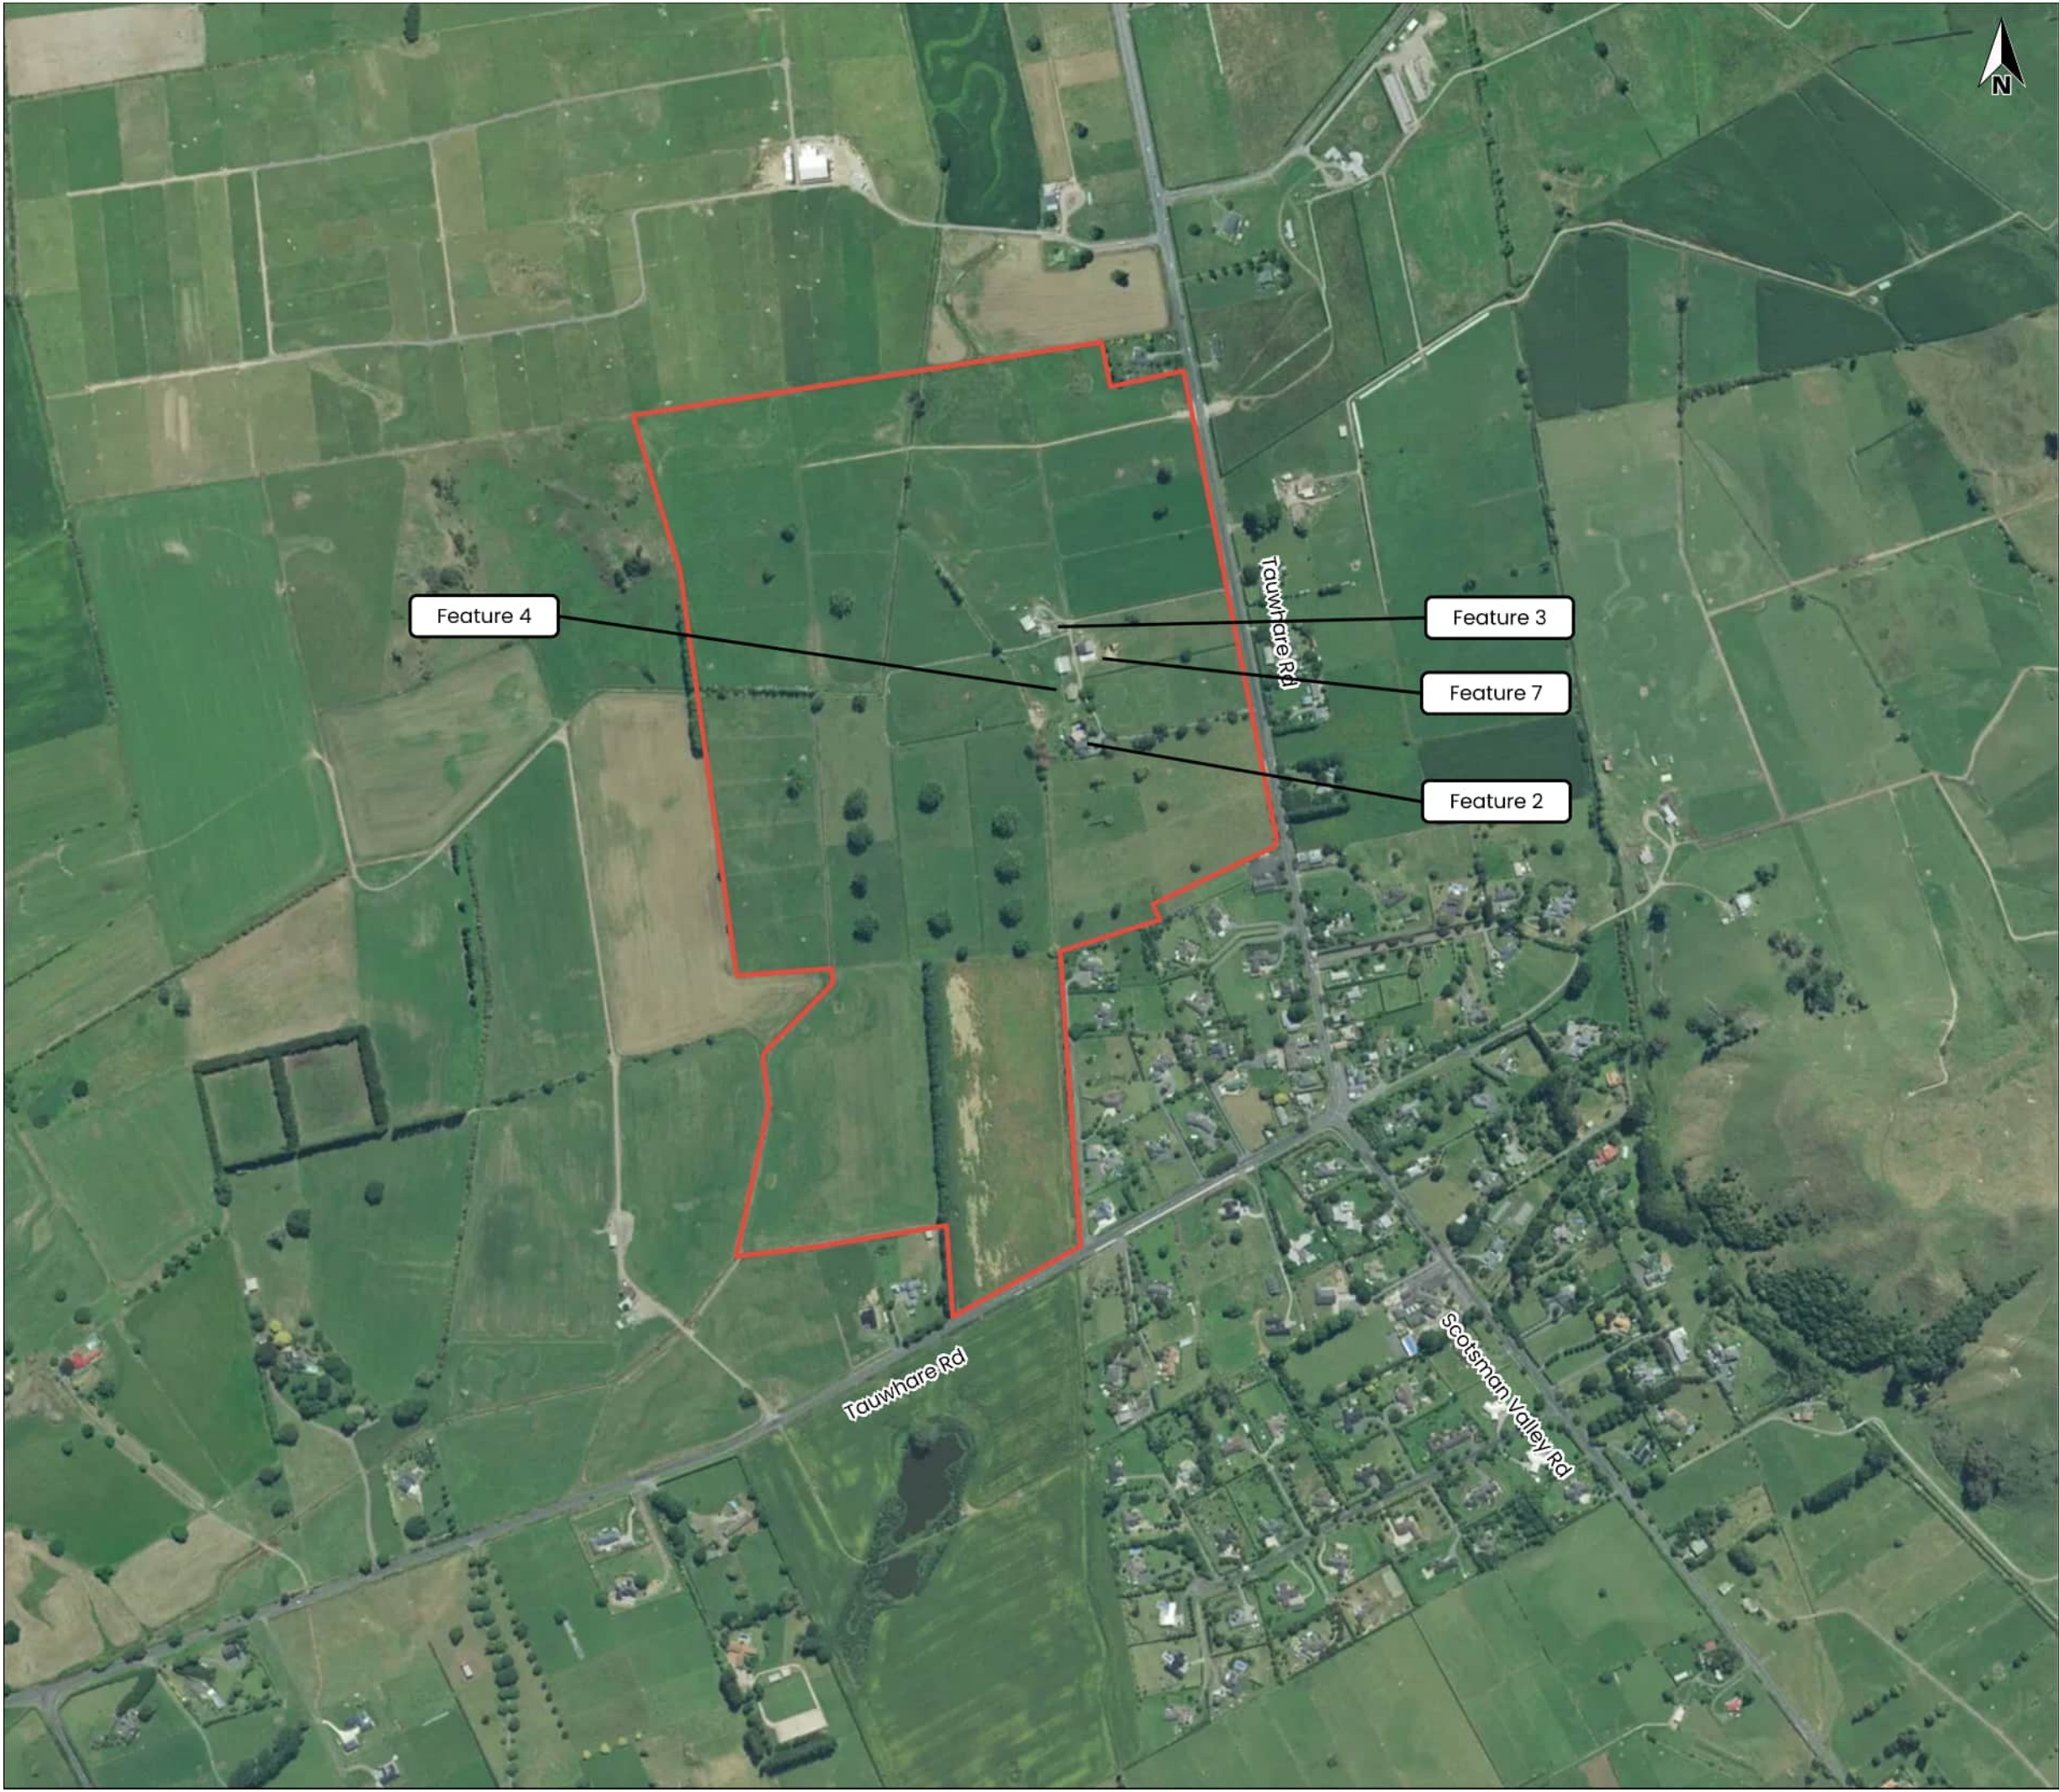
| Year | Reference | Observations |
|---|---|---|
| Current | LINZ Data Service<br>(Colour) | <b>The Site:</b> A structure ( <i>Feature 7</i> ) has been established, this appears to be a shed. No other significant changes from the previous imagery.<br><b>Off-Site:</b> no significant changes from the previous imagery. |
