## Preliminary site investigation

Tauriko West - Tupenga

NZ Transport Agency Waka Kotahi

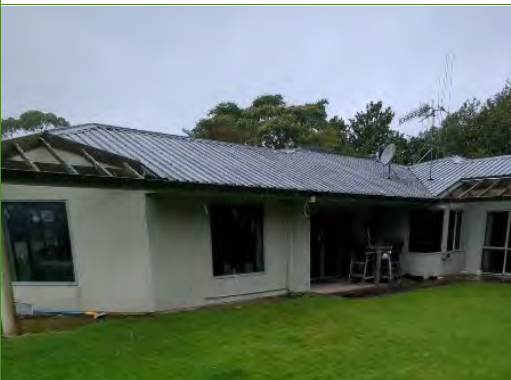
| Site photos | <p>Built in 2003, plaster cladding.</p> | <p>Stockpile of millings of the road and 'cleanfill' for recycling.</p> |

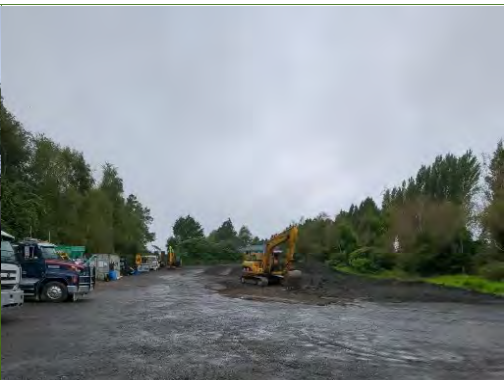
| Summary of potential HAIL land use(s) | Orchard since potentially 1970s. History of burn piles in east, stockpiling of road millings and 'cleanfill', potential fuel storage. Potential ACM and lead impacts unlikely, recent buildings. | |

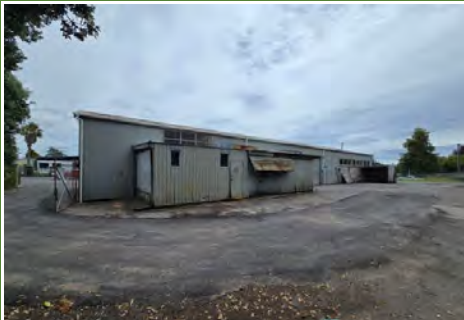
| Site inspection | Yes. No access to interior of building. Staining noted in oil dispensing area and washdown area. Evidence of UPSS noted. | |
| Site photographs | <p>Largely sealed site. Mostly corrugated iron exterior.</p> | <p>Front of shop and fuel forecourt</p> |

| | Workshops with storage tanks or drums for fuel, chemicals or liquid waste, potential ACM and lead impacts around buildings. | |

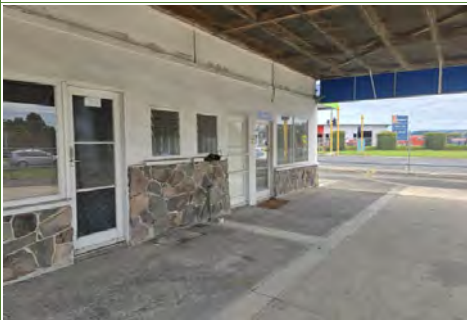
| | <p>Plaster cladding on front of shop</p> | <p>Former pump stations</p> |

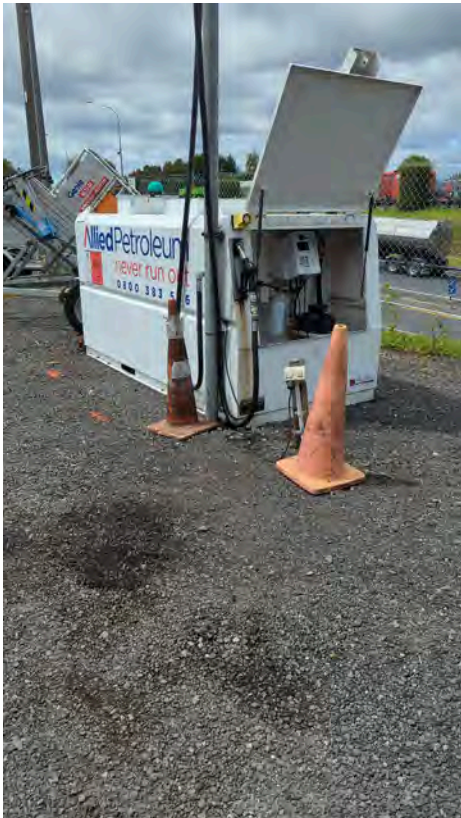
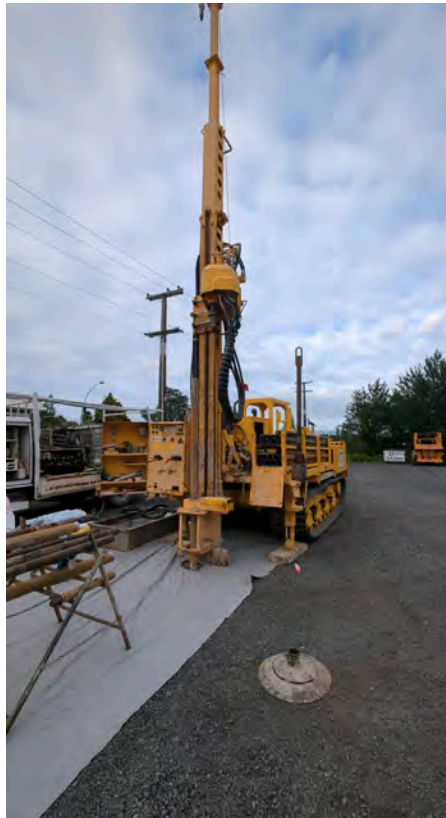
| Photos | <div style="display: flex; justify-content: space-around;"> </div> <p>Diesel supply (adjacent to CPT 1045)      BH1021</p> |
| Summary of potential HAIL land use(s) | <p>Commercial site from 1960s. Site used for storage of roading materials and for truck washing by Western BOP District Council. In 1996 Water Tech Group released toxic chemicals tributynol and several other unidentified chemicals. Some attempt was made to remove the contaminated soil and divert run off. The site was later used as a rubbish dump by a contractor who accumulated a large mass of waste materials from many sources at the site. Potential ACM and lead impacts at the site. Site is adjacent to former timber mill - contaminants may extend onto the site and nature place.</p> <p>A February–March 2026 geotechnical investigation at 2 Nature Place by BECA, with HAIL Environmental oversight, identified generally low-risk conditions (no asbestos or hazardous gases) but confirmed the presence of contaminants above background levels, including metals, TPH, and PAHs. Localised issues include inert fill at shallow</p> |

| | depth, minor diesel staining near a known above ground tank supply, and one hotspot (HA1010) exceeding commercial/industrial criteria for Benzo(a)pyrene. Some soils also exceed cleanfill acceptance criteria, indicating portions of material will require managed disposal or controlled reuse, with targeted delineation of contamination recommended. |

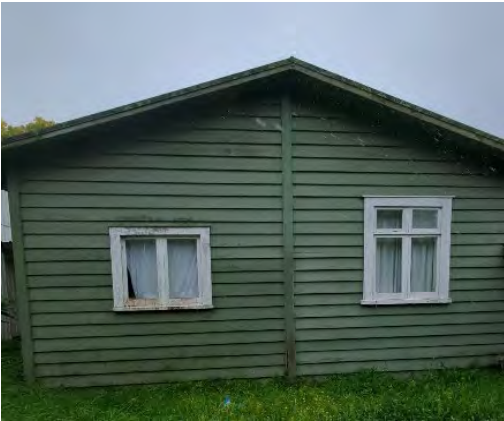
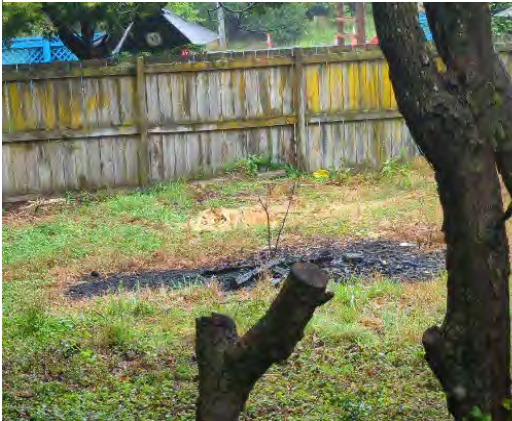
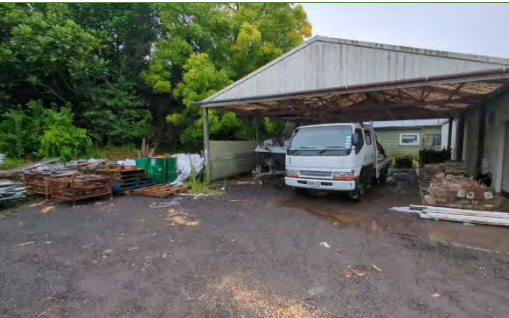
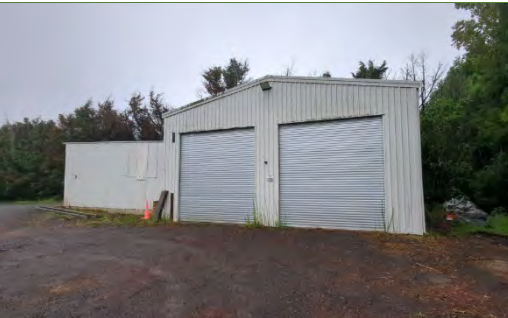
| Site photos | <div> <p>Fiberboard cladding on site building - potential ACM.</p> </div> <div> <p>A burning pit was observed - potential presence of PAHs and heavy metals.</p> </div> <div> <p>Galvanised workshop. Sealed ground surface.</p> </div> <div> <p>Lock up garage/ workshop, sealed ground surface.</p> </div> |
| Summary of potential HAIL land use(s) | Site has been residential with sheds since the 50/60s – potential for ACM and lead impacts around current and former buildings. Orchard from neighbouring site overlaps into the property. A burning pile and a workshop were identified during the site visit. |

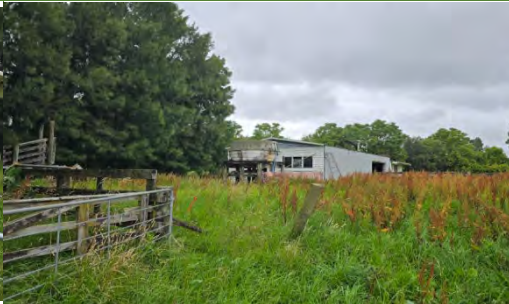
Yes. Small shed in south was observed to contain likely ACM.

| | Weathered shed in southeast corner of site. | |

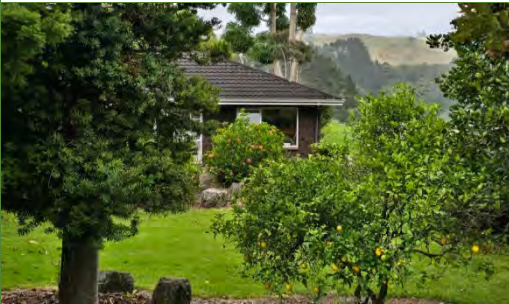
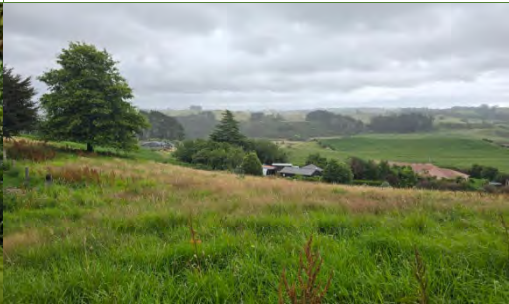
| | Unpainted brick dwelling. | Pastoral grazing surrounds dwelling. |

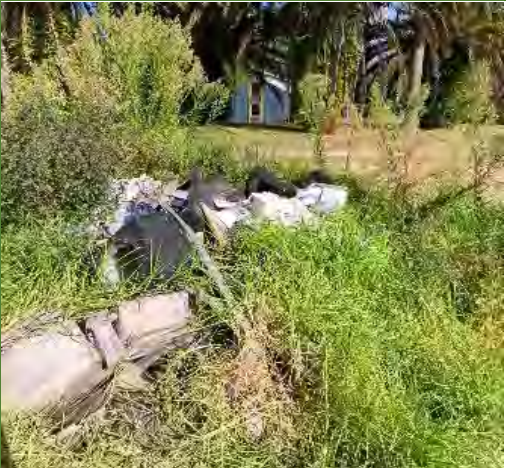
| Site photos | <p>Waste pile containing ash residues, plastic containers, textiles, timber boxes, burnt wood.</p> | <p>Fiberboard soffits in main dwelling.</p> |
