# **Auckland Surf Park Community - Stage 2 Development**

## **Ecological Impact Assessment**

**Prepared for: AW Holdings 2021 Ltd**

**June 2026**

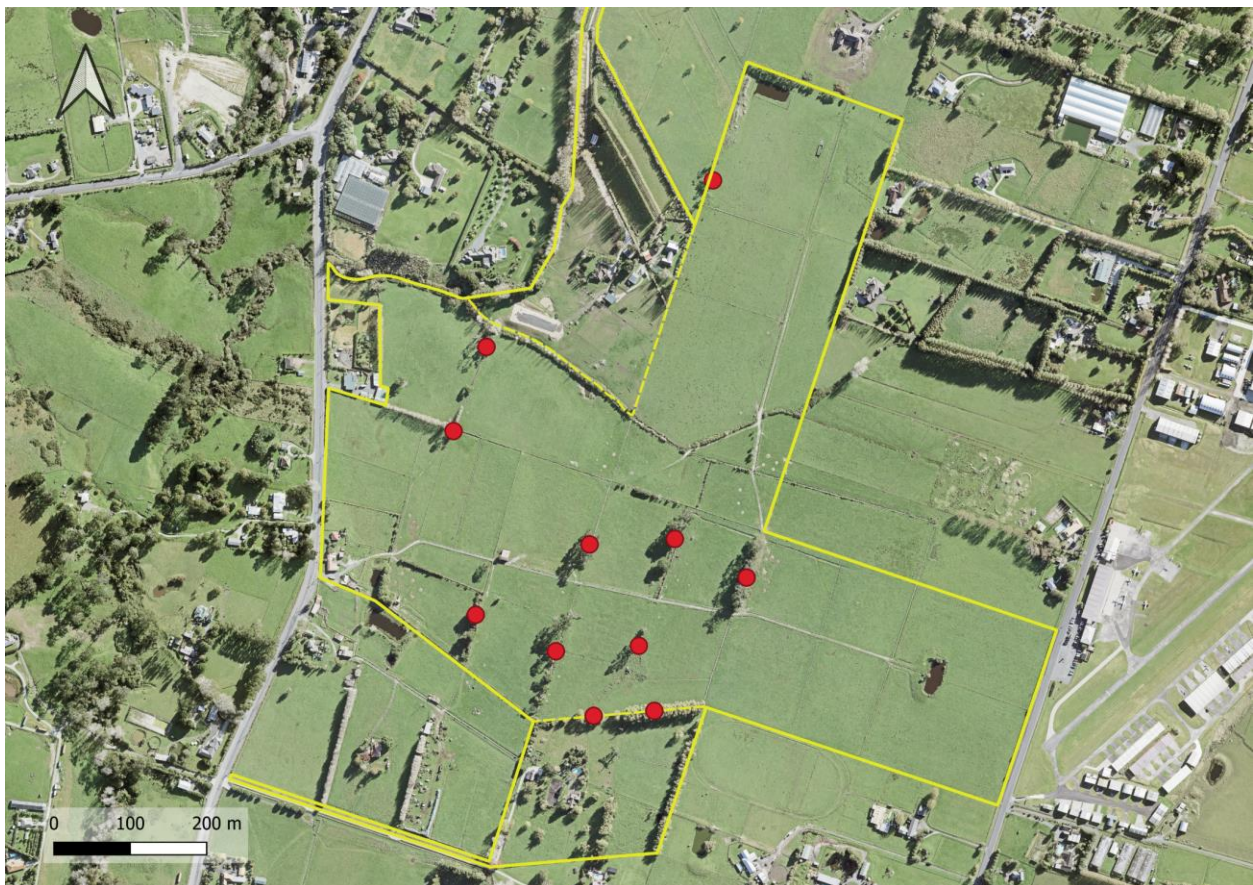
*Figure 3. ABM location within the site (map source: LINZ 2017).*

Bat activity was monitored using Automatic Bat Monitors (ABMs; Song Meter Mini Bat 2 acoustic detectors), which were deployed across the site for varying periods between 13 and 29 January 2025. ABMs were placed in a range of habitats, including riparian edges, shelterbelts, pasture margins and likely flyways, to maximise detection probability. Devices were mounted and oriented to minimise obstruction and interference.

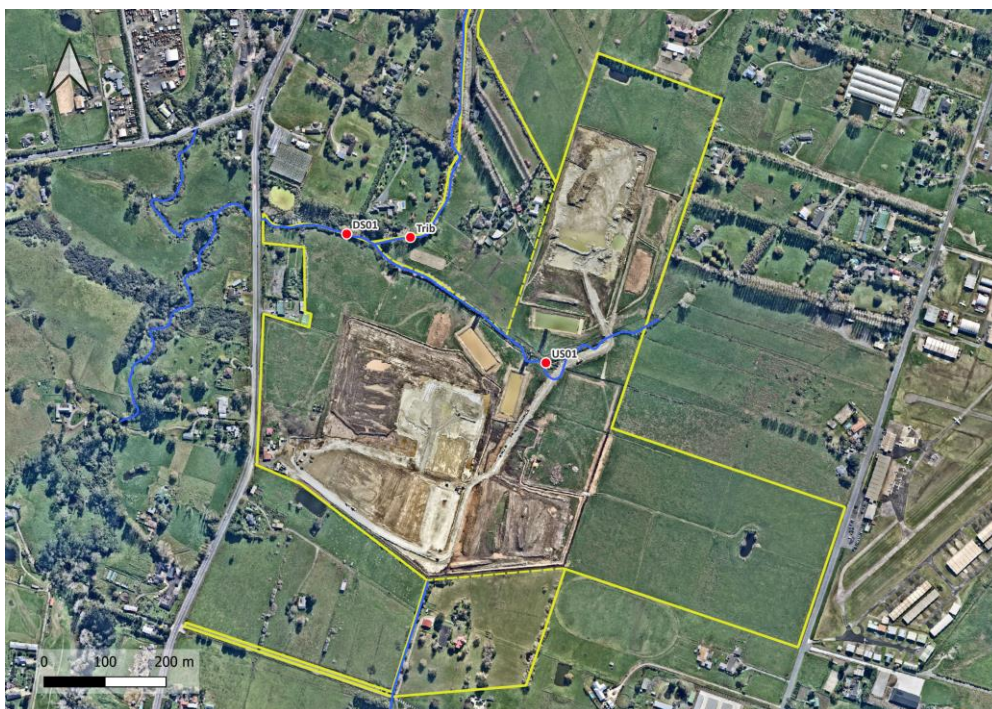
**Figure 4. Macroinvertebrate sampling locations.**

Three macroinvertebrate samples were collected within the site (Figure 4) using a D-net and the quantitative soft-bottomed stream sampling method described in NEMS (2022). All samples were preserved in 70% isopropyl alcohol for subsequent identification and counting. Benthic macroinvertebrates were identified and enumerated to a level appropriate for calculating the Macroinvertebrate Community Index (MCI) and Quantitative MCI (QMCI), following NEMS (2022) protocols. The NPS-FM provides Attribute Bands (A–D) for MCI and QMCI scores to assist interpretation.

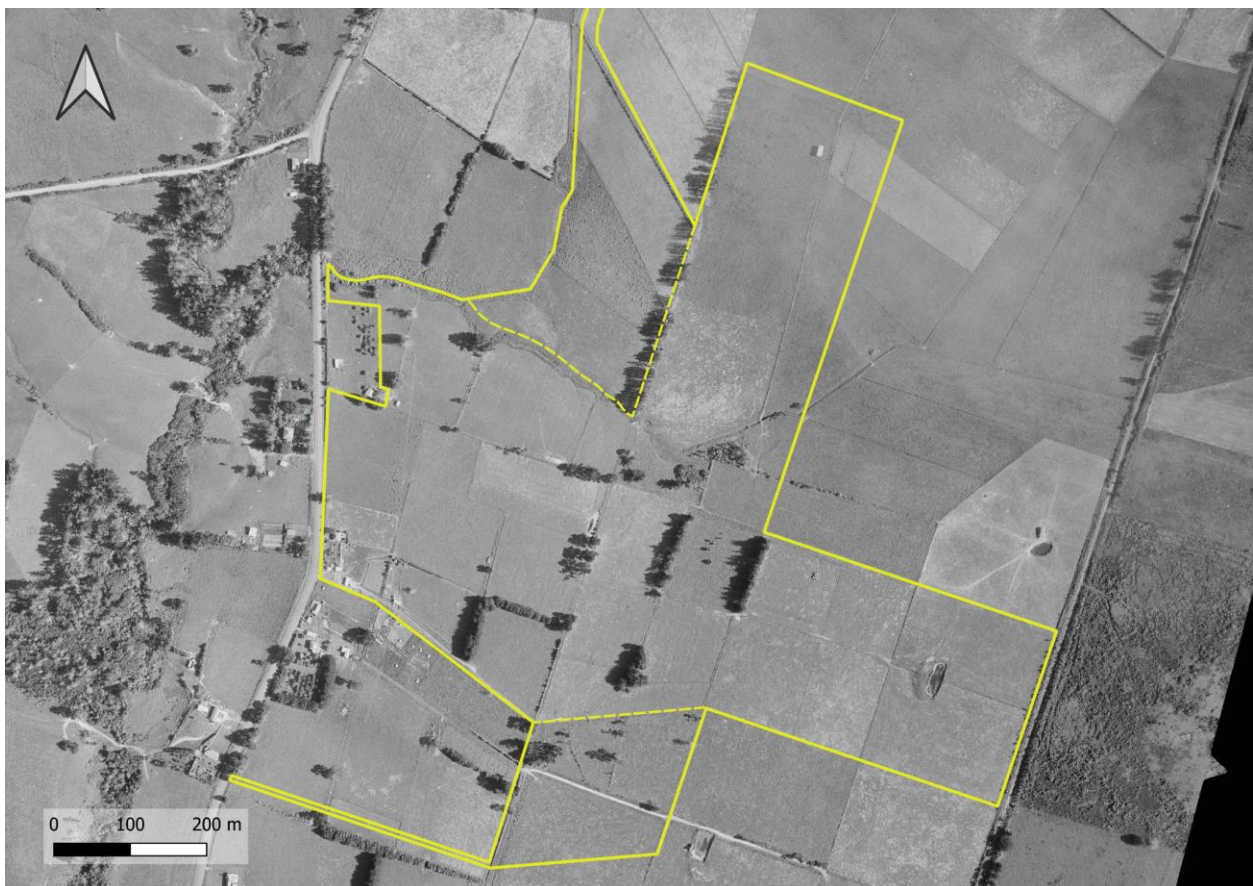
**Figure 5. Historical aerial imagery of the site, dated 1957.**

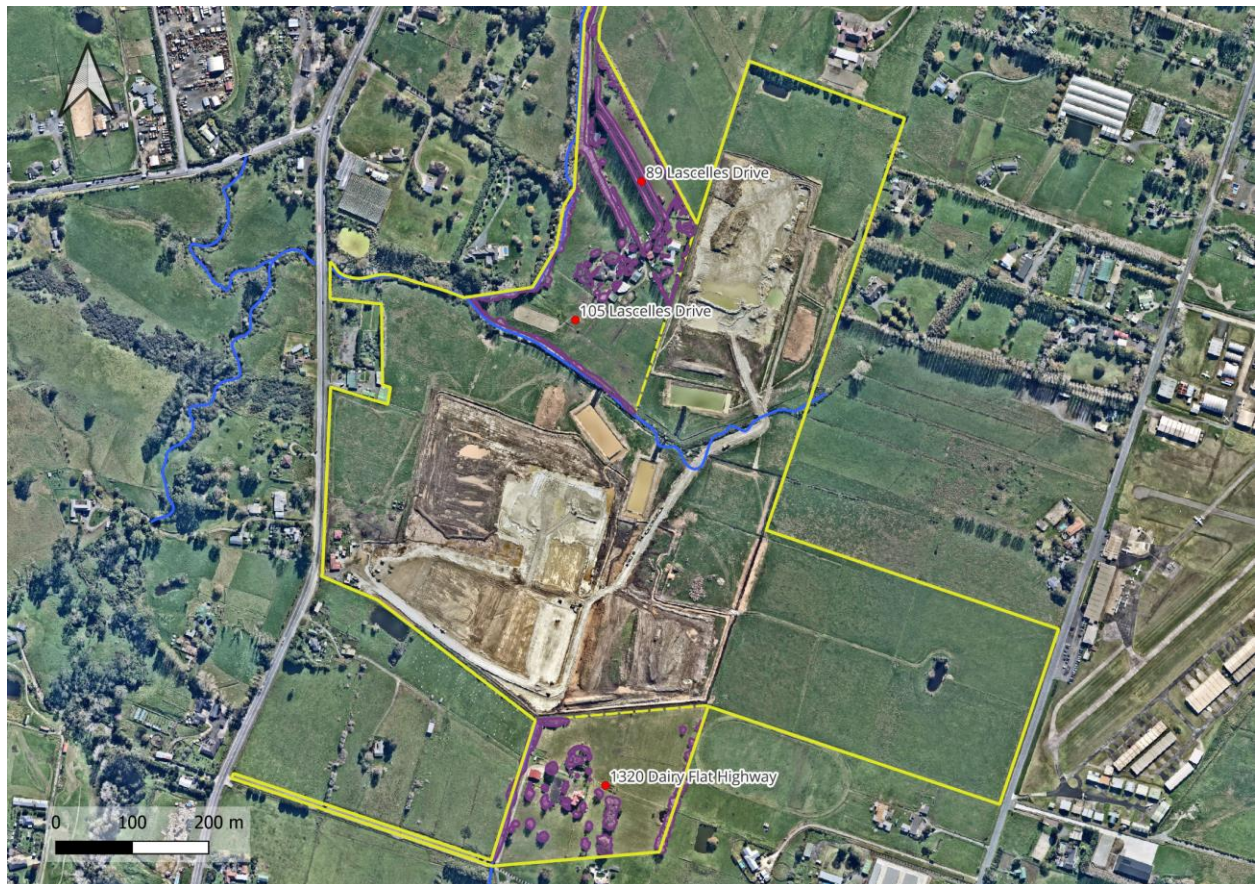
**Figure 6. Exotic dominant trees and shrubs (purple polygons) within Stage 2.**

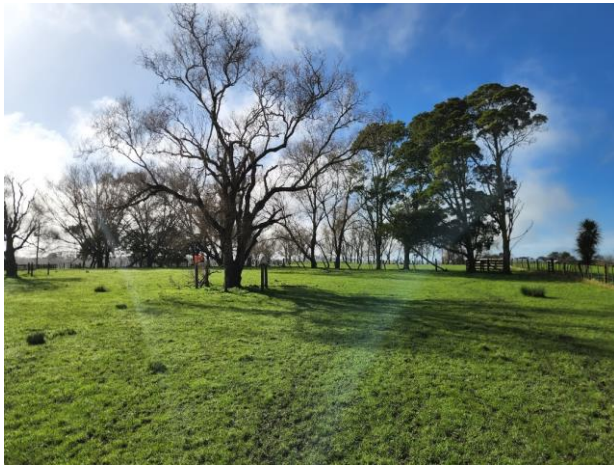
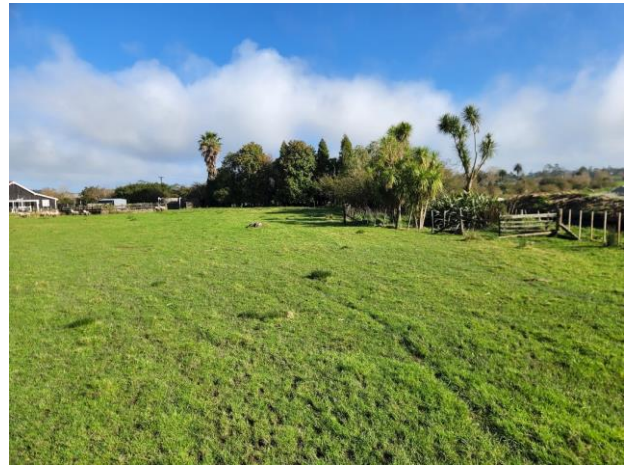
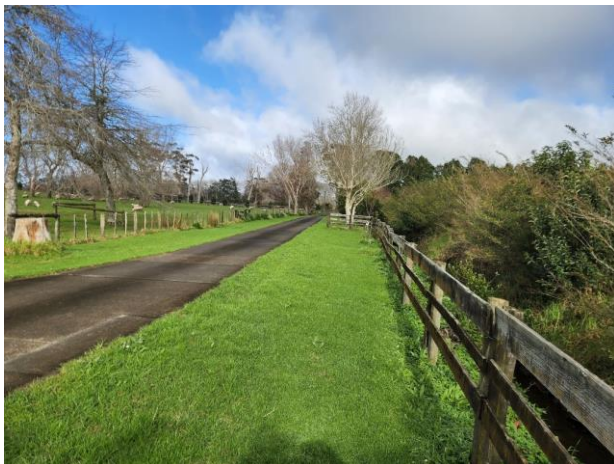
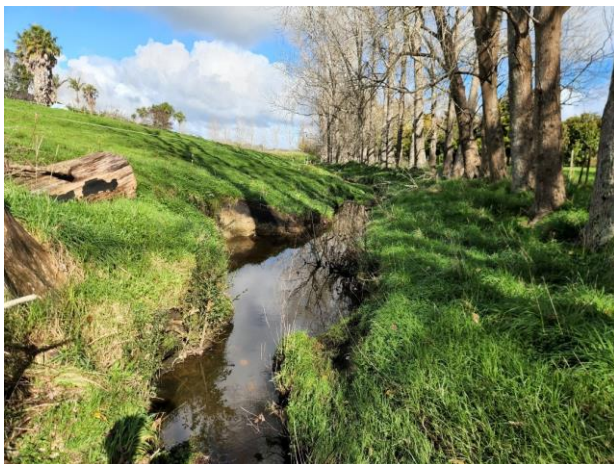
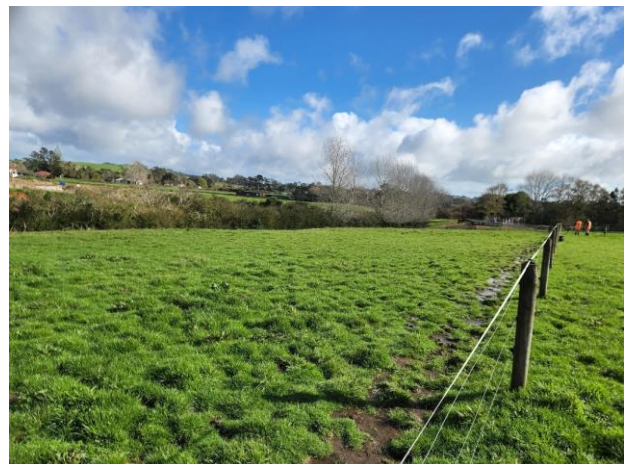
**Figure 7. Typical vegetation within Stage 2: a) scattered trees at 105 Dairy Flat Highway; b) small patch of native vegetation interspersed with exotics at 105 Dairy Flat Highway; c) Chinese privet along the riparian margin at 105 Dairy Flat Highway; d) poplar shelterbelt and pampas at 89 Lascelles Drive; e) upper reach riparian margin at 105 Lascelles Drive; and f) Chinese privet along the lower reach riparian margin at 105 Dairy Flat Highway.**

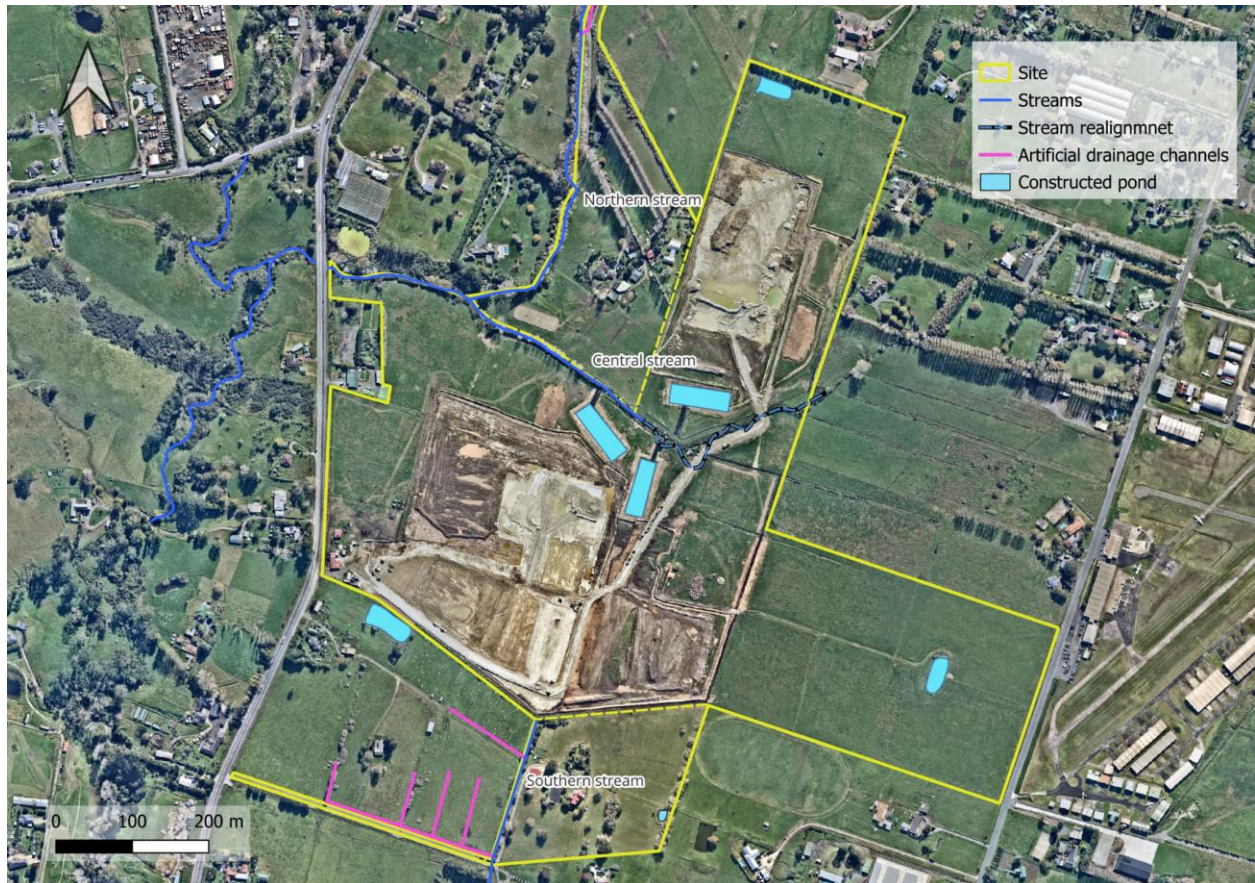
**Figure 9. Freshwater features within the site.**

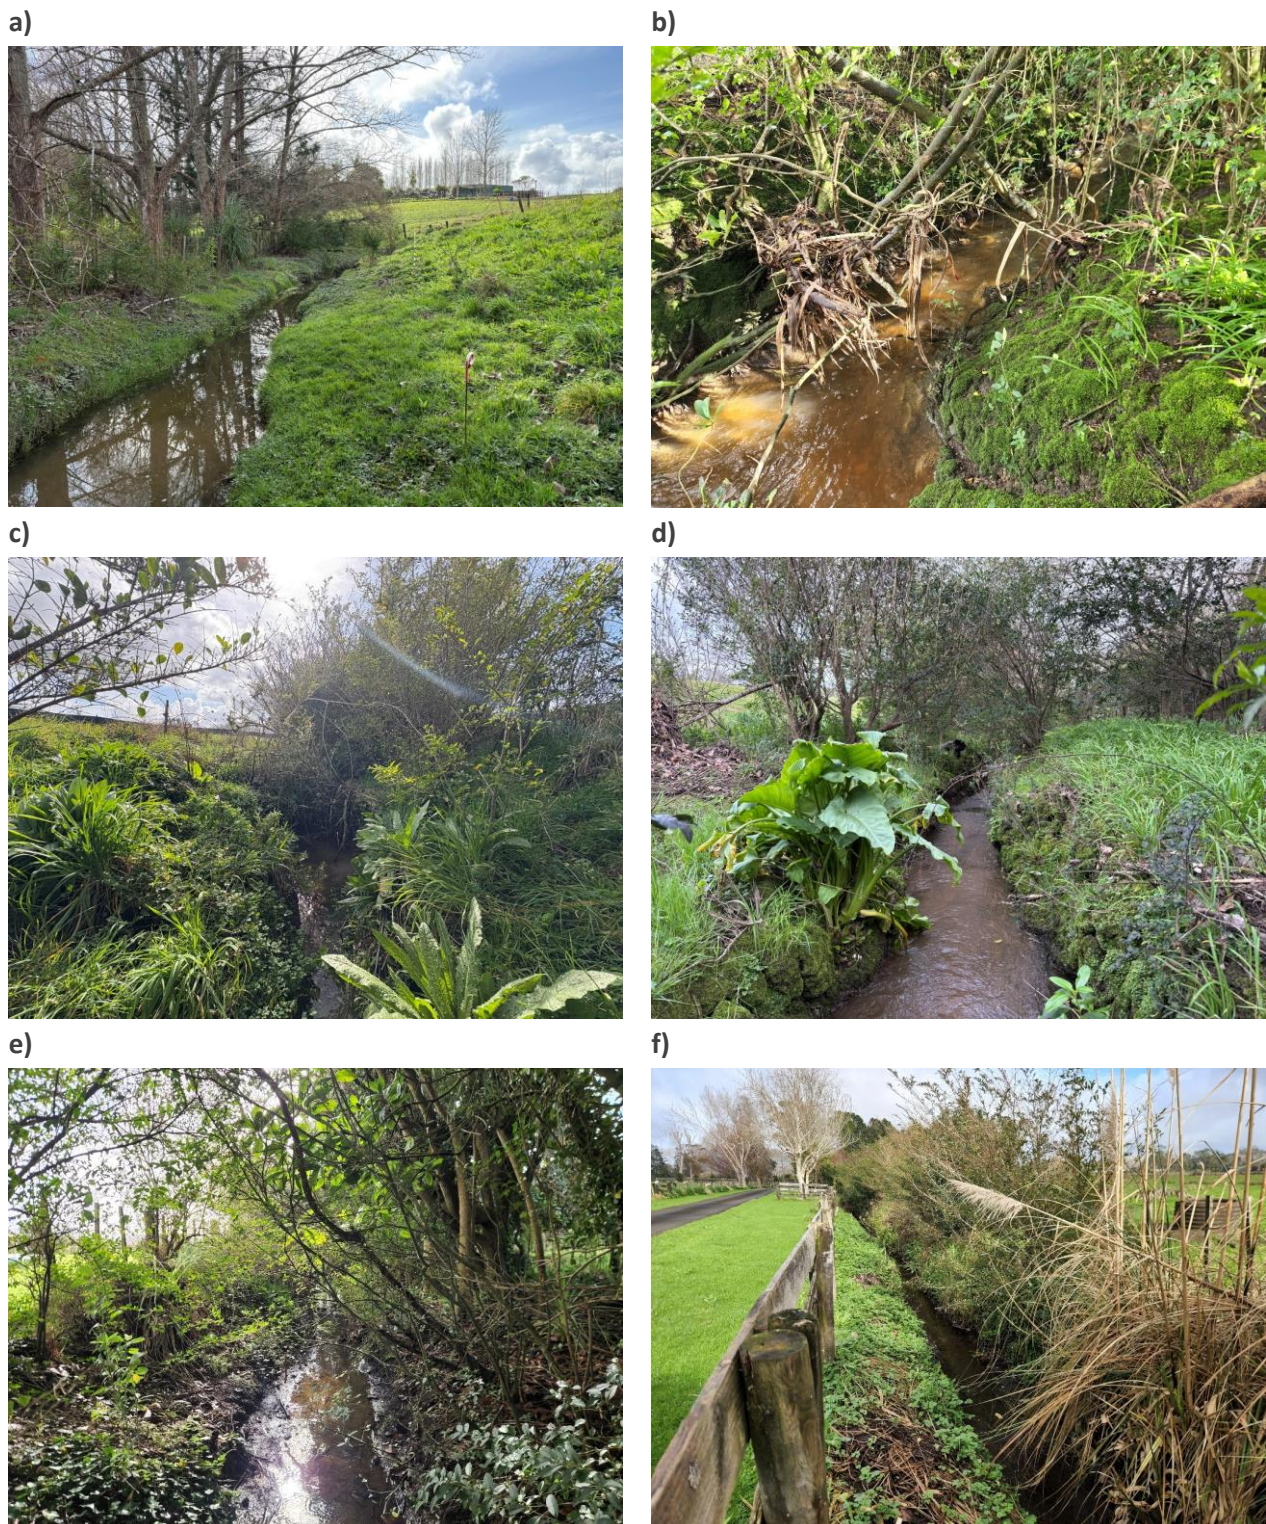
**Figure 10. The northern stream a) upper and b) lower reach, the central stream c) upper and d) lower reach, and the southern stream e) upper and f) lower reach.**

Riparian margins also exhibited low ecological condition (Figure 10c, e & f). The riparian strip within 1320 Dairy Flat Highway was dominated by Chinese privet with patches of arum lily. On the southern edge of 105 Lascelles Drive, riparian vegetation was similarly dominated by dense privet, and extensive pampas grass occurred along the northern boundary of 89 Lascelles Drive.

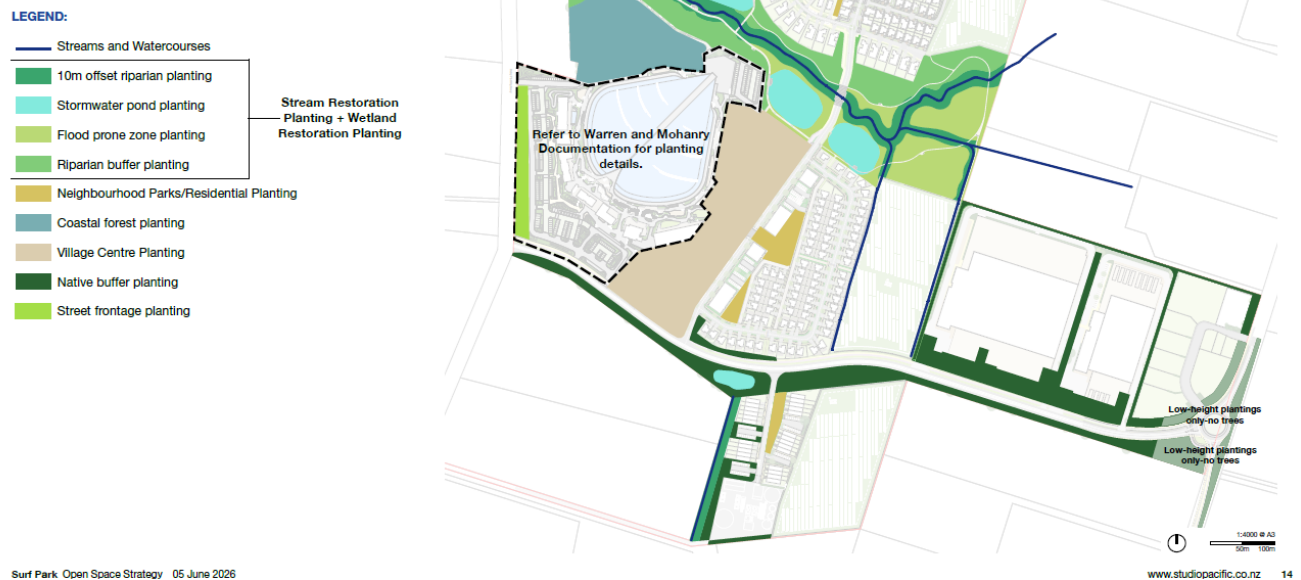
## Vegetation Strategy Overview

Overall, while the vegetation removal results in a short-term loss of low-value exotic cover, the extensive programme of native riparian and landscape planting (Figure 14) will produce a net ecological gain, delivering long-term improvements to vegetation structure, habitat quality and biodiversity values for indigenous birds, lizards, bats and invertebrates.
