Ecological Impact Assessment

Milldale Private Wastewater Treatment Plant

Prepared for: Fulton Hogan Land Development Limited

February 2025

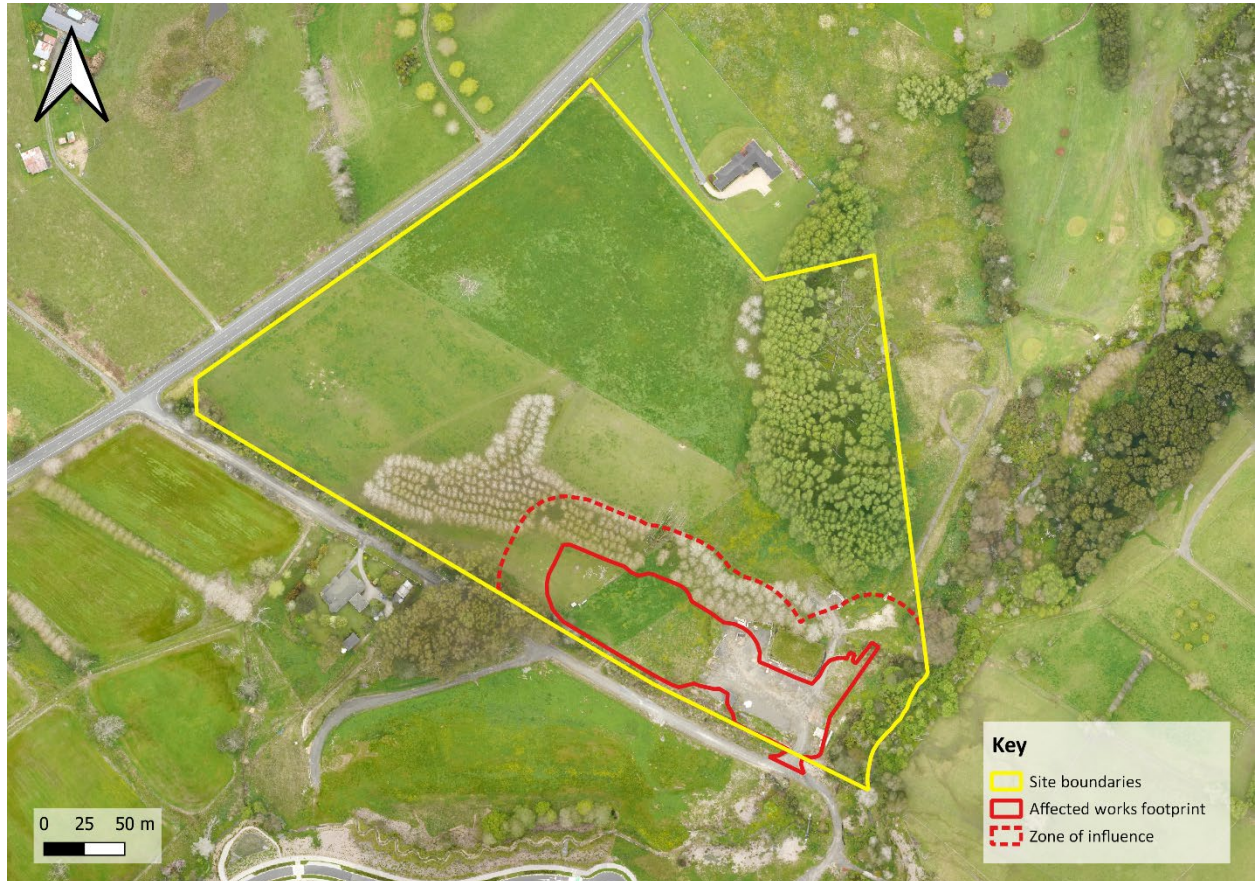
Figure 1. Map showing the affected works area and assessed zone of influence within the wider site boundaries.

The area subject to the works and enhancement planting covers a total land area of approximately 1.21 ha and has been positioned in the southern corner of the parent site, directly adjacent to Lysnar Road. For the purposes of this EclA, a ZOI has been identified approximately 30 m around the proposed affected area within the site, with this ZOI being the primary assessment area (Figure 1). The works site is generally flat and has been utilised as a construction compound supporting the delivery of ongoing delivery of the Milldale development. A hard stand area has already been constructed in this area using quarried material.

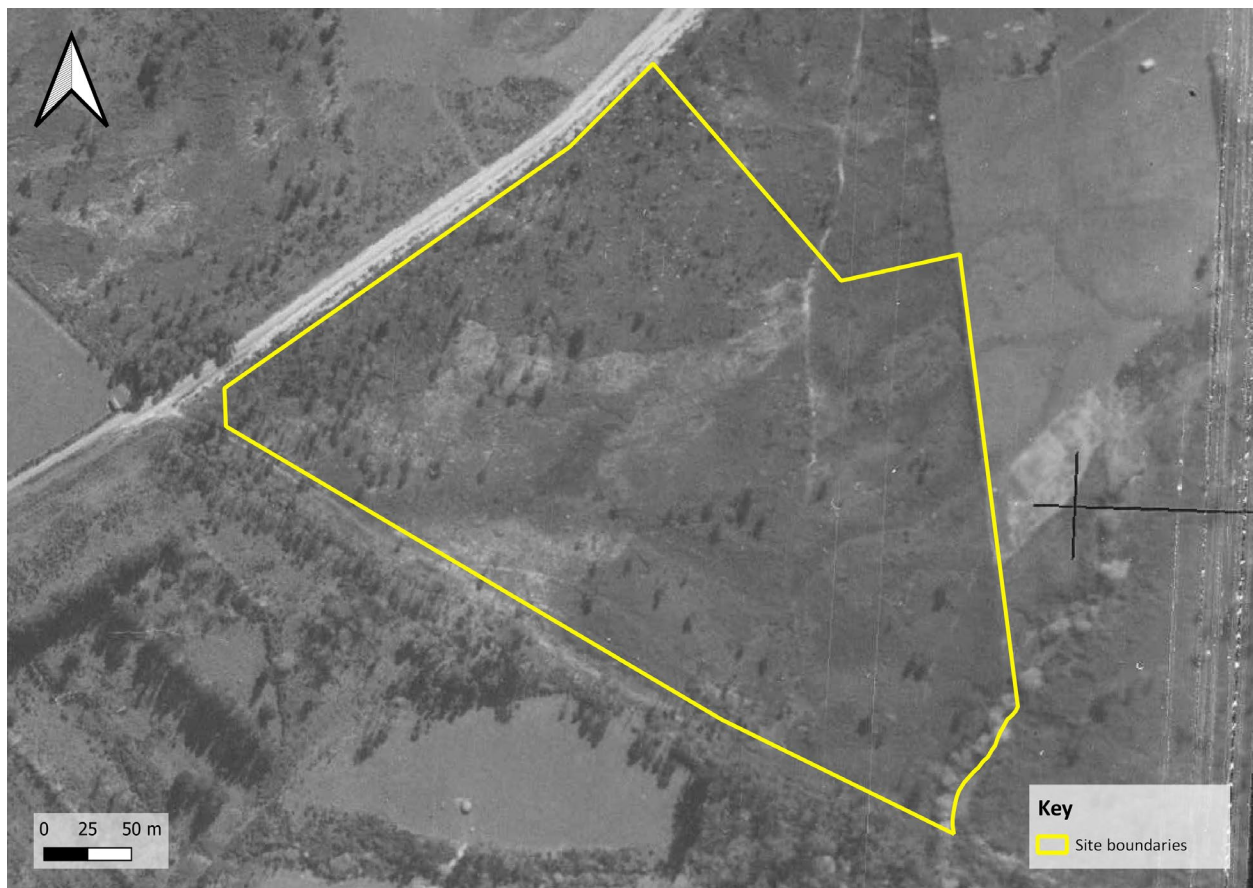
Figure 2. Map of historic aerial imagery of the site from 1940, showing agricultural land use (Aerial source: Retrolens).

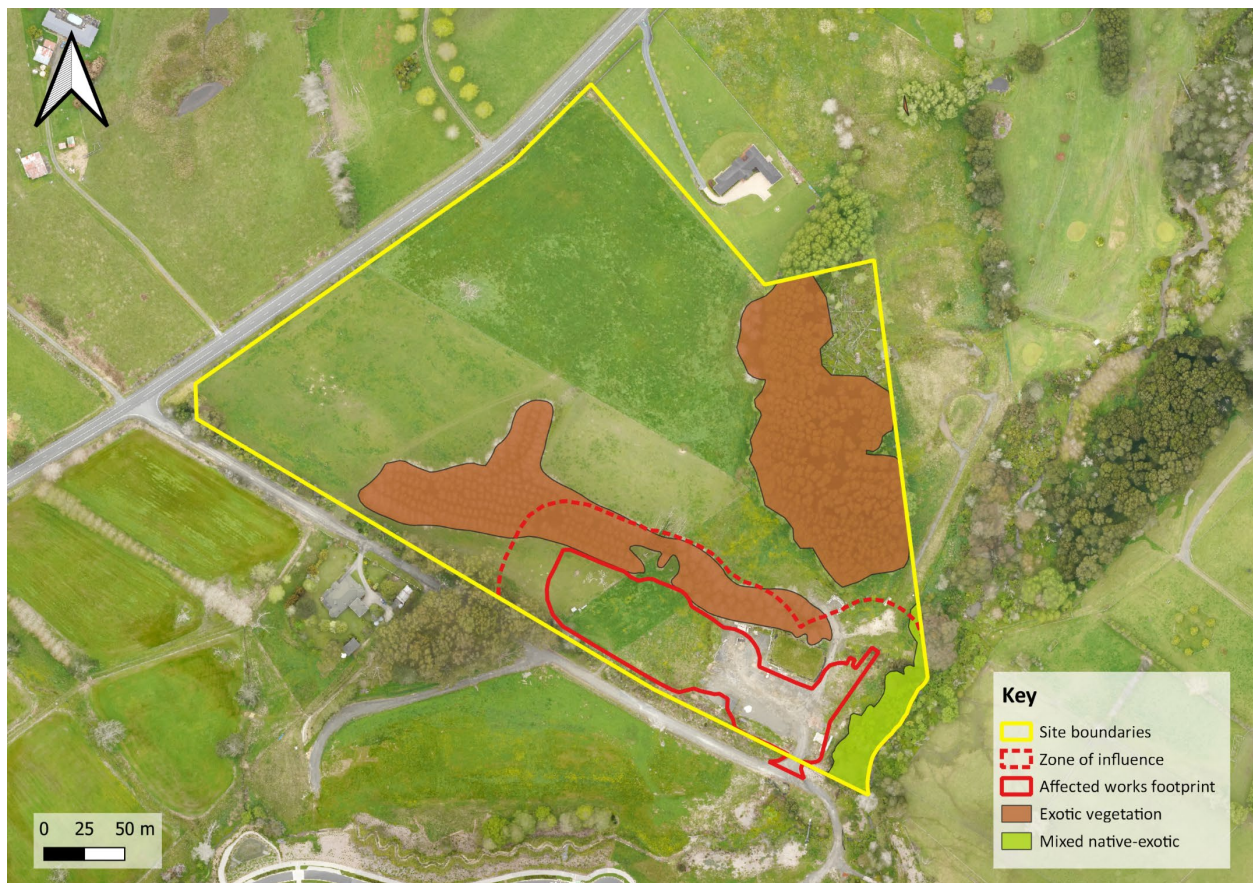
Figure 3. Map showing key terrestrial vegetation types within the ZOI and wider site.

Vegetation within the site was assessed using observations from site visits and aerial imagery. The key vegetation types (excluding pasture) have been mapped as per Figure 3. The vegetation within the ZOI consisted primarily of managed and rank pasture, along with a stand of large exotic poplar trees (*Populus nigra*), and mixed native-exotic riparian vegetation along Waterloo Creek. The AUP-OP does not identify any areas of Significant Ecological Area (SEA) within the ZOI or wider site. An existing gravelled hard stand is present across close to half of the proposed works footprint.

Pest plant abundance was high, particularly along the bush edges, with dense invasion by Chinese privet (*Ligustrum sinense*). Other pest species included crack willow (*Salix × fragilis*) and hawthorn (*Crataegus monogyna*), alongside exotic trees such as golden elm (*Ulmus glabra* 'Lutescens'). Patches of gorse scrub were also present (Figure 3).

Two large stands of exotic trees were present within the site (Figure 3). Within the ZOI, poplar trees (*Populus nigra*) encompassed approximately 5m – 15m southwest from the centre line of the intermittent watercourse (Figure 6; Arborlab 2024).

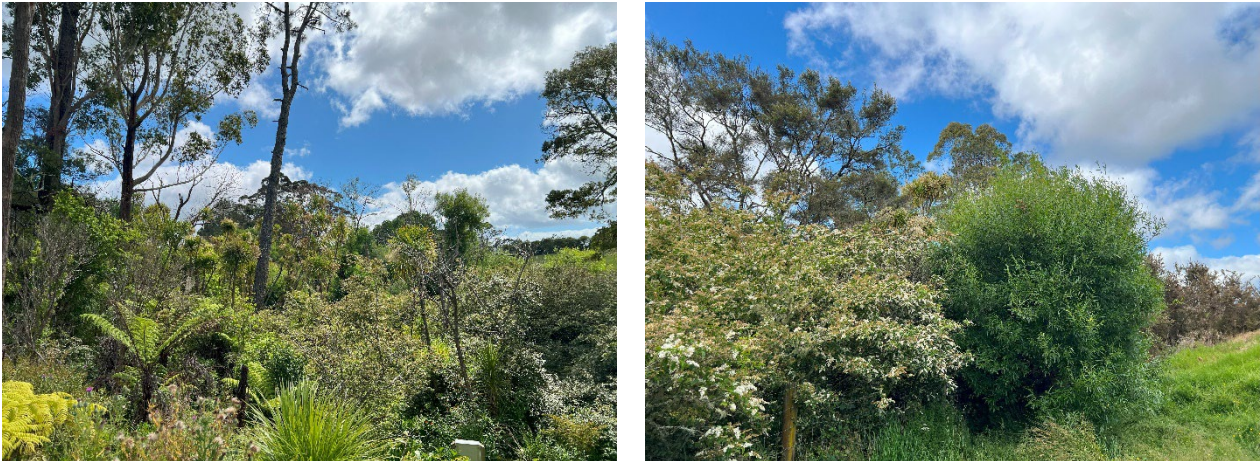
Figure 4. Photos showing examples of the mixed native-exotic vegetation within the riparian margin of Waterloo Creek.

Despite the high presence of pest and exotic species reducing its botanical quality, the vegetation forms part of a riparian corridor that contributes to filtration, shading, and bank stability for Waterloo Creek. It

may also provide moderate-value habitat for indigenous birds and potentially herpetofauna. As such, it was conservatively assessed as having **moderate** ecological value.

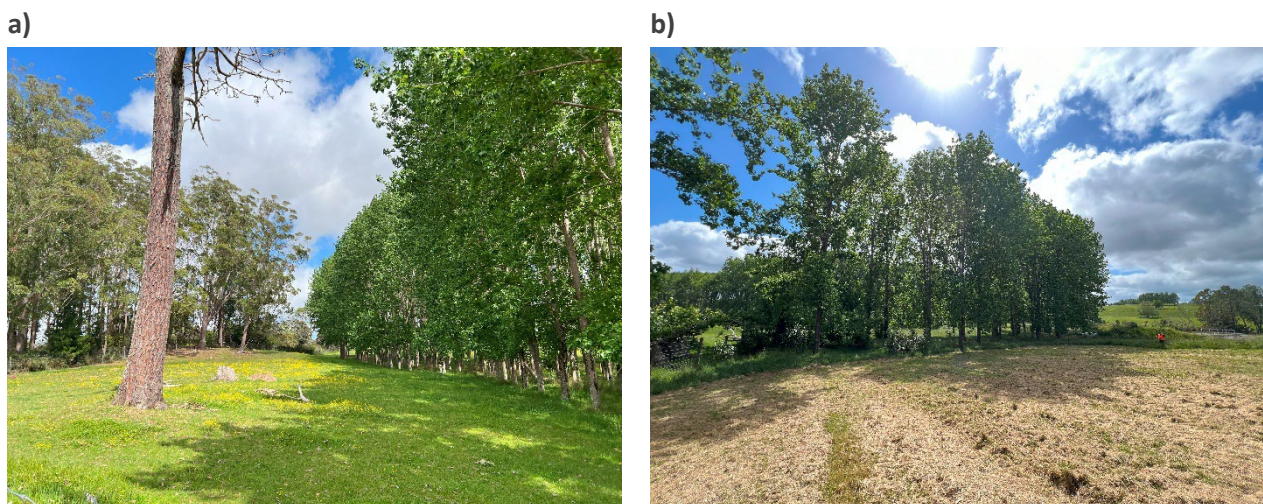
Figure 5. Photos showing the poplar stand within the ZOI, looking towards a) the northwest, and b) north.

The tree stands were isolated, were limited to a monoculture of exotic trees only, contained no understorey, and provided negligible habitat for herpetofauna, and only low value habitat for avifauna. They were assessed as having **low** ecological value.

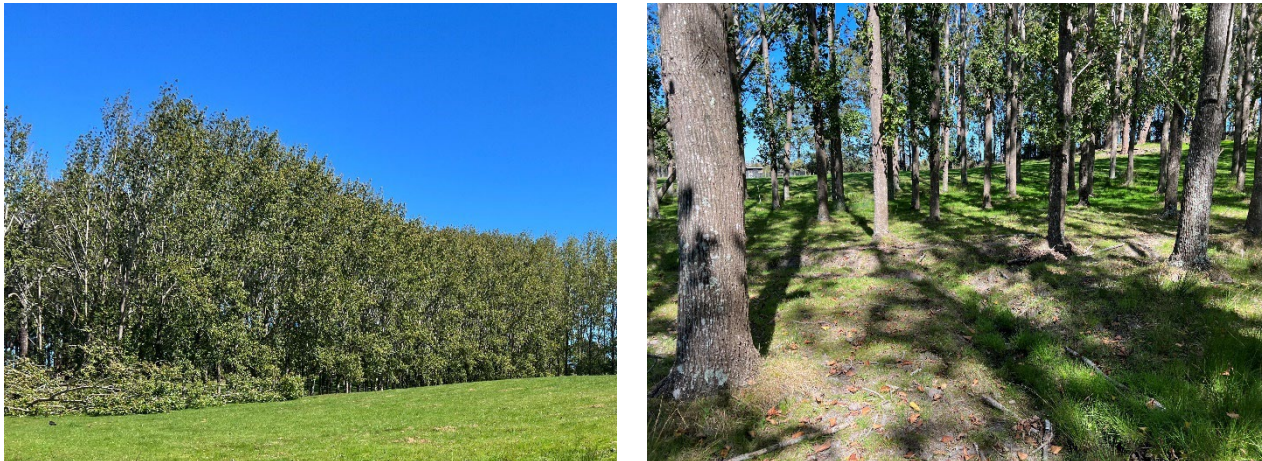
Figure 6. Photos showing the poplar stand, a) standing on the northern side of the stand facing northwest, and b) standing under the trees showing the lack of understorey vegetation.

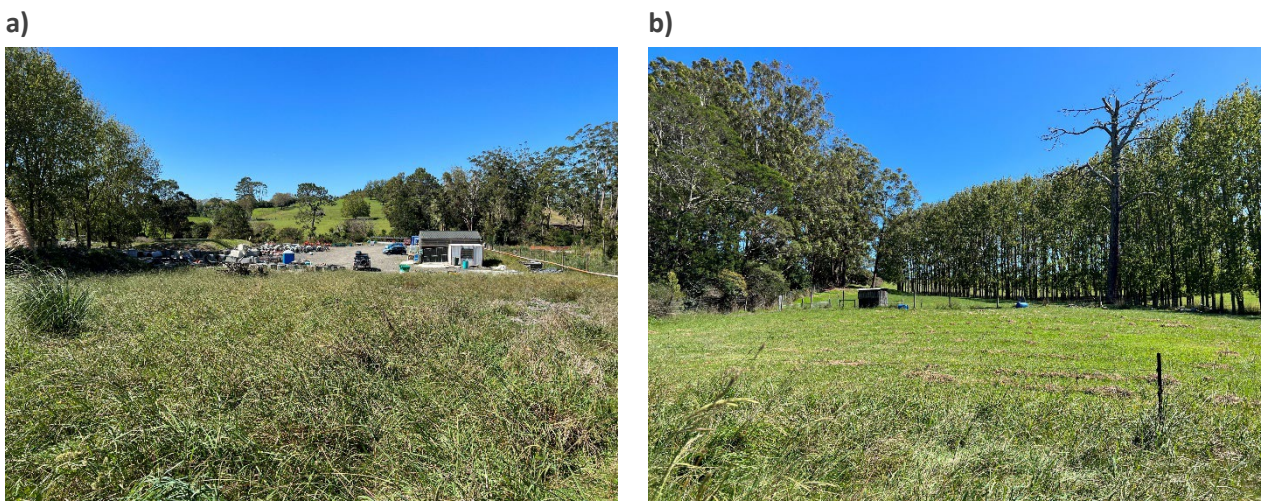
Figure 7. Examples of pasture areas within the west of the ZOI.

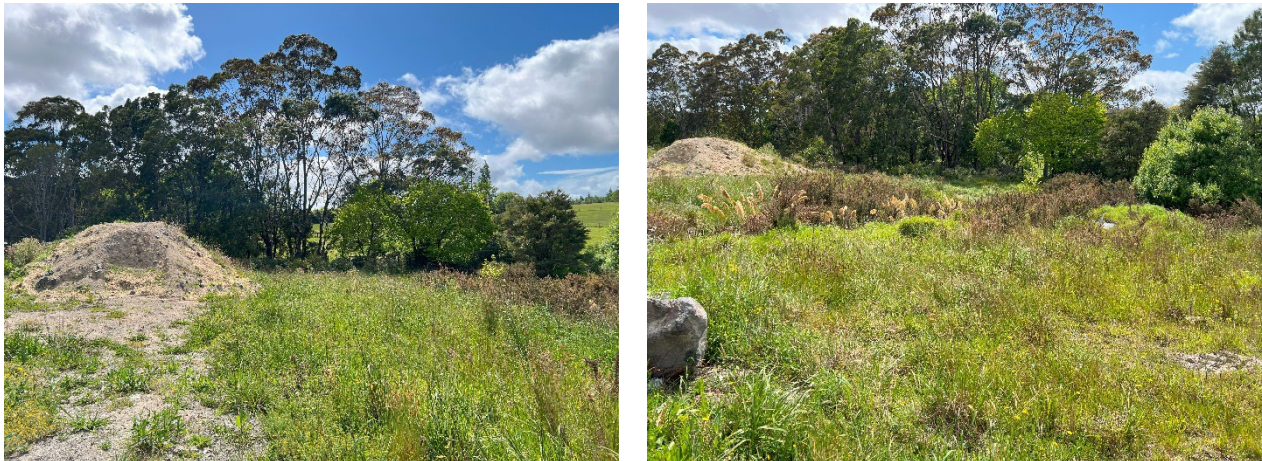
Figure 8. Examples of pasture areas within the east of the ZOI, adjacent to the Waterloo Creek riparian margin.

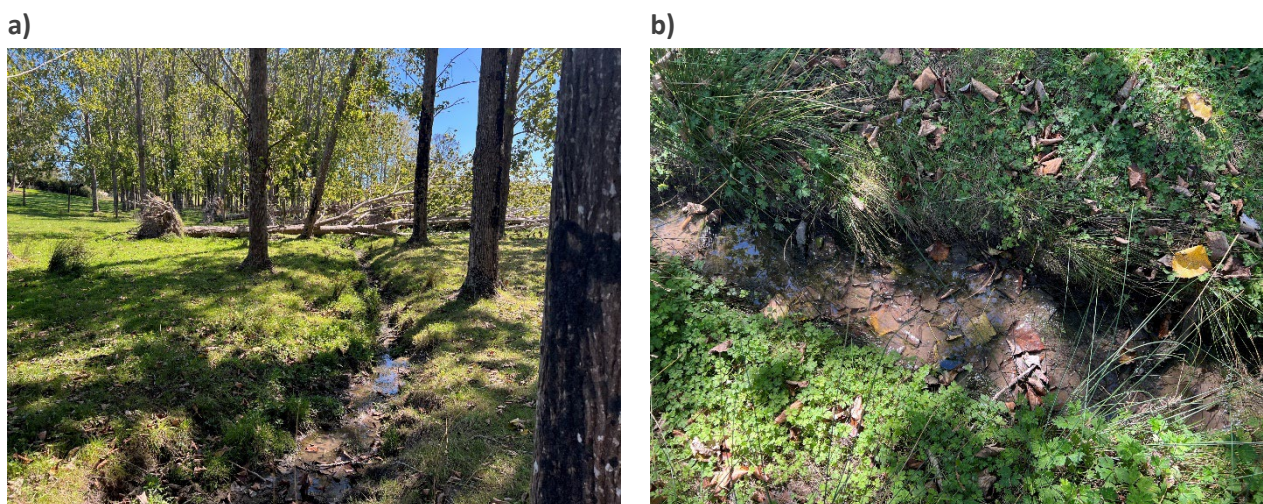
Figure 10. a) Intermittent stream channel under poplar canopy, and b) soft-bottomed modified stream channel containing low flow in March 2023.

During March 2023, the stream had low flow, while in November 2024, it was completely dry. The substrate was entirely soft-bottomed. Hydrological heterogeneity was low, with run habitat being dominant. While the stream may intermittently support highly mobile shortfin eels, intermittent aquatic habitat is expected to be limited to slow-flowing or stagnant water. Due to its intermittent nature, it is highly unlikely that other fish species would be present at any time of the year.

Overall, the intermittent stream was considered to have **low** ecological value due to its highly modified state, poor water quality, and lack of suitable aquatic habitat.
