| REVISION DETAILS | | | | INT | DATE | STATUS | BUILDING B, LEVEL 1 8 NUGENT ST, GRAFTON, AUCKLAND 1023 +64 9 308 9229 WOODS.CO.NZ | | | DRURY CENTRE - ROAD 2 NORTH WETLAND PROPOSED PEDESTRIAN BOARDWALK SECTION D | | | STATUS FOR 85% DESIGN SCALE AS SHOWN COUNCIL AUCKLAND COUNCIL DWG NO P23-315-04-3605-DR | | | REV |

APPENDIX C

Previous Investigations/ Logs

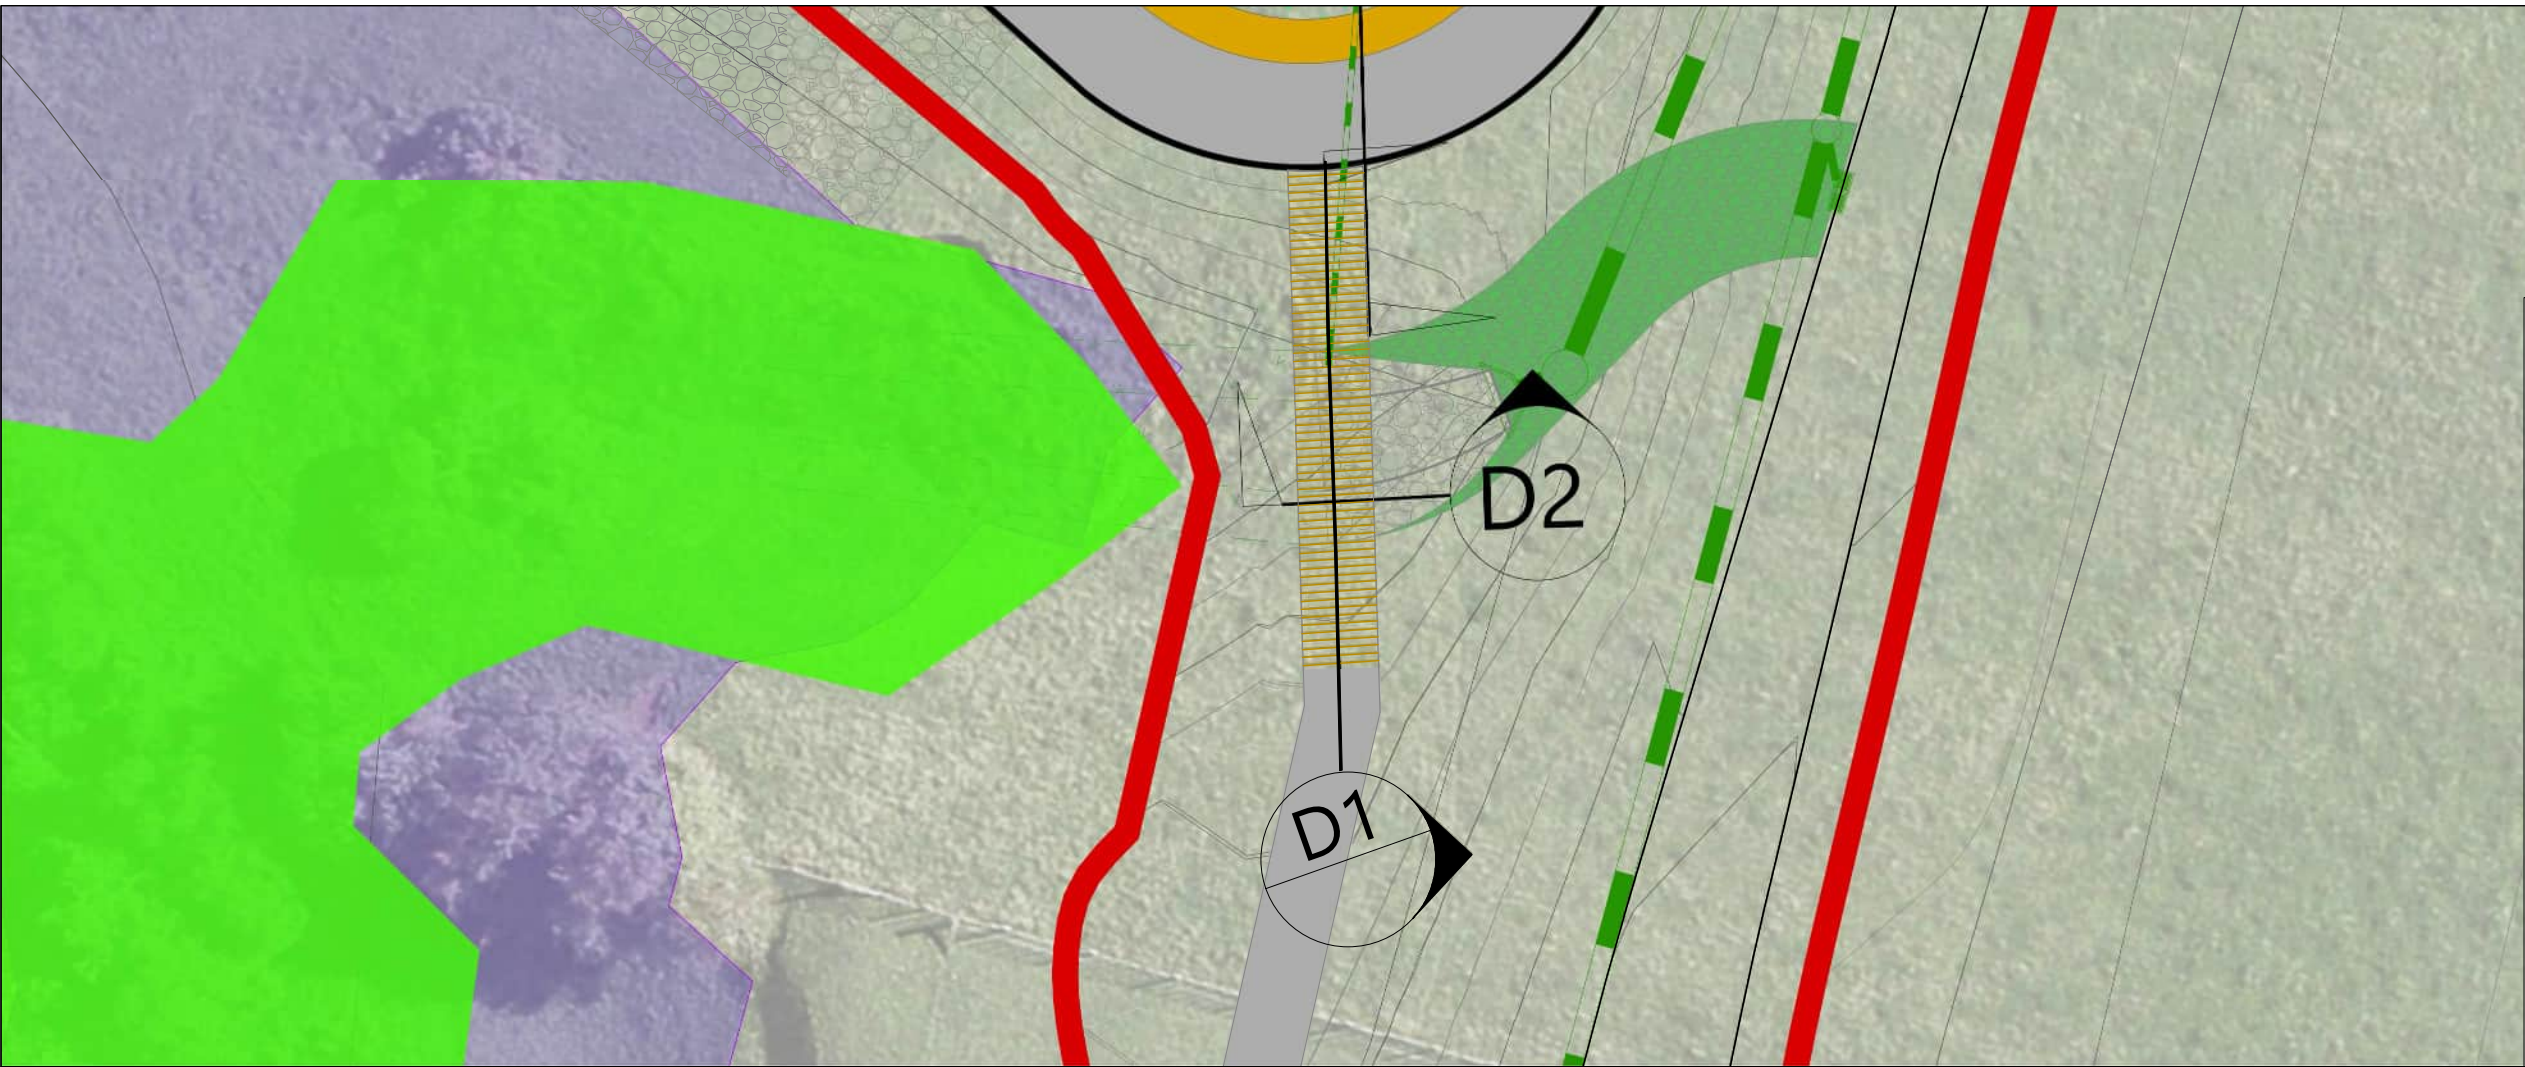
1. TIMBER BOARDWALK IS TO BE DESIGNED IN ACCORDANCE WITH THE LOCAL PATH DESIGN GUIDE AND NZS:3604

PROPOSED PEDESTRIAN BOARDWALK-SECTION-D1

PROPOSED PEDESTRIAN BOARDWALK-SECTION-D2

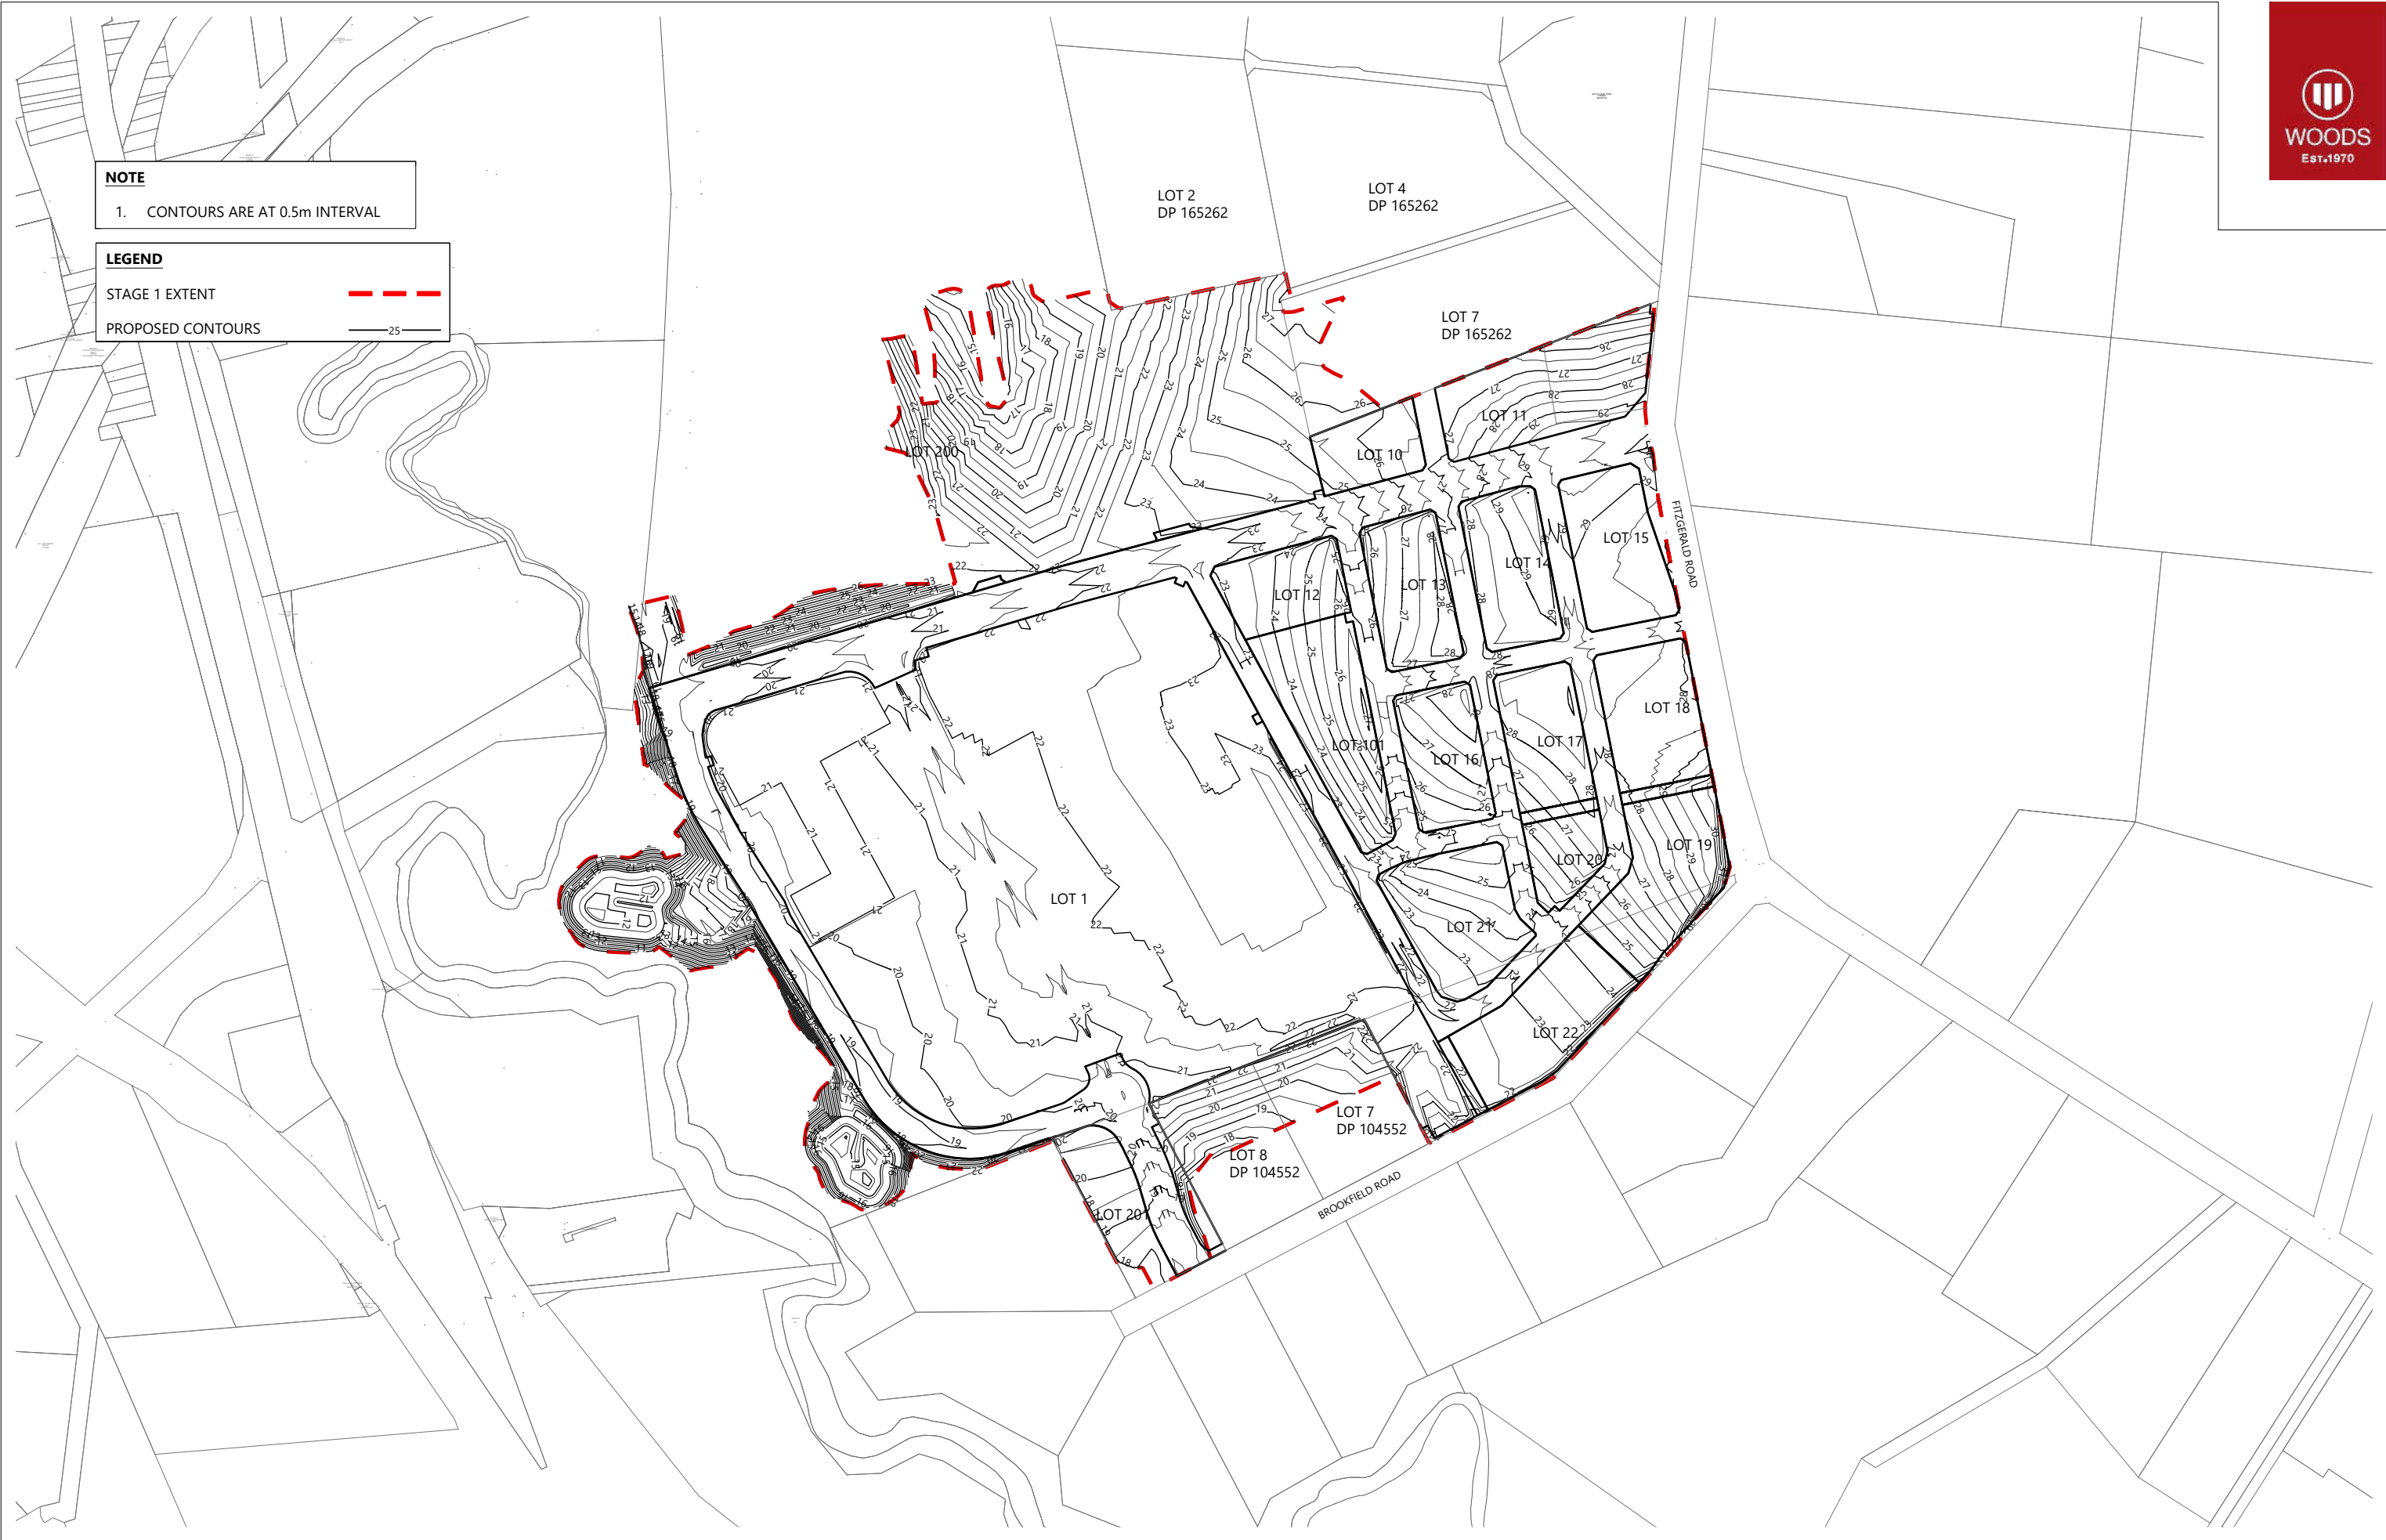
| REVISION DETAILS | | | | | INT | DATE | SURVEYED | | | BUILDING B, LEVEL 1 8 NUGENT ST, GRAFTON, AUCKLAND 1023 +64 9 308 9229 WOODS.CO.NZ | | DRURY CENTRE | | | | | STATUS | FOR INFORMATION | REV |
|---|---|--|--|--|---|---|---|---|---|--|---|---|--|--|--|---|---|---|---|
| 1 | ISSUED FOR INFORMATION | | | | NS | 21/03/24 | DESIGNED | NS | | | | OVERALL PROPOSED CONTOUR PLAN | | | | | SCALE | 1:4000 @ A3 | 2 |

PROPOSED MAJOR CONTOURS

PROPOSED MINOR CONTOURS
