Project Number 20190.000.001

Groundwater Abstraction: Desktop Study

Forestry Road, Riverhead, Auckland

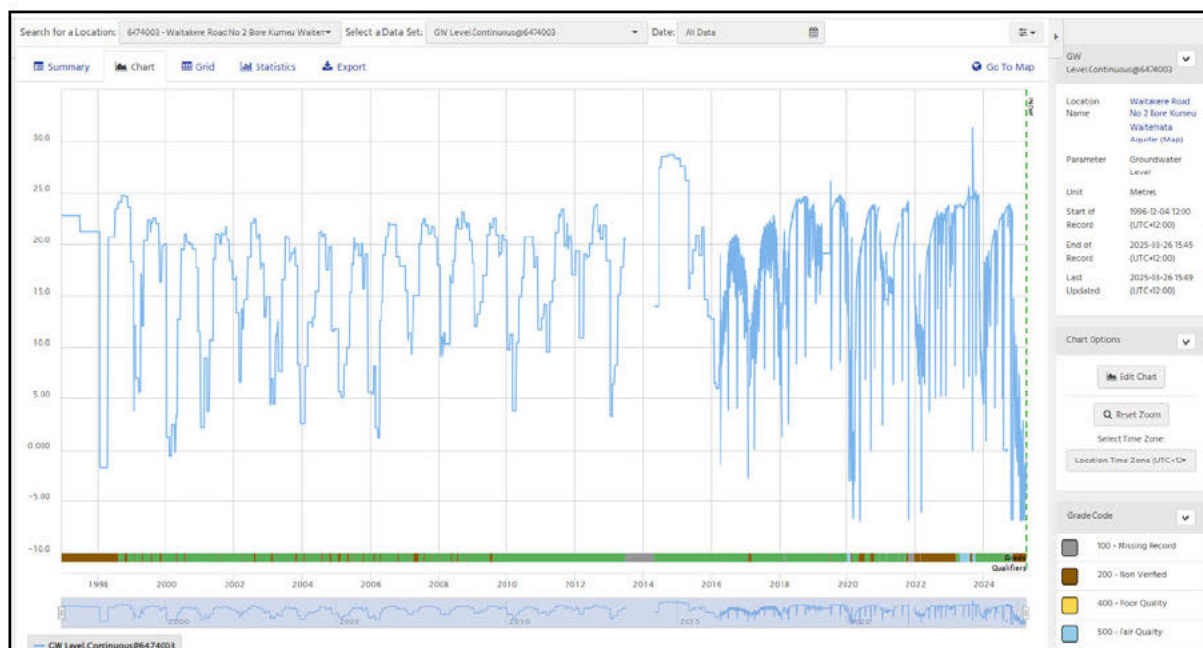
Figure 2: Groundwater Levels – Waitakere Rd No. 2 Bore

Auckland Council monitor groundwater levels as part of the State of the Environment monitoring programme at Waitakere Road No 2 bore, screened from 78 – 150 m depth in the Waitematā Group aquifer, located approximately 4 km to the southwest of the site. Static groundwater levels are recorded as 18 m bgl (15 m RL) (Auckland Council Technical Publication 352, 2007) suggesting depth to groundwater may be deeper within the deeper aquifer systems. Figure 2 provides groundwater level data for this bore from 1998 – 2025 (Auckland Council Environmental Data Portal). Seasonal groundwater level fluctuations are approximately 15 – 20 m, however it is unknown the extent of groundwater abstraction in the area and potential effects on these groundwater levels. Regular pumping drawdown cycles can be seen in the more recent logger data.

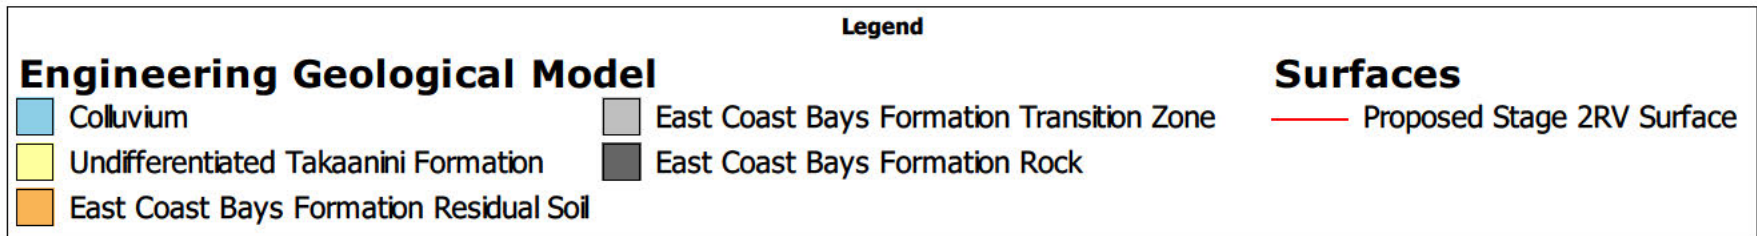
Stage 2RV Geological Cross Section A-A'

A: 383324, 814887, 132
A': 384139, 814151, 132

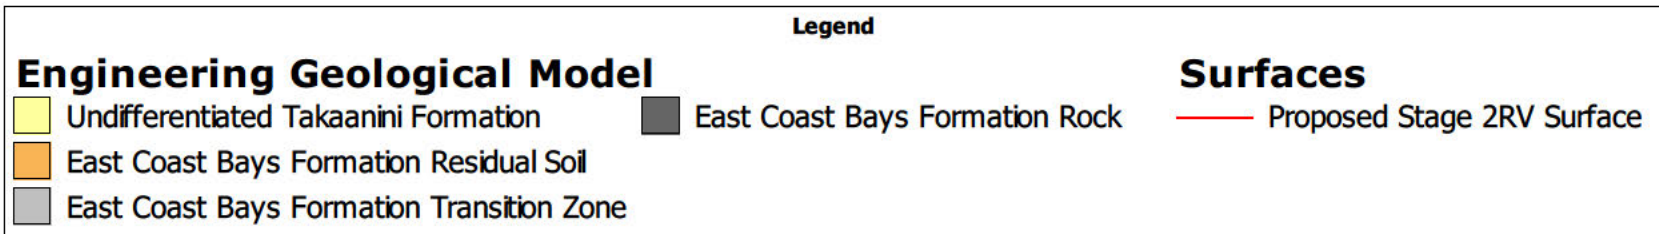
Stage 2RV Geological Cross Section C-C'

C: 383883, 814655, 137
C': 383247, 814094, 137
