**61 Hampton Downs Road**

**Preliminary and Detailed Site Investigation (Ground Contamination)**

NATIONAL GREEN STEEL

WWLA1339 | Rev. 2

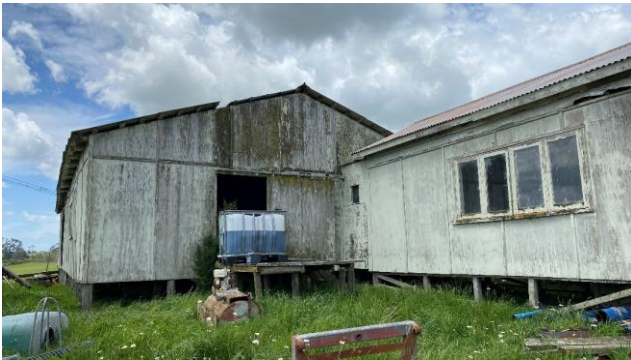
- The wool shed is raised on timber foundations, constructed of timber and plywood with a corrugated (possibly super-six, an asbestos containing material or ACM) roof, and timber joinery. The front room of the woolshed has weatherboard cladding and a corrugated iron roof. A variety of small farm equipment, IBCs (empty or unlabelled), blue drums (Donaghys Uddercontrol), furniture and other household items were present inside the woolshed (**Photograph 4**).

Photograph 1: Wool shed, located on the eastern boundary of the site.

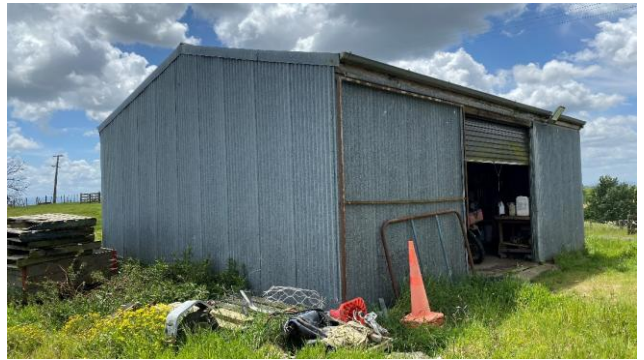
Photograph 2: Implement shed, located on the eastern boundary of the site.

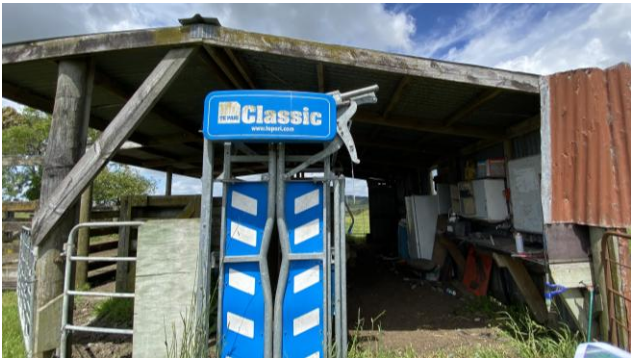
Photograph 3: Cattle shed, located on the eastern boundary of the site.

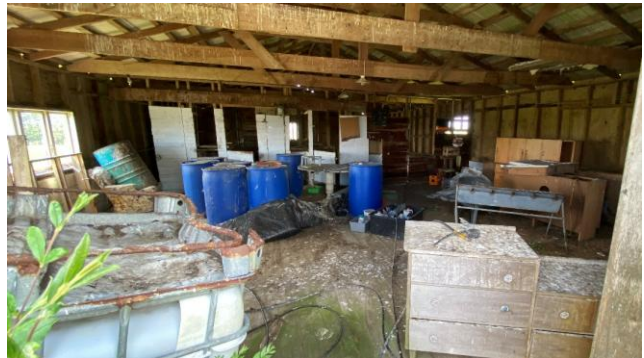
Photograph 4: Interior of the wool shed.

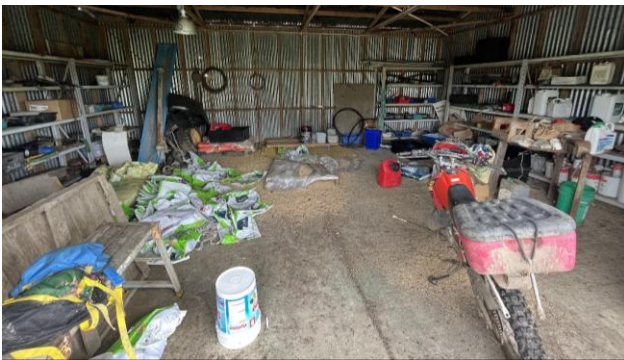
Photograph 5: Interior of the implement shed.

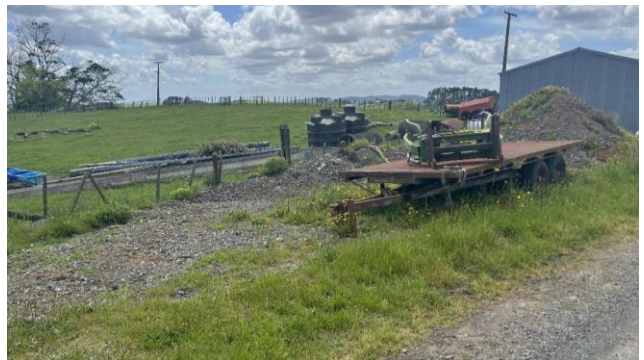
Photograph 6: Gravel pad with trailer, tanks and stockpile adjacent (west) the implement shed.

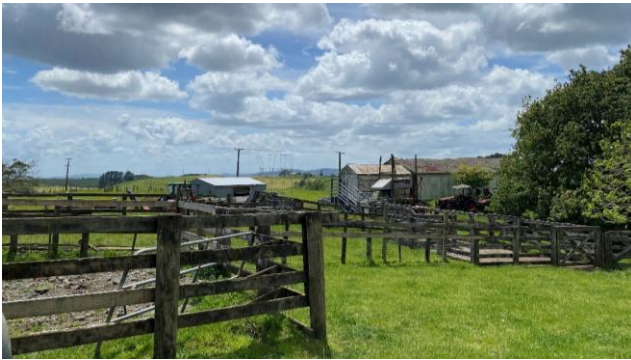
**Photograph 7: Cattle yards with loading ramp on eastern boundary of the site. Implement shed (left) and wool shed (right) visible behind cattle yards.**

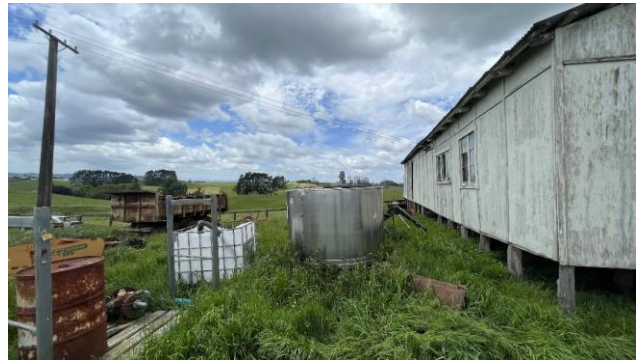
**Photograph 8: Various farm machinery and equipment stored adjacent (north) the woodshed.**

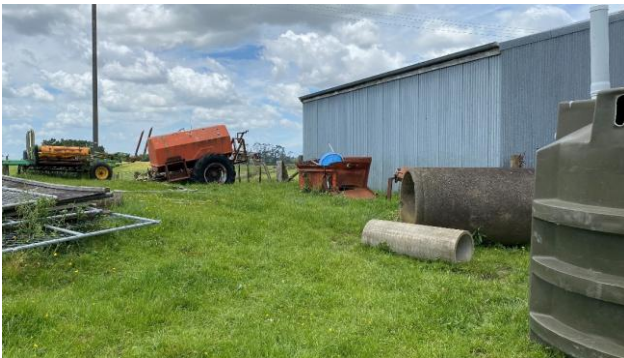
**Photograph 9: Various farm machinery and equipment stored behind (north) the implement shed.**

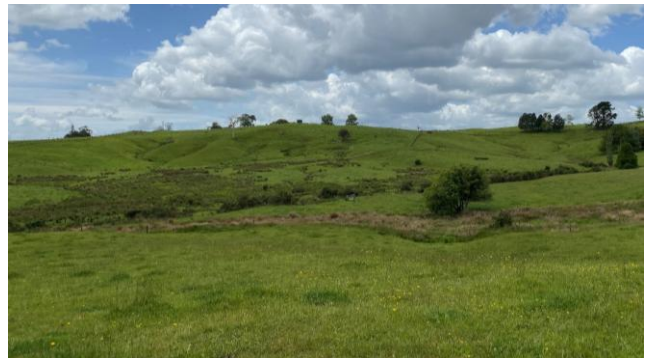
- A large wet/ boggy area is in the centre of the site (**Photograph 10**).
- An oval shaped track/bund is located in the northwest corner of the site, a stockpile of clay is located on the northeastern edge of this oval (**Photograph 11**).

**Photograph 10: View of the boggy area in the centre of the site, facing east.**

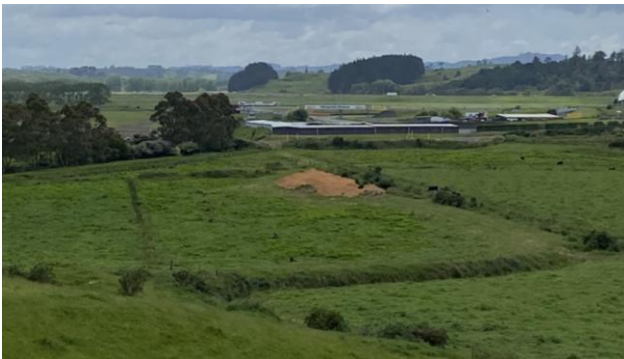
**Photograph 11: View of the oval shape track/bund in northwest corner of the site. Clay stockpile visible on eastern edge of oval.**

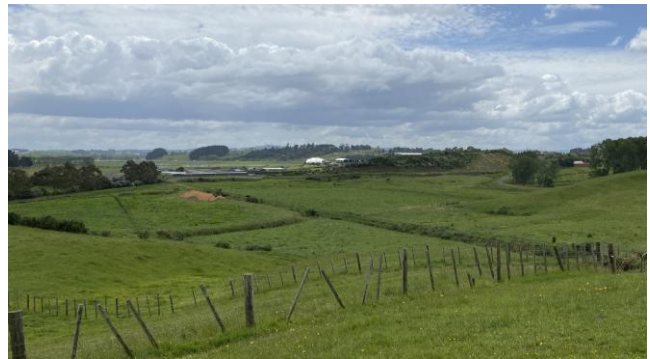
- Several drainage ditches are present on the northern half of the site (**Photograph 12**).

**Photograph 12: View over the fields in the northern half of the site, facing north. Drainage ditches are visible between paddocks.**

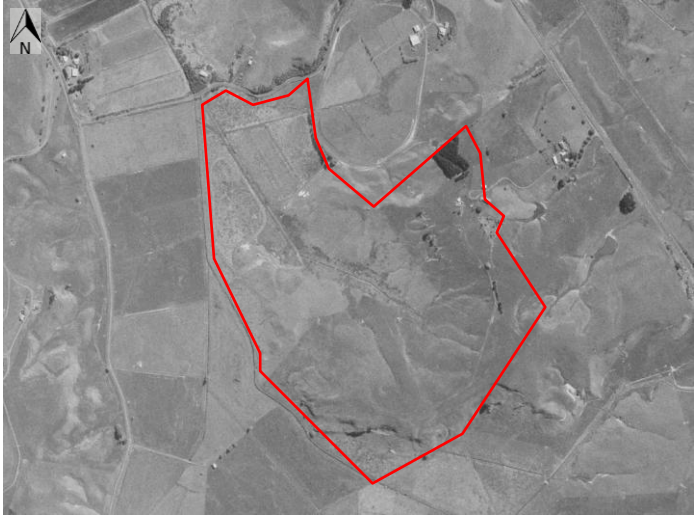
Photograph date (source)	Activities	Aerial image (site in red outline)
<b>1997</b> Retrolens (SN.9615.A.9)	The site remains largely unchanged. Several new structures have been added to the land north of the site, otherwise surrounding land remains relatively unchanged.

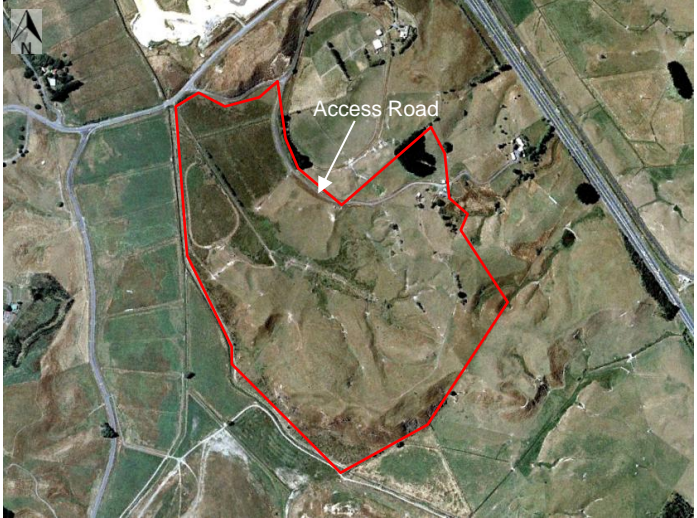
<b>2007</b> Google Earth	An access road, possibly gravelled or sealed, has been added to the site, leading from the road on the northern boundary to the three structures on the eastern boundary. Paddocks in the northern portion of the site appear to be overgrown otherwise the site still appears to be used for pastoral activities. Construction has begun on the motorsport park to the north of the site and the roading network surrounding the site has been developed further.

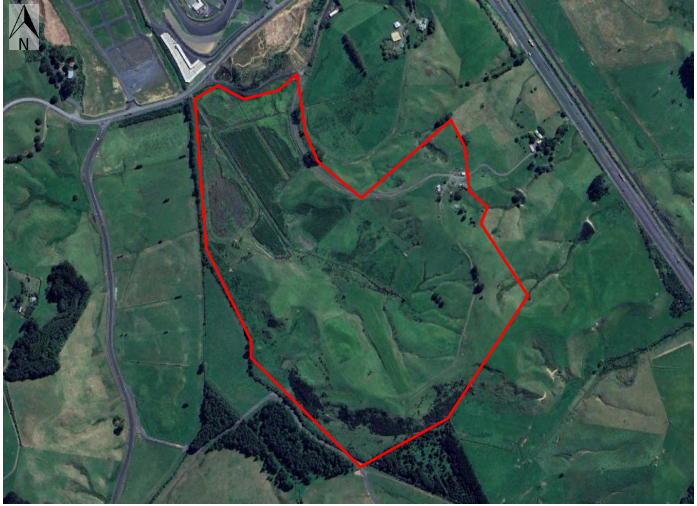
Photograph date (source)	Activities	Aerial image (site in red outline)
2023 Google Earth	The small stockpile visible in the 2020 imagery has been removed. Otherwise, there are no notable changes to the site or surrounding land.

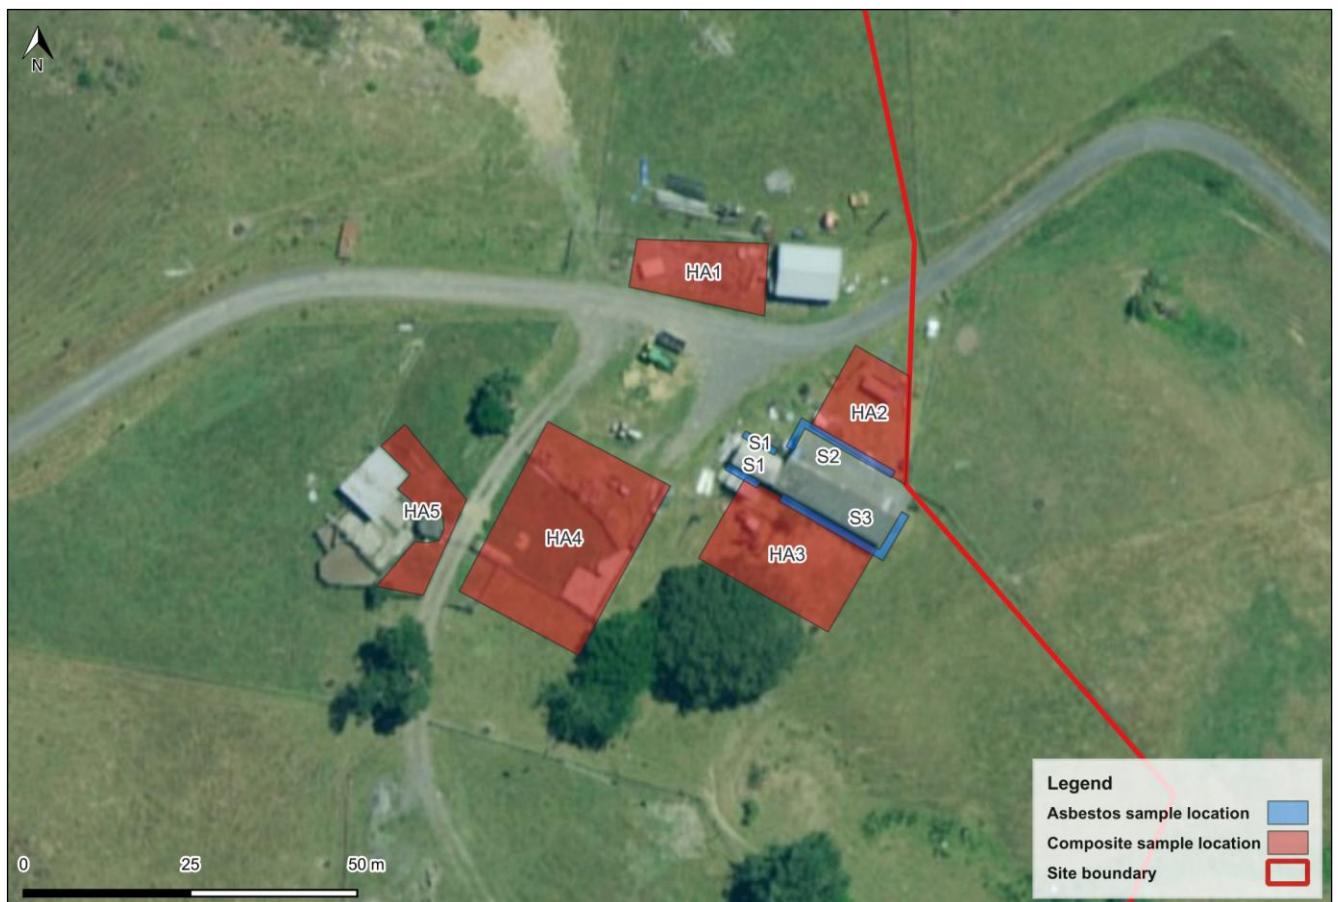
Figure 4 . Sampling locations (image source: LINZ 2023-2024)

- Topsoil was generally present to 0.1-0.2 m bgl and comprised of light greyish brown to dark brown silt with minor clay. Topsoil was soft and dry across all sample locations except HA1 which had gravels / rocks and HA5 which was moist. Topsoil could not be penetrated at HA1 due to the presence of gravels and high level of compaction.
- Natural soils comprising clayey silt, orangey brown with minor dark brown to black inclusions, was encountered beneath the topsoil. The clayey silt was dry to moist and ranged from soft to firm across sample locations.

Soil sampling shows that metals are present above background levels in the tested surficial soils around farm buildings but do not exceed NESCS or Eco-SVG criteria. However, asbestos is present around the woolshed at concentrations the present a potential risk to health risk, we recommend this risk is mitigated.
