**Appendix L – Ecological Impact Assessment**

# *ECOLOGICAL IMPACT ASSESSMENT*

2025 Ōhaupō Road, Te Awamutu,  
Waikato

for Te Awamutu Developments Limited

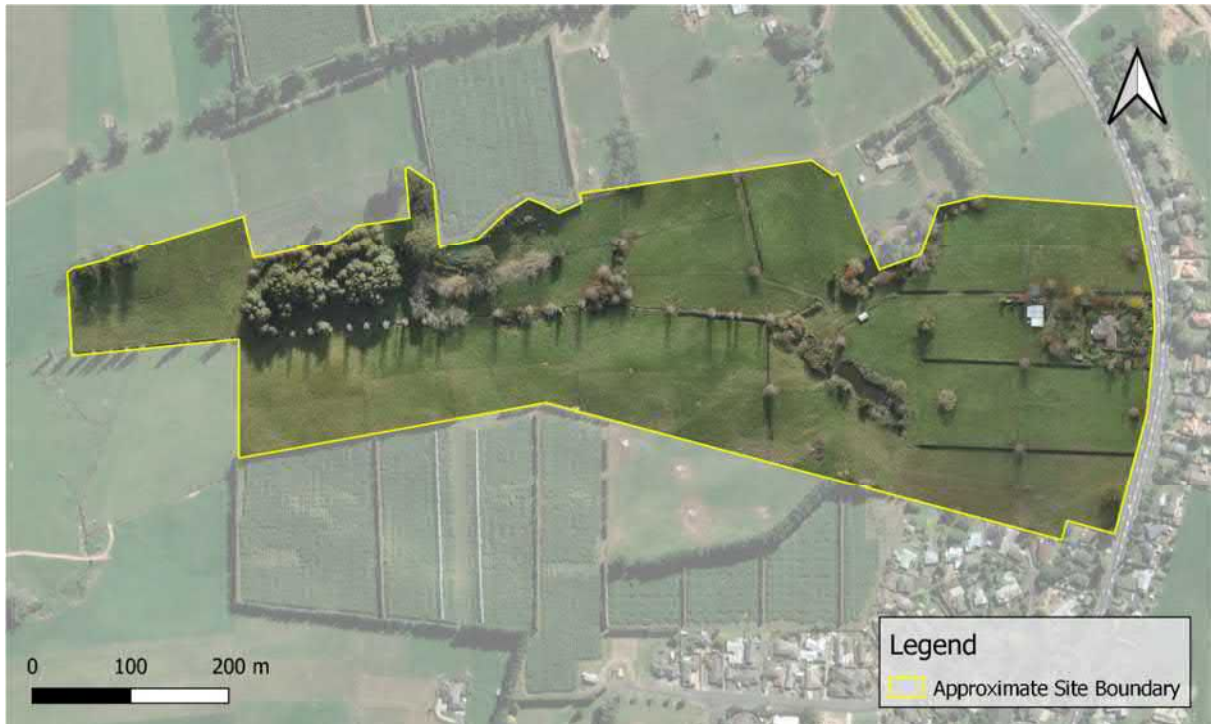
Figure 1.2: Site overview.

Figure 1.2 Site imagery collected by BTW, surrounding aerial imagery sourced from Google Satellite Map Service © 2022 Maxar Technologies.

BTW Company (BTW) was engaged by Te Awamutu Developments Limited (the client) to undertake an Ecological Impact Assessment (EclA) to inform the master planning design process for a proposed development located at 2025 Ōhaupō Road, Te Awamutu, Waikato. The development requires a Private Plan Change Request from the Waipā District Council. Figure 1.1 and Figure 1.2 present site location and aerial image overview.

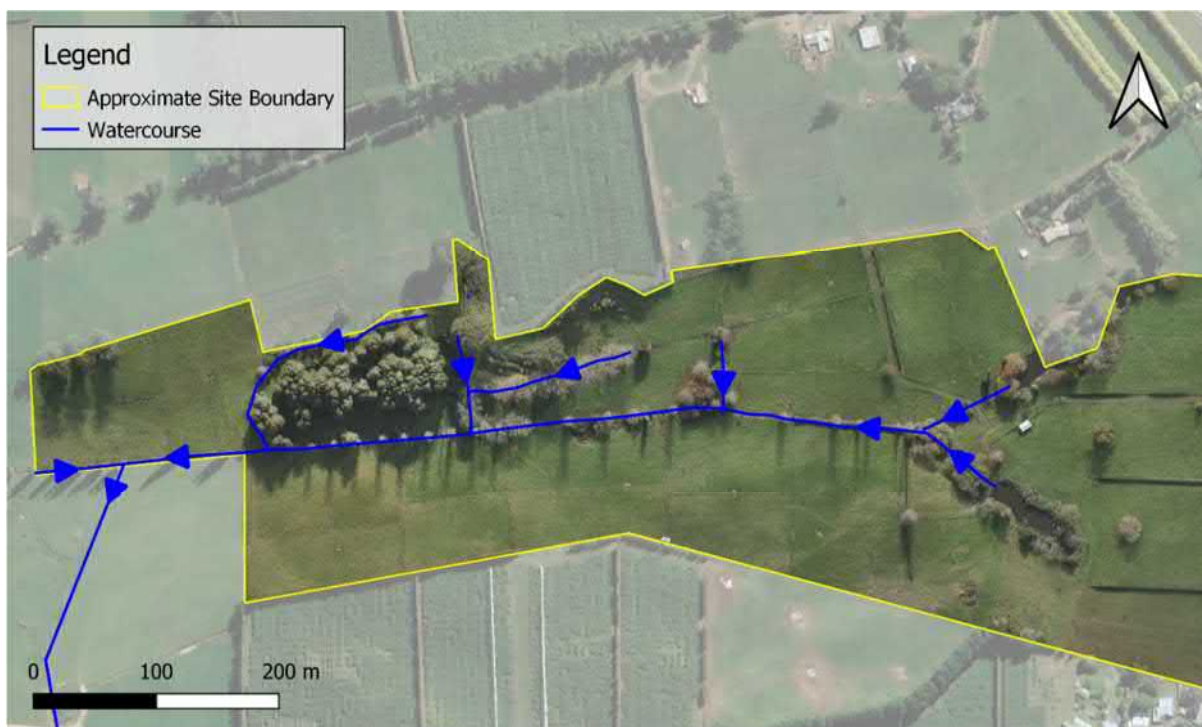
Figure 3.5: Site watercourses and flow direction.

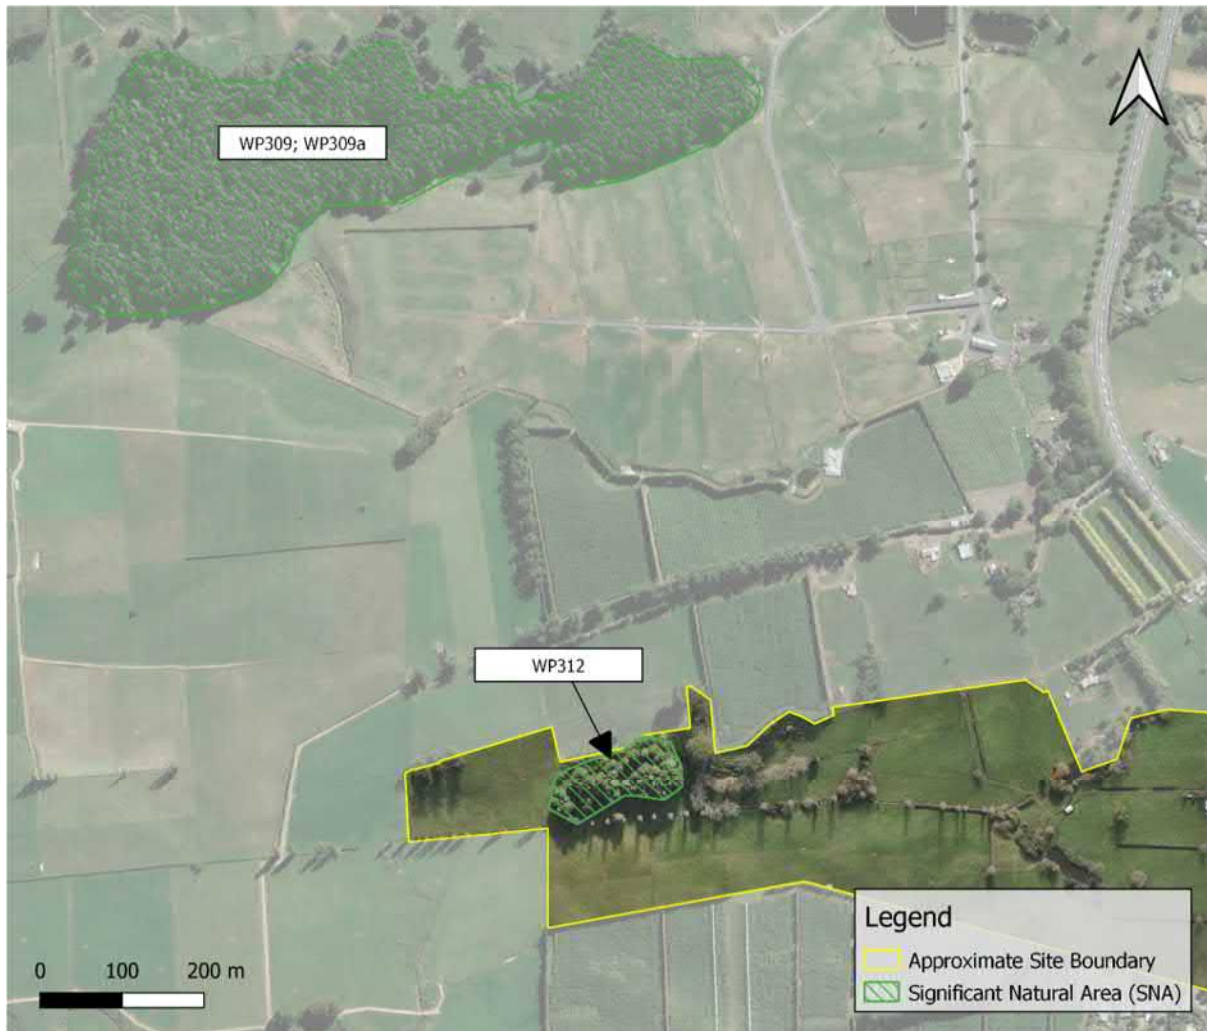
Figure 3.6: Kahikatea (*Dacrycarpus dacrydioides*) remanent forests identified as potential significant natural area (SNA).

Approximately 750 m north of the site is the largest kahikatea (*Dacrycarpus dacrydioides*) remnant in the Waipā District (WP309, WP309a; 13.5 ha). At the site, a kahikatea stand (WP312<sup>30</sup>) is located at in the west. Both these kahikatea forests are defined as potential significant natural area (SNA), see Figure 3.6.

Figure 3.6 data source: Operative Waipā District Plan biodiversity information<sup>30</sup>. Site imagery collected by BTW, surrounding aerial imagery sourced from Google Satellite Map Service © 2022 Maxar Technologies.

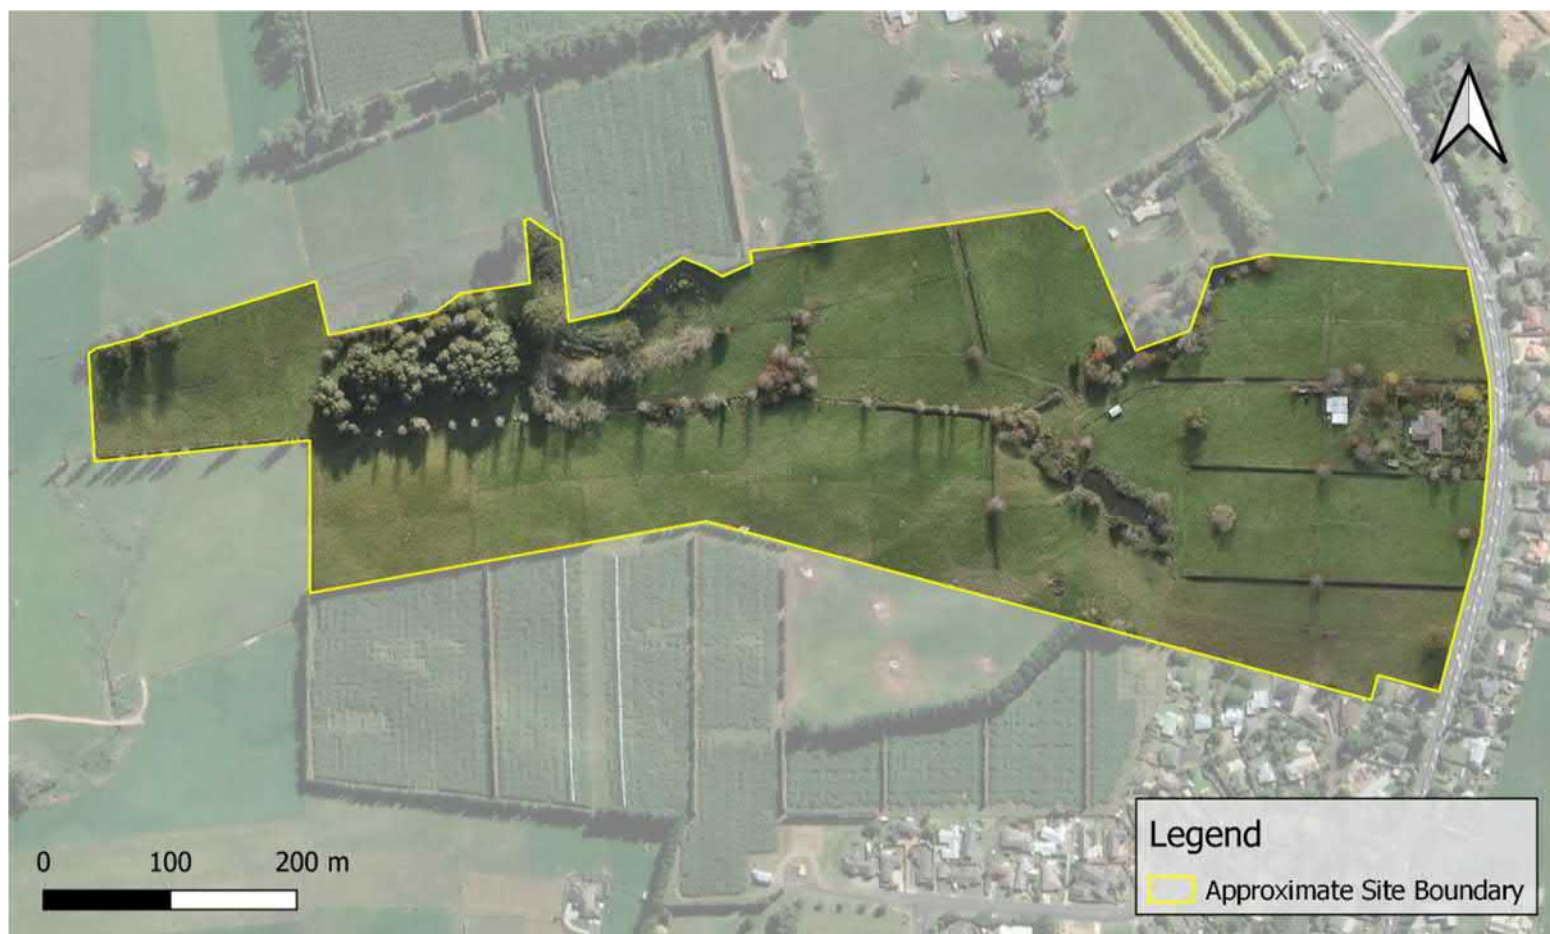
Figure 3.8: 2022 aerial image of the site.

Figure 3.8 Site imagery collected by BTW, surrounding aerial imagery sourced from Google Satellite Map Service © 2022 Maxar Technologies.

Historical aerial imagery indicates the site has been used for agricultural grazing since 1943 to the present day (Figure 3.7, Figure 3.8).

The site is predominantly pasture with exotic trees species including large poplars (*Populus* sp) lining the central watercourse and mature eucalyptus trees located on the banks above the kahikatea stand. The historical imagery suggests the site has been cleared of indigenous vegetation prior to 1943 and replaced with pastoral grasses for agricultural land use.

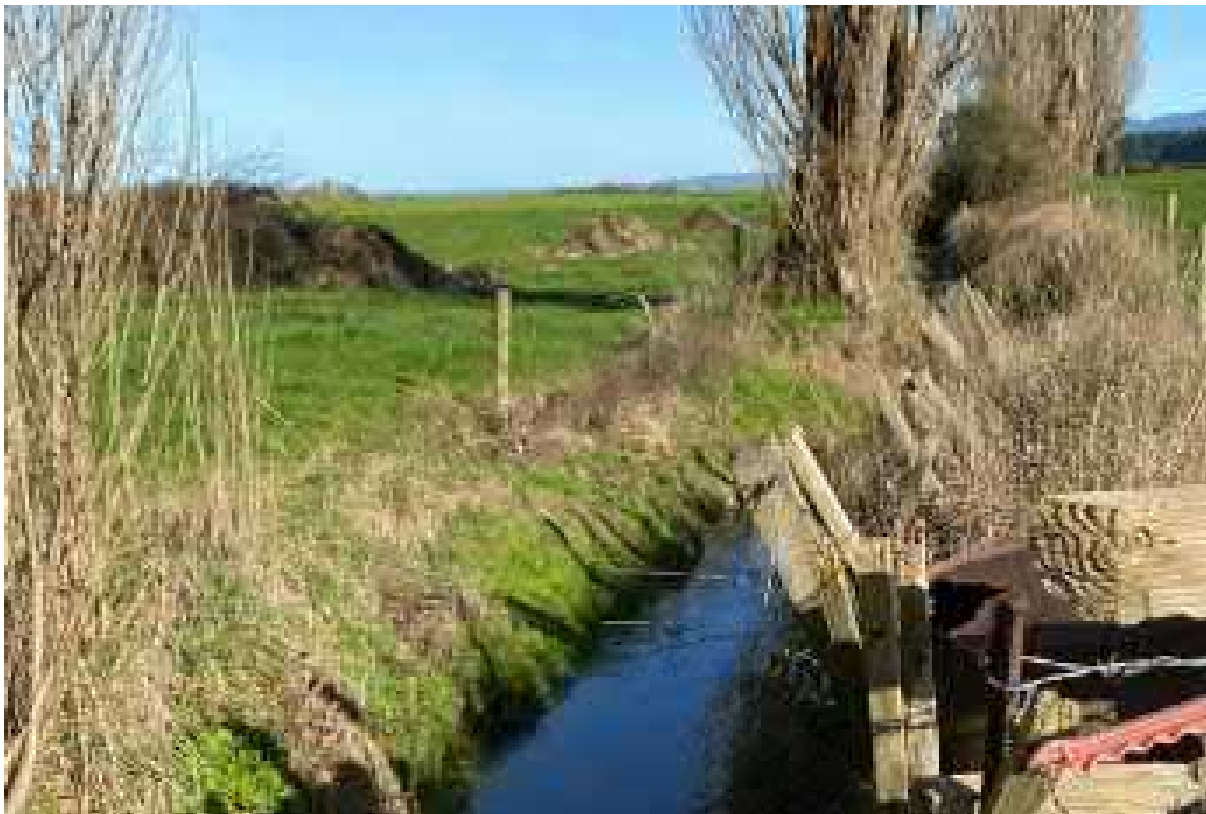
Figure 3.10: Typical reach of the central watercourse at the site.

The key freshwater ecological features of site are wetlands and watercourses that feed into a central channelised watercourse. The central watercourse is an unnamed tributary of the Mangapiko Stream and is classified as a modified watercourse<sup>33,34</sup> (see Figure 3.10 for example of the central watercourse). Multiple discharge points for water to flow into the central site watercourse were observed, from spring-fed streams, natural inland wetlands, drainage ditches, and ponds.

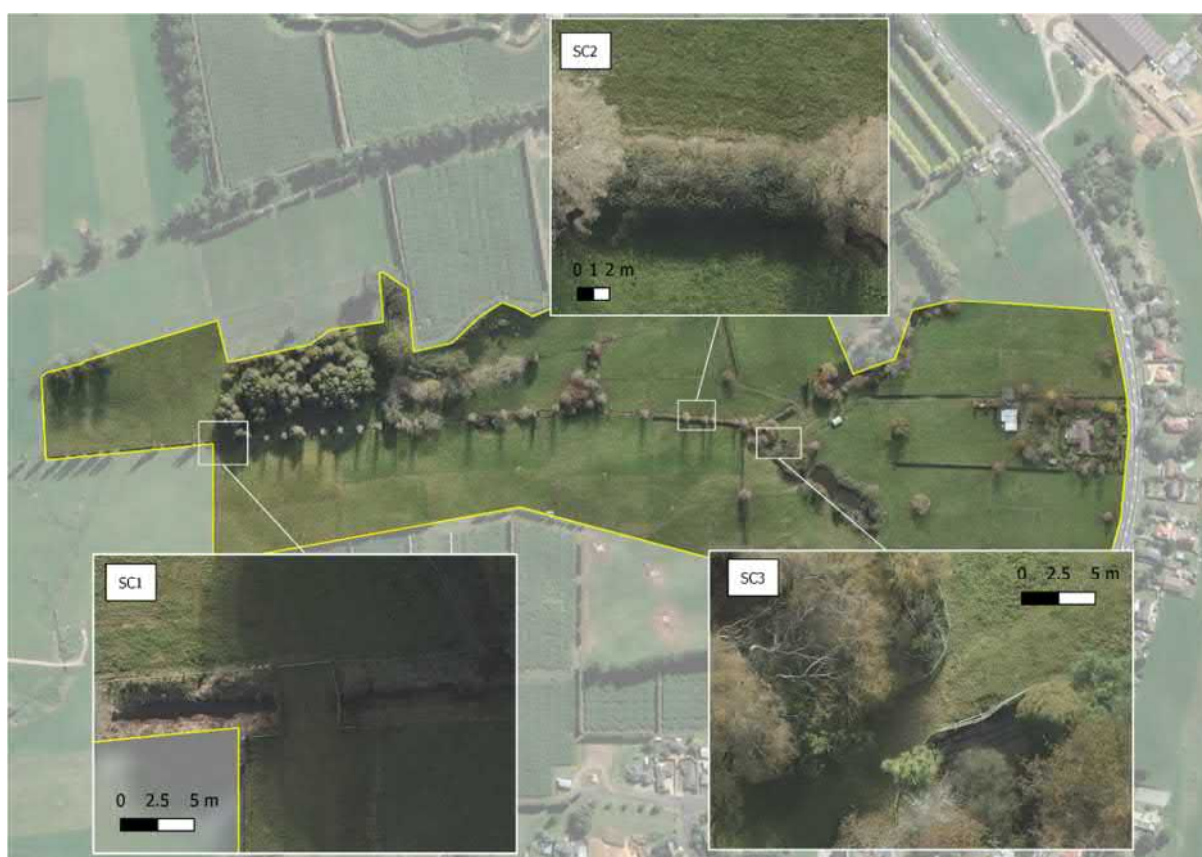
Figure 4.2: Locations of watercourse crossings (SC1, SC2, SC3).

Based on the preliminary engineering design, Figure 4.2 outlines the three required water course crossing points (SC1, SC2, SC3). Table 4.1 and Table 4.2 outline the positional coordinates and spatial extents. Two of the three are existing crossings (requiring significant upgrades) and one additional stream crossing location. Figure 4.3 highlights two existing crossings (A, B) which are proposed to be removed during site development.

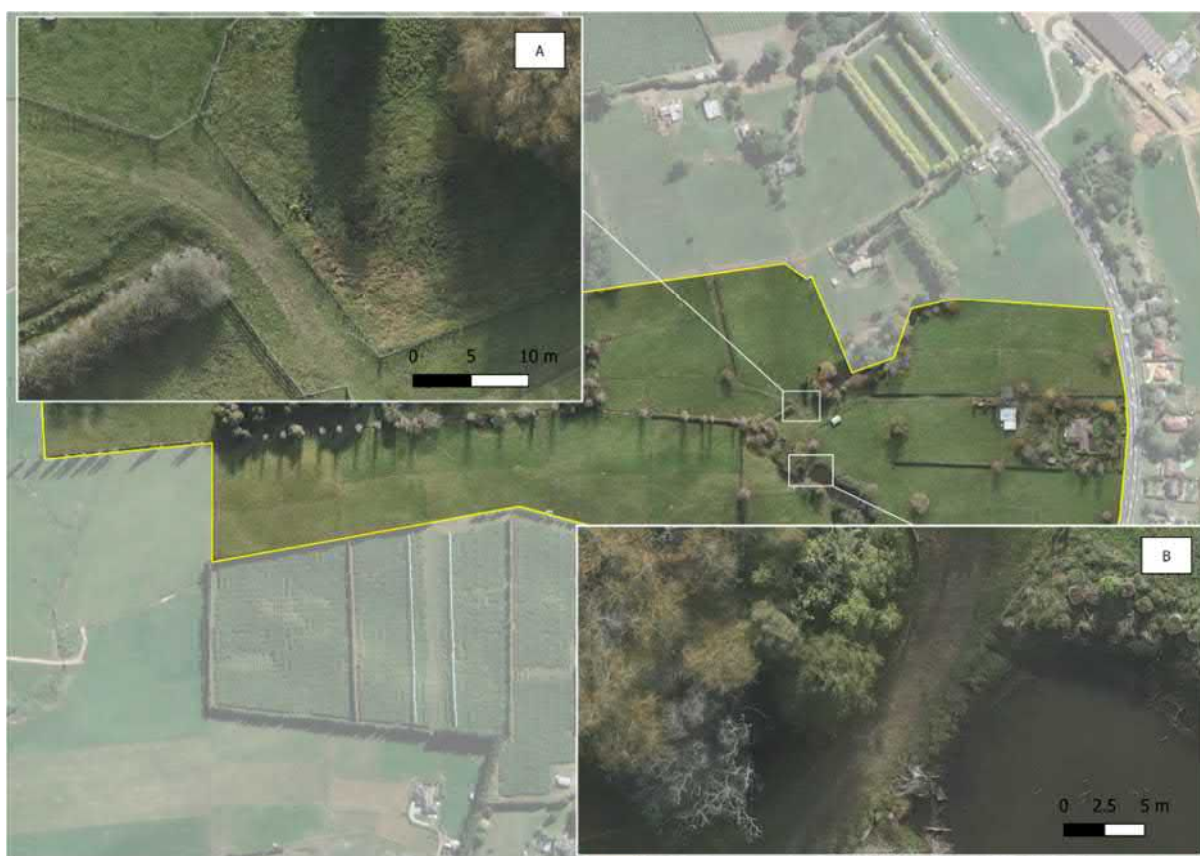
Figure 4.3: Existing watercourse crossings proposed for removal as part of the site development

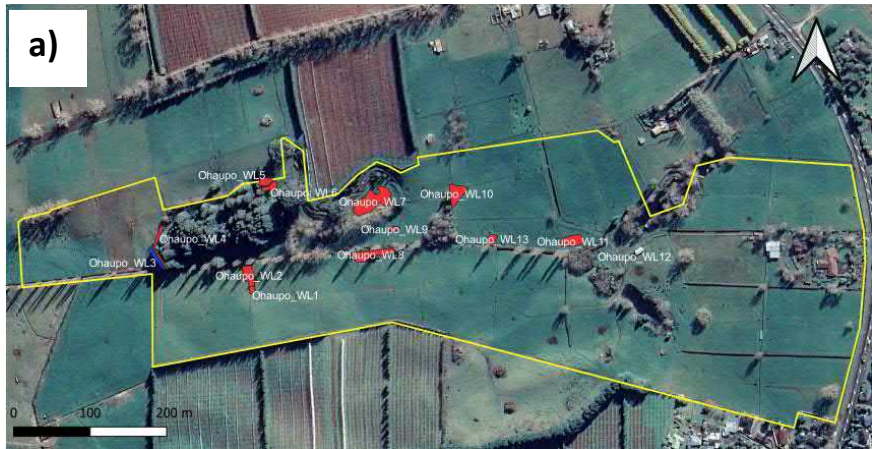
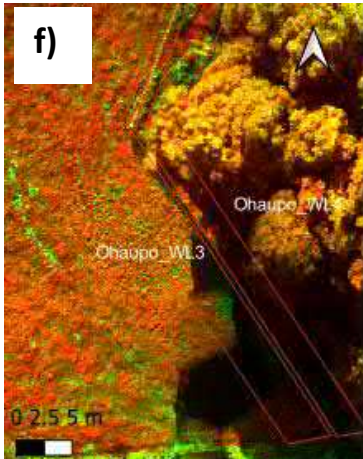
# Wetland Assessment 3: OHAUPO\_WL3

**Notes/results:** Unfenced section of paddock dominated by creeping buttercup (*Ranunculus repens*). Surface soil was unsaturated with mottling and low chroma colours and a significant amount of pugging existed due to stock access. Despite the presence of mottling, the soil was unsaturated, therefore the hydric soils test failed so this site cannot be considered a natural inland wetland. Area would benefit from restoration and with engineering design, could be integrated into the adjacent wetland.

**Figures of WL3:** a) site map with WL3 highlighted in blue; b) aerial RGB image; c) photograph of hydric soil; d) landscape RGB photograph; e) CIR and; f) FCC colour composite imagery

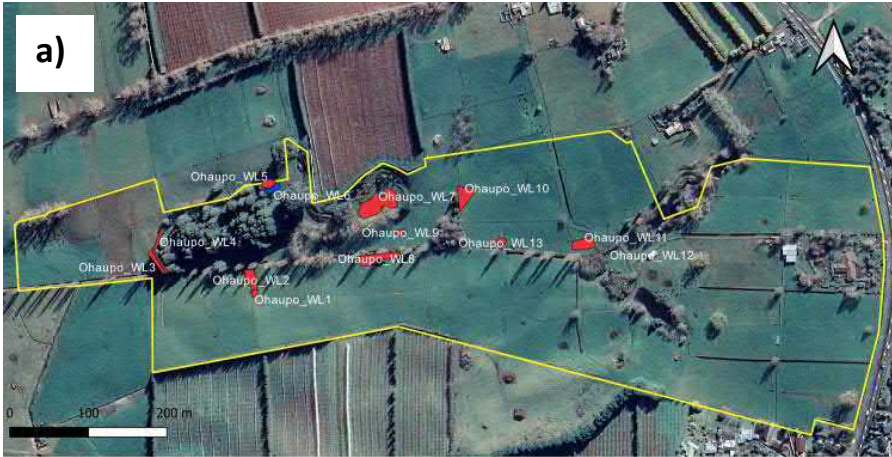
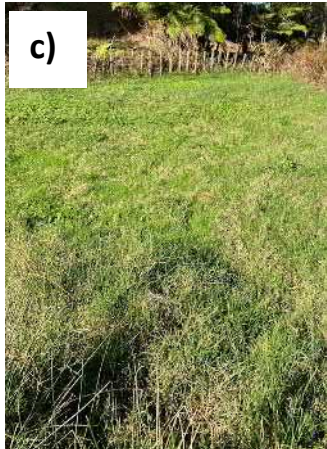
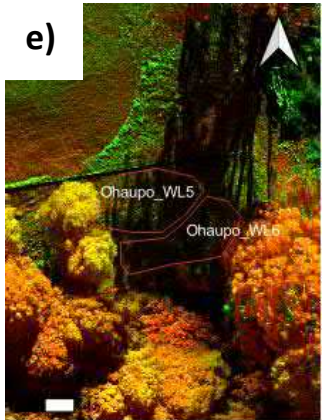
# Wetland Assessment 6: OHAUPO\_WL6

**Notes/results:** Site subject to surface pooling, dominated by facultative species, some hydrophytic rushes present (2%), hydric soils (partly saturated with some mottling). Downgradient from Ohaupo\_WL5 in basin. Site in close proximity to drained Kahikatea stand. The soil was saturated in close proximity to the Kahikatea stand along with multiple primary indicators of wetland hydrology, including surface water, soil saturation, and sheens on pooled groundwater, therefore the wetland passed the hydrology test, and the site is consistent with a natural inland wetland.

**Figures of WL6:** a) site map with WL6 highlighted in blue; b) aerial RGB image; c) landscape RGB photograph; d) CIR and; e) FCC colour composite imagery

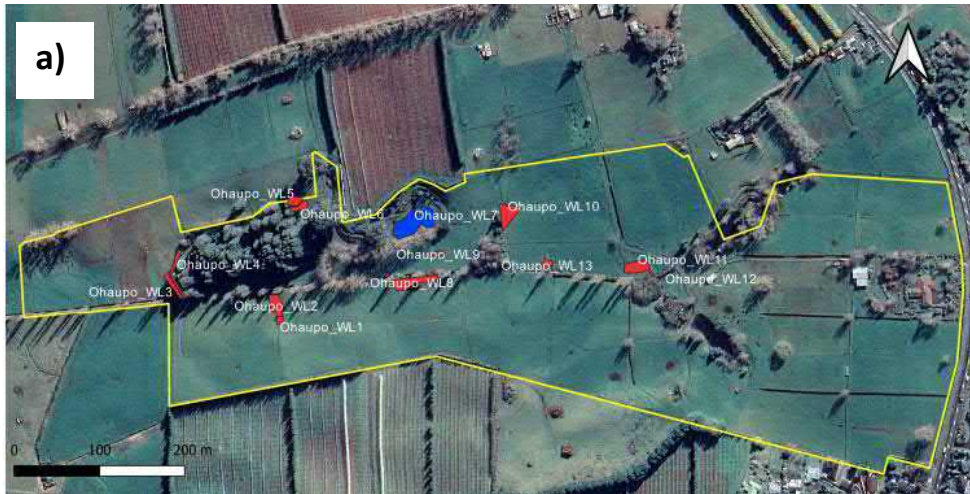
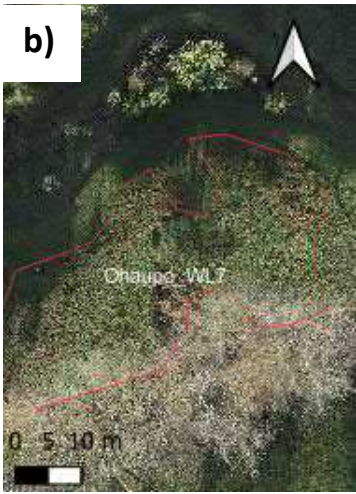
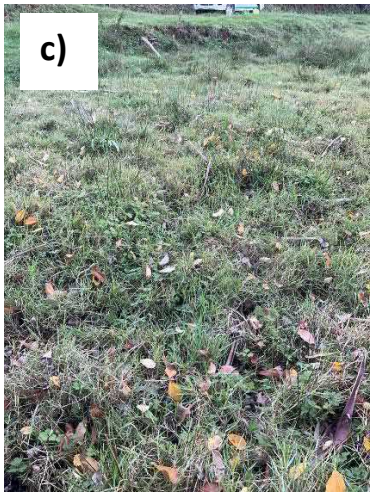
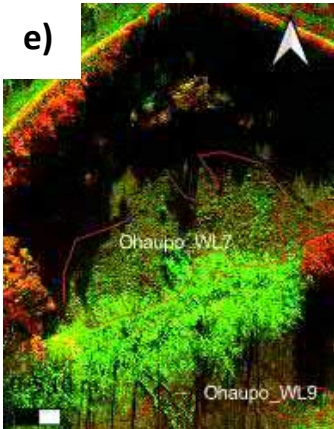
# Wetland Assessment 7: OHAUPO\_WL7

**Notes/results:** Hydrophytic vegetation present, surface water pooling and groundwater slowly flowing towards central drain. Hydric soils with distinct mottling, no odour, low chroma colours. Very wet site with sheens and iron staining.

Multiple primary indicators of wetland hydrology were present, including surface water, soil saturation, groundwater flow, and iron deposits therefore the wetland passed the hydrology test, and is consistent with a natural inland wetland.

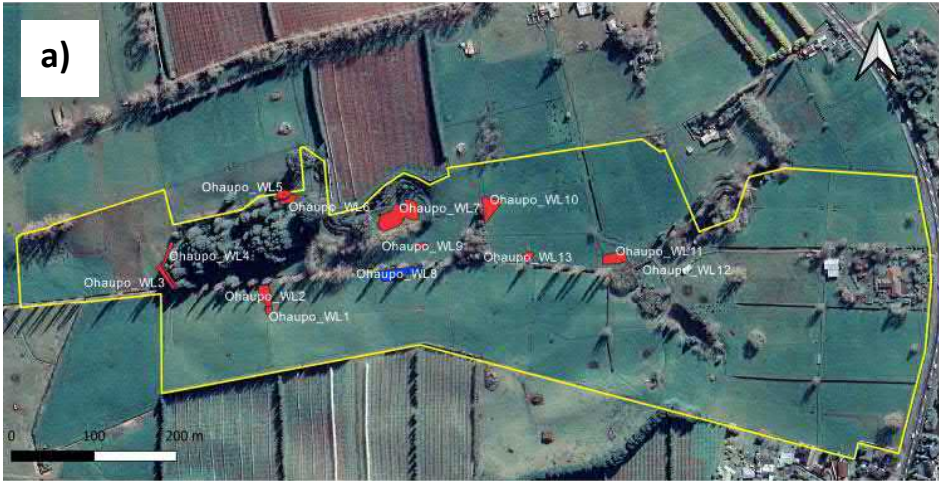
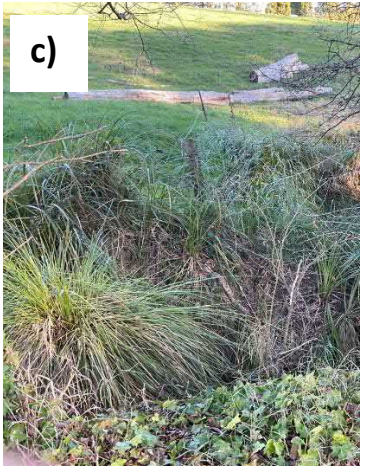
# Wetland Assessment 8: OHAUPO\_WL8

**Notes/results:** Extent of wetland not fully assessed due to accessibility. From viewpoint (through fence line, across stream) sedge (***Carex secta***) was the only plant species present. Aerial imagery revealed the extent of the wetland, running adjacent to the site's central drain.

Soil was saturated at this site (primary indicator of wetland hydrology), therefore the wetland passed the hydrology test, and is consistent with a natural inland wetland.

**Figures of WL8:** a) site map with WL8 highlighted in blue; b) aerial RGB image; c) landscape RGB photograph; d) CIR and; e) FCC colour composite imagery

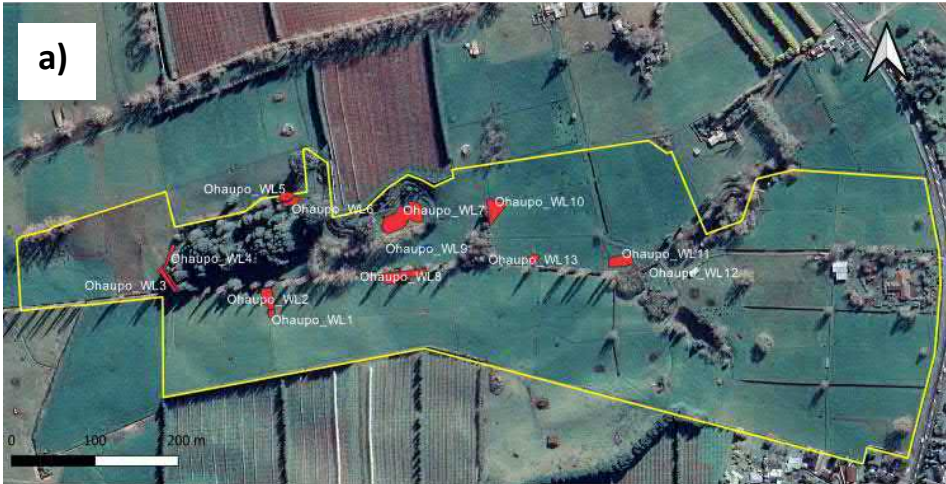
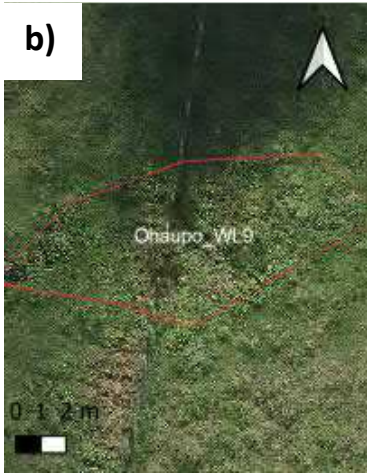
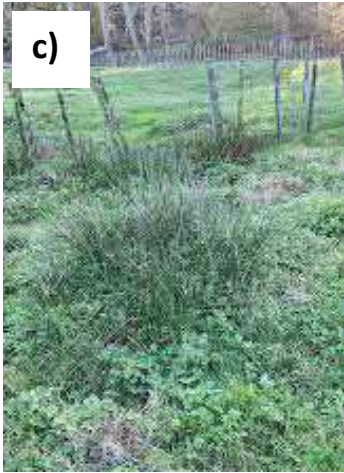
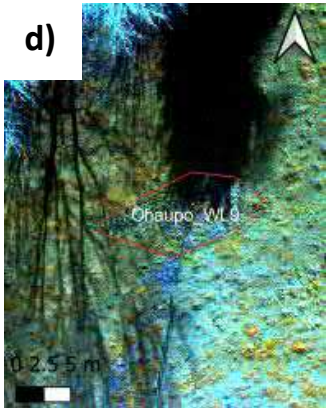
# Wetland Assessment 9: OHAUPO\_WL9

**Notes/results:** Small (~5m<sup>2</sup>) area of hydrophytic vegetation with hydric soils. Wetland hydrology not immediately obvious, but multispectral aerial imagery reveals the flow pathway into the central drain. Site likely has underground drainage piping.

Soil was saturated and surface water pooling was present at this site (primary indicators of wetland hydrology), therefore the wetland passed the hydrology test, and is consistent with a natural inland wetland.

**Figures of WL9:** a) site map with WL9 highlighted in blue; b) aerial RGB image; c) landscape RGB photograph; d) CIR and; e) FCC colour composite imagery

Underground drainage piping is present throughout the site. Piping visible in-field discharges into the central drain and was generally located close to the drain, within the surface soil layer. The wetland hydrology and flow pathways of some wetland sites (e.g., Ohaupo\_WL9) were difficult to understand and could potentially be explained by the presence of underground drainage systems. Disturbance of these systems will likely result in a change in hydrology and flow pattern surrounding the highlighted putative wetlands.

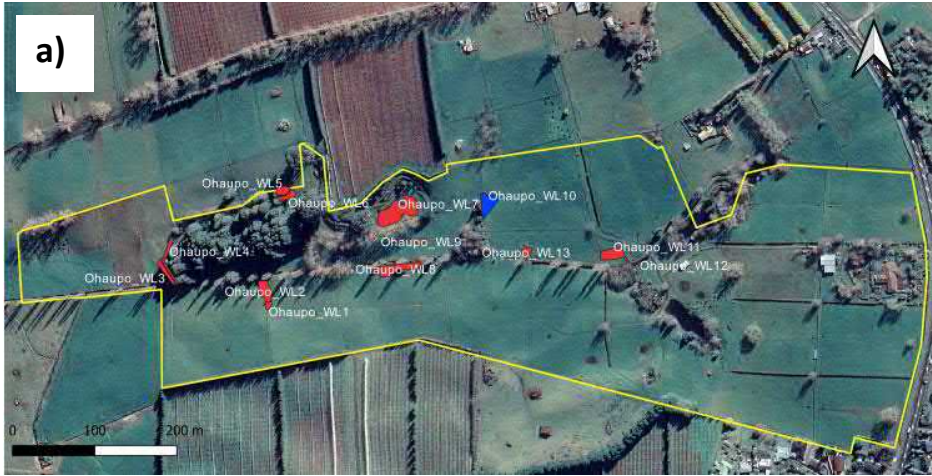
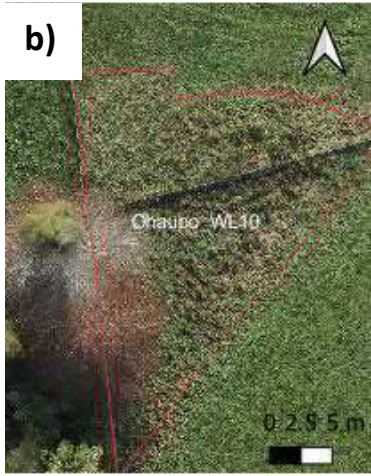
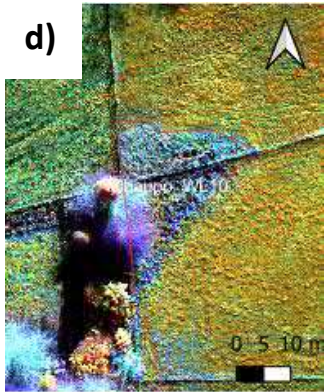
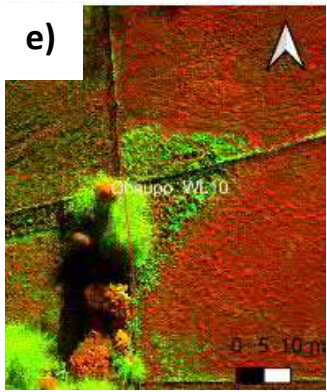
# Wetland Assessment 10: OHAUPO\_WL10

**Notes/results:** Not fully assessed in field. Hydrophytic vegetation (*Juncus pallidus*) and unsaturated partially hydric soils were present within the site. However, the absence of surface pooling or sheens, the position of the site at the lowest point of the sloping, basin-like paddock, and higher chroma soils with worms suggests this site is more affected by seasonal surface flooding than wetland hydrology. The area was also unfenced with a significant amount of pugging. The Prevalence Test was not applicable as vegetation was not fully assessed, although the site is assessed as highly unlikely to be a wetland.

**Figures of WL10:** a) site map with WL10 highlighted in blue; b) aerial RGB image; c) photograph of hydric soil; d) CIR and; e) FCC colour composite imagery

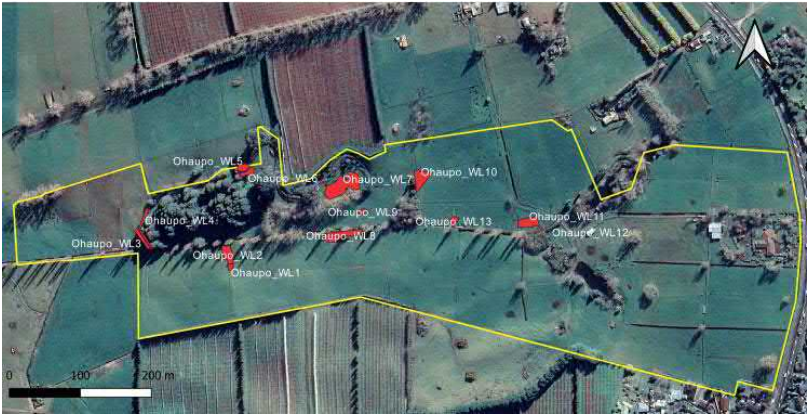
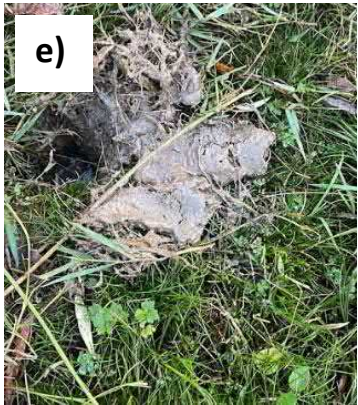
# Wetland Assessment 12: OHAUPO\_WL12

| Stratum | Species Name | % Cover | Indicator Status |
| Herb | <i>Juncus pallidus</i> | 50 | FACW |

- Number of dominant species across all strata: 2
- Percent of Dominant Species that are OBL, FACW and/or FAC: 100%
- Dominant species noted in blue

**Natural inland wetland:** Yes

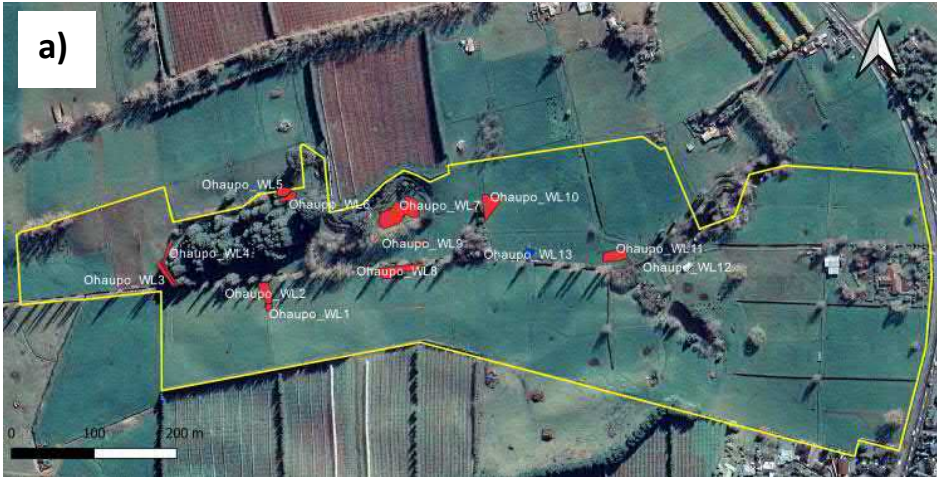
# Wetland Assessment 13: OHAUPO\_WL13

| Stratum | Species Name | % Cover | Indicator Status |
| Herb | N/A | N/A | N/A |

- Number of dominant species across all strata: N/A
- Percent of Dominant Species that are OBL, FACW and/or FAC: N/A
- Dominant species noted in blue

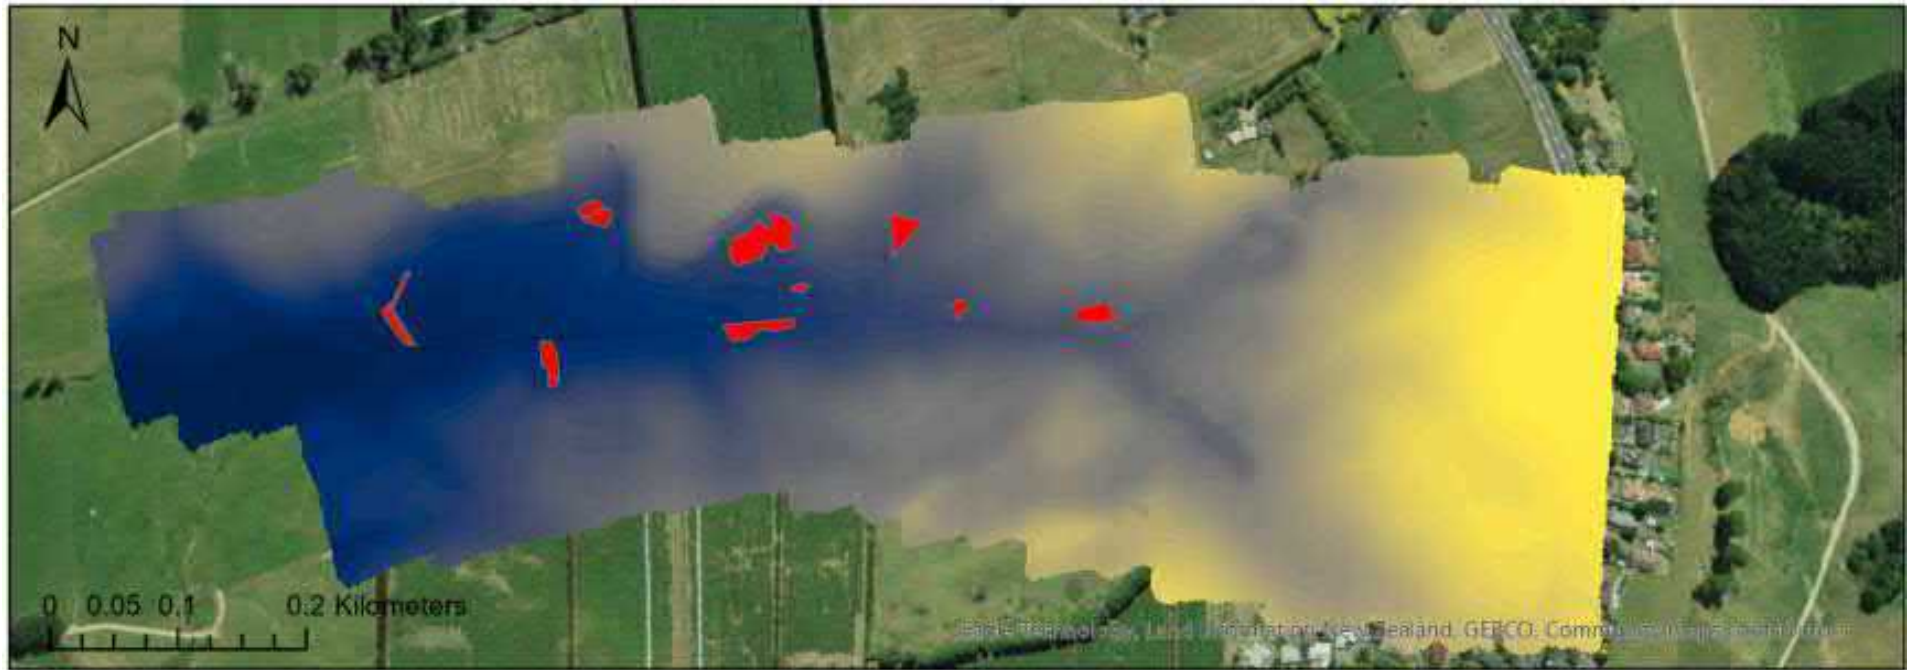
Figure A 1: Figure 1: Digital Terrain Model (DTM) Index Imagery illustrating the terrain of the landscape and the likely position of surface water pooling with potential wetland polygons. Index colour scheme ranges from deep blue (indicating lower elevation) to bright yellow (indicating higher elevation)

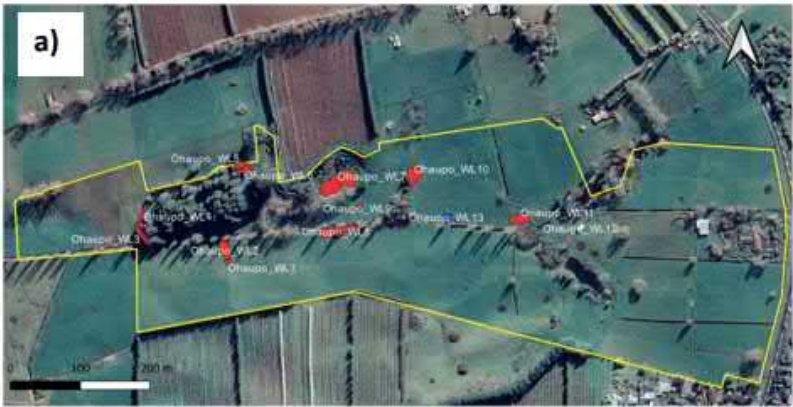
Wetland Assessment 13: OHAUPO\_WL13

| Stratum | Species Name | % Cover | Indicator Status |
| Herb | <i>Ranunculus repens</i> | 60 | FAC |
