KENNEDY ENVIRONMENTAL LIMITED

BLEDISLOE NORTH WHARF & FERGUSON NORTH WHARF EXTENSION CONSTRUCTION – EFFECTS ON THE ECOLOGICAL ENVIRONMENT

Prepared for Ports of Auckland Limited

March 2025

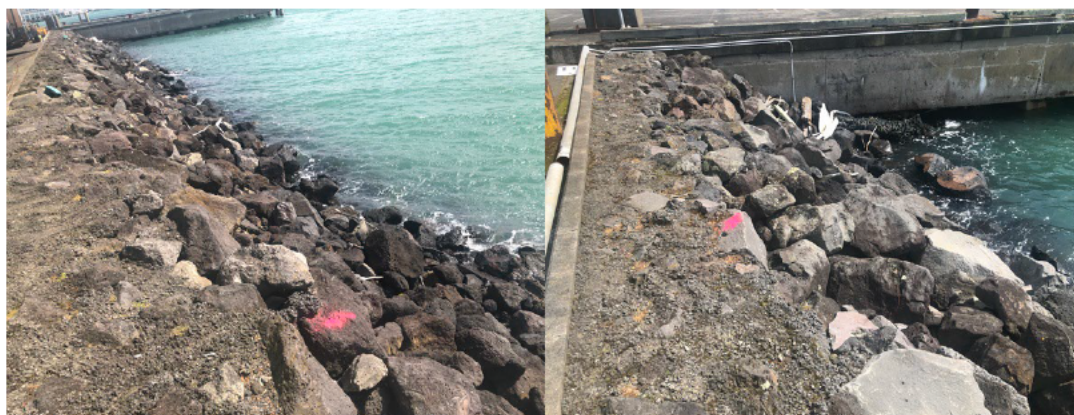
Figure 5: BN rock revetment, tracking tunnel locations.

presence of skinks. During historical walks over the revetment area, there was no indication that any reptiles were present in the upper section of revetment. No plague skinks were sighted. To provide an additional check, six tracking tunnels baited with banana were placed into the rocks in the upper metre of the revetment on 24 September 2024 and removed on 1 October 2024 (Figure 5).

No ink tracks of any kind were found on the track cards. Bait stations (for mice/rats) are maintained throughout the Port and are maintained along the revetment (see green box in left of Figure 5). Overall, there is no indication that indigenous lizards are present within the rock revetment at the proposed BN wharf location.

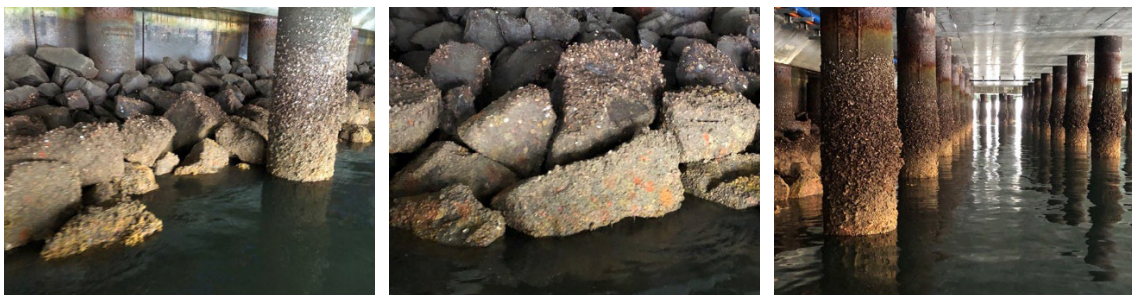
Figure 15: FN under wharf environment (October 2024).

Examination of revetment rocks under the Fergusson Container Terminal wharf (west side) has identified encrusting sponges such as *Cliona celata* and *Microciona coccinsa* and *Tethya aurantium* a golf ball sponge dominated (POAL 1996).

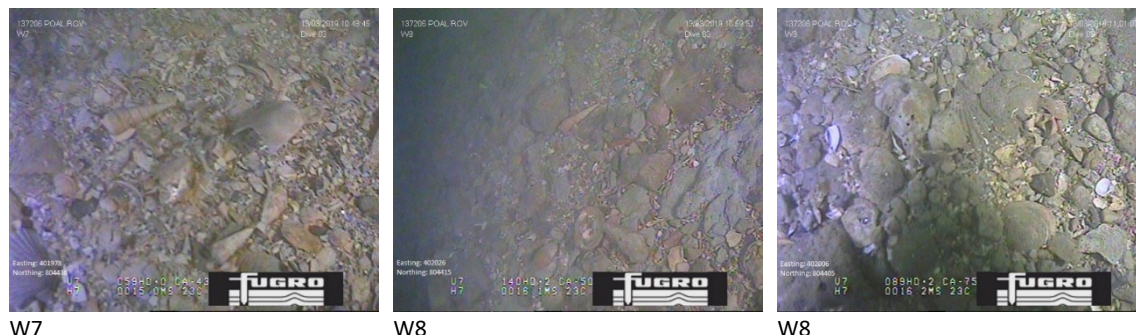
Figure 21: Images from the ROV transects off FN in February 2019 (refer Figure in Appendix E).

The 2019 ROV survey off the FN wharf showed a relatively coarse seabed with little deposited fine material. As shown in the images in Figure 21 many of the photographed locations showed a firm substrate with material suggestive of past local dredging with the surface clear of fines due to high current velocities.

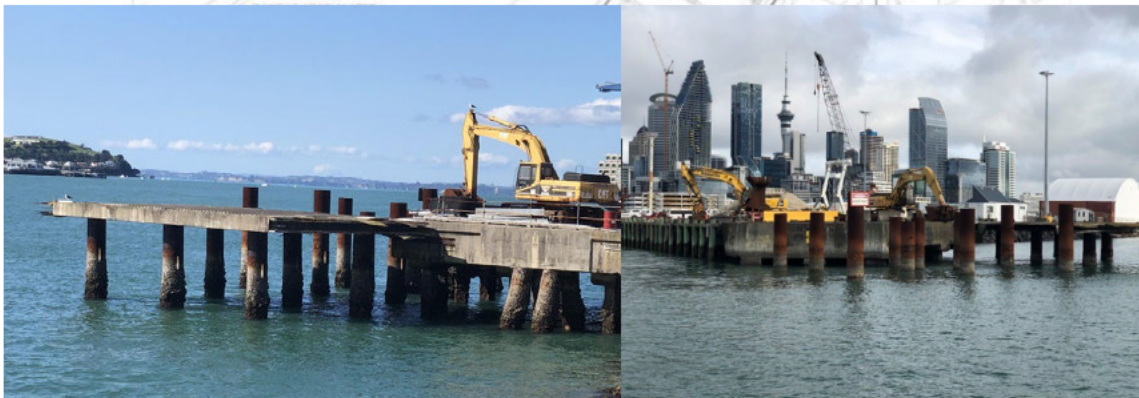
Figure 23: Piles and deck at north-east corner of Bledisloe Terminal to be demolished.

- Remove the piles from their sockets. This is normally accomplished by breaking the seal between the pile/steel jacket and the surrounding material. It may require drilling and vibro-hammering to be able to pull the piles out. The depth of the existing piles is expected to make this very difficult.
- Cut the piles at the seabed. This is typically carried out by divers.

- It is recommended that if the piles are cut, the piles are cut below the surface (e.g., 0.1-0.2 m). This will allow the top of the piles to become covered with sediment.

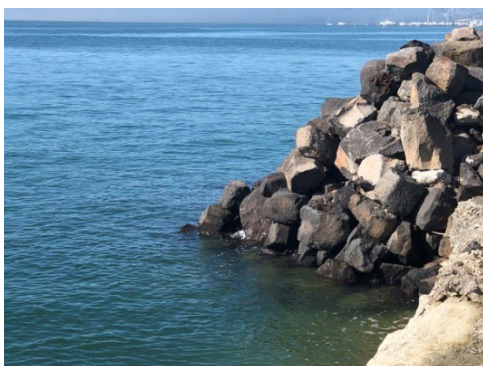
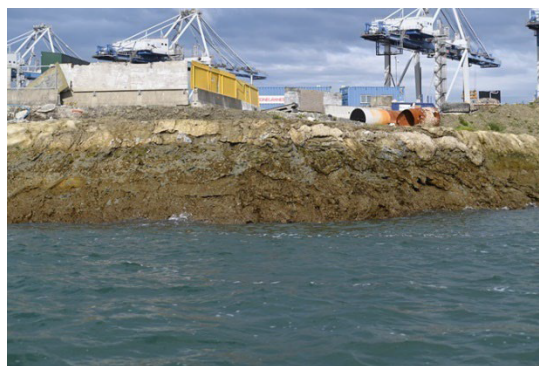
Figure 24. Upper: West end of Fergusson North berth showing Interface between end of existing eastern revetment and mudcrete reclamation.

The works associated with the revetment will involve:

- Trimming the seaward edge of the final mudcrete reclamation edge (existing edge shown in Figure 24) to provide a slope to lay revetment rock onto. The trimmed material will be placed onto the reclamation or disposed to landfill.
- Placement of new revetment rock to extend the existing revetment around to meet the existing revetment under the east end of FN wharf (refer Figure 24).

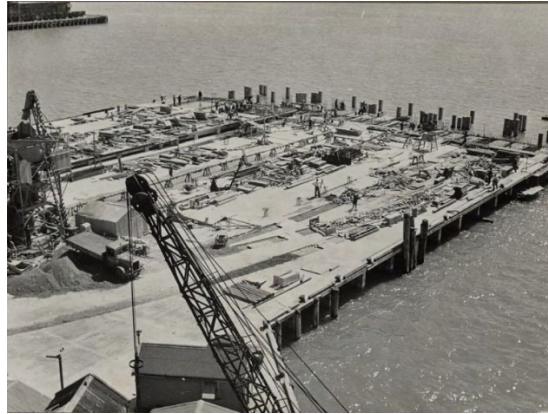
March 1941 early construction of Bledisloe
export wharf AN52

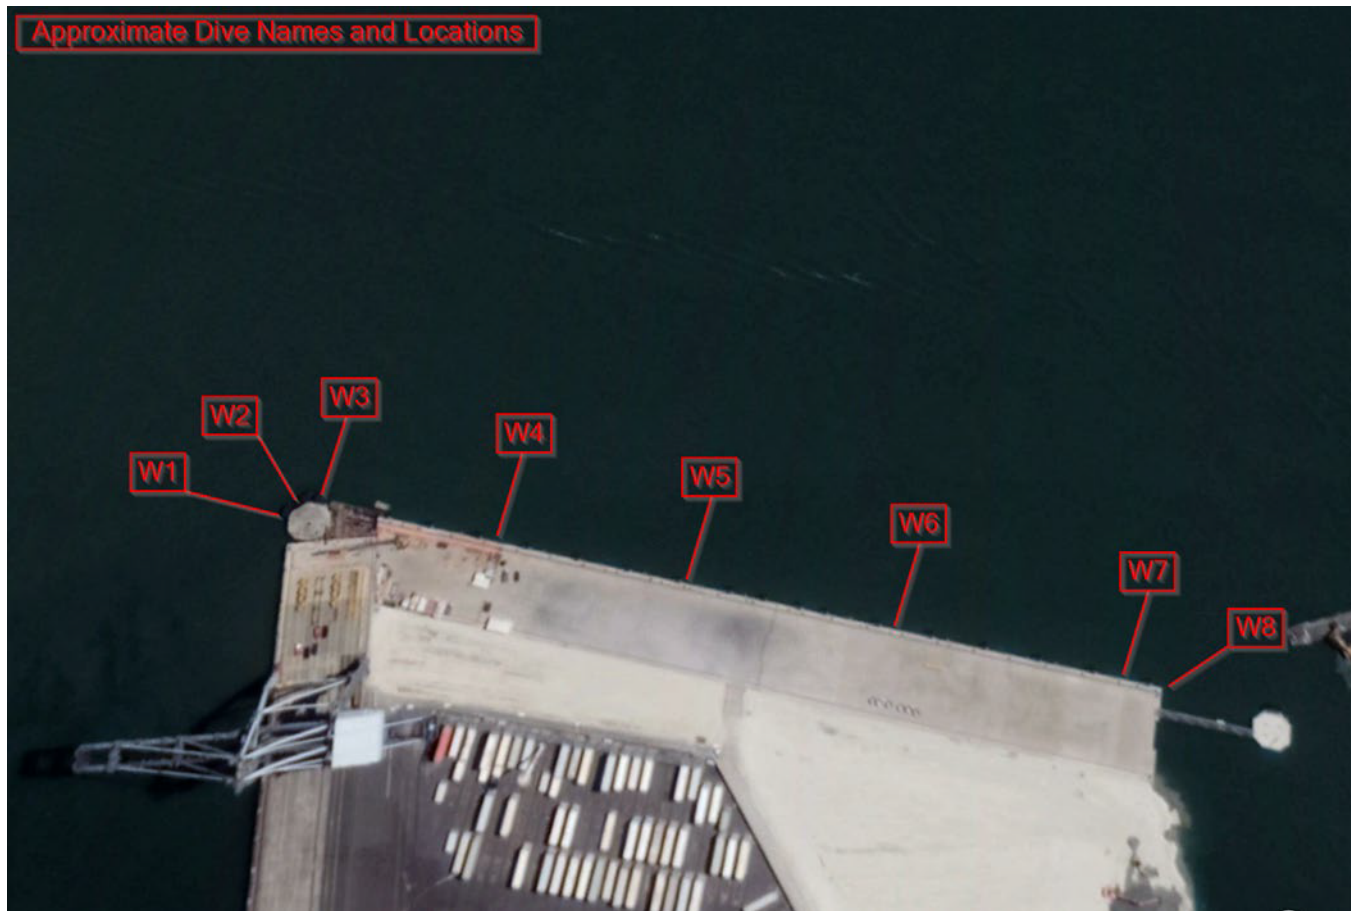
Fergusson North Berth and approaches showing location of ROV dive sites (For original location figures refer Fugro report in Appendix of Ramboll 2019 (Appendix C)).

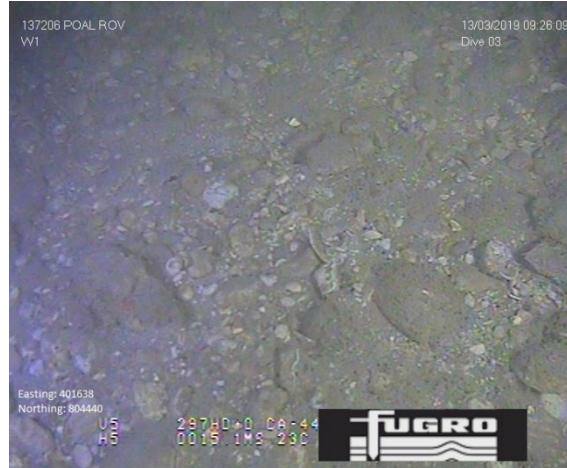
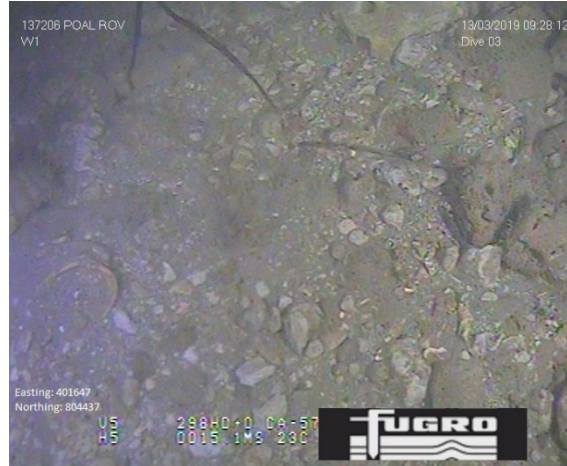
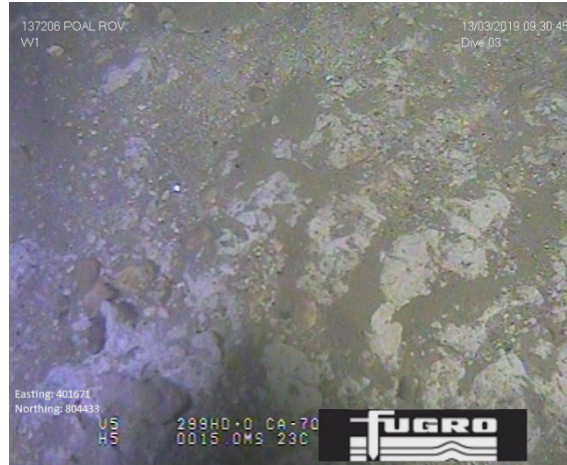
W1

Appendix E: March 2019 ROV images from Fergusson North wharf.
