Preliminary Site Investigation

Document no: IA328200-JAC-GE-00-RPT-EV-00-0001

Belfast to Pegasus Motorway and Woodend Bypass

5 November 2024

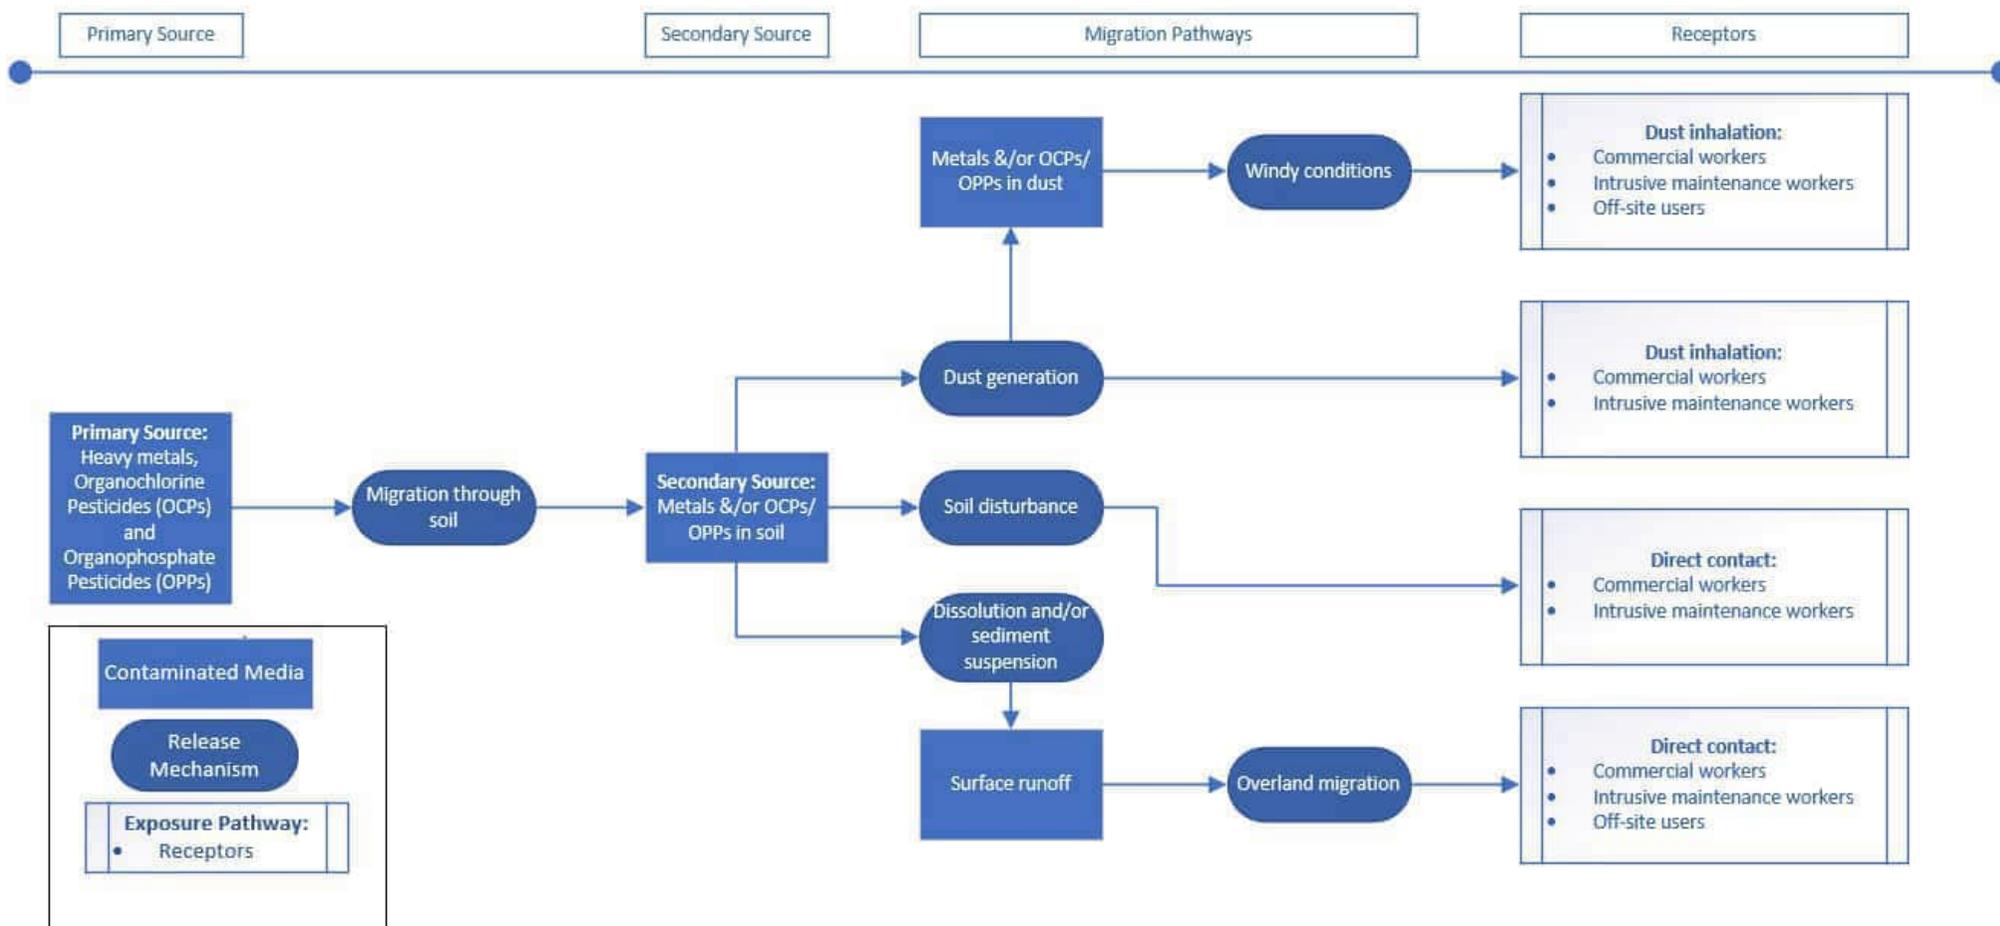
Figure 4-1 CSM for Heavy Metals, Organochlorine Pesticides and Organophosphate Pesticides

This assessment is limited to identified receptors within or directly adjacent to the project corridor. A summary of the potential linkages (exposure pathways) connecting sources, transport mechanisms and receptors are presented in the high-level CSM flowcharts in **Figure 4-1**, **Figure 4-2** and **Figure 4-3**.

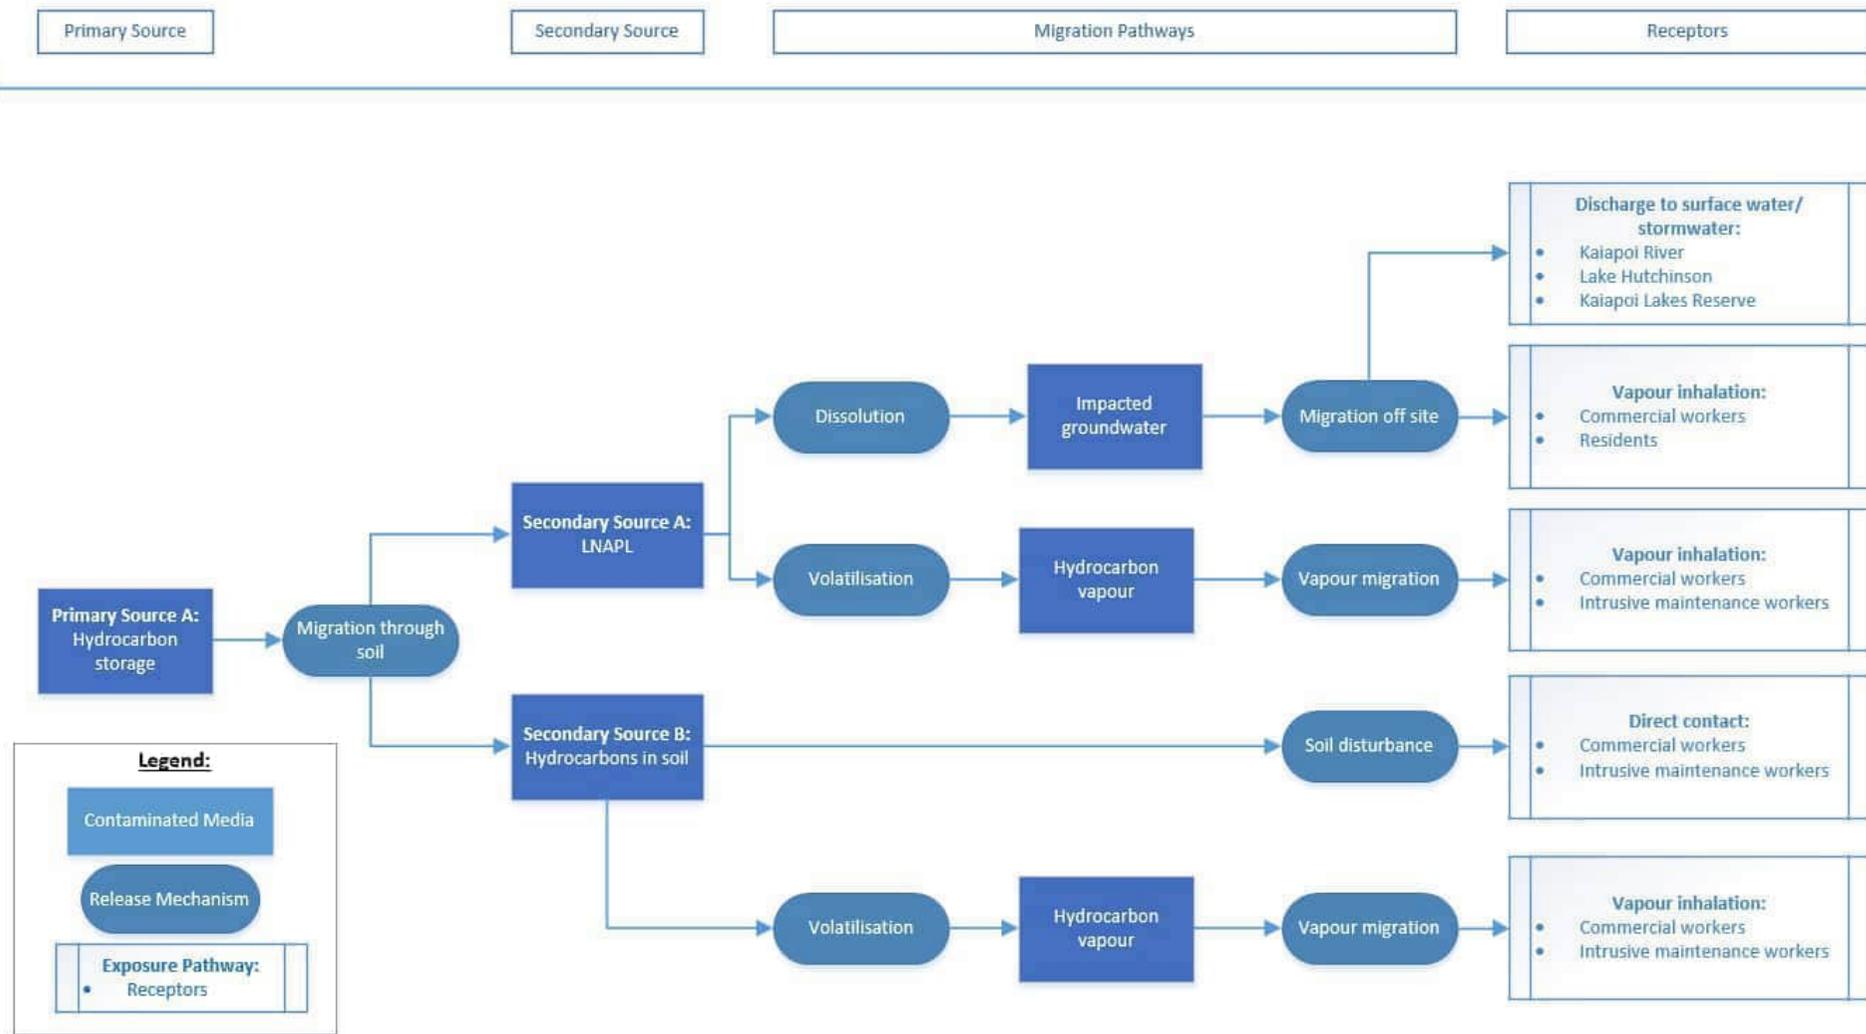
Figure 4-2 CSM for Hydrocarbon Storage

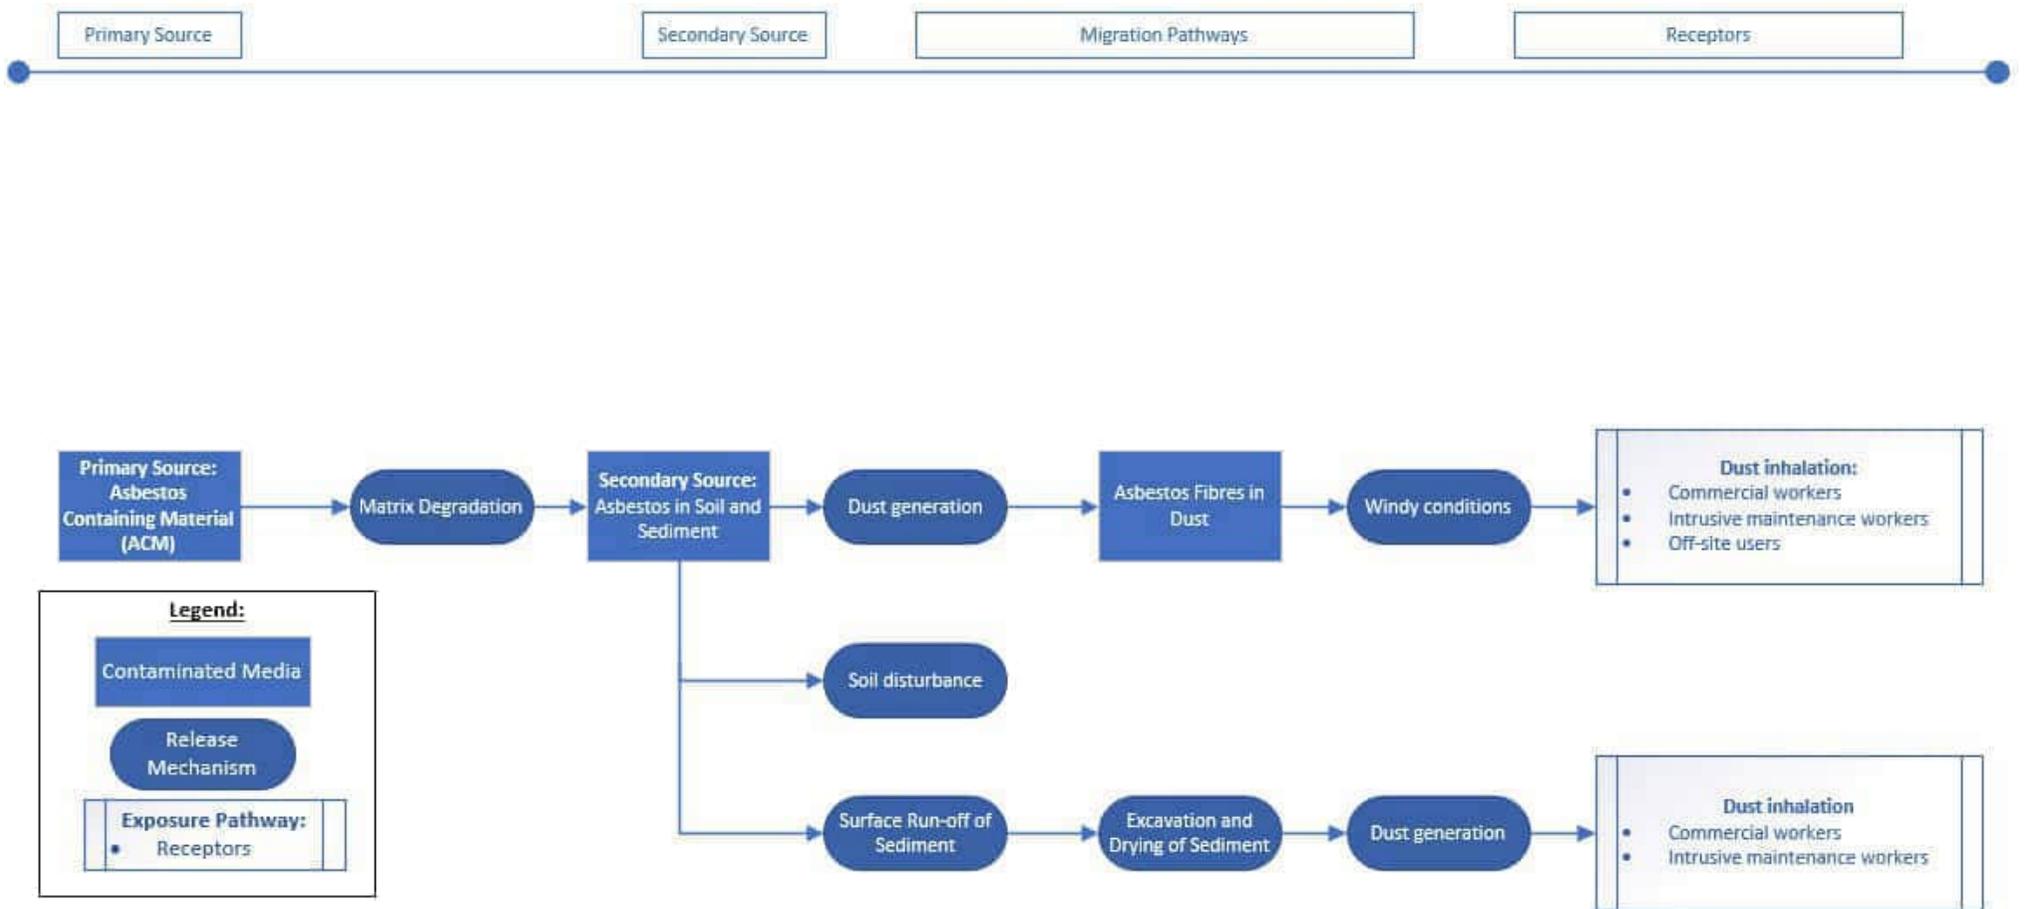
Figure 4-3 CSM for Asbestos

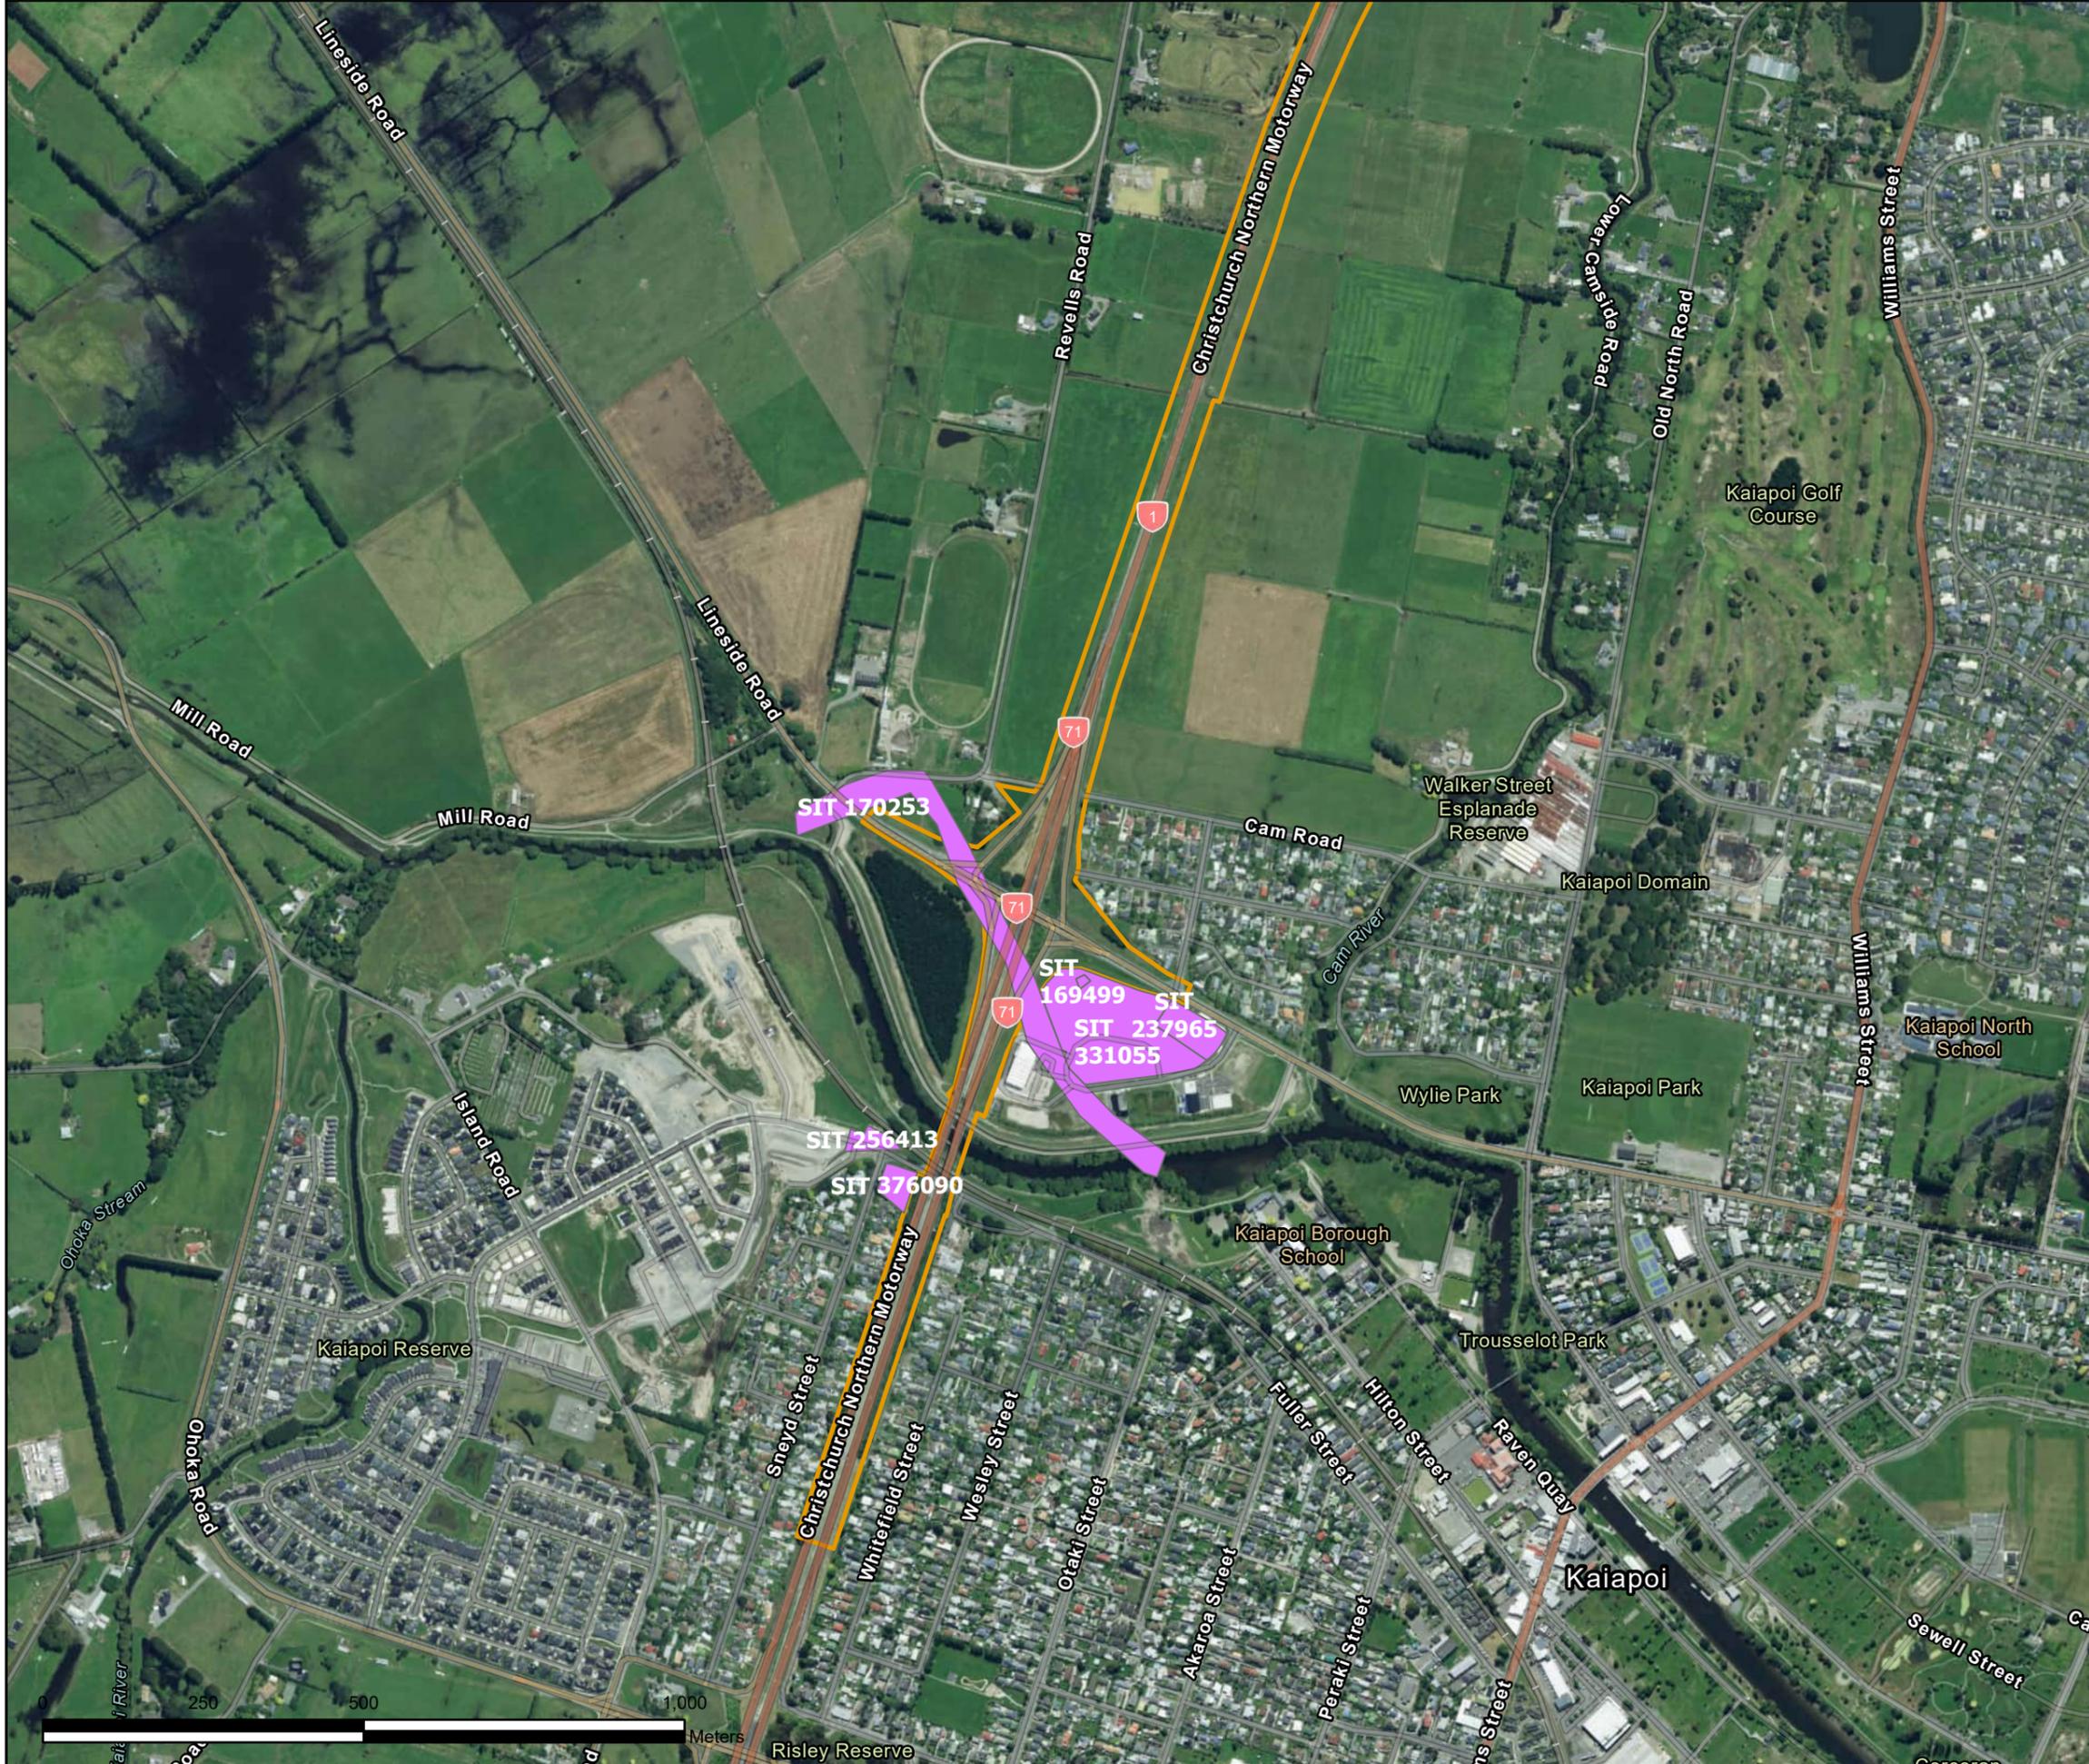
Hail Sites in Section 1 - Start of Project Corridor to Cam Road

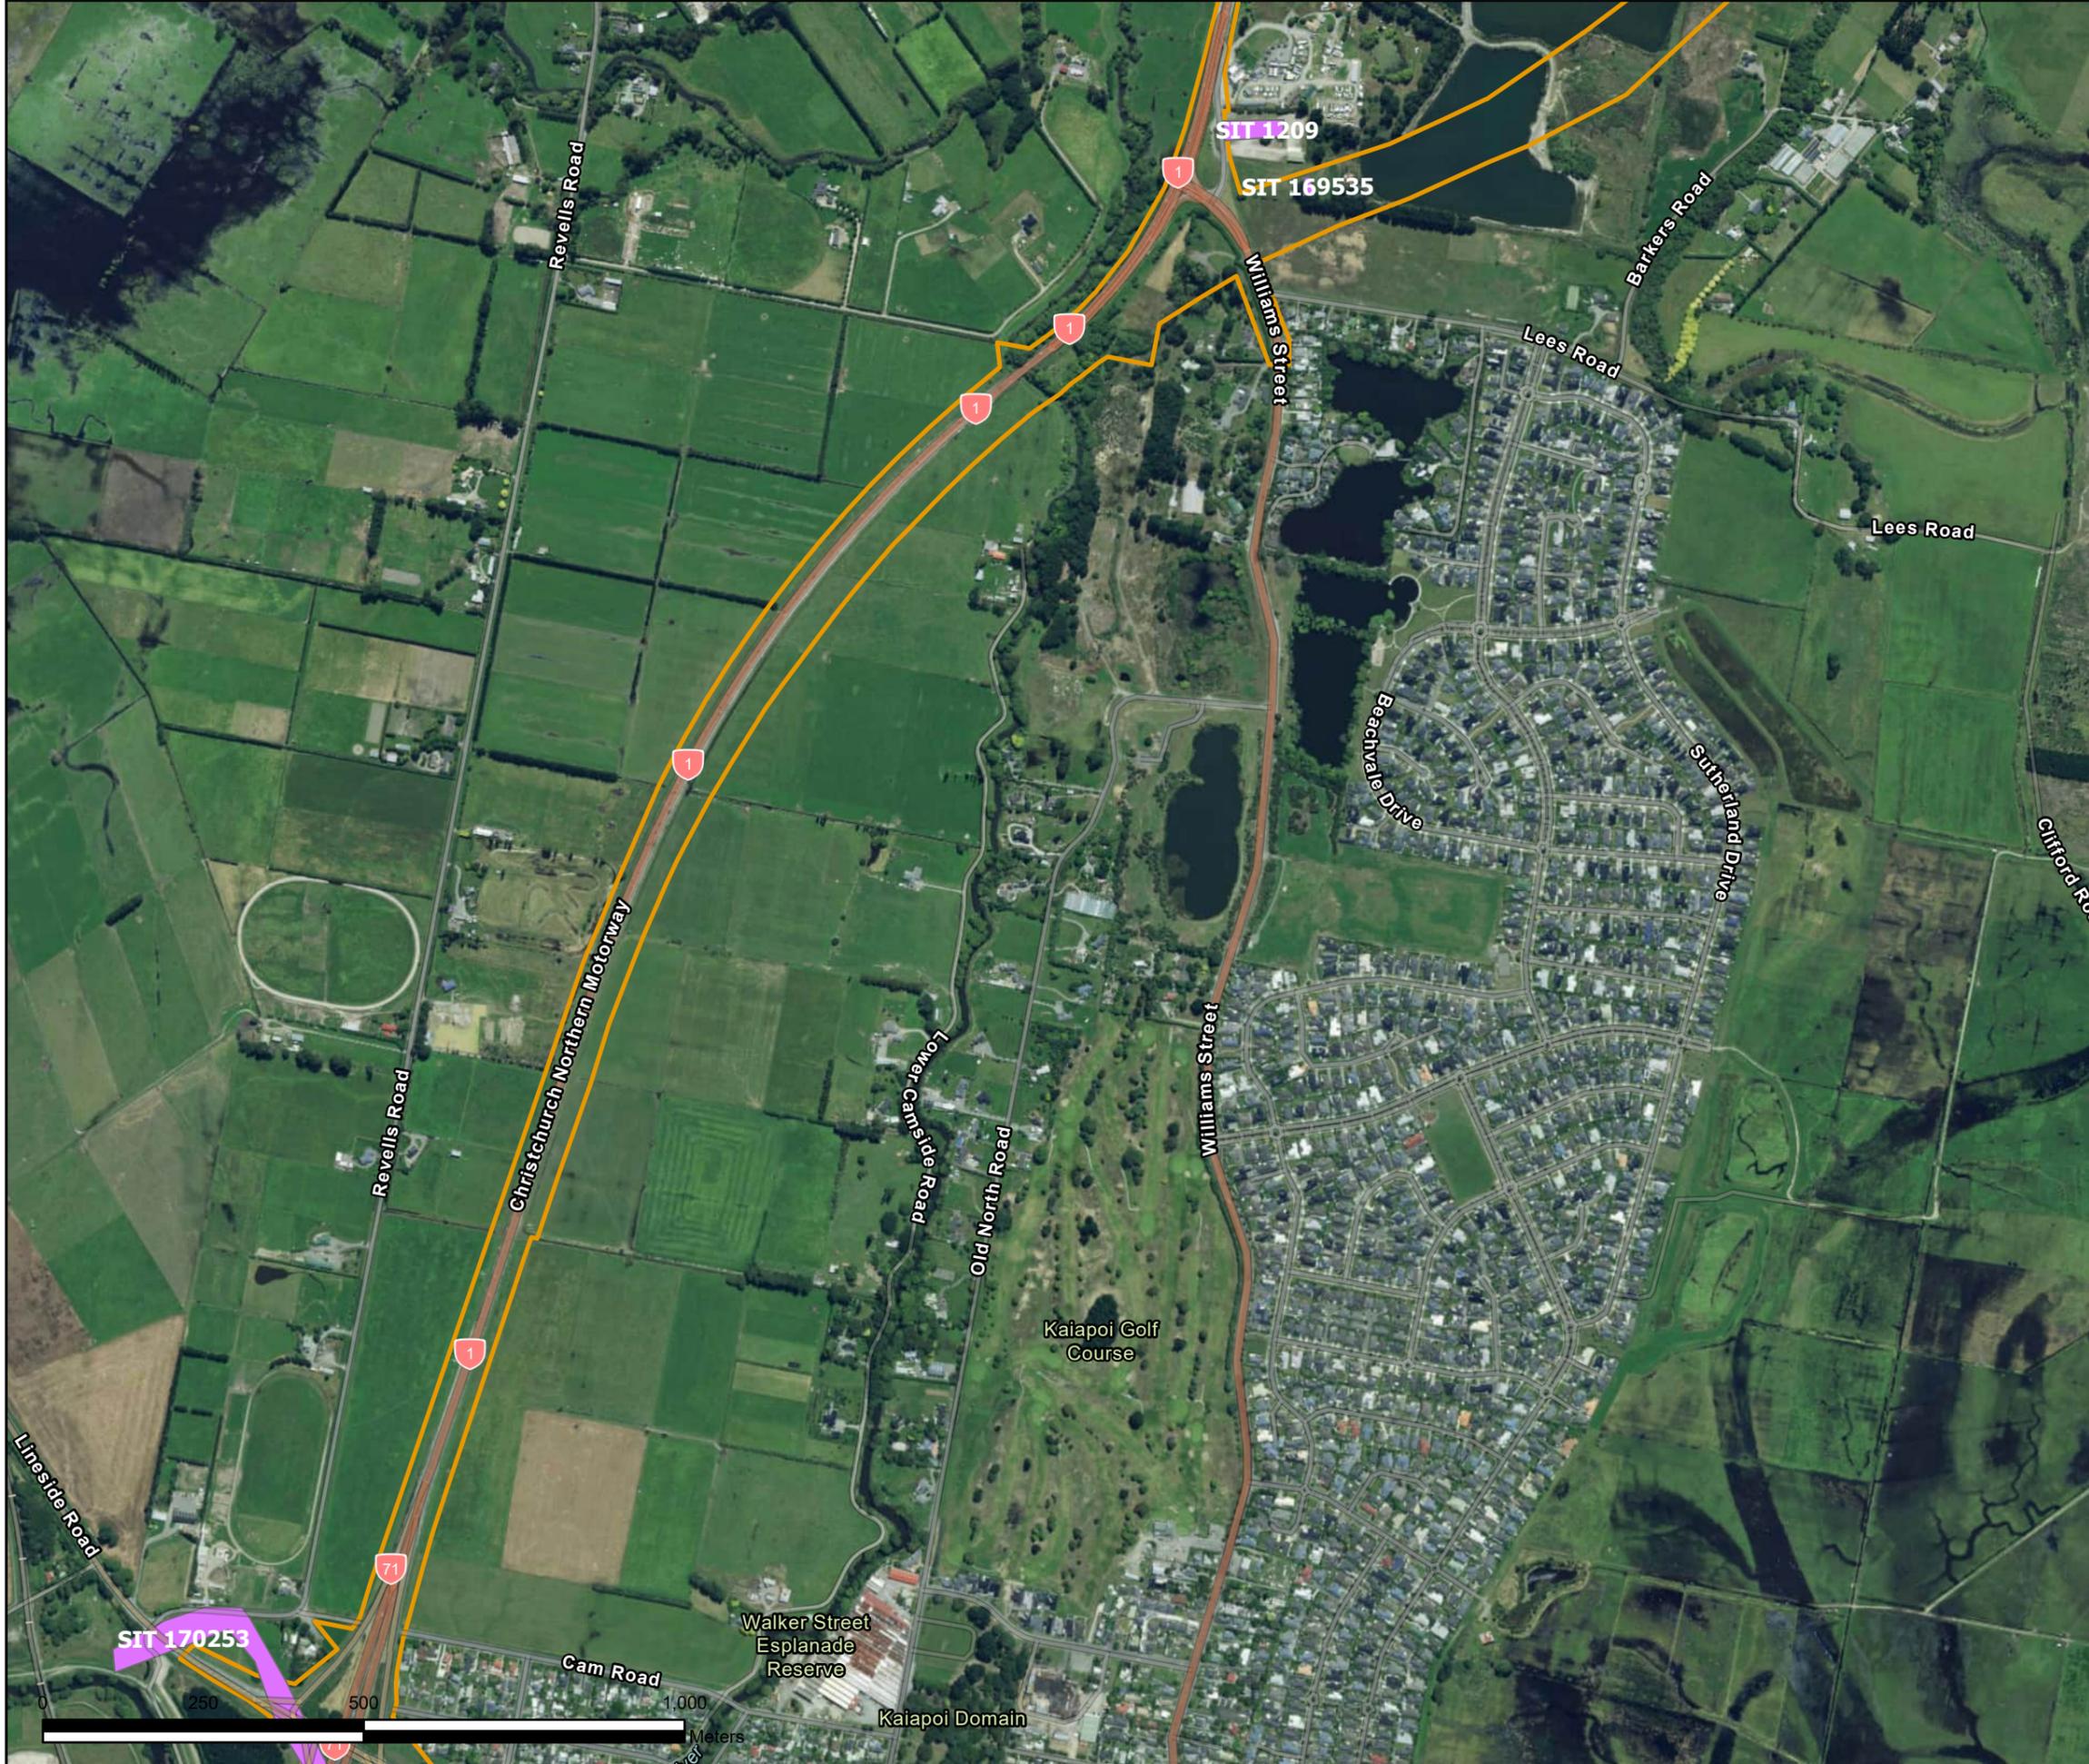
Hail Sites in Section 2- Cam Street to SH1 & William Street Intersection

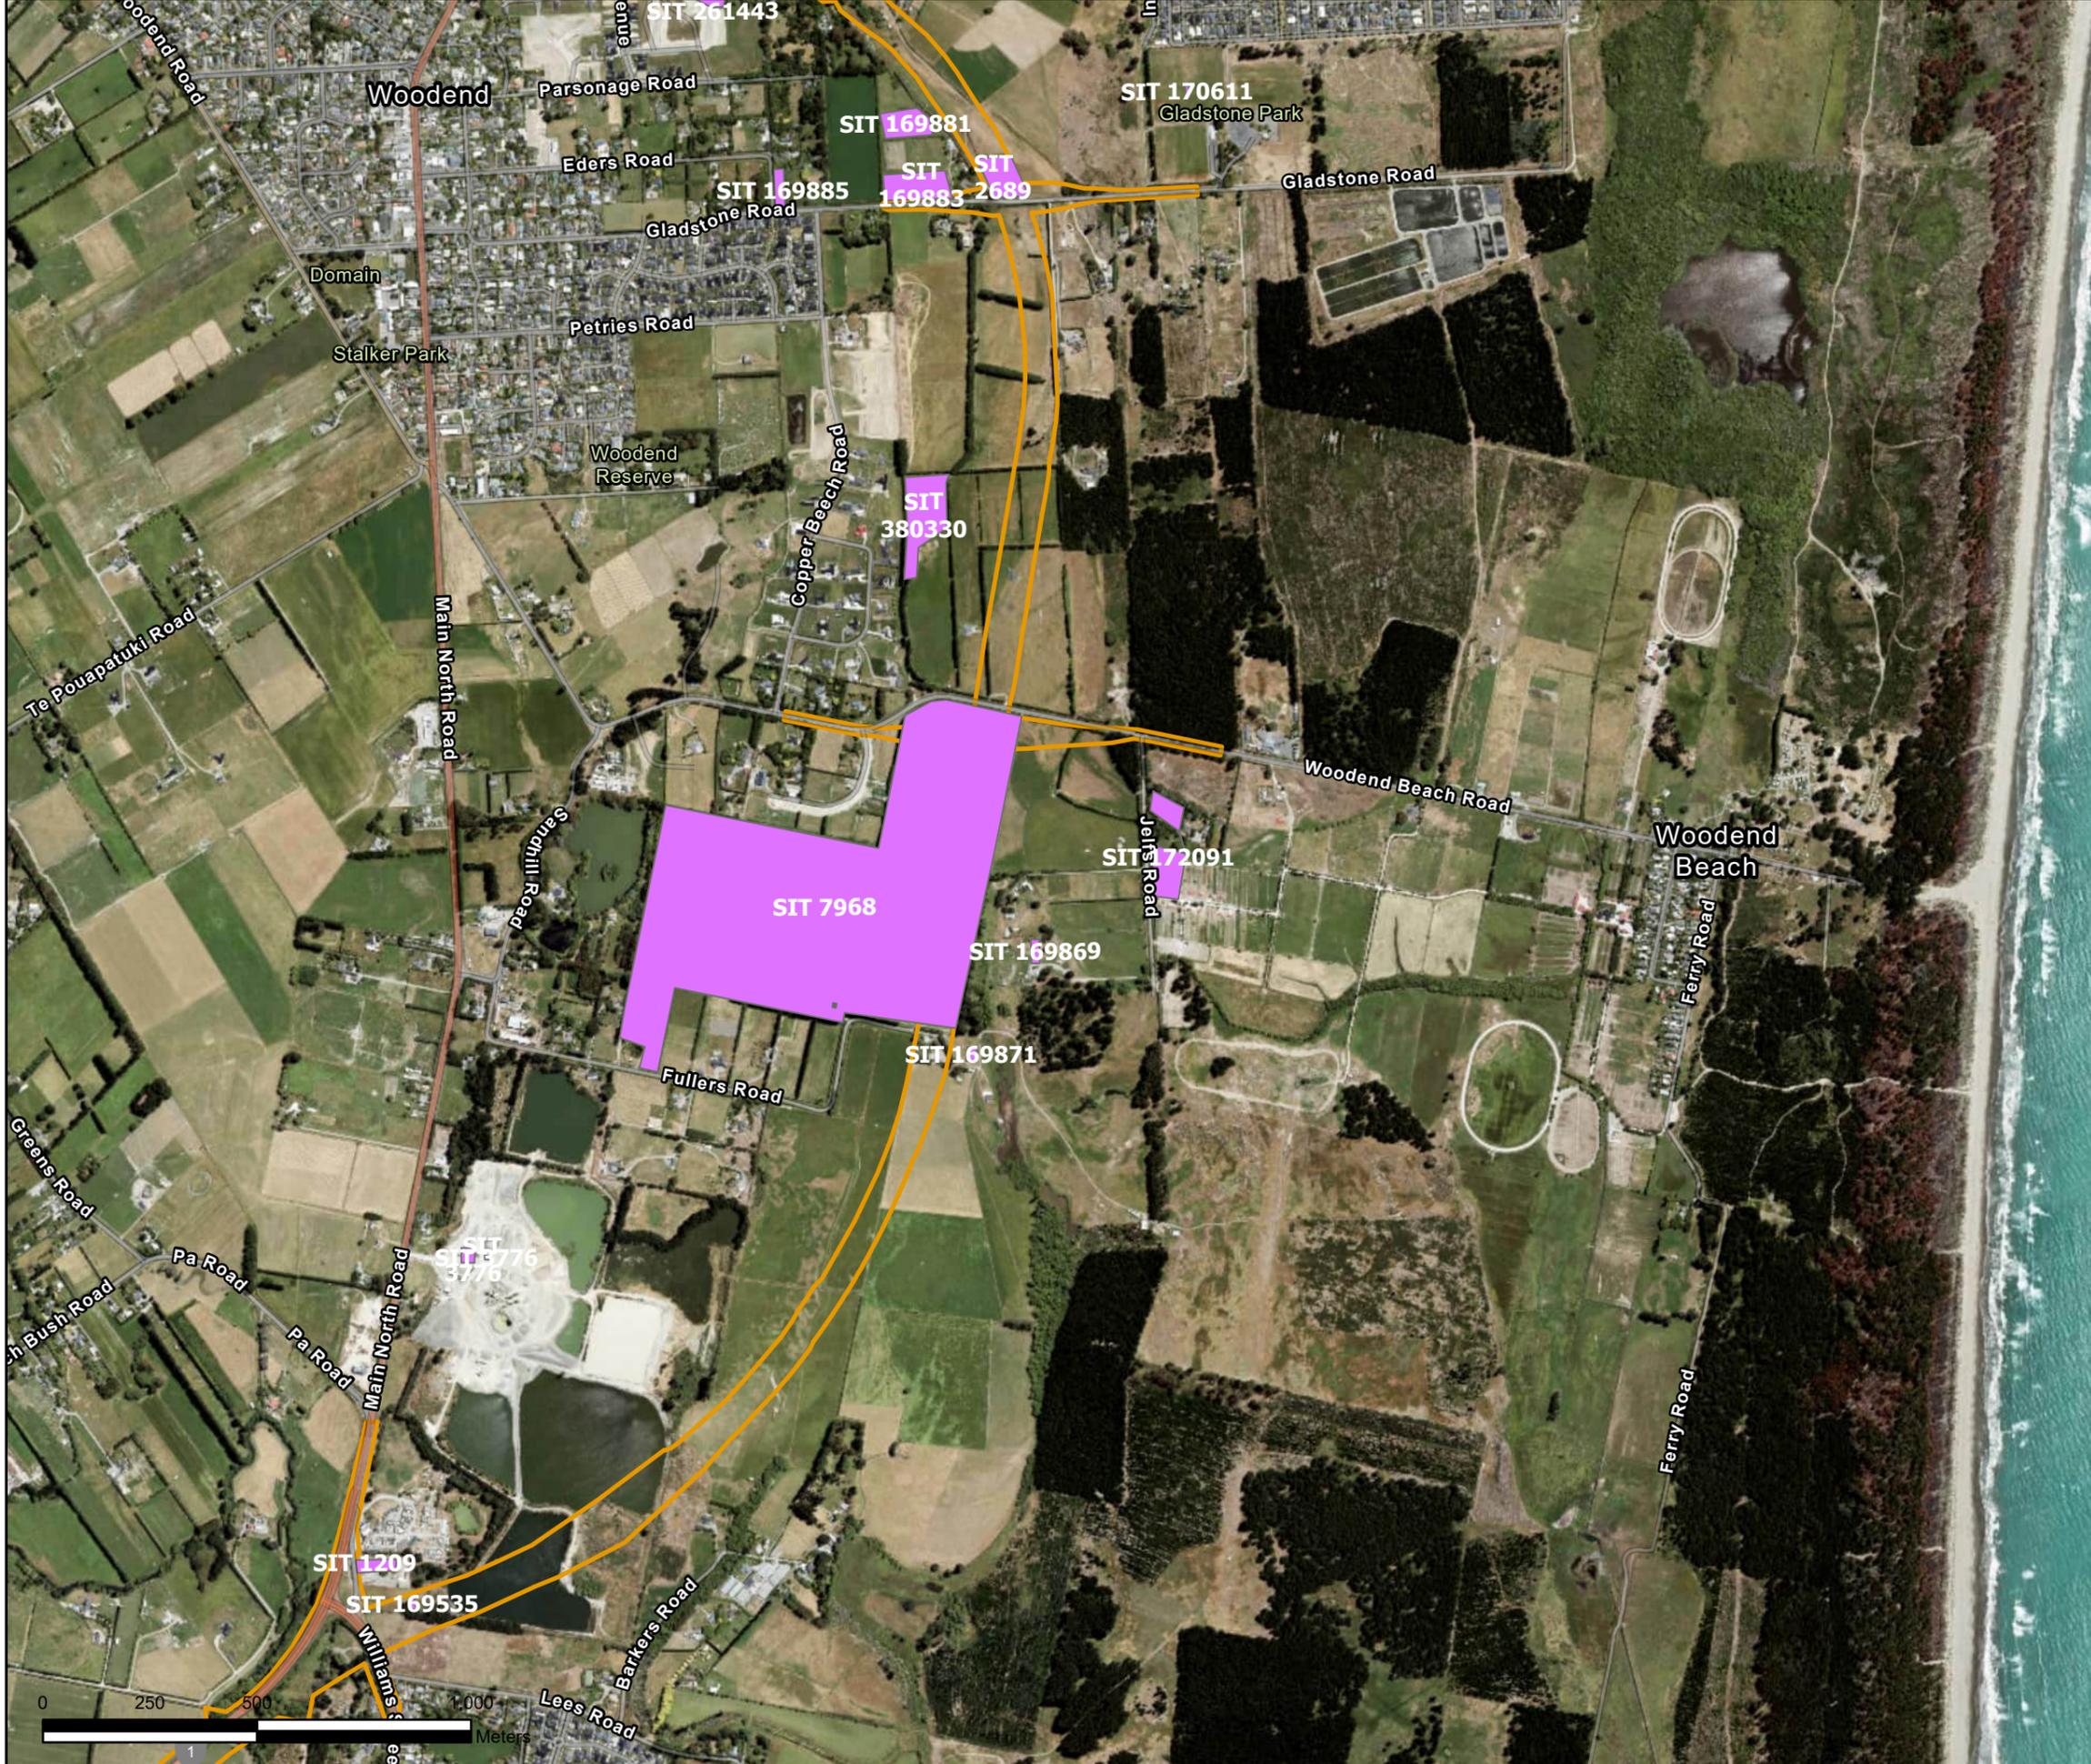
Hail Sites in Section 3 - SH1 & William Street Intersection to Gladstone Road

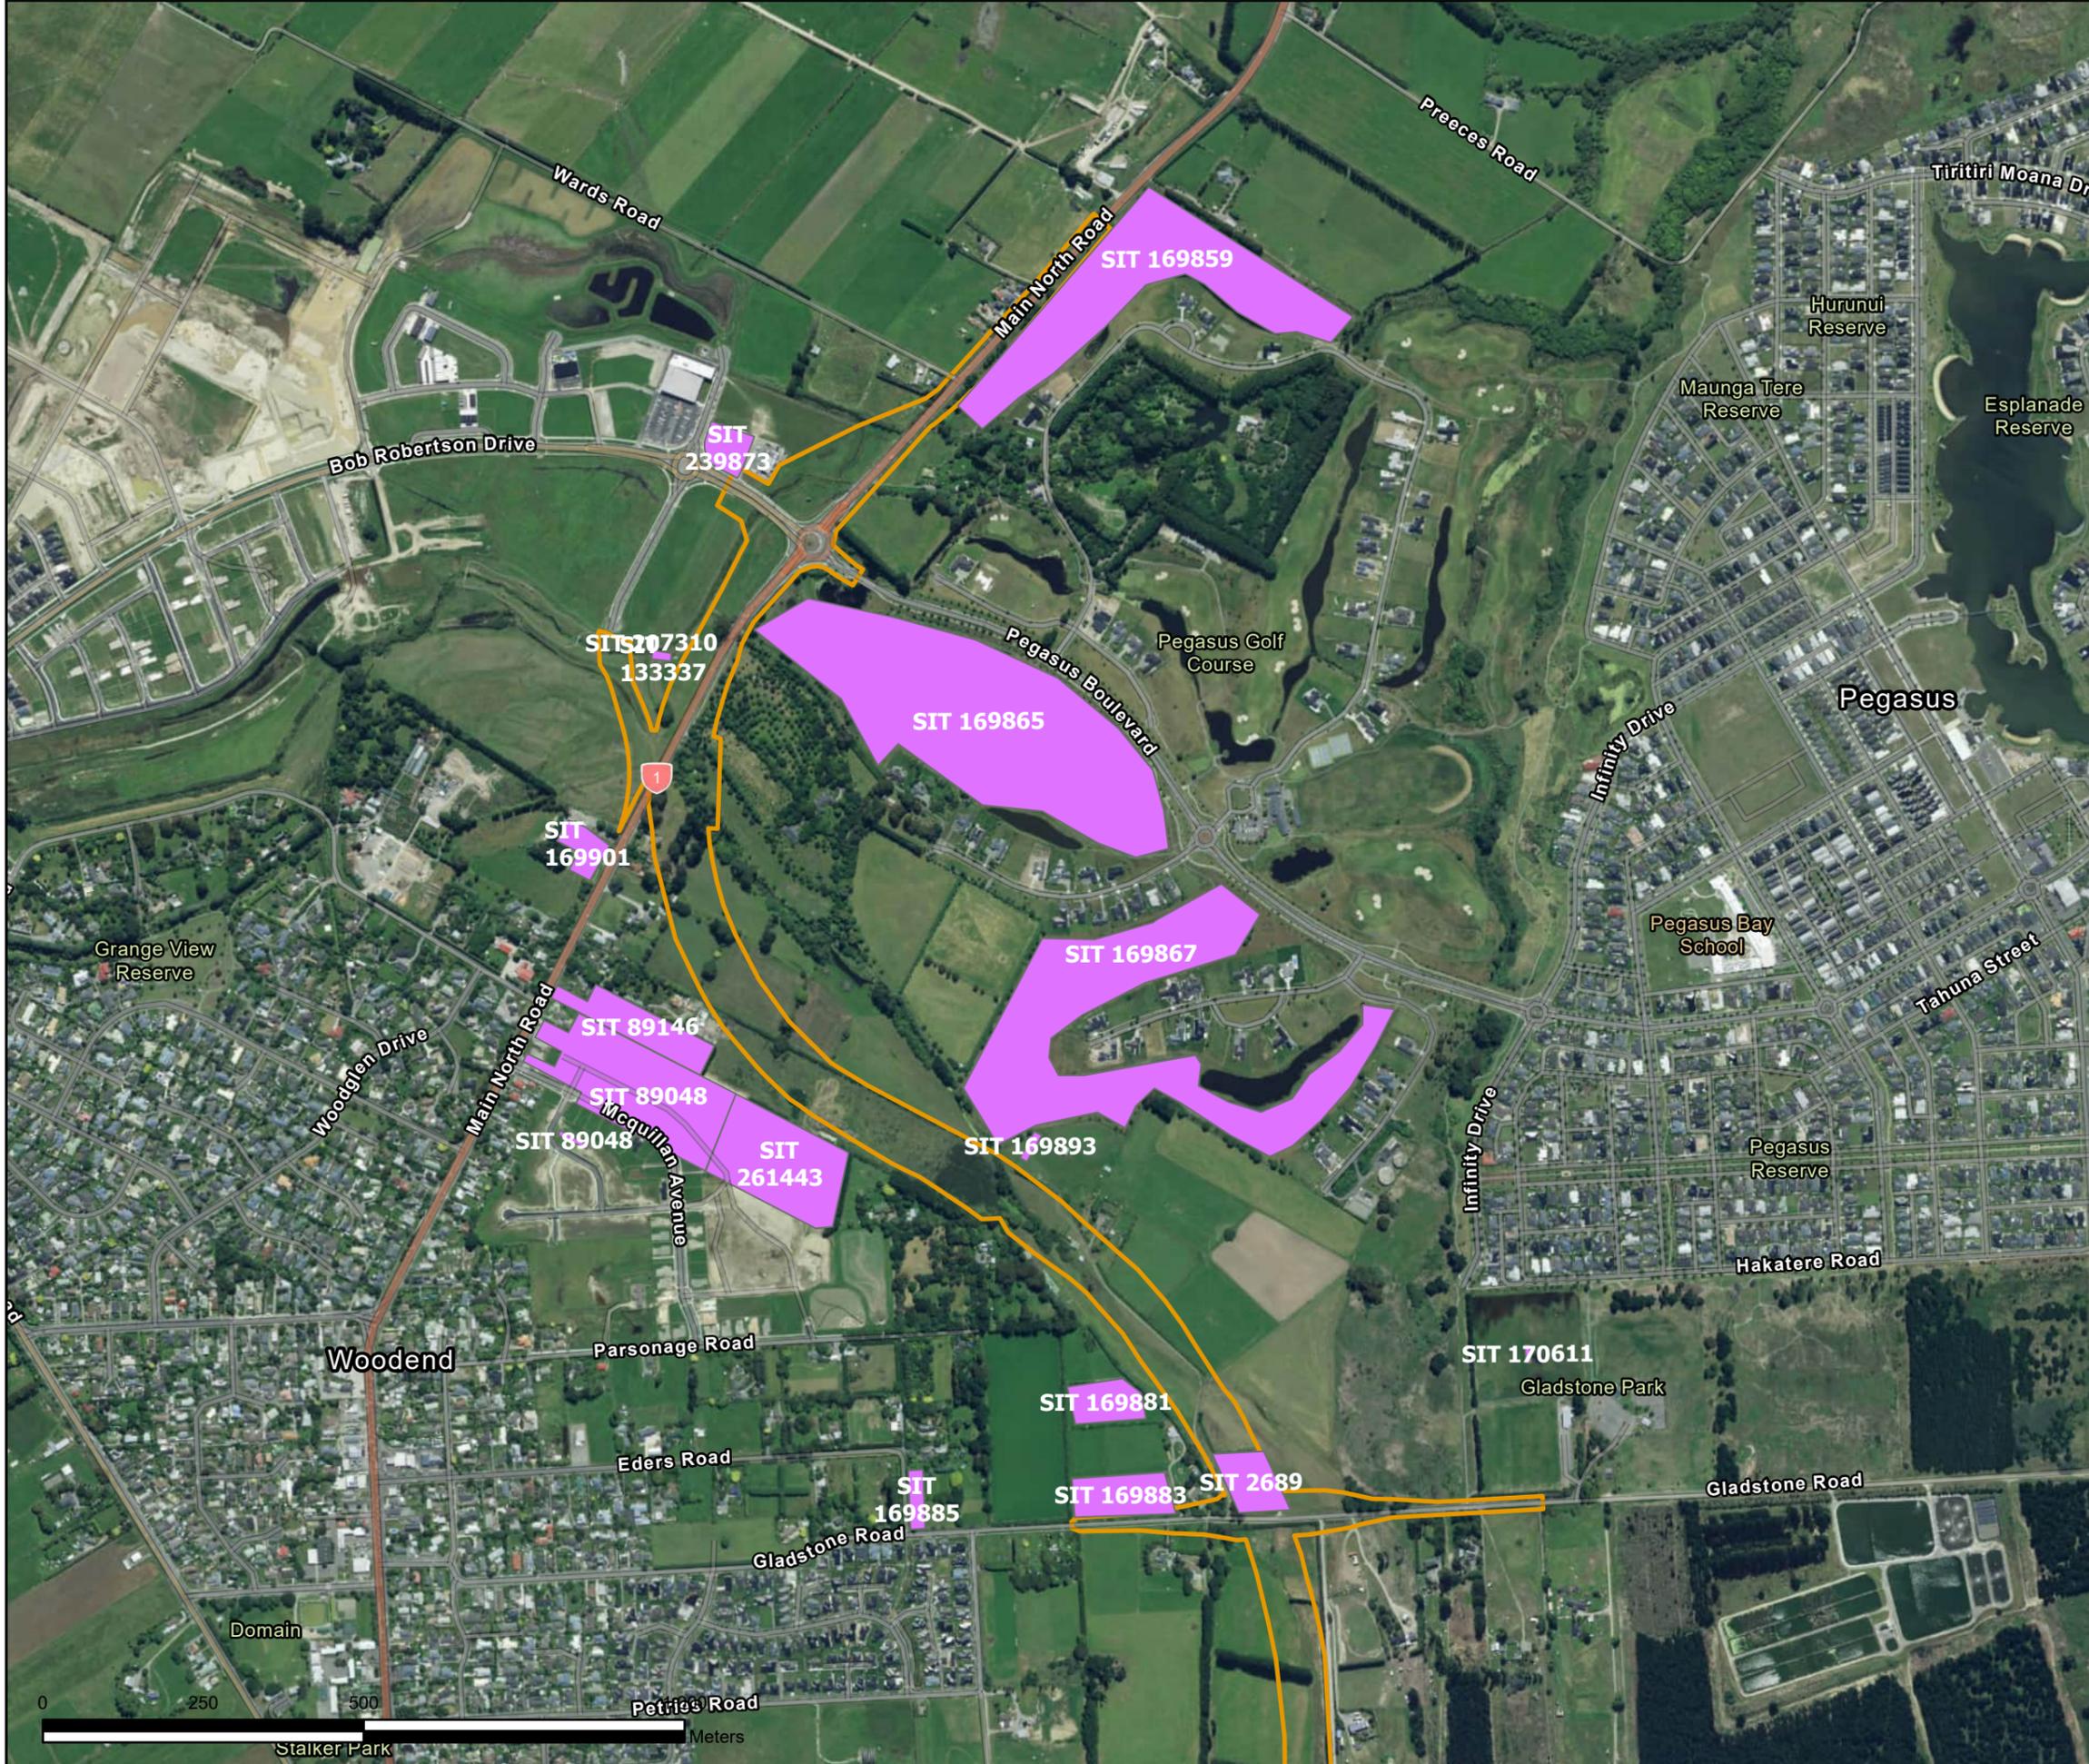
Hail Sites in Section 4 – Gladstone Road to Wards Road
