BOREHOLE LOG

PROJECT: Woodend Bypass and B2P Motorway
 JOB No.: 1095459.0000
 LOCATION: Quarry Ponds OVERWATER

CORE PHOTOS

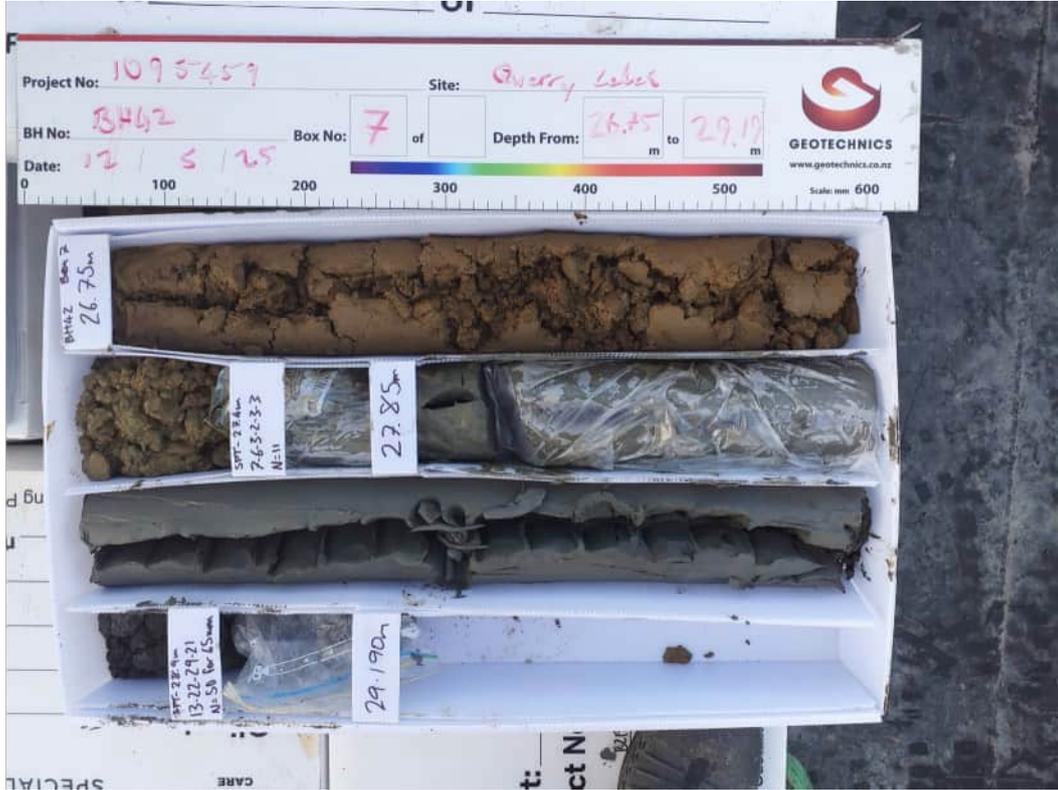
26.75-29.19m

25.55m: Fine to coarse SAND, some silt and some gravel; greenish grey. Moist. Gravel, fine to coarse.																					
	25.90m: Sandy fine to coarse GRAVEL, some silt; light brown. Very dense, wet. Gravel, rounded to sub-rounded; sand, fine to coarse.																	SPT 100	9/18// 28/22 for 25 mm N=50	-25	26.0	[Graphic log symbols]

27.40m: SILT, minor clay; greenish grey. Stiff, moist, medium plasticity.																	SNC 48	7/6// 32/33 N=11			
	27.90m: Fine to coarse SAND, some silt and some gravel; greenish grey. Very dense, moist. Gravel, fine to coarse.																	SPT 100	13/22// 29/21 for 65 mm N=50	-27	28.5	[Graphic log symbols]

28.90m: Fine to coarse SAND, some silt and some gravel; greenish grey. Very dense, moist. Gravel, fine to coarse.		SNC 100		-28	29.0	[Graphic log symbols]

29.19m: EOBH. Target depth

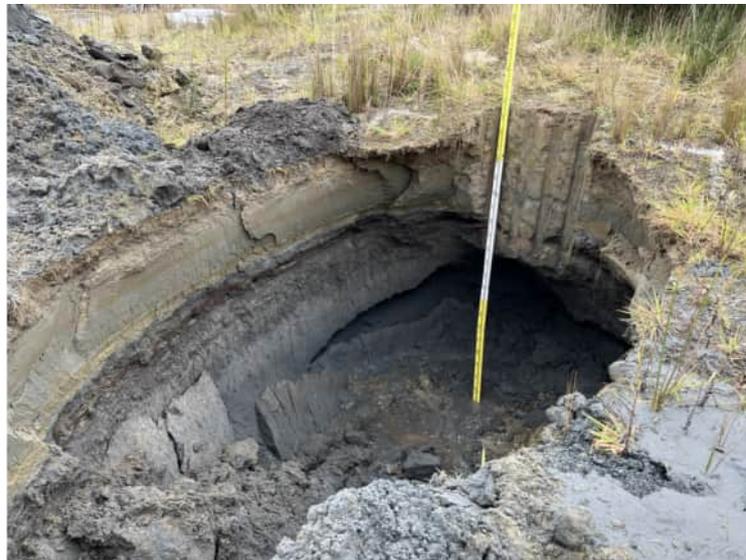
0.0 - 2.5m:

<p>0.00m: SAND, minor rootlets, trace gravel; brown. Loose, dry to moist. Gravel, fine to coarse, sub-rounded to sub-angular. (TOPSOIL).</p> <p>0.20m: Fine to medium SAND; light brown. Loose to medium dense, dry to moist.</p> <p>0.70m: Silty fine to coarse SAND, some organics; grey. Medium dense, moist, well graded. Organics, wood fragments.</p> <p>0.80m: Fine to coarse SAND, minor silt; grey. Medium dense, moist to wet, well graded.</p> <p>1.00m: Grades to dense</p> <p>1.80m: Grades to wet</p> <p>2.30m: Gravely fine to coarse SAND; dark grey. Dense, wet, well graded. Gravel, fine to coarse, sub-rounded to sub-angular.</p> <p>2.5m: END OF INVESTIGATION. Collapsing.</p>			<p>0.00m: L</p> <p>0.20m: L-M</p> <p>0.70m: M</p> <p>0.80m: M-W</p> <p>2.30m: W</p> <p>2.5m: D</p>		Christchurch Formation	Top

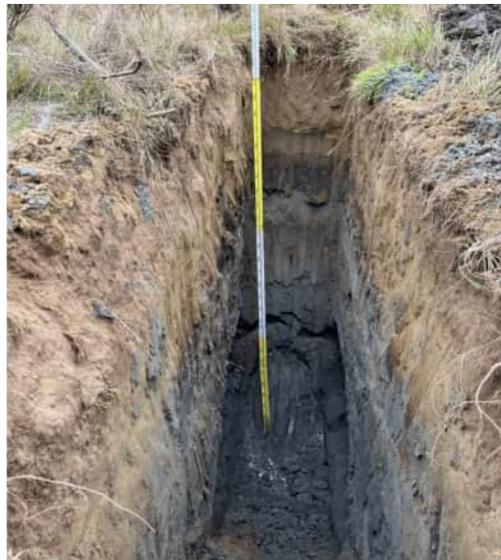
0.0 - 3.3m:

<p>0.00m: Fine to medium SAND, some rootlets, trace gravel and trace cobbles; light brown. Very loose to loose, dry. Gravel, fine to coarse. (TOPSOIL).</p> <p>0.20m: Fine to medium SAND, trace rootlets; light brown. Loose, dry to moist.</p> <p>0.80m: Silty fine SAND, some organics; dark grey. Loose, dry to moist. Organics, timber fragments. (BURIED TOPSOIL LAYER).</p> <p>0.90m: Fine to medium SAND, some silt; grey. Loose to medium dense, dry to moist. 1.30m: Grades to moist to wet. Dilatant</p> <p>1.80m: Grades to medium dense</p> <p>2.20m: Fine to coarse SAND; grey. Dense, wet, well graded.</p> <p>3.3m: END OF INVESTIGATION. Collapsing.</p>		D D-M L L-M D	VL-L L D	<p>0.00</p> <p>0.25</p> <p>0.50</p> <p>0.75</p> <p>1.00</p> <p>1.25</p> <p>1.50</p> <p>1.75</p> <p>2.00</p> <p>2.25</p> <p>2.50</p> <p>2.75</p> <p>3.00</p> <p>3.25</p> <p>3.50</p> <p>3.75</p> <p>4.00</p> <p>4.25</p> <p>4.50</p>		Top Christchurch Formation

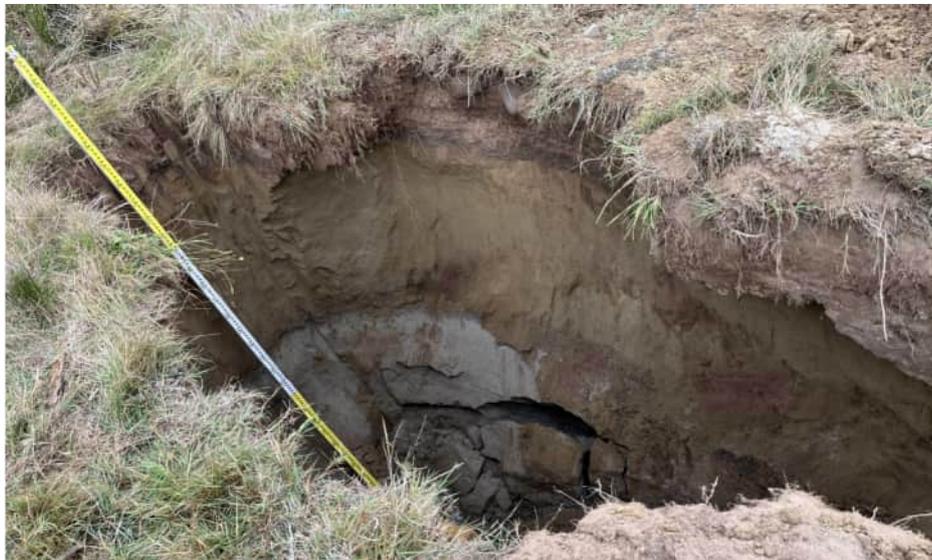
0.0 - 2.6m:

0.0		<p>2.6m: END OF INVESTIGATION. Collapsing.</p>

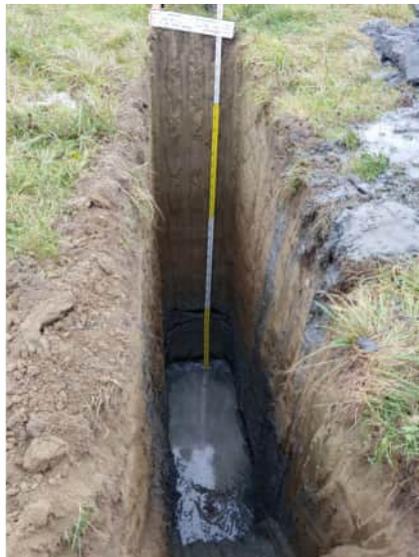
SKETCH / PHOTO:

0.0	2.5		2.50m: Silty fine to medium SAND; bluish grey. Medium dense, wet to saturated.	W-S	MD			2.6m: Shear vane most likely in SAND.	Christchurch Formation
						-1.0	3.0		2.50 - 3.70m: Silty sand grading to sand.					3.0m: GW seepage from sides and bottom of test pit	
						-2.0	4.5		3.7m: END OF INVESTIGATION. Collapsing.

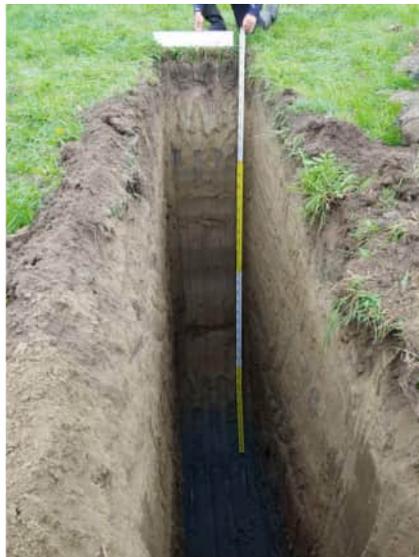
SKETCH / PHOTO:

● 70/43 kPa Insitu			3.0								
							3.5		3.50m: Silty fine to coarse SAND; bluish grey. Dense, moist. 3.50 - 4.00m: Silty fine to coarse sand grading to fine to coarse sand.			D

4.0		4m: END OF INVESTIGATION					4.0m: GW up welling from the bottom of test pit	
							4.5								
							-1

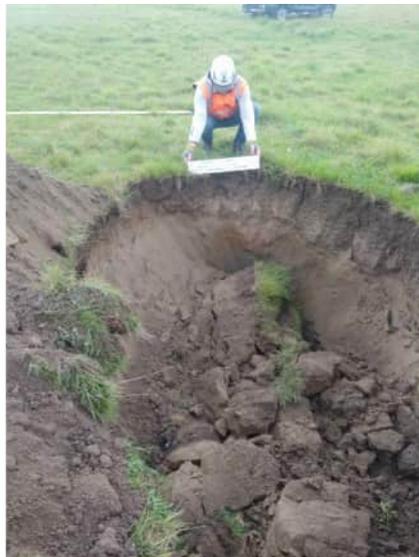
SKETCH / PHOTO:

EXCAVATION TESTS				ENGINEERING DESCRIPTION				GEOLOGICAL						
PENETRATION	SUPPORT	WATER	SCALA PENETROMETER (Blows/50mm)	SAMPLES	RL (m)	DEPTH (m)	GRAPHIC LOG	SOIL NAME, PLASTICITY OR PARTICLE SIZE CHARACTERISTICS, COLOUR, SECONDARY AND MINOR COMPONENTS	WEATHERING CLASSIFICATION	MOISTURE CLASSIFICATION	CONSISTENCY / DENSITY CLASSIFICATION	ESTIMATED SOIL SHEAR STRENGTH (kPa, 1kPa)	DEFECTS, STRUCTURE, COMMENTS	UNIT
1-3			0-9			0.00	TS	0.00m: TOPSOIL. Dry.	D					Top
						0.50		0.20m: Sandy SILT, trace rootlets; light brown with orange mottling. Dry to moist. Sand, fine to medium.	D-M					Christchurch Formation
						1.00		0.60m: Fine to medium SAND; light brown grading to grey. Medium dense, moist.	M	MD				
						2.00		2.00m: Fine to medium SAND; light grey with black mottling. Dense, wet.	W	D				
						3.00		3m: END OF INVESTIGATION. Collapsing.

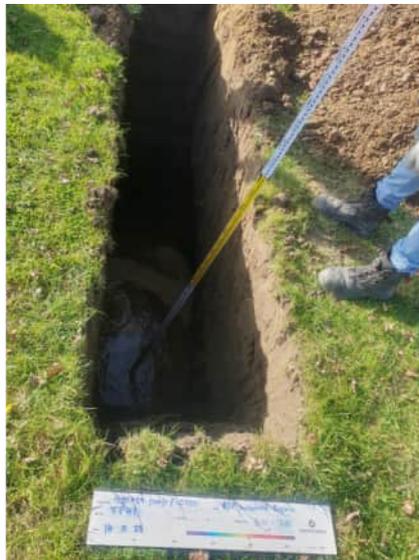
SKETCH / PHOTO:

<p>0.00m: Silty fine SAND, trace rootlets and trace gravel; dark brown. Very loose, moist, poorly graded. Gravel, fine, sub-rounded. (TOPSOIL).</p> <p>0.30m: Fine SAND, some silt, trace rootlets; greyish brown with orange mottle. Loose, moist.</p> <p>1.00m: Fine to coarse SAND, trace rootlets; light brown with orange mottle. Loose, moist, well graded.</p> <p>1.40m: Medium to coarse GRAVEL, some sand; greyish brown. Medium dense, moist, well graded. Gravel, sub-rounded to sub-angular; sand, fine to coarse.</p> <p>1.45m: Sandy fine to coarse GRAVEL; greyish brown. Dense, moist, well graded. Gravel, sub-rounded to sub-angular; sand, fine to coarse.</p> <p>1.50m: Very dense. 2.00m: Wet. 2.10m: Saturated.</p>	M	VL	L	VD	W S				TS	Springston Formation

3.0		3m: END OF INVESTIGATION. Collapsing.

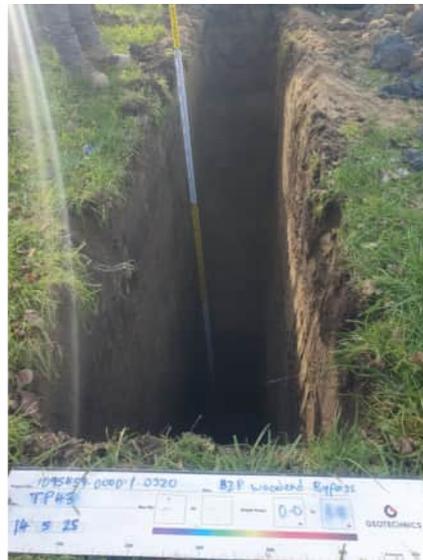
SKETCH / PHOTO:

2.80m: SILT, trace organics; greyish brown with orange mottle. Firm to stiff, moist, low plasticity. Organics, sticks, grasses and rootlets. 3.00m: Bluish grey with orange mottle. 3.10m: Bluish grey.		F-St			Springston Formation

3.80m: Sandy SILT; bluish grey. Firm, wet, non-plastic. Sand, fine to medium.	W	F				
						4.5		4m: END OF TEST PIT. Target depth reached.

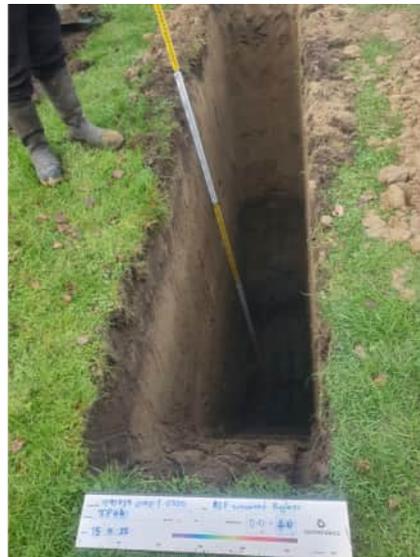
SKETCH / PHOTO:

0.30m		0.30m: Fine to medium SAND, some silt, trace rootlets; light brown. Loose, moist, well graded.		L					
				39/14 kPa Insitu			1.20m		1.20m: Fine to medium SAND, trace silt; light brown. Loose, moist, well graded.						Springston Formation	
				22/4 kPa Insitu			1.50m		1.50m: SILT, trace sand; greyish brown. Soft to firm, wet, non-plastic.	W	S-F					
				27/7 kPa Insitu			2.80m		2.80m: SILT, trace organics; bluish grey. Soft to firm, wet, low plasticity. Organics, Rootlets + white flecks (not shell).							
				22/7 kPa Insitu			4.0m		4m: END OF TEST PIT. Target depth reached.							
				18/9 kPa Insitu												
				32/14 kPa Insitu

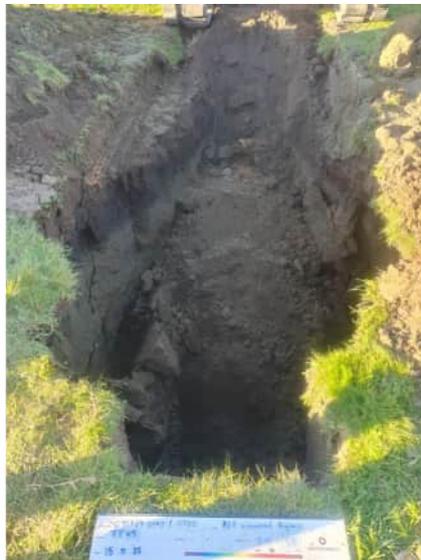
SKETCH / PHOTO:

3.50m: Sandy SILT; brown. Saturated, non-plastic, collapsed before shear vane. Sand, fine.		S	95-105			Springston Formation
						2.0	3.60		3.6m: END OF INVESTIGATION. Collapsing.						Springston Formation

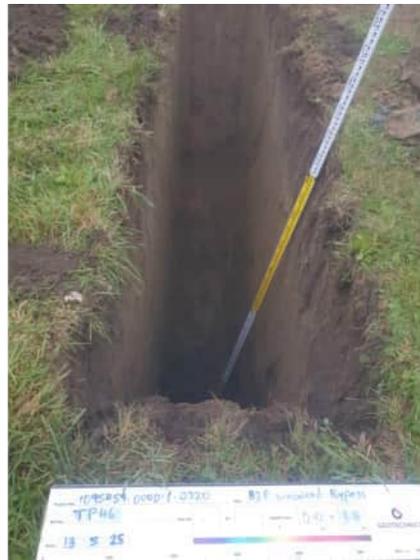
SKETCH / PHOTO:

● 20/13 kPa Insitu		3.0		3.00m: Sandy SILT; bluish grey. Soft, wet to saturated, non-plastic, orange mottling to 3.1 m. Sand, fine.	W-S	S		3.0-4.0	Springston Formation	
				● 14/7 kPa Insitu		4.0		4.00m: Very soft.				4.0-4.5		
				● 11/0 kPa Insitu		4.5		4m: END OF TEST PIT. Target depth reached.				4.5-5.0	4.0m: Water starting to ooze into base.

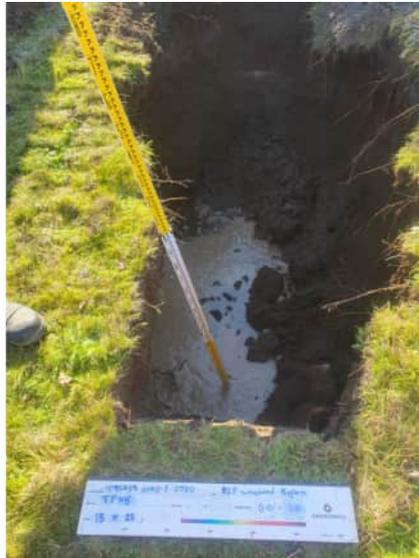
SKETCH / PHOTO:

1.0	0.50m: Fine to medium SAND, trace rootlets; light brown. Dense, moist, well graded.							
						1.5	0.60m: Sandy fine to coarse GRAVEL, trace organics; greyish brown. Dense, moist, well graded. Gravel, sub-rounded to sub-angular; sand, fine to coarse; organics, roots and rootlets.

2.0	1.50m: Wet. 1.60m: Wood fragments and roots. Saturated, water pooling.							
						2.5	2.5m: END OF INVESTIGATION. Collapsing.

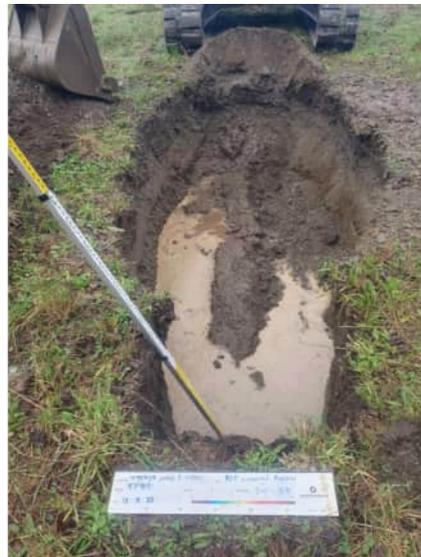
SKETCH / PHOTO:

0	2.0	0.60m: Very dense.						
							1	2.5	0.70m: Sandy fine to coarse GRAVEL; greyish brown. Very dense, wet, well graded, orange staining to 0.8 m. Gravel, sub-rounded to sub-angular; sand, fine to coarse.						
							0	3.0	1.00m: Saturated, water pooling.						
							-1	4.5	1.5m: END OF INVESTIGATION. Collapsing.

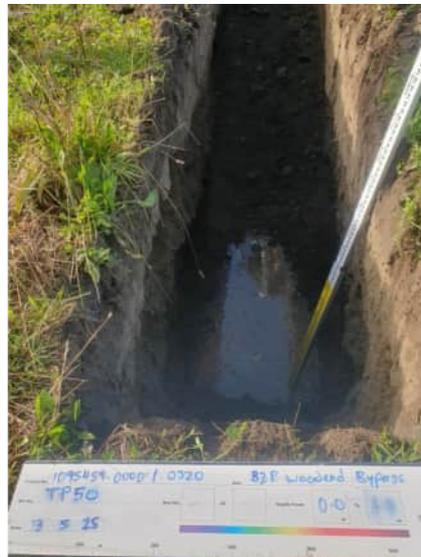
SKETCH / PHOTO:

<p>0.00m: SILT, minor sand, trace rootlets and trace gravel; dark brown. Firm, moist, non-plastic. Sand, fine to coarse; gravel, fine to medium, sub-rounded to sub-angular. (TOPSOIL).</p> <p>0.25m: Fine to medium SAND, minor silt, trace rootlets; brownish grey with orange mottle. Loose, moist, well graded.</p> <p>0.45m: Sandy fine to coarse GRAVEL, trace rootlets; brownish grey. Medium dense, moist, well graded. Gravel, sub-rounded to sub-angular; sand, fine to coarse; rootlets, to 1 m.</p> <p>0.80m: Dense. 0.90m: Very dense. 1.20m: Wet. 1.50m: Saturated, water pooling.</p> <p>1.70m: Silty fine to medium SAND; greyish brown. Saturated, well graded.</p> <p>1.75m: SILT, trace sand; brown. Saturated, non-plastic. Sand, fine.</p> <p>2.3m: END OF INVESTIGATION. Collapsing.</p>	M	F	0.00-0.25: 100-150 0.25-0.45: 100-150 0.45-0.80: 100-150 0.80-0.90: 100-150 0.90-1.20: 100-150 1.20-1.50: 100-150 1.50-1.70: 100-150 1.70-1.75: 100-150 1.75-2.30: 100-150	<p>1.2 - 1.4m: Gravels have a slimy dark brown coating.</p> <p>1.75m: Unsure of total silt layer as it was underwater and the hole kept collapsing.</p>	Top Springston Formation

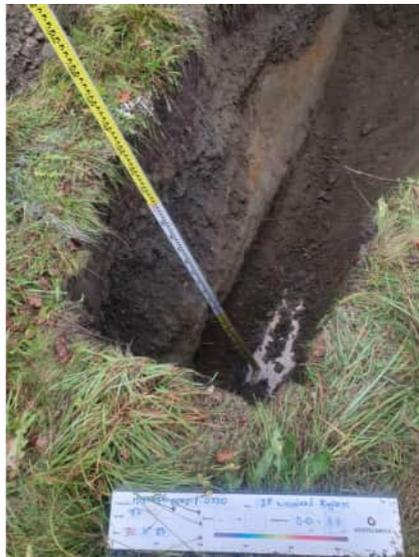
SKETCH / PHOTO:

<p>0.00m: Sandy SILT, trace rootlets and trace gravel; dark brown. Soft, moist, non-plastic. Sand, fine to coarse; gravel, fine to coarse, sub-rounded to sub-angular. (TOPSOIL)</p> <p>0.40m: Sandy fine to coarse GRAVEL, trace rootlets; brownish grey. Dense, moist, well graded, bands of orange staining at base. Gravel, sub-rounded to sub-angular; sand, fine to coarse.</p> <p>0.50m: Very dense.</p> <p>1.20m: Fine to coarse SAND, trace gravel; light brown. Very dense, moist to wet, well graded. Gravel, fine to coarse, sub-rounded to sub-angular.</p> <p>2.10m: Sandy fine to coarse GRAVEL, trace cobbles; grey with reddish mottling. Very dense, saturated, well graded. Gravel, sub-rounded to sub-angular; sand, fine to coarse; cobbles, sub-rounded to sub-angular.</p> <p>2.3m: END OF INVESTIGATION. Collapsing.</p>	M	S	12-24

2.1						2.1m: Water pooling	TSoil	
							0.0							Springston Formation

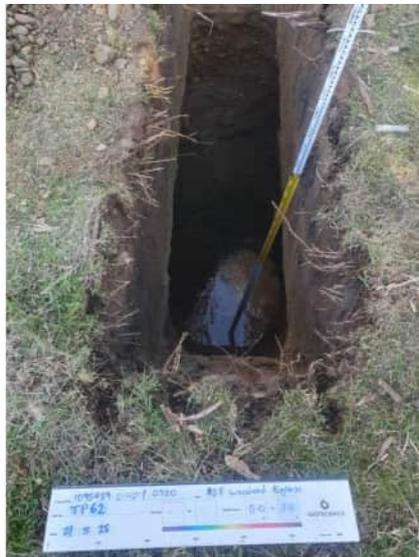
SKETCH / PHOTO:

2.80 - 3.20m		2.80 - 3.20m: Moist.			M			
						3.20 - 3.40m		3.20 - 3.40m: Wet.			W			
						3.40m		3.40m: Saturated.			D			
						3.7m		3.7m: END OF INVESTIGATION. Collapsing.

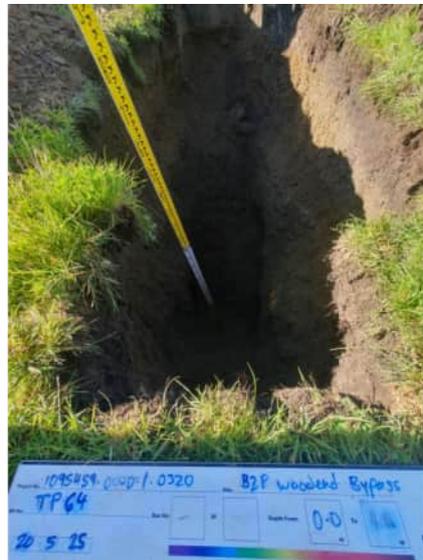
SKETCH / PHOTO:

30-39				1.10		1.10m: Fine to medium GRAVEL, some sand, trace rootlets; brownish orange. Dense, moist, well graded. Gravel, sub-rounded; sand, fine to coarse.						
			40-49				1.20		1.20m: Sandy fine grading to coarse GRAVEL; greyish brown. Very dense, moist, well graded. Gravel, sub-rounded to sub-angular; sand, fine grading to medium to coarse.						
			50-59				2.00		2.00 - 2.10m: Brownish orange band.						
			60-69				2.10		2.10m: Sandy fine to coarse GRAVEL, minor cobbles; greyish brown. Moist, well graded. Gravel, sub-rounded to sub-angular; sand, coarse; cobbles, up to 100mm, sub-rounded to sub-angular.						
			70-79				2.80		2.80 - 3.00m: Wet.						
			80-89				3.00		3.00 - 3.40m: Saturated.						
			90-99				3.40		3.4m: END OF INVESTIGATION. Collapsing.

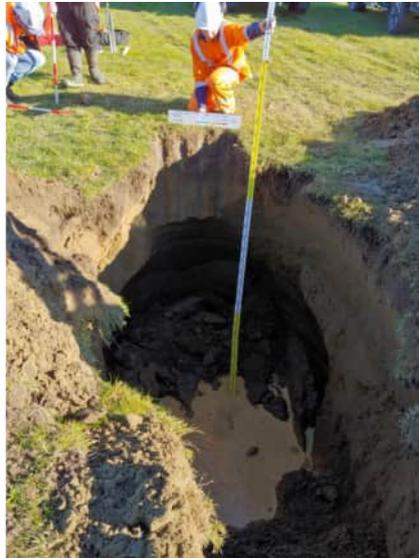
SKETCH / PHOTO:

0.5		0.20m: Silty fine to coarse SAND, trace organics; light brown. Moist. Organics, roots greater than 2mm diameter. (REWORKED ALLUVIUM/FILL).					0.5m: Fence wire (no.8) and barbed wire encountered	Fill
					9	1.00m		1.00m: Fine to coarse SAND, trace rootlets and trace silt; light brown with orange mottling. Loose, moist grading to wet. Rootlets, and roots.		L			1.0m: Plastic plant pots (black PE) and soft plastic wrap (white/clear)	Springston Formation
					8	2.00m		2.00m: Sandy fine to coarse GRAVEL, minor cobbles, trace wood; reddish brown. Medium dense, saturated. Gravel, rounded to sub-rounded, greywacke; sand, fine to coarse; cobbles, rounded to sub-rounded, greywacke; organics, wood fragments. 2.30 - 2.80m: Dense. 2.80 - 3.00m: Medium dense.	S	MD		2.0m: Ground water ingress flowing from west to east		
					7	3.0m		3m: END OF INVESTIGATION. Collapsing.					3.0m: Test pit collapse

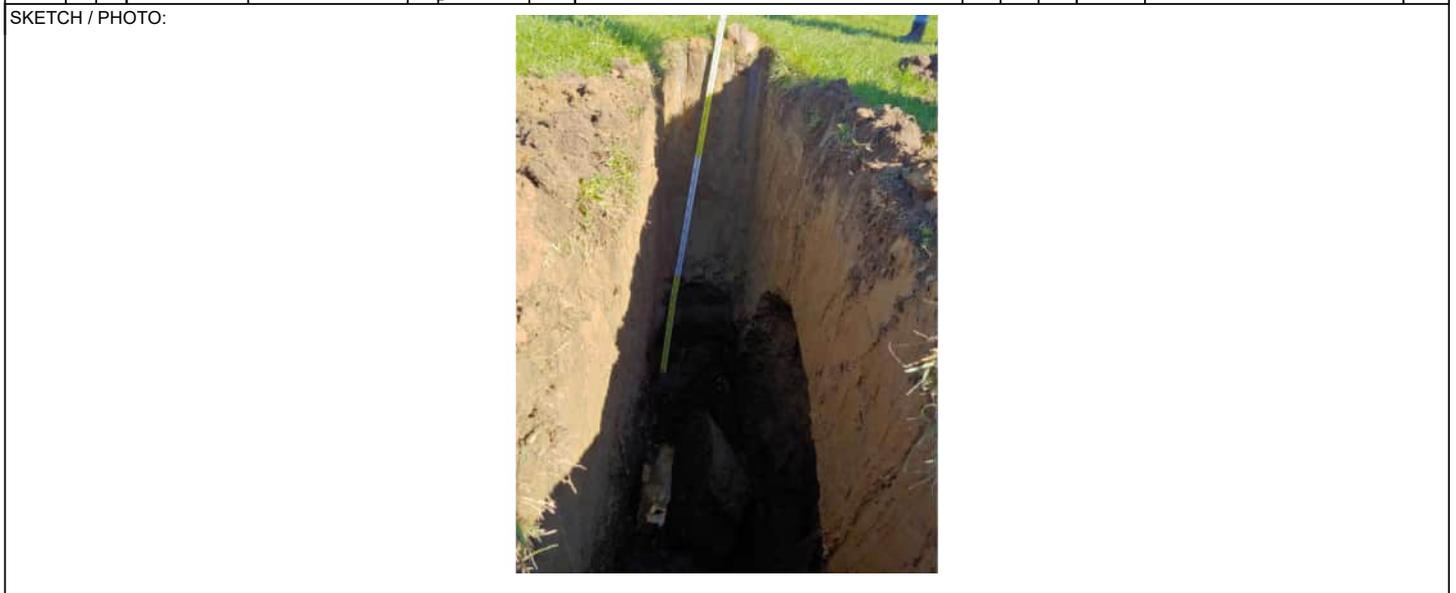
1.30		1.30m: Sandy SILT, trace gravel; brownish grey with orange mottling. Moist grading to wet. Sand, fine to medium; gravel, fine.						
						2.60		2.60m: Coarse SAND, trace organics; reddish brown. Saturated. Organics, Tanic residue throughout the sand layer.	S

2.70		2.70m: SILT, minor sand, trace clay; grey with brown/orange mottling. Wet, low plasticity. Sand, fine.	W					Springston Formation
						4.00		4m: END OF INVESTIGATION

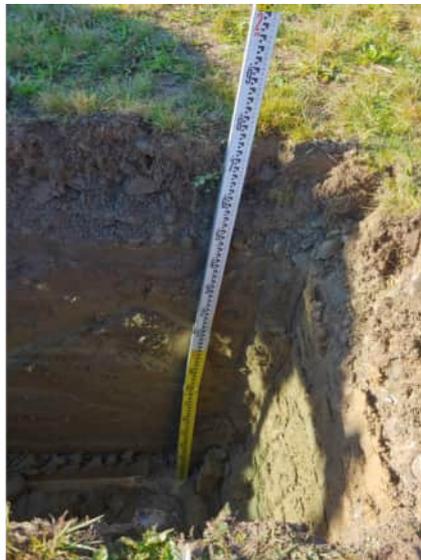
SKETCH / PHOTO:

6.0		3m: END OF INVESTIGATION. Collapsing.				3.0m: Test pit collapsing approximately 3.0m

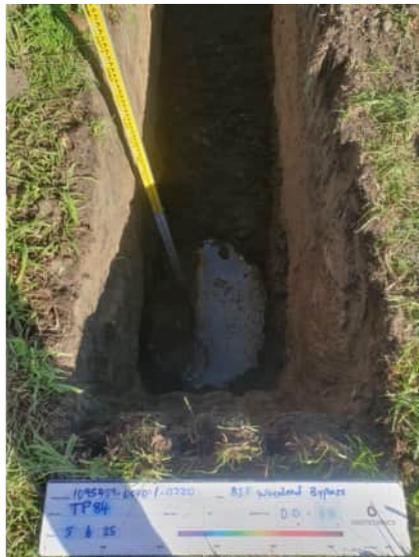
SKETCH / PHOTO:

5	1.50m: Sandy fine to coarse GRAVEL; brownish grey. Very dense, moist, well graded. Gravel, sub-rounded to sub-angular; sand, fine to coarse.		W					
							5	1.90m: Silty sandy fine to coarse GRAVEL, trace cobbles; reddish brown. Very dense, wet, well graded. Gravel, sub-rounded to sub-angular; sand, fine to coarse; cobbles, up to 80mm, sub-rounded to sub-angular.		S					
							4	2.10m: Sandy fine to coarse GRAVEL, trace silt and trace cobbles; brownish grey. Very dense, wet, well graded. Gravel, sub-rounded to sub-angular; sand, fine to coarse; cobbles, up to 110mm, sub-rounded to sub-angular.							
							4	2.50m: Saturated.							
							3	3.8m: END OF INVESTIGATION. Collapsing.

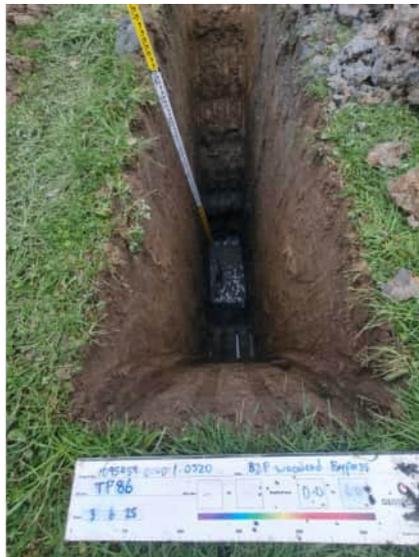
SKETCH / PHOTO:

4.50		3.80m: Silty fine SAND; bluish grey. Dense, saturated, poorly graded.			D			
							4.50		4m: END OF TEST PIT. Target depth reached.
