The Point Mission Bay

Comments

Adverse effects on [REDACTED] Rukutai Street

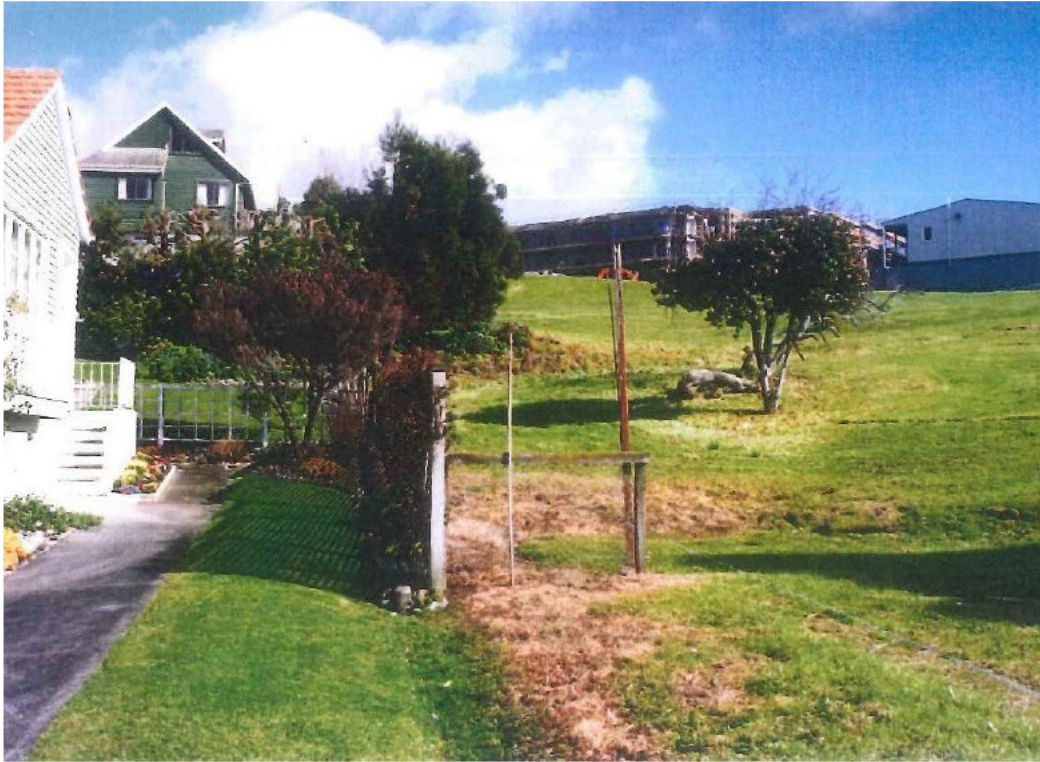
The photograph below, taken prior to the first development, shows the boundary where originally the land was level between the properties of ██████████ Rukutai Street and where the land either remained flat for some distance or sloped gently to the north.

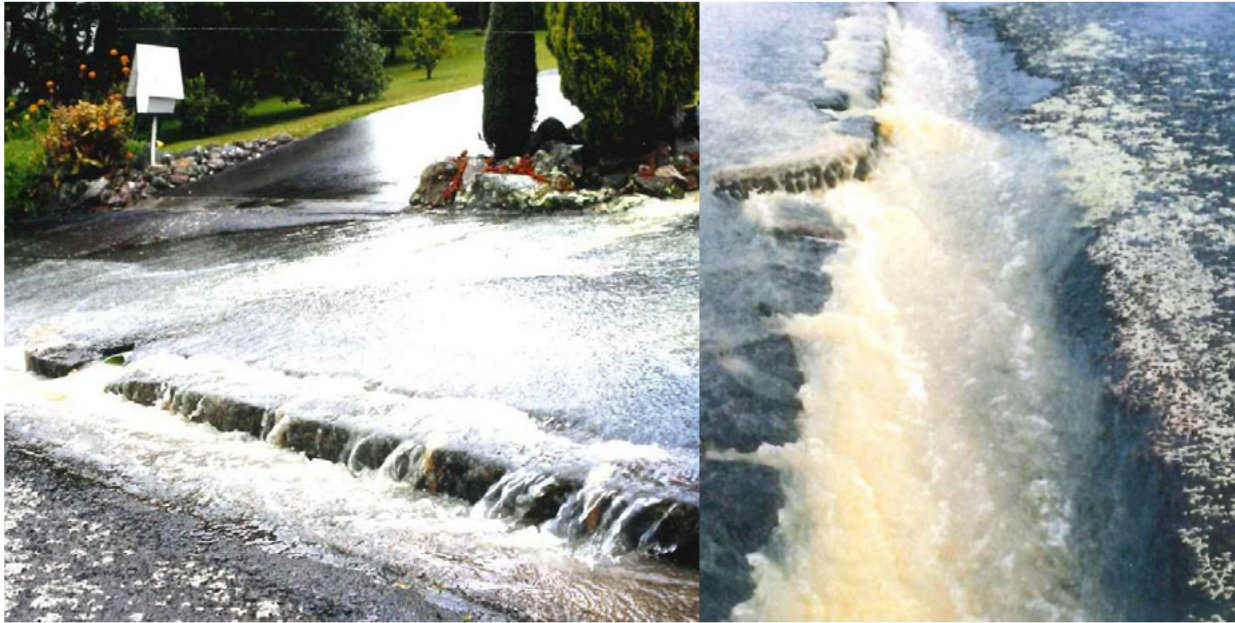
2. Water over footpath to kerbside from [REDACTED]

3. Water from [REDACTED] and gully and drain on [REDACTED]

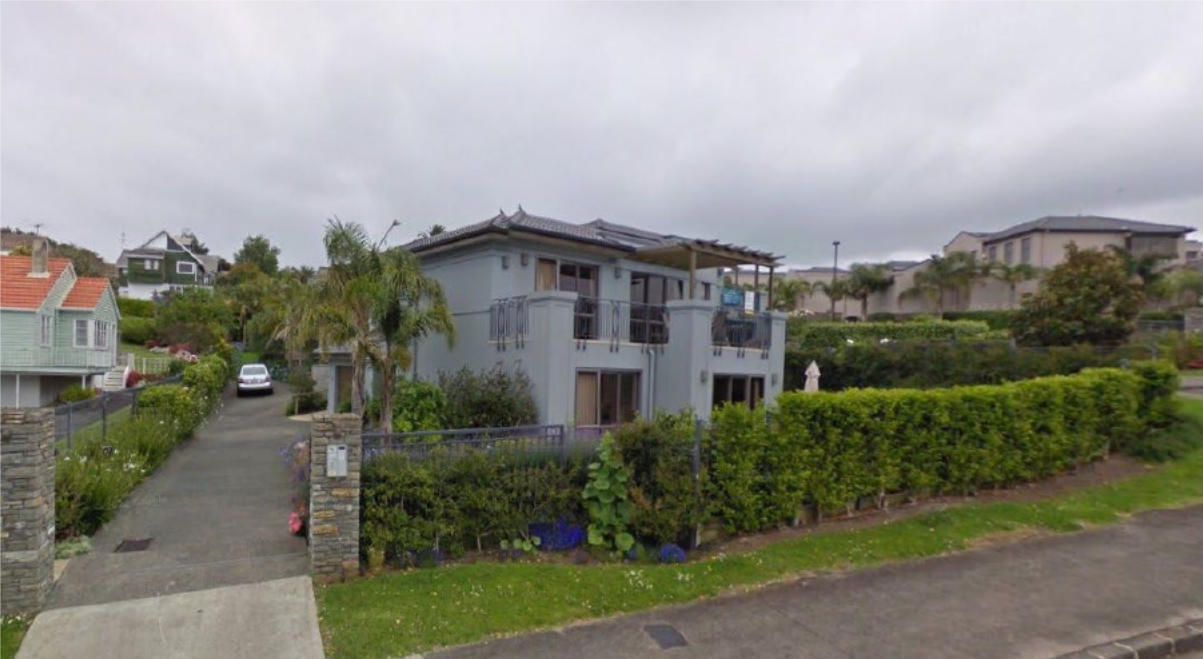
Planners for the previous development recognized water issues on the development land. The measures taken i.e. adequate drainage, not raising land and building Apartment 1 on level ground, managed runoff onto [REDACTED]

5. Apartment 1 built on ground level at [redacted] Rukutai Street (Google Earth 2009)

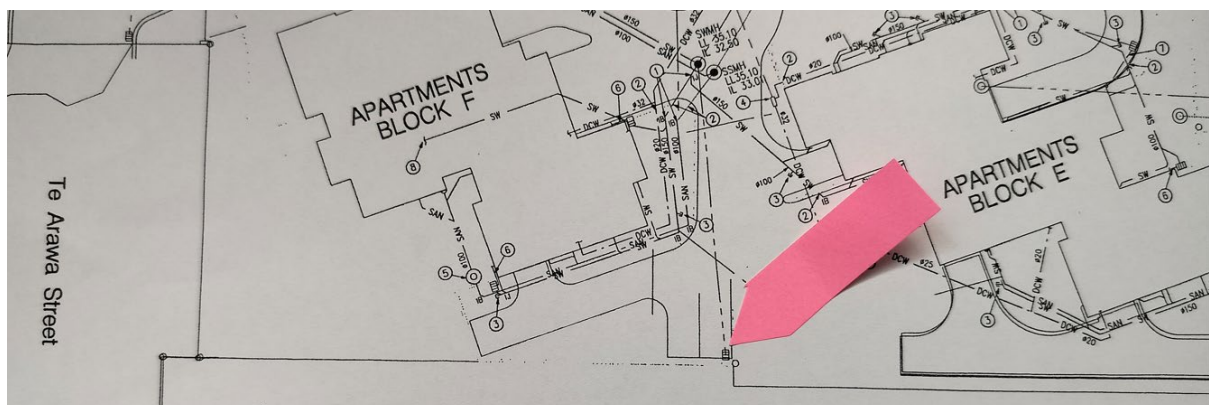
However, during July to September 2025 the drain (Figure 6) on the development property just north of the western boundary of 106 Rukutai St was in fact demolished and changed into what appears to be a soak hole. This resulted in seepage onto the property of [REDACTED]. This seepage did not occur previously. This has now made lawn maintenance difficult and created a wet area on the north-west corner of [REDACTED] close to where the drain was dismantled.

6. Location of drain on the site which previously directed water north to the site drainage system

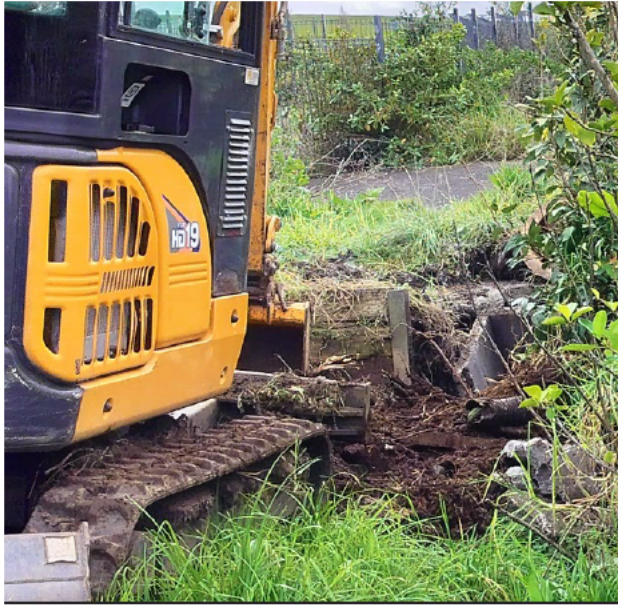
7. Drain being dismantled and removed

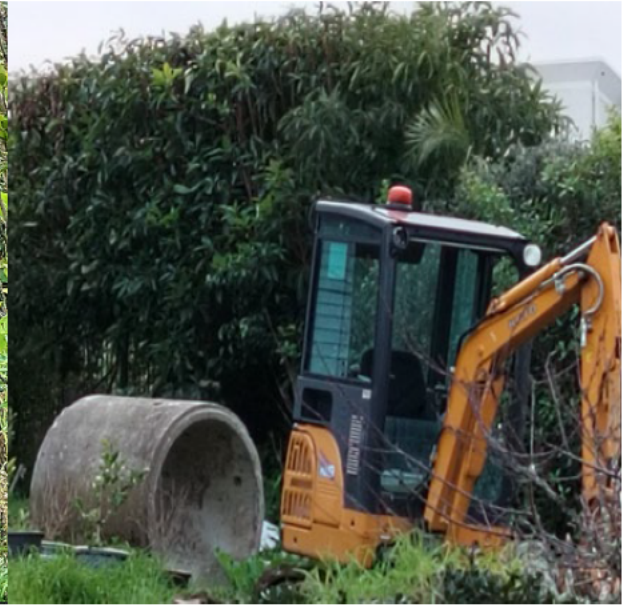
8. Pipe which replaced the drain

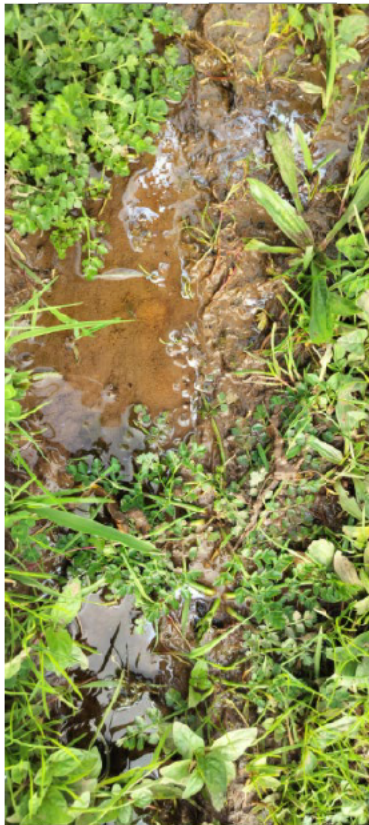
Photos below show significant water influx into the lawns on [REDACTED] after the drainage was changed.

9. Water with unknown substance running down northern side of [REDACTED]

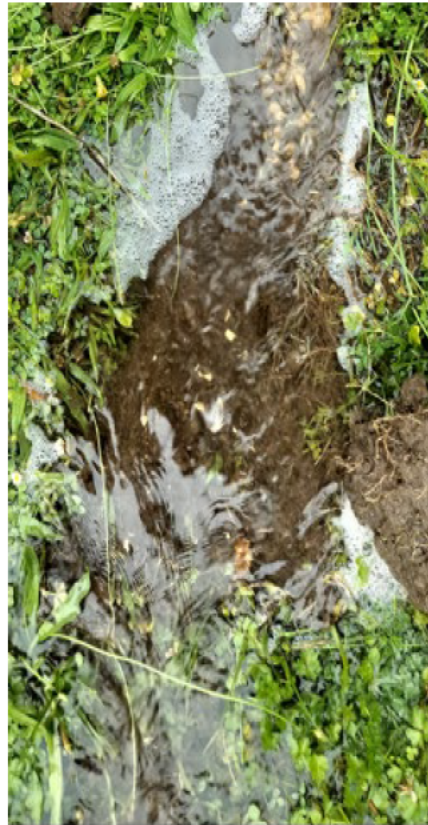
10. More water running down the northern side of [REDACTED]

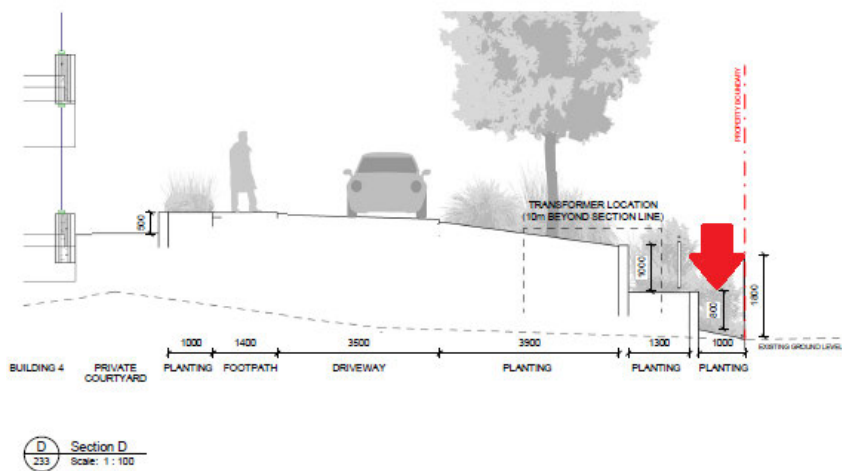
In particular we object to the metre wide sloped portion of land next to the boundary (shown in Attachment 019B, Page 52) beginning at Te Arawa Street and continuing down the full length of [REDACTED]. This can only send water into the adjacent property. This strip would also be difficult to maintain, being narrow and hard to access for any weed control. This strip of land should not be sloped nor raised, but lowered to take the water from the site to the street and there should be drainage beneath ground to capture underground water.

11. Cross section of raised land next to [REDACTED] Rukutai St

A significant portion of land next to the road is being raised. Changing the land level this far out from the road creates a slope that forces water and accompanying contaminants towards an adjacent property, which is already drained for the current land form for underground and overland water. We do not want to be flooded again during ground excavation, construction or landscaping, nor in the future.

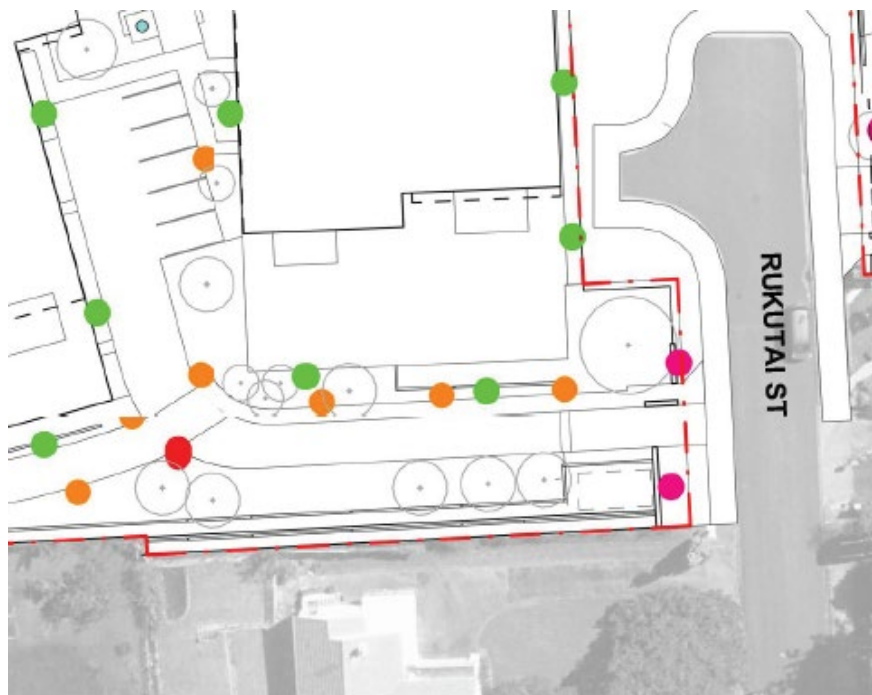
The proposed bollard and façade lighting around the southern side of Building 4 next to the two-way road would light up the full length of the property of [REDACTED]. The pole lights on the intersection between the walkway and road could result in significant light spill and light invasion. Metal Halide (MH) lights are described as suitable for industrial and retail zones, stadiums, street lighting and parking lots.

12. Aerial view of light strategy from Attachment 19C showing the proposed location of artificial light

Pole lights should be shielded and directed downwards to prevent glare/spill onto neighbouring properties, and façade lights installed with shielded or recessed fixtures.

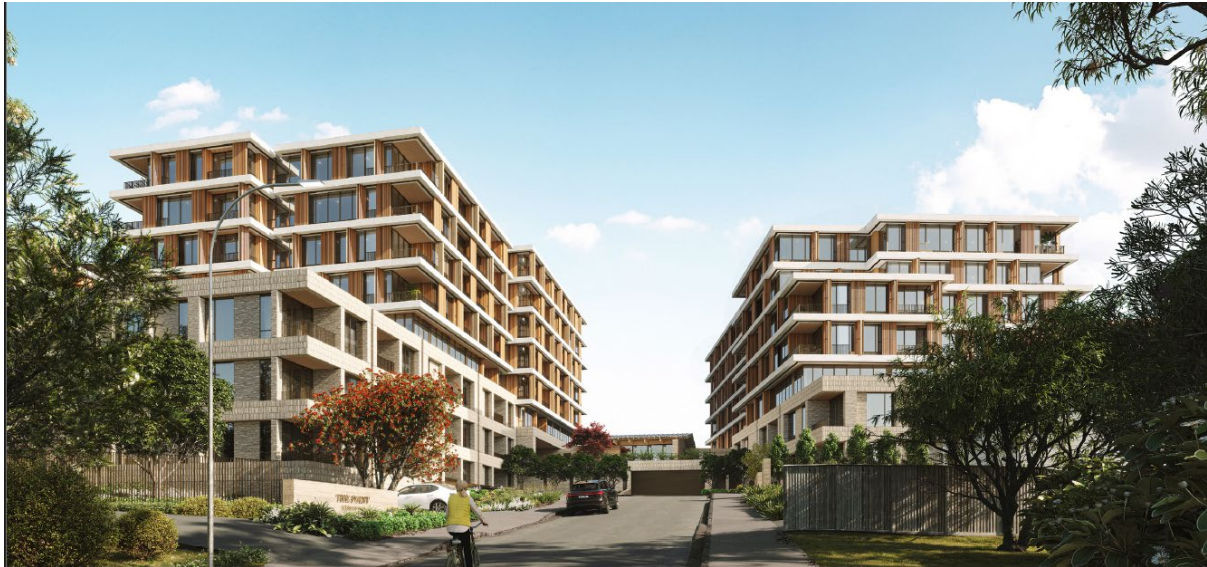
The imposing impression of the proposed development will be particularly obvious while facing up towards the cul-de-sac end of Rukutia Street.

14. View of the proposed development from a favourable perspective at end of Rukutai St.
