# **GREENHILL INDUSTRIAL PARK**

## **PRELIMINARY SITE INVESTIGATION**

PROJECT NO: HD3783  
GREENHILL INDUSTRIAL PARK  
CONSORTIUM  
REFERENCE: DSI  
22 OCTOBER 2025

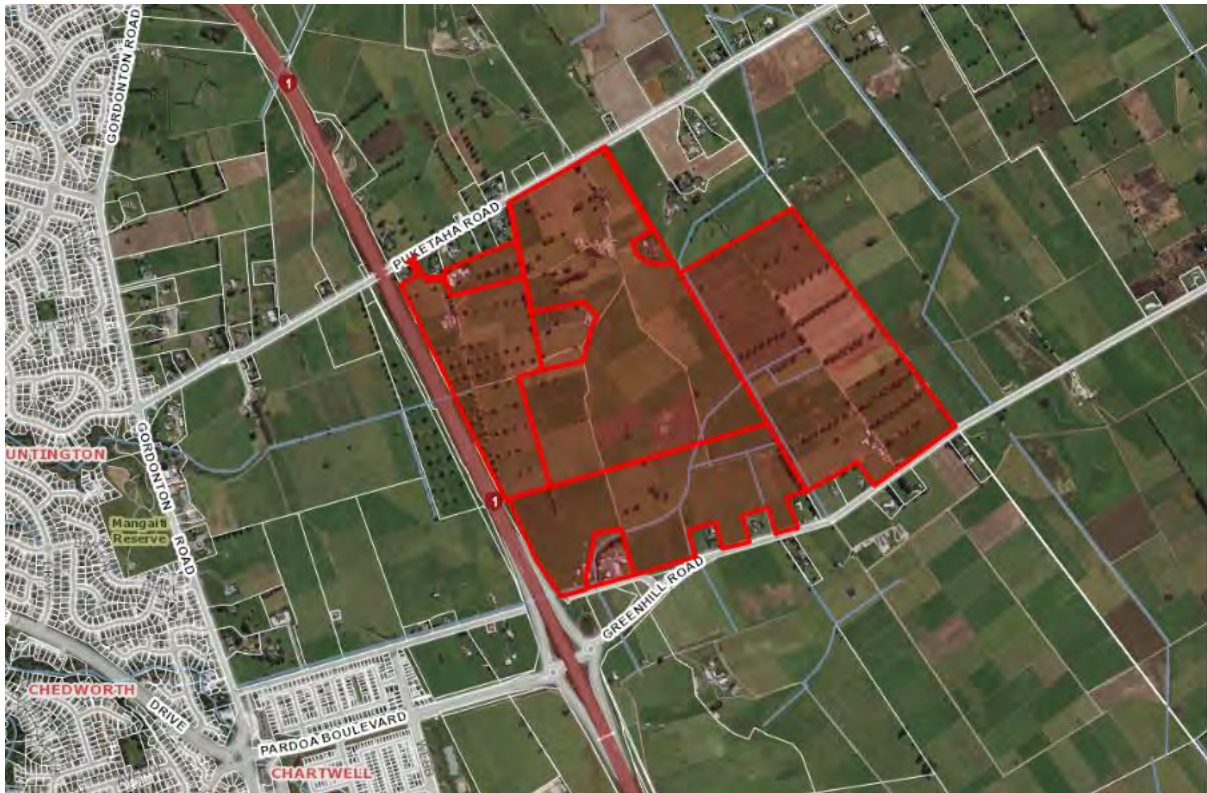
Figure 1: Site location

The site is accessed from Puketaha Road to the north and Greenhill Road to the south. The Waikato District and Hamilton City jurisdiction boundary is defined by Gordonton Road, which is located approximately 1 kilometre to the west of the Waikato Expressway.

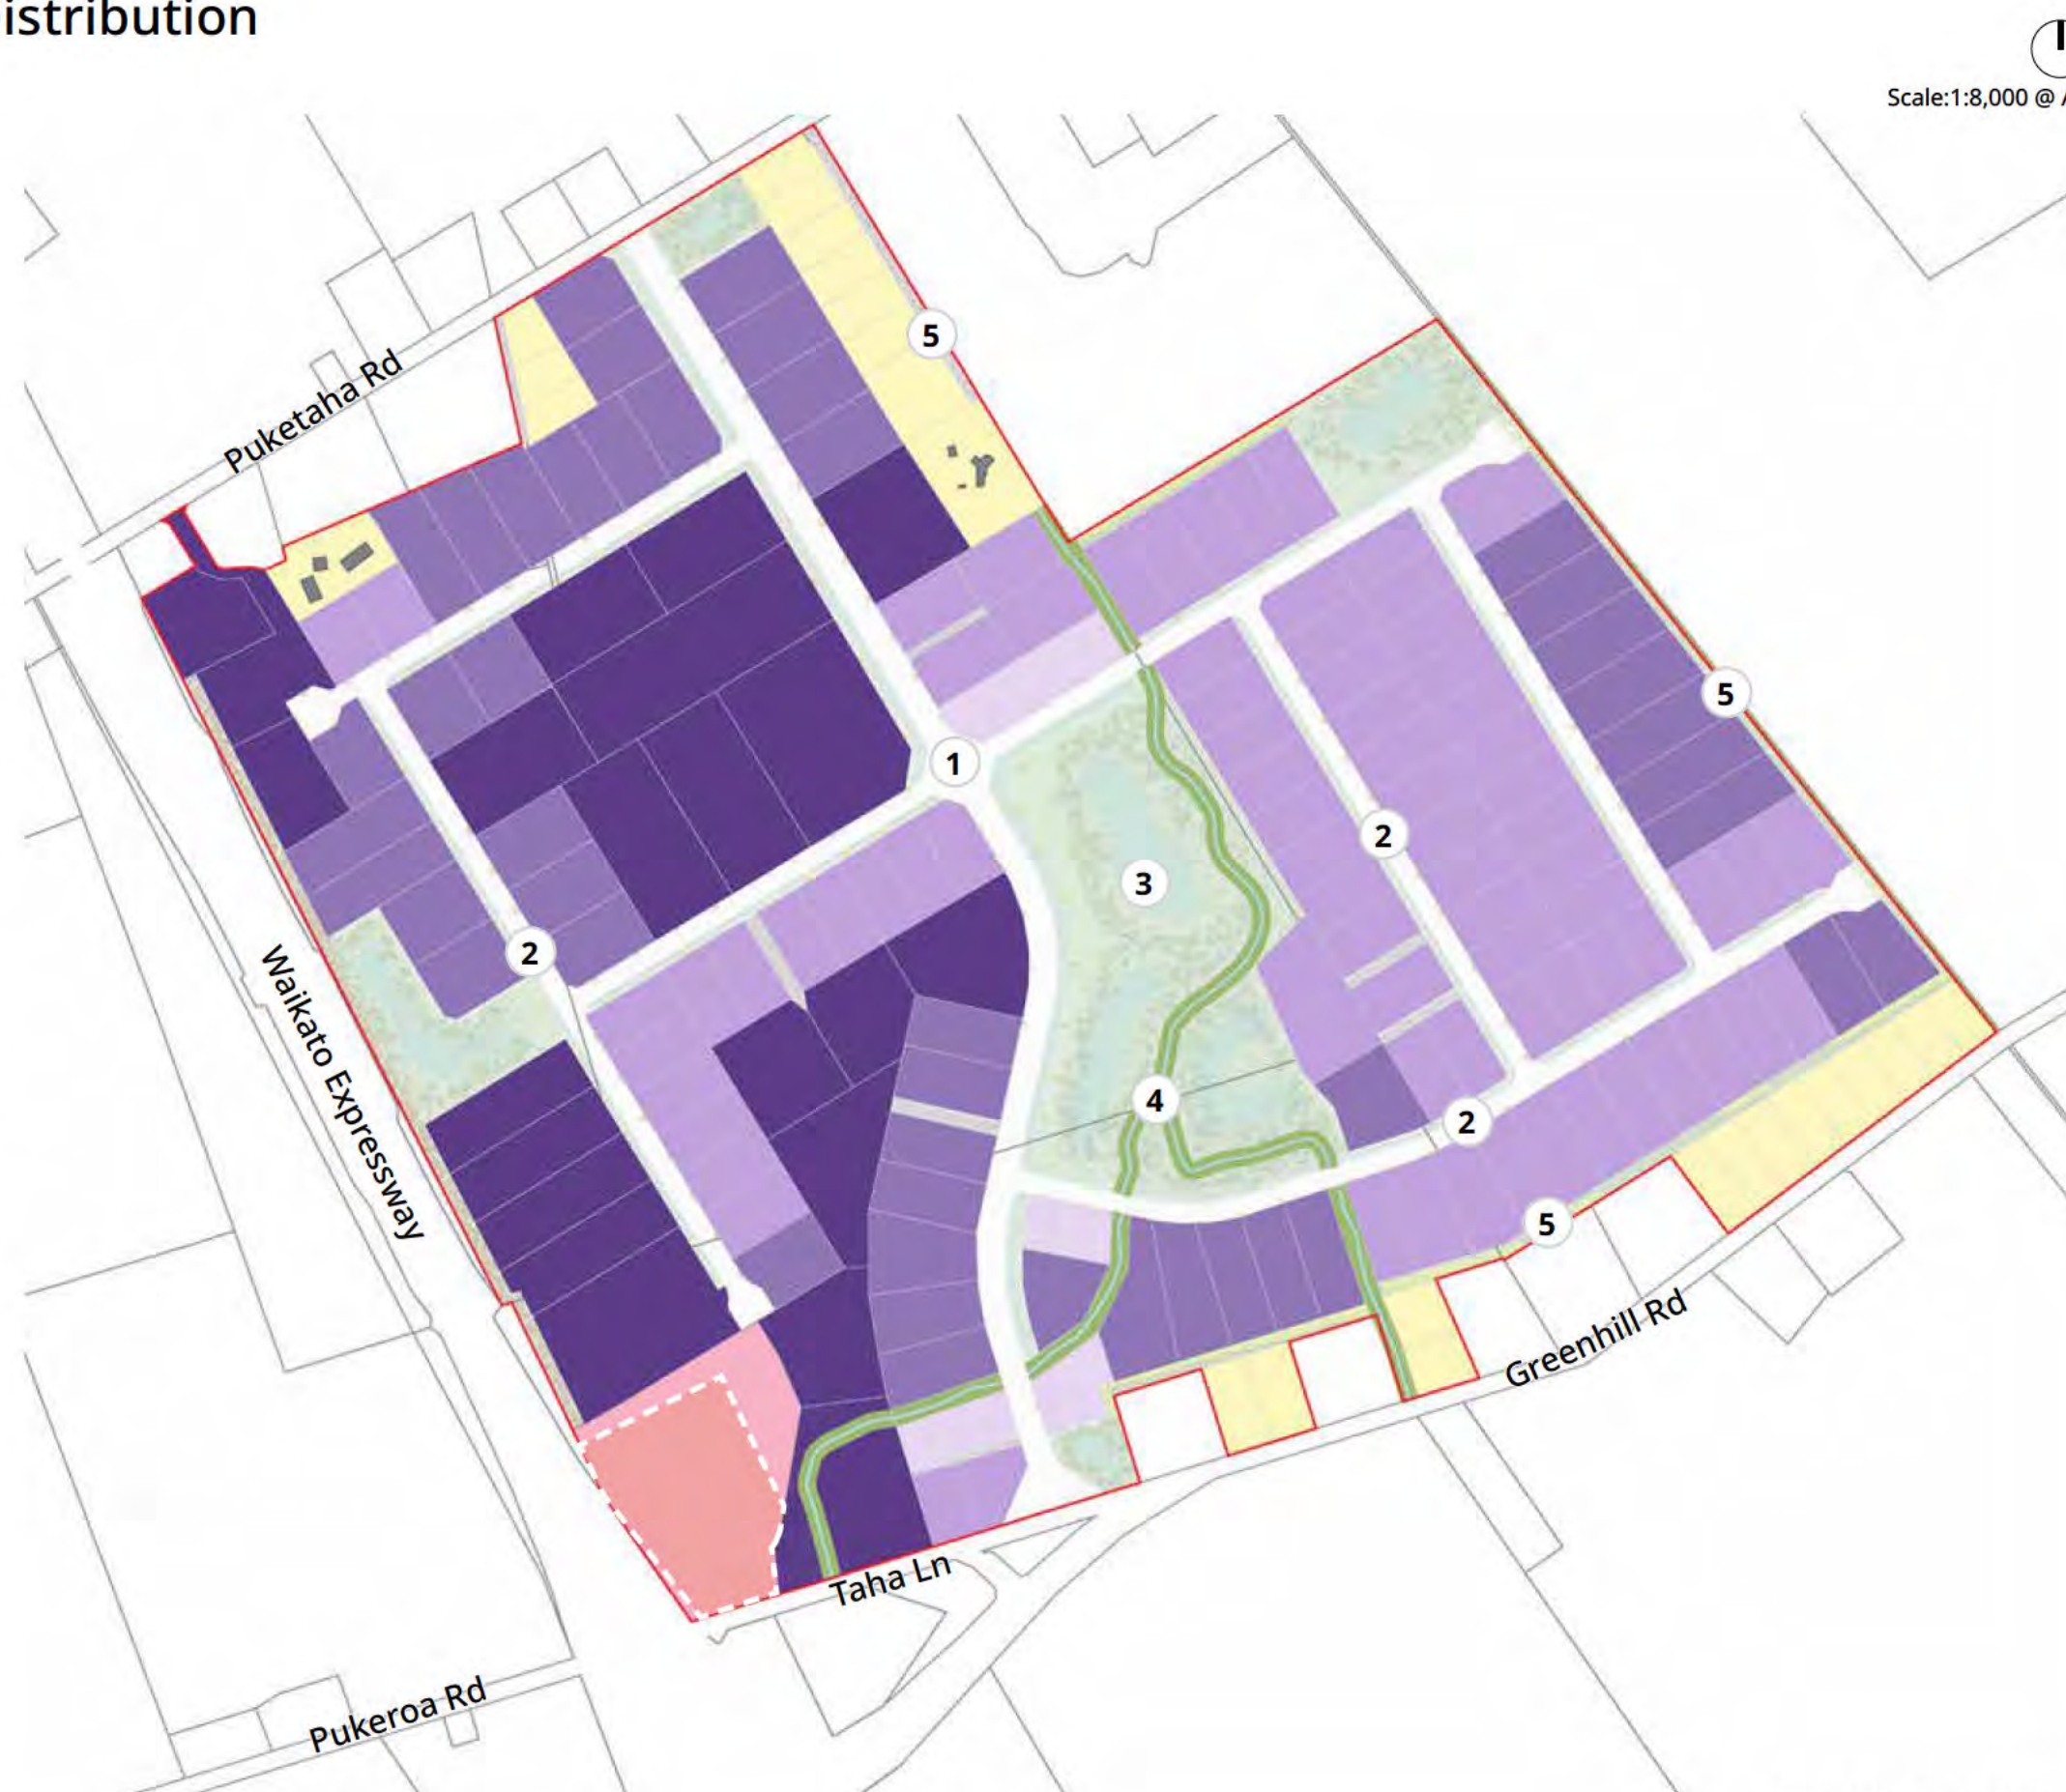
Figure 10 Land Uses and Densities

- Site Boundary
- Existing Residential Dwellings to Retain
- 1 Proposed Industrial Collector Road
- 2 Proposed Industrial Local Road
- 3 Proposed Stormwater Ponds and Riparian Areas
- 4 Existing Regional Council Drains for Realignment & Renaturalisation
