Middle Road Fast Track Application

Ecology Report
Prepared for CDL

3 April 2026

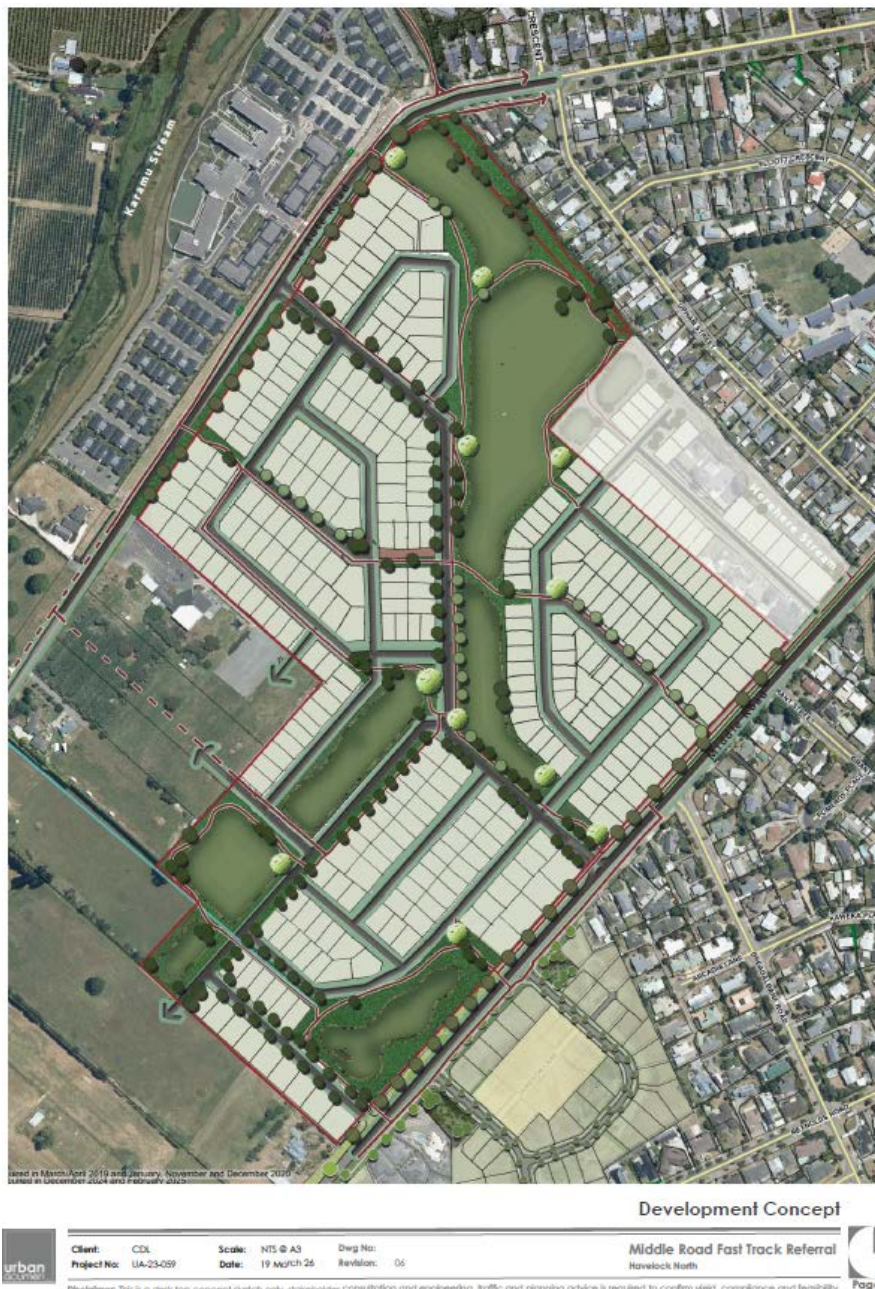
Figure 2. Middle Road Project Development Concept (Urban Acumen, 19 March 2026).

The Middle Road project will provide for the residential subdivision of the site to enable the development of approximately 300 to 350 lots. The intended subdivision layout will provide for a range of lot sizes to enable conventional residential development along with medium density development opportunities. The development will be supported by integrated three-waters and transport infrastructure and an open space network. The indicative concept plan is shown in Figure 2.

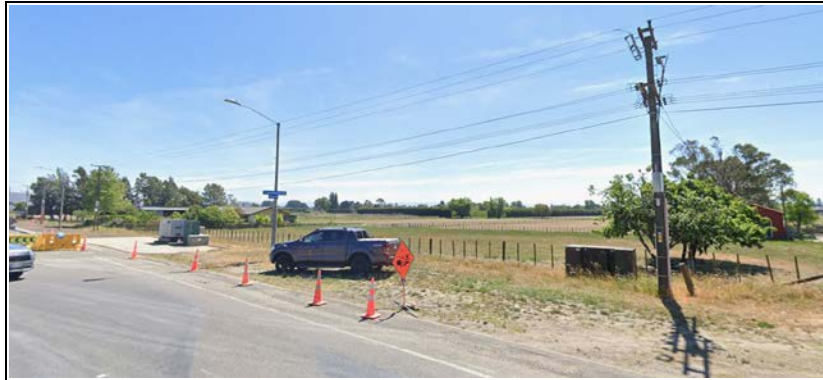
Photo 1. 108 Middle Road - View across south of site toward horticulture block (Google Streetview, 2024)

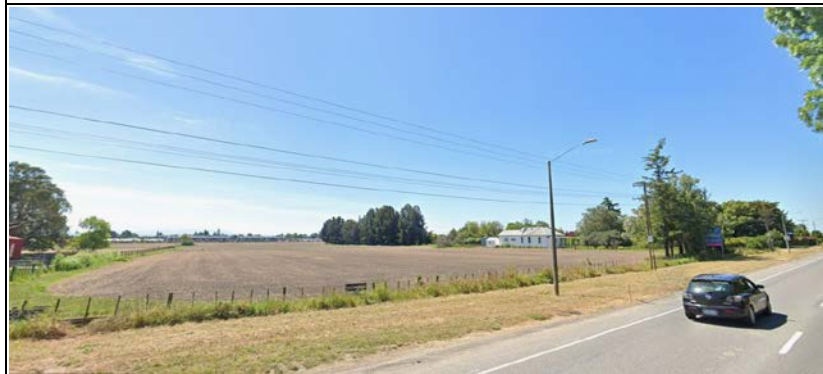
Photo 2. View across northern part of site from 92 Middle Road (Google Streetview, 2024).

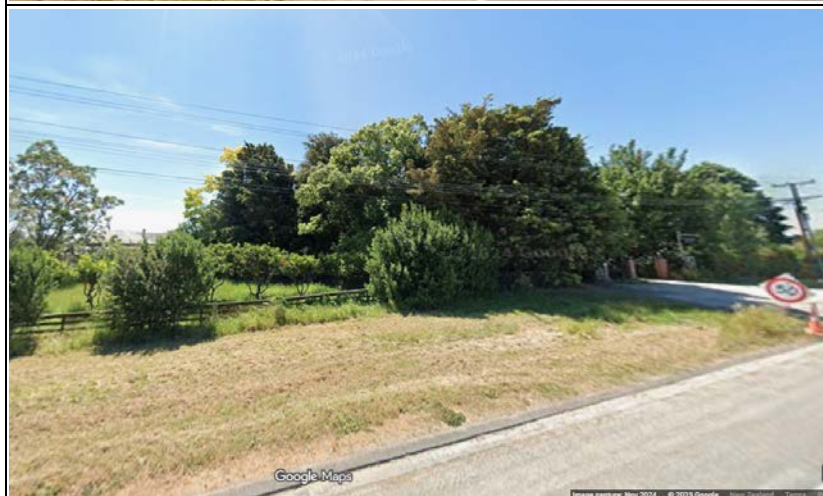
Photo 3. 92 and 84 Middle Road – citrus and ornamental trees, eastern corner of site and McKenna Block. View northwards (Google Streetview, 2024).

The vegetation surrounding the residential dwellings provide habitat of limited extent and quality for indigenous fauna. Some of the mature trees, especially around the cluster of dwellings, potentially provide nesting habitat for avifauna and temporary roost habitat for bats, while garden beds may provide cover habitat for indigenous skink species.

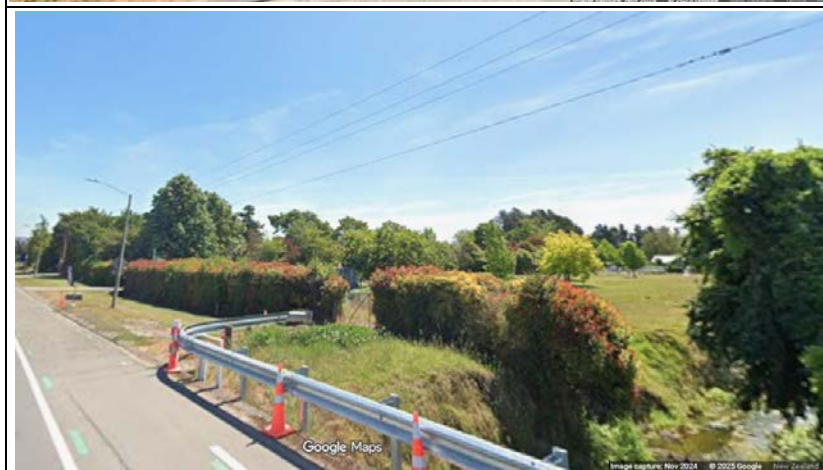
Photo 4. 80 Middle Road – Herehere Stream and landscape with trees, eastern corner of McKenna Block. View southwest (Google Streetview, 2024).

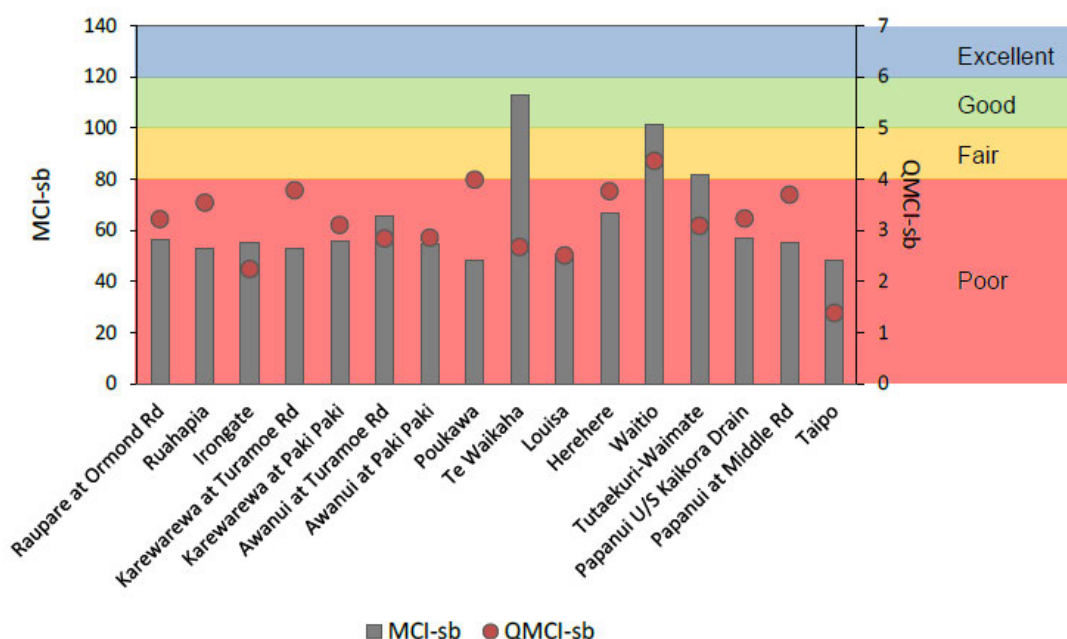
Figure 3. Macroinvertebrate community index results from Hawkes Bay Regional Council (2016).

Macroinvertebrate communities	Ampipods (<i>Paracalliope</i>) and snails (<i>Potamopyrgus</i>) were the most abundant taxa. Taxa Richness was 13. MCI-sb was 66. QMCI-sb was c.3.5, in the poor range but slightly above most other sites (ranking fourth of 16 sites; see Figure 3). Only two EPT taxa recorded and were rare (0.2% of sample abundance. The EPT taxa were <i>Hudsonema</i> and <i>Zephlebia</i>), moderately sensitive taxa that were not recorded at other sites in the survey.
Fish	Common bully, inanga, shortfin eel recorded in an electrofishing survey at Te Aute Road in 2007. Longfin eel and common smelt have also been recorded in other streams in the locality, together with the exotic species goldfish and mosquitofish (HBRC website).

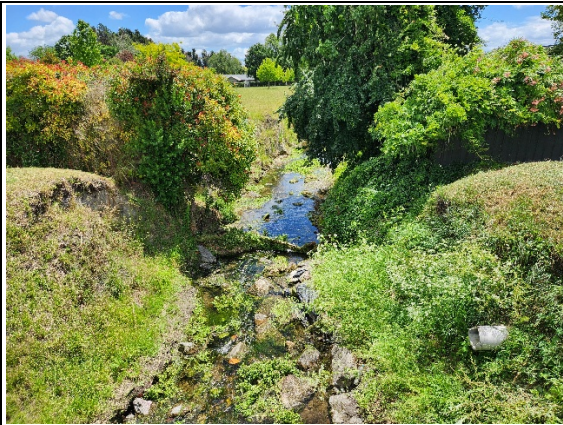
Photo 5. Herehere Stream at Middle Road. December 4, 2025.

Herehere Stream (photos 5 to 8) was included in HBRC studies undertaken in 2024-2016 (HBRC, 2016a and 2016b). The report found that the Herehere Stream had a rocky substrate, unlike most streams in the area, that provided instream habitat opportunities for fauna and helps maintain dissolved oxygen concentrations. Instream habitat function scores were relatively high (Table 3). Macroinvertebrate indicator metrics were low (MCI-sb of 66). The MCI metrics ranked the stream fourth of 16 sites surveyed by HBRC in 2016. Fish recorded were common bully, inanga, and shortfin eel. Nutrient levels were high and the level of *E.coli* contamination was also notably high. This suggests that water quality factors are having adverse effects on stream ecosystems. Data is summarised in Table 3.

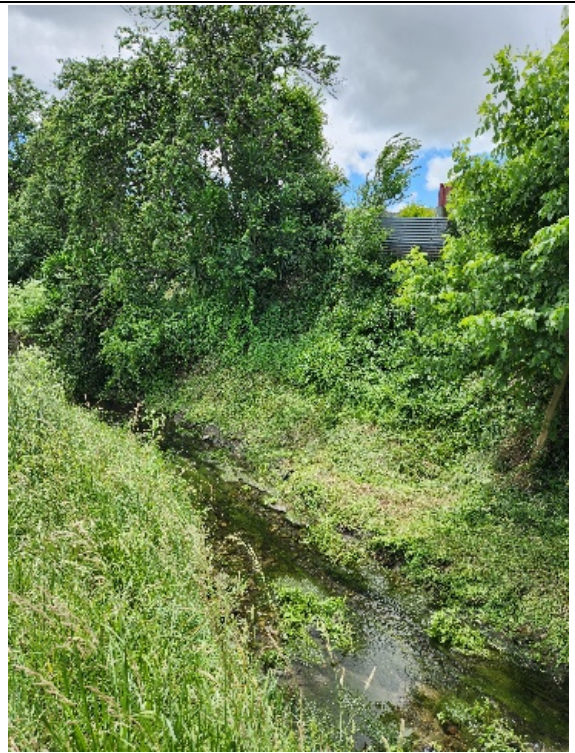
Photo 6. Herehere Stream downstream of Middle Road. December 4, 2025.

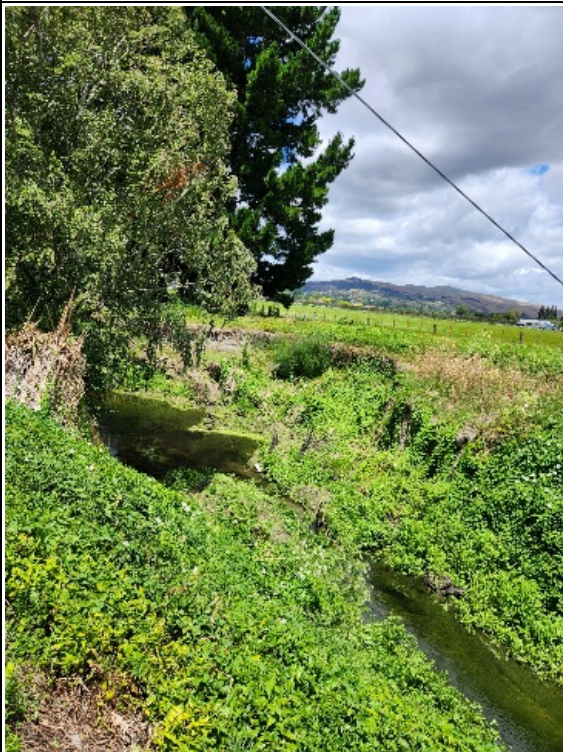
Photo 7. Herehere Stream upstream of Te Aute Road. December 4, 2025.

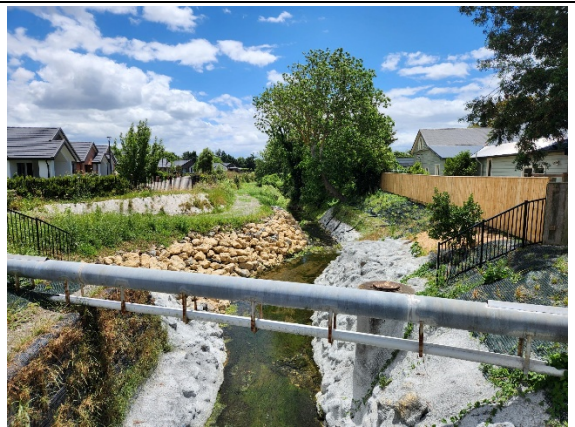
Photo 8. Herehere Stream downstream of Te Aute Road. December 4, 2025.

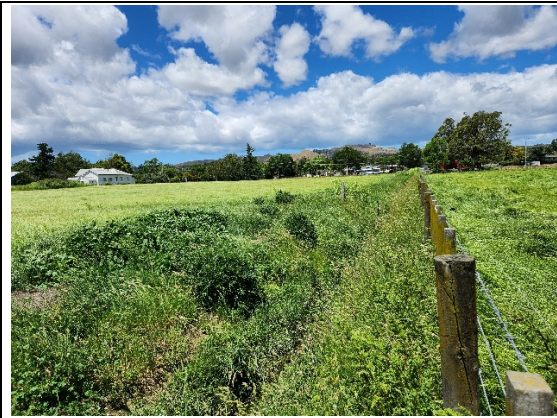
Photo 9. Landscape and drains within the site, view eastwards. December 4, 2025.

These watercourses are therefore classified as artificial and not as streams or rivers under the RMA (1991). In terms of ecological values they perform conveyance functions and provide habitat for aquatic plants and animals. These are likely to be tolerant fauna often found in lowland watercourses in agricultural catchments, such as shortfin eel. There are unlikely to be any threatened species present.

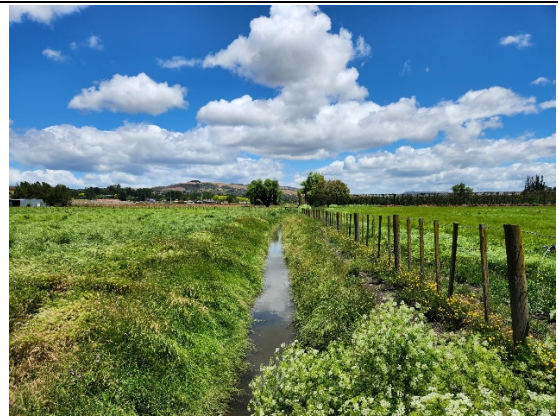
Photo 10. Landscape and drains within the site, view southwards. December 4, 2025.

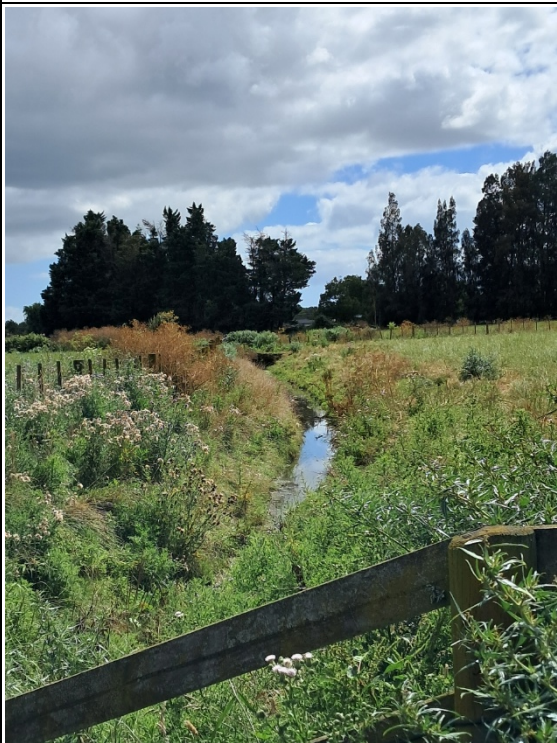
Photo 11. Farm drain within the site, view eastwards. February 5, 2026.

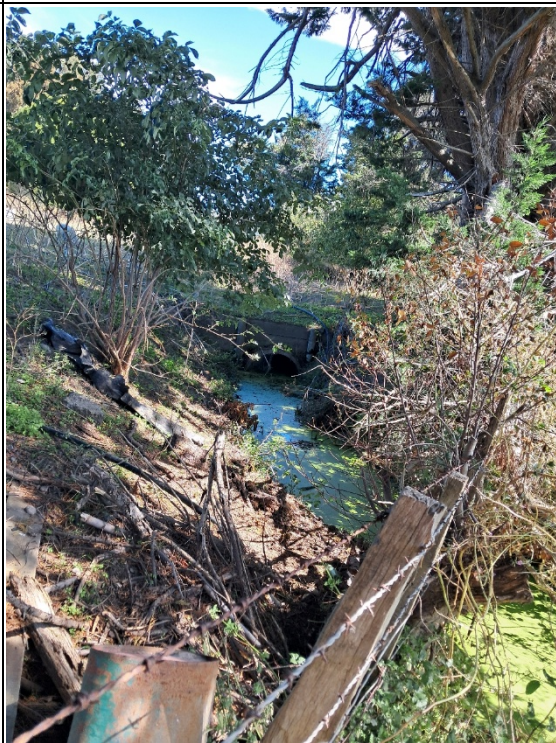
Photo 12. Farm drain on western boundary of McKenna Block. February 5, 2026.

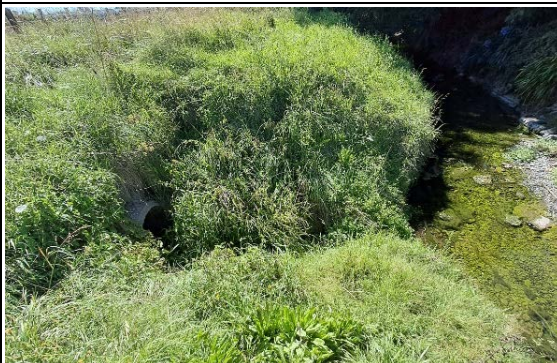
Photo 13. Farm drain outlet into Herehere stream. February 5, 2026.

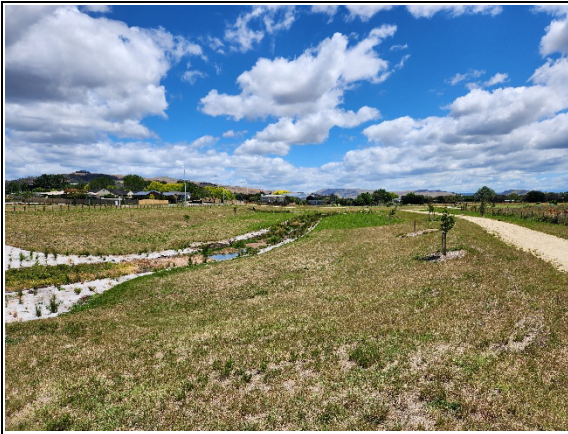
Photo 14. Stormwater management area for Iona subdivision, south of site. December 4, 2025.

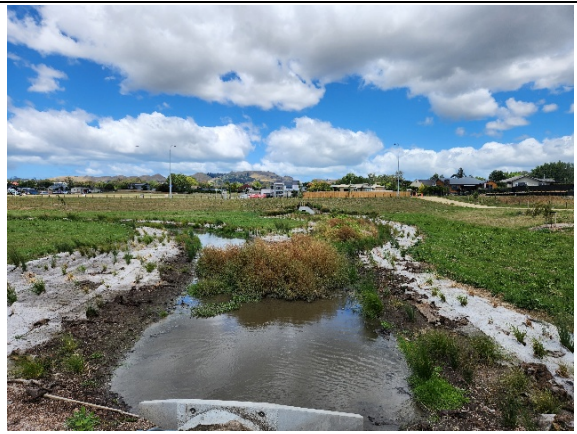
Photo 15. Stormwater management area for Iona subdivision, south of site. December 4, 2025.

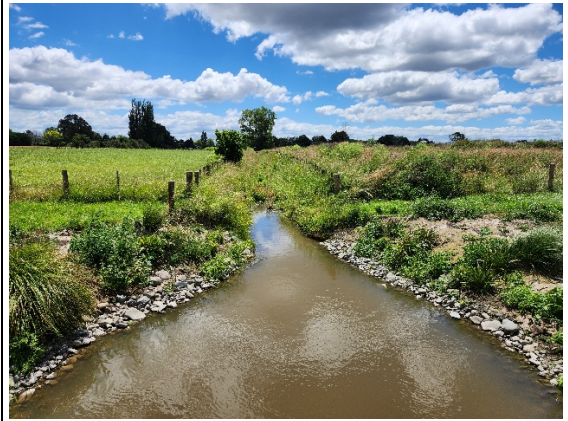
Photo 16. Outlet from stormwater management area for Iona subdivision, south of site. December 4, 2025.

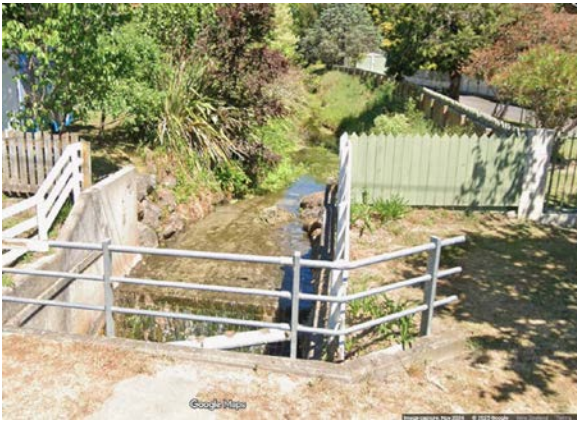
Photo 17. Herehere Stream At Reynolds Road (c. 500 m upstream of site). The vertical fall over 0.5m height is likely to impair fish passage. Google Streetview, 2024.

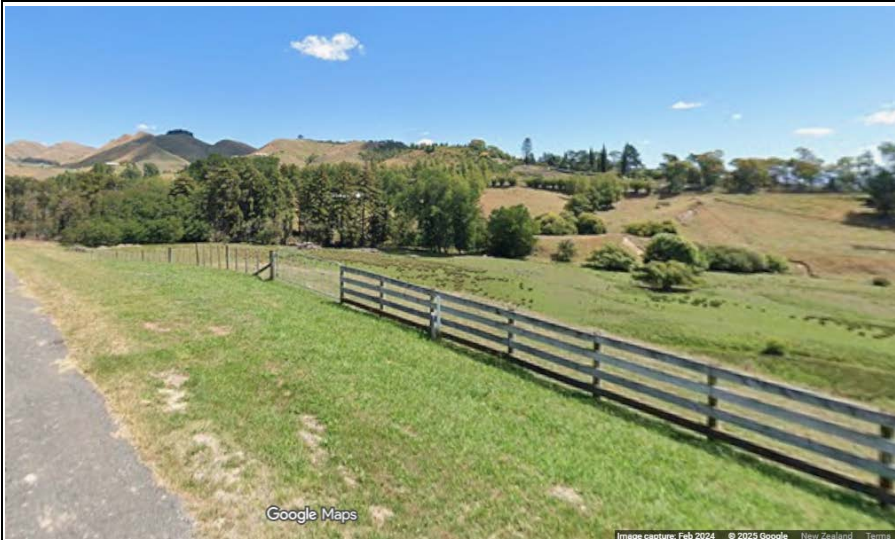
Photo 18. Herehere Stream, upper catchment at Aintree Road. Google Streetview, 2024.

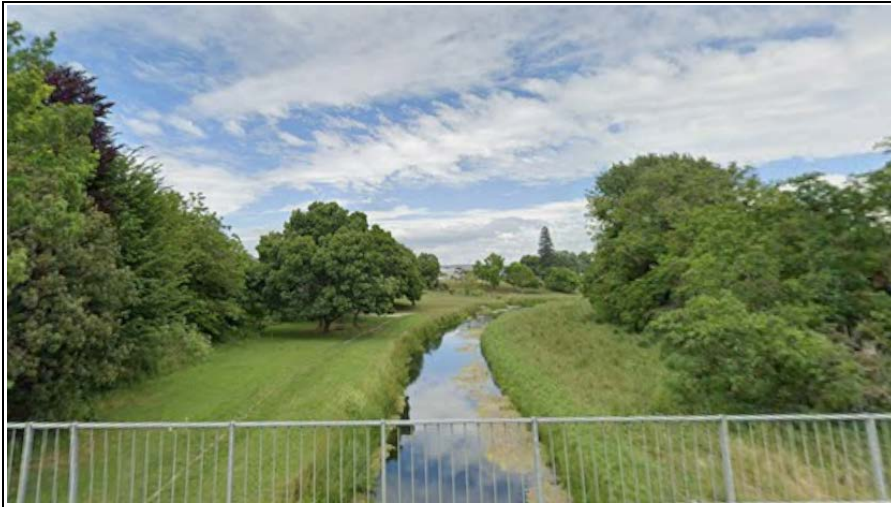
Photo 19. Karamu Stream at Havelock Road, view upstream. Approximately 1.3 km from site. (Google streetview).
