PRELIMINARY SITE INVESTIGATION

Waikato Thoroughbred Racing Greenfield Hub

Preliminary Site Investigation Report

23-1883 Waikato Thoroughbred Racing New Racecourse – Pencarrow Road

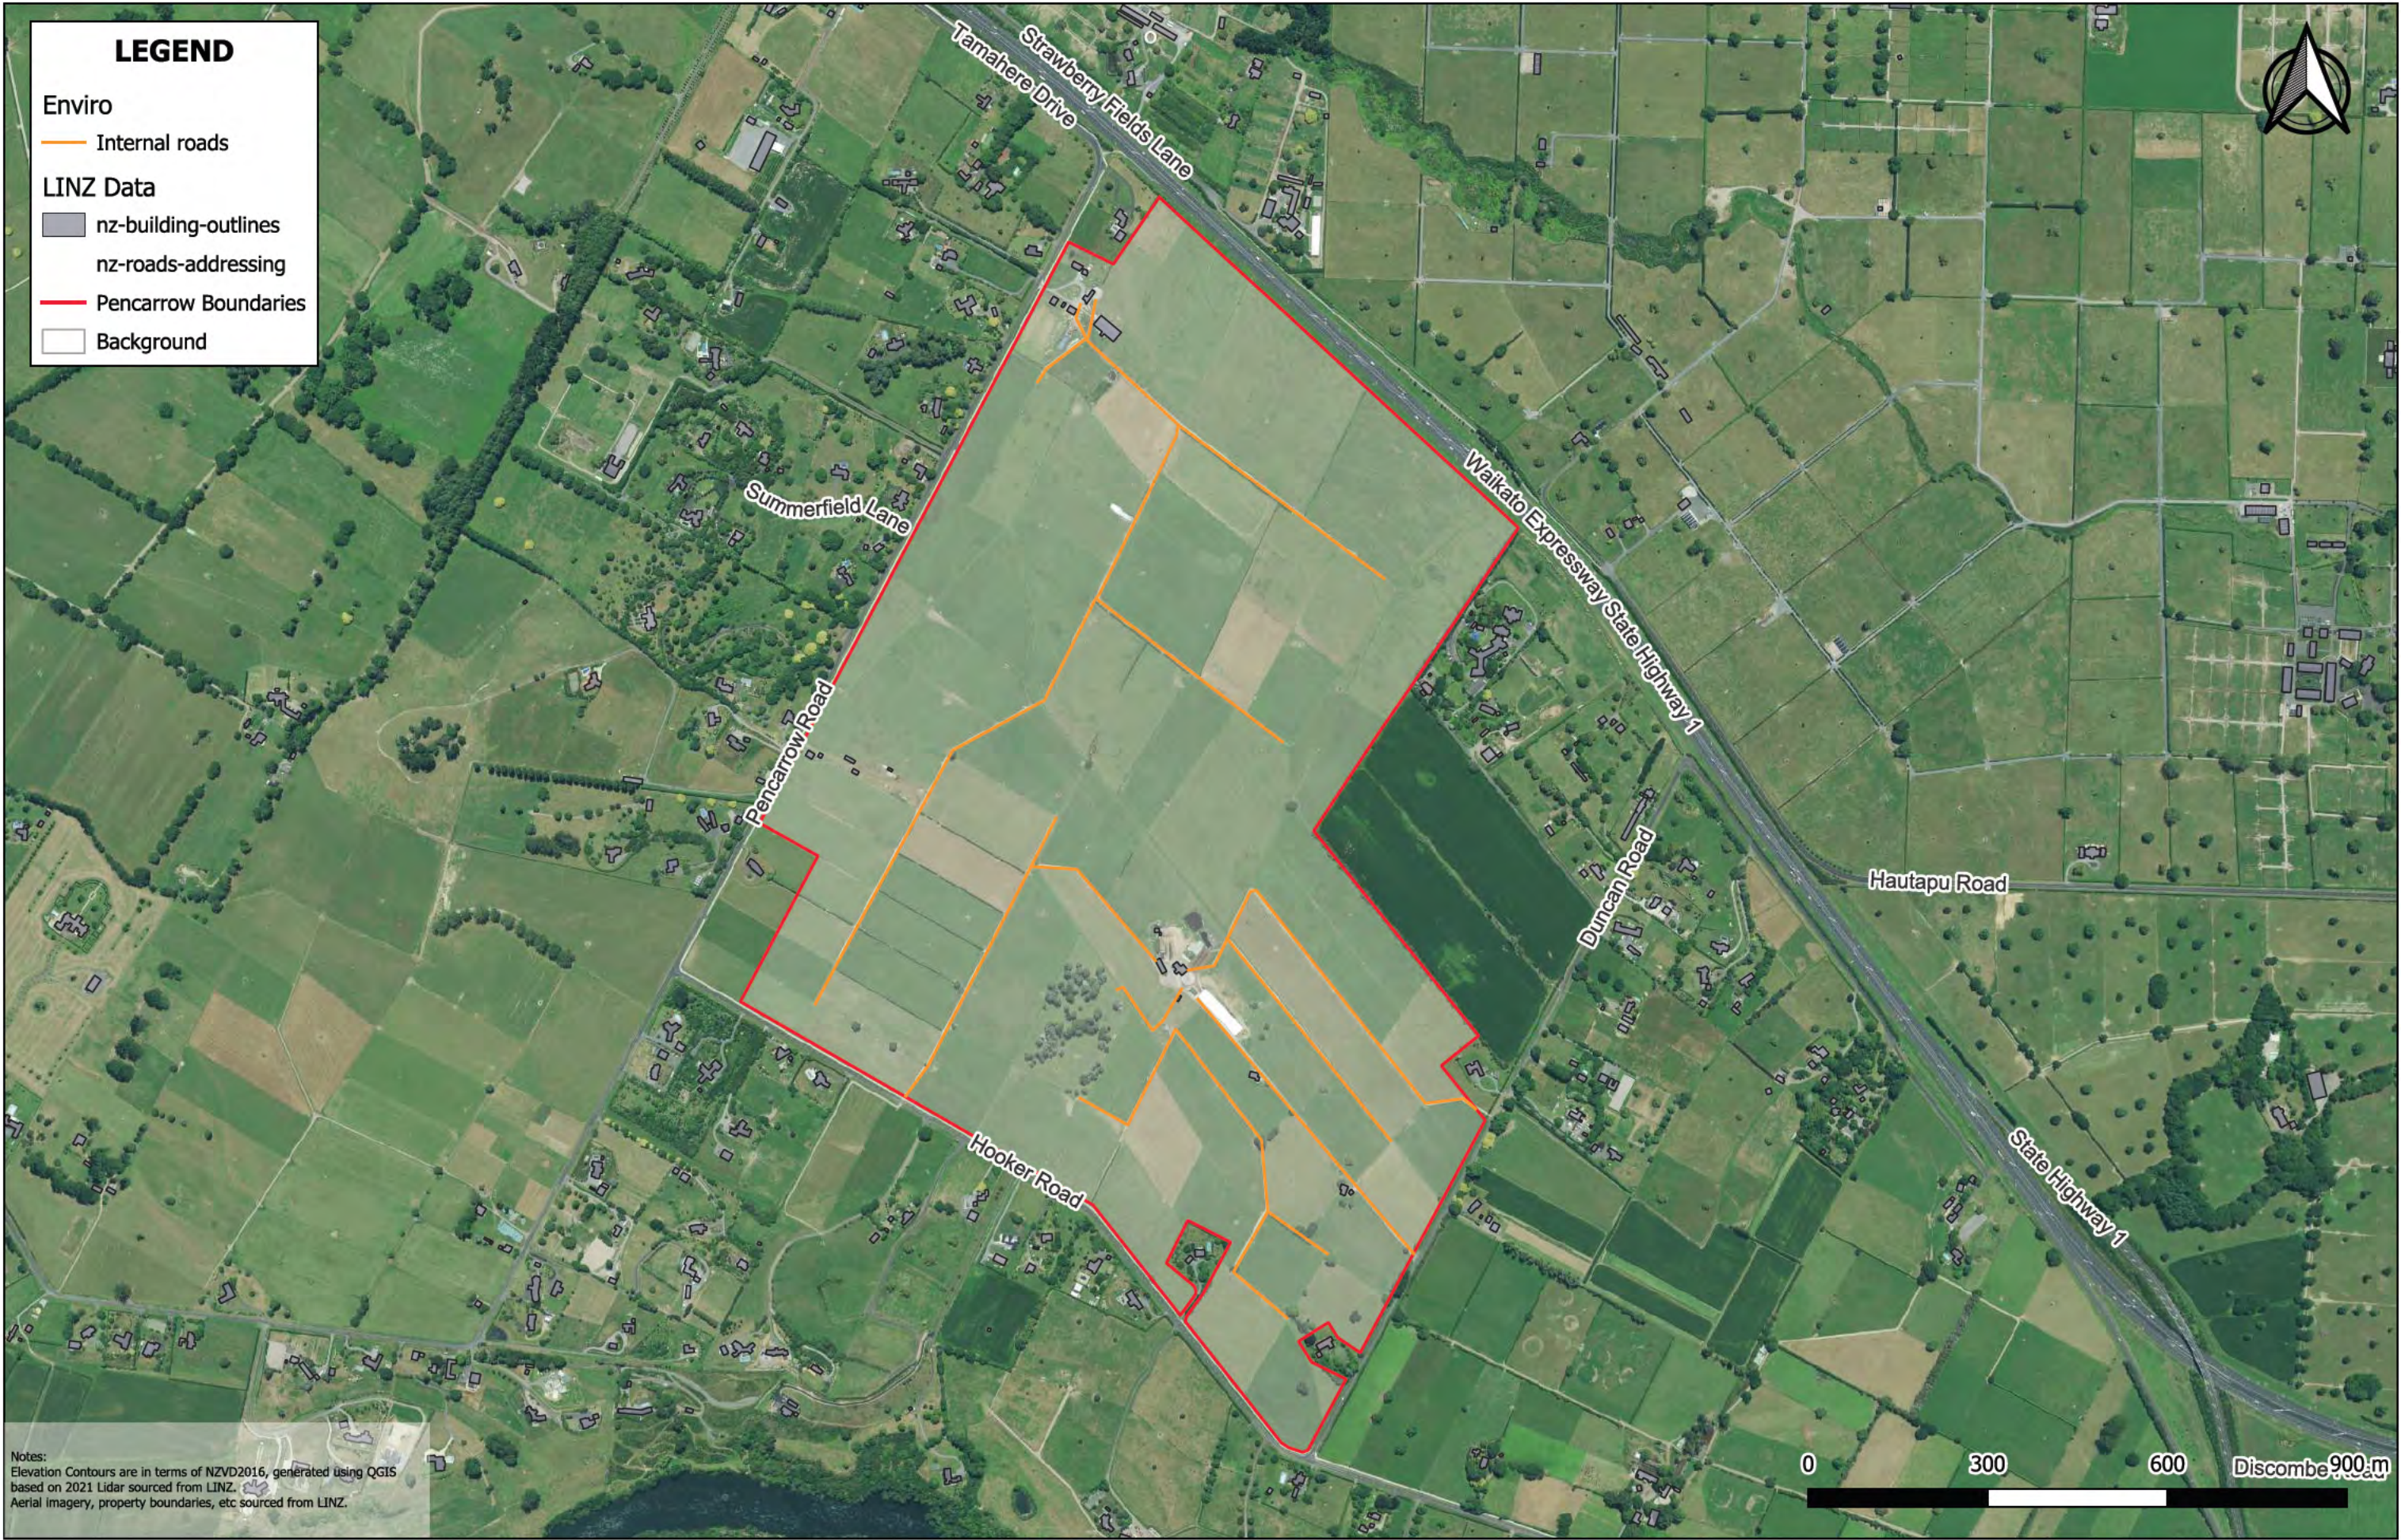
Notes:
 Elevation Contours are in terms of NZVD2016, generated using QGIS based on 2021 Lidar sourced from LINZ.
 Aerial imagery, property boundaries, etc sourced from LINZ.

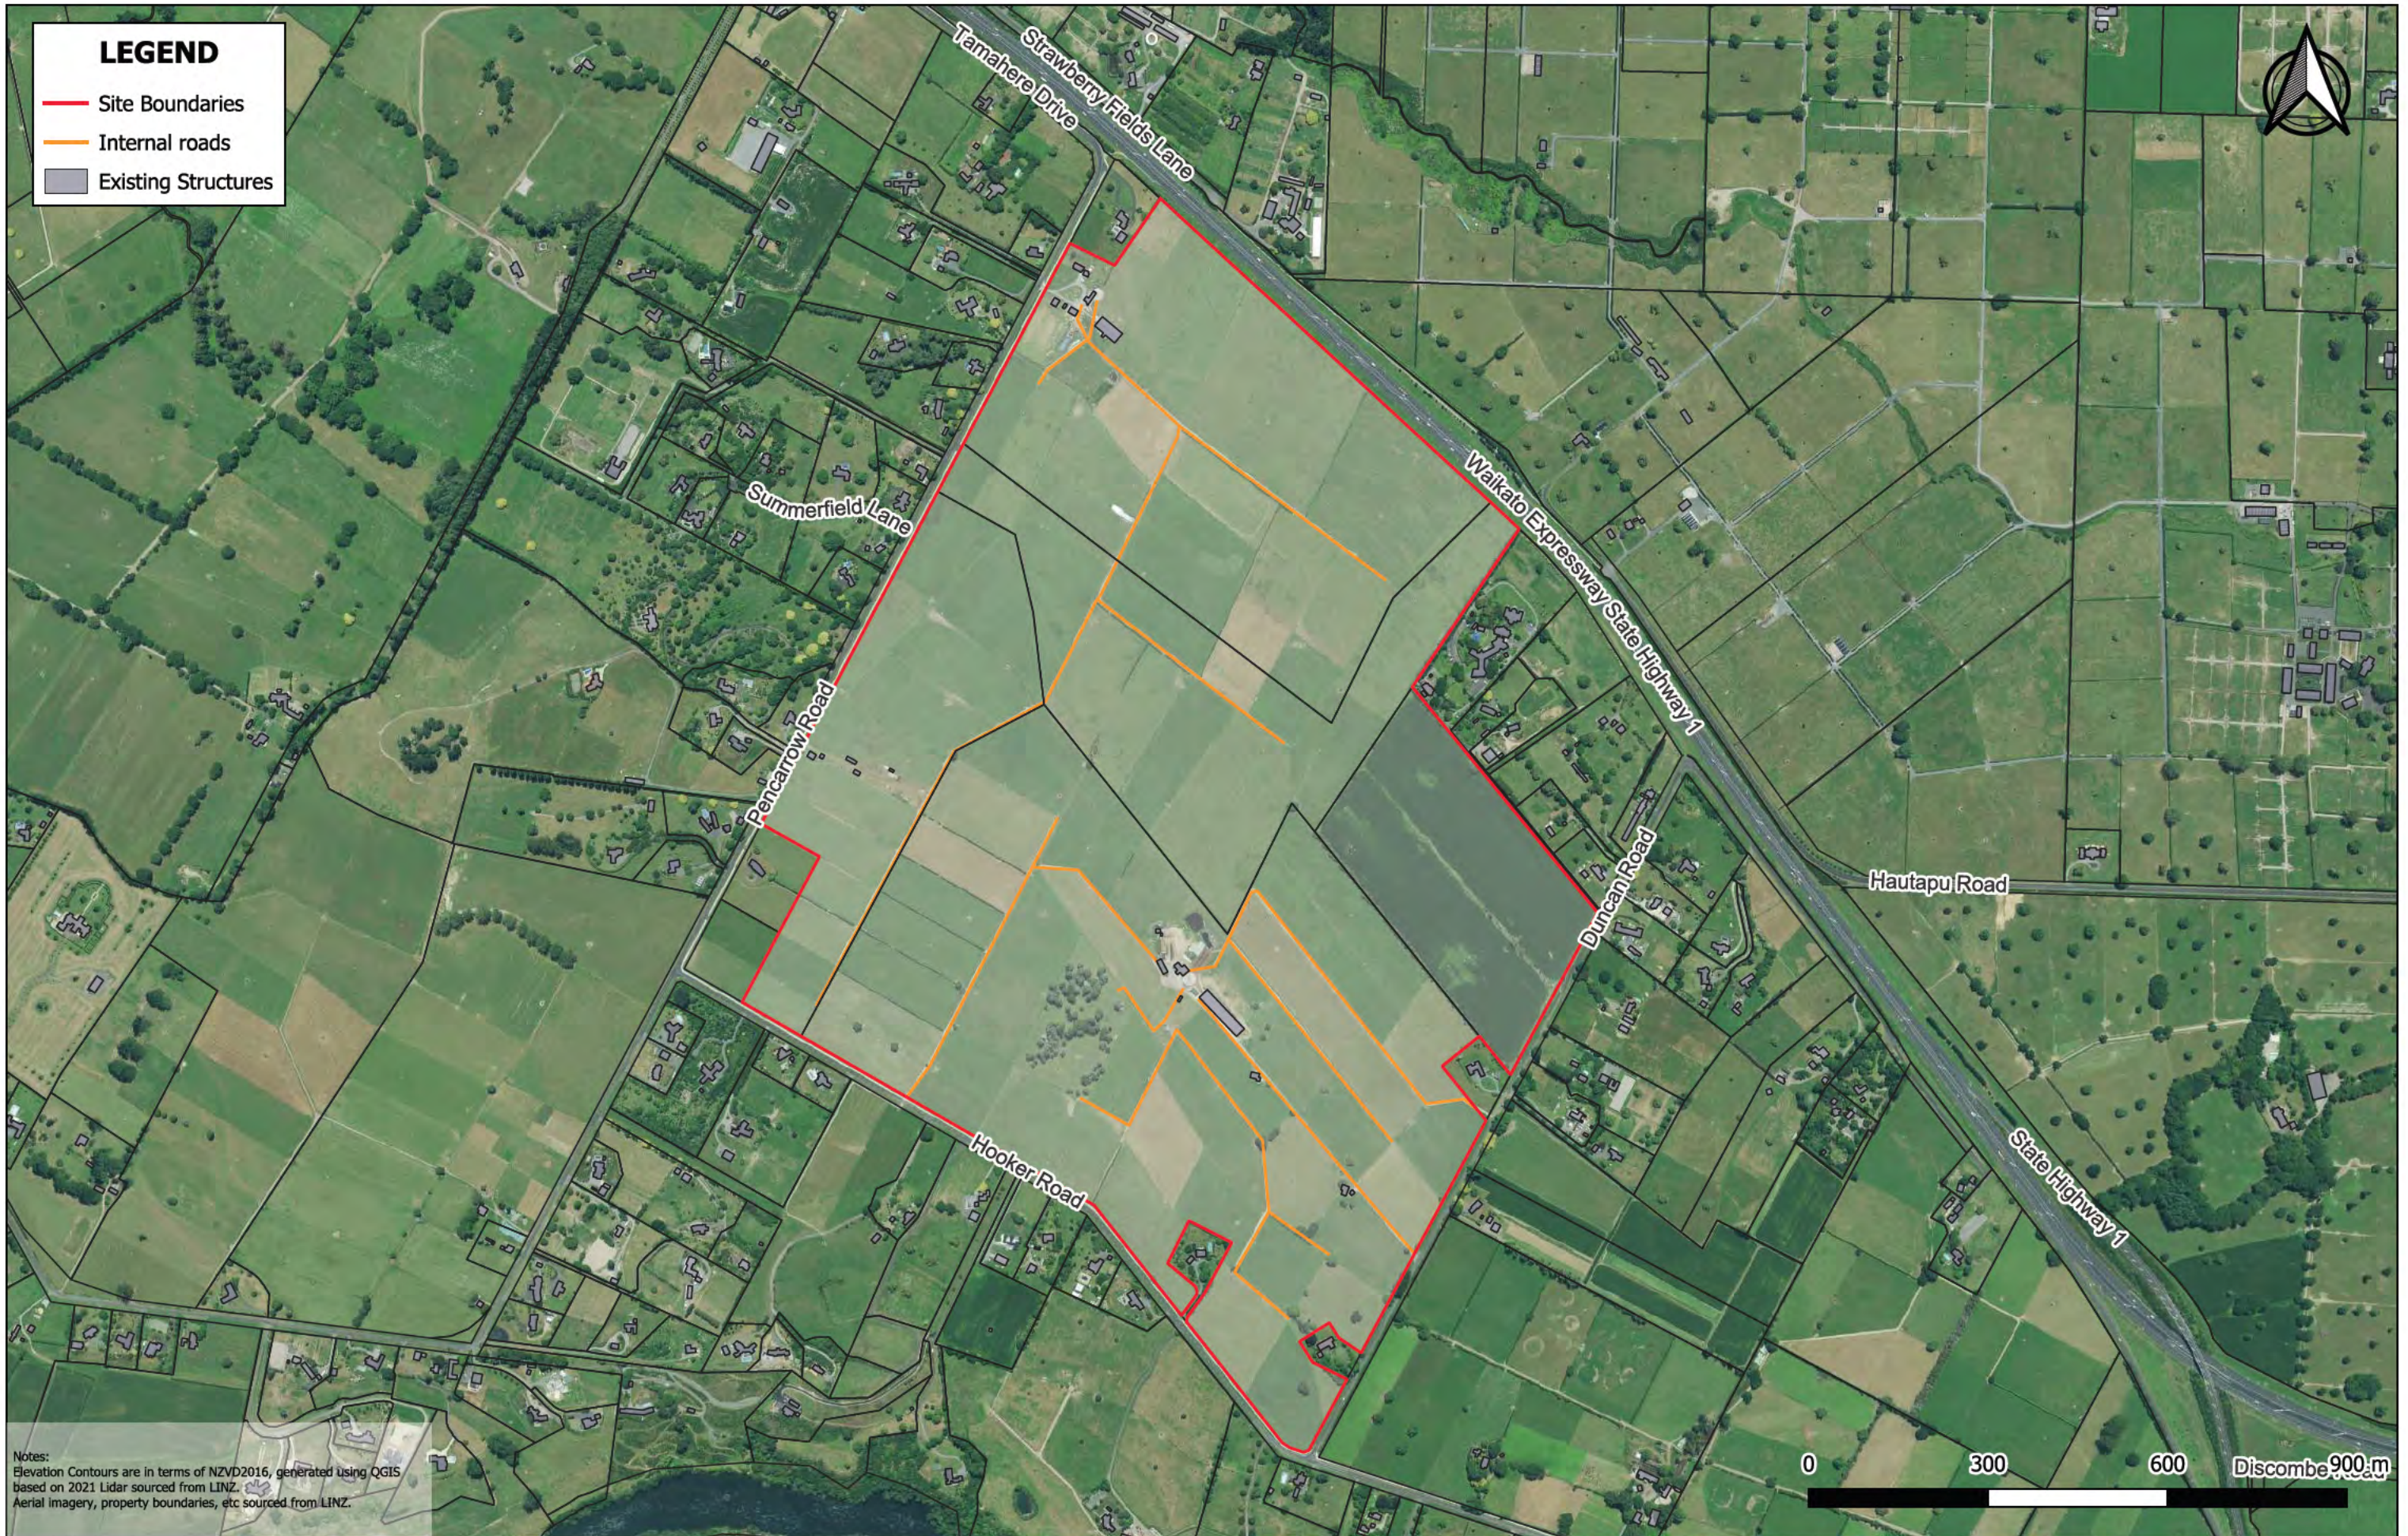
Notes:
 Elevation Contours are in terms of NZVD2016, generated using QGIS based on 2021 Lidar sourced from LINZ.
 Aerial imagery, property boundaries, etc sourced from LINZ.

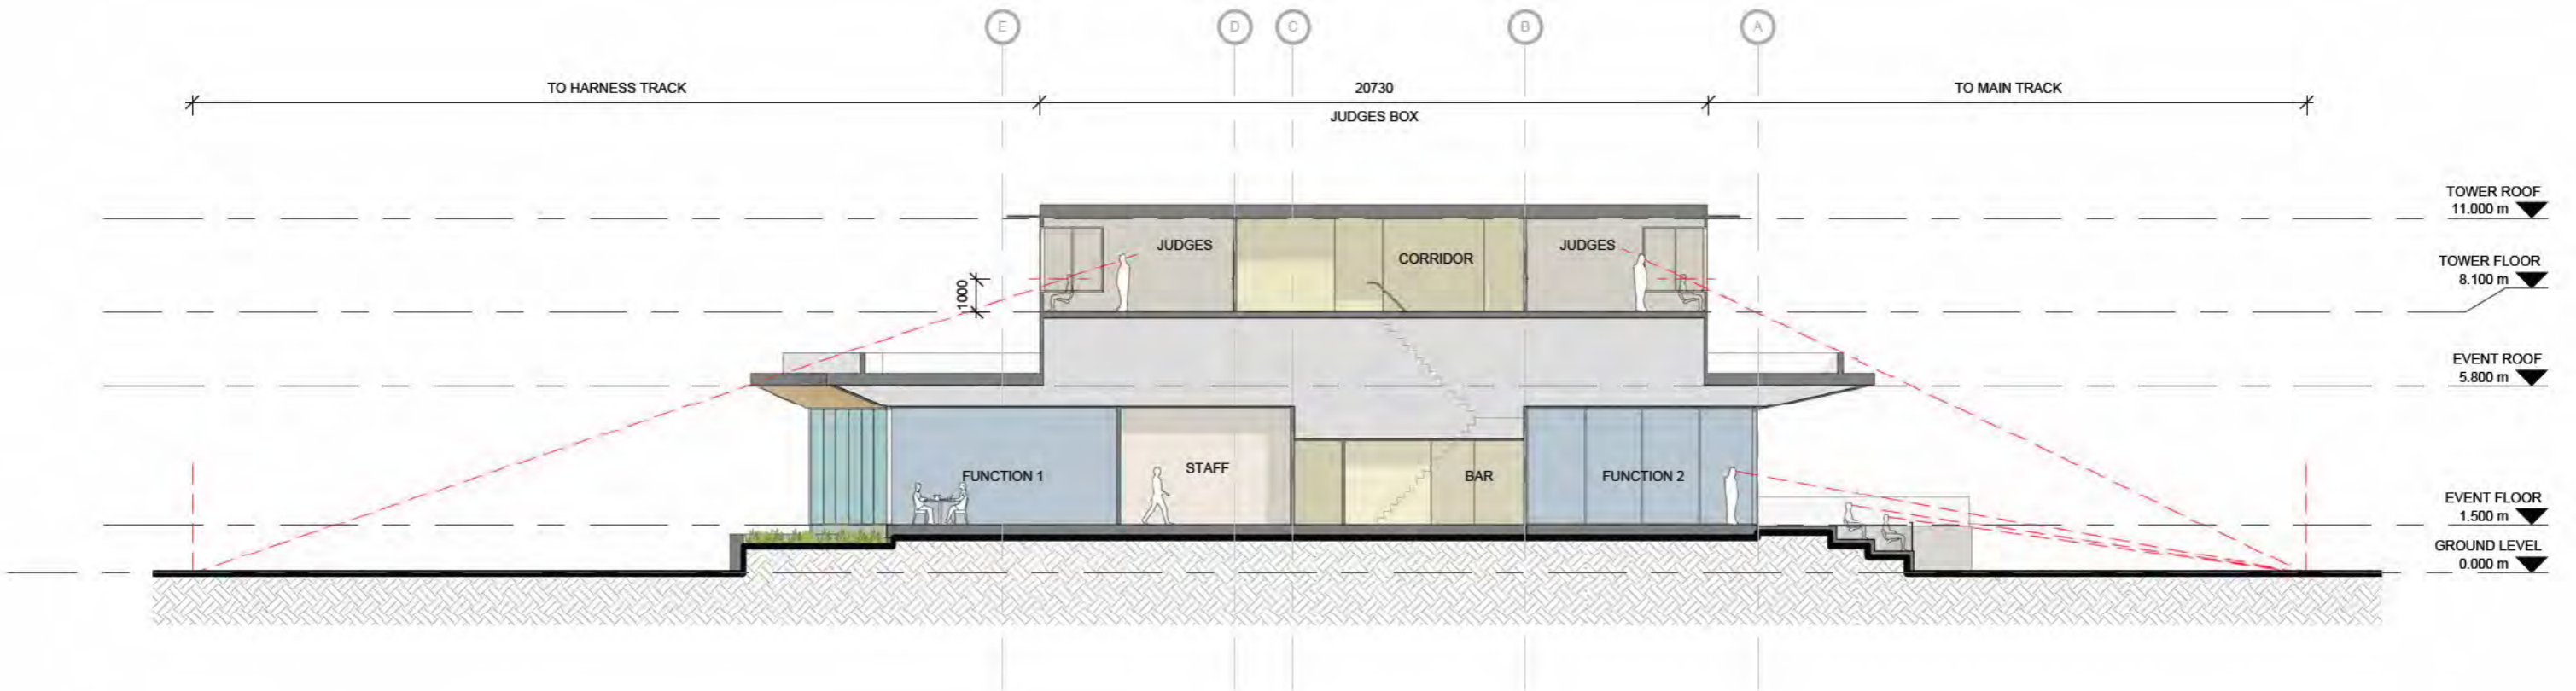
3.6 EVENT + OPERATIONS BUILDING SHORT SECTION

SHORT SECTION
SCALE @ A3 - 1 : 200

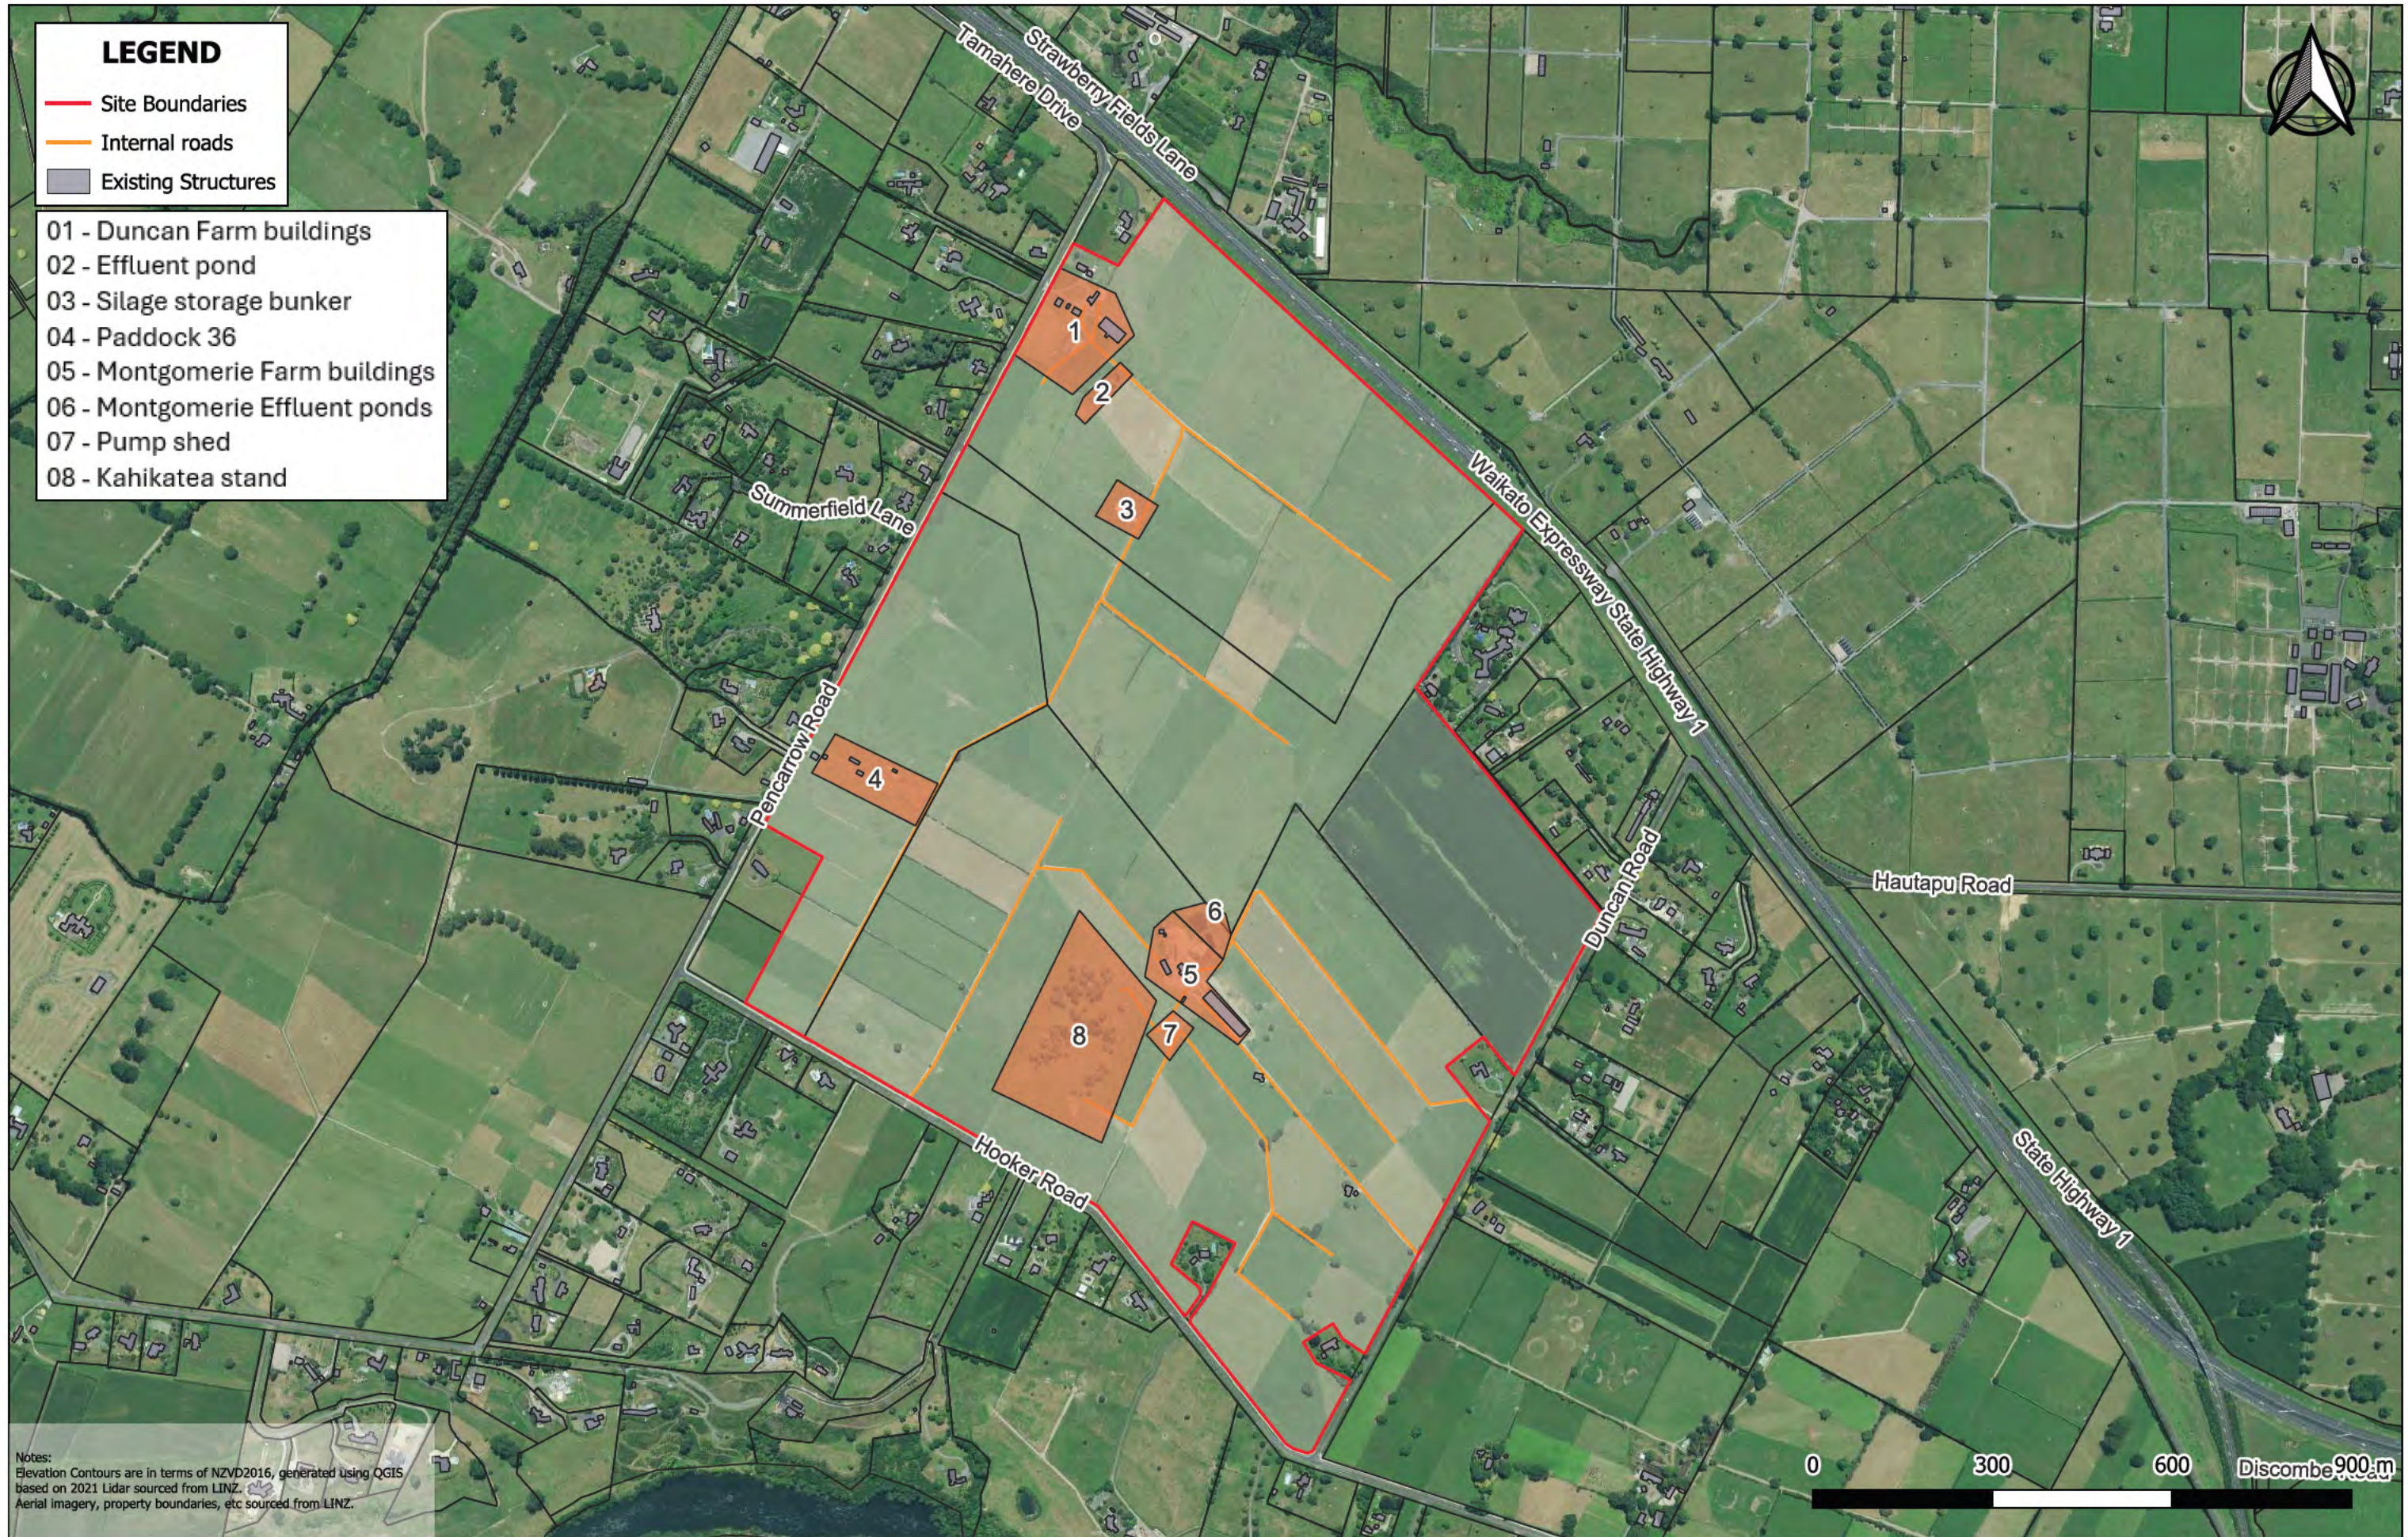
Appendix C Site layout

- 01 - Duncan Farm buildings
- 02 - Effluent pond
- 03 - Silage storage bunker
- 04 - Paddock 36
- 05 - Montgomerie Farm buildings
- 06 - Montgomerie Effluent ponds
- 07 - Pump shed
- 08 - Kahikatea stand

Notes:
 Elevation Contours are in terms of NZVD2016, generated using QGIS based on 2021 Lidar sourced from LINZ.
 Aerial imagery, property boundaries, etc sourced from LINZ.

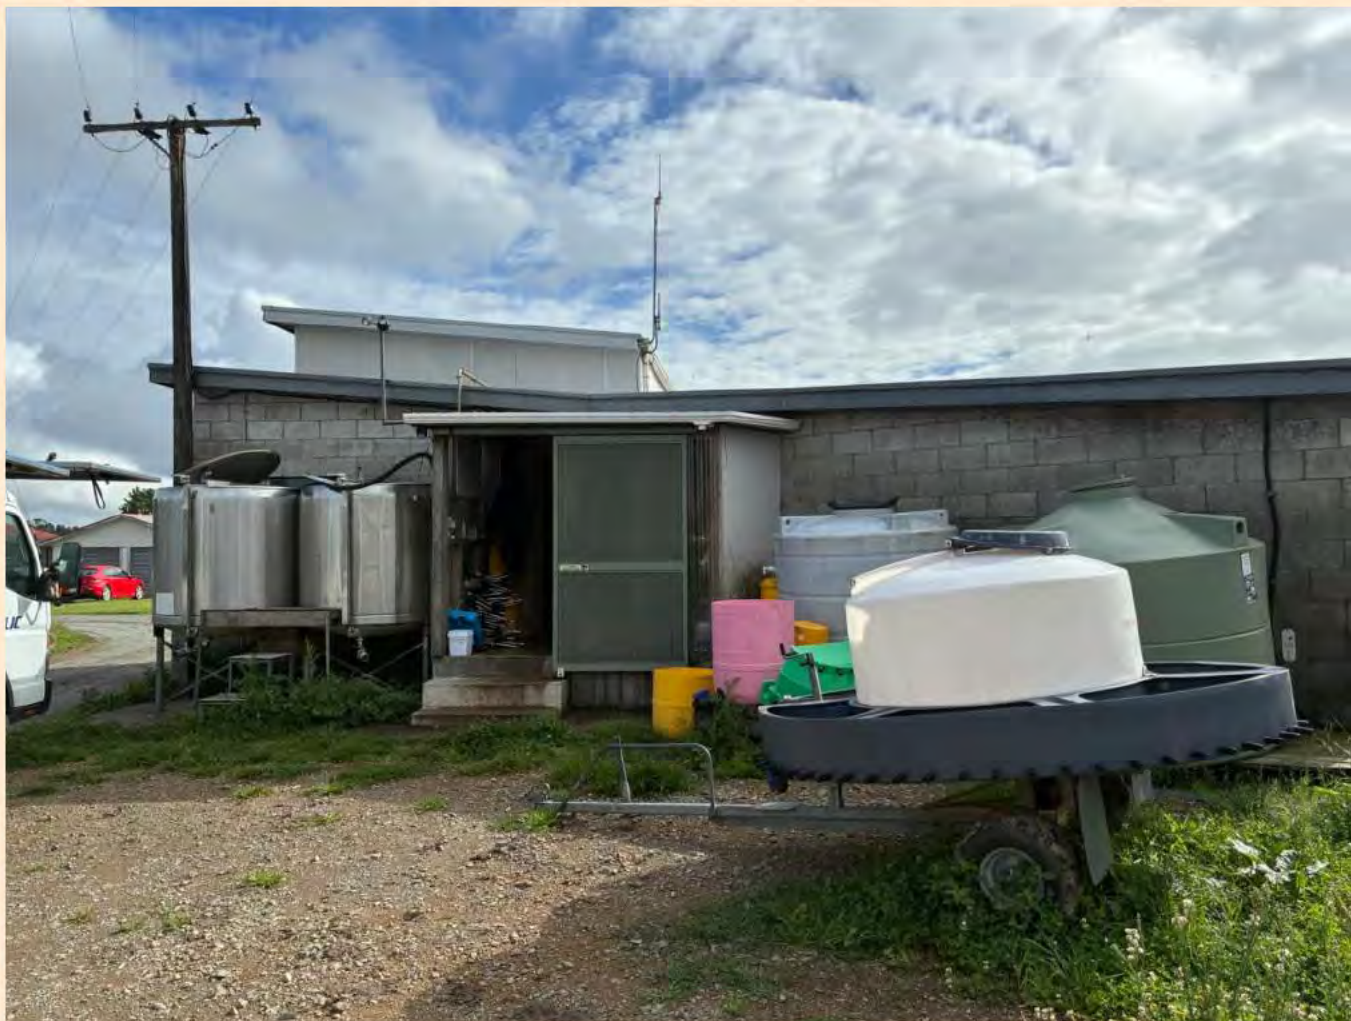
01 Duncan
farm: milking
shed

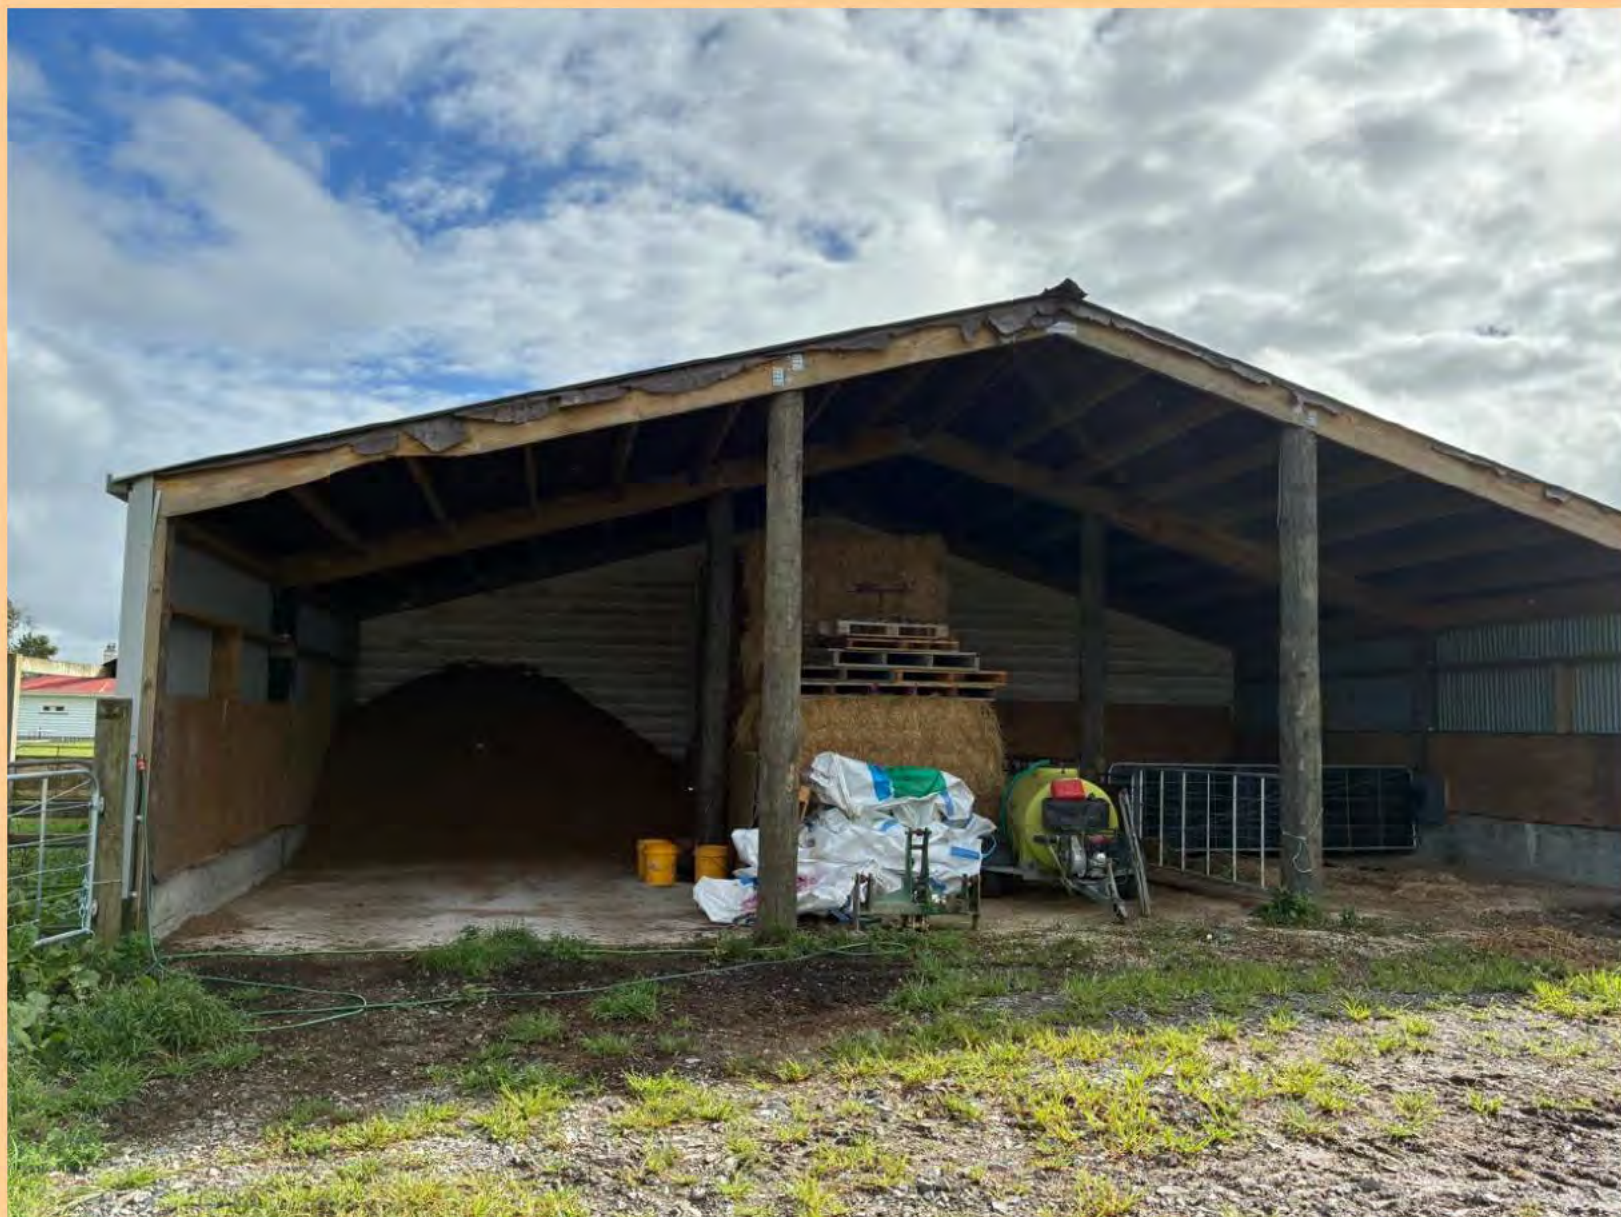
04 Duncan
Farm: Shed
storage

Stockpiles of soil were also observed in this area, as well as stockpiled fence posts. Chemical storage was observed in the storage shed, which had a concrete floor.	
Effluent ponds	6	Two effluent ponds are present at the Site. The dairy shed waste drains into these ponds, which are spread across the Site.	19
Pump shed	7	A pump shed is present in this location, with two water storage tanks.	20
Kahikatea stand	8	A stand of Kahikatea trees is present in this area. The remnants of a burn pile were observed.	21
Remainder of site	N/A	Two residential areas are located at the Site, including a house and shed. A small network of roads is present to service the paddocks	N?A

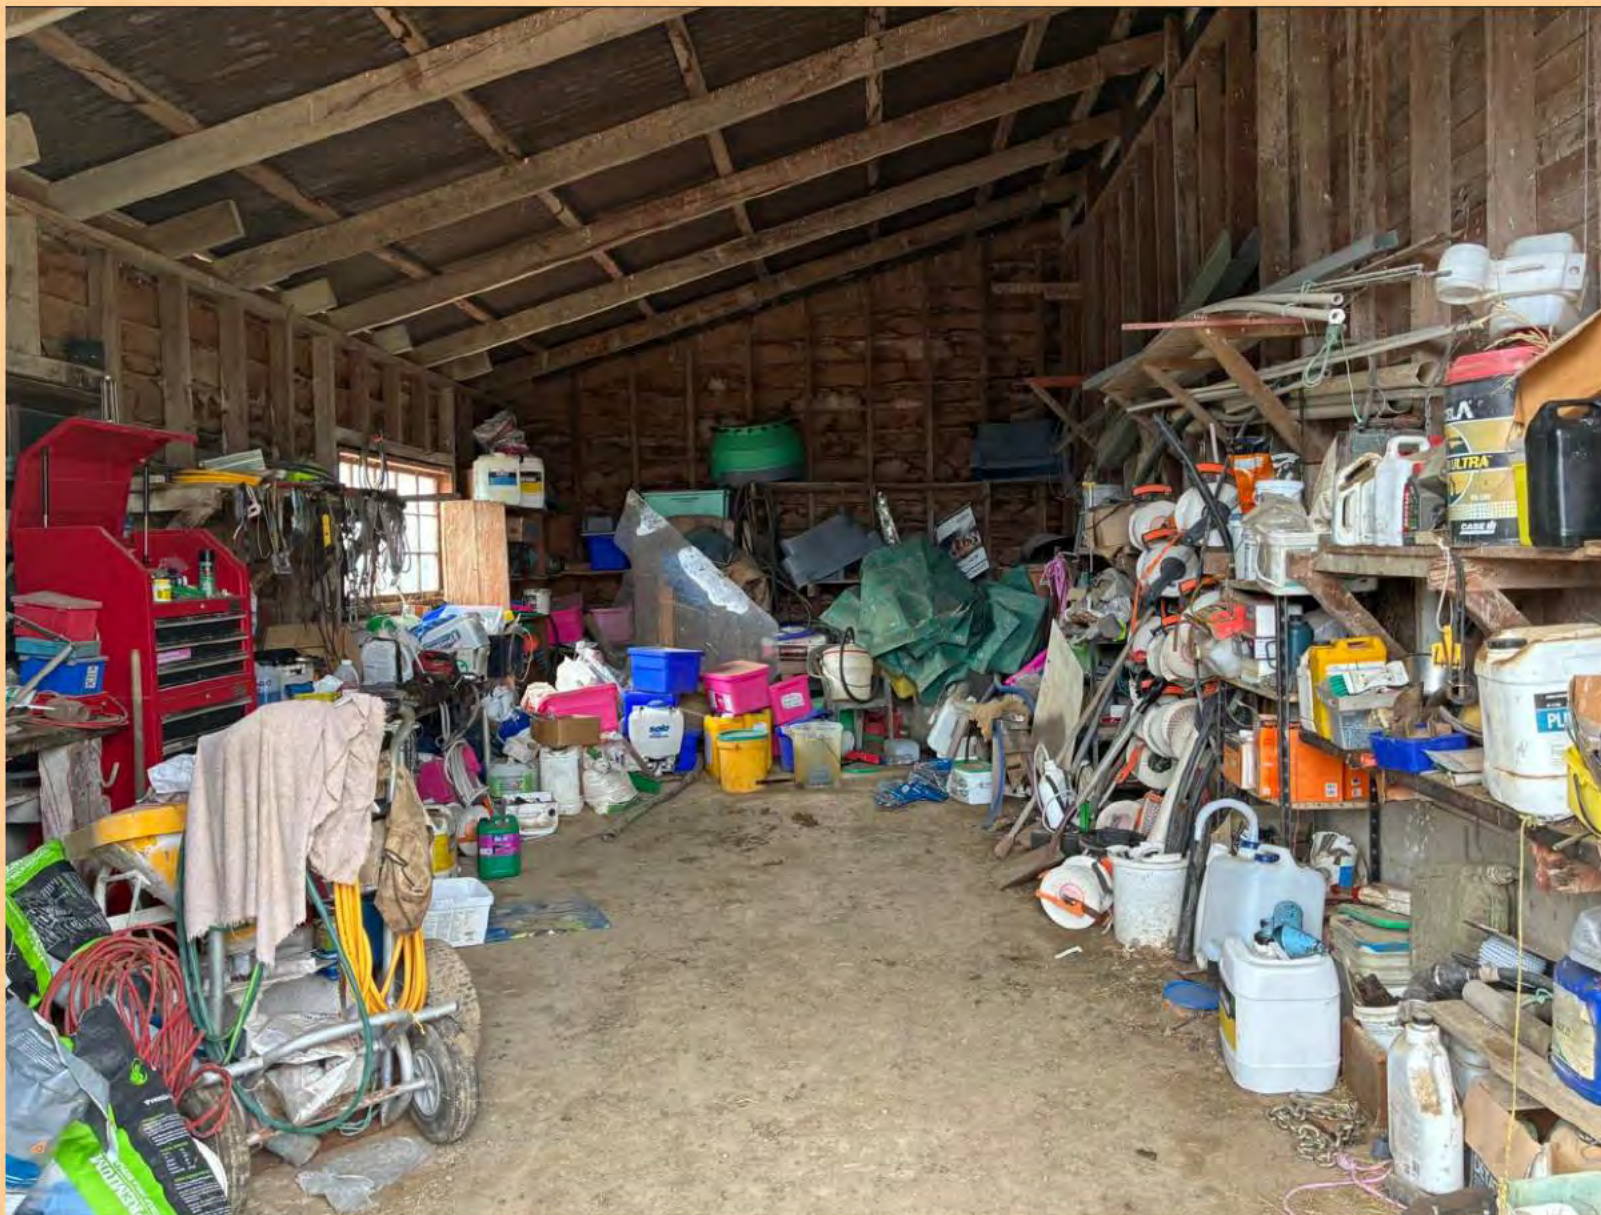
06 Duncan
Farm:
Storage
Shed

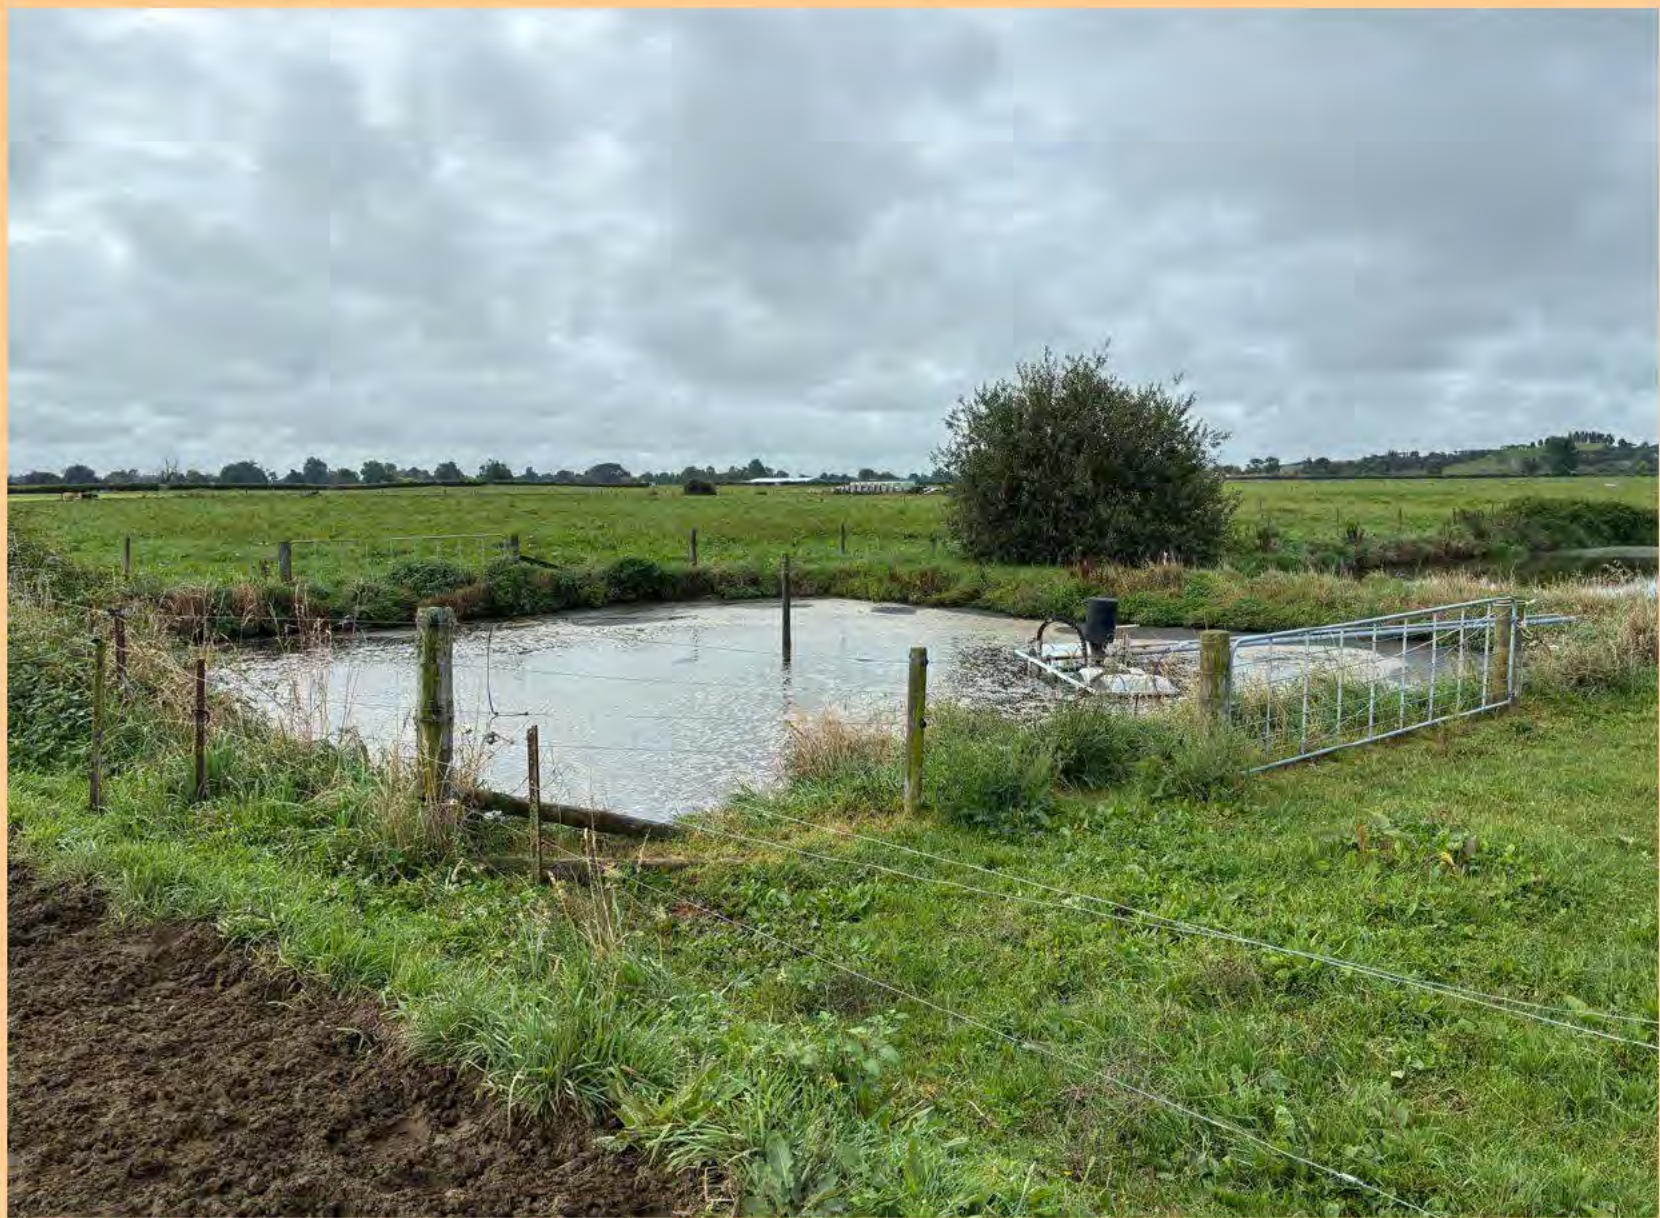
08 Duncan
Farm:
Effluent
pond

Based on this the effluent ponds have been discounted as an activity on the HAIL for this investigation (although has been noted as a potential impact at the Site in Table 12.

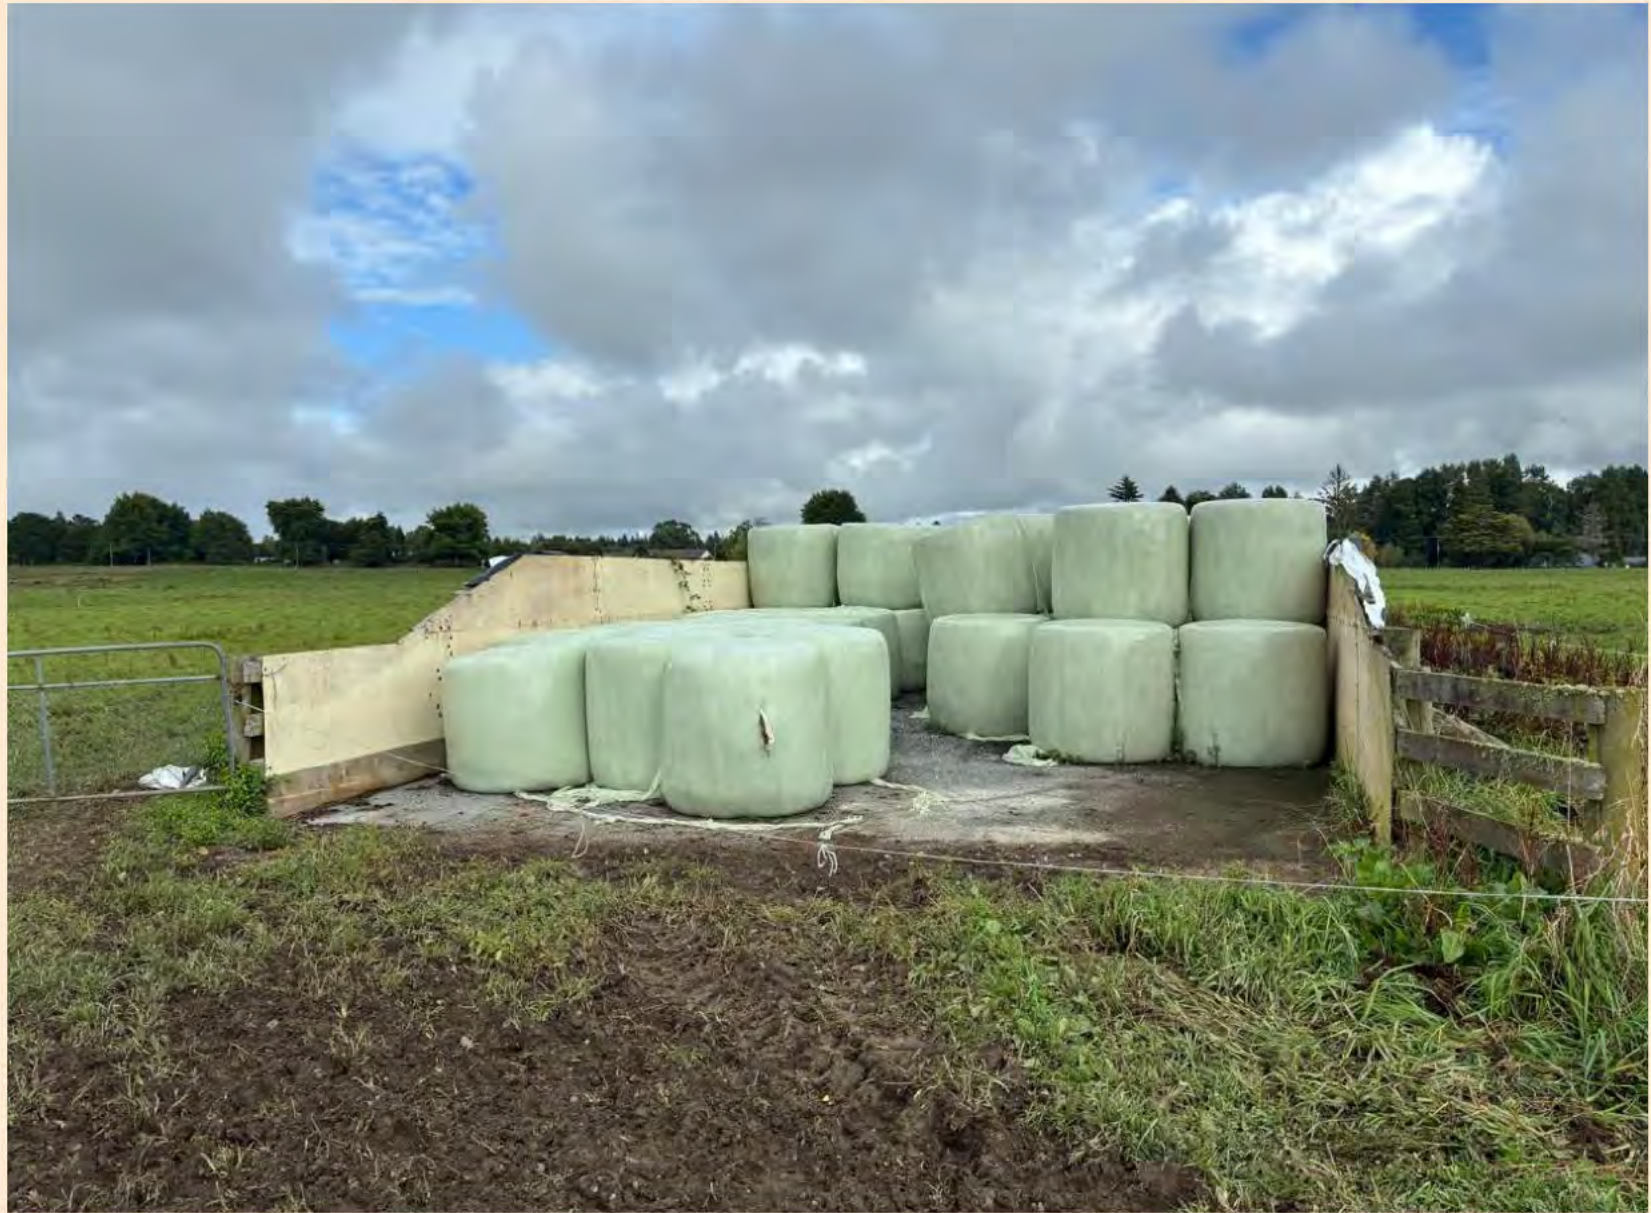
09 Duncan
Farm: Silage
bunker
