PRELIMINARY SITE INVESTIGATION

Waikato Thoroughbred Racing Greenfield Hub

Preliminary Site Investigation Report

23-1883 Waikato Thoroughbred Racing New Racecourse – Pencarrow Road

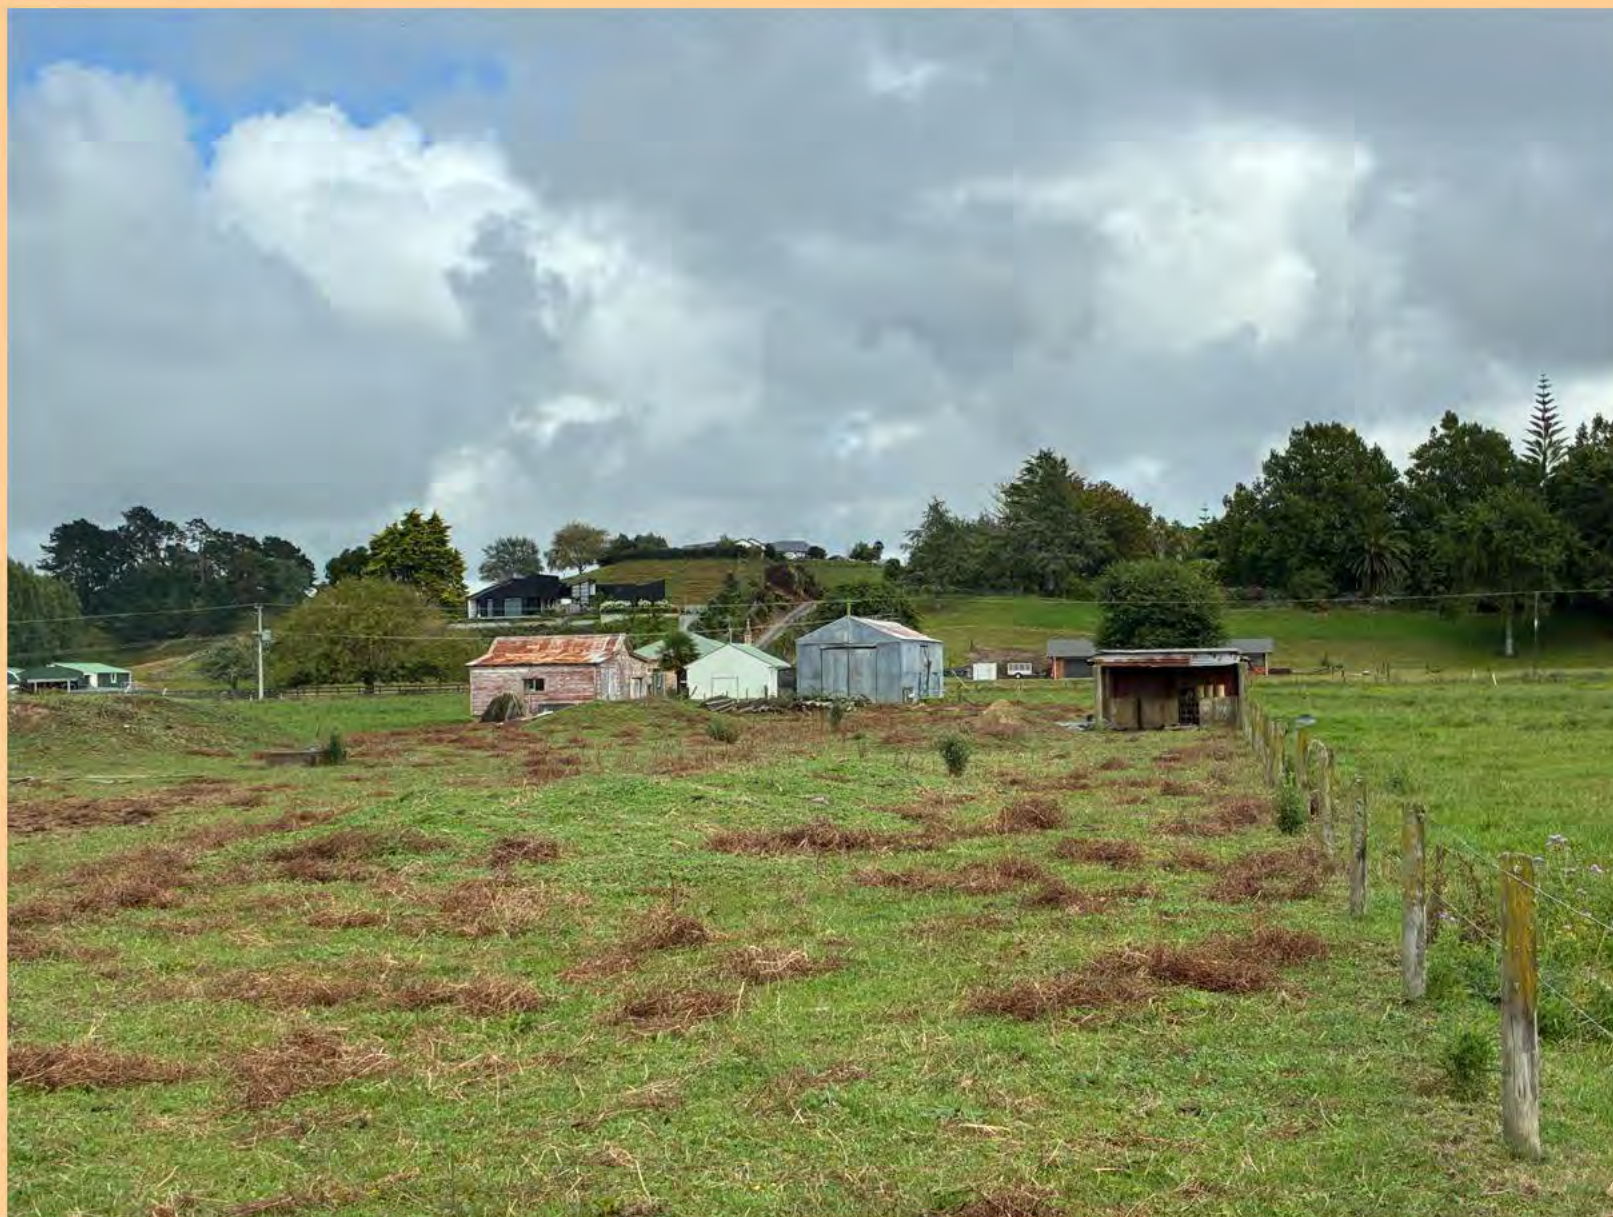
10 Duncan
Farm:
Paddock 36
buildings

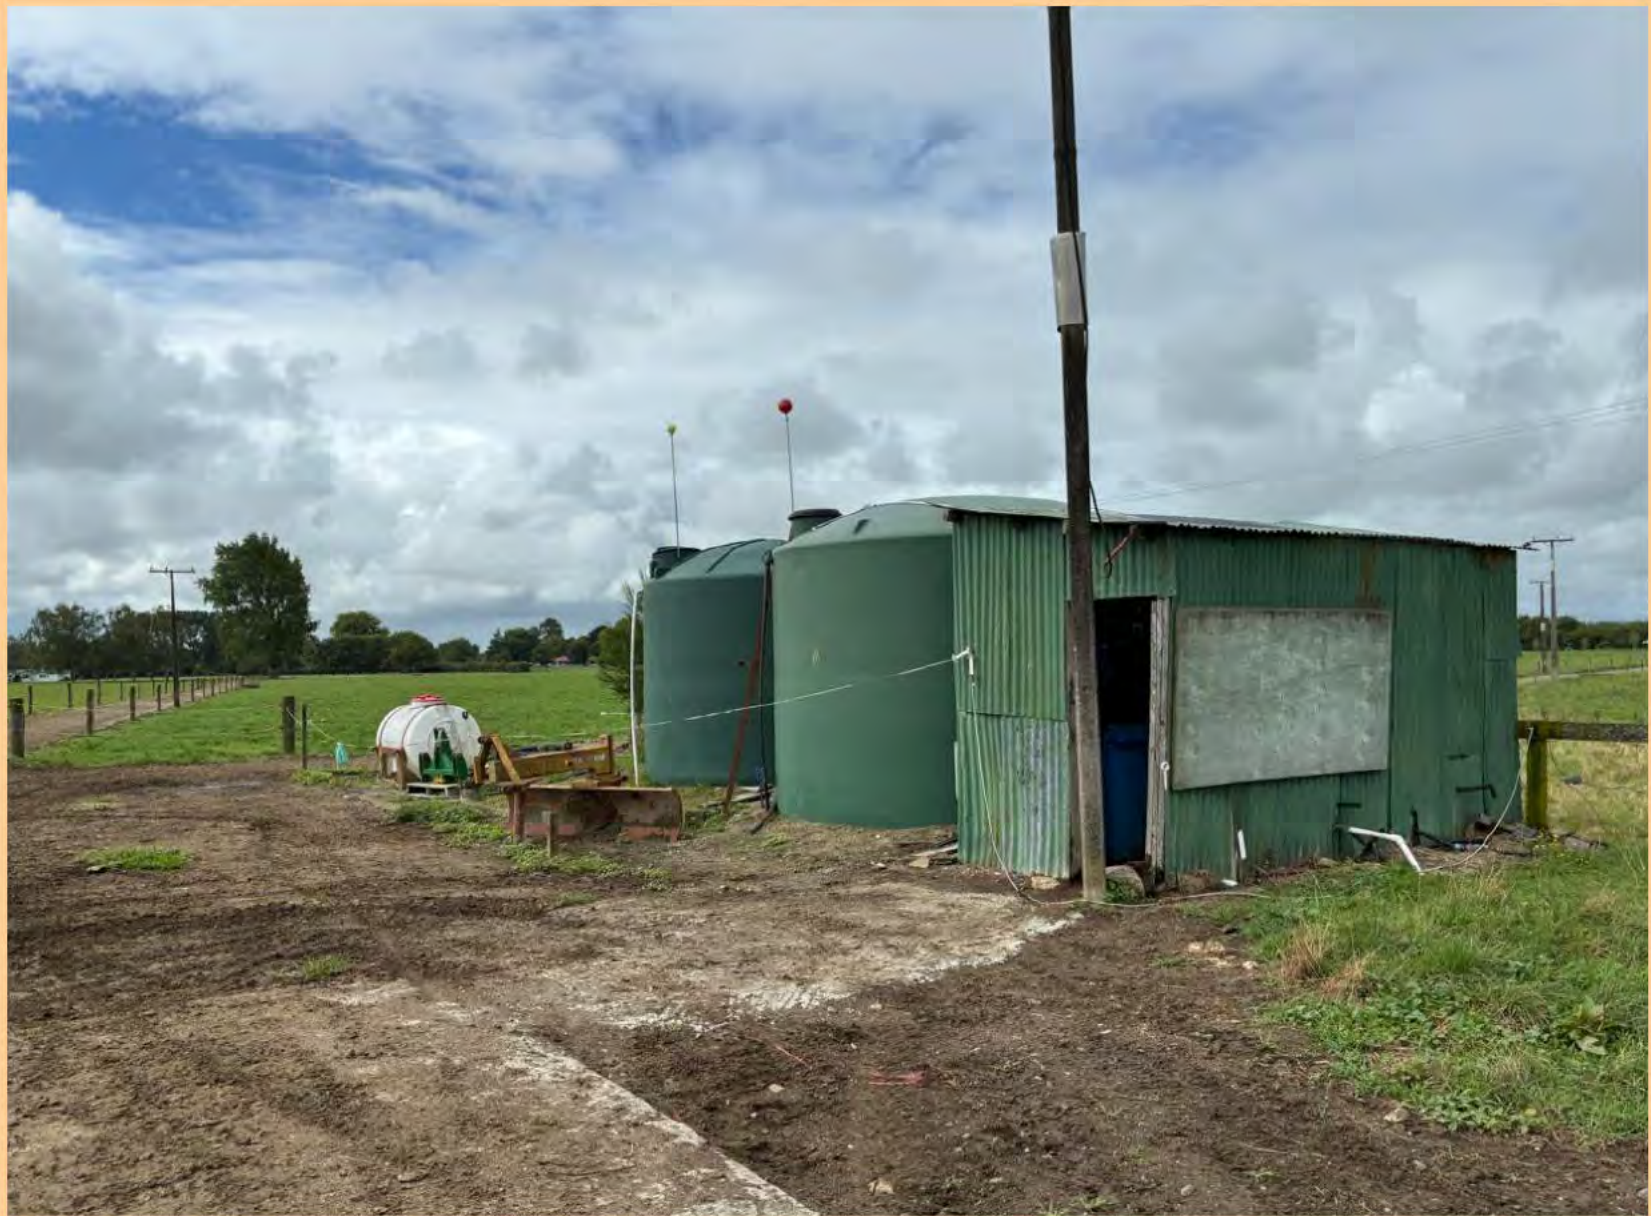
20
Montgomeri
e Farm:
Pump shed

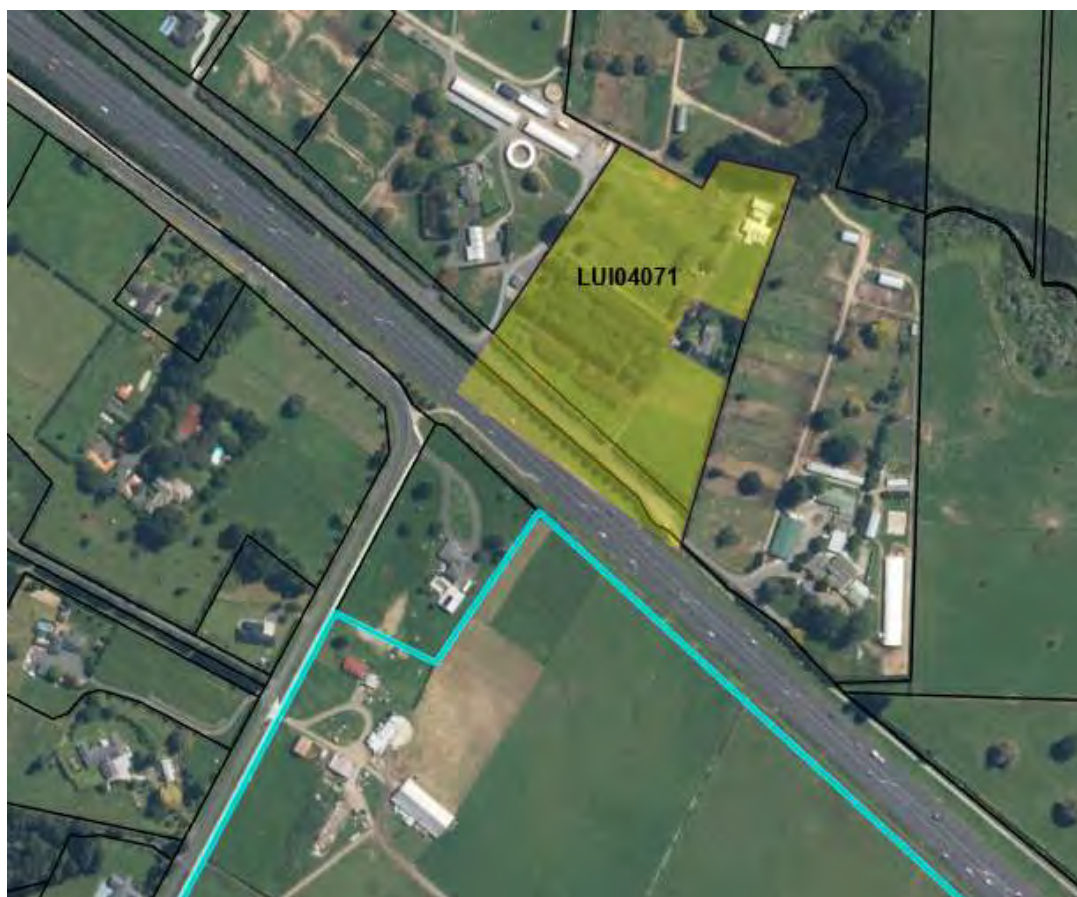
The area shaded yellow above (LUI04071) appears on the Land Use Information Register with a classification of 'Verified HAIL – Limited Sampling' due to current land use for HAIL activity 'A10. Persistent pesticide bulk storage or land use (unknown – present)' associated with Strawberry Fields.

Very limited sampling included as part of Cambridge Expressway works. Reporting not sufficient to determine whether the land is or is not contaminated. See DM refs #3775113, #3775118 & #3775121 - [REQ225178 - Sampling reports](#)

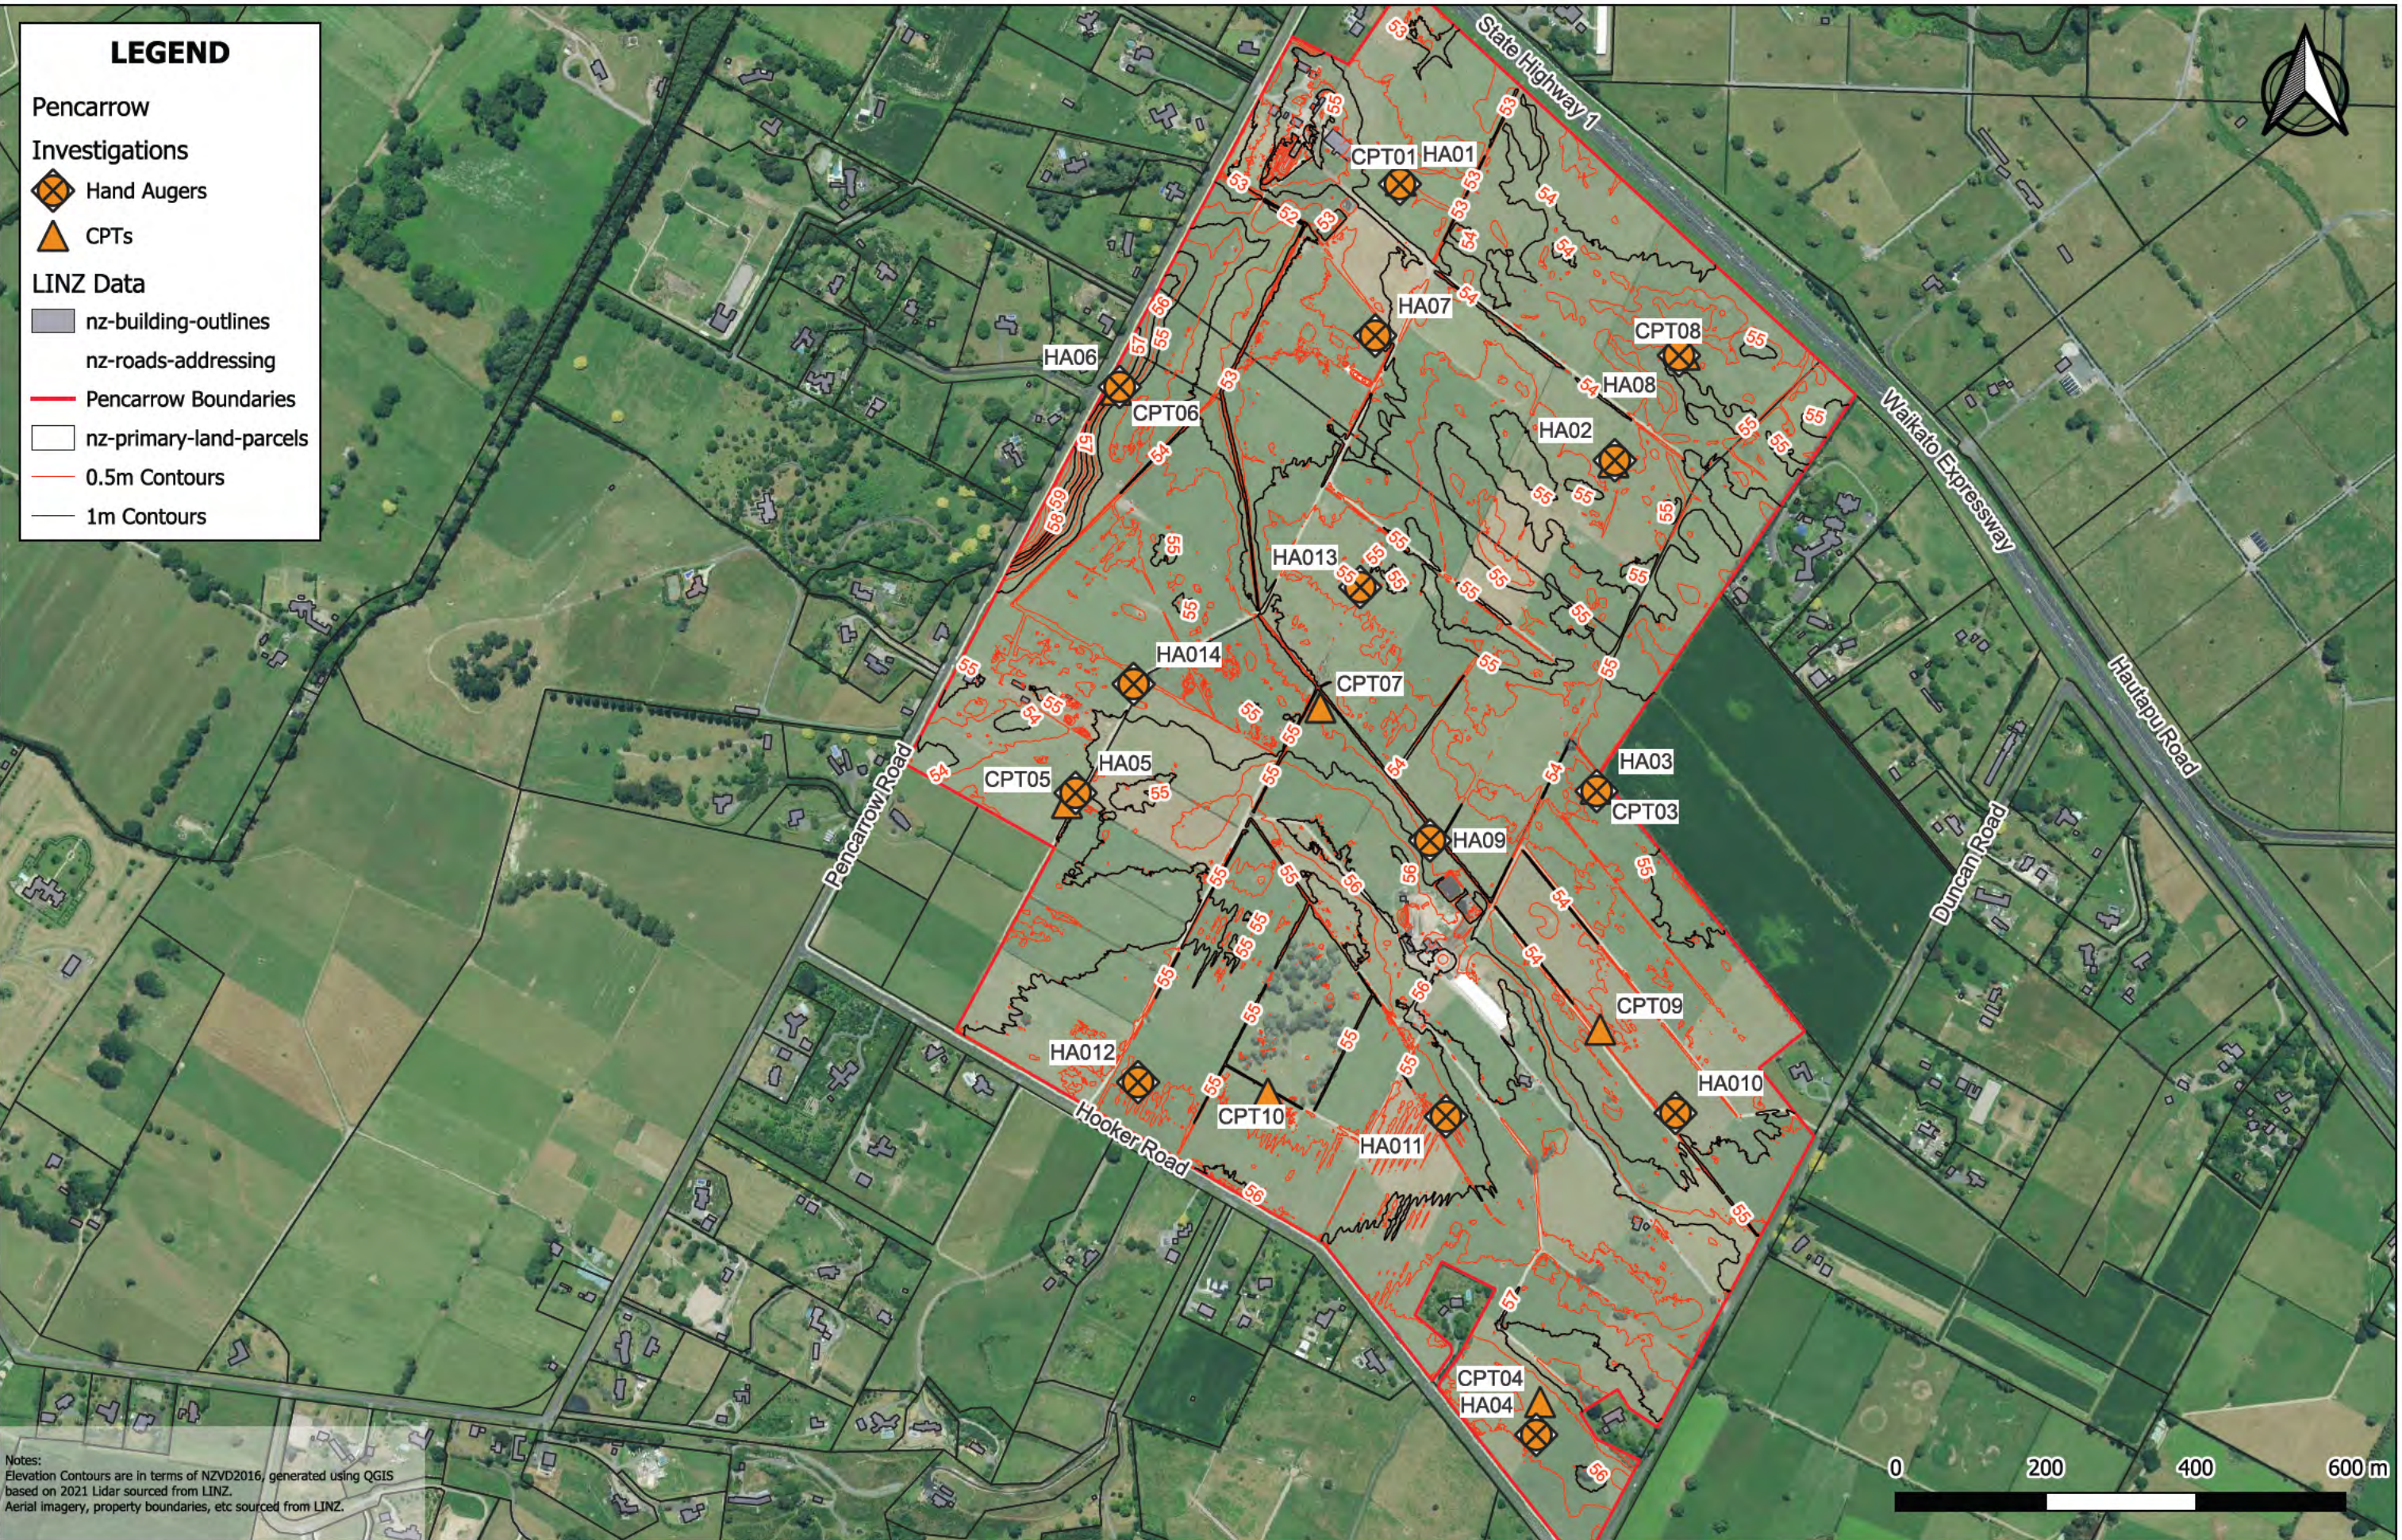
Appendix H Sampling locations

Notes:
The maps are based on results of discrete points and are subject to change with additional investigations.

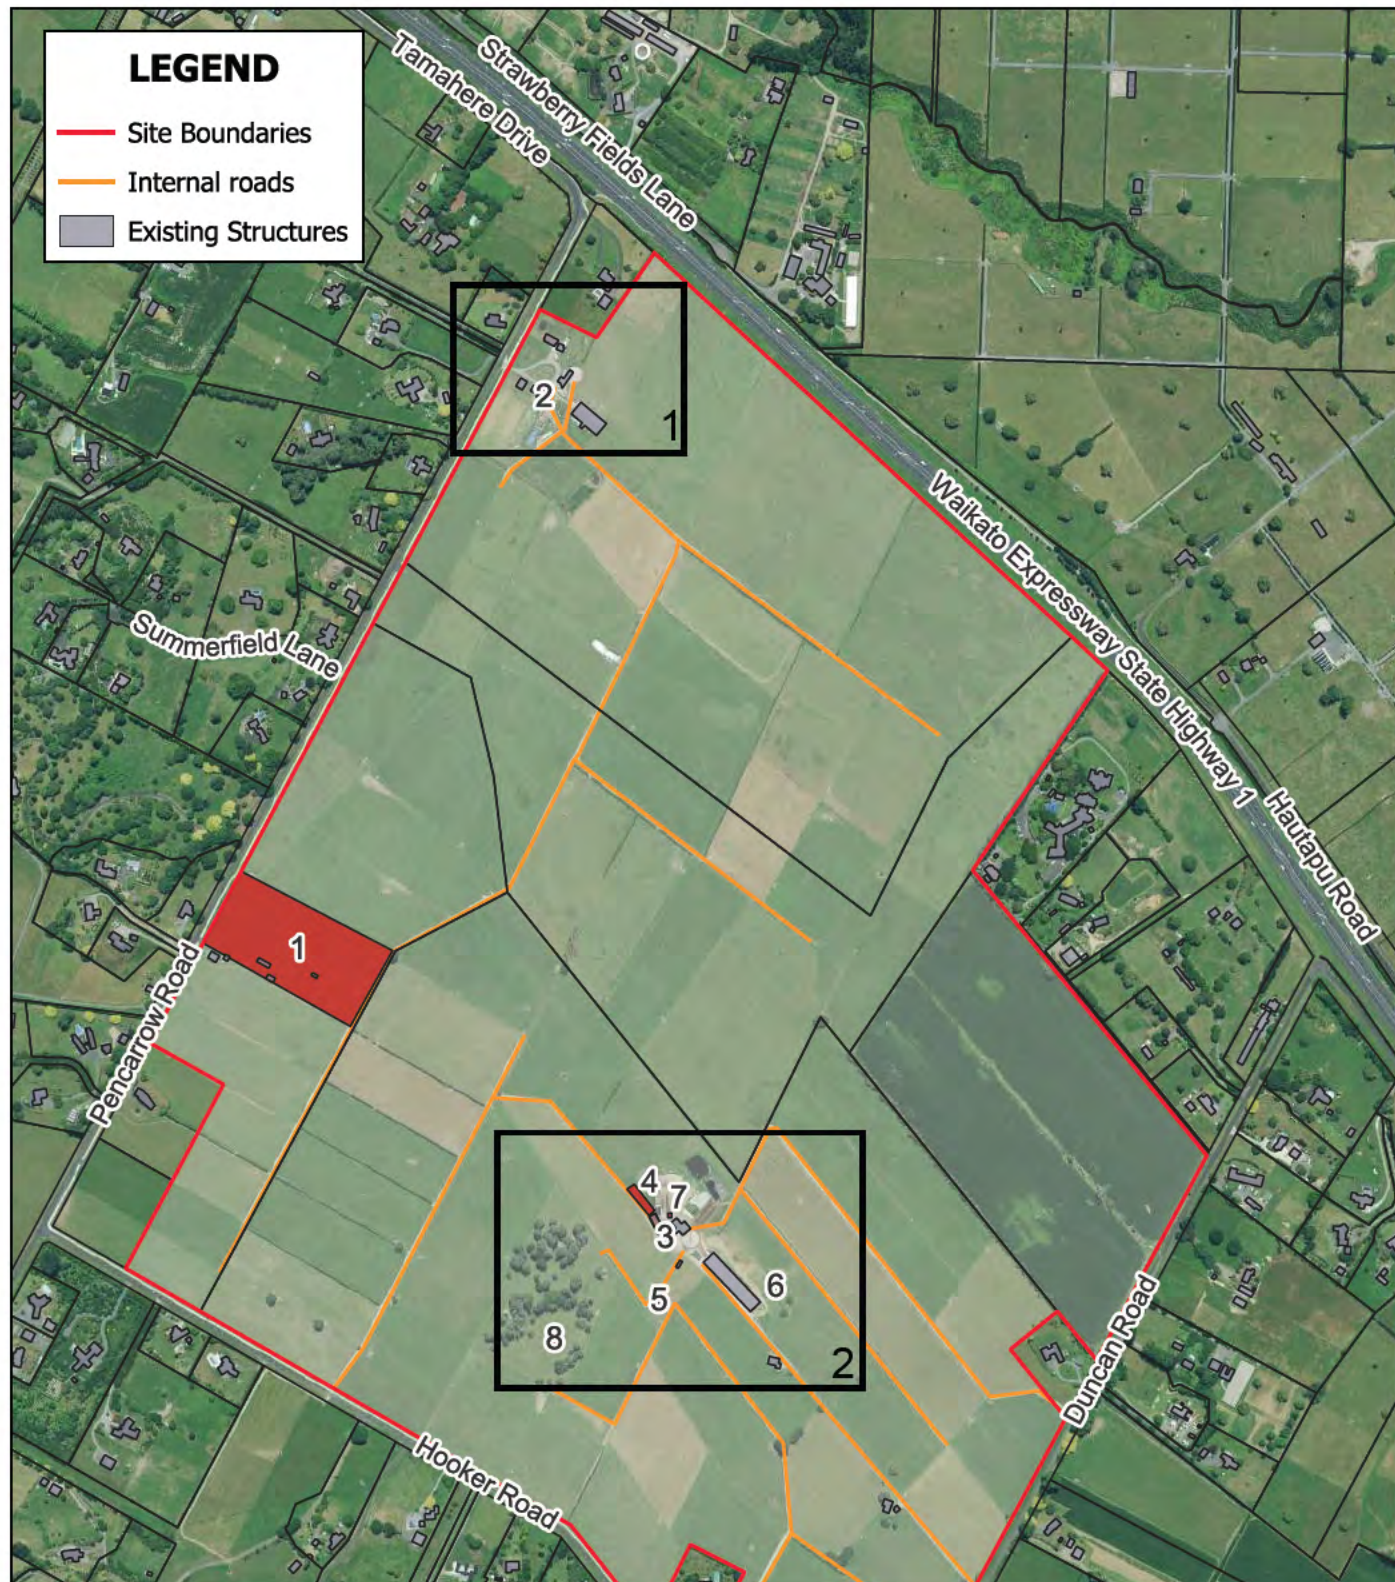
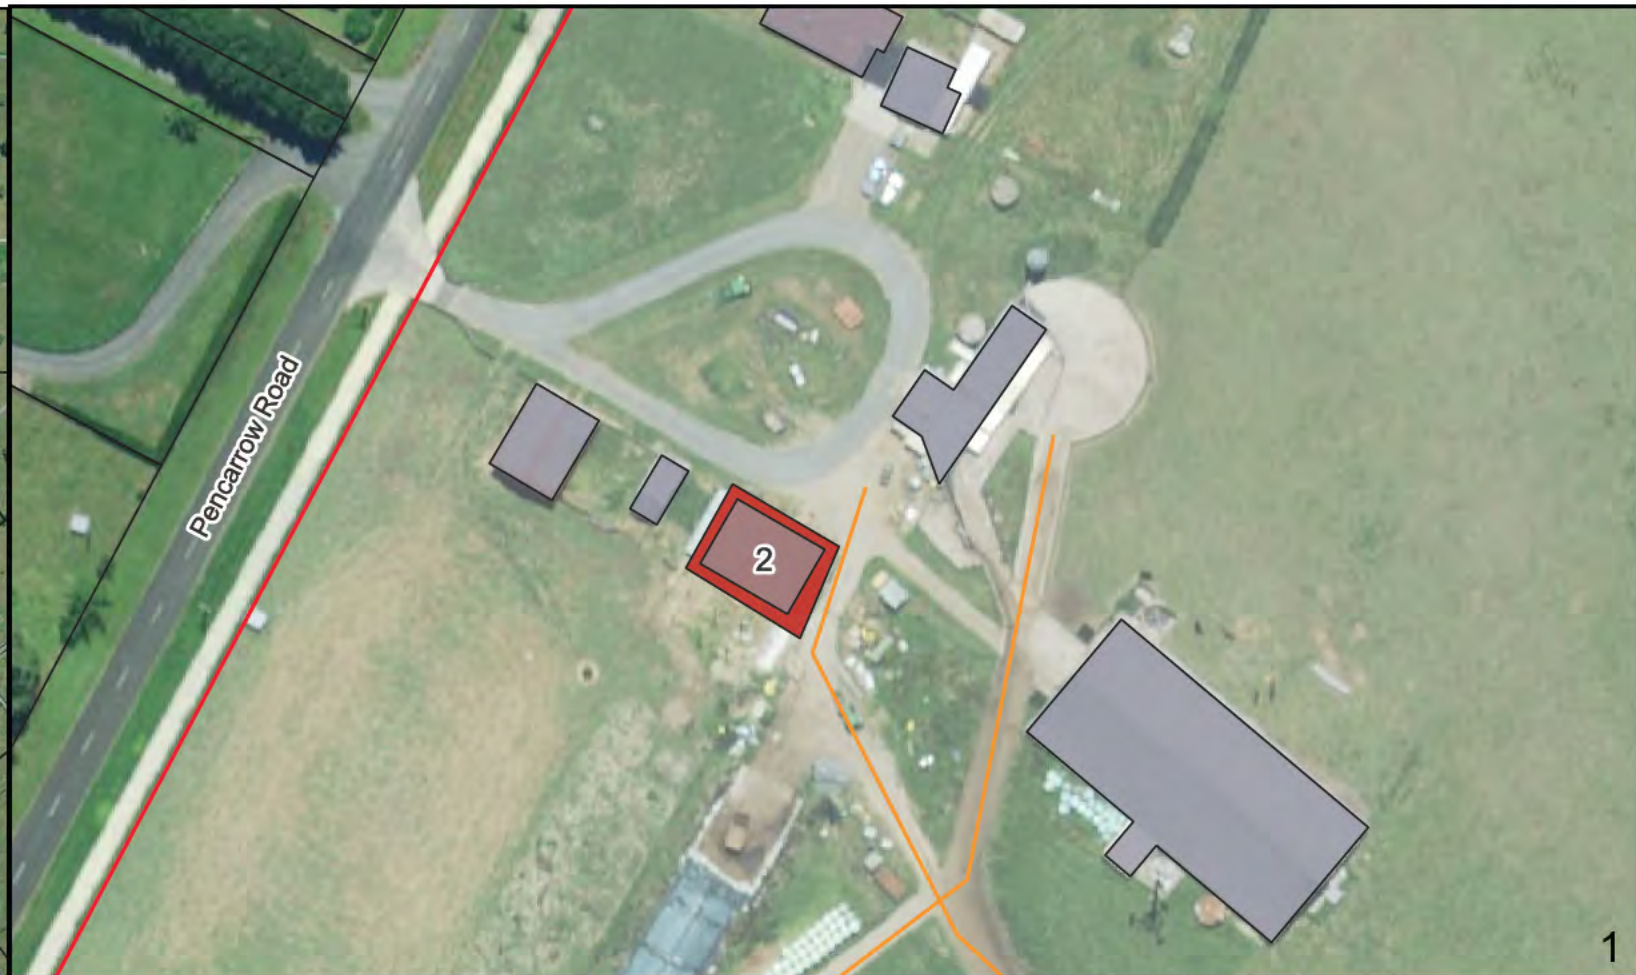
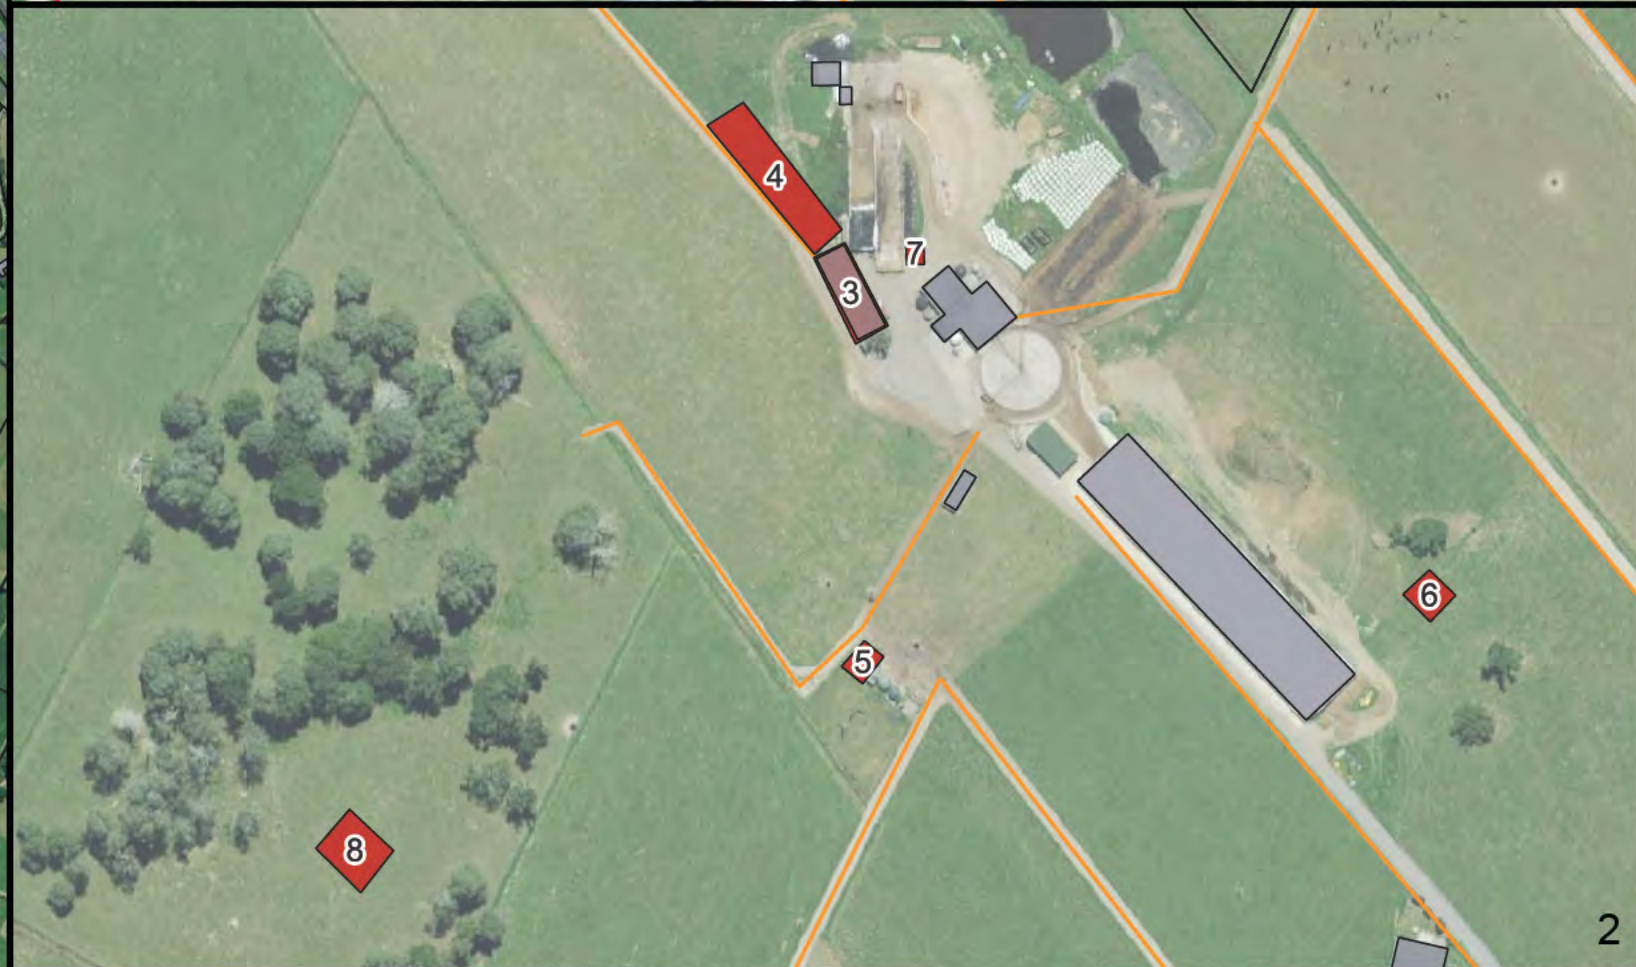
Appendix J HAIL locations

HAIL ID	Activity description
01	Farm dump located in Paddock 36 of the Duncan property
02	Storage shed and fuel tanks
03	Vehicle shed
04	Offal pit
05	Offal pit
06	Offal pit
07	Fuel storage tanks
08	Burn pile
