# Graymont South-Western Pit – Geology and Soil Report

Graymont (NZ) Ltd

✦ June 2026

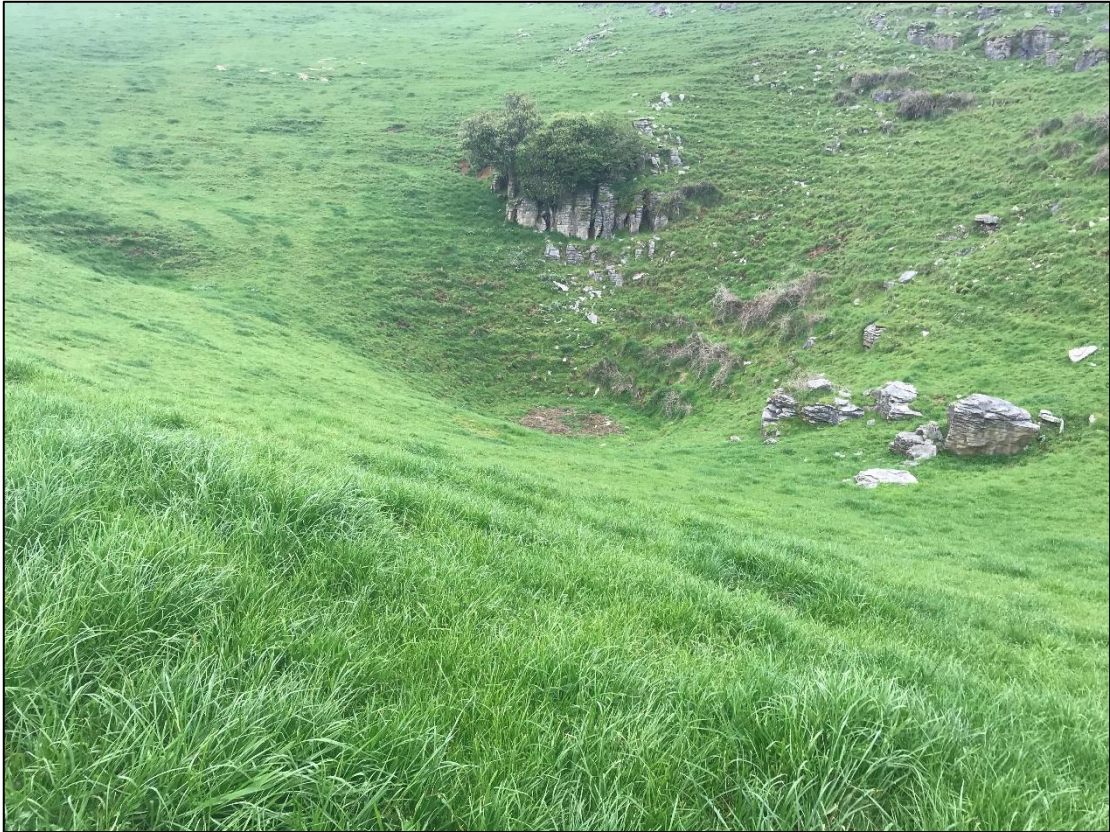
**Photograph 1: Karst and Doline (Sample location 6329, Figure 3)**

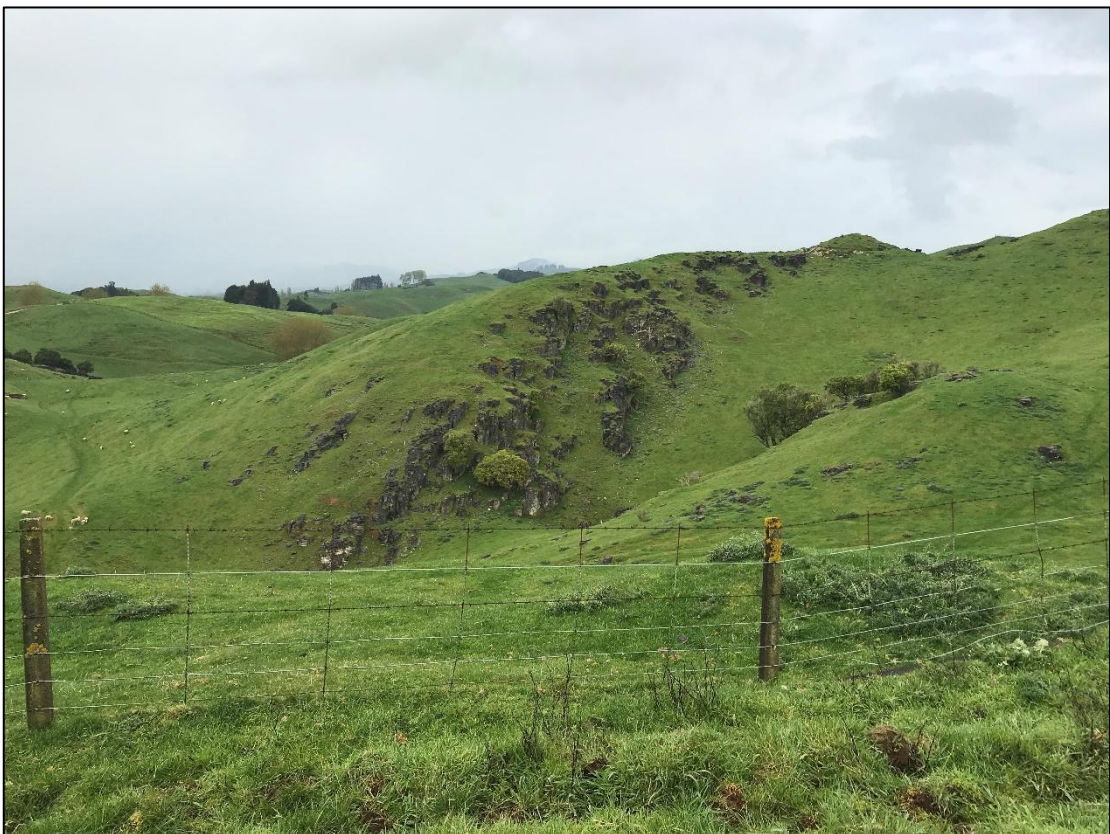
**Photograph 2: Karst (Sample location 6349, Figure 3)**

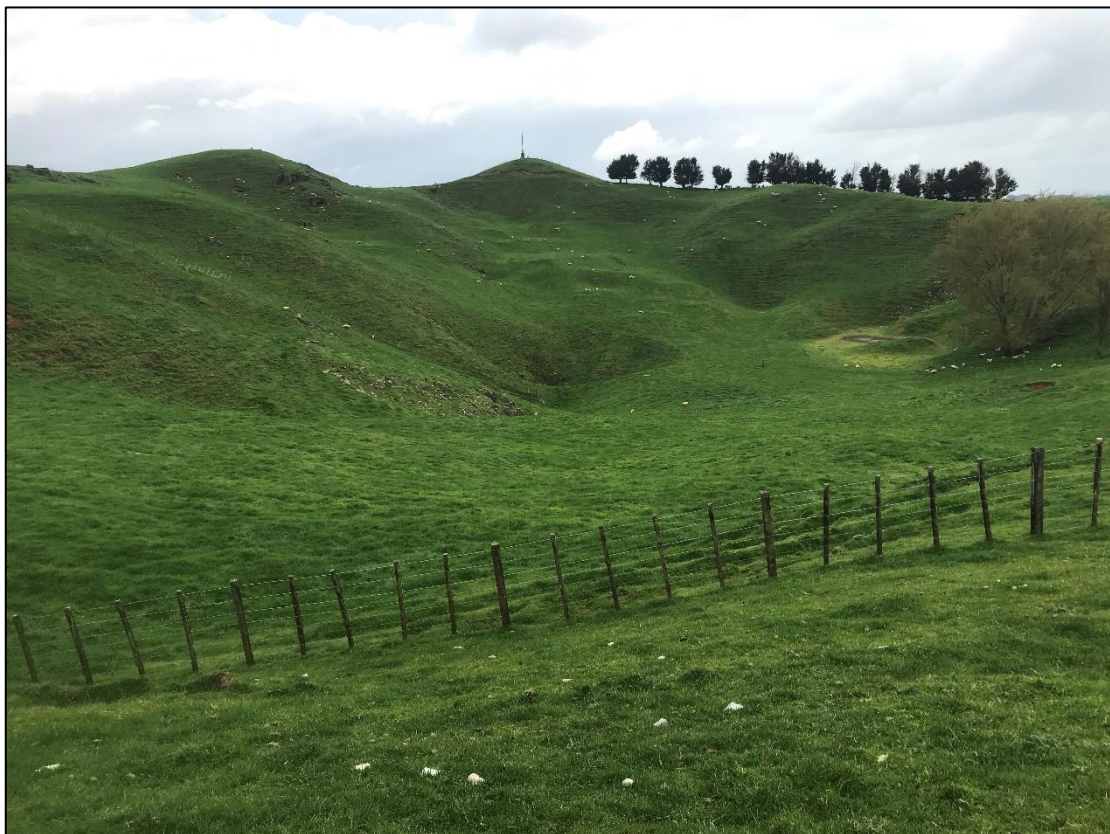
**Photograph 4: Landslide – Hummocky Ground and Dolines (Sample location 6383, Figure 3)**

The main geomorphic distinction in the South-Western Pit area to the Oparure Pit area is the limited mapped Taumatamaire Formation (mudstone) cover overlying the Otorohanga Limestone. The mudstone is present in the north of the project area and localised landslide features can be observed on the larger slopes (Photograph 4, Appendix B).

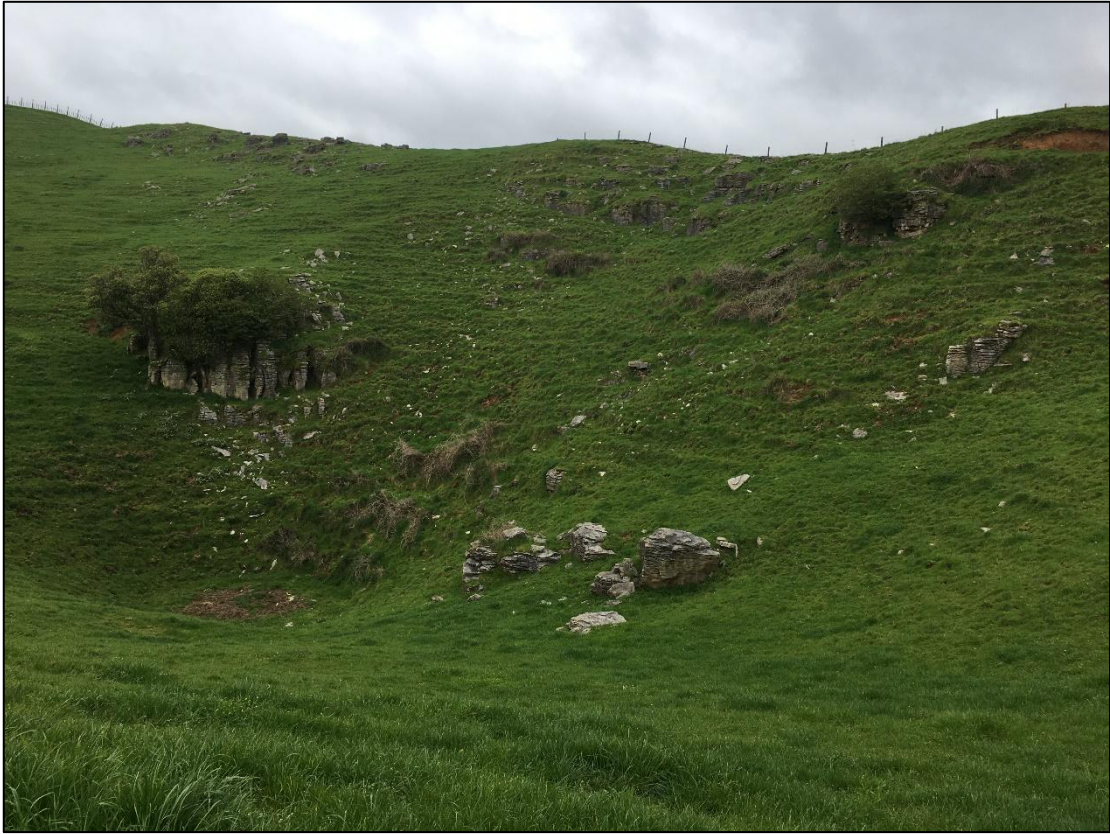
**Photograph 5: Pakeho Polygonal Karst (overview image)**

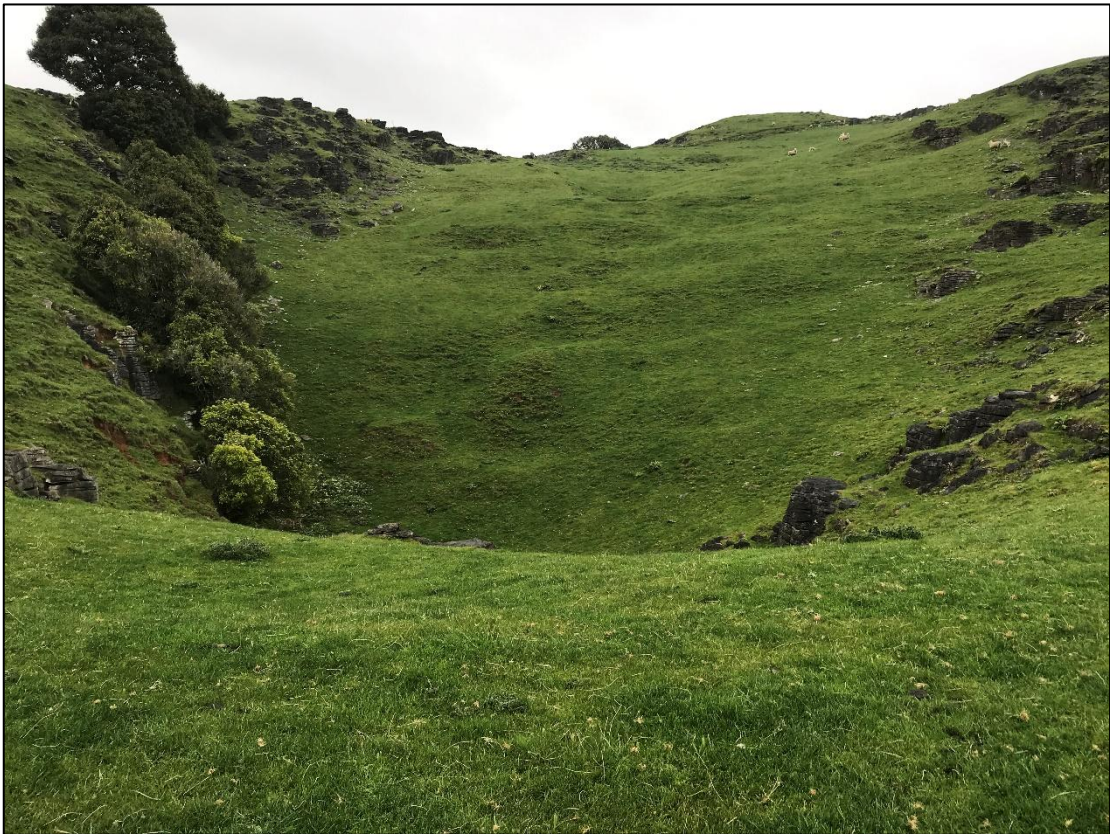
**Photograph 6: Pakeho Polygonal Karst (overview image)**

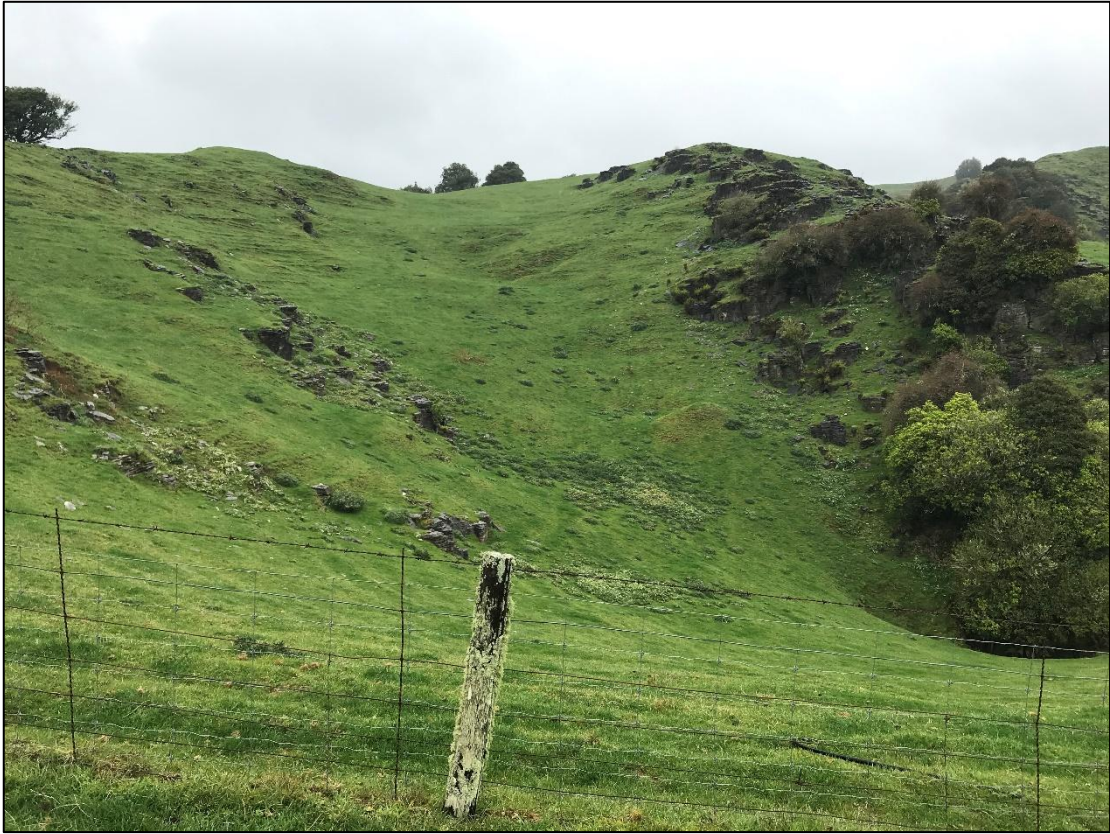
**Photograph 7: Pakeho Polygonal Karst (overview image)**

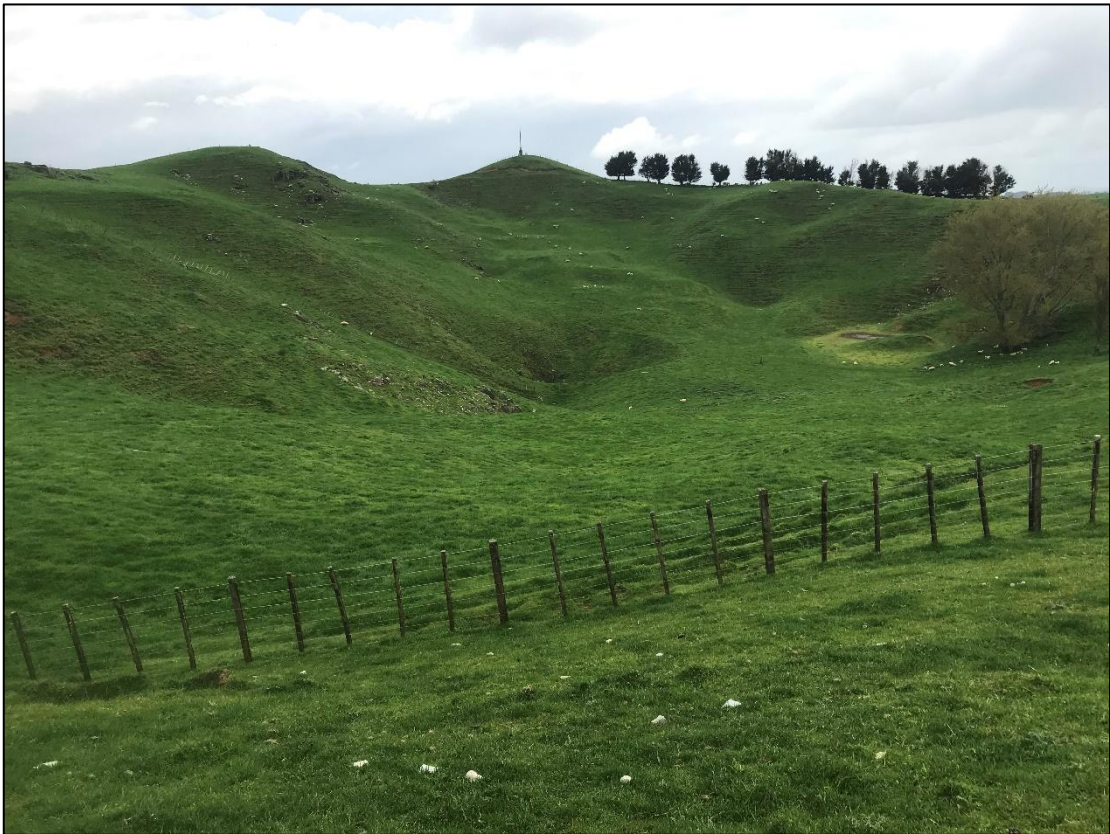
**Photograph 8: Pakeho Polygonal Karst (overview image)**

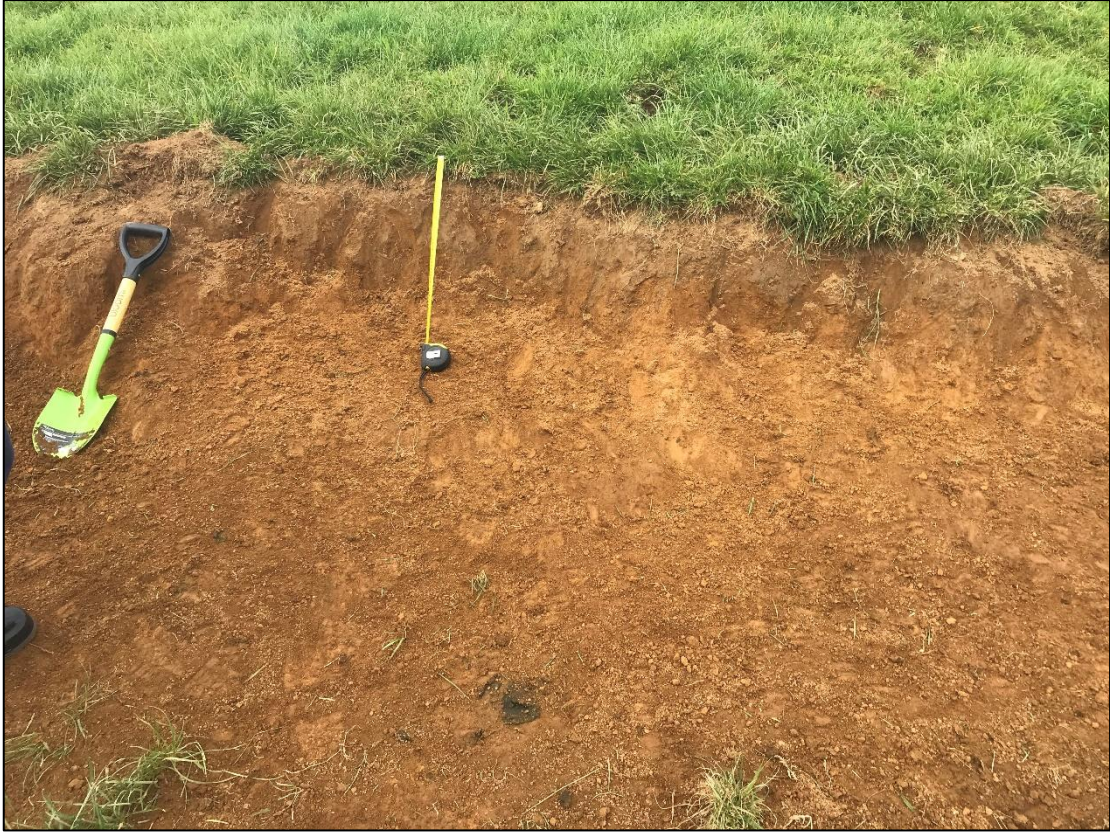
**Photograph 1: Soil profile (sample location 6324, Figure 3)**

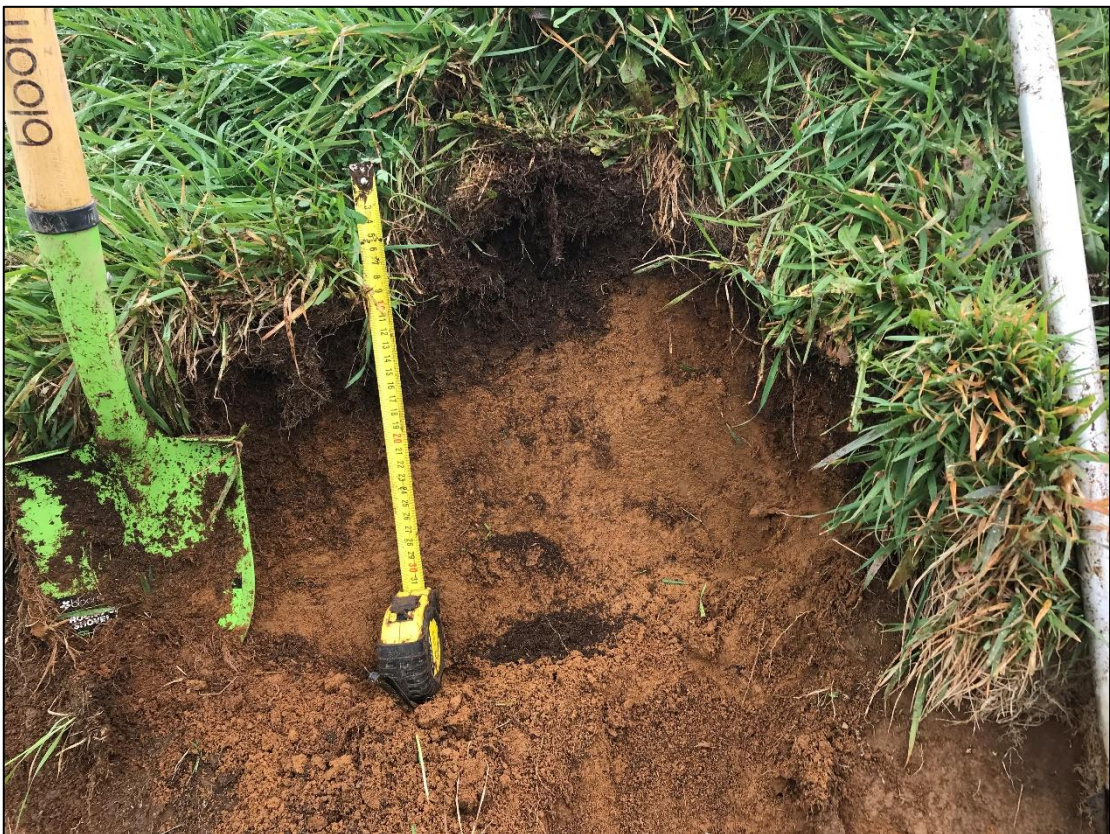
**Photograph 2: Soil profile (sample location 6350, Figure 3)**

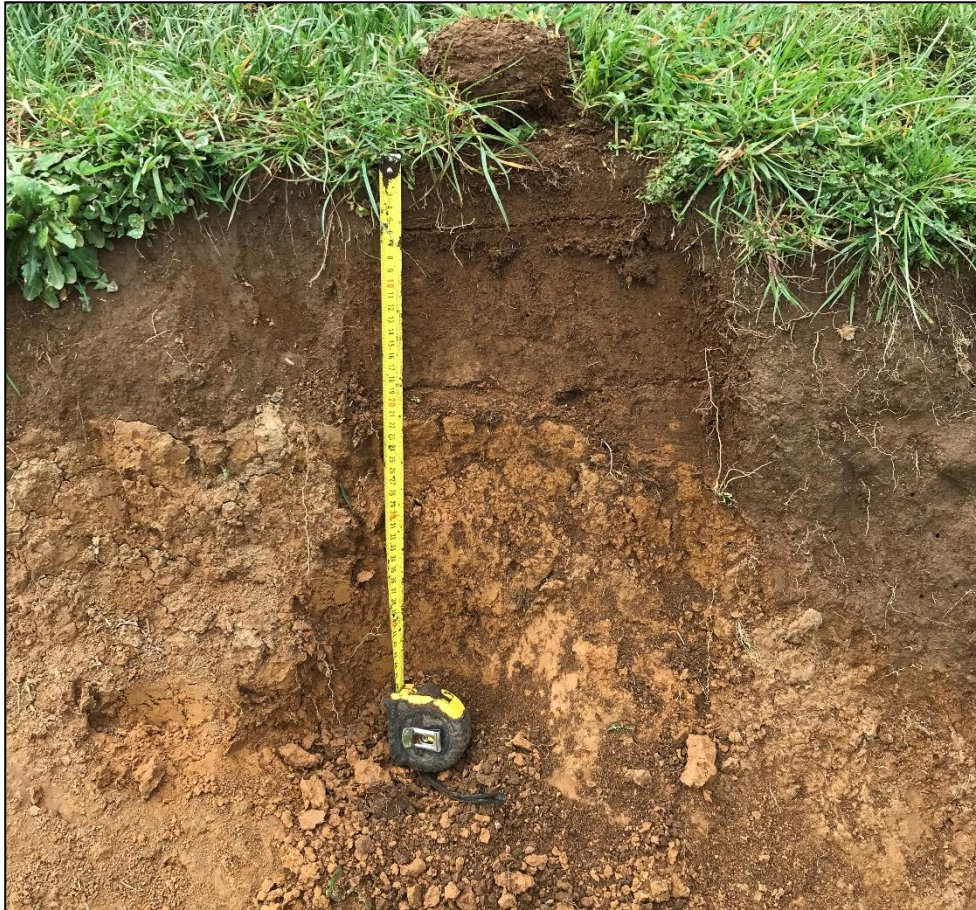
**Photograph 3: Soil profile (sample location 6353, Figure 3)**

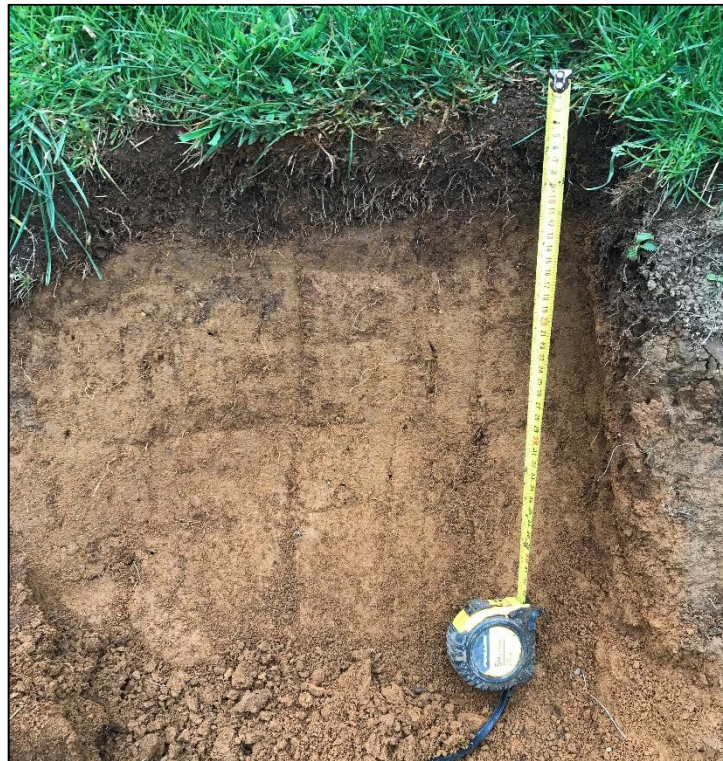
**Photograph 4: Soil profile (sample location 6378, Figure 3)**

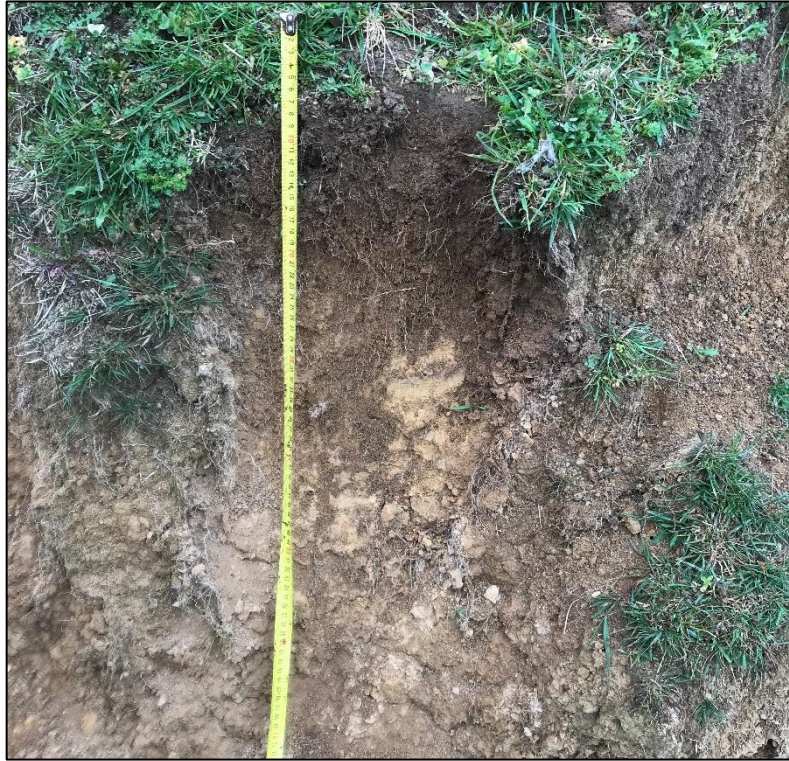
**Photograph 5: Taumatamaire Formation mudstone (sample location 6386, Figure 3)**

The Taumatamaire Formation (Mahoenui Group) is a weakly bedded to massive, calcareous fine to sandy mudstone. The formation was deposited in the Early Miocene and lies conformably on the Otorohanga Limestone. The contact of this unit with volcanic ash or Otorohanga Limestone was not observed during site investigations.

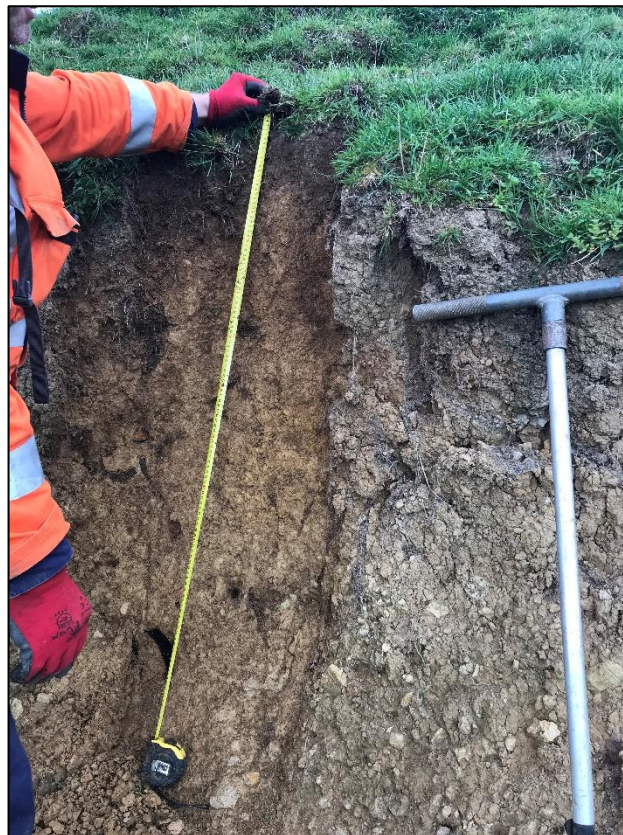
**Photograph 6: Taumatamaire Formation mudstone (sample location 6386, Figure 3)**

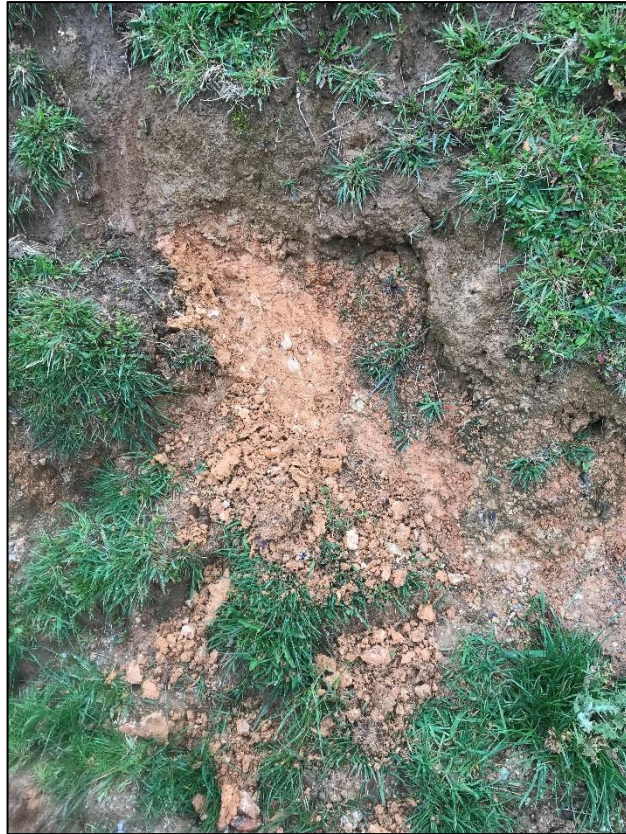
**Photograph 7: Weathered ignimbrite (sample location 6388, Figure 3)**

A thin layer of pinkish red weathered ignimbrite (inferred to be the Ongatiti Formation of the Pakamanau Group) was observed on an isolated ridge in the site area. In outcrop the weathered ignimbrite overlies the Taumatamaire Formation and underlies the volcanic ash.
