Appendix B Ross Reid Survey - May 2023

Appendix C

Earthworks Specification and Practical Completion
Certificate

Section 7 Drury Centre Bulk Earthworks: Earthworks **Specifications** Leading. Vibrant. Global.

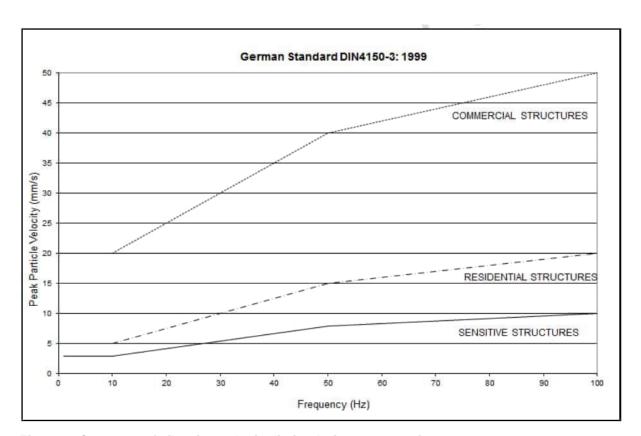
Figure 1: Summary of vibration velocity limits during construction

Construction vibration monitoring shall be undertaken to demonstrate that all vibrations to third party buildings or structures generated from construction activities are less than the maximum limits recommended in the German Standard DIN 4150-3:1999 "Structural Vibration – Effects of Vibration on Structures". In the first instance the Contractor shall undertake vibration monitoring at the property boundary. Additional monitoring inside the neighbouring property shall be undertaken where the vibration limits at the boundary exceed the above standard, or where complaints are received. Where access is granted such additional monitoring shall be undertaken either outside the building but connected to the building foundation, or inside the building. The peak particle velocity (ppv) limits which are to be applied are summarised in Table 1 and Figure 1 or as otherwise required by the Resource Consent.

The Contractor shall note that building occupants may notice or be disturbed by vibrations at levels lower than those cited in DIN 4150-3:1999 (i.e. vibration is perceptible at levels above 0.3 mm/s), which might give rise to complaints. This vibration is often due to occupants concern over building damage, and can generally be mitigated through effective consultation regarding the project objectives and timeframes, vibration monitoring and demonstration to the occupant that vibration levels are within acceptable levels. The Contractor shall take responsibility for liaison and discussions with neighbouring occupants to relay this information to them, and to keep them informed of construction activities and programme. On request of the Engineer, the Contractor shall provide vibration records to the occupants. The Contractor shall also take all practicable steps to minimise disruption to the occupants as much as possible.

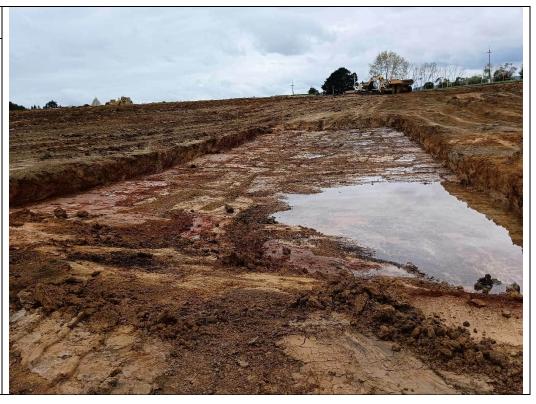
The perch water can be observed in the pit.

Shearvane readings ranged from 25 to 140+ kPa.

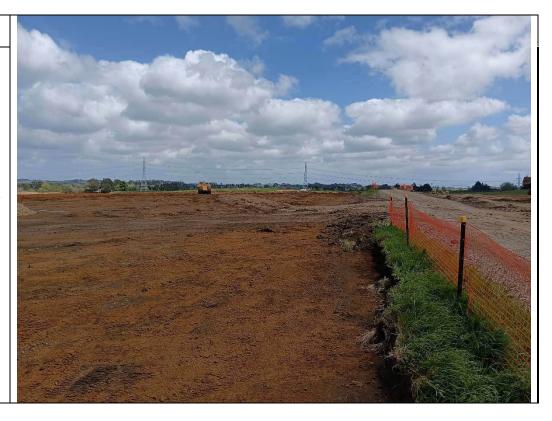
No soft spots are heaving observed during the inspection.

Approximately 3.0m cut to be actioned in the current area of inspection.

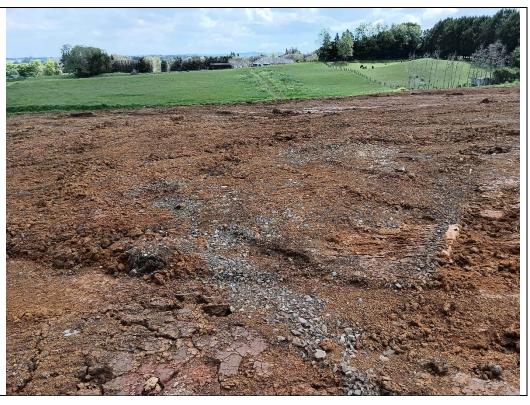
View of the gravel scattered below the topsoil was observed across the strip site.

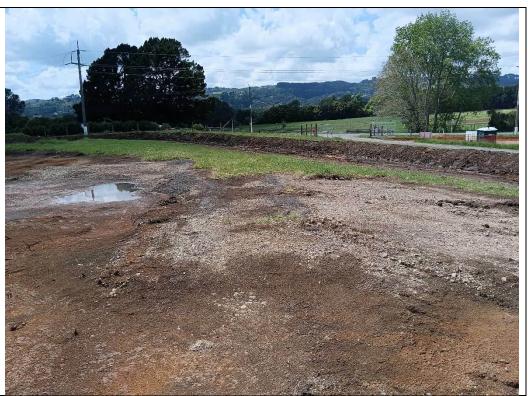
Gravel can be observed underneath the topsoil.

As per Reid contractors, the gravel layer to be excavated and placed on a stockpile deemed as unsuitable.

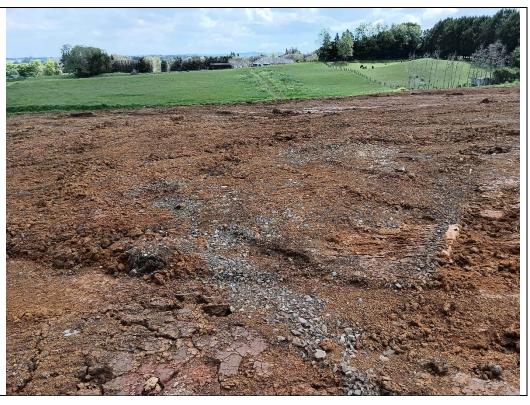
View of the gravel scattered below the topsoil was observed across the strip site.

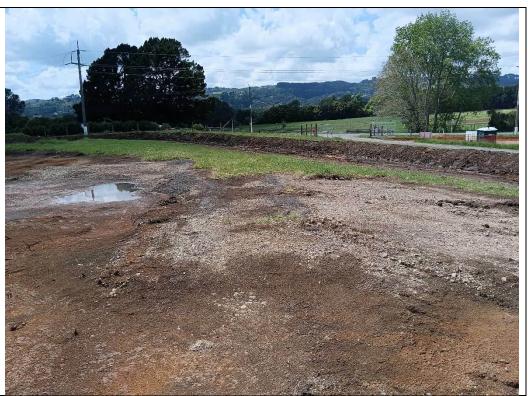
Gravel can be observed underneath the topsoil.

As per Reid contractors, the gravel layer to be excavated and placed on a stockpile deemed as unsuitable.

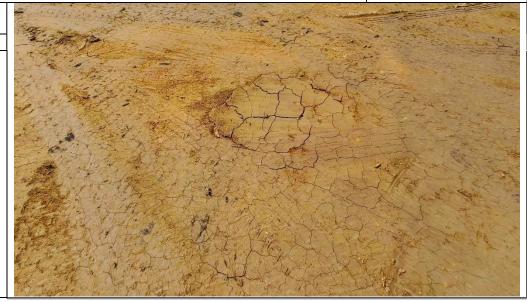
Cracking of subgrade, evidence of clayey soil.

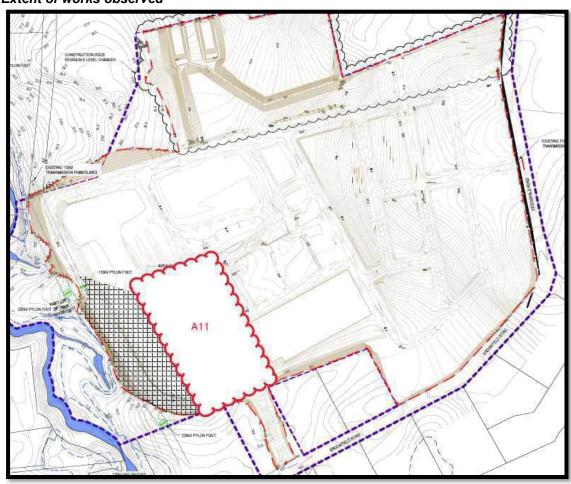
Figure 1: Extent of works observed

Area A11 – Underlying subgrade was firm underfoot, uniformly graded, and free of organics. This area is to be filled
