Drury Centre Project

Detailed Site Investigation

Kiwi Properties Holdings Ltd

Reference: 510611

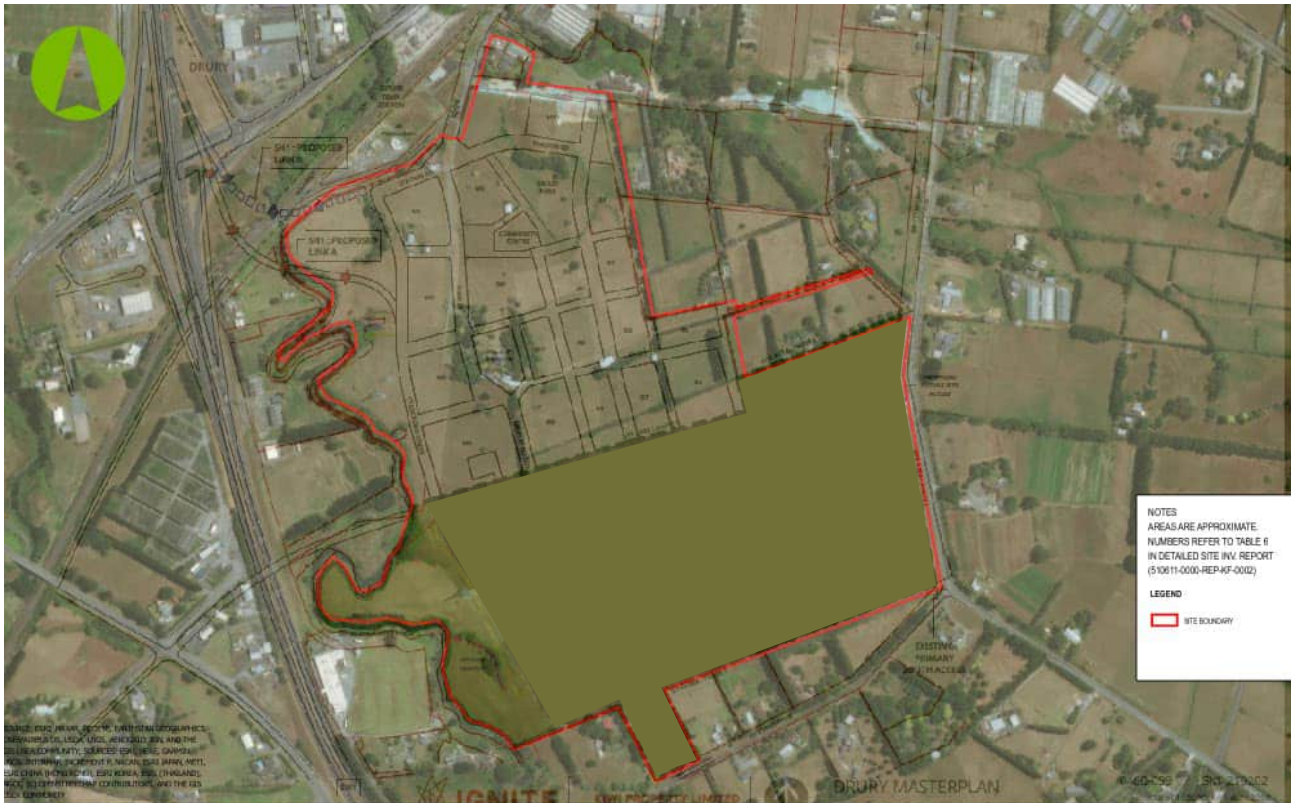
Figure 1 Site Layout with Stage 1 Extent

Kiwi Properties Holdings No.2 Limited (Kiwi Properties) have engaged Aurecon New Zealand Limited (Aurecon) to undertake a Detailed Site Investigation (DSI) at 64, 68, 108, and 120 Flanagan Road, 133 Fitzgerald Road and 97 Brookfield Road, Drury, Auckland (the site). A site layout reference plan is presented in Appendix A (501611_0200_DRG_KF_0001-A) and Figure 1 below.

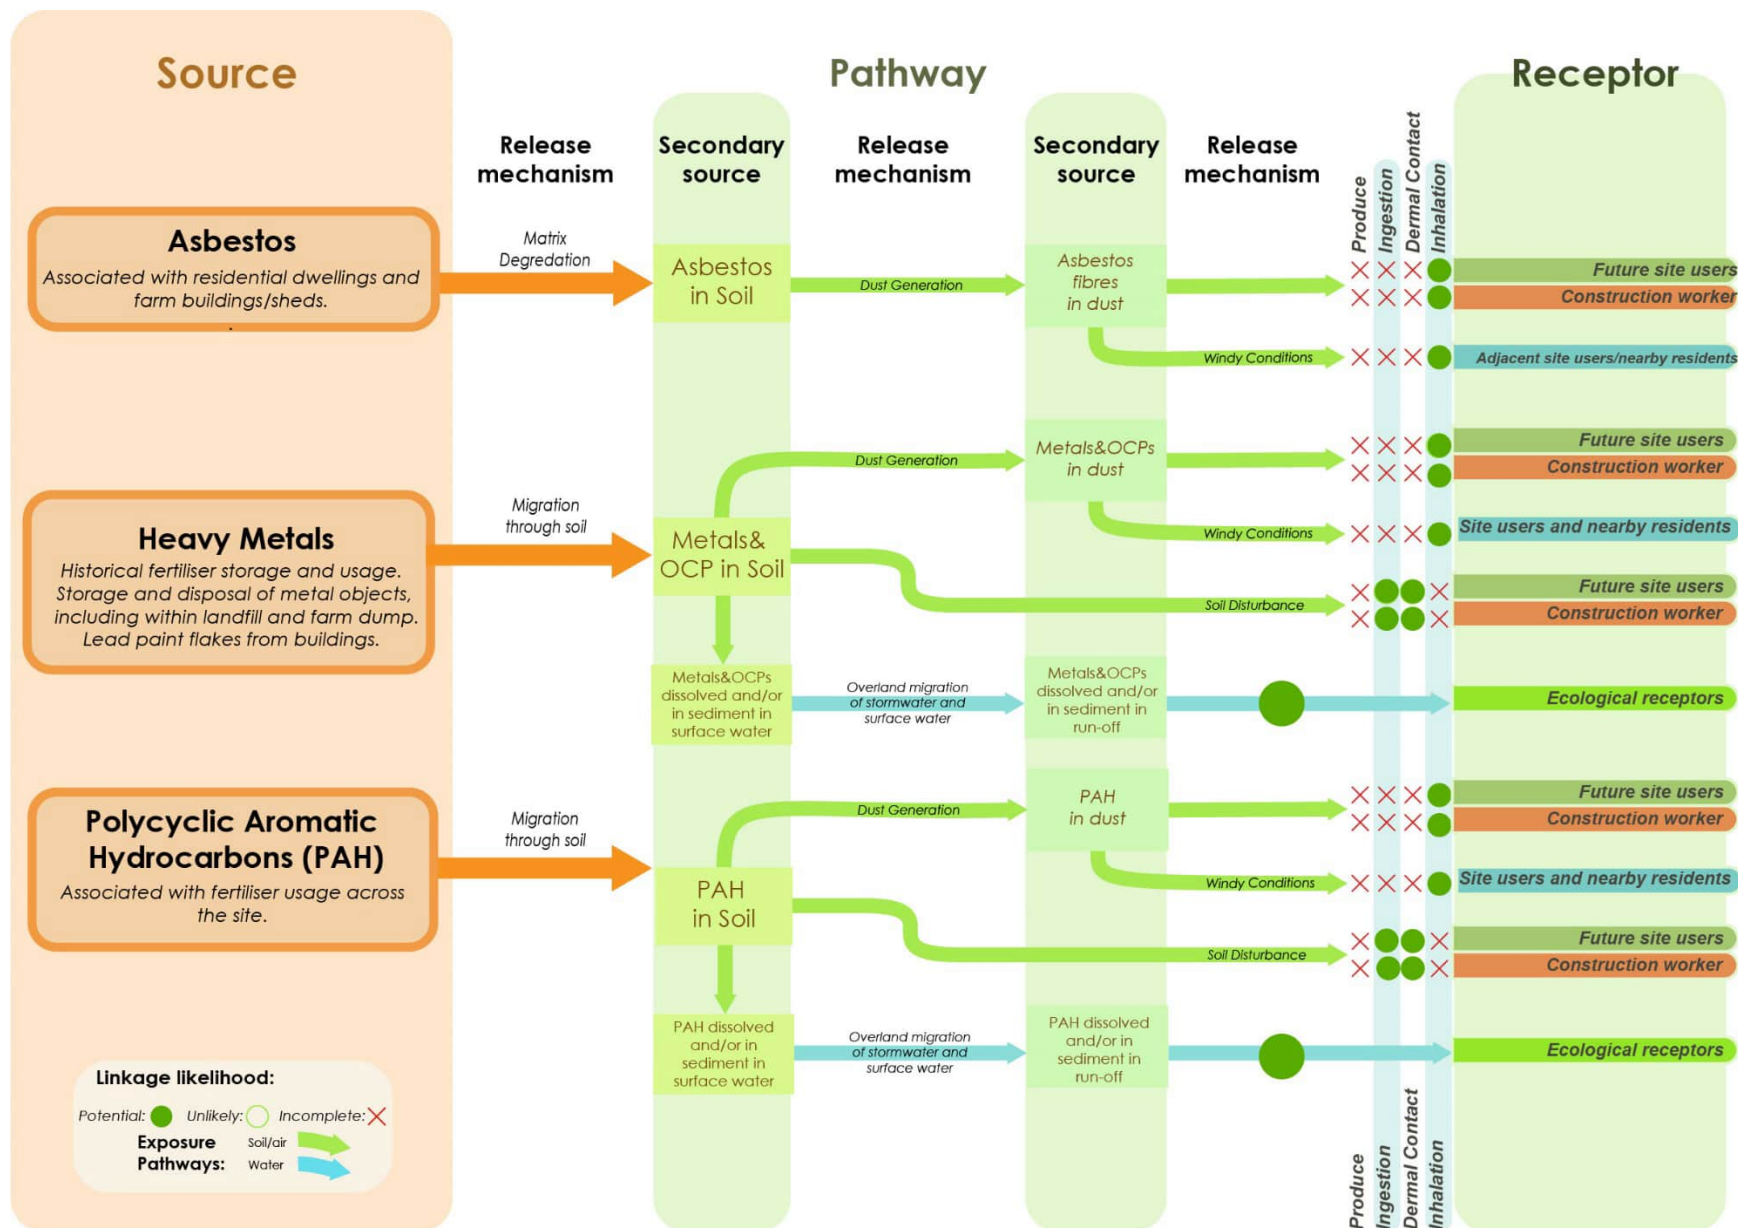
Figure 2 Conceptual Site Model

Based on the findings of this investigation, the CSM has been updated and is presented in Figure 1. This model indicates that there are three potentially complete pathways identified that could present a risk to human health: the direct contact and inhalation of contaminated soil dust, or in contaminated surface water runoff, from heavy metals, asbestos and PAH during soil disturbance activities around residential dwellings and farm buildings, posing a risk to future residents, site users, adjacent residents and earth workers. It is not expected that a significant migration pathway to off-site human health receptors exists for the majority of the site. However, there is the potential for off-site migration of contaminants in leachate from the landfill identified in the north-western corner of the site.

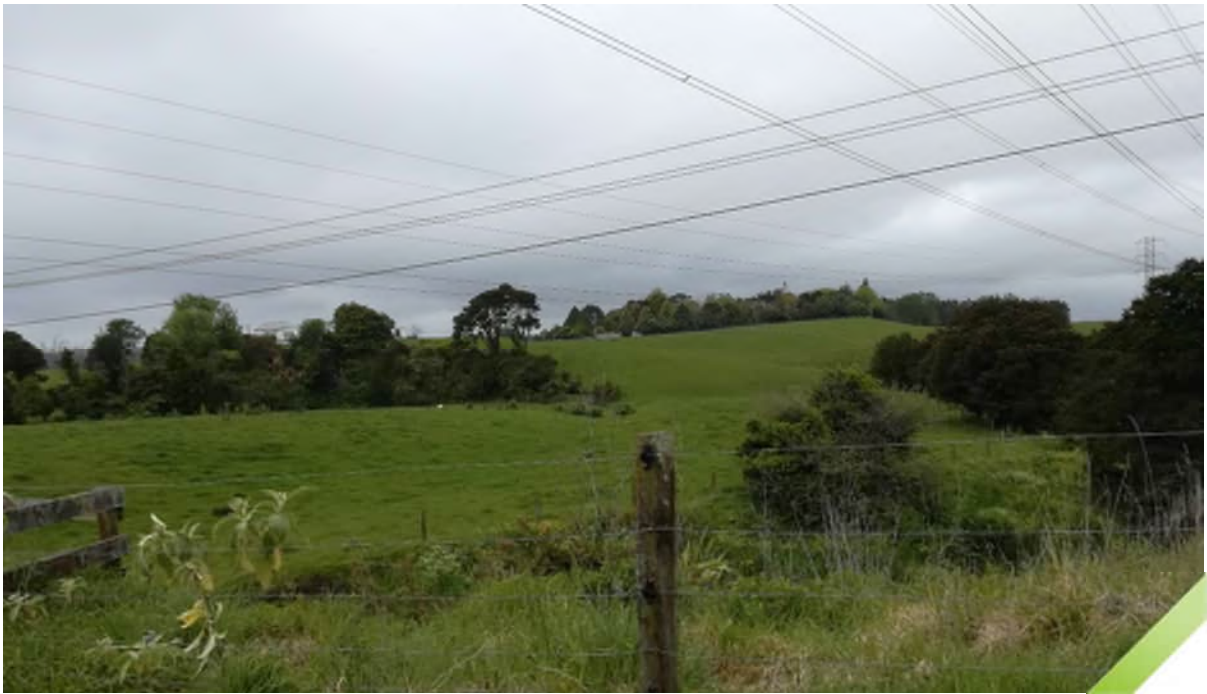
Photograph 11 108 Flanagan Road, looking south-east. On the left side is the area where the forest was historically cleared (potential HAIL G5).

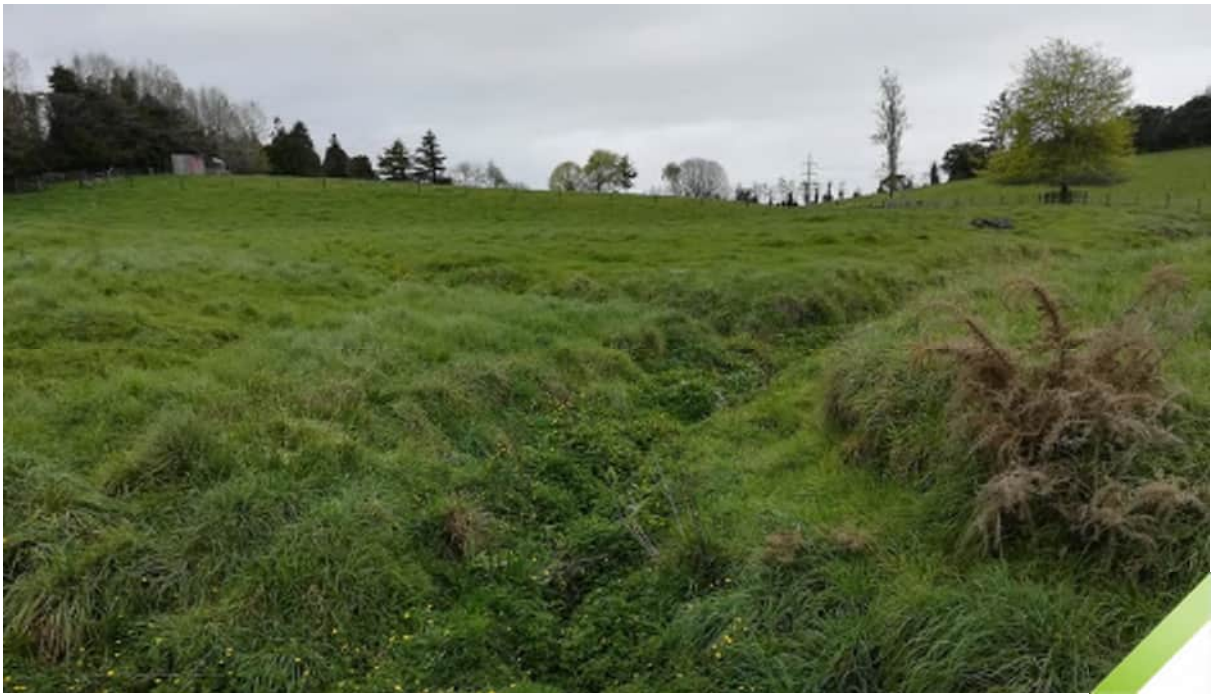
Photograph 15 120 Flanagan Road, looking south. Offal pit visible in the top right corner, and unnamed stream in the middle.

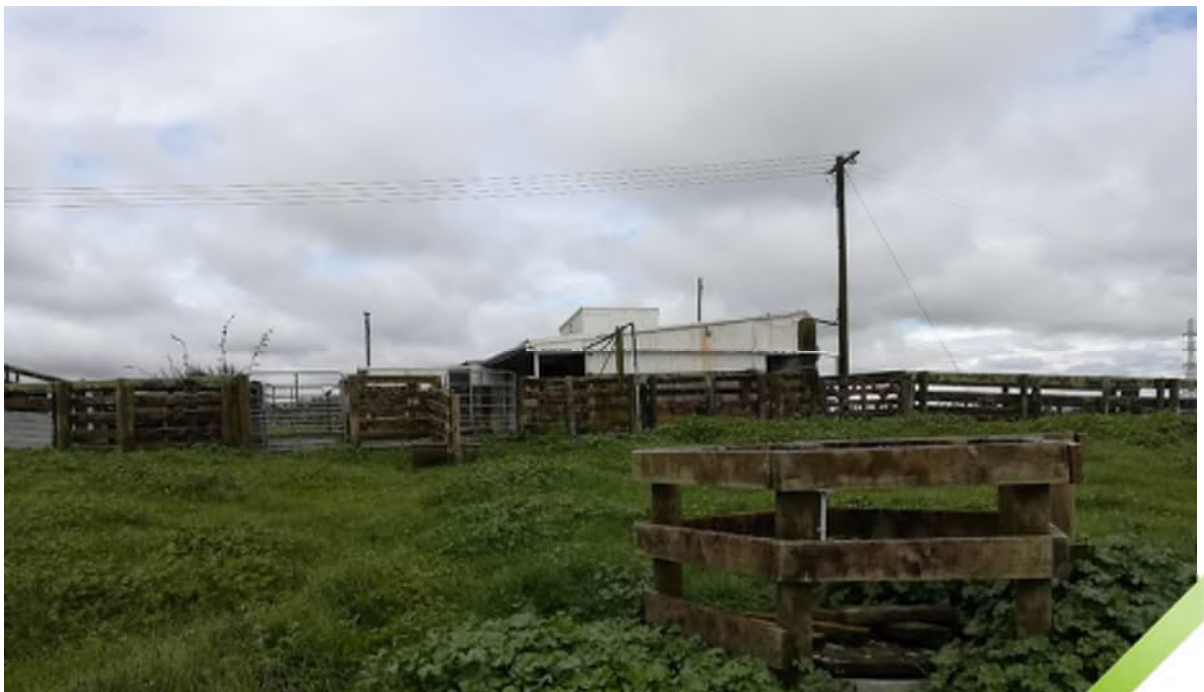
Photograph 26 Milking shed at 133 Fitzgerald Road, showing the two sumps/wells where runoff is stored.

This lot has historically been used for cattle farming, with a residential dwelling, storage sheds and garaging present on the eastern portion. Two sheds visible in the 1960 aerial photograph had been demolished by the 1981 aerial, and a third metal shed was observed as dilapidated during the site walkover. The lot contains a milking shed west of the dwelling; which includes a cattle crusher, milk tank and effluent run off infrastructure. Spray paint was visible on the fencing during the site walkover. Runoff generated from the milk shed is collected into a sump, before being sprayed across the surrounding landscape.

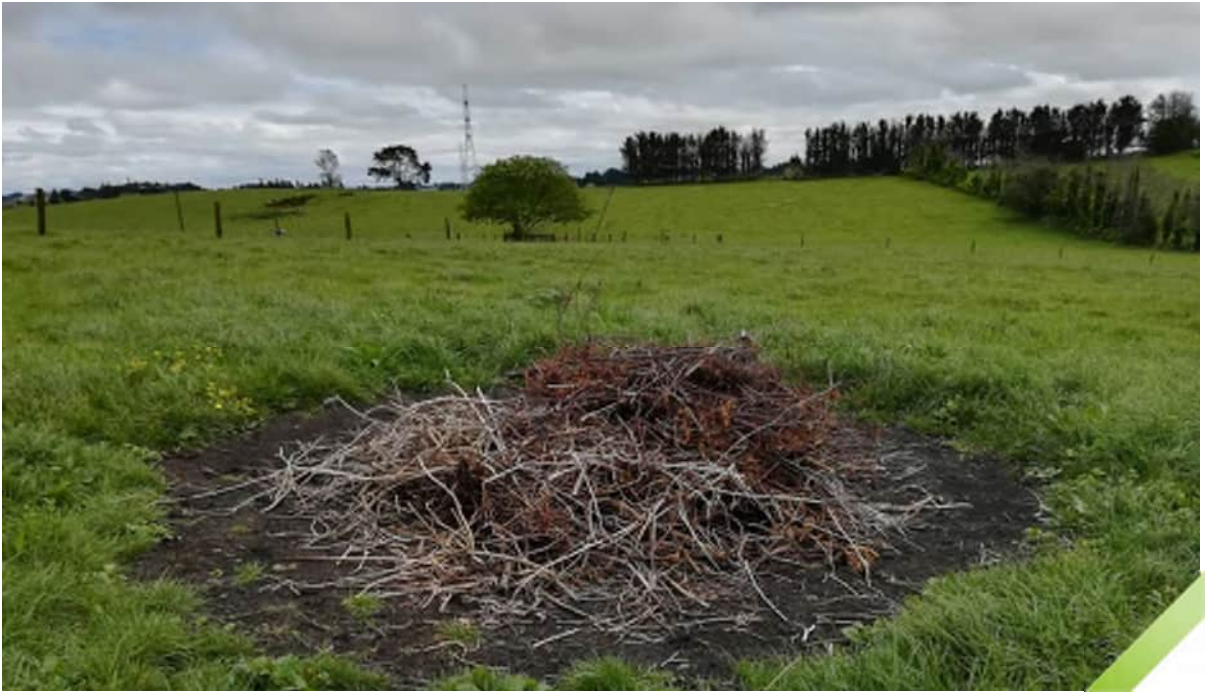
Photograph 27 Burn pit north of the milk shed at 133 Fitzgerald Road.

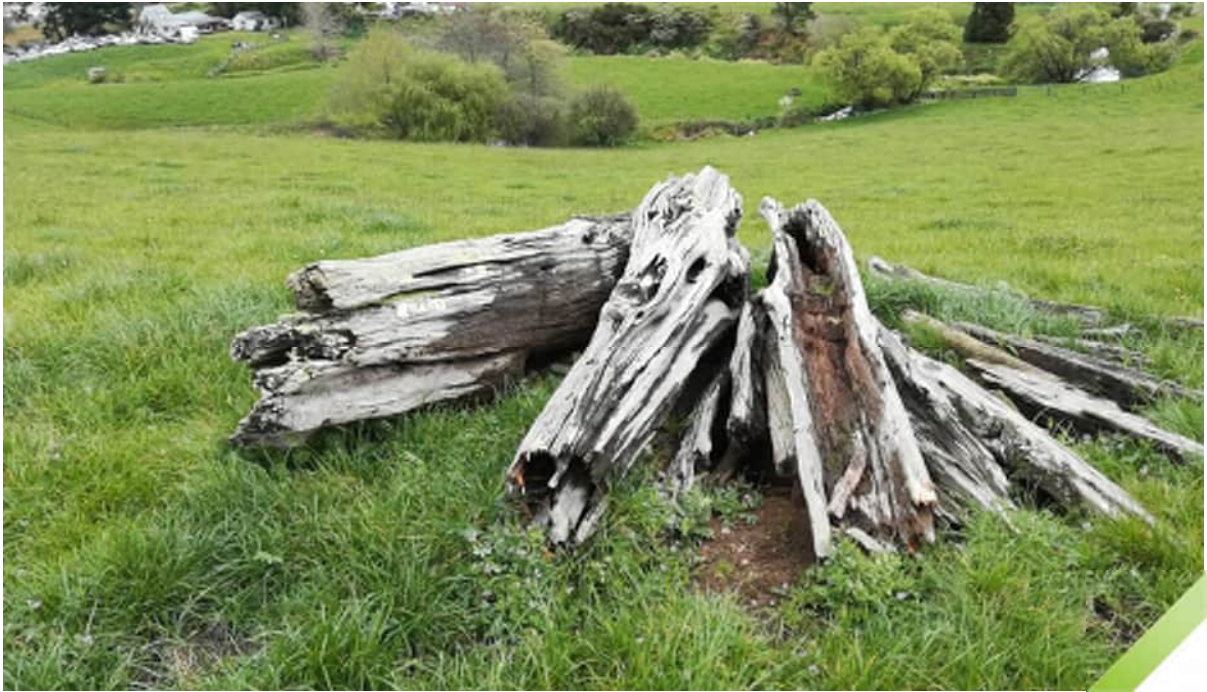
Photograph 31 Suspected offal pit / burn pit at highest point of 133 Fitzgerald Road, in south-western portion.

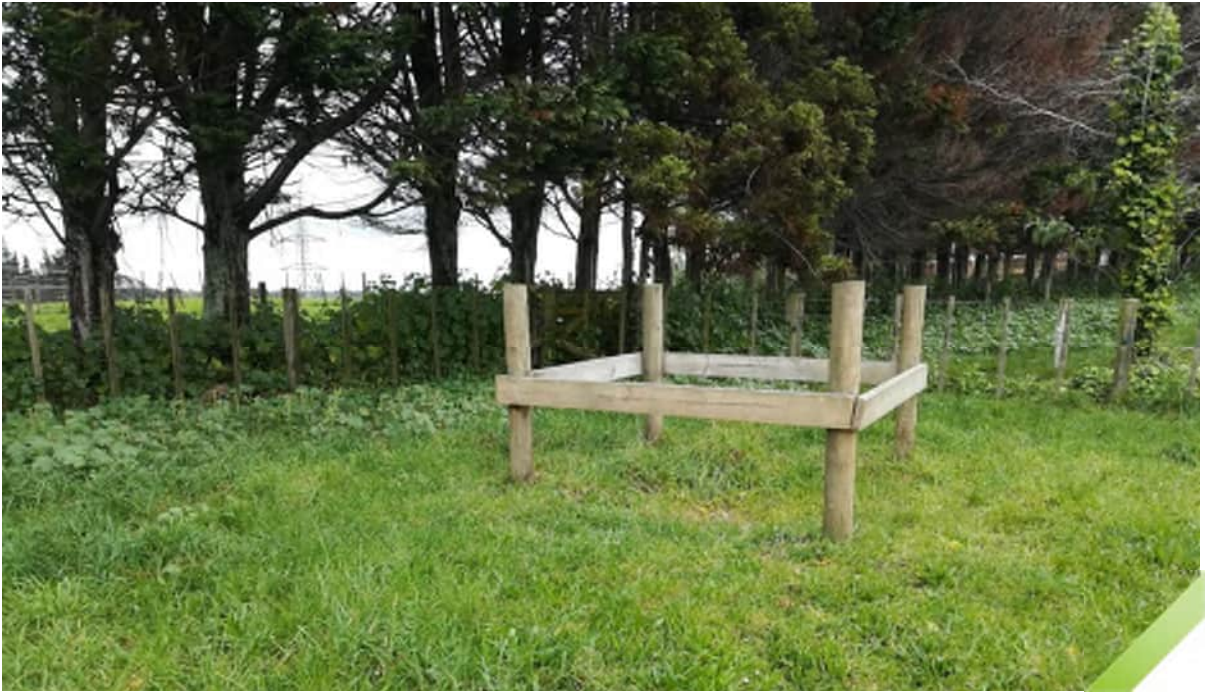
Photograph 35 Offal pit located in the north-western corner of 133 Fitzgerald Road.

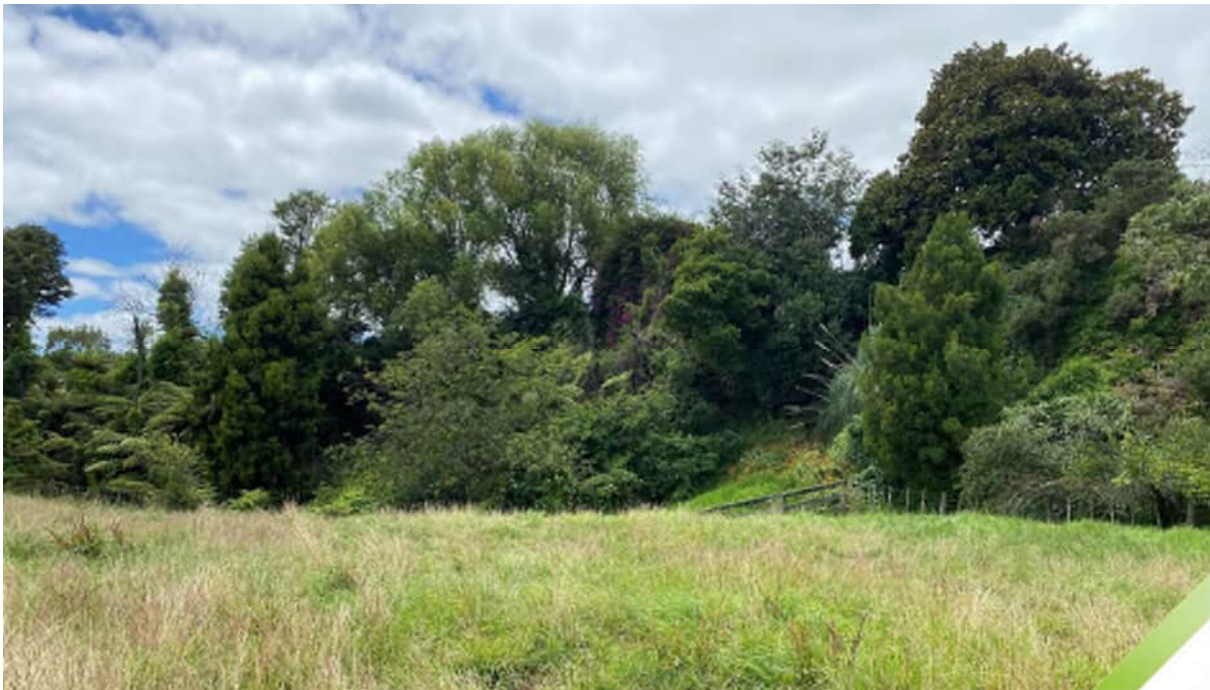
Photograph 40 Landfill identified at 108 Flanagan Road, looking east. Landfil bound to south and east by steep cliff.

Anthropogenic material was encountered in all test pits excavated as part of this investigation. TP035 - TP039 and TP041 targeted an area of suspected filling within 108 Flanagan Road, and identified a landfill consisting of glass fragments, brick, metal sheeting and machinery, steel, wood, rope, potential asbestos-containing material, and terracotta pottery. Isolated pockets of blue silty-sand material was encountered at depth in test-pits TP035 and TP039, within the waste-bearing layer. A strong hydrocarbon odour was observed during the excavation of TP036, specifically once groundwater had been encountered. The groundwater at this test pit had a hydrocarbon sheen on the surface.

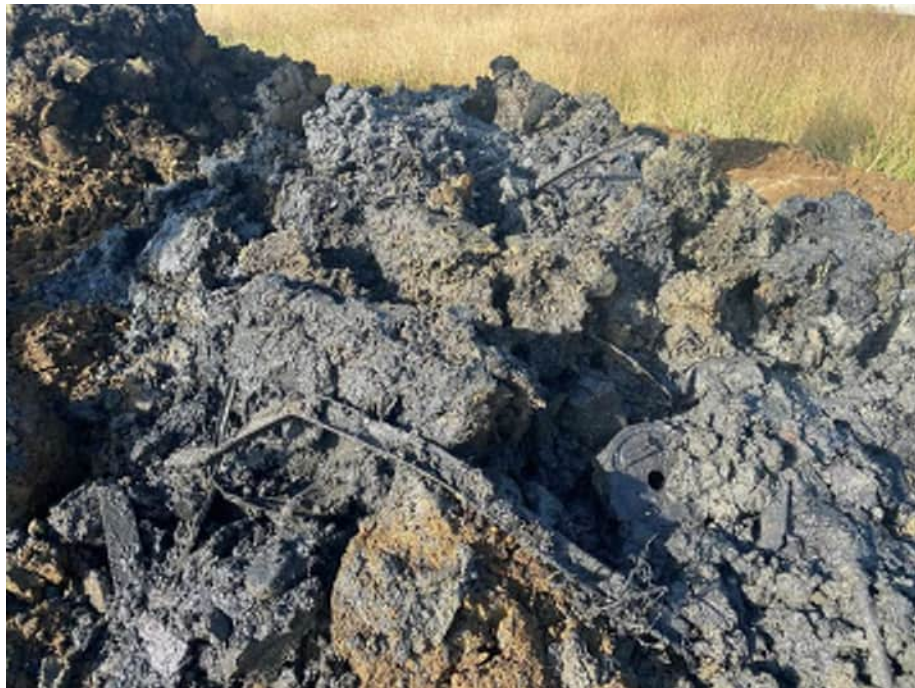
Photograph 42 Waste material encountered at TP036.

The asbestos type identified included loose fibres of chrysotile and amosite, as well as ACM debris and fibre cement. One sample (TP036 2.1-2.2 m bgl) reported a concentration of asbestos fibres at 0.001%, which does not exceed BRANZ Guidelines. Asbestos was also found in one sample during the ENGEO (2017) investigation, located within the farm track near the residential dwelling at 133 Fitzgerald Road and the concentration reported below the adopted BRANZ guidelines.

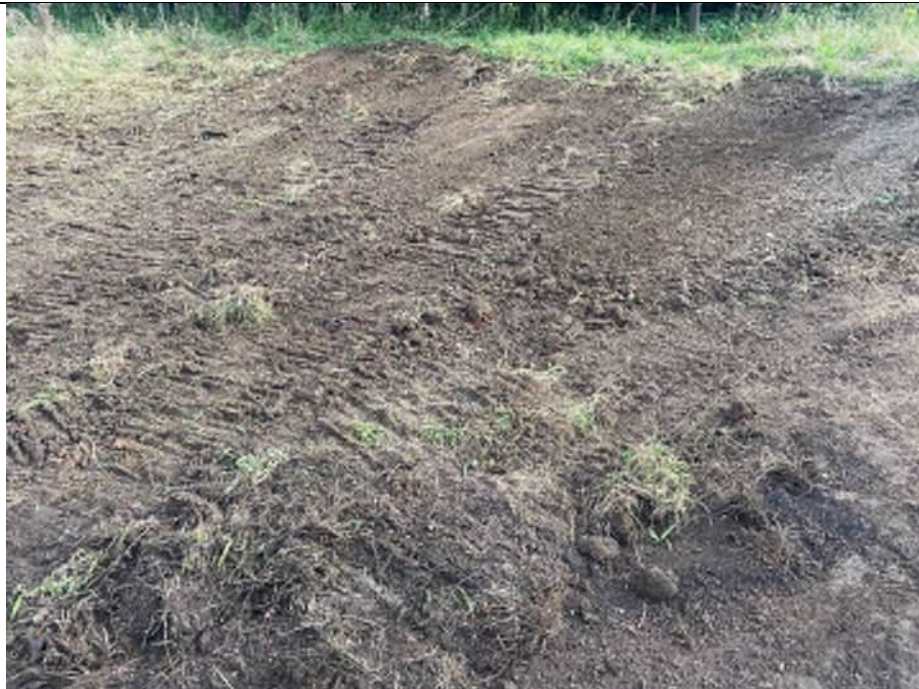
Photograph 44 TP040, excavated and backfilled.

TP040, located south of the homestead at 120 Flanagan Road, identified a farm dump, with anthropogenic material encountered consisting of glass bottles, metal horse-shoes and other broken pieces, bricks, and rope.
