| Project: | Project Quattro | | | | | |
| Analysis Description: | Orientated Core - IRA Planar Sliding | | | | | |

| Project: | GEOTECHNICAL STUDY GLADSTONE-WINNER HILL OPEN PIT | | | | | |

### **Assessment of Landslides**

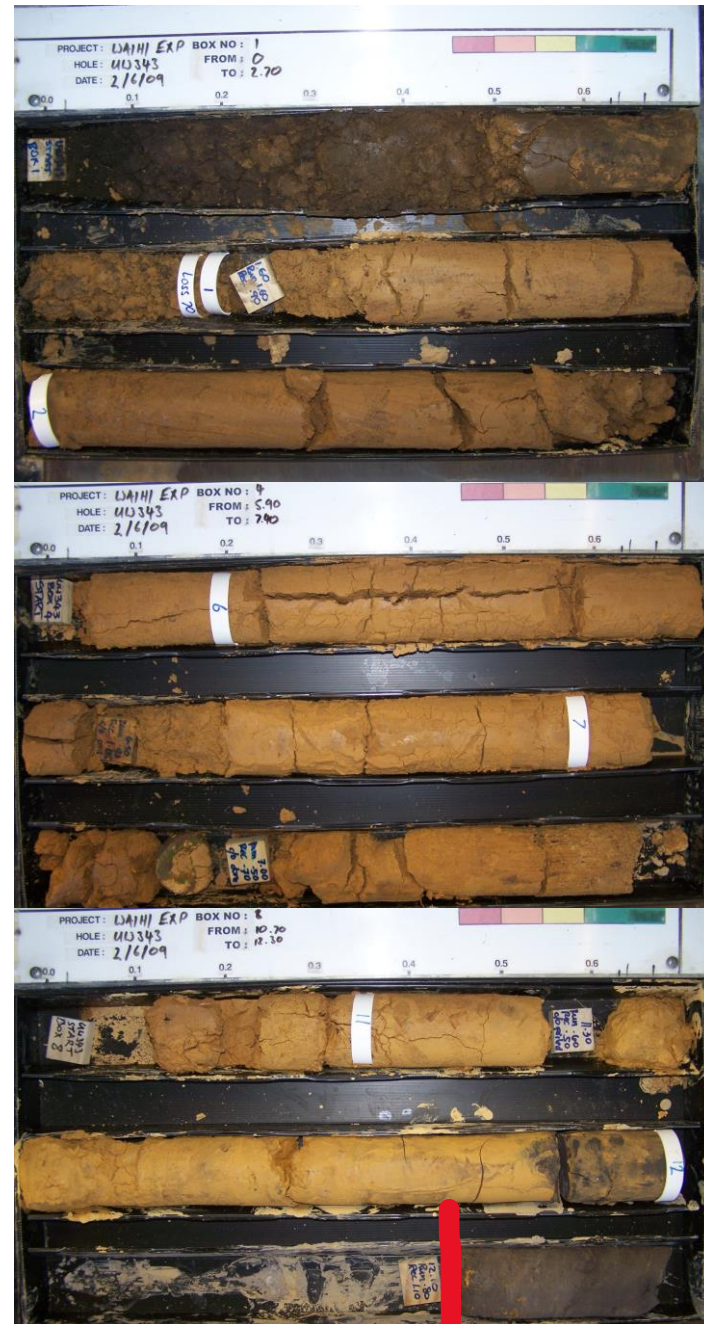
# BH: UW343

- Abrupt change from light brown clay to in-situ dark brown ignimbrite at 12.1 m (Downhole Depth) interpreted as slip surface (red line)
- Slip surface interpreted at ~ 8.3 m depth (True Depth)
