Geotechnical Assessment Report

Ryans Road Fast Track

Carter Group Ltd

Reference: 773-CHCGE377712

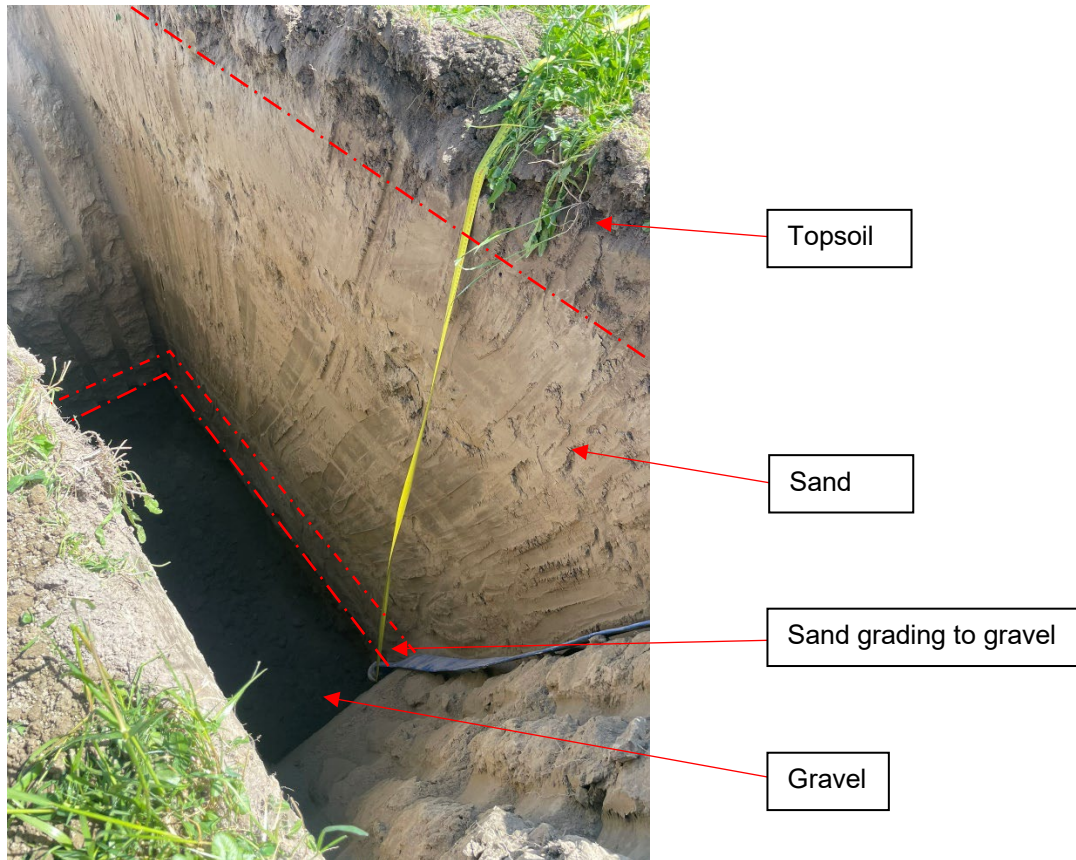
Figure 3: TP-04 with markup of stratigraphy.

As an illustration of the stratigraphy in TP-04 we have provided a markup of a test pit photo showing the generalised layer in Figure 3 below.

The site stratigraphy has been derived from the geotechnical investigations referenced above and is based on the material descriptions of the logged soils. The site has relatively uniform layers as outlined in Table 4. Silty lenses were observed within the sand layer and it is expected that silt content is variable throughout this layer across the site.

For civil design we consider that the infiltration rate described in TP-04 is likely to be achievable provided that sufficient embedment into the gravel layer is undertaken. We recommend that Tetra Tech Coffey is engaged to observe the construction of any to ground stormwater systems to comment on the suitability of the “target soakage layer”.

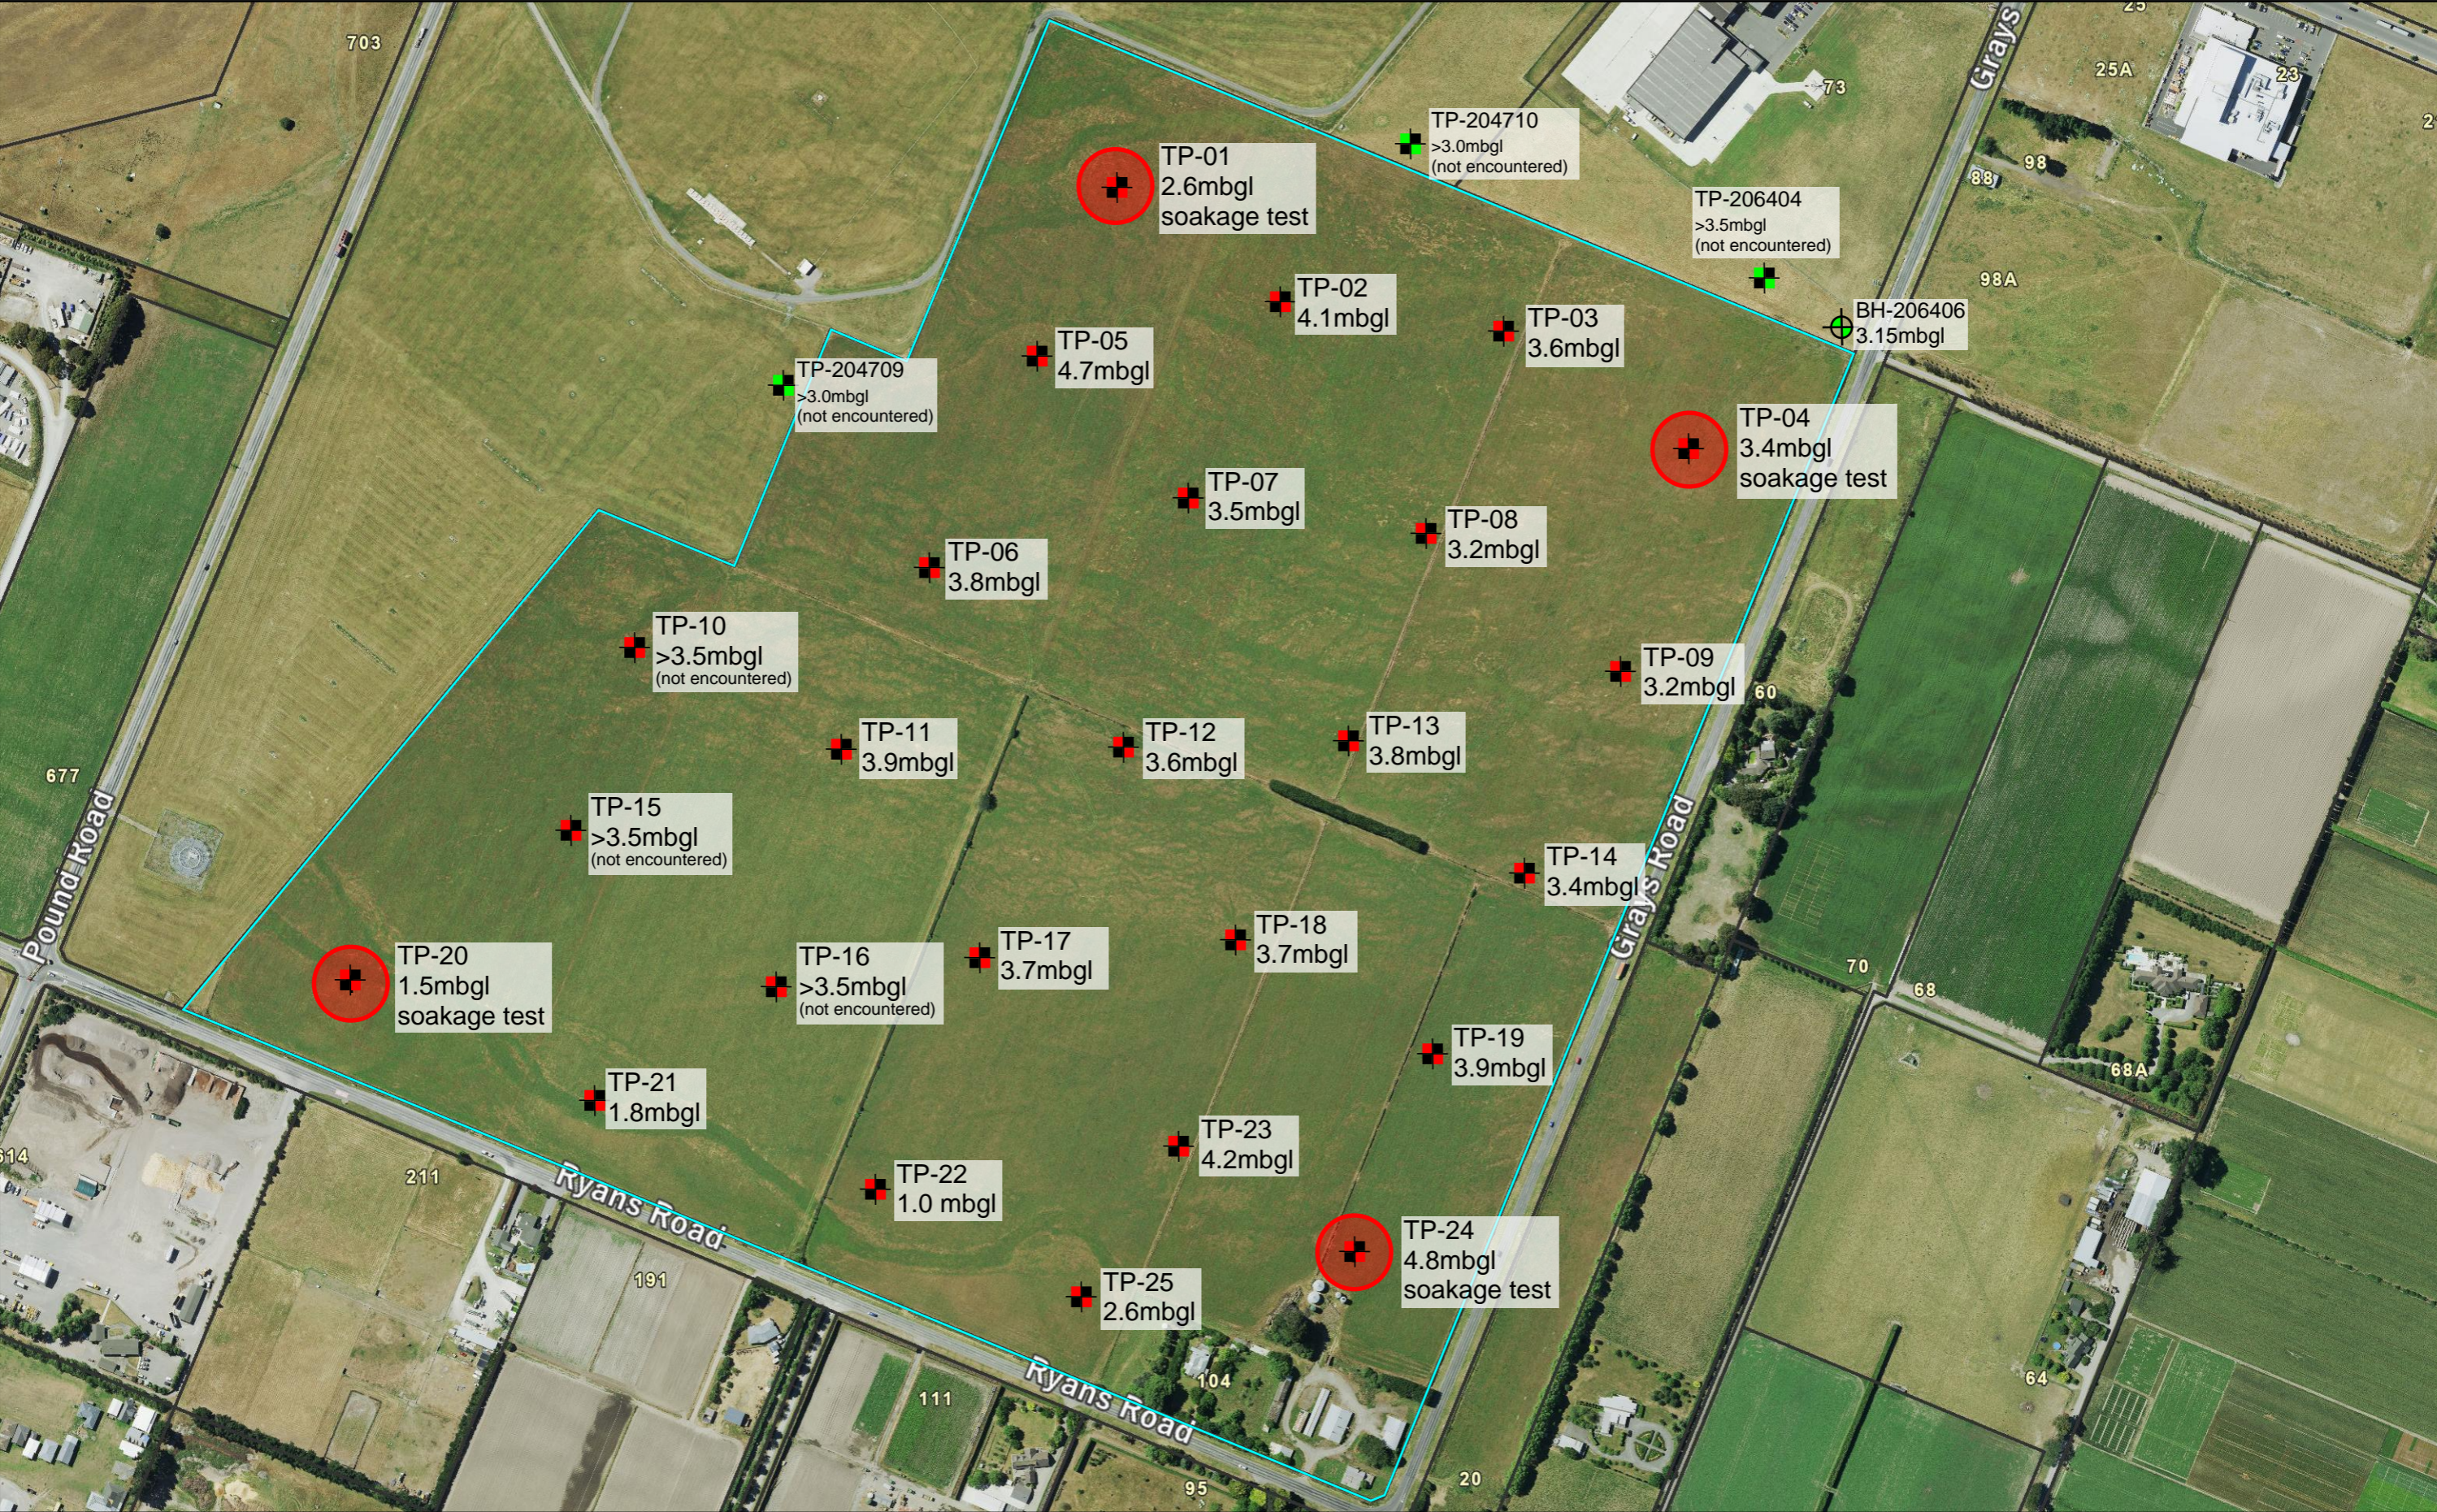
revision	no.	description	drawn	approved	date
	1	Test pit locations, depth to gravel & soakage	J.M	J.M	13/11/24
	2	Client name correction	N.C	C.T	07/01/25

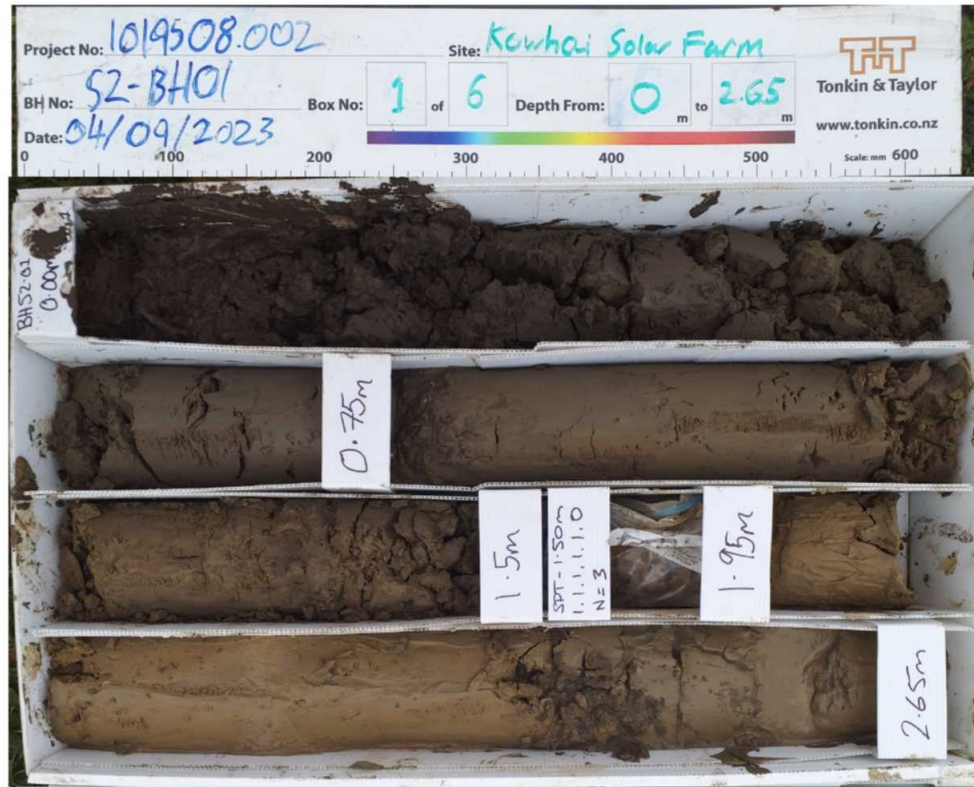
0.00-2.65m

CORE PHOTOS

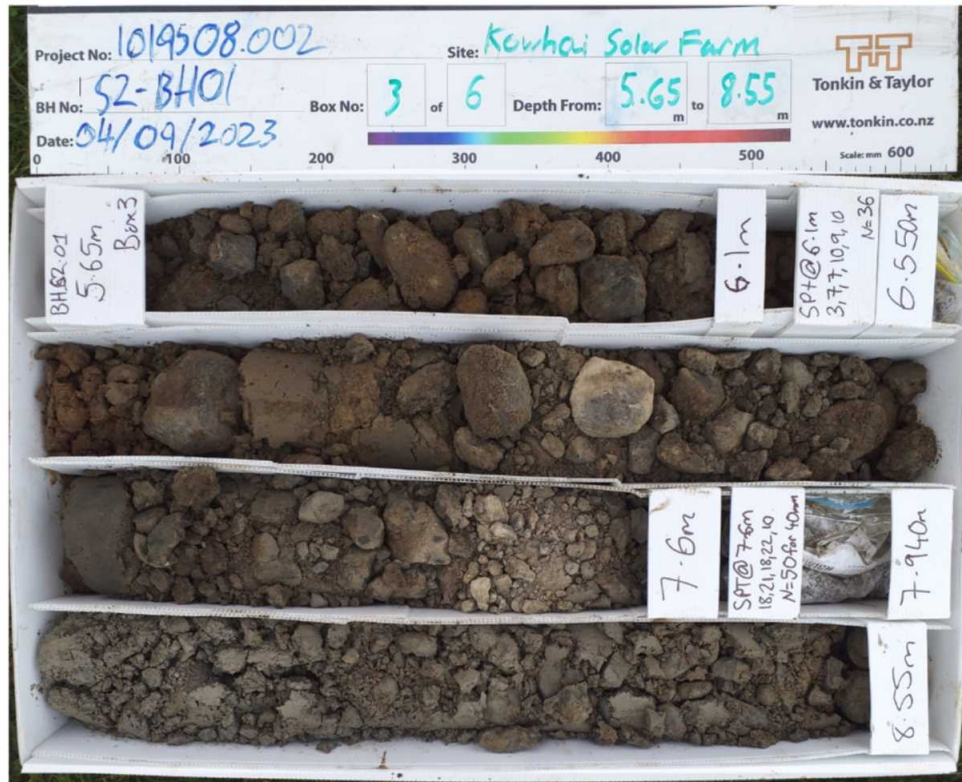
5.65-8.55m

CORE PHOTOS

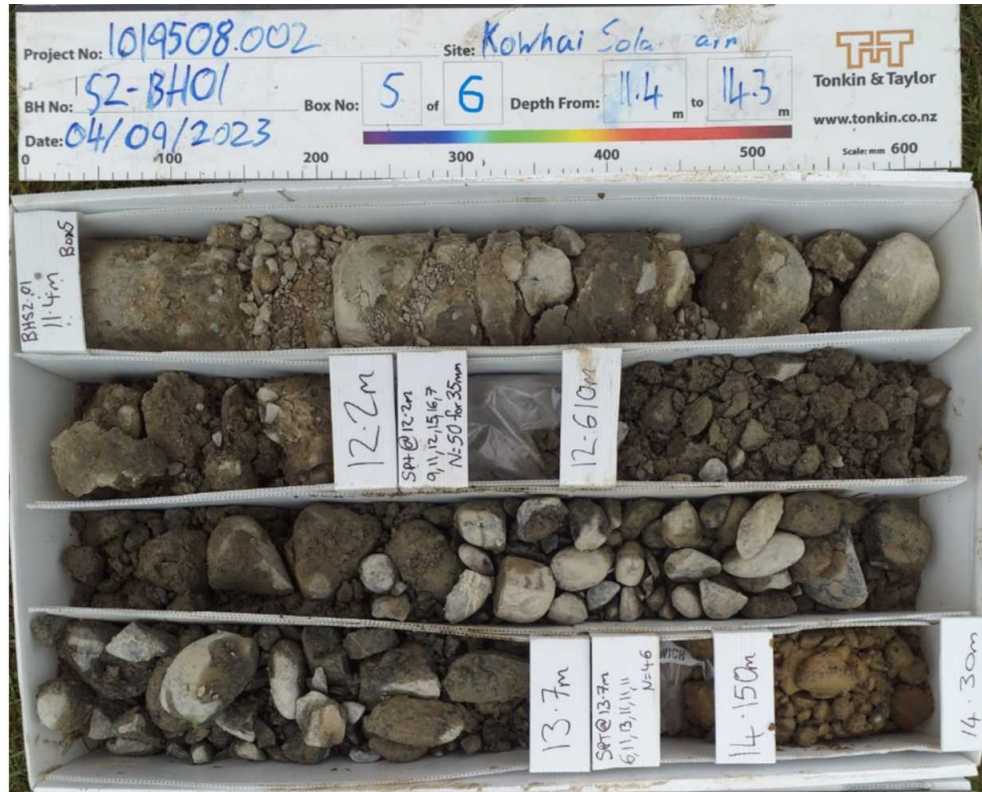
11.40-14.30m

PROJECT: CIAL - Kōwhai Solar Park Geotechnical		LOCATION: Kowhai Park Stage 2		JOB No.: 1019508.0020	
CO-ORDINATES: 5183429.94 mN (NZTM2000) 1561844.81 mE		DRILL TYPE: Fraste CRS XL		HOLE STARTED: 04/09/2023	
R.L.: 33.57m		METHOD: Sonic core drilling		HOLE FINISHED: 04/09/2023	
DATUM: NZVD2016		DRILL FLUID: WATER		DRILLED BY: ProDrill	
				LOGGED BY: EDFA	
				CHECKED: CRB

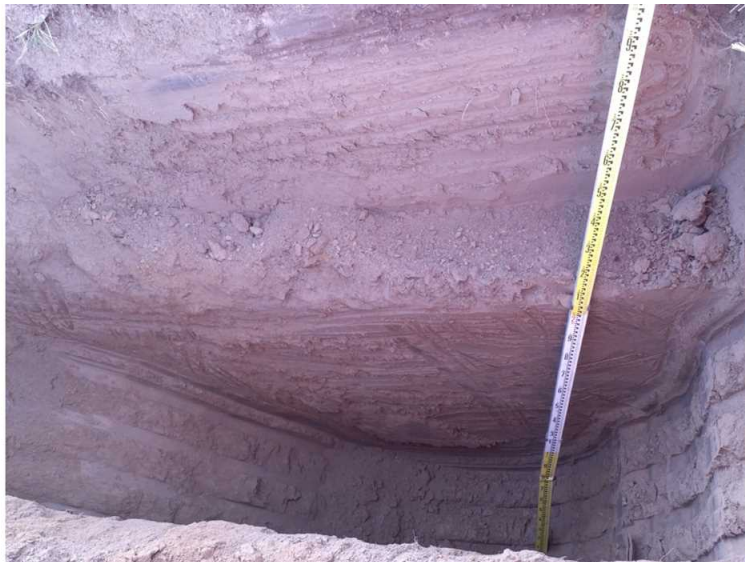
0.0 - 3.0m:

COMMENTS: [Civil]: PSD; Standard Compaction; Natural Water Content; CBR. Thermal Resistivity (TR) testing: @0.5m In-situ TR test; @1.0m In-situ TR test + TR laboratory test.

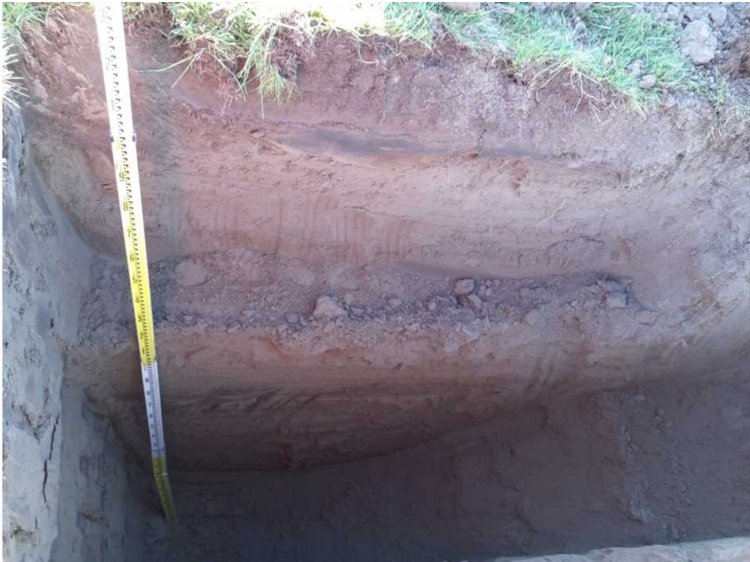
0.0 - 3.0m:

COMMENTS: [Civil]: PSD; Standard Compaction; Natural Water Content; CBR. Thermal Resistivity (TR) testing: @0.5m In-situ TR test; @1.0m In-situ TR test + TR laboratory test.

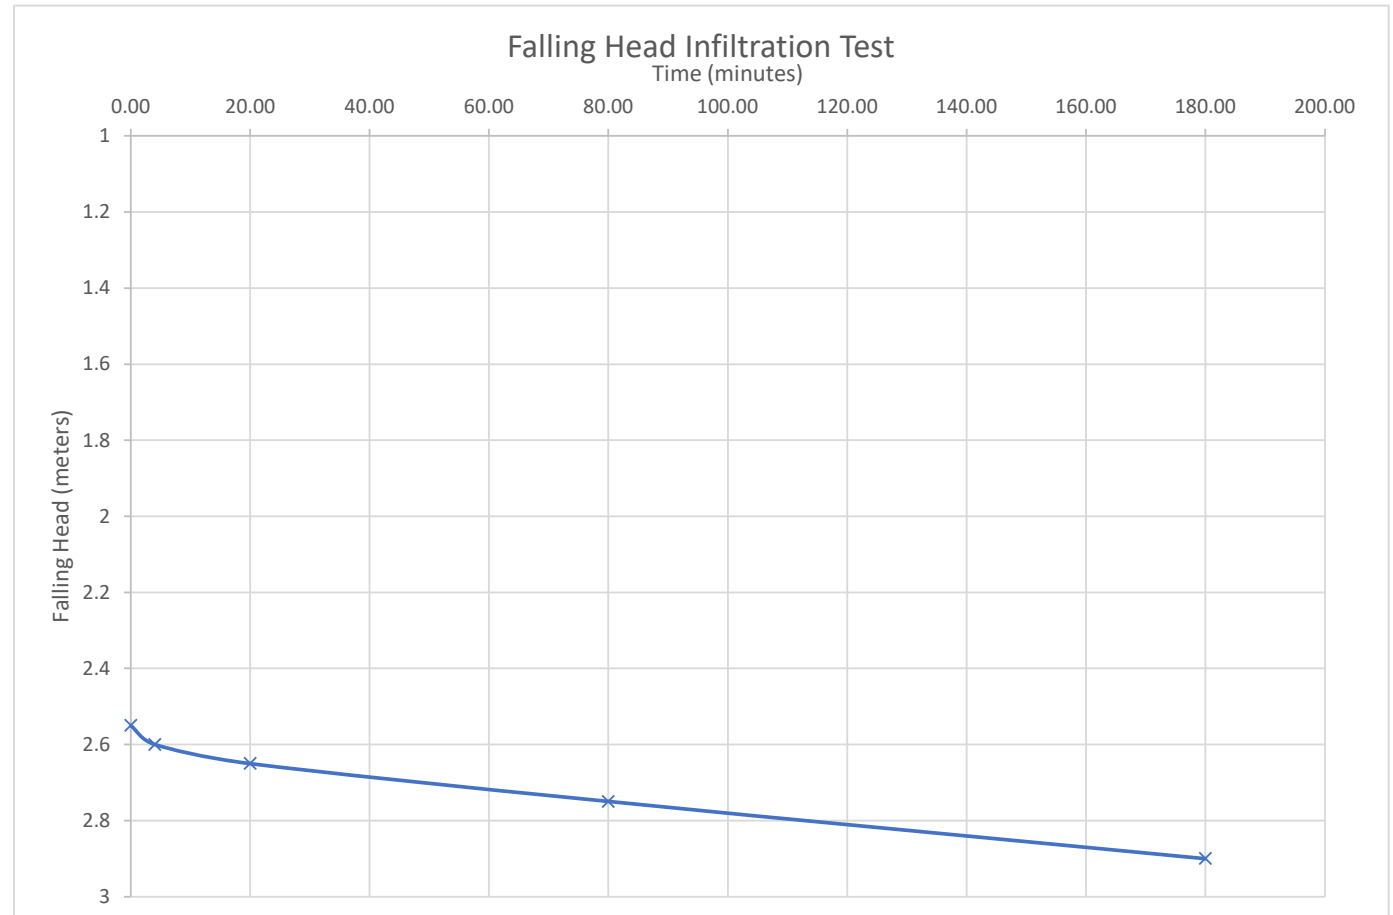
Average expected infiltration rate
125 mm/hr
3.47E-05 m/s

Completed: J. Monk
Ref: 773-CHCGE377712
Name: Ryans Rd, Yaldhurst
Date tested: 13/11/2024

gravel depth (mbgl):	2.8
depth of hole (mbgl):	3.2
depth into gravel (m)	0.4

Location	Average Expected Infiltration Rate		Depth of hole	Depth into gravel
	mm/hr	m/s	m	m
TP-01B	125	3.47E-05	3.2	0.4
TP-04B	600	1.67E-04	5	1.6
TP-20	6,000	1.67E-03	3.5	1.3
TP-24B	50	1.39E-05	5.4	0.6

We note that the embedment of the test into the underlying gravel for TP-01 and TP-24 were 0.4m and 0.6m whereas TP-04 and TP-20 were embedded 1.6m and 1.3m respectively. Considering this we anticipate that TP-01 and TP-24 may have achieved faster infiltration rates if the test embedment was increased.

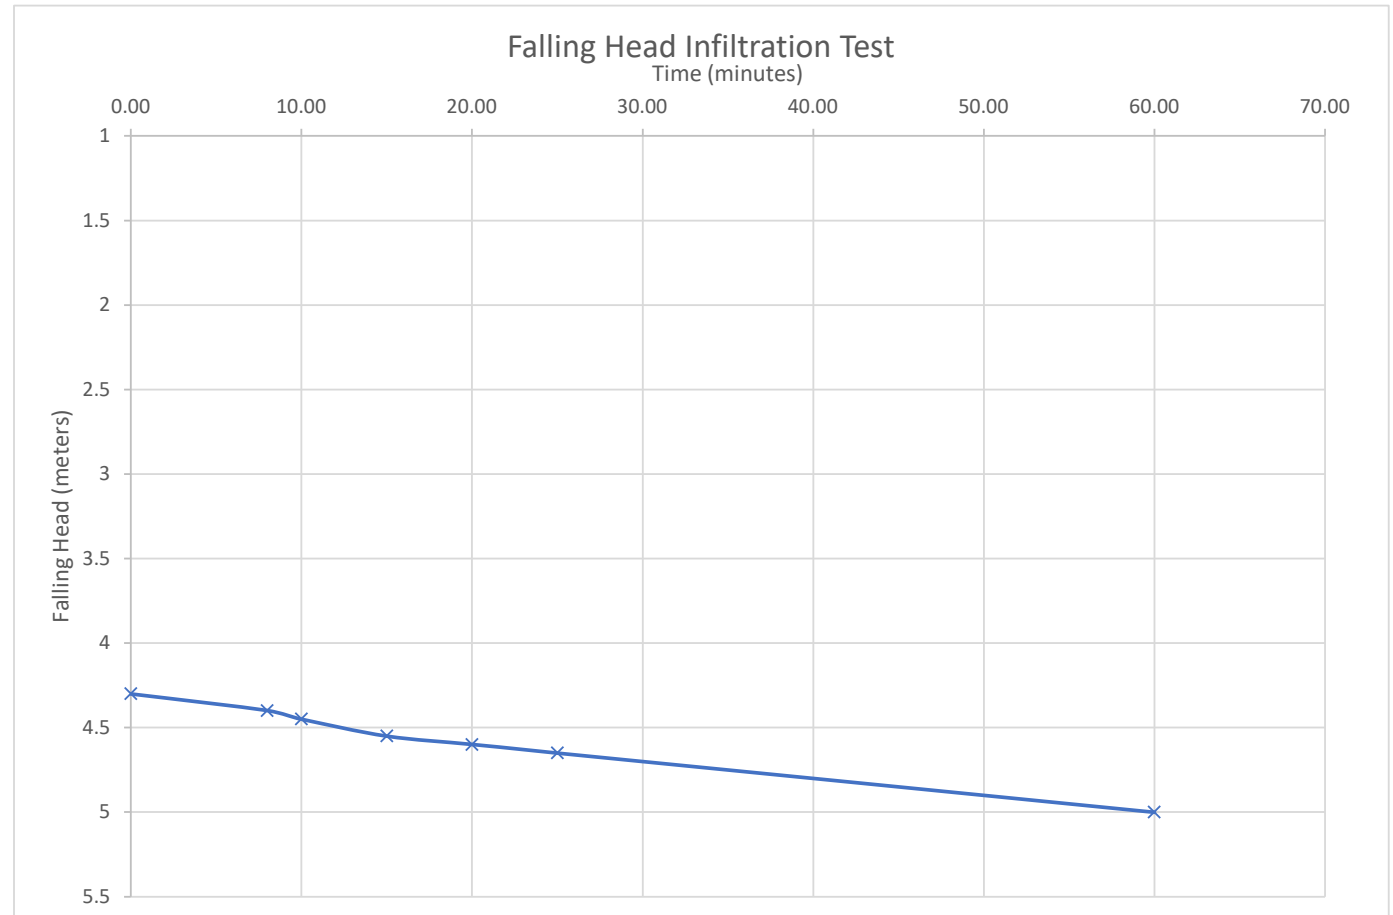
Average expected infiltration rate
600 mm/hr
1.67E-04 m/s

Completed: J. Monk
Ref: 773-CHCGE377712
Name: Ryans Rd, Yaldhurst
Date tested: 13/11/2024

gravel depth (mbgl):	3.4
depth of hole (mbgl):	5.0
depth into gravel (m)	1.6

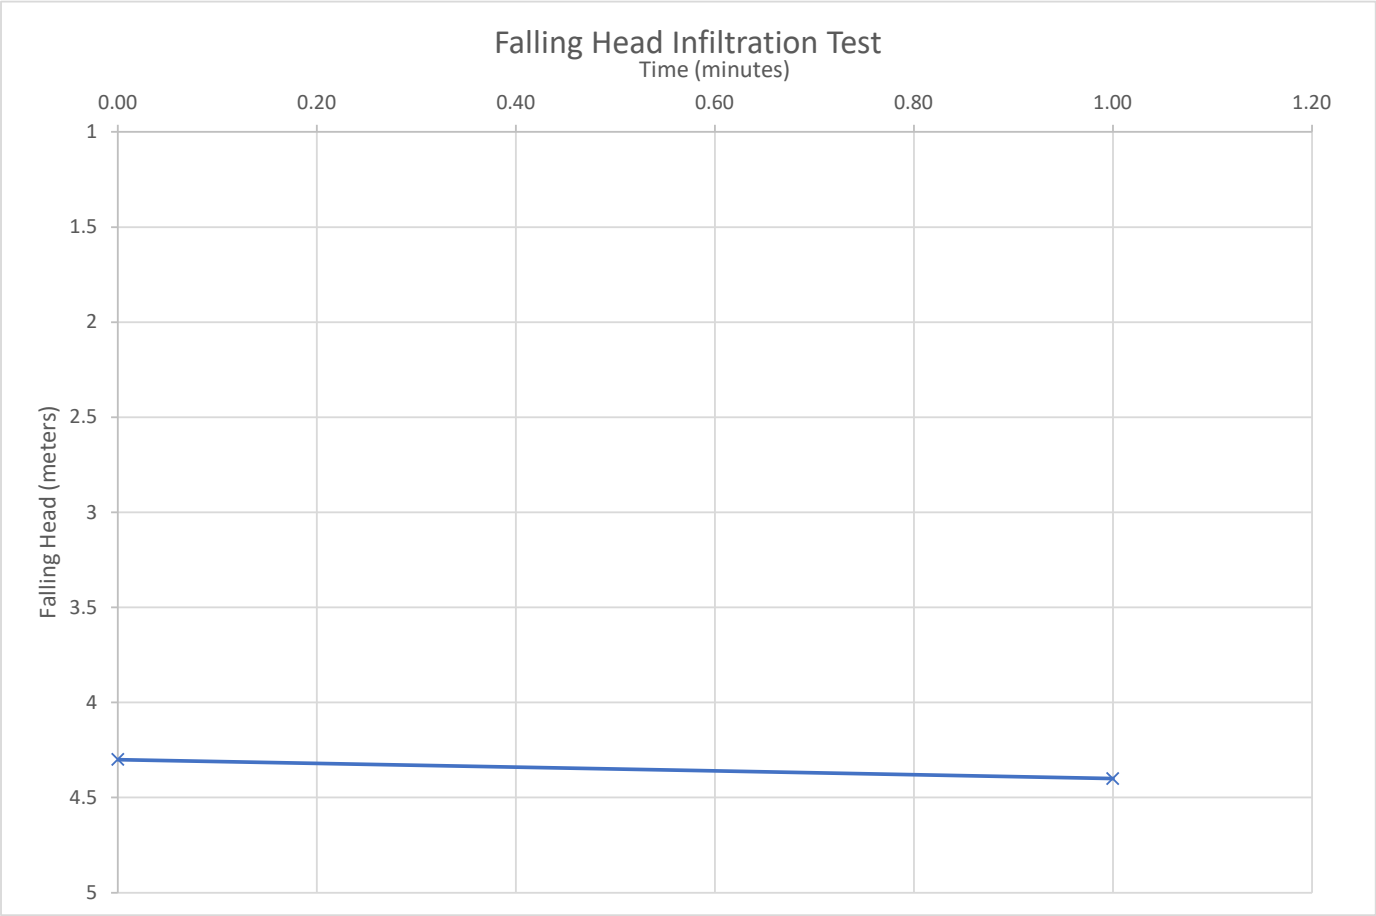
Average expected infiltration rate
6000 mm/hr
1.67E-03 m/s

Completed: J. Monk
Ref: 773-CHCGE377712
Name: Ryans Rd, Yaldhurst
Date tested: 13/11/2024

gravel depth (mbgl): 2.2
depth of hole (mbgl): 3.5
depth into gravel (m) 1.3

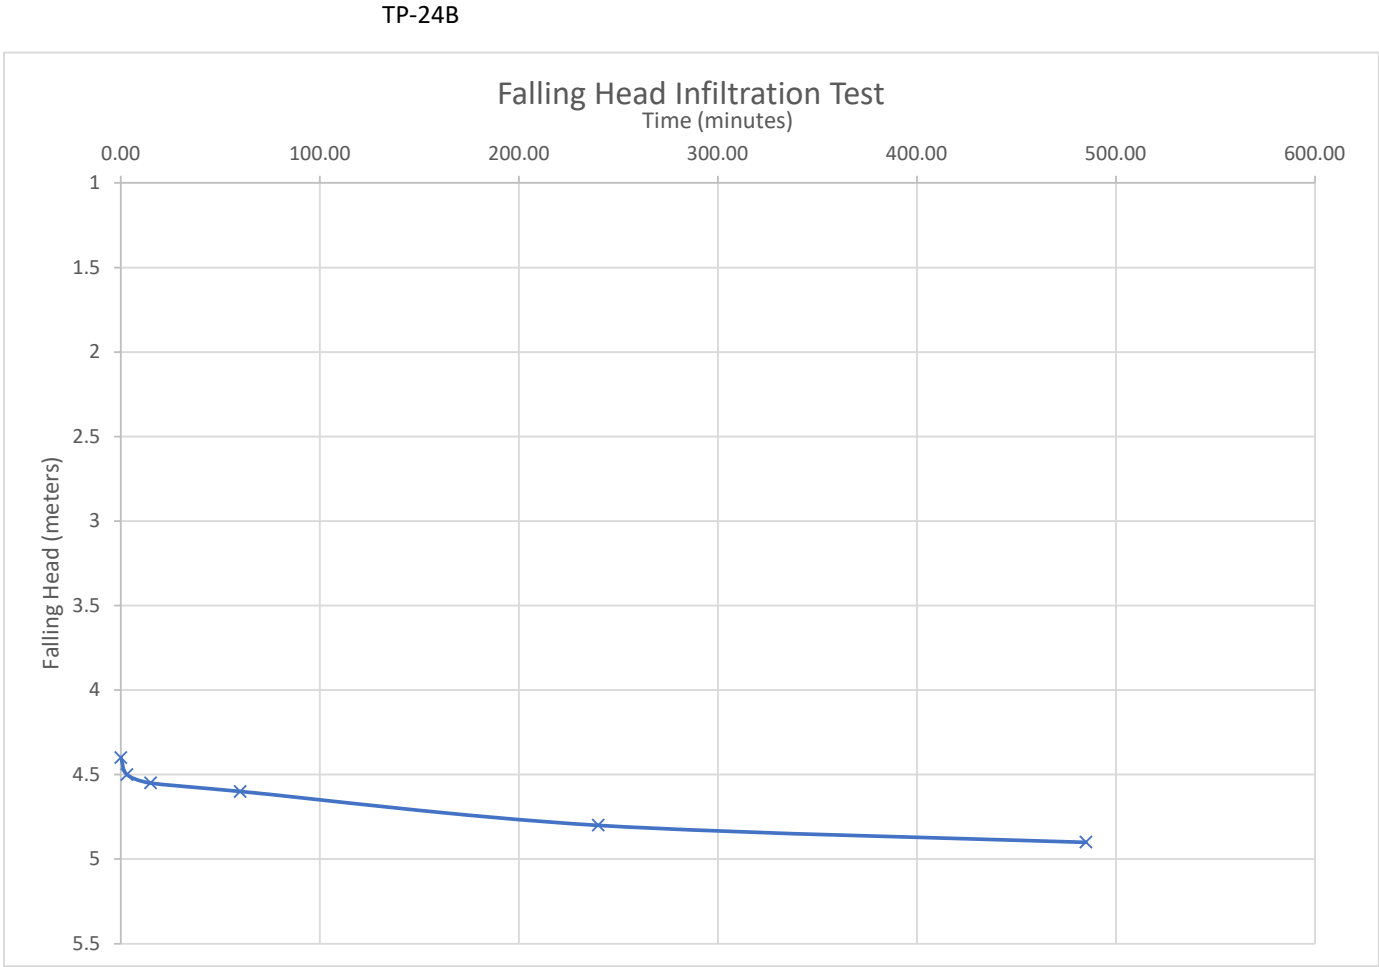
Average expected infiltration rate
50 mm/hr
1.39E-05 m/s

Completed: J. Monk
Ref: 773-CHCGE377712
Name: Ryans Rd, Yaldhurst
Date tested: 13/11/2024

gravel depth (mbgl): 4.8
depth of hole (mbgl): 5.4
depth into gravel (m) 0.6
