ENVIRONMENTAL REPORT

Preliminary Site Investigation (PSI) at 2025 Ohaupo, Te Awamutu

for Ultimate Global Group

Rev A - 22/12/2021

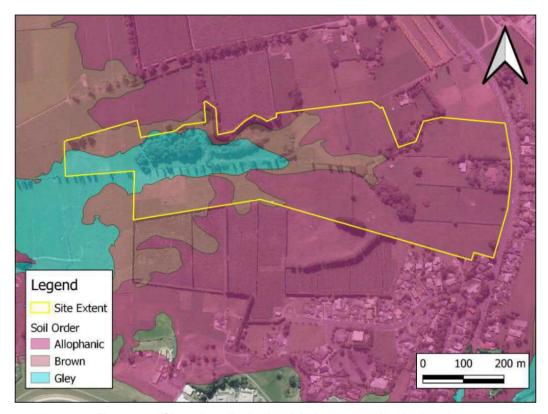
Figure 2.3: Site soils – allophanic (pink), brown (peach), gley (aqua).

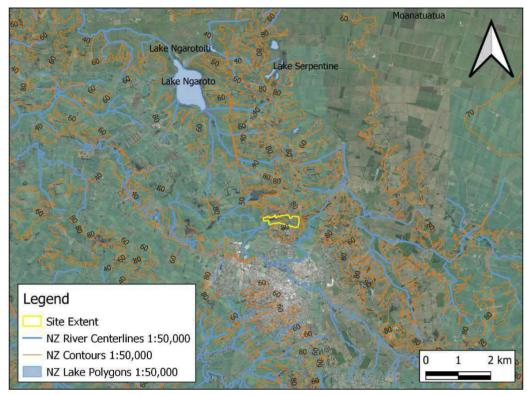
Figure 2.4: Topographic contours (orange) and hydrology surrounding the site (light blue).

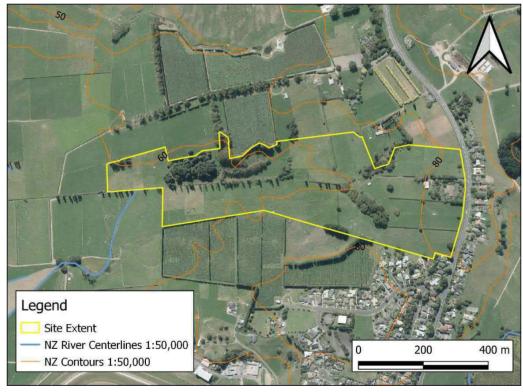
Figure 2.5: Site topography (orange) and hydrology (light blue).

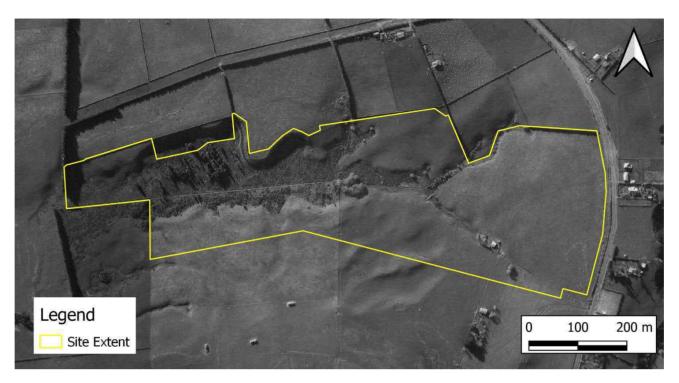
Figure 3.1: 1943 arial image of 2025 Ohaupo Road, Te Awamutu (the site – highlighted yellow). Image source: Retrolens, plotted by BTW.

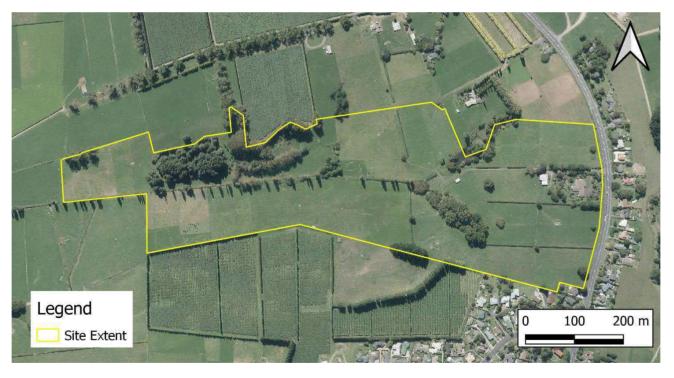
Figure 3.2: 2017 aerial image of 2025 Ohaupo Road, Te Awamutu (the site – highlighted yellow). Image source: Waipa District Council, plotted by BTW.

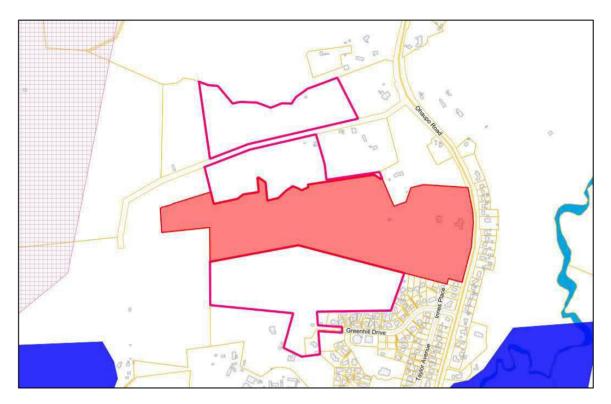
Figure 3.3: Outline of orchard (HAIL) boundaries on adjacent properties. Source: WDC IntraMaps.

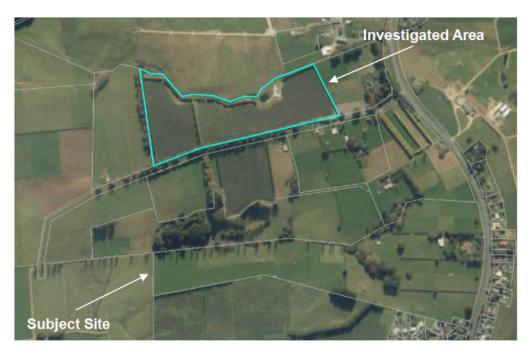
Figure 3.4: Investigated area in the 2011 PSI report completed by Guy Sowry (CSI).

PSI report for 5022 Ohaupo Road, Te Awamutu (Lot 2 DPS 82004) (dated February 2011) was provided by WDC. Figure 3.4 illustrates the property investigated in the PSI. The PSI identified that a section of Lot 2 DPS 82004 was planted in kiwifruit prior to 2000 and was completely planted in kiwifruit in 2009. The report notes that by 1997 all kiwifruit orchards in New Zealand were required to be members of KiwiGreen. Being a part of KiwiGreen meant that only 'soft' chemicals ('basically organic chemicals') could be applied to the orchards to control pests. The report states that the site was certified by Bio-Gro as organic in 2007.

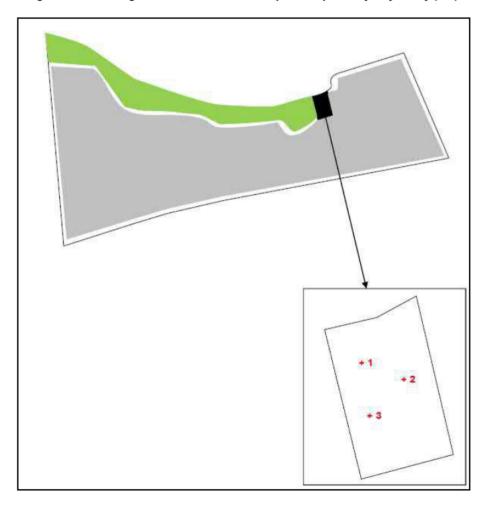
Figure 3.5: Sampling plan for PSI report at 5022 Ohaupo Road, Te Awamutu, February 2011.

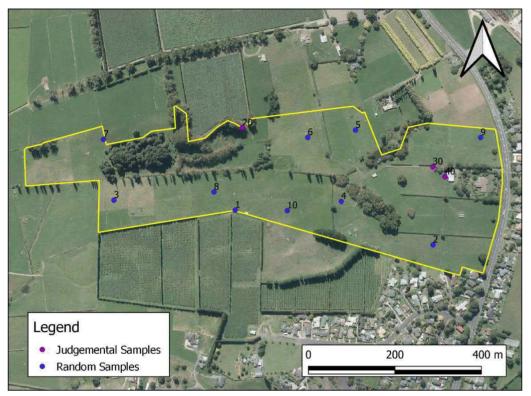
Figure 4.1: Sampling location plan.

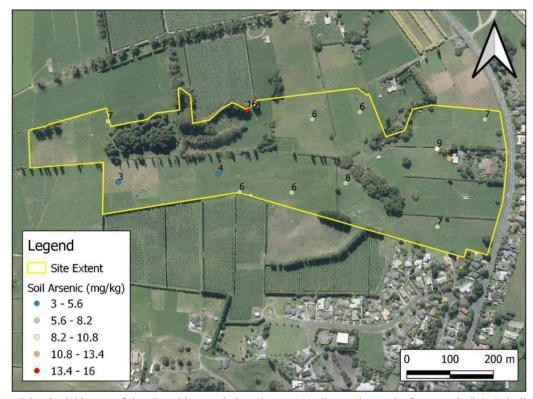
Figure 5.1: Aerial image of the site with sample locations and soil sample results for arsenic (labels indicate concentration in mg/kg).

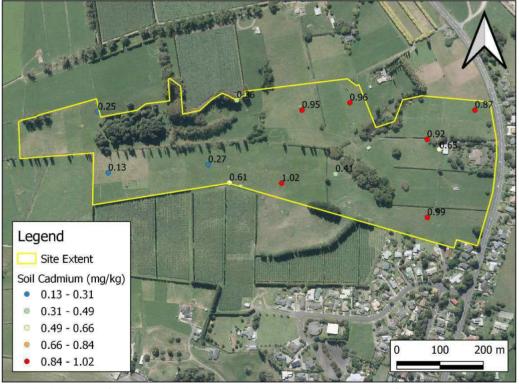
Figure 5.2: Aerial image of the site with sample locations and soil sample results for cadmium (labels indicate concentration in mg/kg).

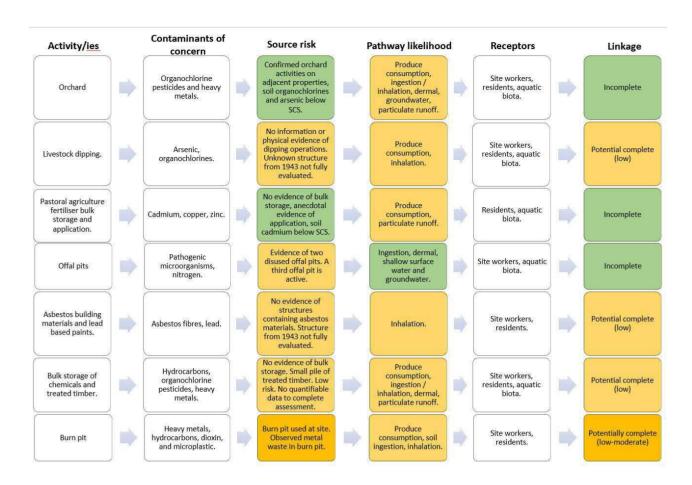
Figure 6.2: Simple flow diagram Conceptual Site Model (CSM) for the site. Where risk and probability is coded, low (green), low to moderate (yellow), moderate to high (orange), and high (red).

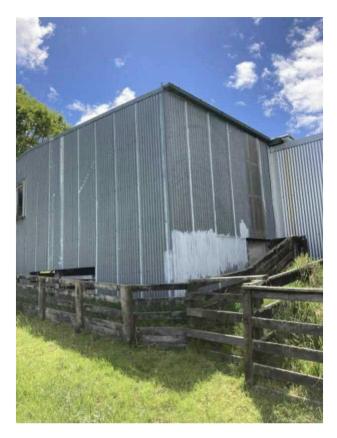
investigation is required to evaluate the potential risk of soil contamination from dipping and spray operations.

Figure 6.3: Photo of the woolshed at the site.

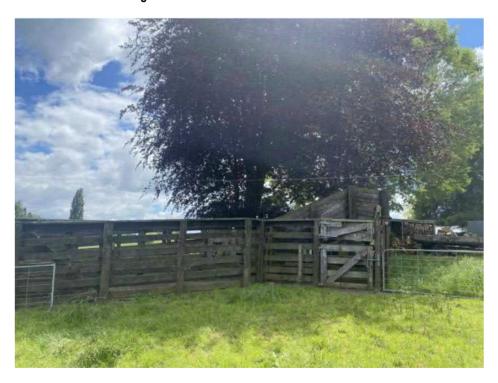
Figure 6.4: Photo of the stockyard at the site.

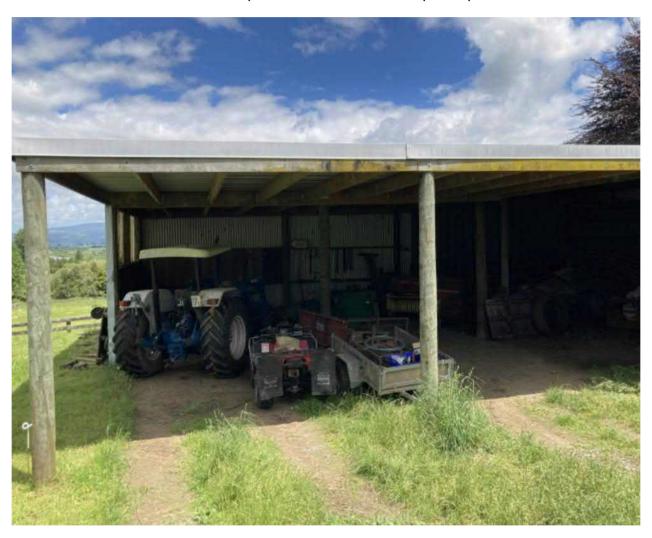
information suggests that fuel storage is small scale. The shed has a concrete surface in the workshop area and exposed soil in the implement storage area. Surrounding the implement shed and workshop, a pile of treated timber (Figure 6.7) and a pile of scrap metal was observed on bare soil during the site visit.

Overall, the activities associated with the main farm shed and surrounding area are small scale and present a low risk to human health. However, in the absence of quantifiable data (e.g., bulk storage of copper-chromium-arsenic (CCA) treated timber is likely to create an elevation in concentrations of copper, chromium, and arsenic in the soil beneath and the workshop activities could result in hydrocarbon contamination of soils) there is insufficient evidence to conclude that the source-pathway-receptor linkage is incomplete. Therefore, the main farm area is identified as a 'piece of land' (Appendix A). It is recommended that any further investigation into the potential soil contamination risk at this area is completed once the site development plan is established.

Figure 6.5: Photo of the implement shed storage area.

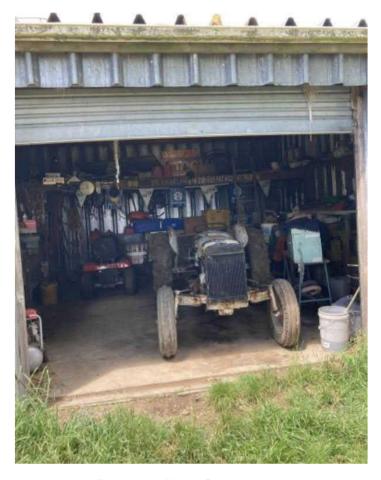
A workshop/implement shed is located on the subject site. The shed was first identified in aerial imagery from 1995 to 2021. The shed is used as a maintenance, hobby restoration, and storage shed for machinery (e.g., tractors, quad bikes, hay mower, lawn mower), see Figure 6.5 and Figure 6.6. No bulk storage of chemicals or fuel was observed during the site visit and anecdotal

Figure 6.6: Photo of the workshop.

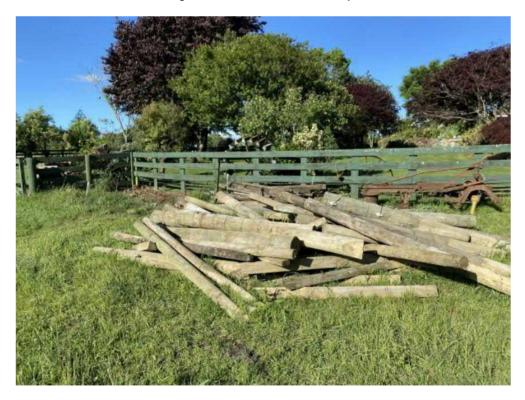
Figure 6.7: Photo of treated timber fence posts.

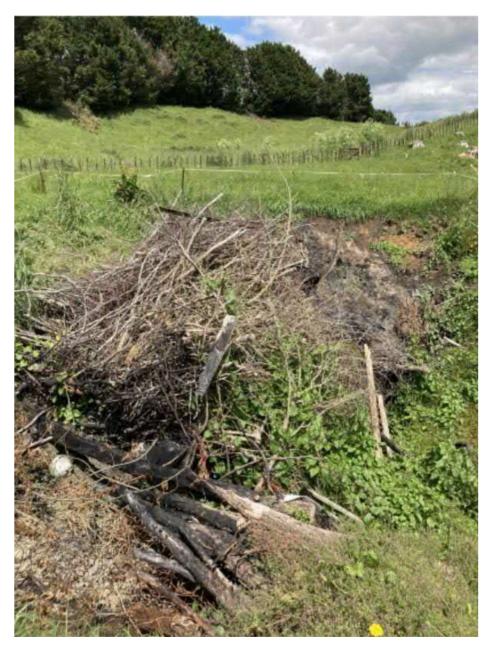
A burn pit was observed during the site visit, see Figure 6.8. The burn pit was also identified in historical imagery from 1979 to 2021 imagery. Anecdotal information suggests the burn pit was originally an old silage pit, however it is now used as a burn pit to dispose of tree cuttings from around the site. Although tree cuttings were the predominant material observed a small amount of rubbish was noted (e.g., fencing wire). Contaminants associated with burn pits are dependent on the original waste that is disposed of into the pit. This activity could result in metal, hydrocarbon, dioxin, and microplastic contamination at the site. In the absence of quantifiable data, there is a potential risk to human health at this location. Therefore, the burn pit is identified as a 'piece of land' (Appendix A). It is recommended that any further investigation into the potential soil contamination risk at this area is completed once the site development plan is established.

Figure 6.8: Photo of burn pit.

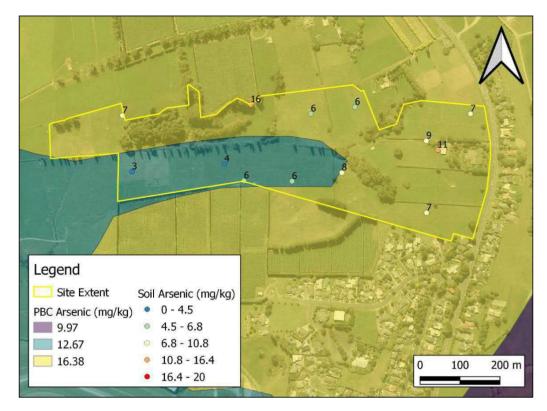
Figure E 1: Upper 95% predicted background concentration (PBC) of arsenic, overlaid with discrete soil sample results for arsenic (labels indicate concentration in mg/kg).

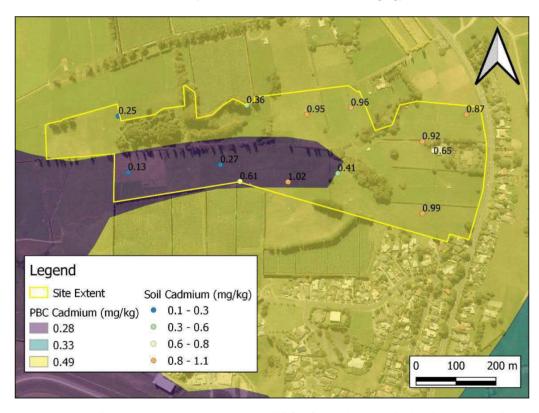
Figure E 2: Upper 95% predicted background concentration (PBC) of cadmium, overlaid with discrete soil sample results for cadmium (labels indicate concentration in mg/kg).

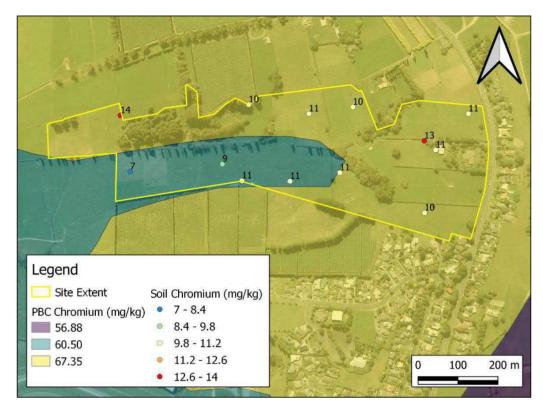
Figure E 3: Upper 95% predicted background concentration (PBC) of chromium, overlaid with discrete soil sample results for chromium (labels indicate concentration in mg/kg).

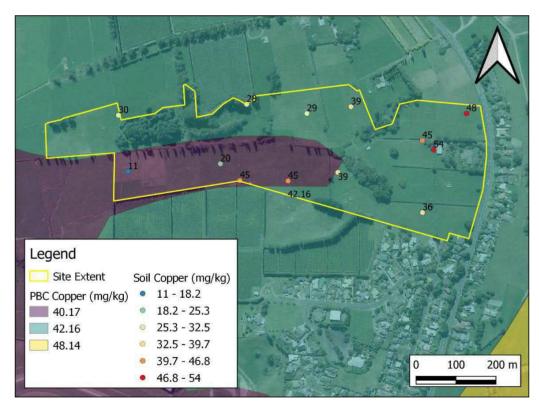
Figure E 4: Upper 95% predicted background concentration (PBC) of copper, overlaid with discrete soil sample results for copper (labels indicate concentration in mg/kg).

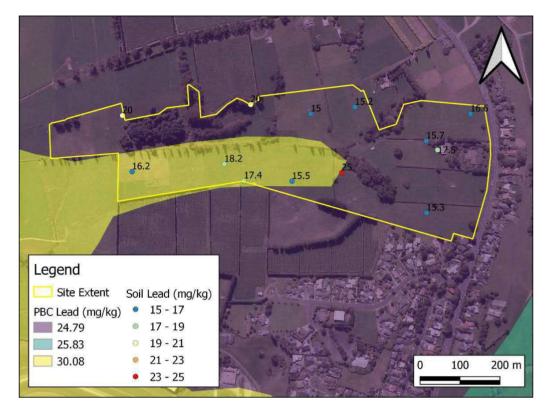
Figure E 5: Upper 95% predicted background concentration (PBC) of lead, overlaid with discrete soil sample results for lead (labels indicate concentration in mg/kg).

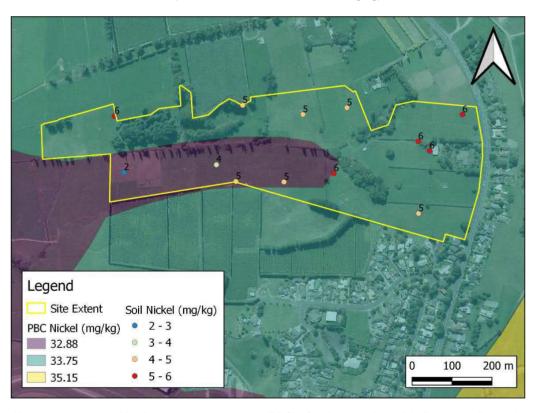
Figure E 6: Upper 95% predicted background concentration (PBC) of nickel, overlaid with discrete soil sample results for nickel (labels indicate concentration in mg/kg).

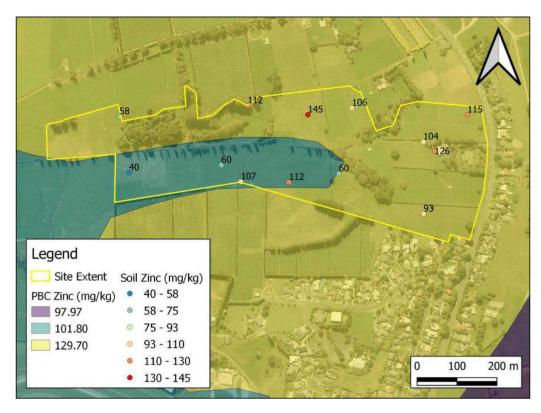
Figure E 7: Upper 95% predicted background concentration (PBC) of zinc, overlaid with discrete soil sample results for zinc (labels indicate concentration in mg/kg).

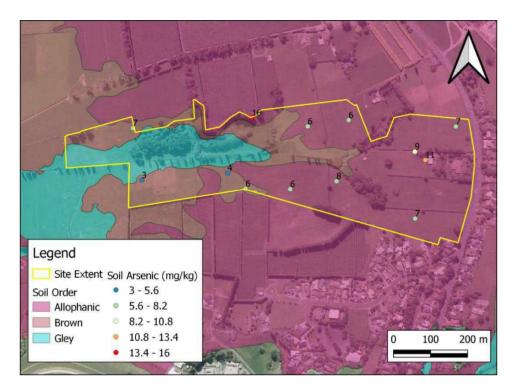
Figure F 8: Soil order overlaid with discrete soil sample results for arsenic (labels indicate concentration in mg/kg).

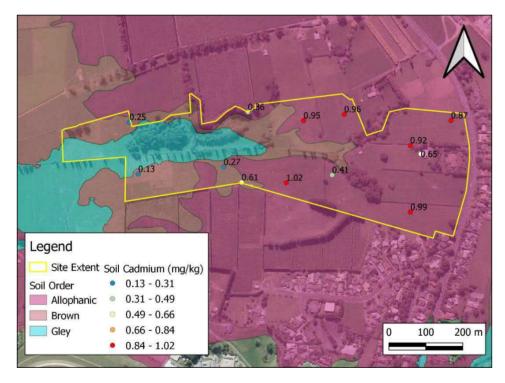
Figure F 9: Soil order overlaid with discrete soil sample results for cadmium (labels indicate concentration in mg/kg).
