EGL Ref: 9702

MATAKANUI GOLD LIMITED BENDIGO-OPHIR GOLD PROJECT SITE GEOTECHNICAL FACTUAL REPORT

Data and observations presented in this Site Geotechnical Factual Report relate to geology and landform features within the project study area and the results of geotechnical investigation completed during 2024 and 2025.

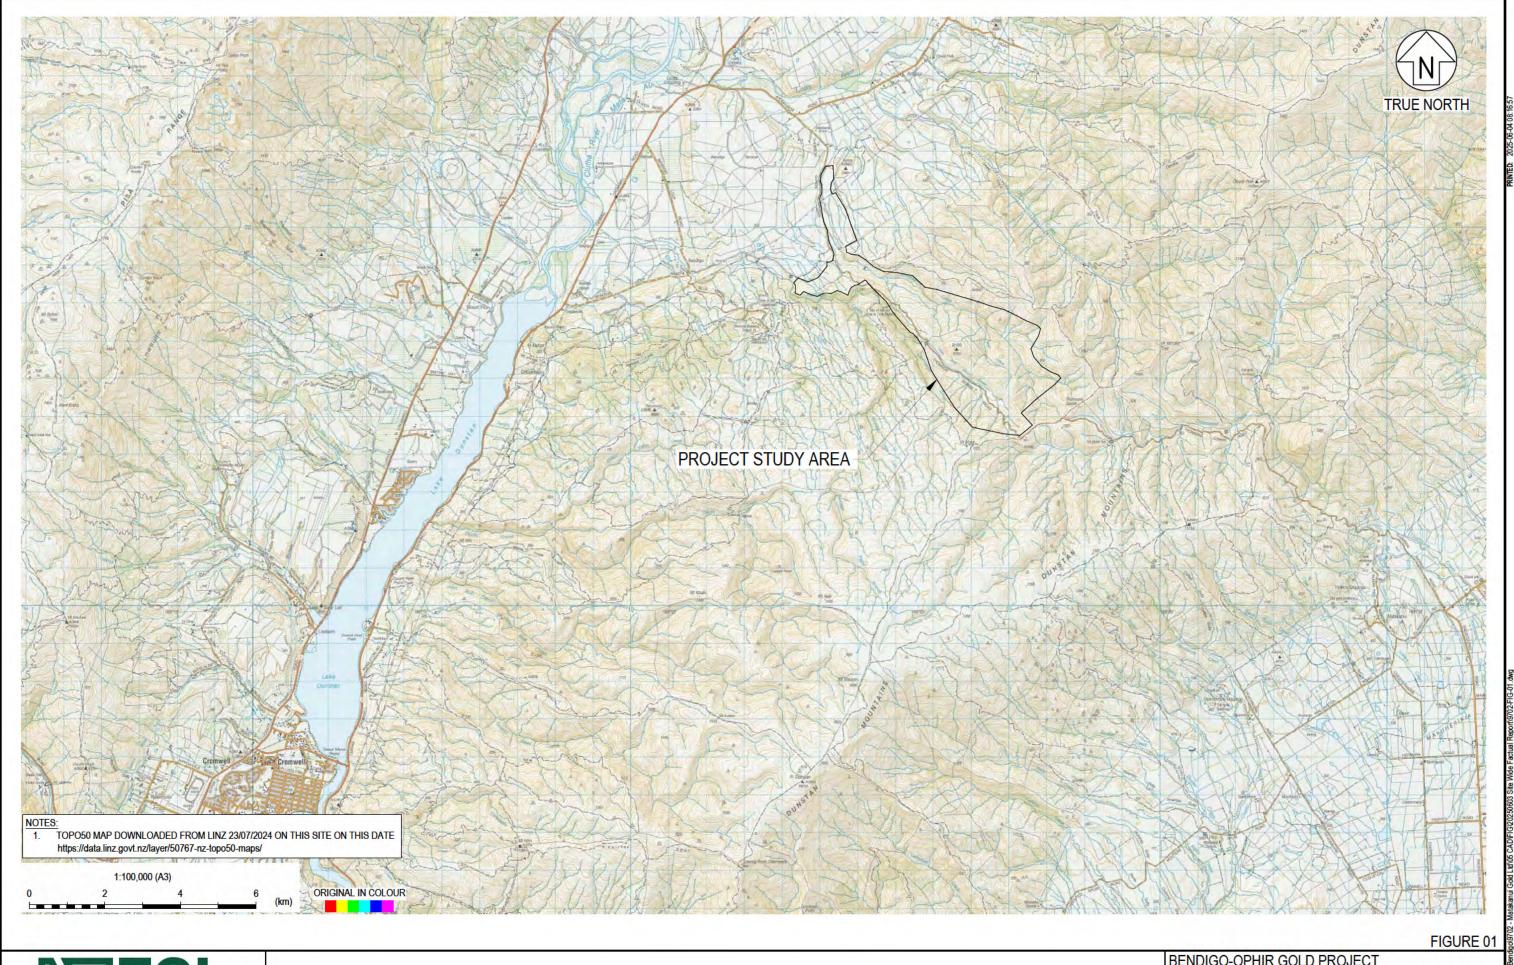
BENDIGO-OPHIR GOLD PROJECT SHEPHERDS CREEK & RISE & SHINE CREEK AREA GENERAL SITE ARRANGEMENT LOCALITY PLAN

The proposed site is located approximately 20 km northeast of Cromwell as shown in Figure 1. It is on the edge of the Bendigo Terrace and within the Dunstan Mountains of Central Otago.

MGL are proposing to establish the BOGP, which comprises a new gold mine, ancillary facilities, and environmental mitigation measures, on the Bendigo and Ardgour Stations in the Dunstan Mountains of Central Otago. The location of the project study area is shown in Figure 1.

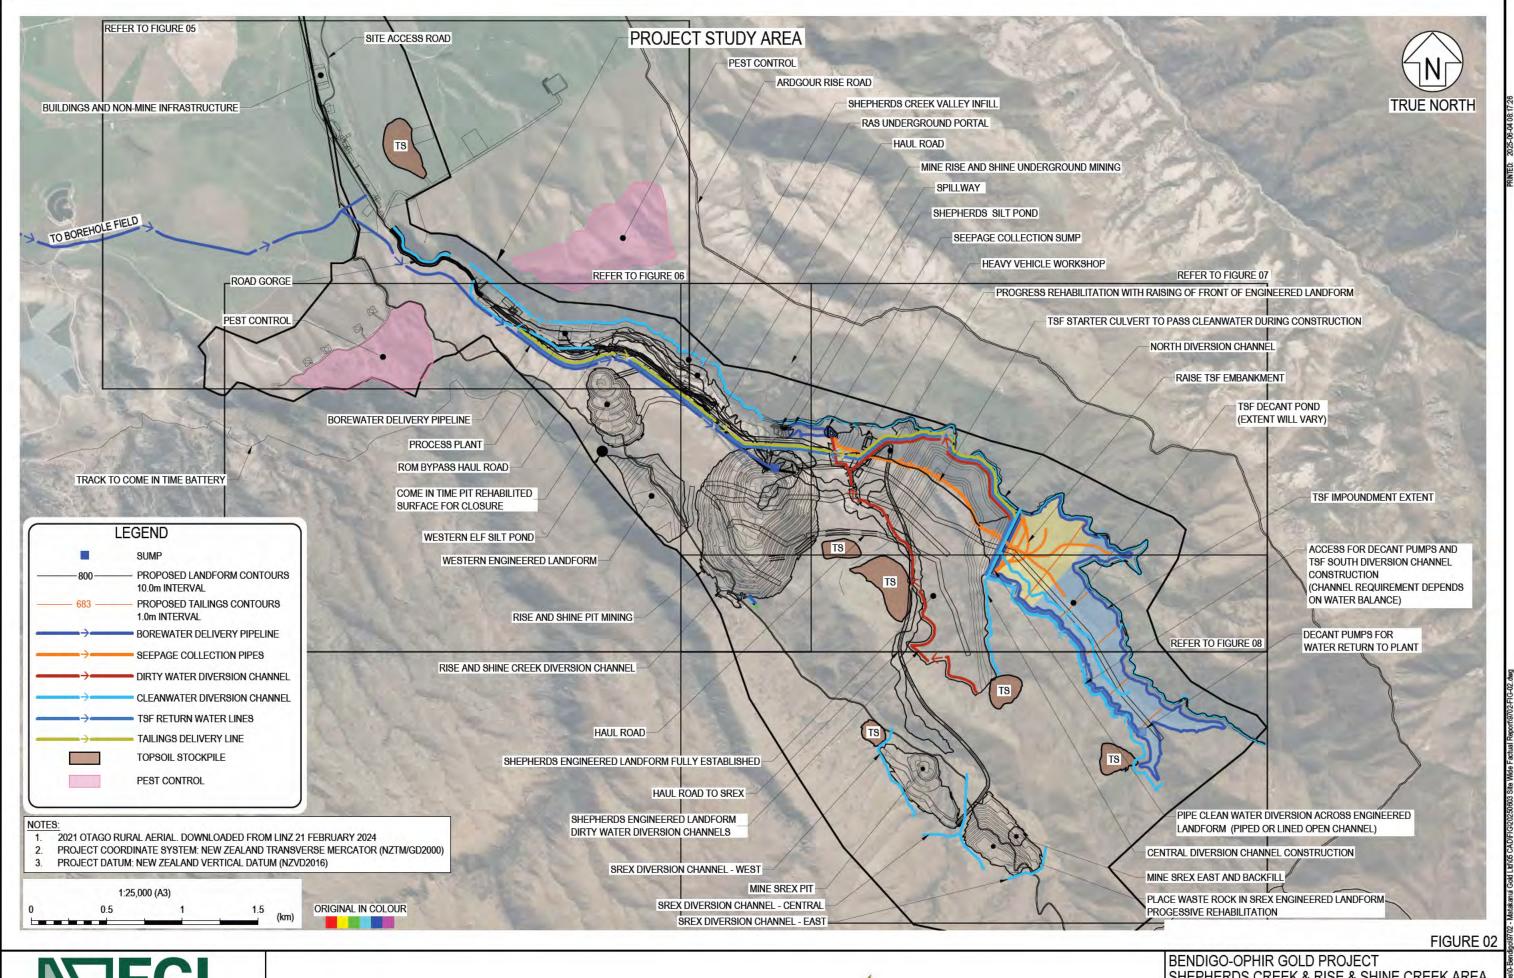
BENDIGO-OPHIR GOLD PROJECT SHEPHERDS CREEK & RISE & SHINE CREEK AREA SITE WIDE FACTUAL REPORT GENERAL SITE ARRANGEMENT

The proposed site layout is shown on Figure 2. The proposed mine site will comprise the following surface infrastructure:

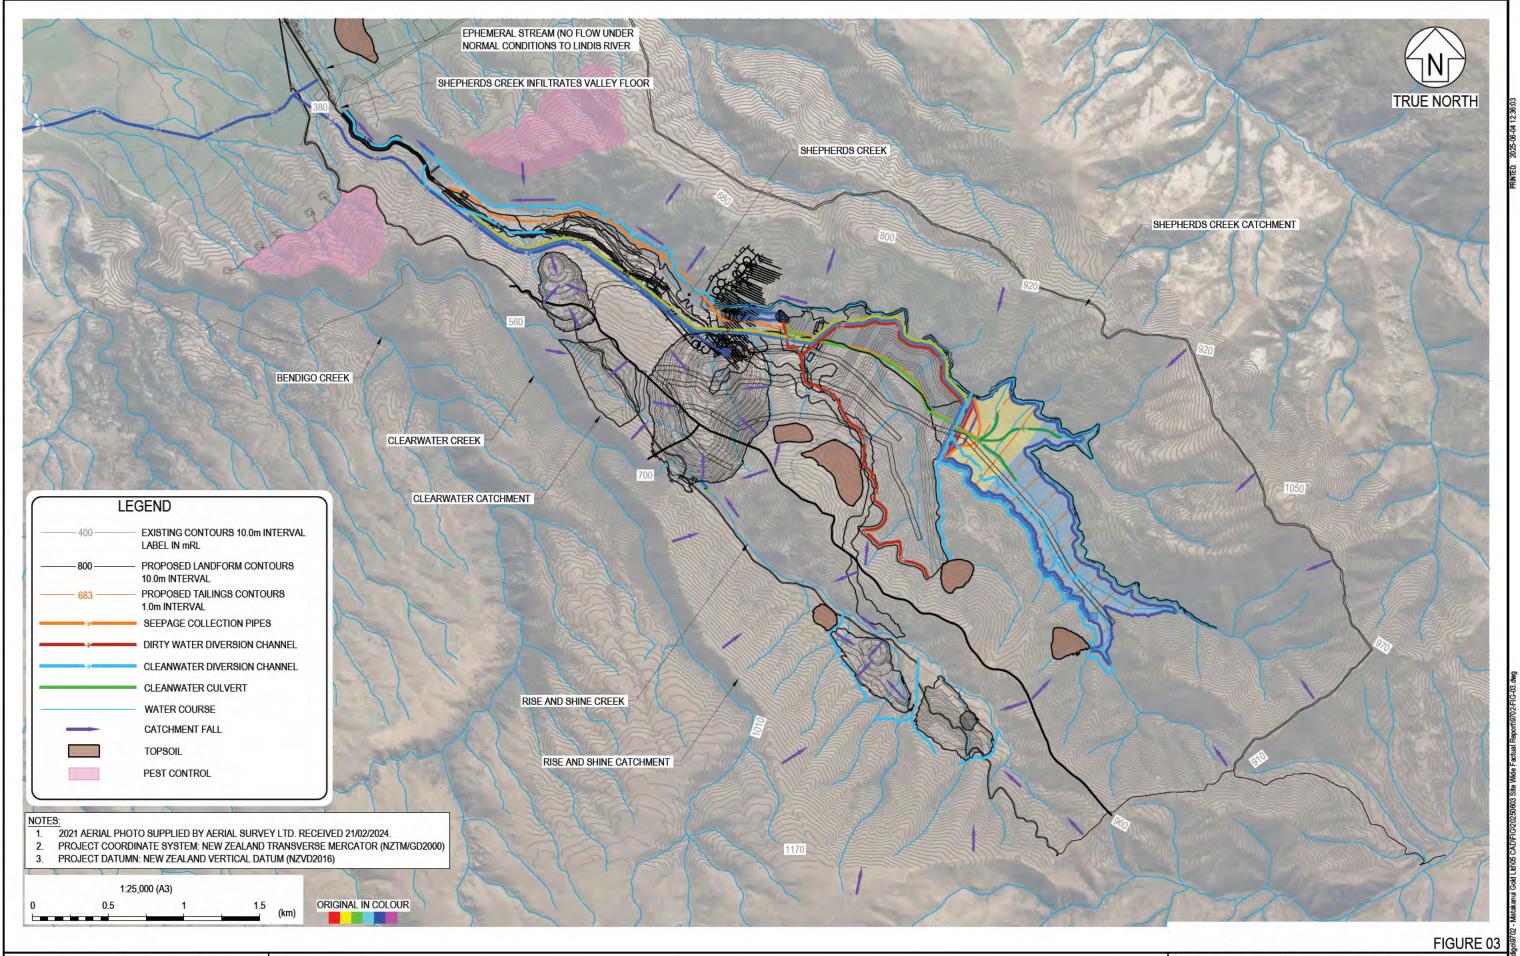
BENDIGO-OPHIR GOLD PROJECT SHEPHERDS CREEK & RISE & SHINE CREEK AREA SITE WIDE FACTUAL REPORT TOPOGRAPHY PLAN

The site topography, named creeks, and main catchments are shown in Figure 3. The site extends across the gravels of the Bendigo Terrace and schist rock of the Dunstan Mountains.

Both creek catchments start from a divide at approximately 950 mRL in the southeast and flow to the northwest. The creeks flow over schist rock within the valleys and onto gravel terraces in the northwest. Shepherds Creek is approximately 150 m lower than Rise and Shine Creek. The ridge between the creeks is approximately 60 to 190 m above the floor of Rise and Shine Creek, and 200 to 350 m above the floor of Shepherds Creek. Rise and Shine Creek flows into Clearwater Creek at approximately 650 mRL which in turn flows into Bendigo Creek at about 570 mRL. Shepherds Creek and Bendigo Creeks flow off the schist rock onto gravel terraces at approximately 350 mRL.

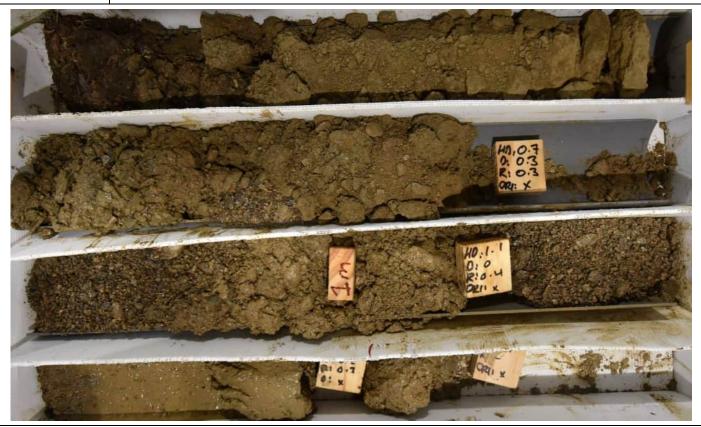
Depth: 0m to 1.4m

MDD327 - CORE PHOTOGRAPHS

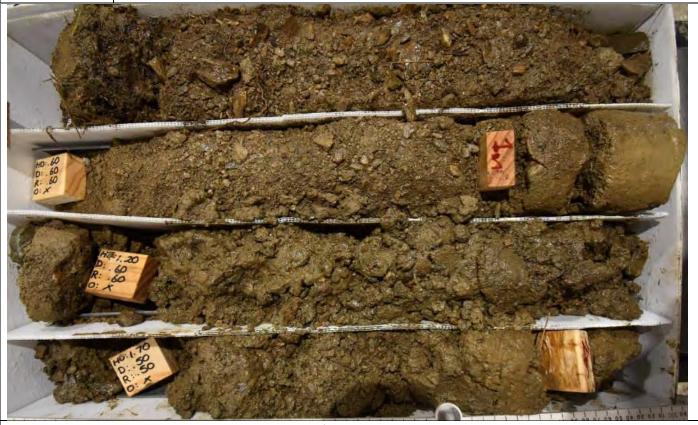
Depth: 0.0m to 2.1m

MDD333 - CORE PHOTOGRAPHS
