To:	Doyle Smith Knight Investments Limited
From:	Shane Lander Principal Geotechnical Engineer (Geotechnical Assessments) Tobias Francis Associate Geotechnical Engineer (Coastal Assessments)
Copy:	Daniel Nakhle Knight Investments Limited
Subject:	Application for Fast Track Referral, various sites Clarks Beach Road, Clarks Beach (Orawaahi)
Date:	15 July 2025
Project Ref:	J01842
Document ID:	627403
Revision Status:	For Fast Track Referral Application

1 INTRODUCTION

LDE has been engaged to provide a concise high-level assessment of the site's geotechnical stability and coastal erosion (the latter for Lot 3 DP 337204), the anticipated challenges, and how these can be effectively managed throughout development. If the referral application is accepted, then more substantive geotechnical and coastal evaluations will be undertaken.

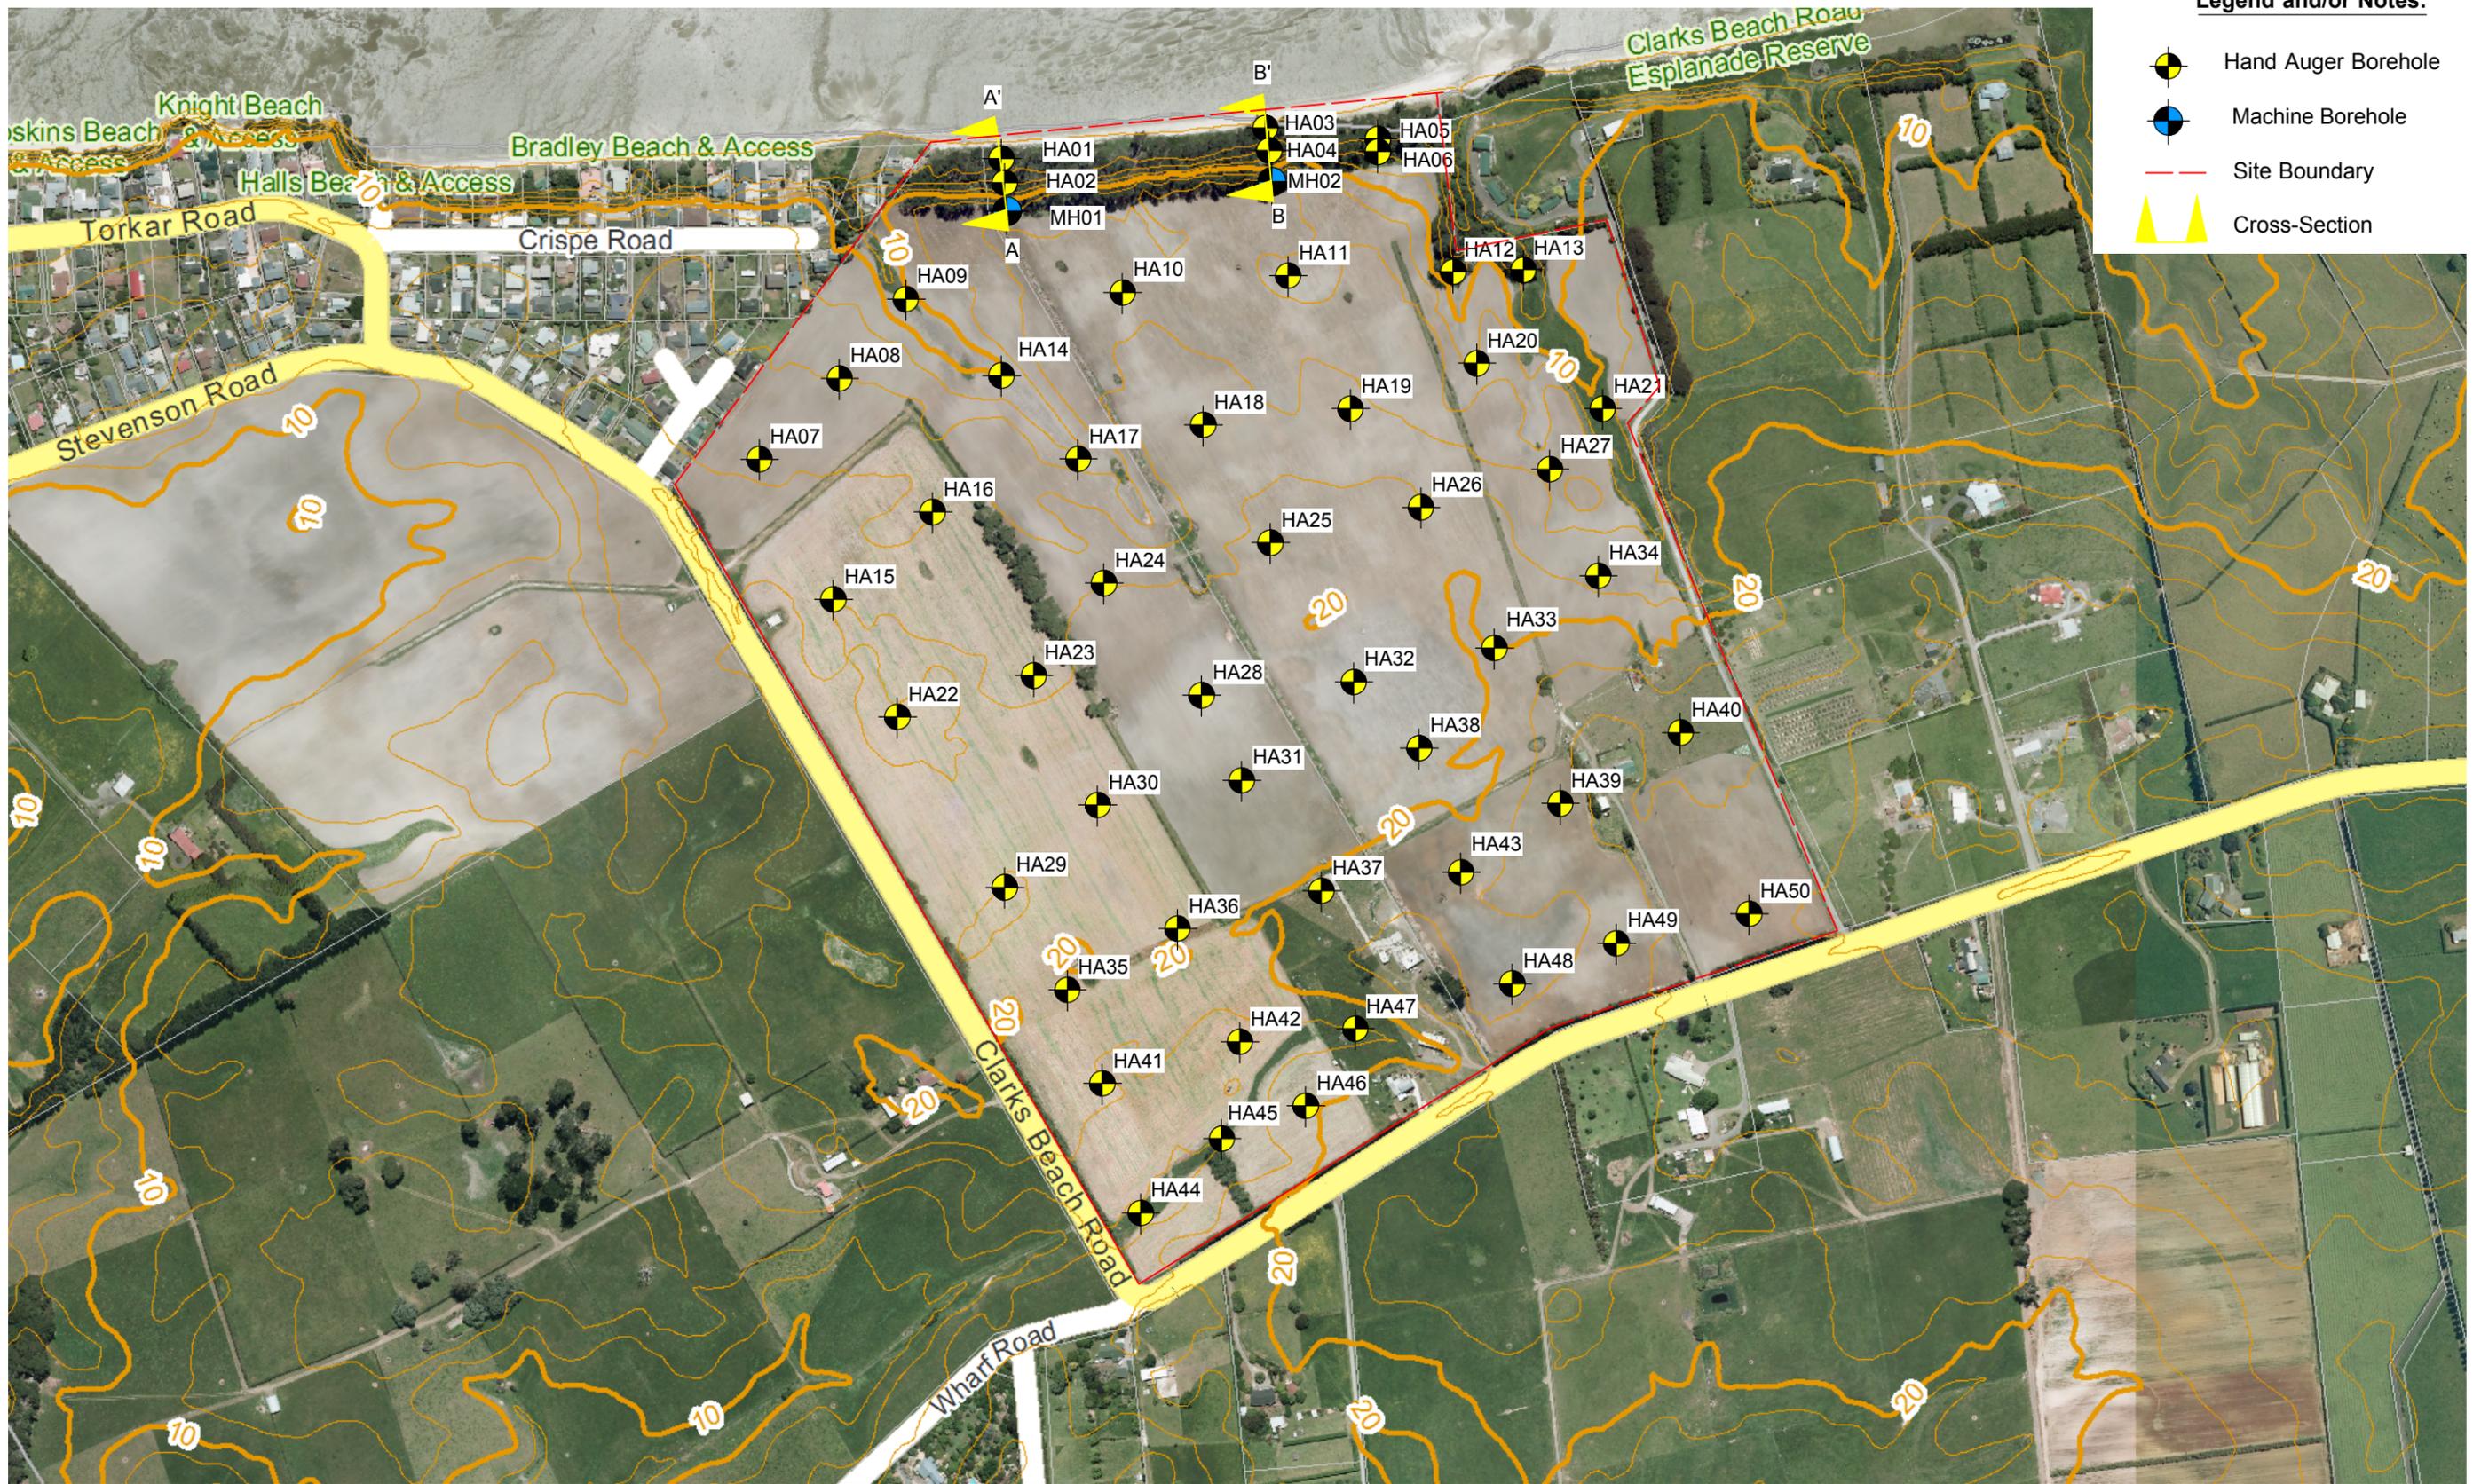
client:	KNIGHT INVESTMENTS LIMITED
						approved	SGL		project:	137 CLARKS BEACH ROAD, CLARKS BEACH
						date	10.05.16		title:	SITE INVESTIGATION PLAN
						scale	1:5000		project no:	J 00318
						original size	A3

The most relevant report is the Lander 2021 report, which involved the drilling and interpretation of 18 hand auger boreholes across the site. A site plan showing various test locations and full borehole records (for Lot 3 DP 337204 only) are attached in Appendix A.

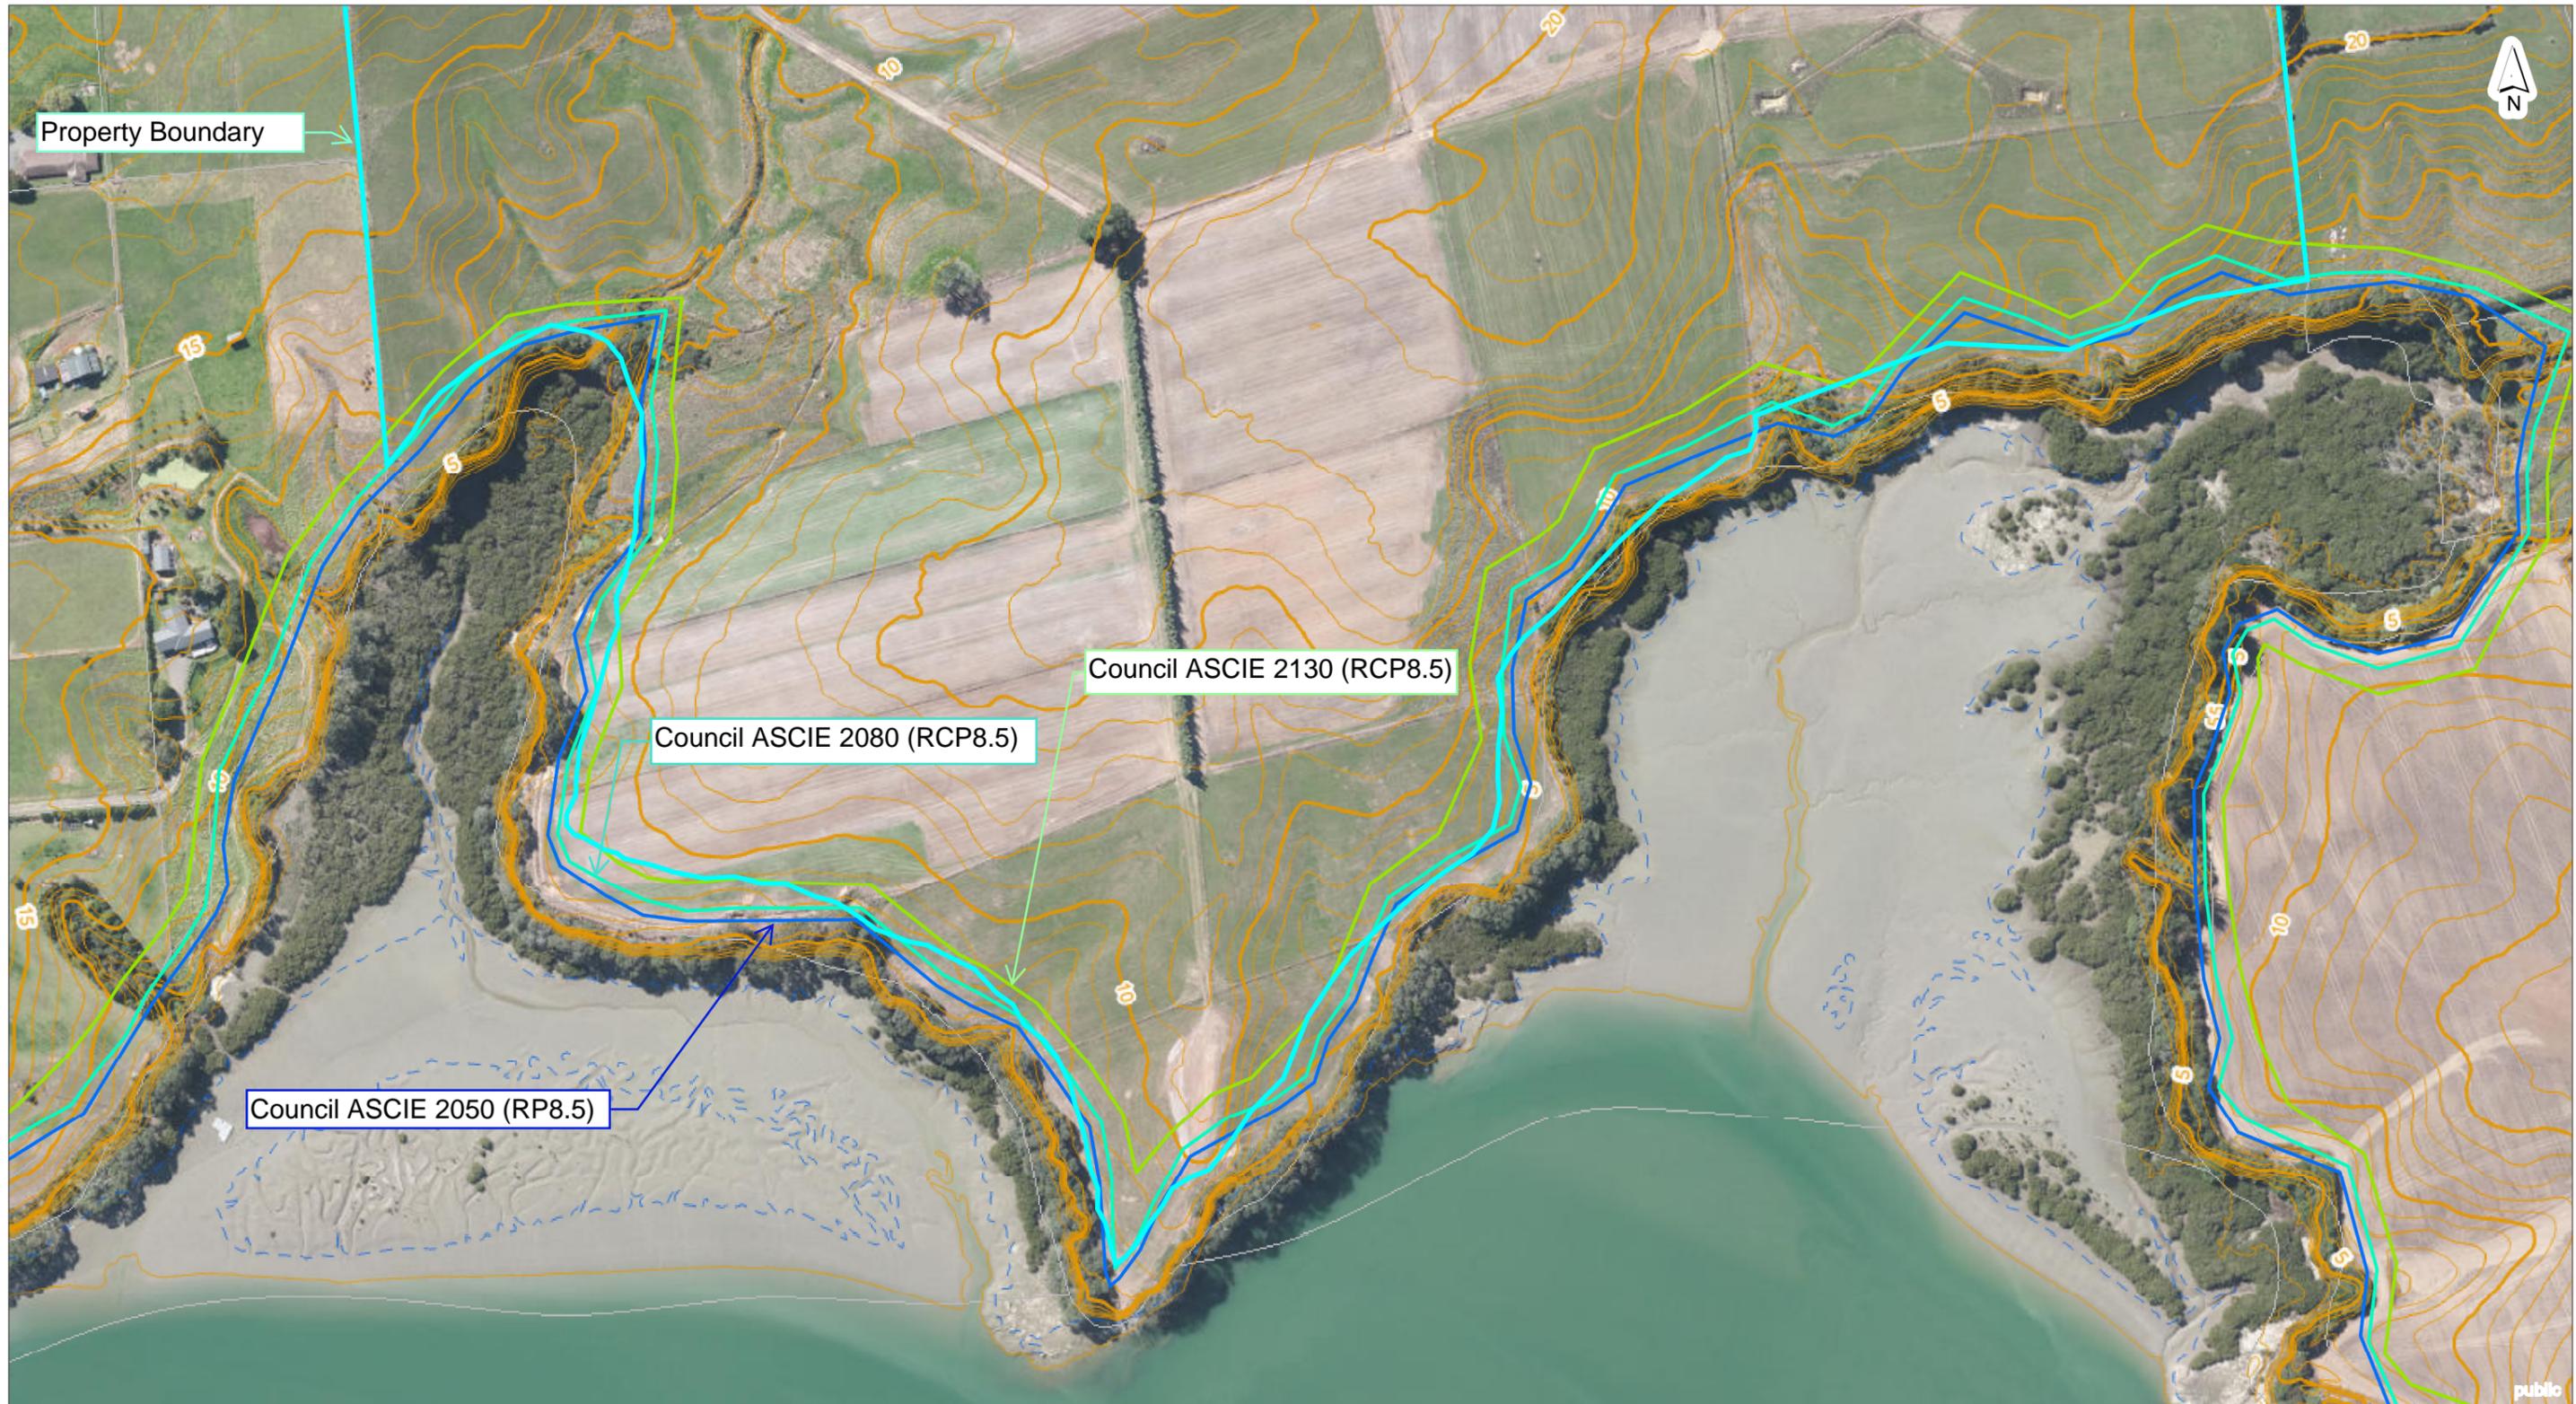
ASCIE Plan

The site includes coastal margins along the Taihiki River, a tidal inlet of the Manukau Harbour. Portions of the property are within areas identified as susceptible to coastal instability and erosion (ASCIE). However, the region-wide hazard mapping by Auckland Council is broad-brush and based on generalised coastal classifications, which may not reflect local geomorphology with high precision. The indicative ASCIE lines from Council mapping are shown on the appended plan (Appendix B). A detailed, site-specific assessment would likely show a reduced inland extent of ASCIE.

ASCIE LINES (FROM COUNCIL GEOMAPS)
