Acid Sulfate Soils Desktop Assessment

Waikato Thoroughbred Racing

23-1883 **Acid sulfate soils – desktop assessment**

Pencarrow Road, Tamahere

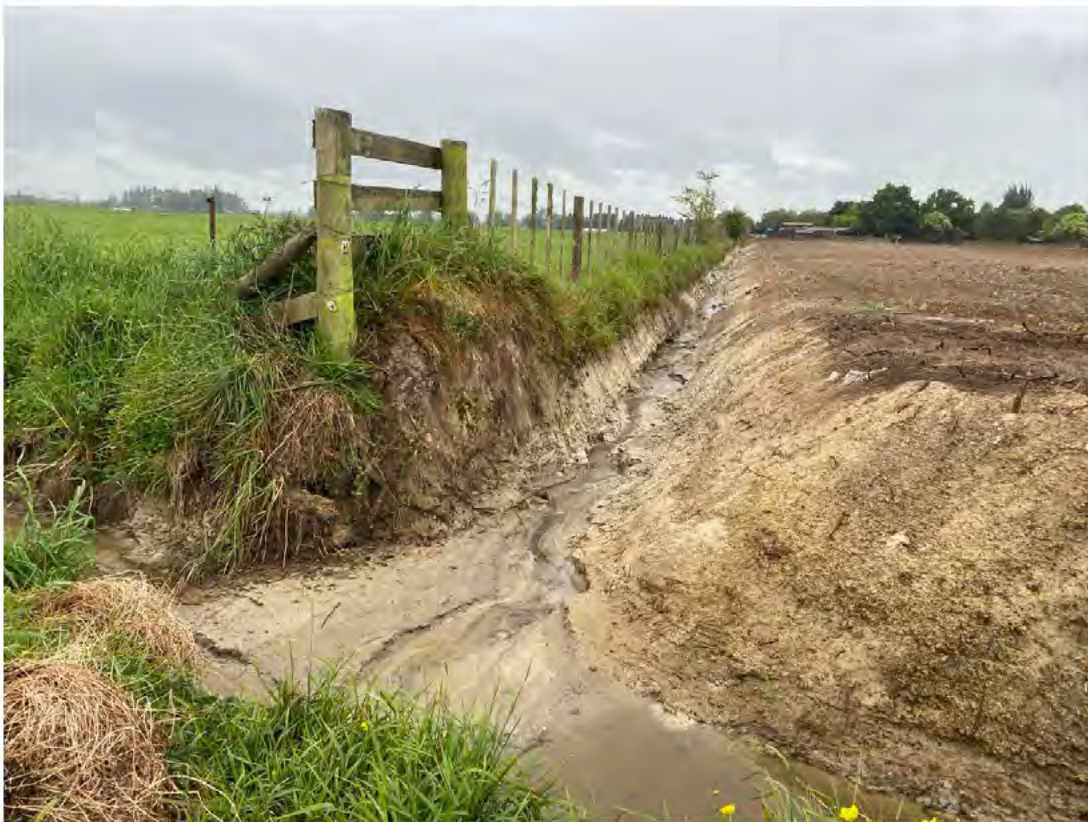
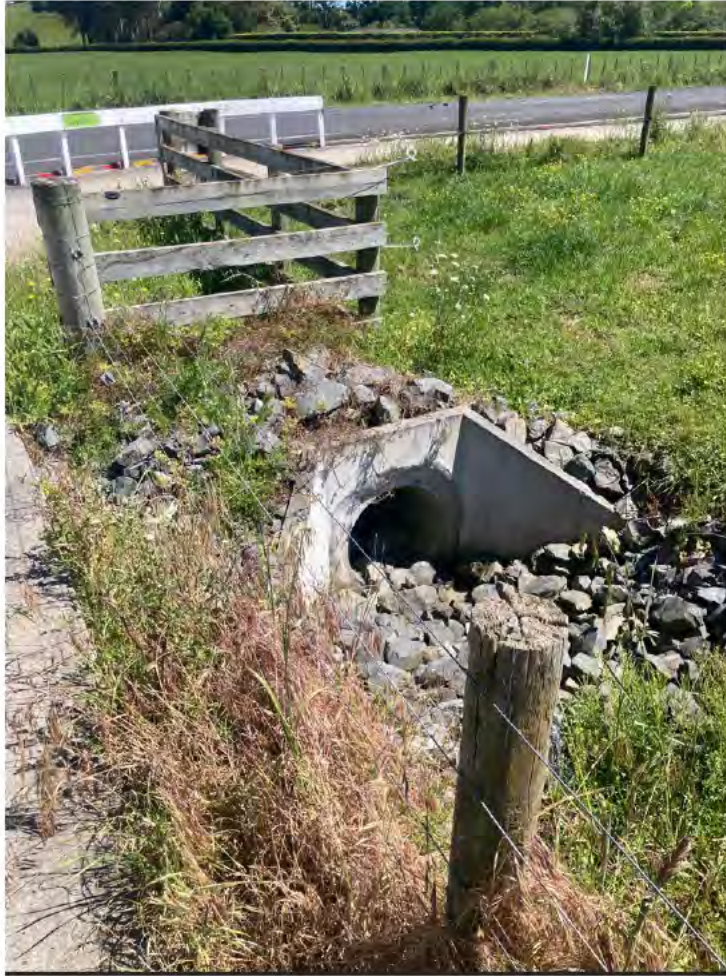
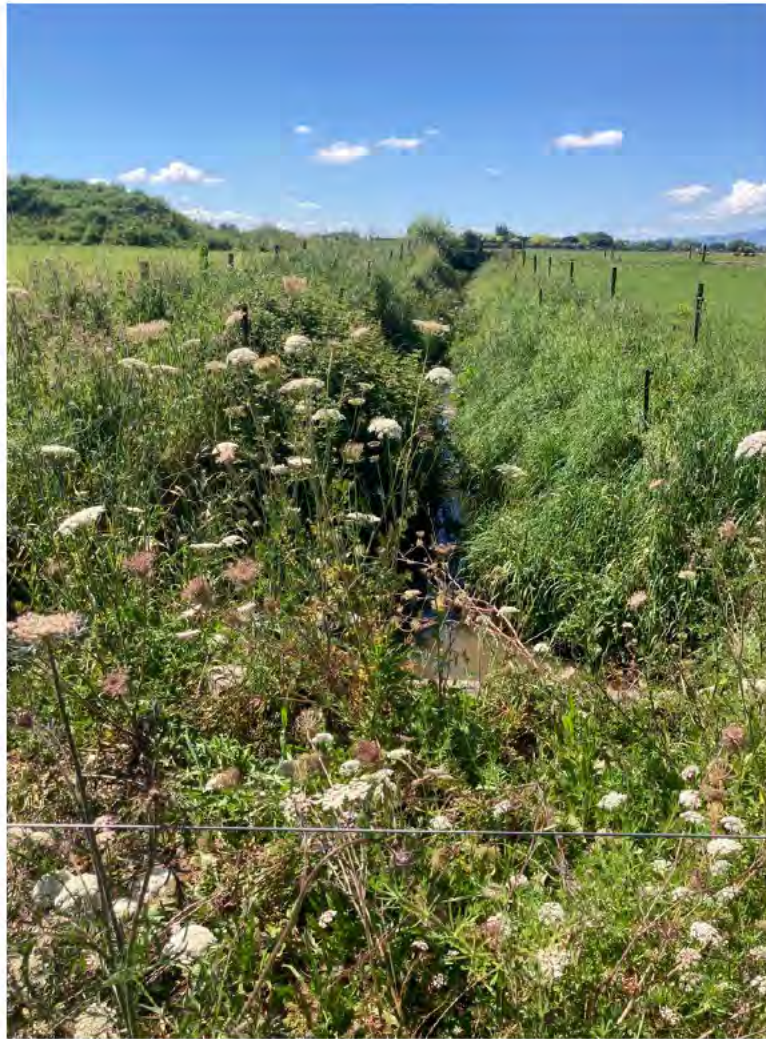
Figure 3: Examples of waterways at the Site

A site inspection was undertaken on 12 November 2025 during the fieldwork. Assessment focused on the drainage system. Water in the drains had sediment, and no observations of unusually clear or milky blue-green water were observed, and no signs of distressed vegetation were observed on the edges of the drains. No physicochemical assessment was undertaken of the water in the drains. No corrosion of concrete structures or iron staining were observed. No jarosite minerals or mottling was observed in the Site drains. No sulfuric odours were identified during the walkover. Representative photos are included below.

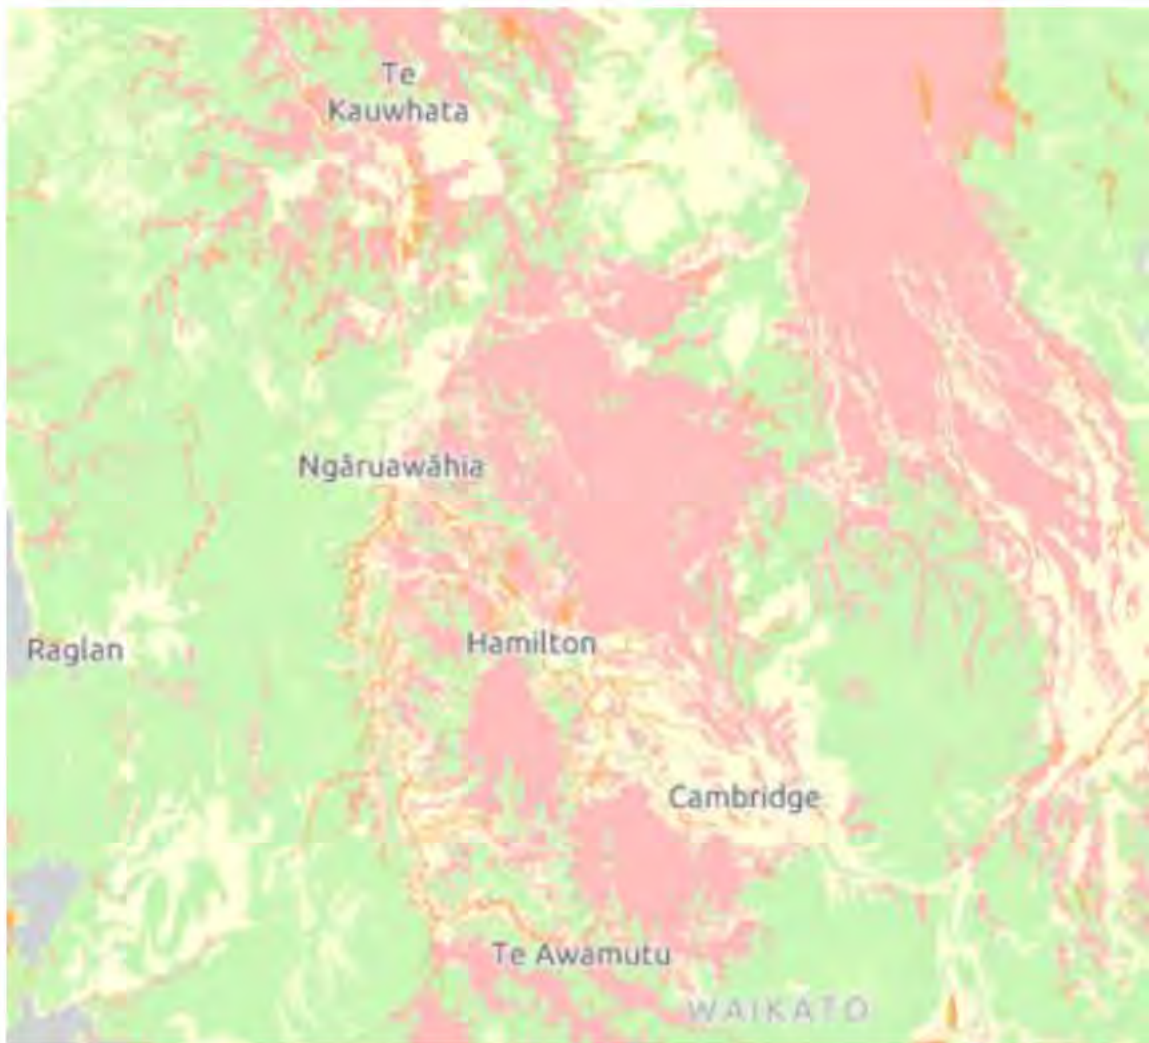
Figure 4: Waikato acid sulfate risk

It is noted that while the Site is in a medium and higher risk area, over 17% of the Waikato is classified in one of these categories. An excerpt from the risk map showing the Cambridge – Te Awamutu – Hamilton region and the areas of risk are shown in Figure 4 below.

Key colour	Risk ranking
 	High
 	Medium
 	Low

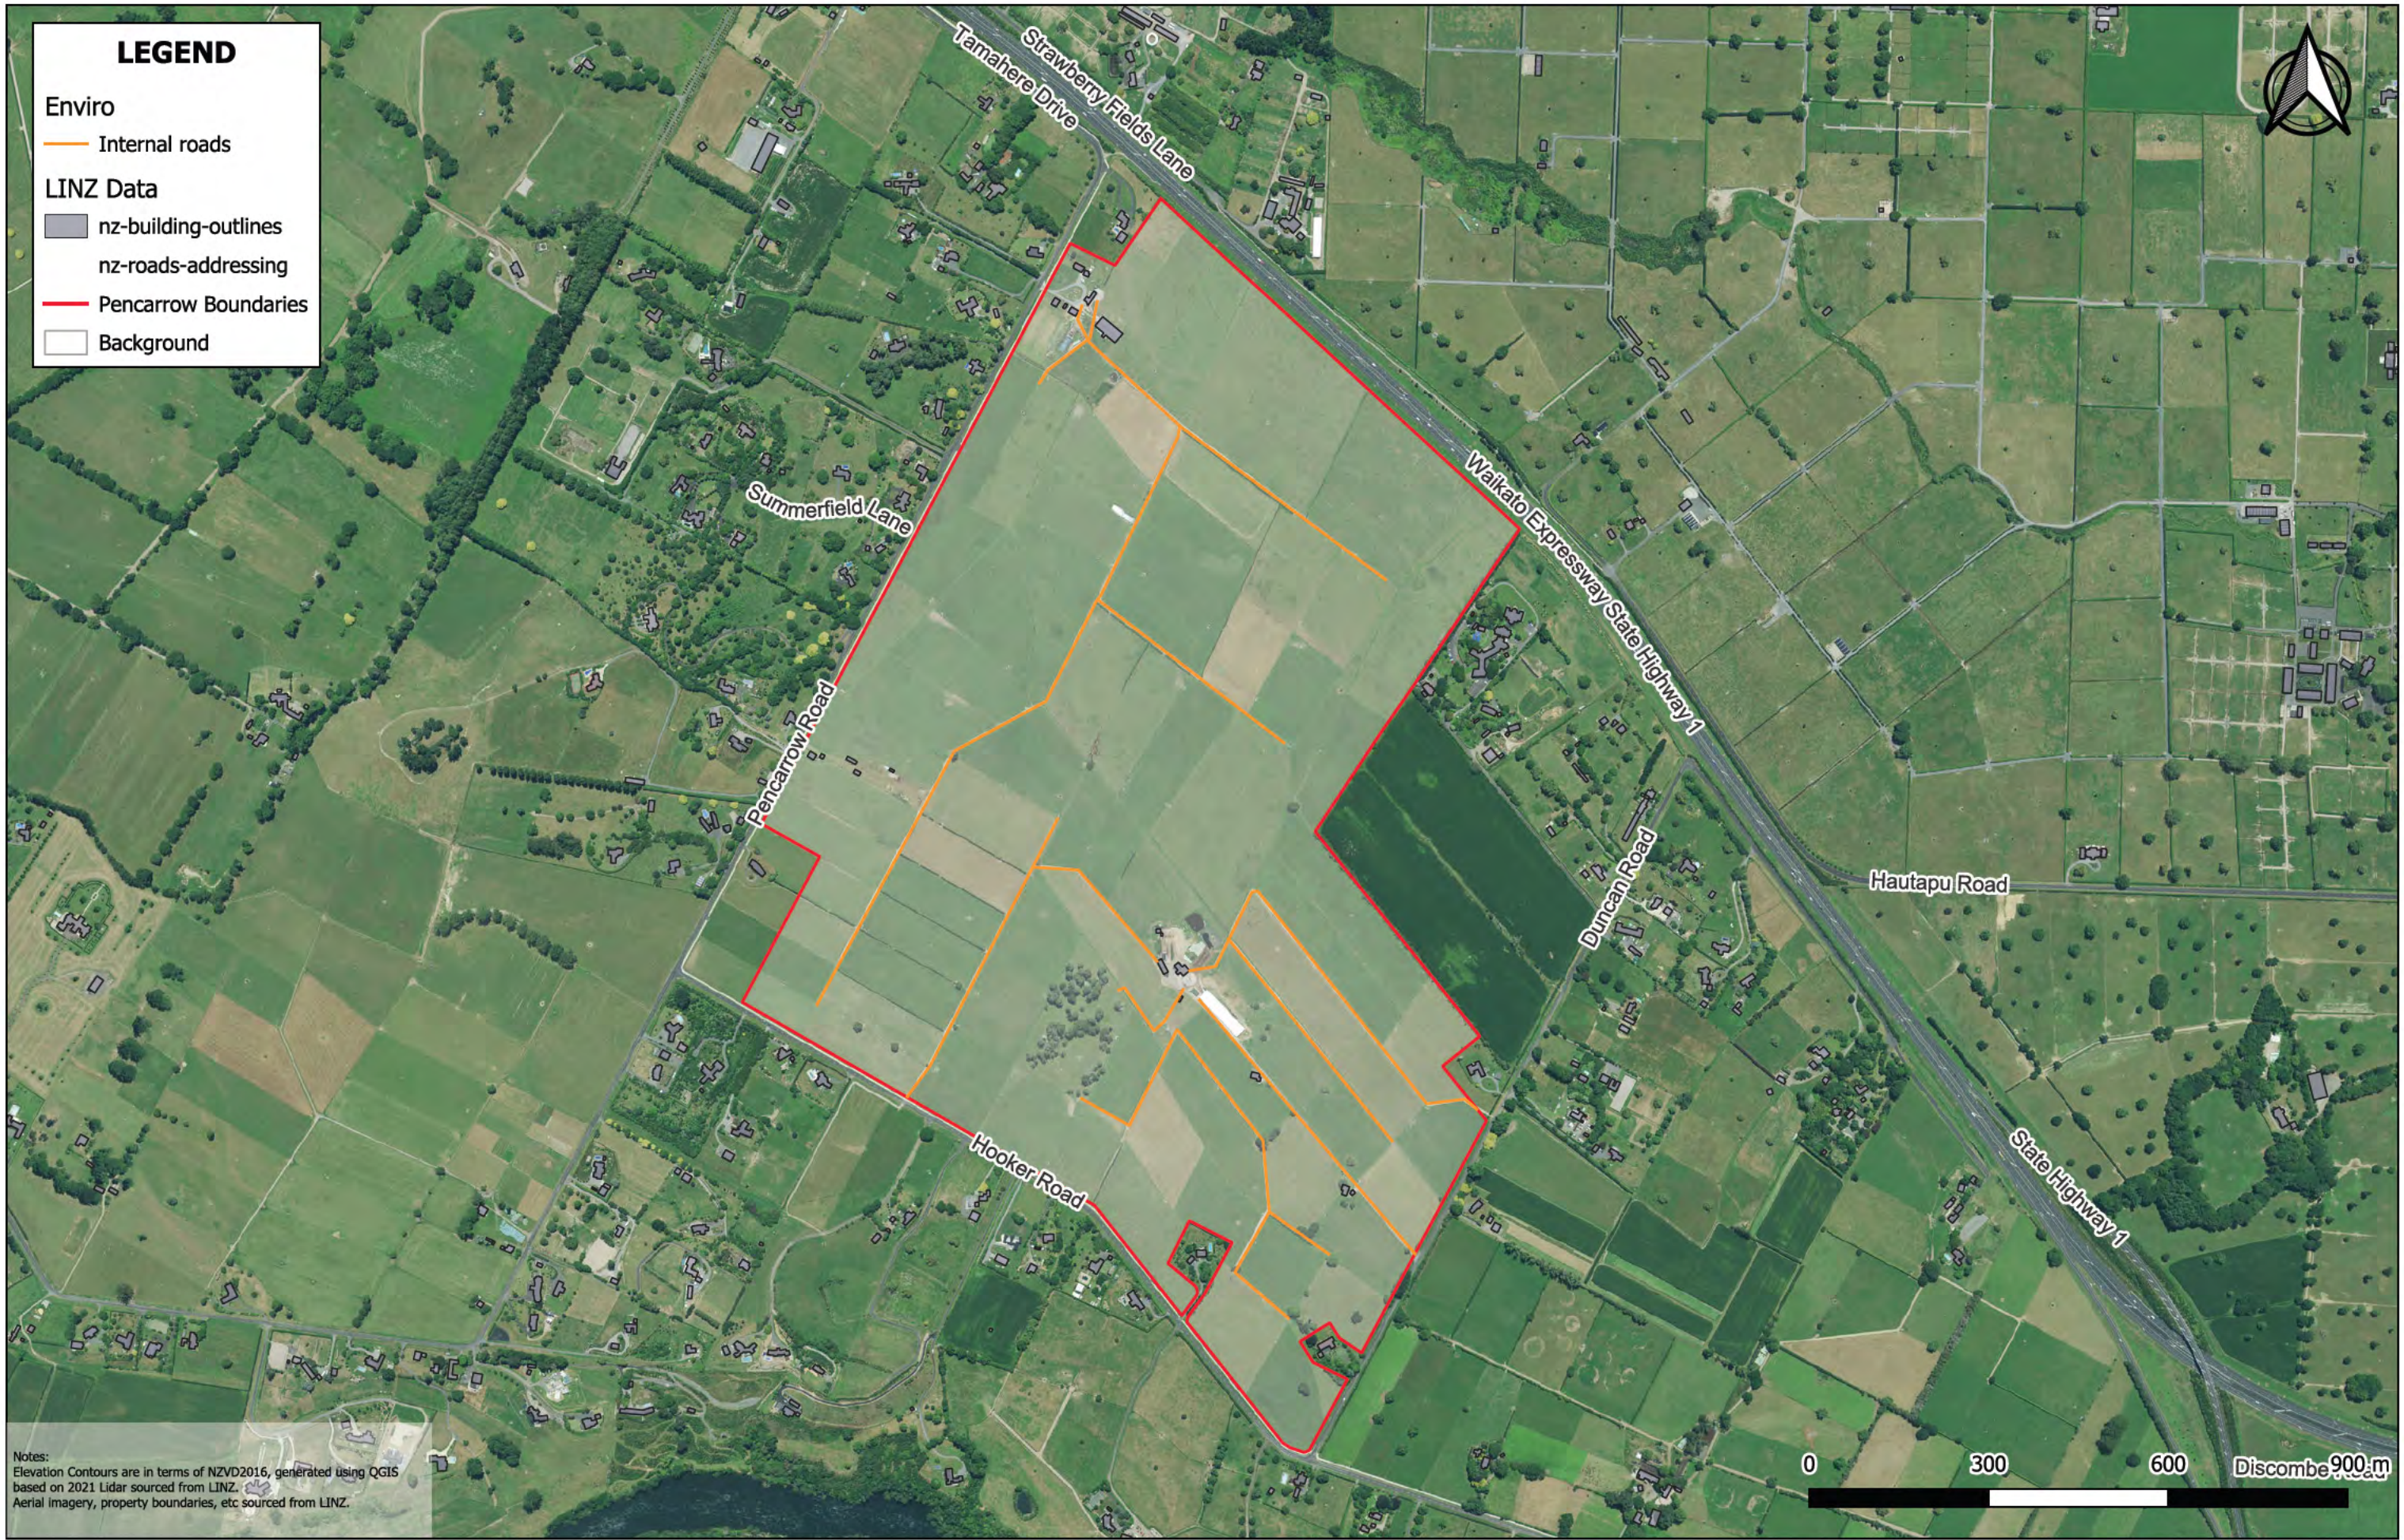
Notes:
 Elevation Contours are in terms of NZVD2016, generated using QGIS based on 2021 Lidar sourced from LINZ.
 Aerial imagery, property boundaries, etc sourced from LINZ.

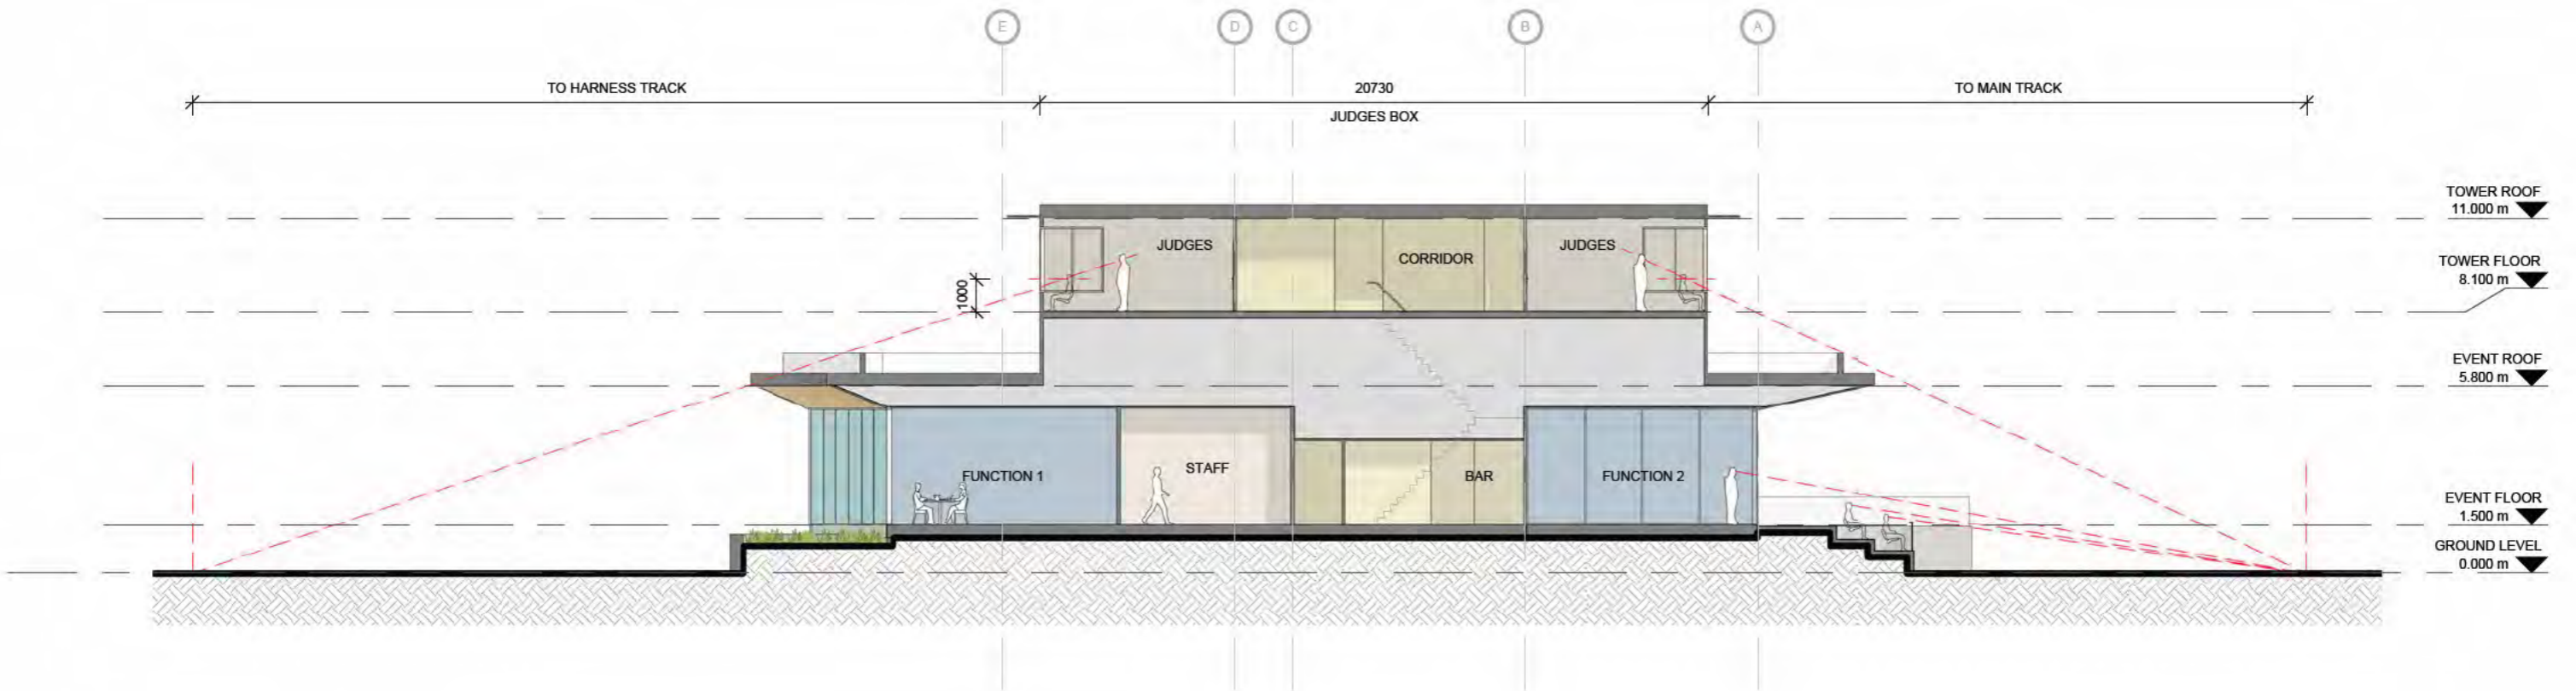
SHORT SECTION
SCALE @ A3 - 1 : 200

3.6 EVENT + OPERATIONS BUILDING SHORT SECTION

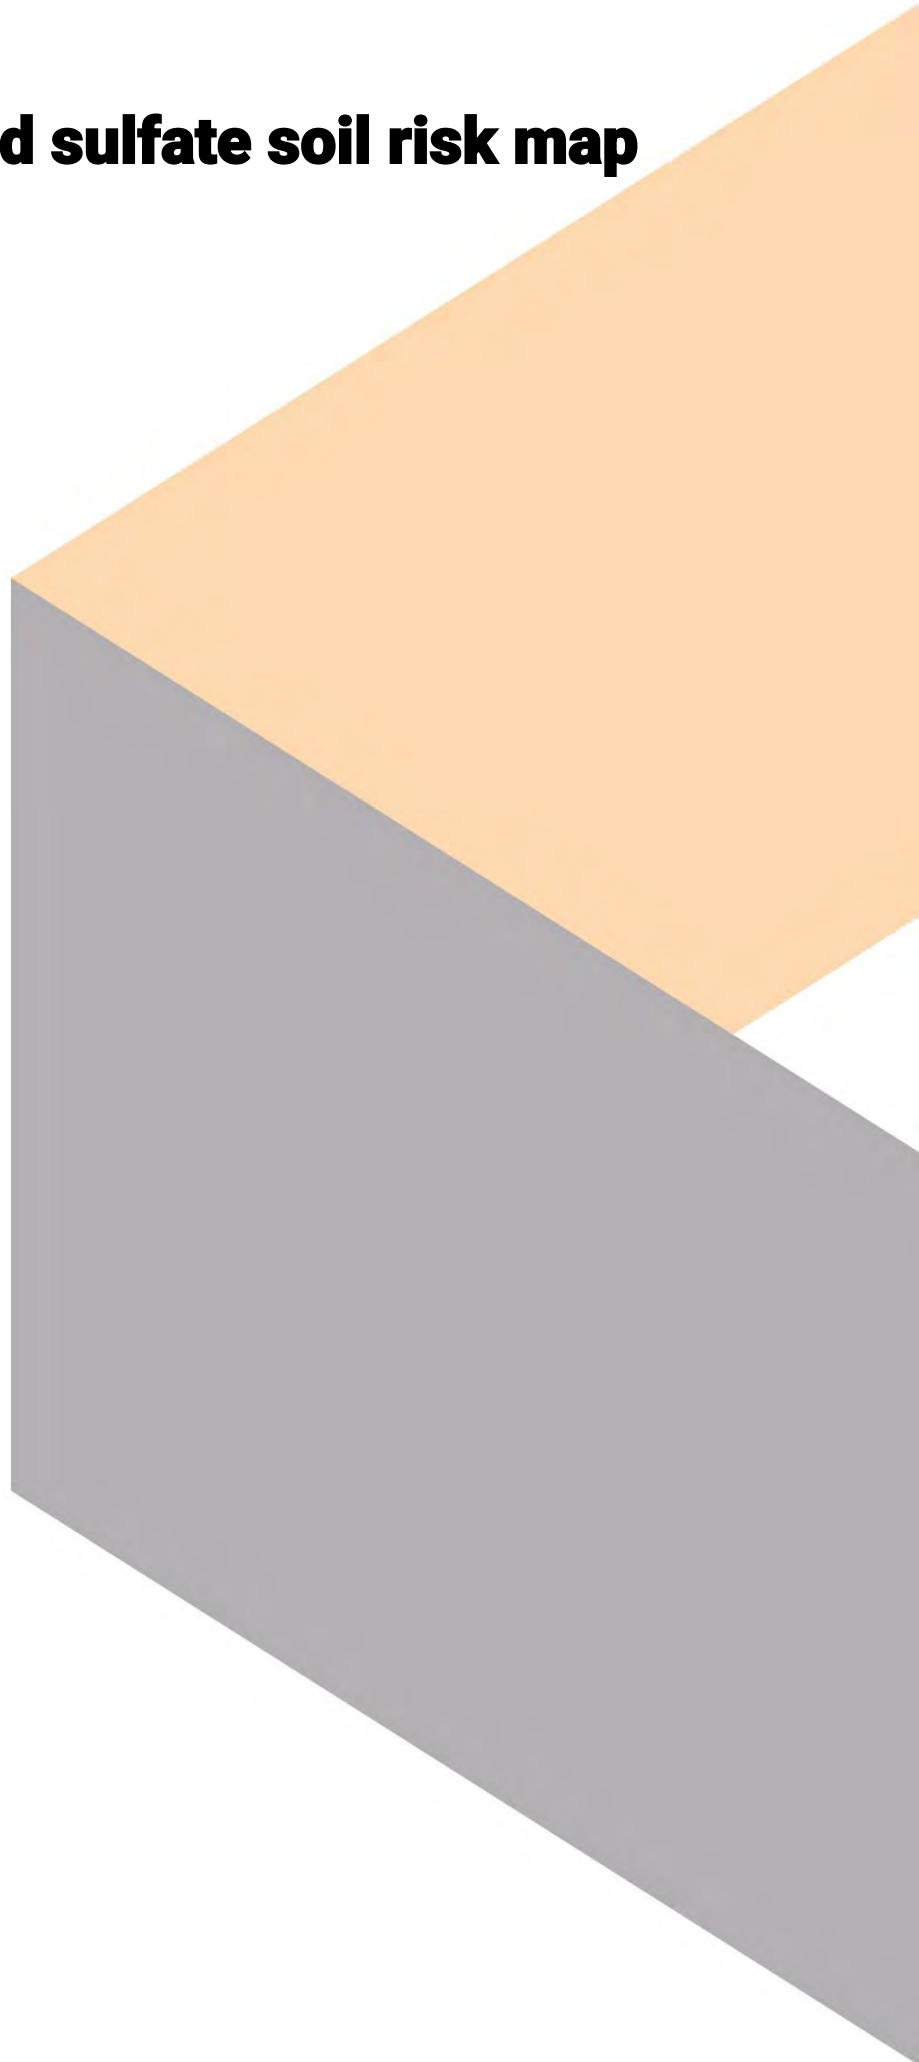
Appendix C Acid sulfate soil risk map

Notes:
 Elevation Contours are in terms of NZVD2016, generated using QGIS based on 2021 Lidar sourced from LINZ.
 Aerial imagery, property boundaries, etc sourced from LINZ.

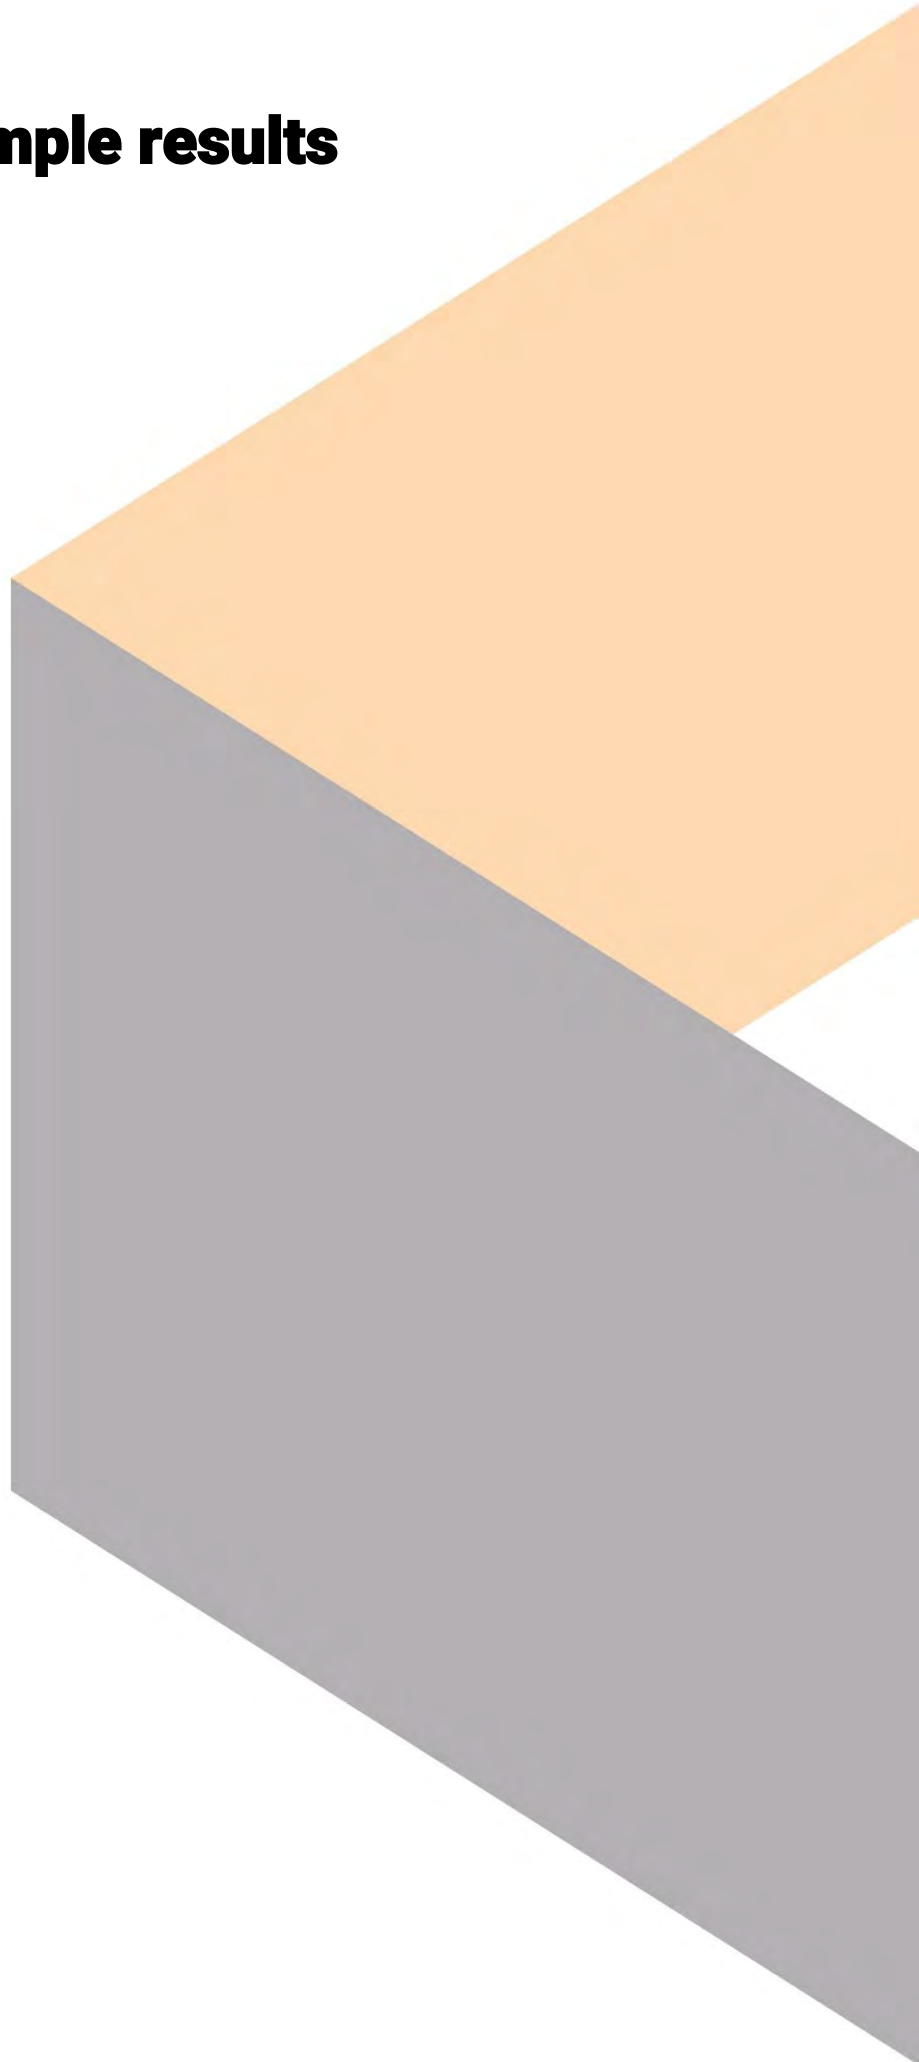
Appendix E Sample results

Adopted screening criteria				Field pH	Sulfurous smell	Jarosite / mottling?	Soil description	pHfox	Delta pH	Reaction rating	Sulfurous gas release?
				4		Yes		3	1	H	Yes
Sampling location	Depth to groundwater	Depth	Date								
HA02.1	0.9	0.5	13/11/2025	6	No	No	Orange brown silt trace sand moist	5.03	0.97	L	No
HA02.2		0.7	13/11/2025	6.79	No	Some orange brown mottles	Light grey silty sand moist orange brown mottles	4.7	2.09	L	Yes
HA02.3		1.2	13/11/2025	6.23	No	No	Light grey sandy silt wet to saturated	4.93	1.3	L	No
HA02.4		1.4	13/11/2025	6.26	No	No	Saturated silty Sand light grey	4.96	1.3	L	No
HA02.5		1.9	13/11/2025	6.08	No	No	Sgravelly sandy silt greyish brown saturated	5.1	0.98	M	Yes
HA03.1	1	0.2	12/11/2025	5.03	No	Trace orange mottling	Silt light greyish brown	3.84	1.19	L-M	No
HA03.2		0.9	12/11/2025	6.2	No	None	Silt light greyish brown	4.98	1.22	L	No
HA03.3		1.5	12/11/2025	5.63	No	None	Sand fine to medium l grey wet to saturated	4.85	0.78	L	No
