# POINT LOAD STRENGTH OF ROCK TEST REPORT

Project : Ground Investigation for Northland Corridor  
 Location : Alternative to Brynderwyn Hills Section  
 Client : NZTA C/- Aurecon & WSP NZ Ltd  
 Contractor : N/A  
 Sampled by : NC Site Team  
 Date sampled : 25/08/25  
 Sampling method : Core  
 Sample description : Interbedded SILTSTONE/MUDSTONE  
 Sample condition : As Received

# UNCONFINED COMPRESSIVE STRENGTH (UCS) WITH YOUNG'S MODULUS

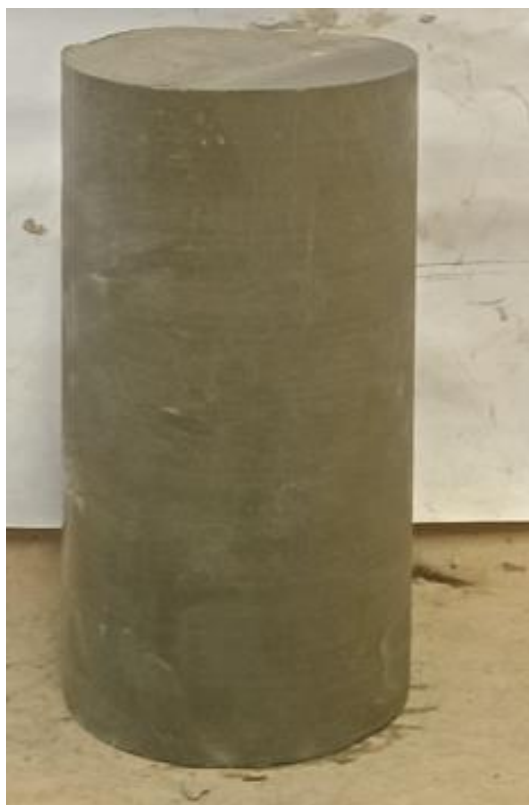
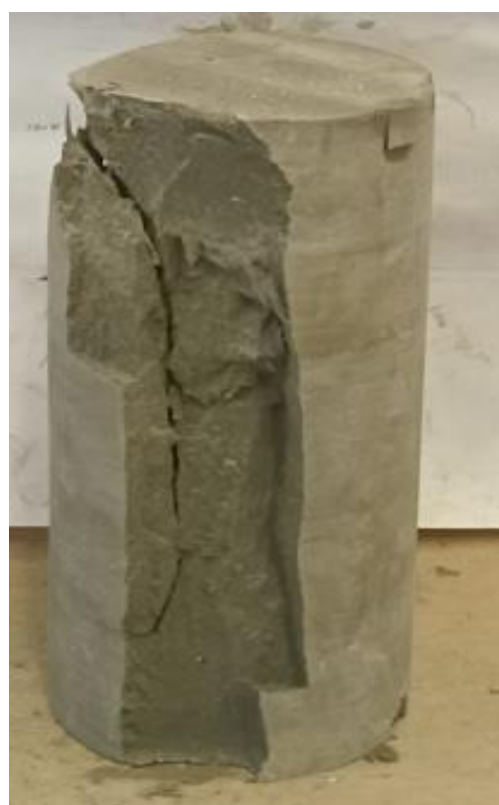
**Test photos**

Before Test

Post Test
