## **Auckland Surf Park: Stage 2**

# **Preliminary and Detailed Site Investigation (Ground Contamination)**

AW HOLDINGS 2021 (LP) PARTNERSHIP

WWLA1368 | Rev. 1

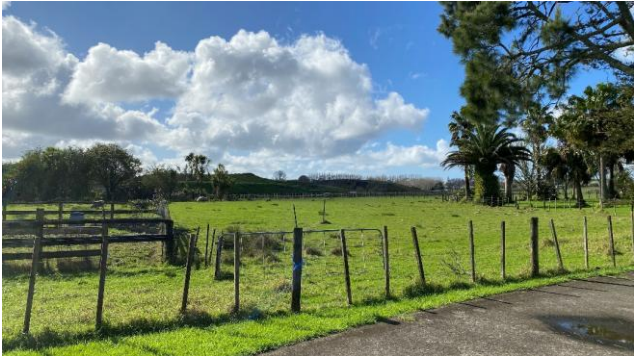
| <p>Photograph 1. General paddocks, looking north towards the Stage 1 earthworks</p> | <p>Photograph 2. General house view</p> |

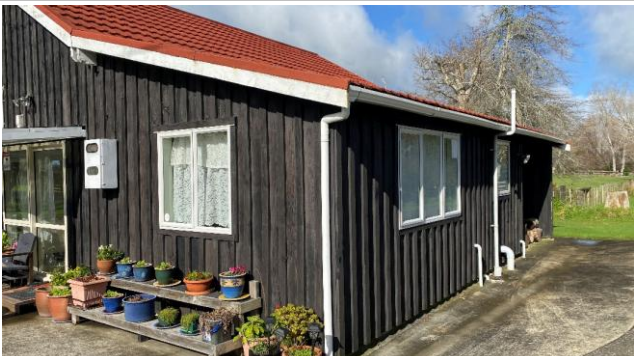
| <p>Photograph 3. Minor dwelling</p> | <p>Photograph 4. Stockyards, looking towards vegetable garden. Metal shed to the left.</p> |

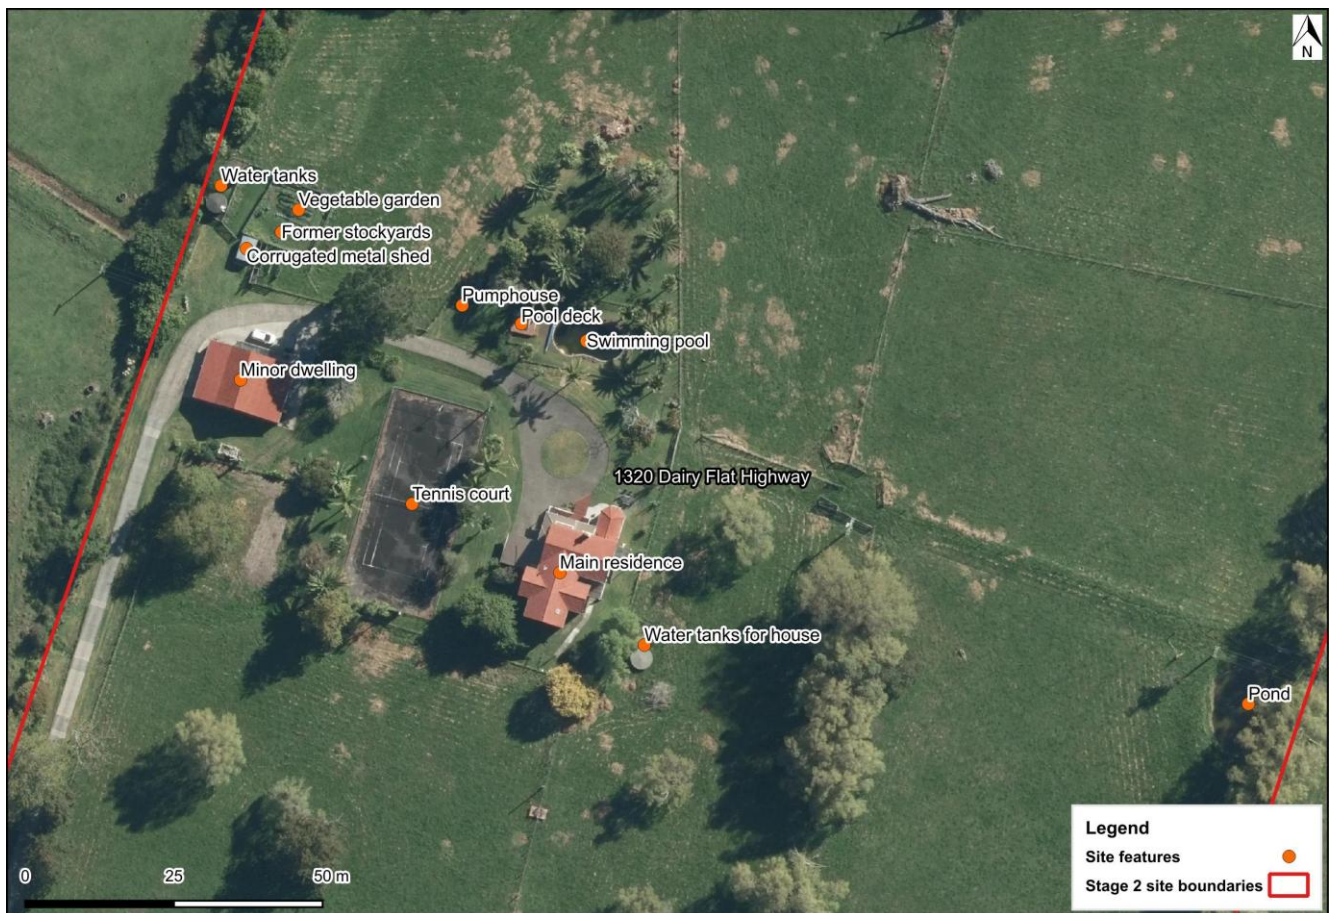
| <p><b>1320 Dairy Flat Highway</b></p> | <p>This property is a lifestyle block with the following features:</p> <ul style="list-style-type: none"> <li>• The majority of the property is paddocks and isolated trees and a small pond on the eastern boundary (<b>Photograph 1</b>).</li> <li>• Structures are clustered near the western boundary, with a driveway leading from the west to a minor dwelling, then tennis court and main residence, all on the southern side of the driveway. To the north of the driveway is a metal shed, former yards, vegetable garden (within the yards) and swimming pool with associated pump house.</li> <li>• The main residence is constructed of timber (board and batten) with a tiled roof and potential asbestos-containing soffits (<b>Photograph 2</b>).</li> <li>• The minor dwelling is also board and batten construction, with a tiled roof (<b>Photograph 3</b>).</li> <li>• The tennis court is concrete and both the tennis court and swimming pool appear to be no longer maintained.</li> <li>• The shed is constructed from metal, it was locked and could not be inspected internally but is similar to a large garden shed. Adjacent to the east are small stockyards that are typical of lifestyle blocks, including a small race. The northern part of the stockyards is now being used for a vegetable garden (<b>Photograph 4</b>).</li> <li>• Northeast of the shed are water tanks.</li> </ul> |

Figure 3. 1320 Dairy Flat Highway, site features and layout (source: LINZ, 2024-2025)

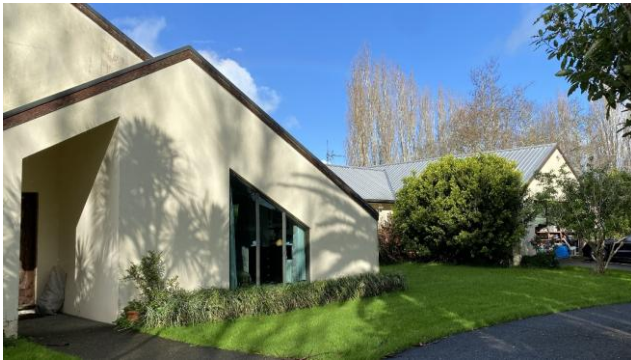
Photograph 5. View of the main residence showing typical construction materials, facing southeast.

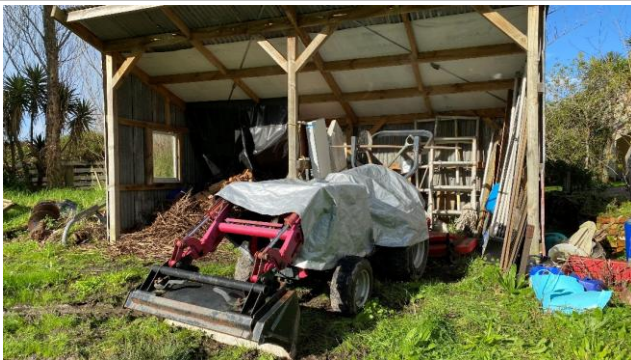
Photograph 7. Tractor/ mower shed

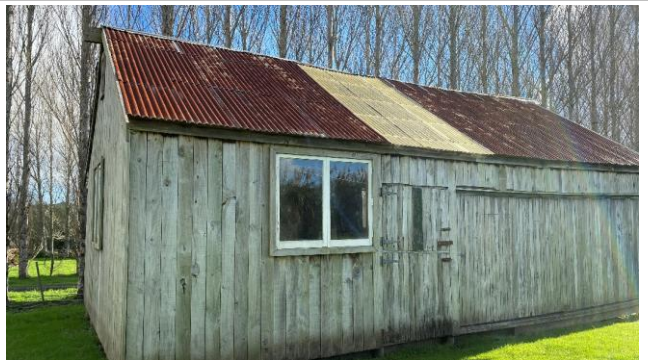
Photograph 8. Minor dwelling located north of main residence.

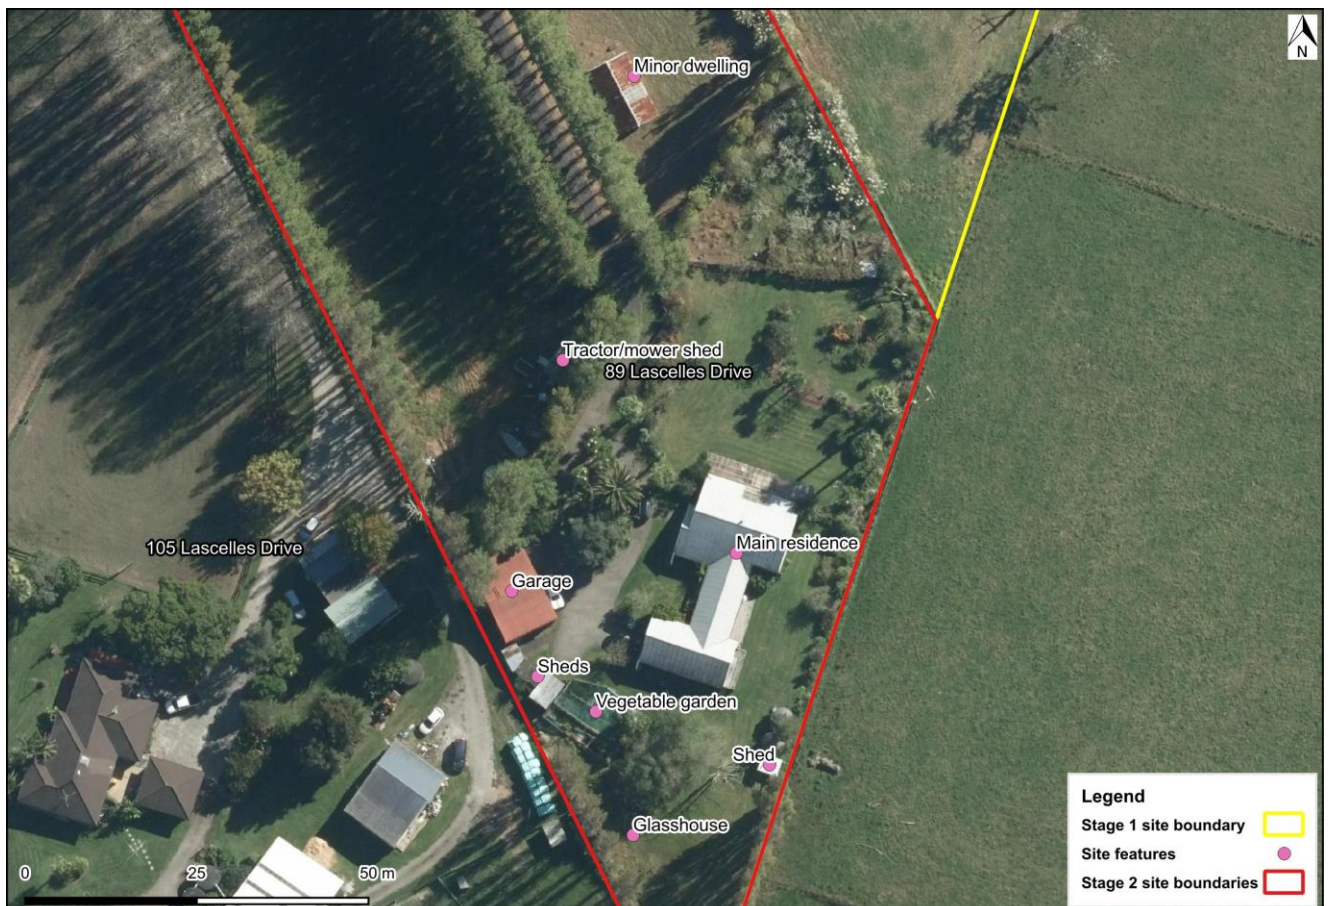
| <p><b>89 Lascelles Drive</b></p> | <p>This property is a lifestyle block with the following features:</p> <ul style="list-style-type: none"> <li>• A modern main residence is located in the south of the property along with associated small sheds, a garage and domestic glasshouse and vegetable garden. <ul style="list-style-type: none"> <li>- The main residence is constructed of timber, and concrete/ plaster cladding with a corrugated metal roof (<b>Photograph 5</b>).</li> <li>- The garage has corrugated metal cladding and roofing with timber framing (<b>Photograph 6</b>).</li> <li>- The sheds are constructed of timber, corrugated metal and plywood cladding, and corrugated metal roofing (<b>Photograph 6</b>).</li> </ul> </li> <li>• To the north of the main residence complex is a tractor shed constructed of timber framing with corrugated metal cladding and roofing. The floor comprises gravel with a plastic mud-grid. The shed currently stores a tractor/ mower, firewood and various property maintenance items (<b>Photograph 7</b>).</li> <li>• Further north again is a minor dwelling constructed of timber framing and cladding with a corrugated metal and corrugated clear plastic roof (<b>Photograph 8</b>).</li> <li>• The remainder of the site is predominantly paddocks and landscaping. There is a small, rectangular old farm shed, constructed from timber and corrugated metal roofing and cladding, located in the northwestern corner of the site near the driveway.</li> </ul> |

Figure 4. 89 Lascelles Drive, site features and layout (source: LINZ, 2024-2025)

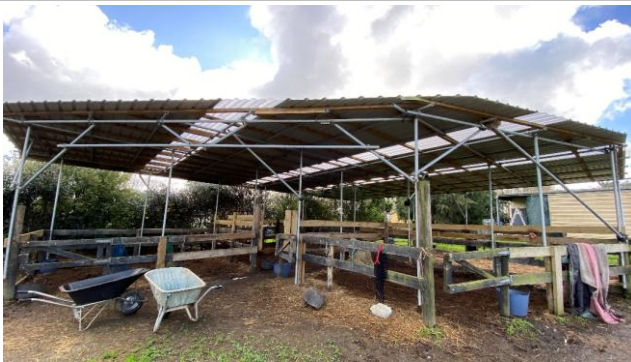
Photograph 13. View of the covered yards, facing northeast.

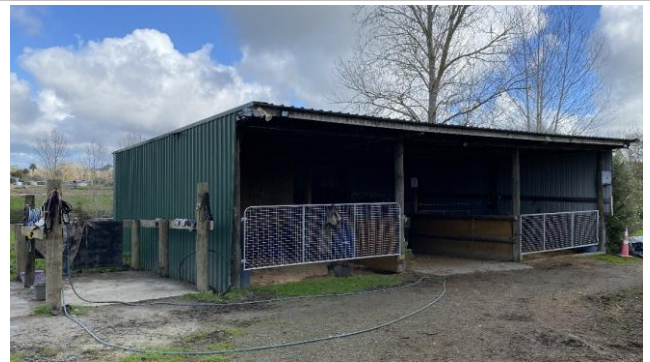
Photograph 14. View of the barn and stables (green building) and the horse washbay (concrete pad to left of image), facing southwest.

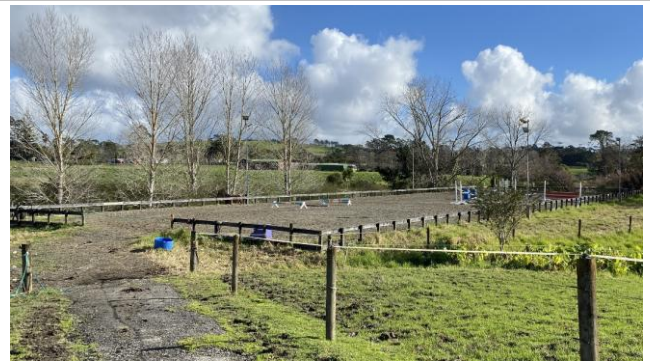
Photograph 16. View of the sand horse arena, facing west.

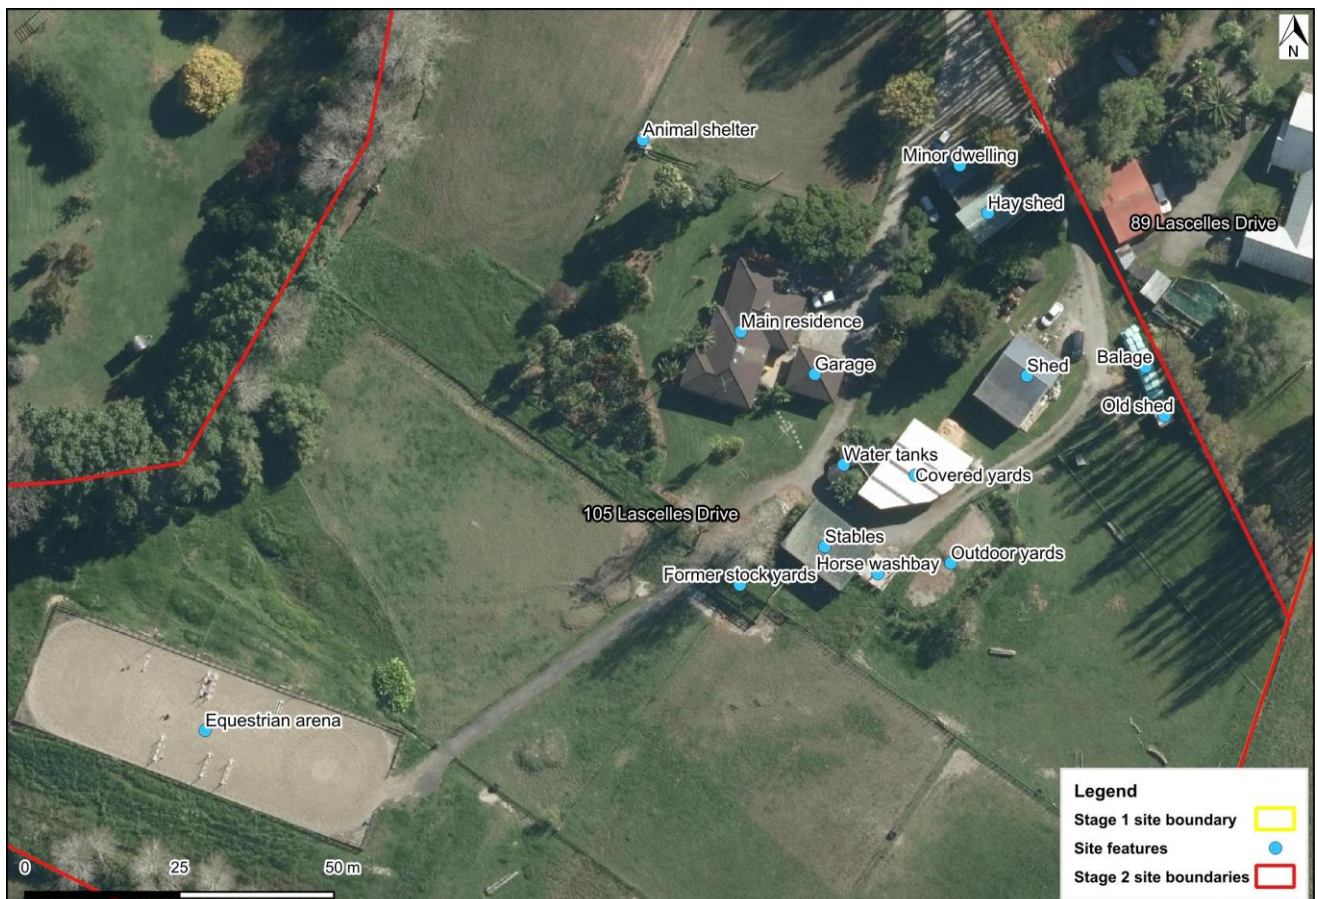
| <p><b>105 Lascelles Drive</b></p> | <p>This property is an equestrian lifestyle block with the following features:</p> <ul style="list-style-type: none"> <li>• A modern main residence is located in the central and eastern of the property along with a garage, minor dwelling, and sheds. <ul style="list-style-type: none"> <li>- The main residence is constructed of brick and hardboard cladding with a tile roof and timber deck (<b>Photograph 9</b>).</li> <li>- The garage is also constructed from brick and hardboard cladding with a tile roof (<b>Photograph 10</b>).</li> <li>- To the northeast of the main residence is a minor dwelling constructed with weatherboard cladding, a corrugated metal roof and a timber deck (<b>Photograph 11</b>).</li> <li>- On the immediate southeastern side of the minor dwelling is a hay shed constructed from metal framing with corrugated plastic cladding and corrugated metal roofing (<b>Photograph 11</b>).</li> <li>- Another larger farm shed is constructed of corrugated metal cladding and roofing with metal roller doors (<b>Photograph 12</b>).</li> </ul> </li> <li>• South and northwest of the main residence and sheds complex are the equestrian facilities: <ul style="list-style-type: none"> <li>- To the southeast of the main residence is a block of covered horse yards constructed from corrugated plastic and metal roofing (<b>Photograph 13</b>).</li> <li>- Southwest of the covered yards is a barn/ stable block constructed from timber with corrugated metal cladding and roofing, with a concreted outdoor space on the eastern side for washing horses (<b>Photograph 14</b>).</li> <li>- To the immediate south of the barn/stables are old wooden stockyards (likely for sheep) (<b>Photograph 15</b>).</li> <li>- To the east of the stables and the covered yards are two large outdoor wooden yards (also for the horses).</li> <li>- The remainder of the site is paddocks surrounding the complex of buildings to the southeast, south, west and northwest, with a sand horse arena located near the southwestern corner (<b>Photograph 16</b>). The area around the arena appears to have been earthworked to create a flat platform.</li> </ul> </li> </ul> |

Figure 5. 105 Lascelles Drive, site features and layout (source: LINZ, 2024-2025)

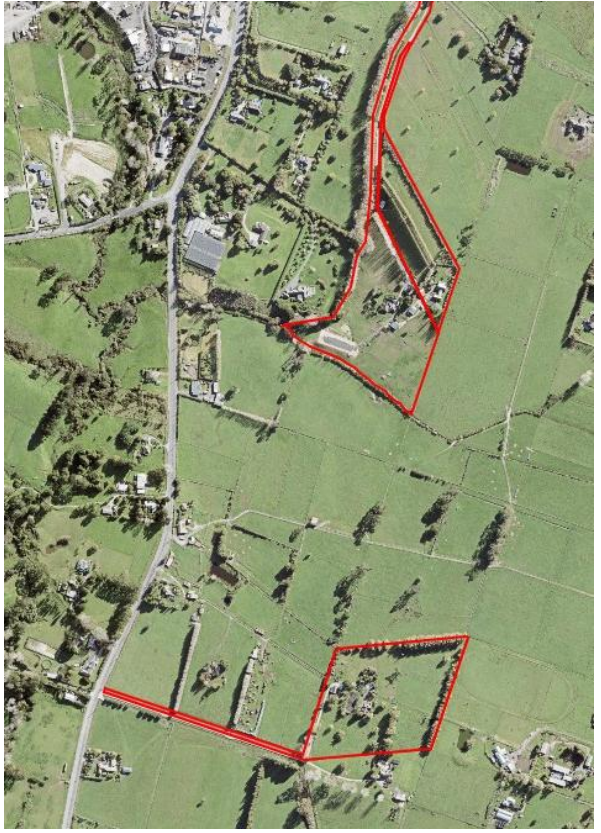
| Photograph date (source): | Description: | Aerial image (approximate site in red outline): |
|---|---|---|
| 2010-17<br>Auckland Council<br>Geomaps<br>(Images viewed: 2010-2011 and 2017)<br><i>[2017 image shown]</i> | <p>At 89 Lascelles Drive, a large garage shed and two smaller garden sheds were constructed to the southwest of the main dwelling between 2010-11 and 2017.</p> <p>Several buildings including the minor dwelling, shed, covered stables and stockyards were constructed at 105 Lascelles Drive between the 2001 and 2010-11 aerial photographs. The covered stable block replaced the previously existing small, long rectangular building and two water tanks that formerly occupied the location. By 2017, the arena was under construction.</p> <p>At 1320 Dairy Flat Highway, removal of the small square structure near the northwestern corner occurred by 2010-11 and two water tanks were added along the western boundary by 2017.</p> <p>The surrounding land continues to slowly undergo residential densification and commercial redevelopment; however, the predominant land use remains farmland and rural residences.</p> | |

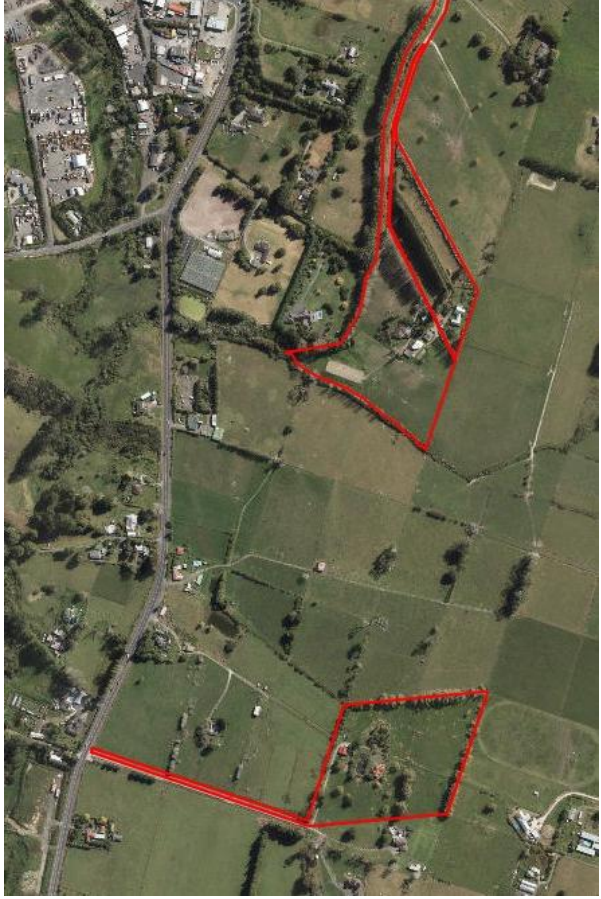
| Photograph date (source): | Description: | Aerial image (approximate site in red outline): |
|---|---|---|
| 2024-25<br>Auckland Council<br>Geomaps | <p>By 2024, a minor dwelling has been added further north of the main dwelling at 89 Lascelles Drive, and a small square garden shed has been added along the eastern boundary. A tractor/mower shed has been constructed northwest of the main dwelling.</p> <p>At 105 Lascelles Drive, construction of the sand arena was complete. A block of covered yards and two larger outdoor yards (for horses) had also been established to the north and east of the covered stable block, respectively.</p> <p>By the 2024-25 aerial photograph, a small square wooden deck had been constructed to the immediate west of the swimming pool at 1320 Dairy Flat Highway, and a small rectangular shed had been added to the southwestern side of the stockyards.</p> <p>The surrounding land continues to undergo redevelopment to residential and commercial/industrial properties, particularly further northwest and east of the site.</p> | |

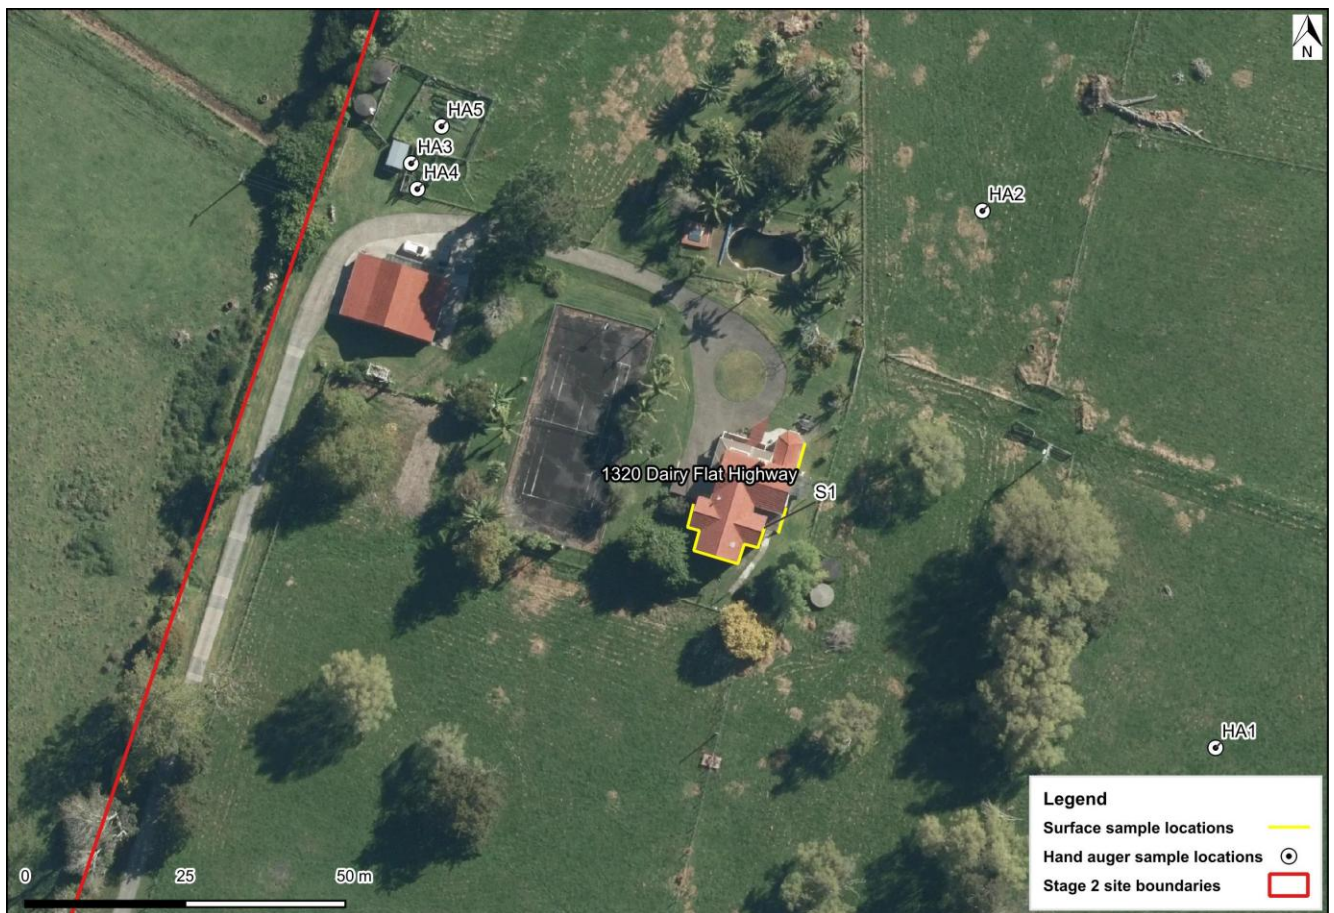
Figure 6. Sampling locations at 1320 Dairy Flat Highway (source: LINZ 2024-2025).

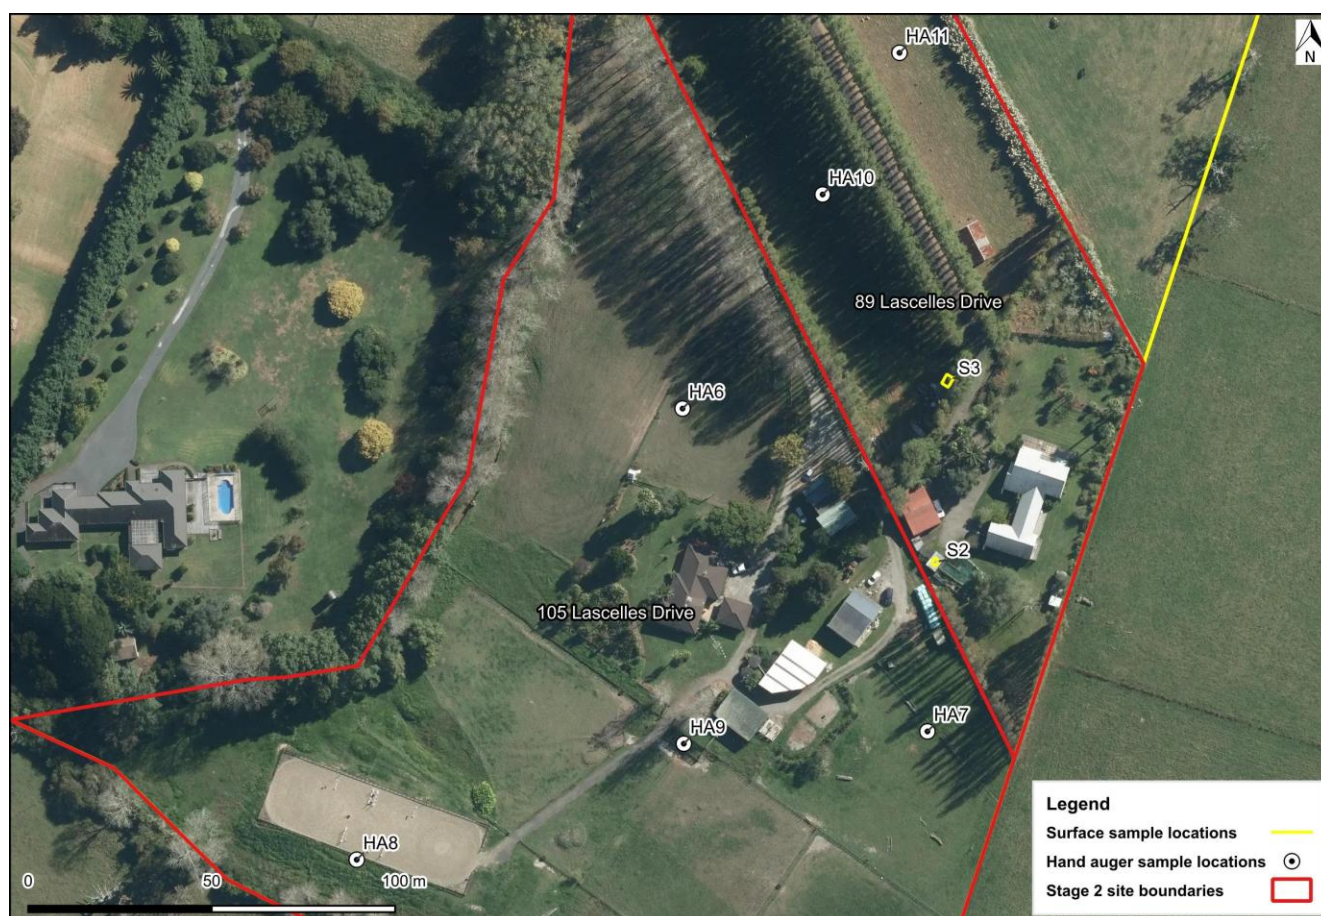
Figure 7. Sampling locations at 89 and 105 Lascelles Drive (source: LINZ 2024-2025).

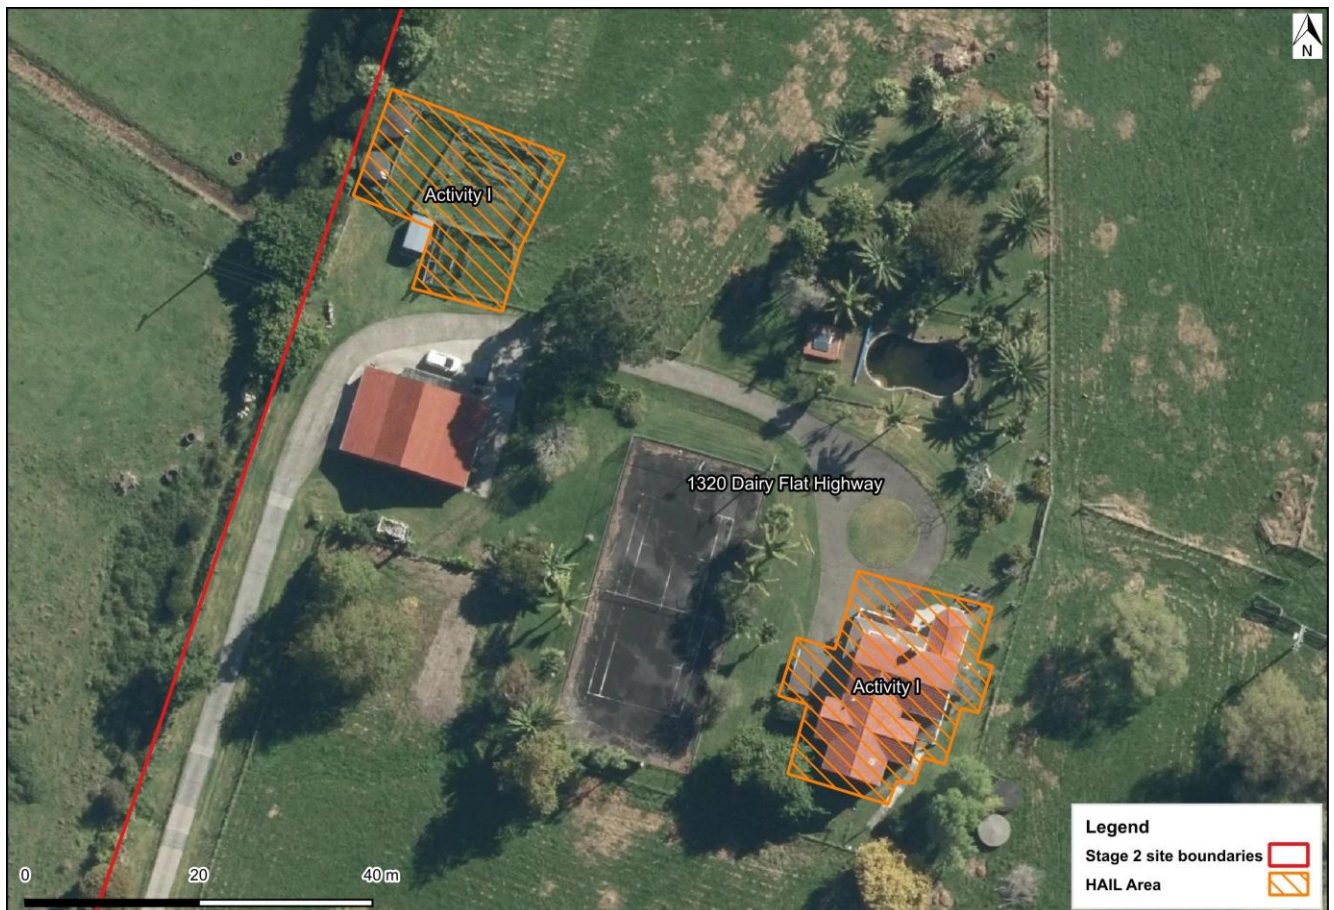
However, as concentrations of arsenic at 1320 Dairy Flat Highway present a risk to human health, **HAIL Activity I does apply to areas where timber structures are present (house and yards)**. Refer to **Figure 8** for the confirmed HAIL area.

Figure 8. Location and extent of HAIL Activity I on the site (source: LINZ 2024-2025).

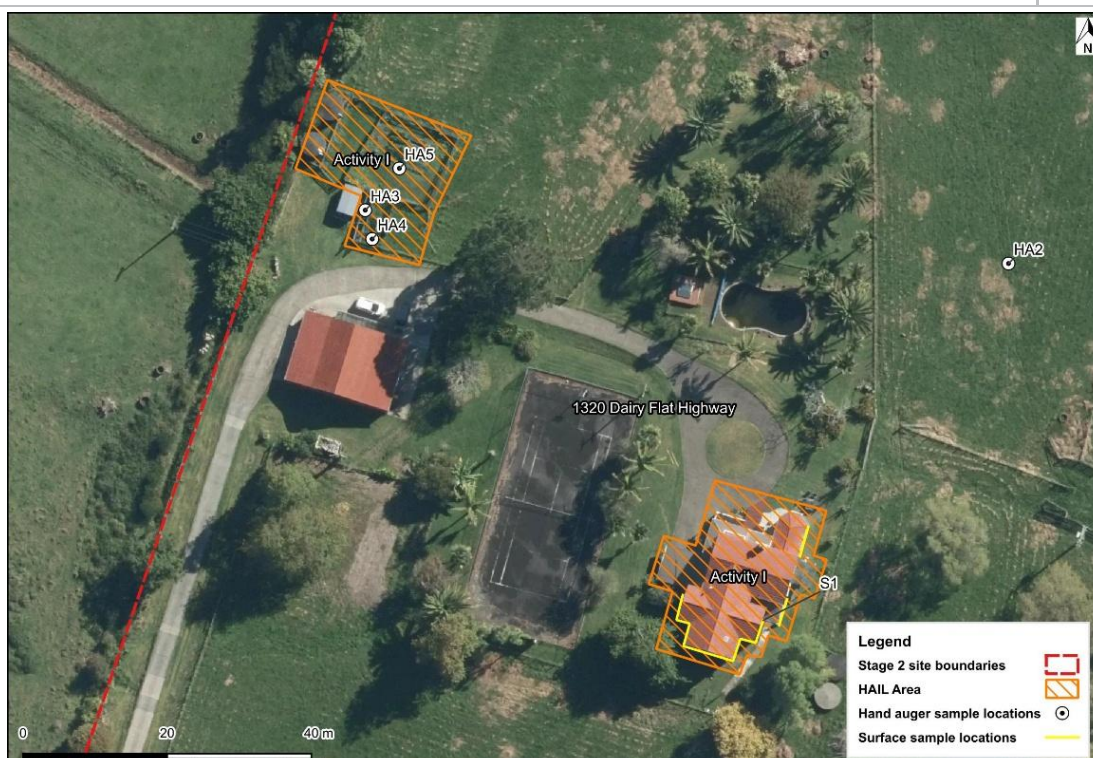
Figure 2. HAIL Areas (remediation areas) and PSI/ DSI sampling locations.

| Task | Description | Check |
|---|---|---|
| | <ul style="list-style-type: none"> <li>While not compulsory, pre-works sampling is recommended to further delineate the area of remediation, and the depth, as this may reduce the volume of contaminated soil that requires management. Refer to <b>Figure 2</b> for the HAIL/ remediation plan.</li> <li><b>The SQEP will determine the sampling plan;</b> provisionally: <ul style="list-style-type: none"> <li>Sampling at 0.4 and 0.5 m depth in two locations in the yards.</li> <li>Sampling on a 10 m grid around the dwelling, at surface, 0.3, 0.4 and 0.5 m bgl.</li> <li>Testing of (selected) samples at an IANZ accredited laboratory for arsenic.</li> </ul> </li> </ul> | <input type="checkbox"/> |

**Hold Point: Confirm remediation method and area. SQEP to update SMP to final version**

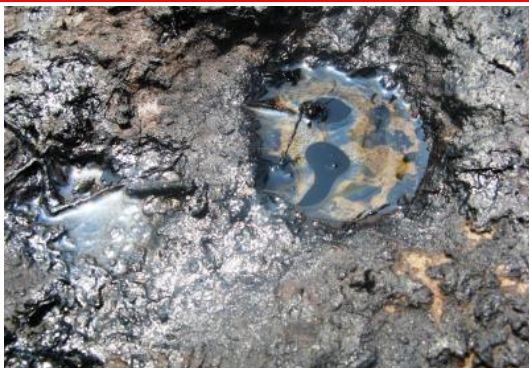
| Task | Description | Check |
|---|---|---|
| | Odours/sheen such as hydrocarbons or solvents. | Asbestos fibres and/or building products. |

| Task | Description | Check |
|---|---|---|
| | <p>If unexpected contamination is encountered the following shall be taken by the Contractor:</p> <ol style="list-style-type: none"> <li>Cease works in the immediate vicinity of the suspected contamination and tape off.</li> <li><i>Notify the client representative and the SQEP.</i></li> <li>Implement any contaminated land-related health and safety procedures and PPE if deemed necessary by the SQEP.</li> <li>Update the Hazard Board to direct site workers should continued exclusion of the area be required.</li> <li>Implement and maintain any additional controls required by the CLS to manage contamination.</li> <li>Notify GDC via the <i>SQEP within 24 hours of implementing any contamination mitigation measures</i></li> </ol> <p>If asbestos is identified subsequent to the demolition and clearance, requirements of the Health and Safety at Work (Asbestos) Regulations must be adhered to. The <i>SQEP shall provide direction</i> and if required, a Licensed Asbestos Removal Supervisor shall be engaged.</p> | <input type="checkbox"/> |

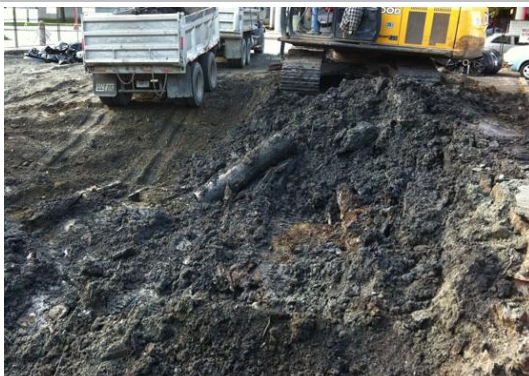
| Task | Description | Check |
|---|---|---|
| | Discoloured soil such as black, blue or green staining. | Underground structures such as fuel tanks, drums, pits. |

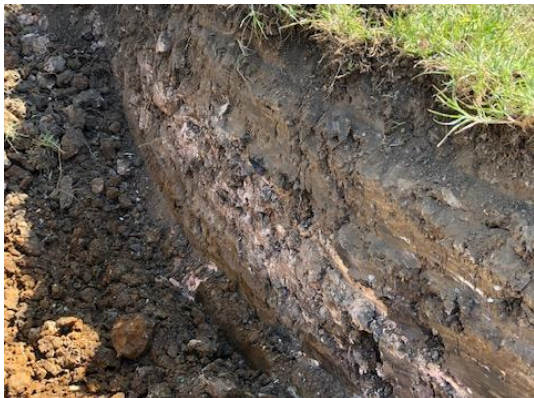
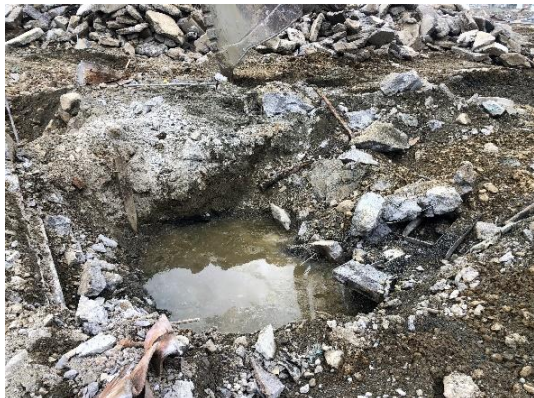
| Task | Description | Check |
|---|---|---|
| | <p>Fill materials.</p> <p>Fill materials.</p> | |
