# Existing Stockton Mine Topography

Proposed Buller Coal Continuation Project

Stockton - Existing

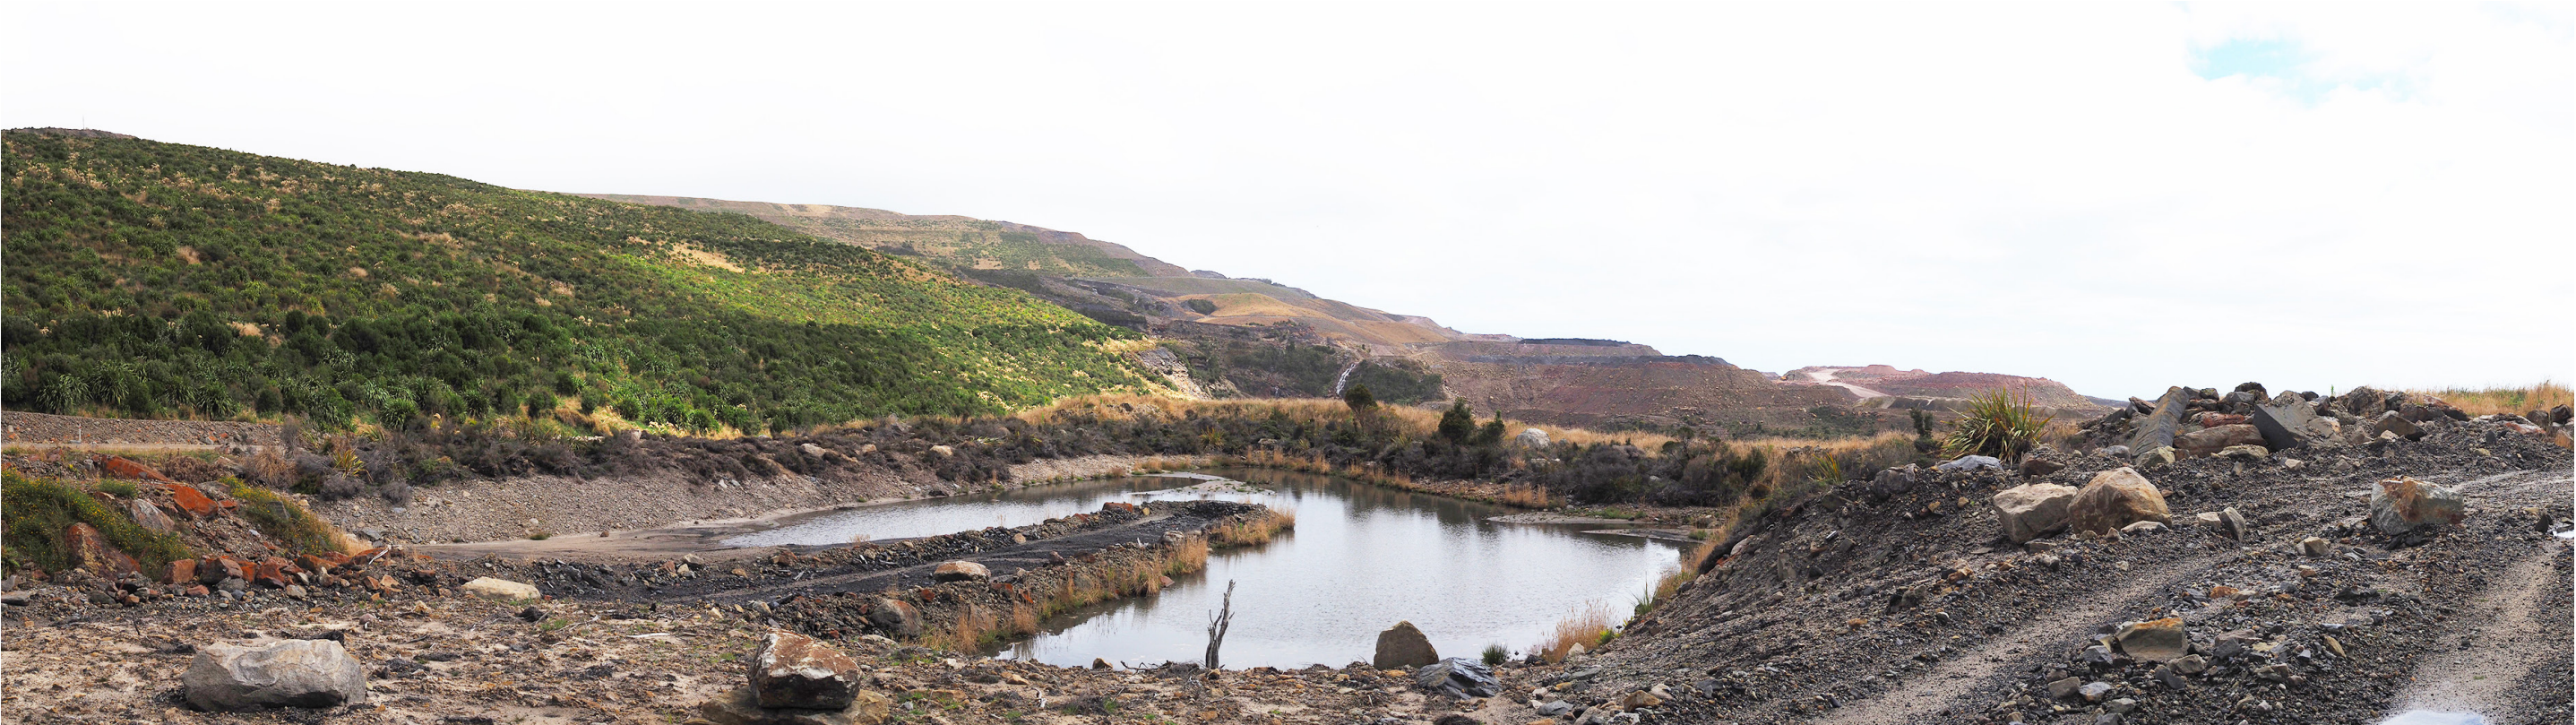
**Site Photograph 1:** Rehabilitated hillslopes, Water infrastructure and active mining activity. Located in the Mangatini Mining block, facing north.

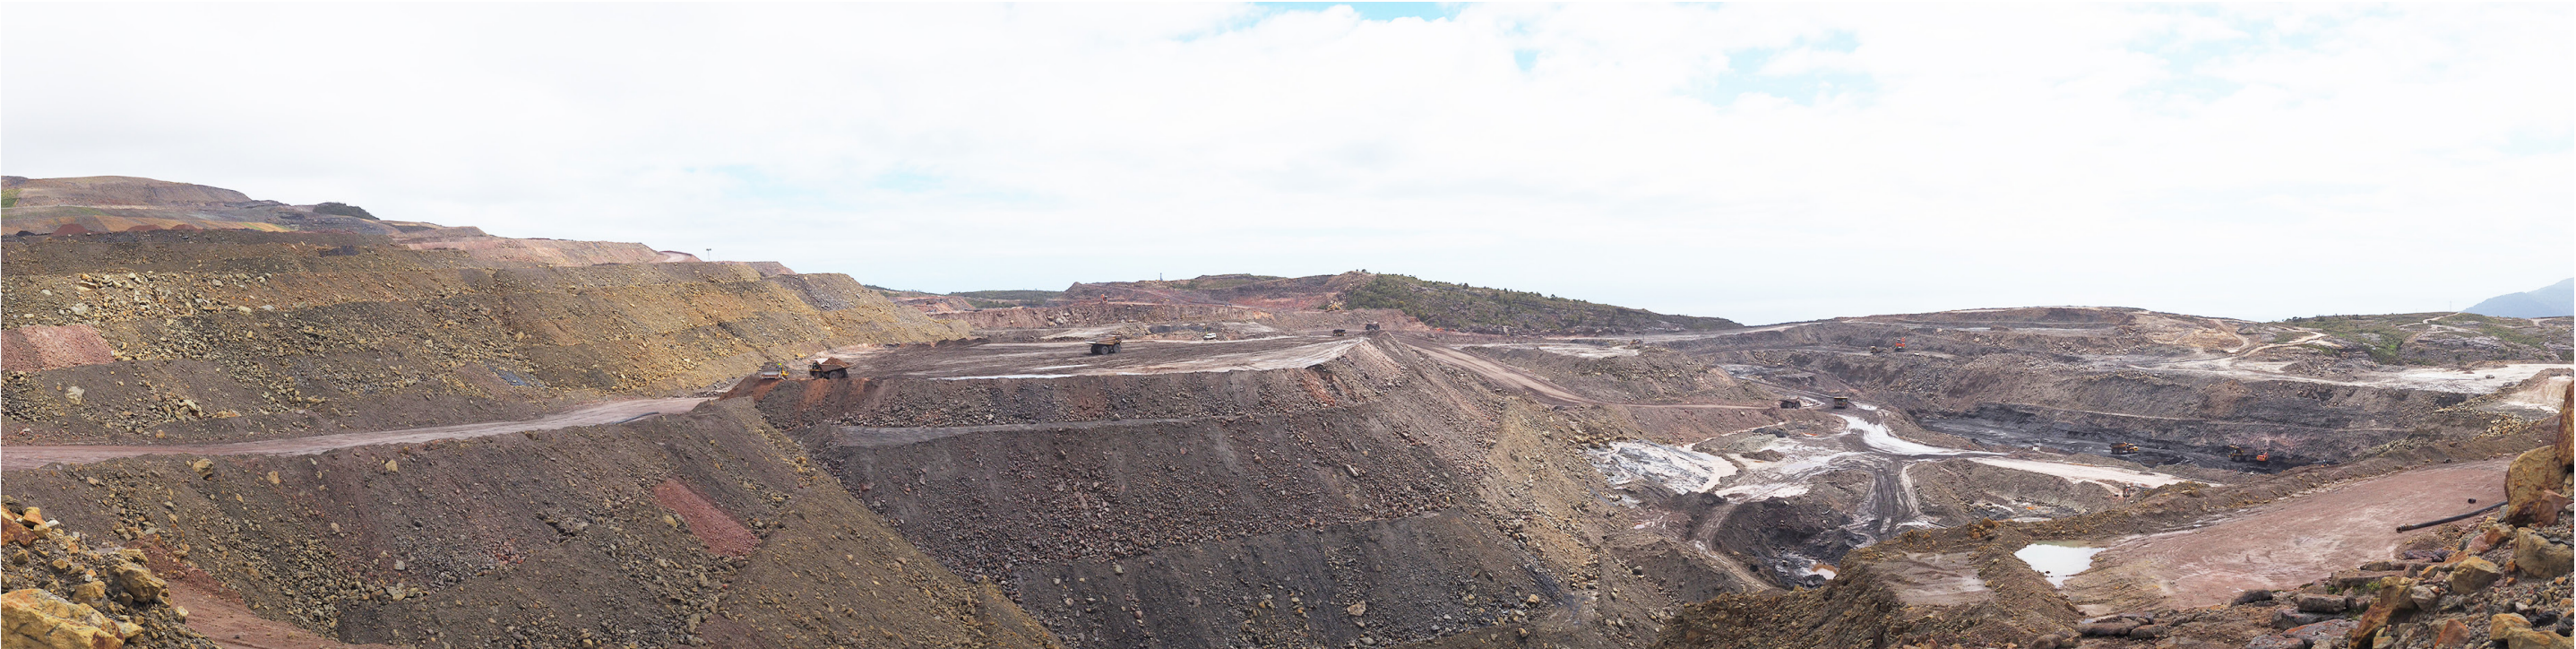
**Site Photograph 2:** Mining and overburden dump. Located in Millerton East Mining block, facing west.

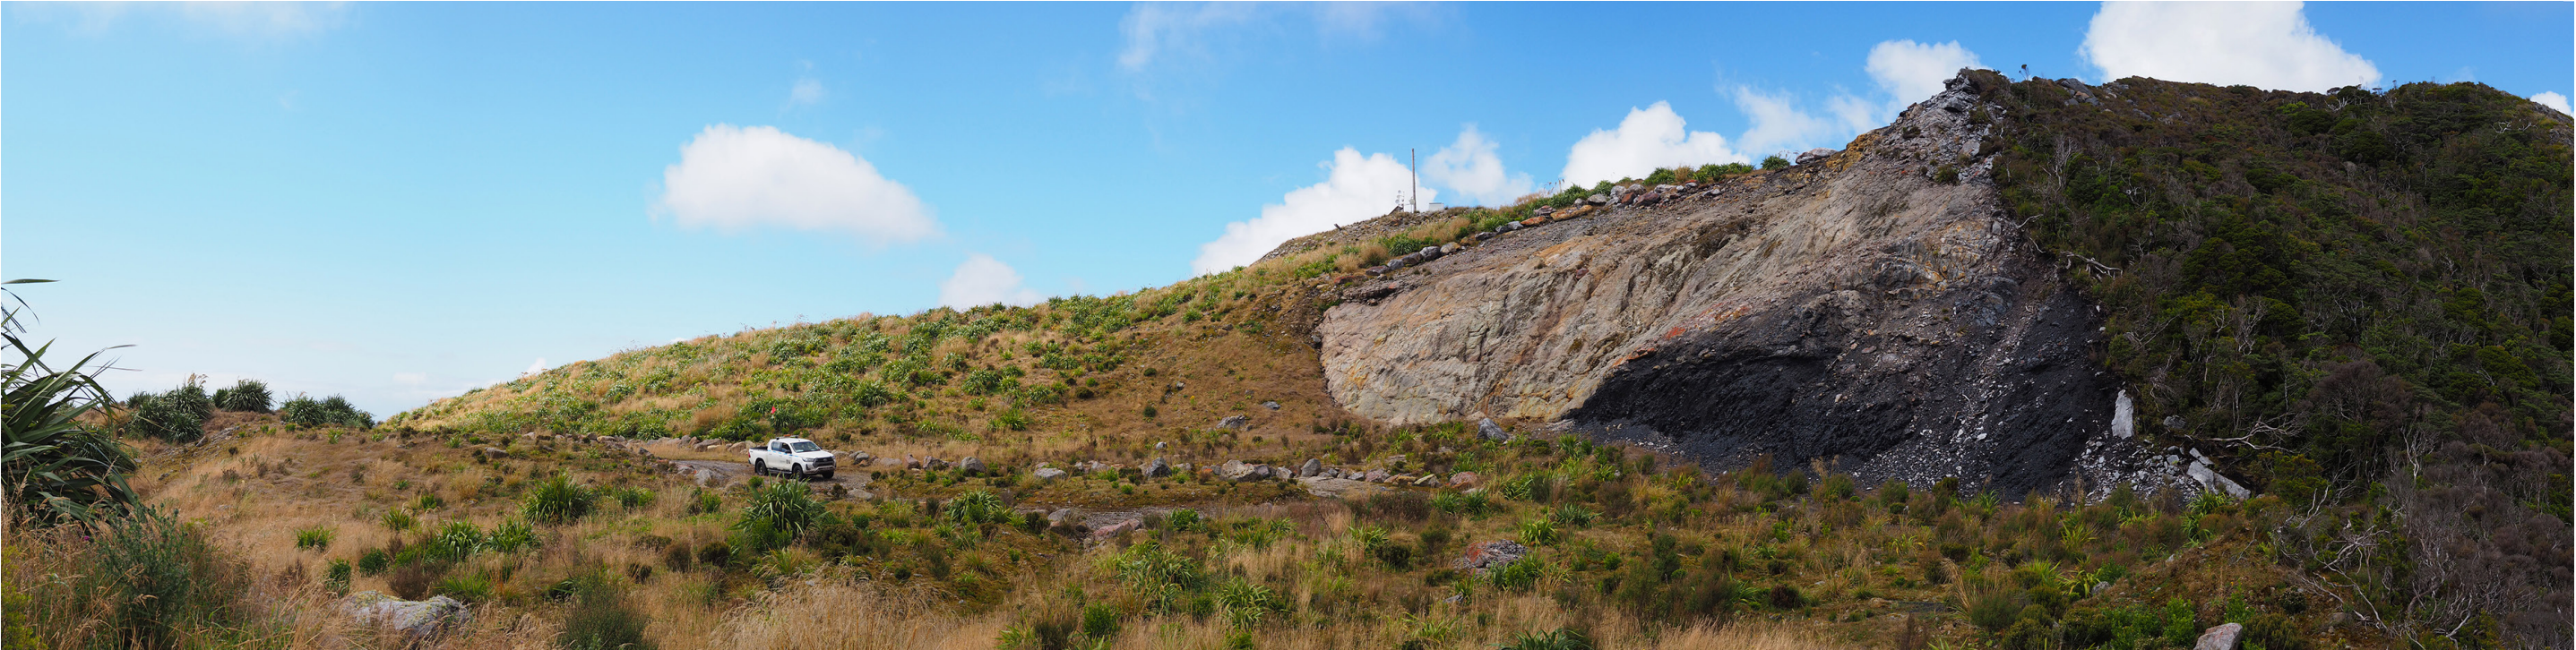
Site Photograph 3: Rehabilitation and exposed coal seam. Located in the Rockies Mining block, facing north east.

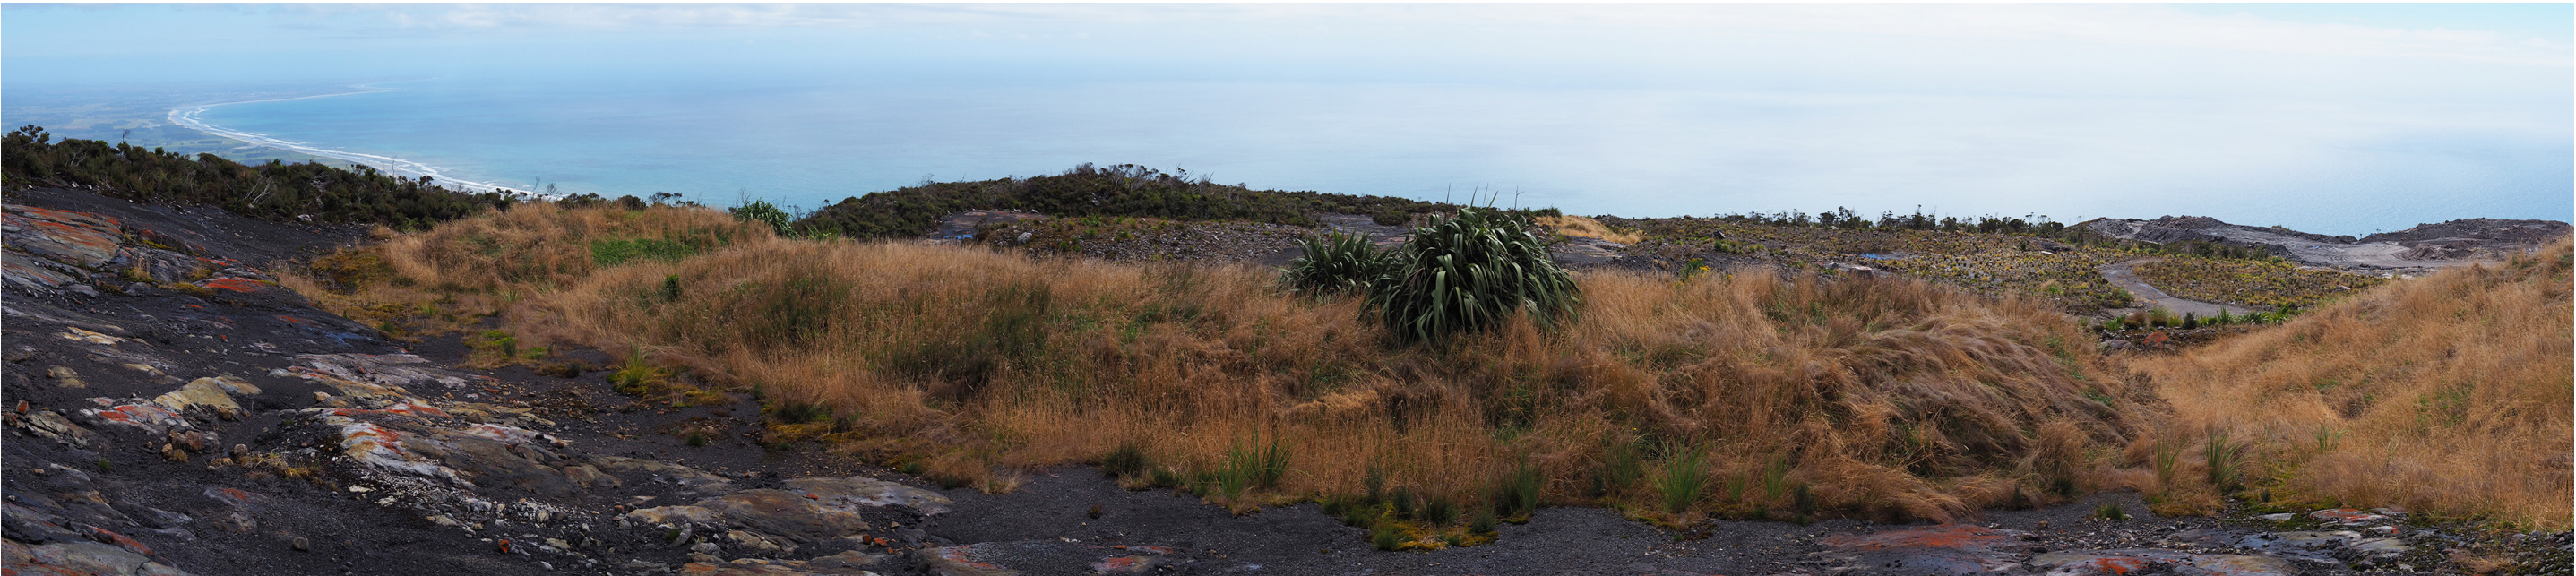
Site Photograph 4: Rehabilitation. Located in the Rockies Mining block, facing north west.

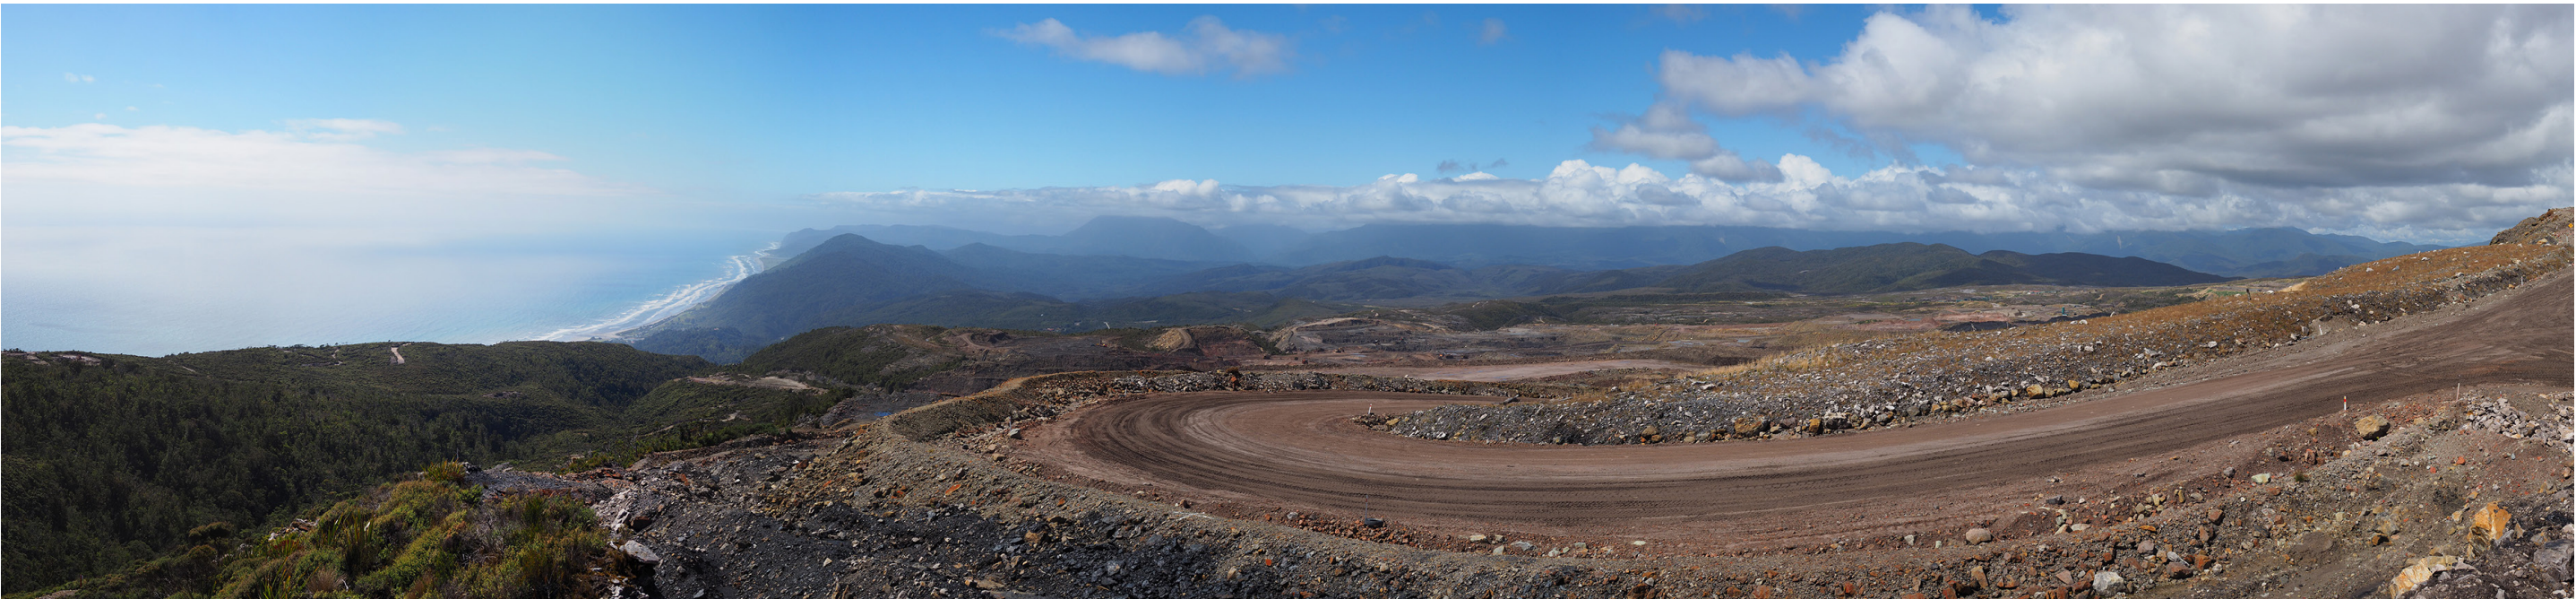
Site Photograph 5: Active mining and roading infrastructure. Located in the Millerton Mining block, facing north.

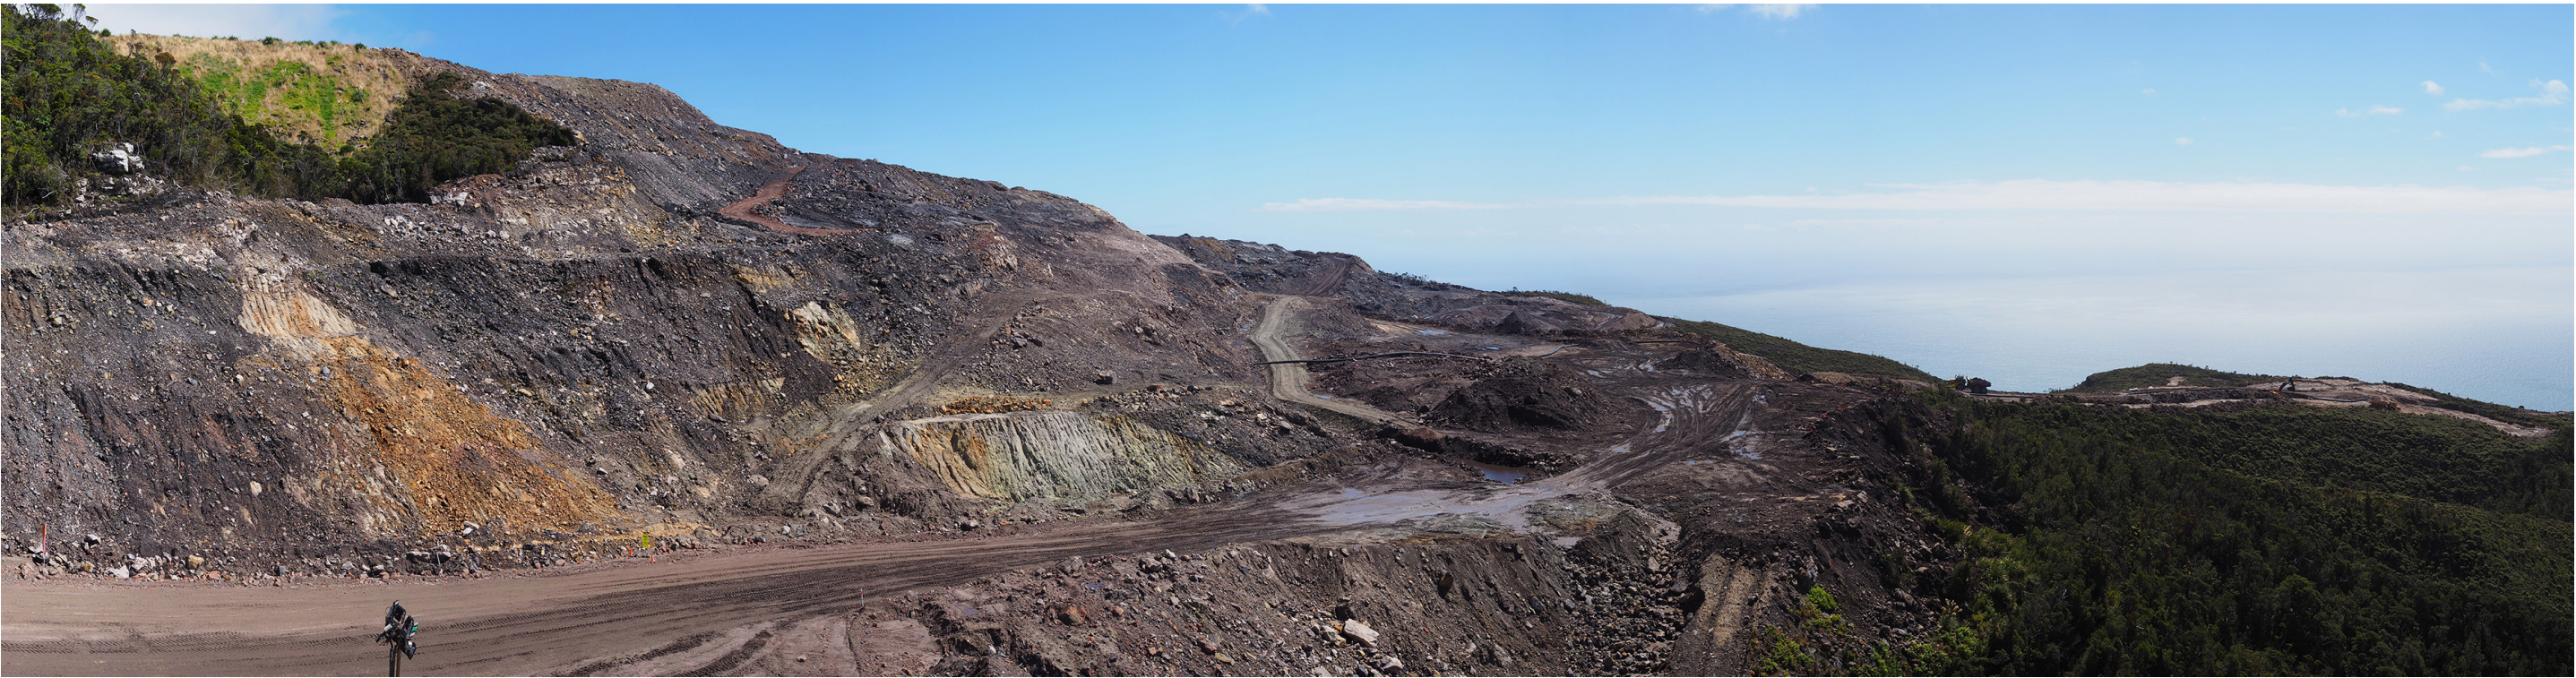
Site Photograph 6: Active mining and roading infrastructure. Located in the Millerton Mining block, facing south.

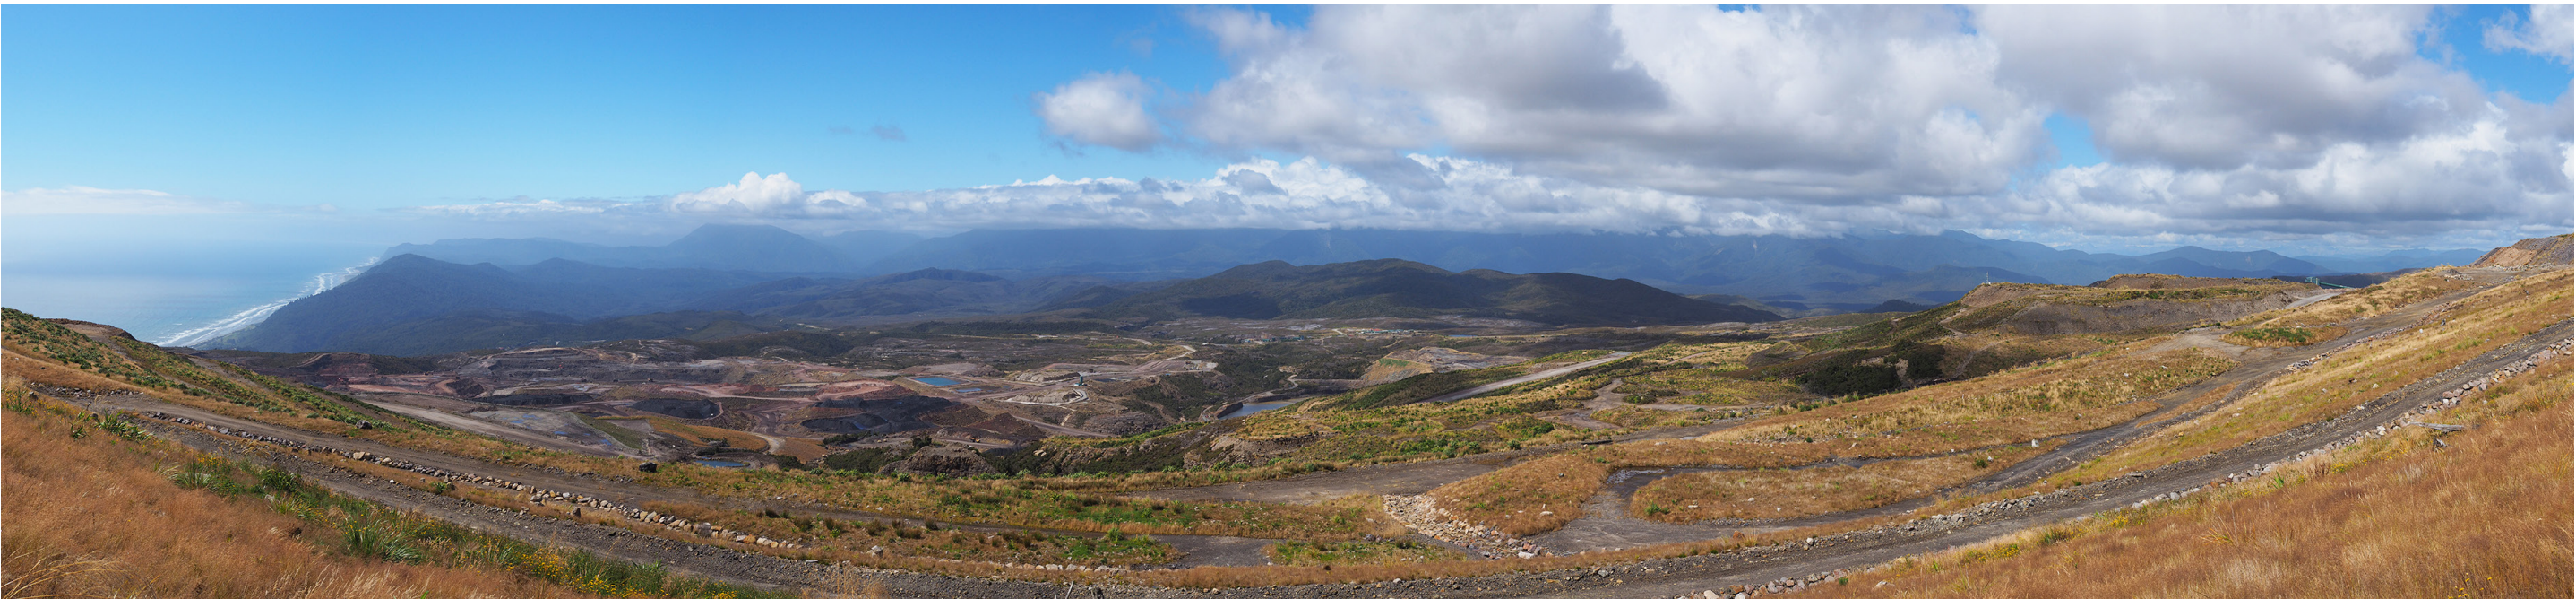
**Site Photograph 7:** Active mining and roading infrastructure. Located in the Millerton Mining block, facing north.

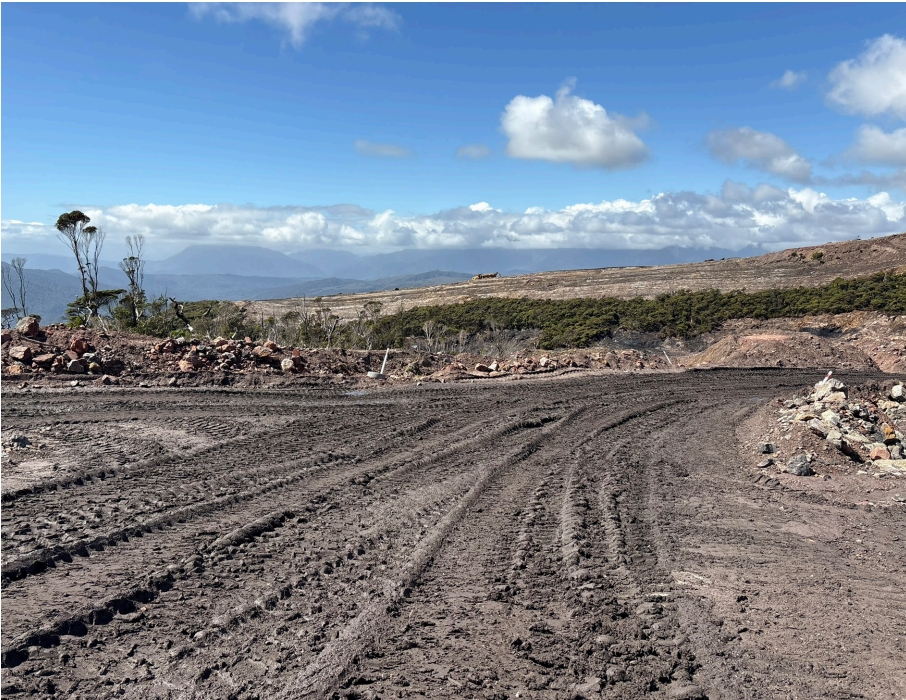
Site Photo 8: Active pit. Located in the Rockies N Mining block, facing north.

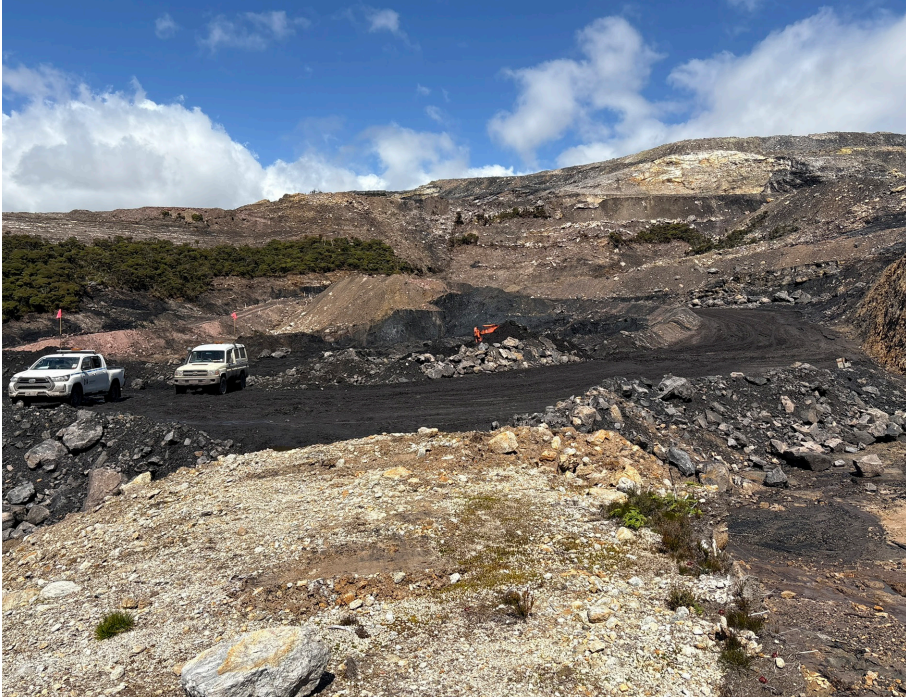
Site Photo 10 : Active pit. Located in the Rockies N Mining block, facing east.

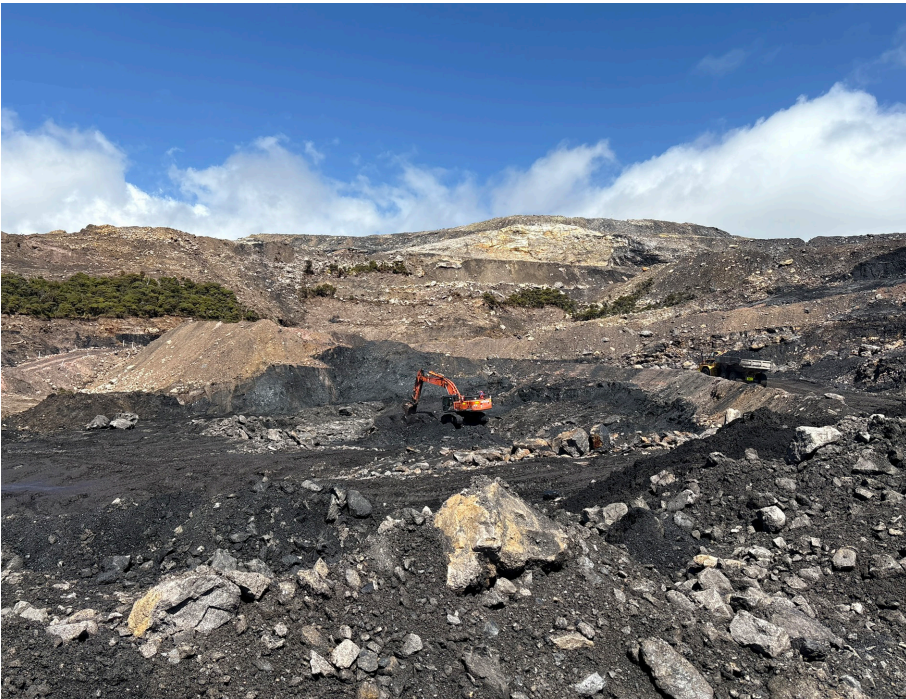
Site Photo 11: Mining following seam. Located in the Rockies N Mining block, facing east.

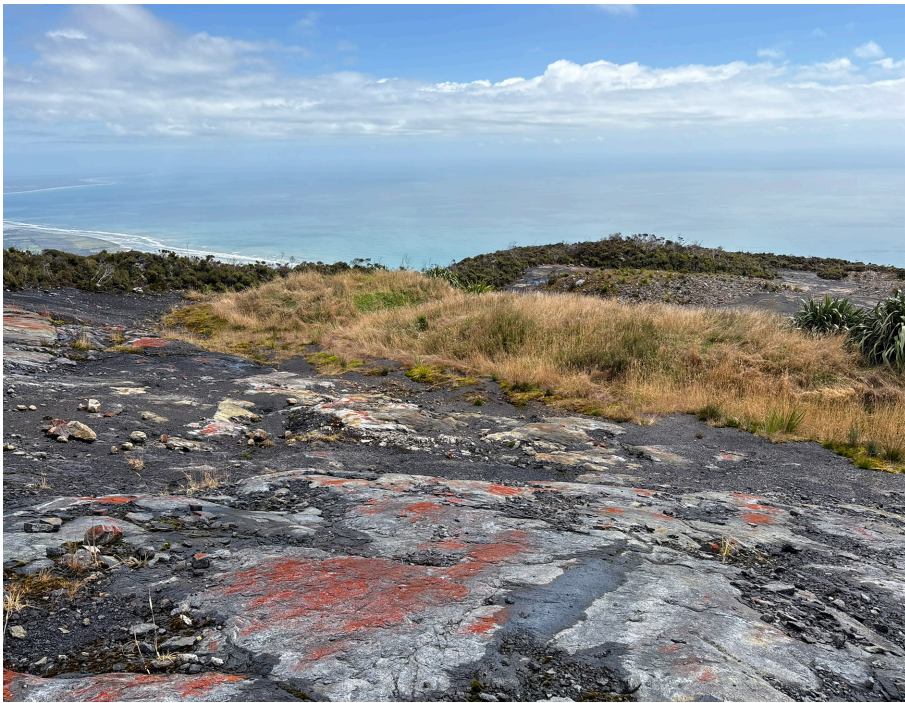
**Site Photo 15:** Ridge rehabilitation, combination of coal floor and revegetation. Located in the Rockies Mining block, facing west.

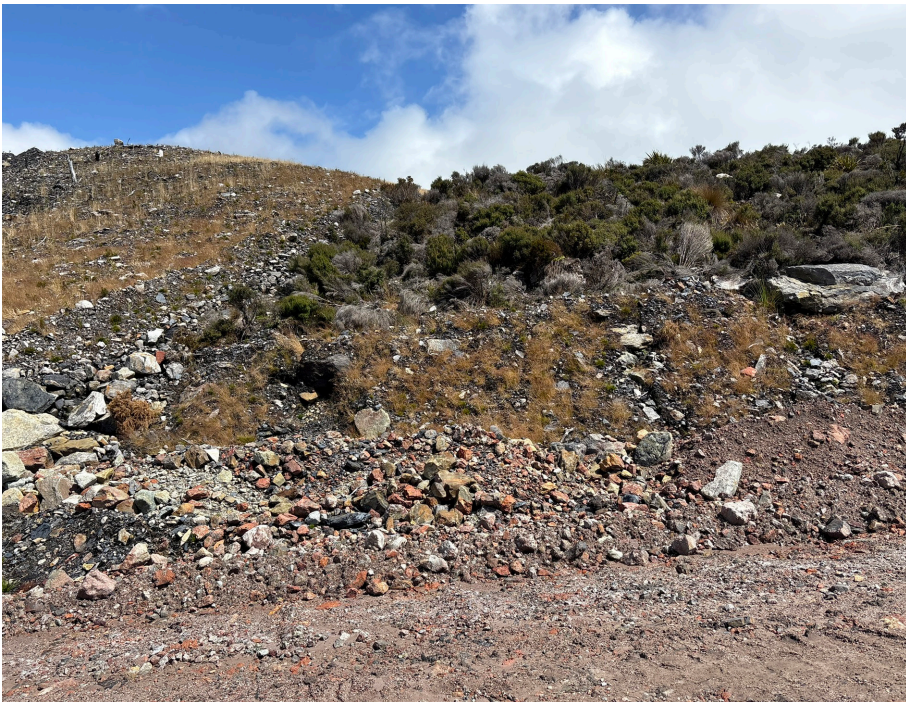
**Site Photo 16:** Vertical Direct Transfer Rehabilitation (VDT). Located in the West Mining block, facing south.

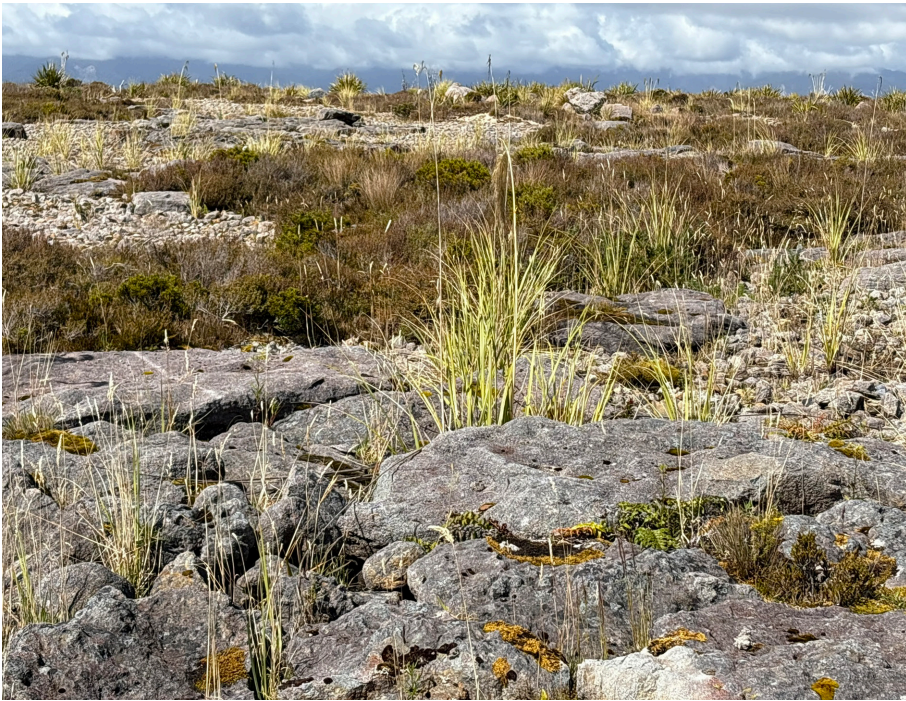
**Site Photo 17:** Rock pavement rehabilitation and wetland. Located in the Webb Mining block, facing north.
