# **SOUTHERN LINKS 1: RESIDENTIAL DEVELOPMENT - DETAILED SITE INVESTIGATION**

**Prepared by Swiftsure Consultants Ltd**

**30 August 2026**

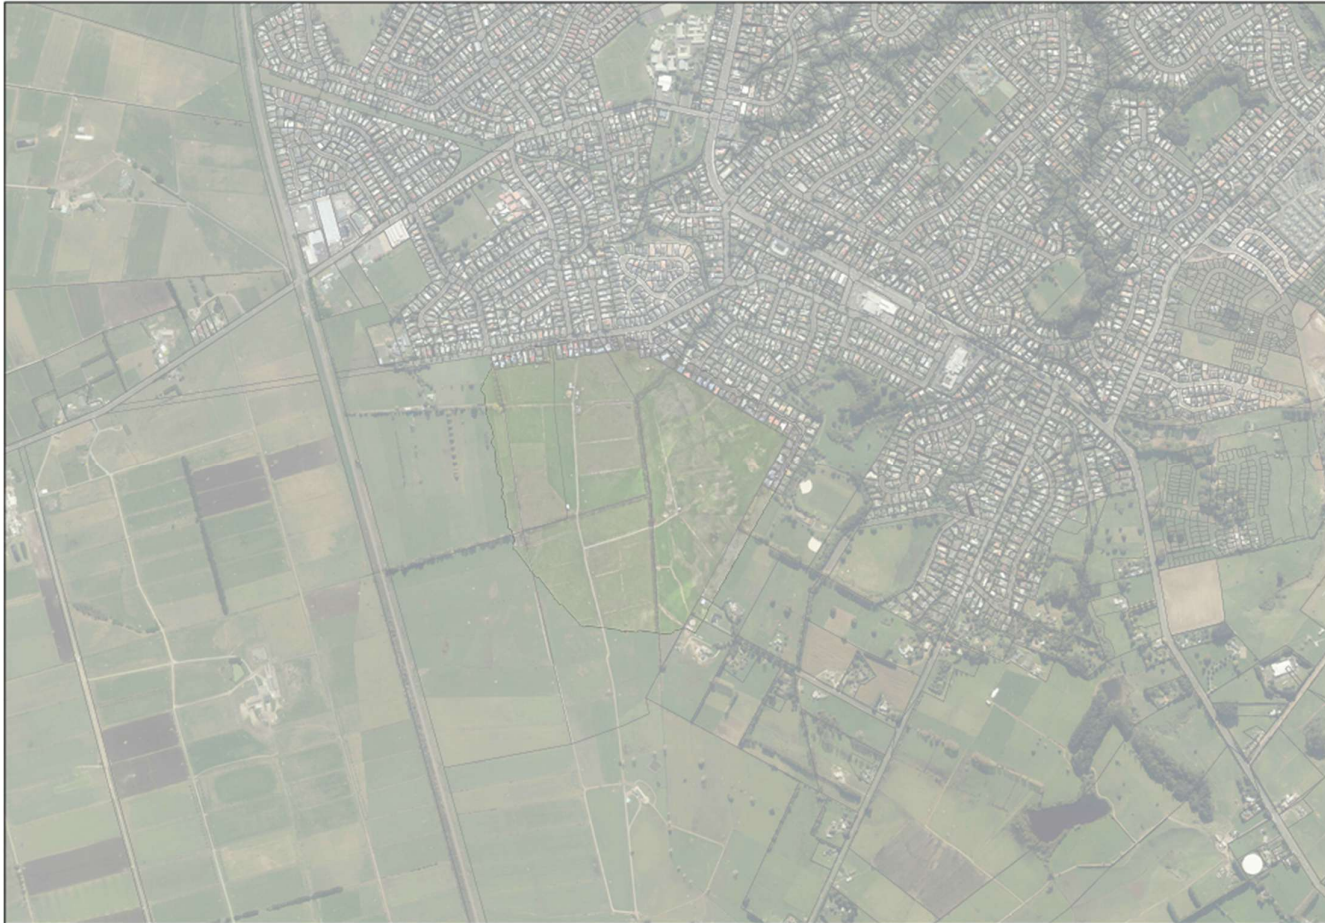
**Figure 2: Aerial images of the SL1 Southern Block**

The Residential Site location is shown in **Figure 1** and an aerial image of the SL1 Block is shown in **Figure 2**. The area of proposed development is topographically flat across the site with no elevation changes included on the Waipa District Council online mapping layer.

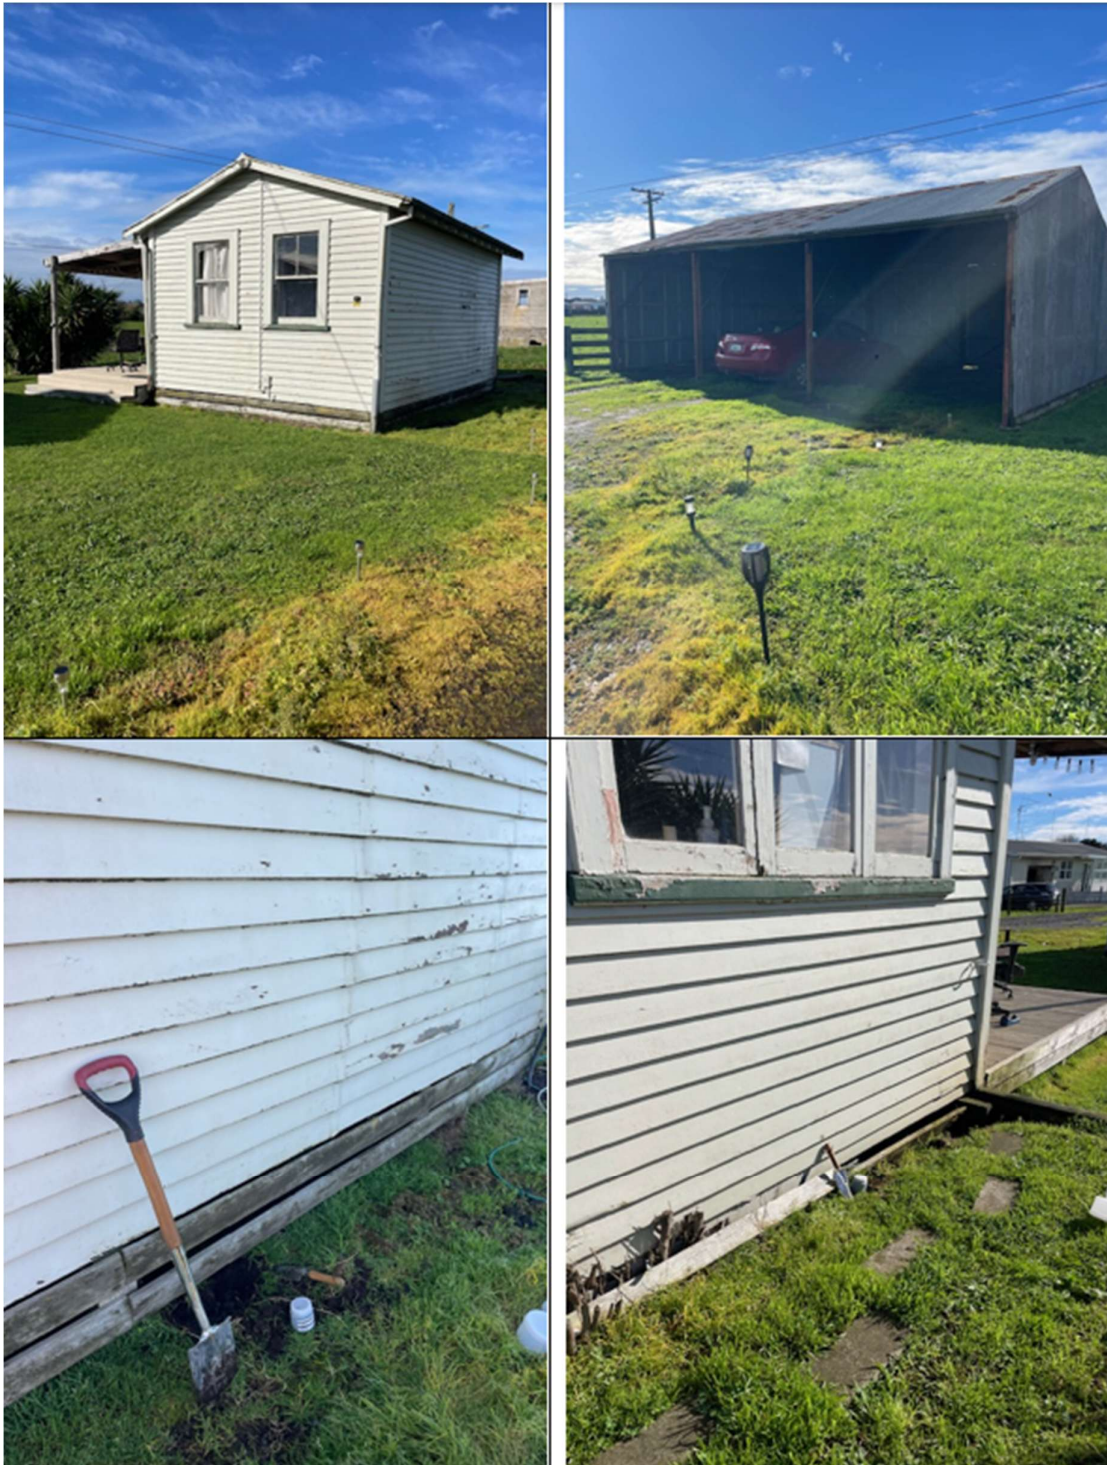
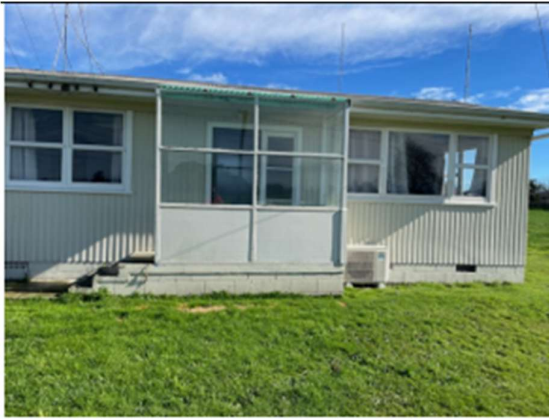
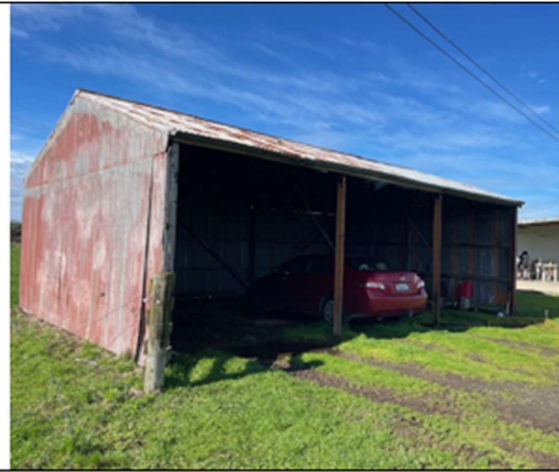
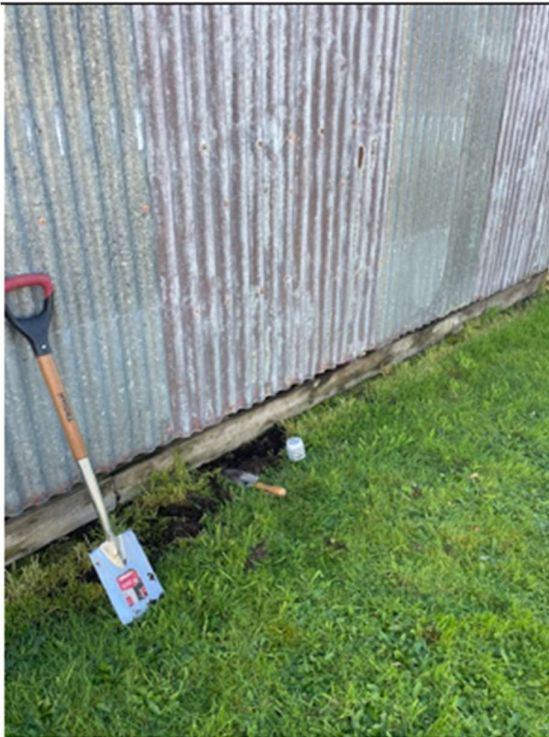
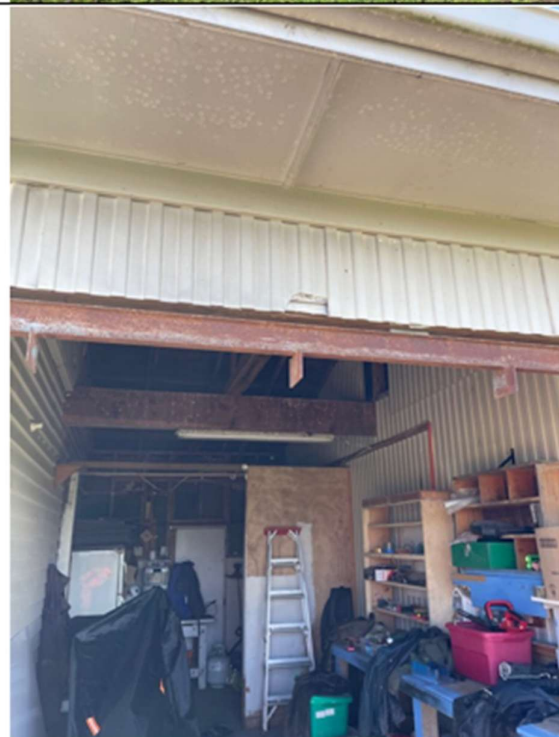
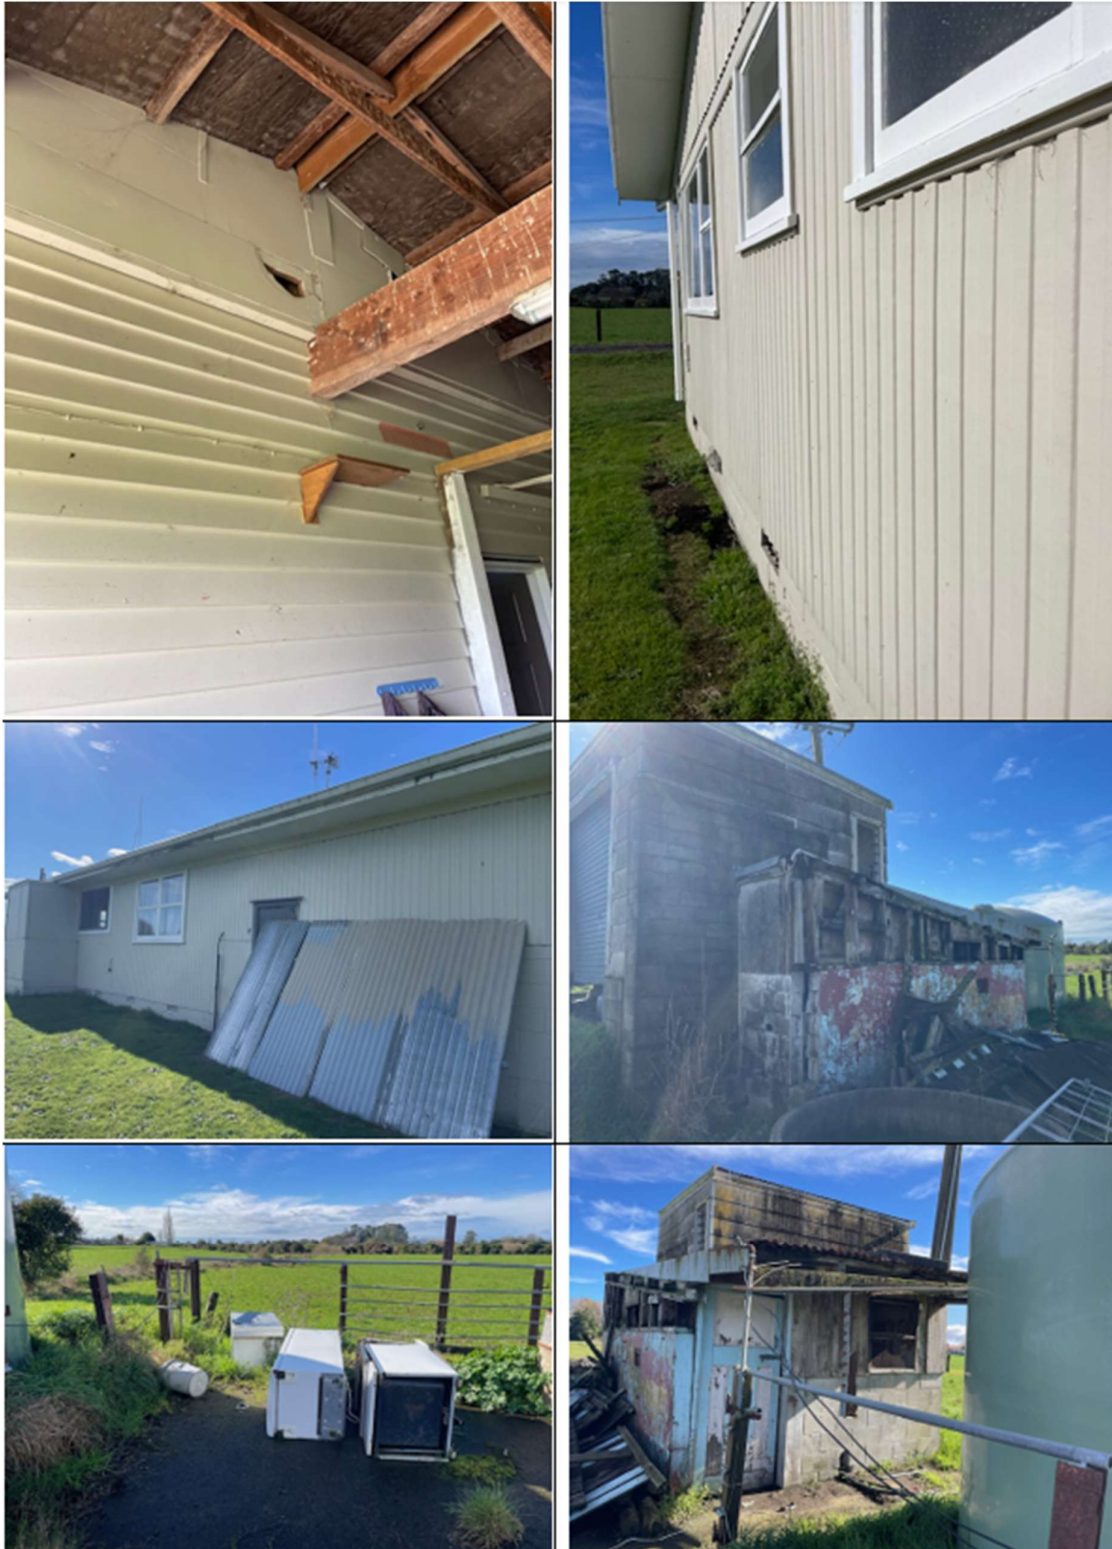
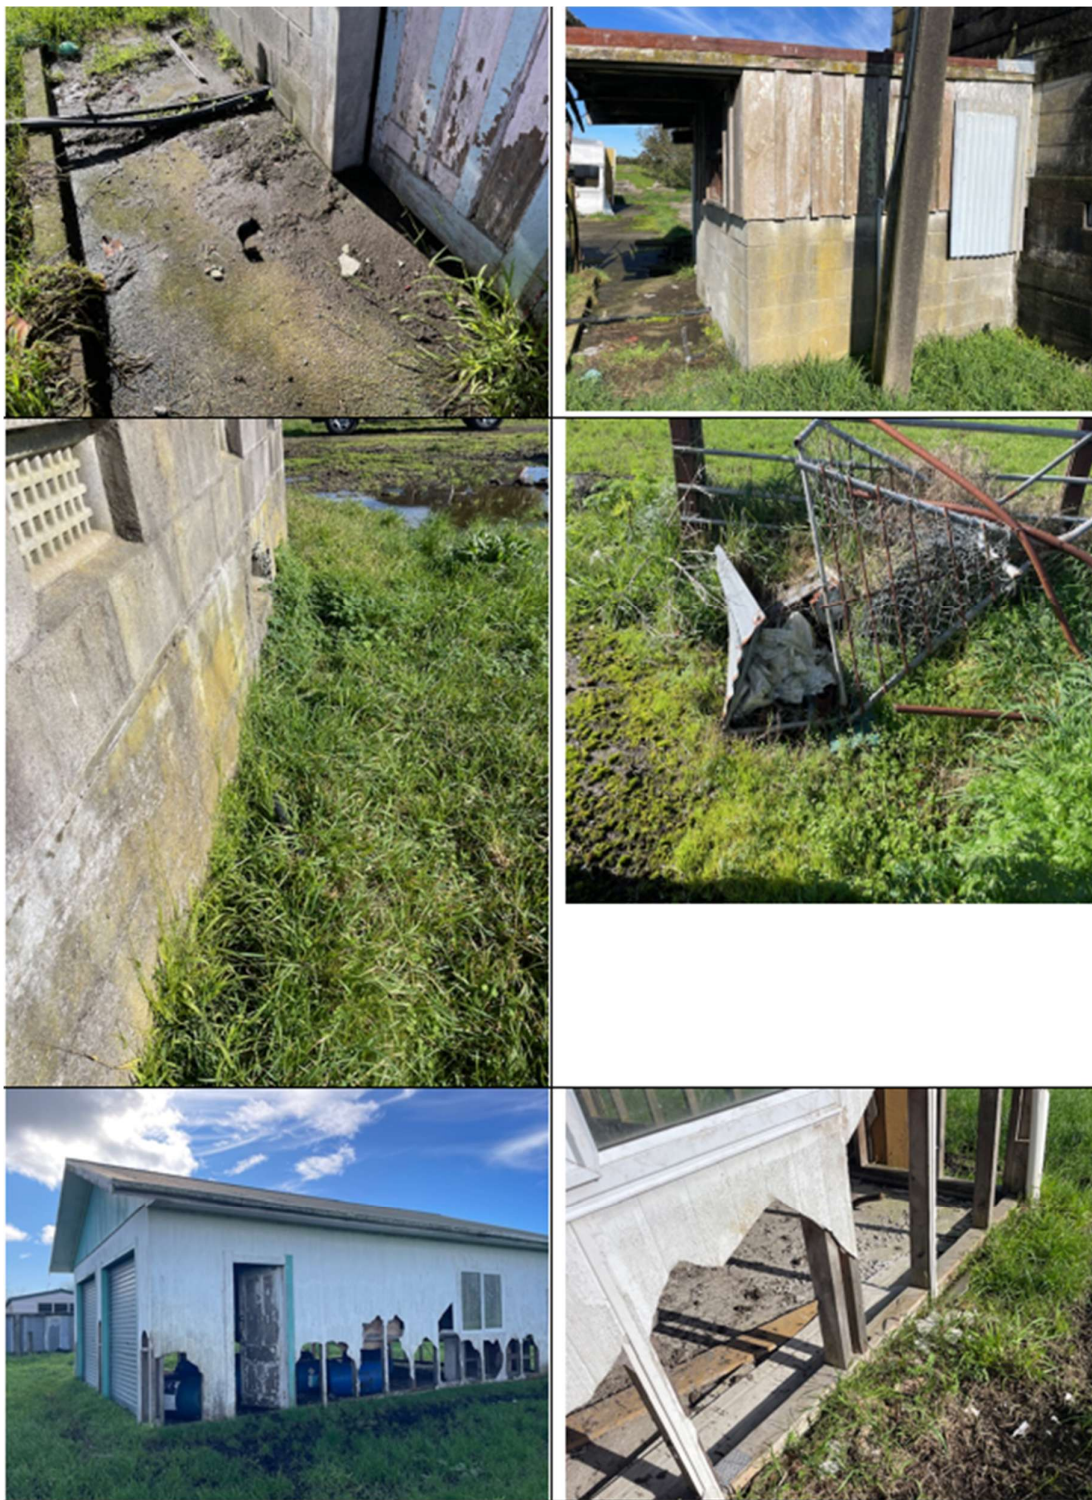
## **APPENDIX B:** Site Photographs

The ground conditions surrounding the existing dwellings consist of compacted turf, herbaceous topsoil, and underlying sandy silt. No evidence of fill material was observed. Suspected asbestos-containing material (ACM) debris was identified at the rear of the main residential dwelling, likely associated with the recent removal of a covered deck. Additional suspected ACM debris was also observed on the ground within the carport area. The debris was sampled for analysis. The ground conditions at the layout area comprised compacted fill material. Photographs taken during the soil investigation are provided as **Appendix A**.

Prior to development of the site and removal of structures it is recommended an asbestos surveyor be engaged to assess the risk posed by ACM materials used in structures prior to site development.
