KINGS QUARRY STAGE 2

PEBBLE BROOK ROAD, WAINUI

GEOTECHNICAL REPORT

AKL2023-0190AB Rev. 1

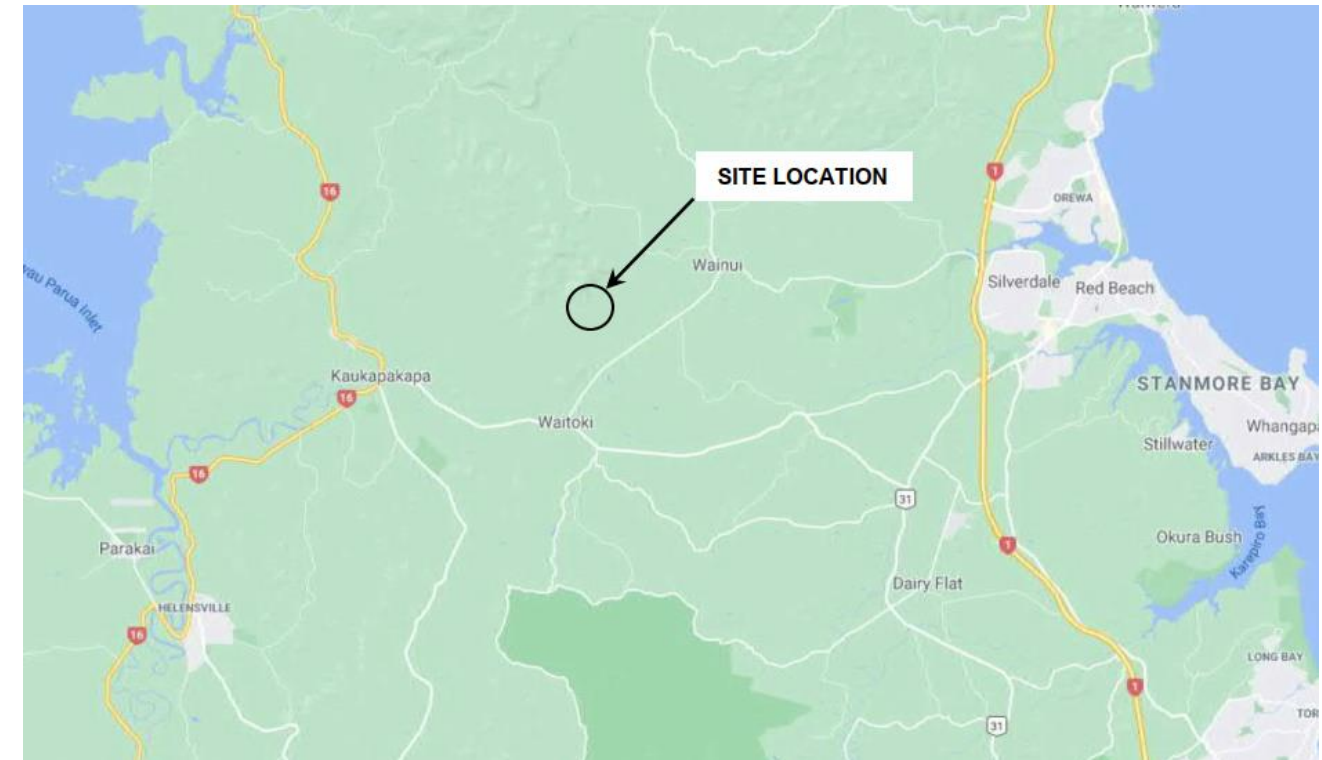
Figure 1: Site Location Plan (Auckland Council GeoMaps)

The site is located adjacent to 162 Pebble Brook Road, Wainui as shown on **Figure 1**.

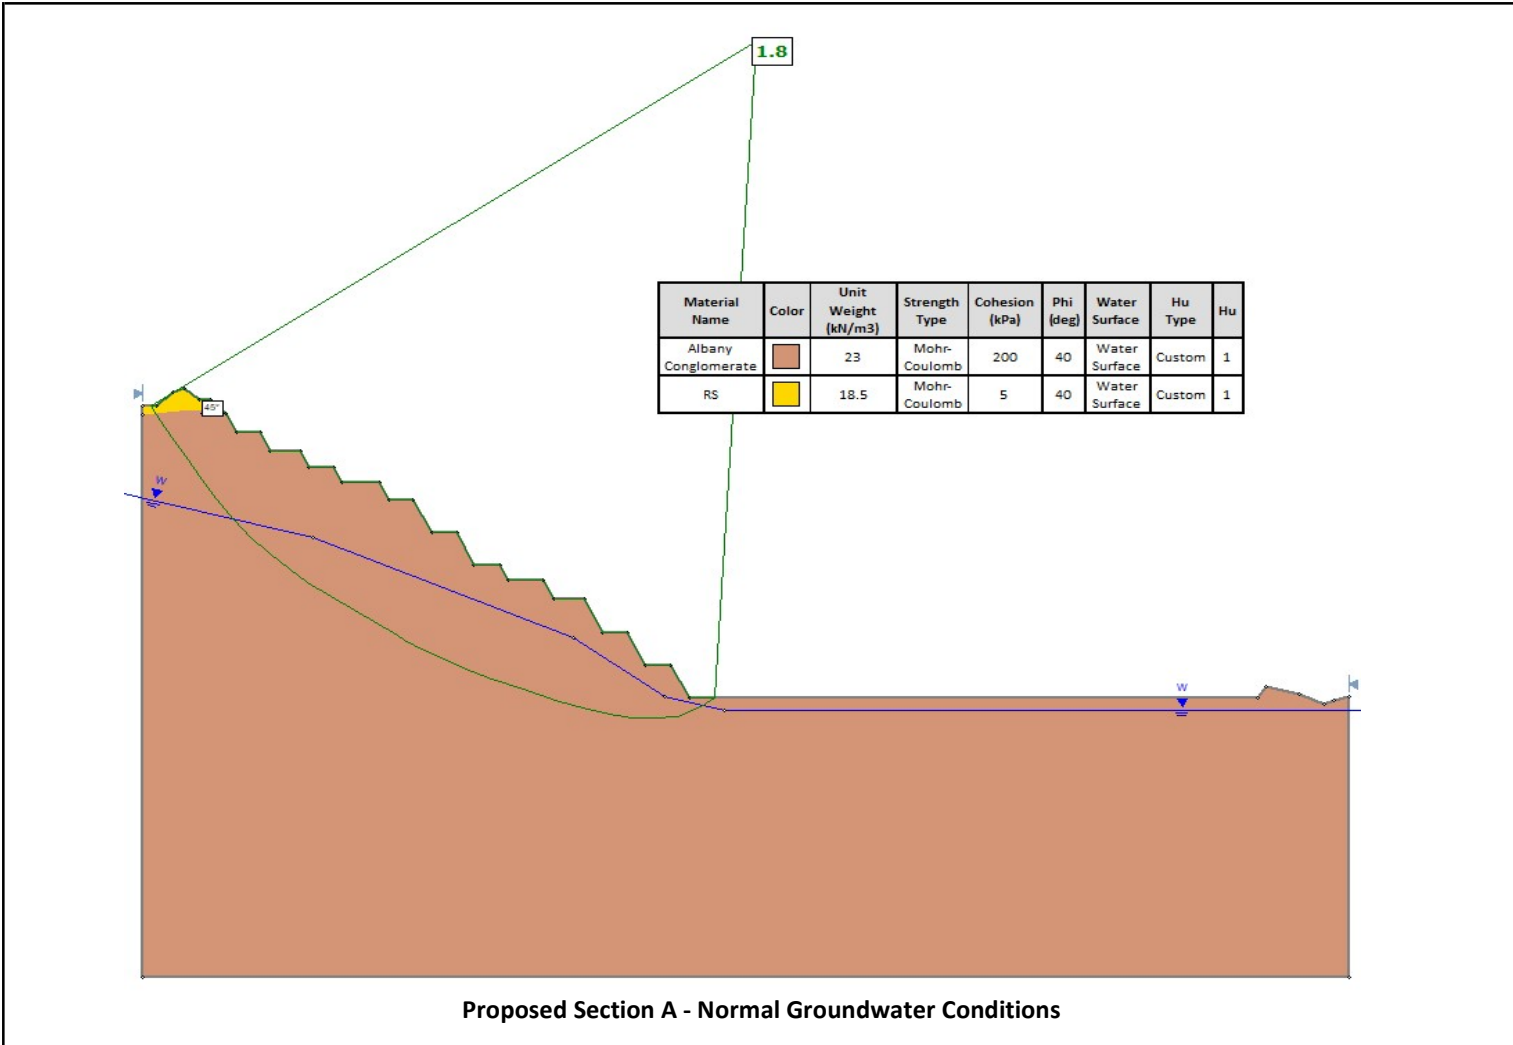
CMW Geosciences Great People Practical Solutions	Project	Kings Quarry, Wainui	Analysis	Cuckoo	Project No.	AKL2023-0190
	Title	Section A - Proposed	Date	10/10/2023	Drawing	STAB 01

Material Name	Color	Unit Weight (kN/m3)	Strength Type	Cohesion (kPa)	Phi (deg)	Water Surface	Hu Type	Hu
Albany Conglomerate		23	Mohr-Coulomb	200	40	Water Surface	Custom	1
RS		18.5	Mohr-Coulomb	5	40	Water Surface	Custom	1

Material Name	Color	Unit Weight (kN/m3)	Strength Type	Cohesion (kPa)	Cohesion Type	Water Surface	Hu Type	Hu
Albany Conglomerate (Undrained)		23	Undrained	2000	Constant	Water Surface	Custom	1
RS Undrained		18.5	Undrained	80	Constant	Water Surface	Custom	1

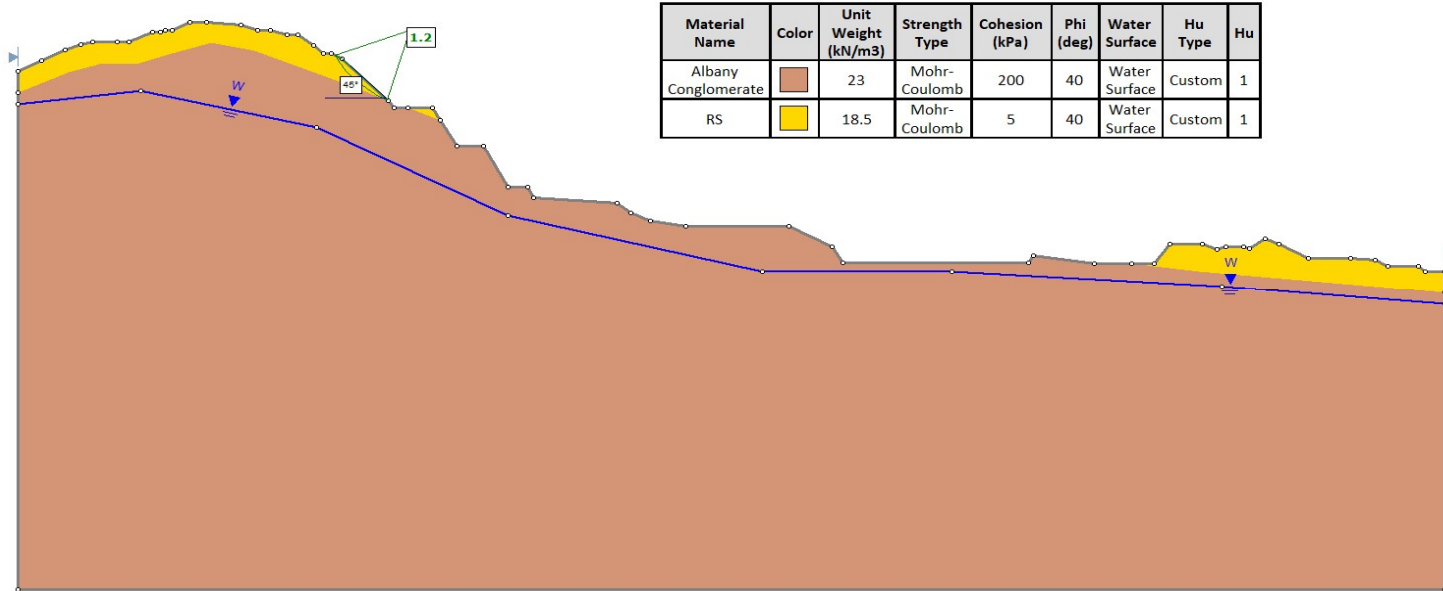
Proposed Section C (Pit) - Normal Groundwater Conditions

Material Name	Color	Unit Weight (kN/m3)	Strength Type	Cohesion (kPa)	Phi (deg)	Water Surface	Hu Type	Hu
Albany Conglomerate		23	Mohr-Coulomb	200	40	Water Surface	Custom	1
RS		18.5	Mohr-Coulomb	5	40	Water Surface	Custom	1

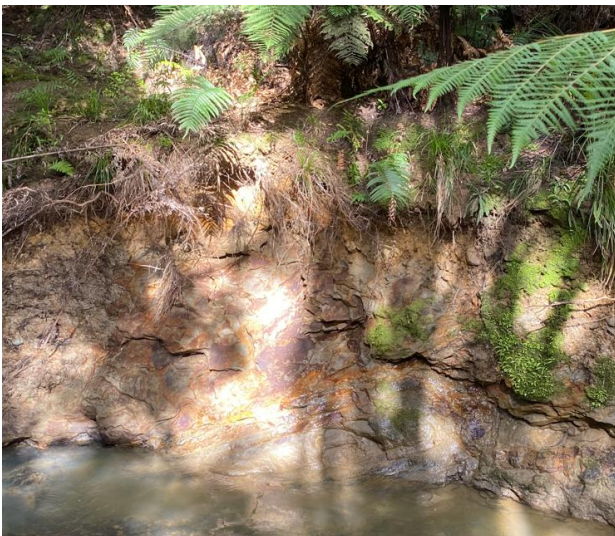
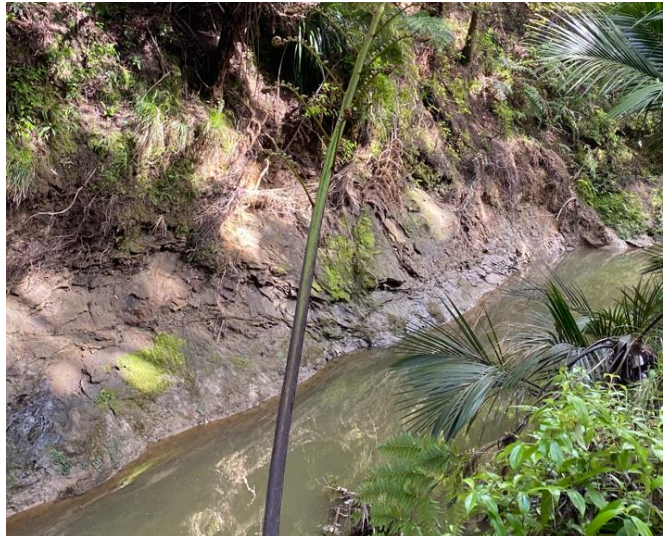
SITE REPORT – LOCALITY 2

- Mapped exposed outcrops along gully alignment.
- Geology logged as massive siltstone and sandstone of the East Coast Bays Formation with localised surficial outwash deposits (<1m) deposited via overland flow.

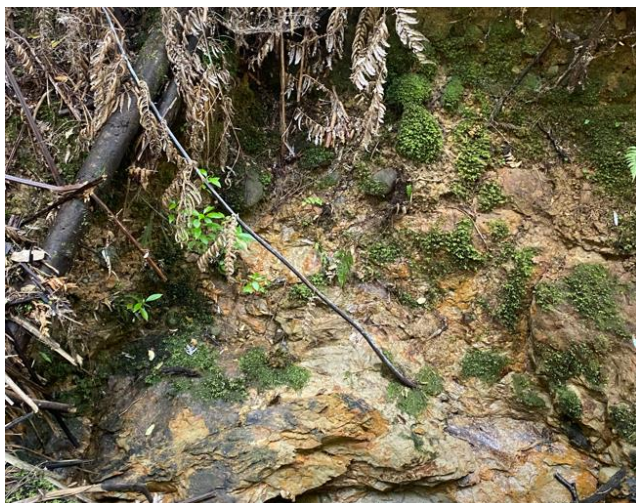
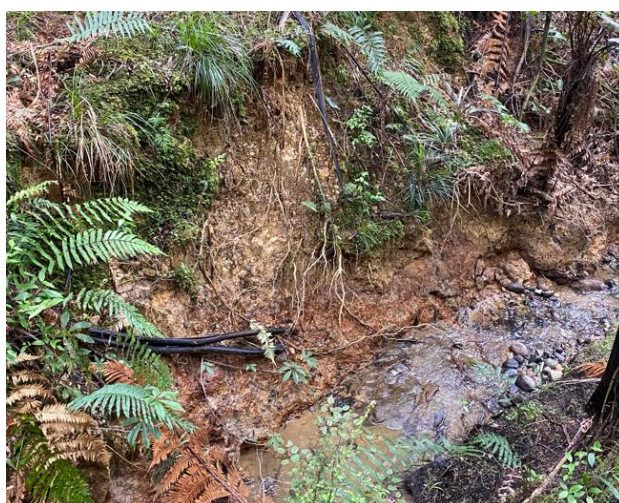
SITE REPORT – LOCALITY 3

- Mapped exposed outcrops along gully alignment.
- Geology logged as massive siltstone and sandstone of the East Coast Bays Formation with localised surficial outwash deposits (<1m) deposited via overland flow.

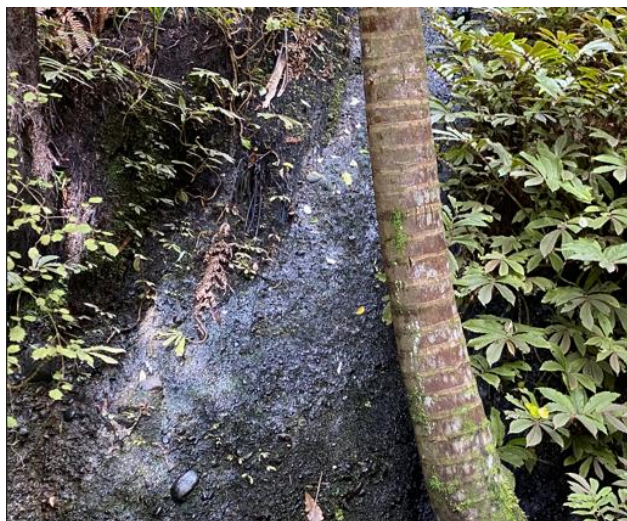
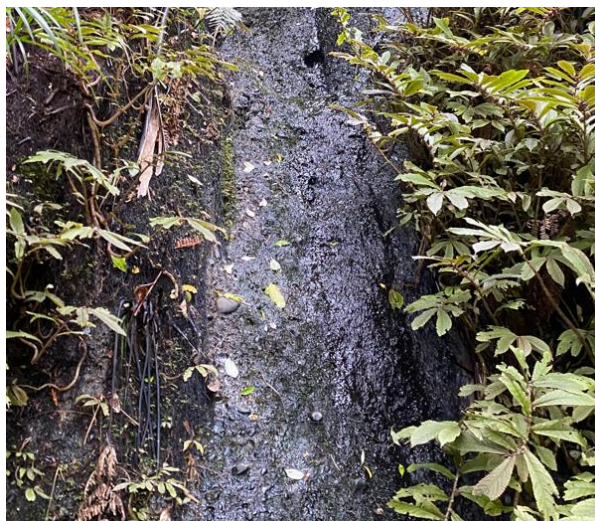
- Mapped exposed outcrops along gully alignment.
- Geology logged as gravels (generally subrounded up to cobble sized) suspended in a cemented sand/mud matrix of the Albany Conglomerate.

Locality 4: Albany Conglomerate – gravels (generally up to cobble sized) suspended in a cemented sand/mud matrix.
