ADAPTIVE MANAGEMENT PLAN

EARTHWORKS STAGES 10 - 13

MILLDALE

FULTON HOGAN LAND DEVELOPMENT LTD

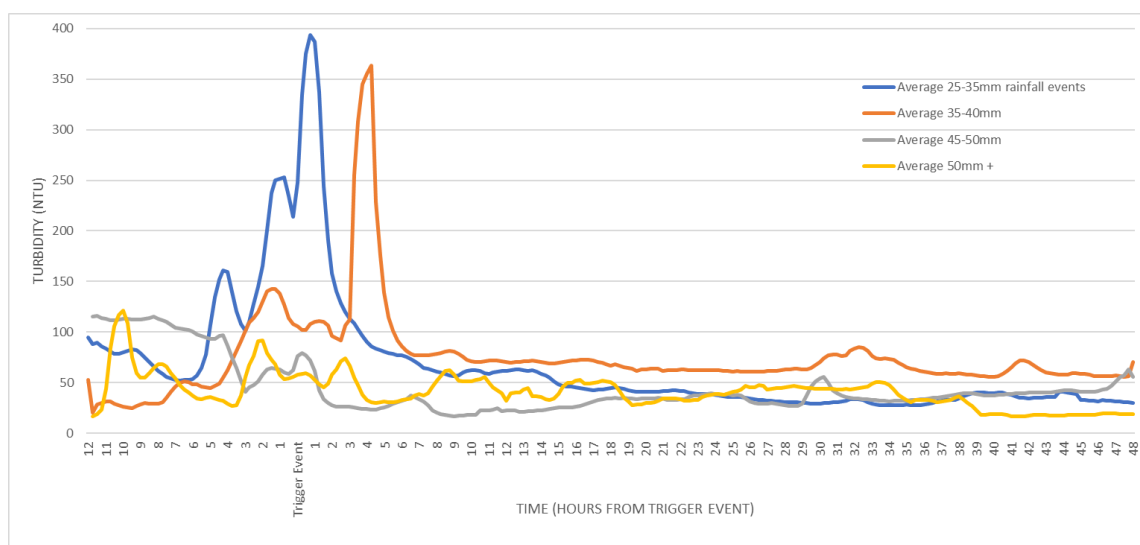
Figure 1: Milldale Stream 'baseline' pre-construction turbidity.

The Argent Lane Milldale Stream turbidity sensor has been in place since 2021. Figure 1 demonstrates the turbidity trend recorded for rain events of varying intensity. This shows the variation in the turbidity with minimal earthworks activities being undertaken upstream of the sensor. Utilising this 'baseline' data it is proposed to retain the current Milldale Stream monitoring site and compare the baseline turbidity to future rain events of similar nature. If the recorded turbidity exceeds 75 NTU and the elevated or gross exceedances as detailed below, then the management practices detailed in Section 5 will be actioned.

The data used in Figure 1 was sourced from single trigger events. The data was averaged using a moving average to smooth out spikes and irregularities.

An analysis of the Waterloo Stream turbidity was completed as part of the EW4 and 5 AMP. The analysis confirmed that during dry days and periods of minimal earthworks within the catchment the turbidity recorded at the downstream monitoring station fluctuates between 20 and 70 NTU. As a result, 75 NTU is taken as the upper end of the 'normal' range of turbidity in the stream. The following responses will apply when triggers are exceeded, and the downstream turbidity is greater than 75 NTU.

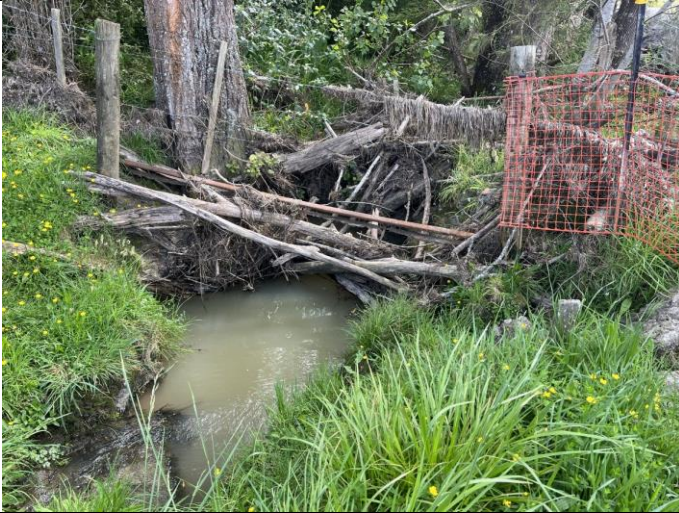
Photo No.	Location and description	Photo
1	0m Photo looking downstream at upstream extent and start point (fence line).

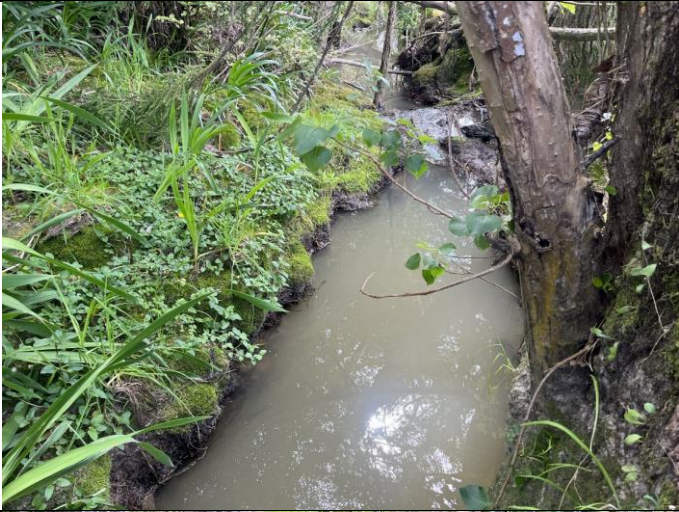
A photograph of a stream with a fence line in the background. The stream is surrounded by lush green vegetation, including tall grasses and yellow wildflowers. A red plastic fence is visible in the background, partially obscured by trees and branches.
2	0m Photo looking downstream at 0m just downstream of fence line.

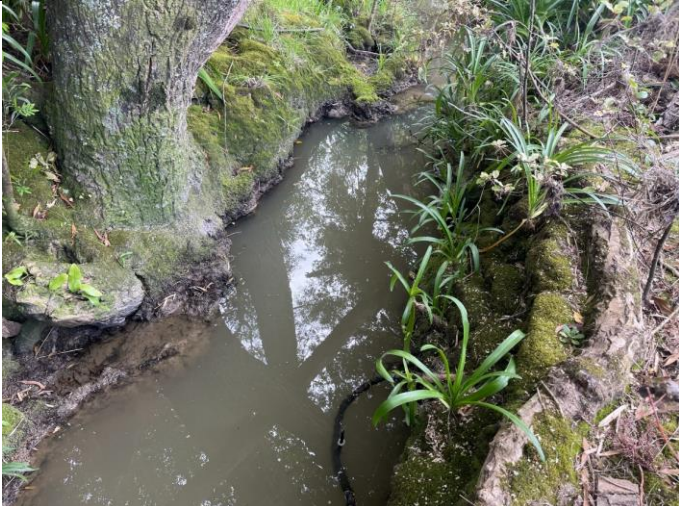
A photograph of a stream flowing through a wooded area. The water is murky and brown. The stream is bordered by dense green vegetation and trees. A large tree trunk is visible on the right side of the frame.
3	15m Photo of Cross-section 1 location, birds eye view.

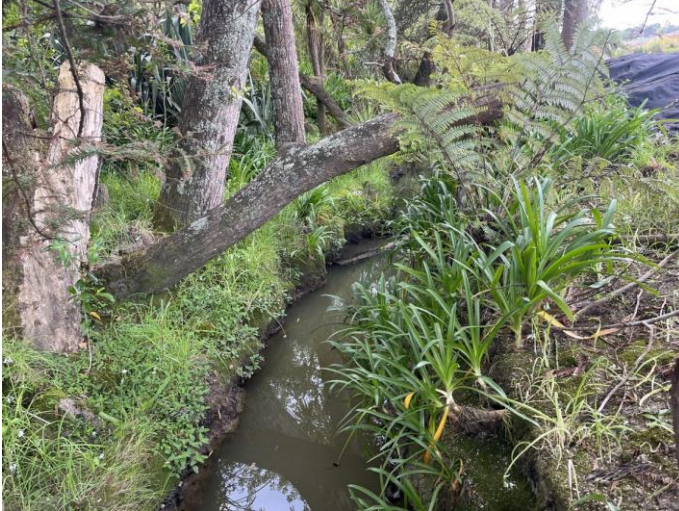
4	15m Photo of Cross-section 1 location looking downstream.

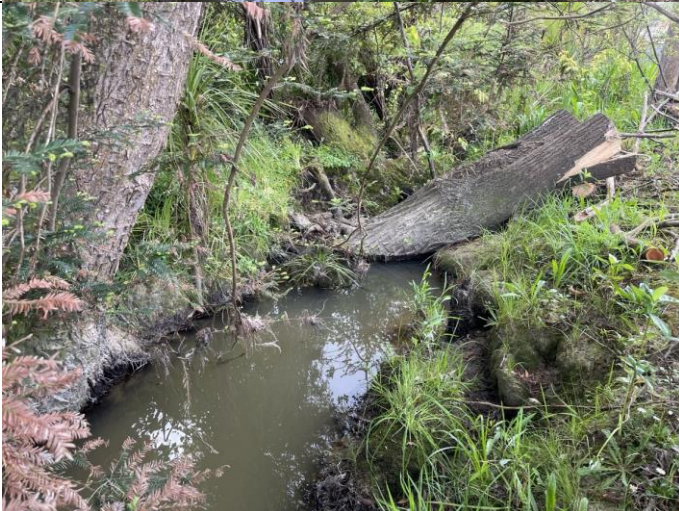
5	Existing feature. Tree in stream. Tree trunk recently cut.

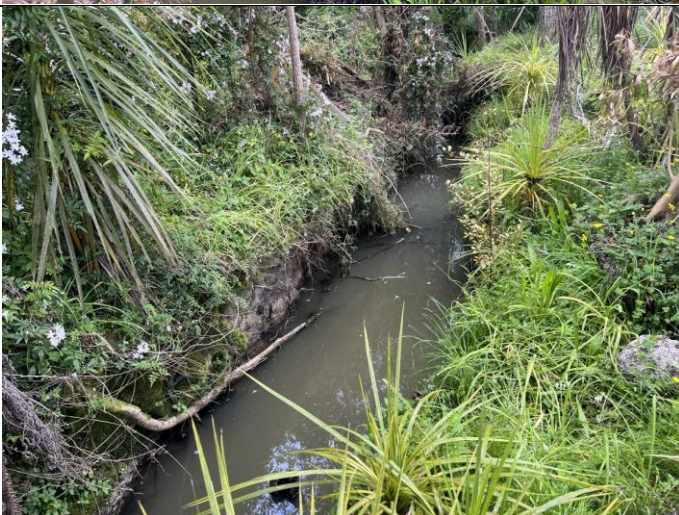
6	50m Cross-section 2 looking downstream.

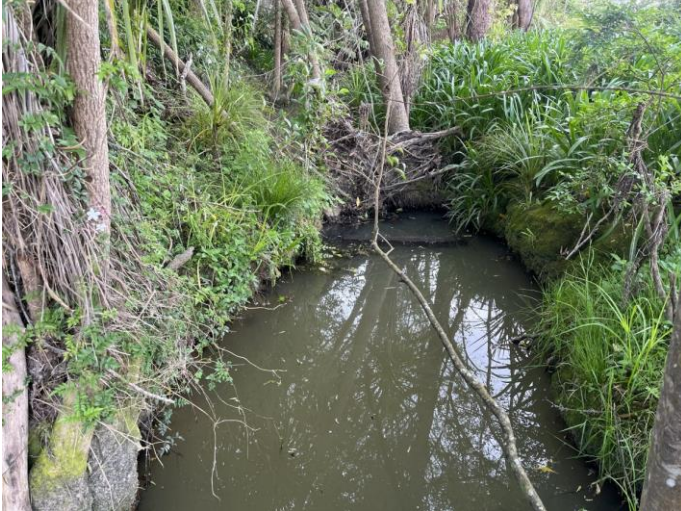
7	Existing feature. Debris/vegetation in stream.

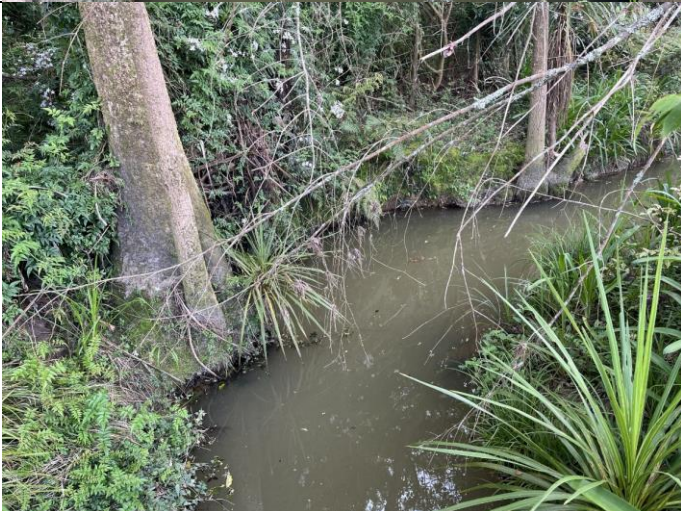
8	Stream channel.

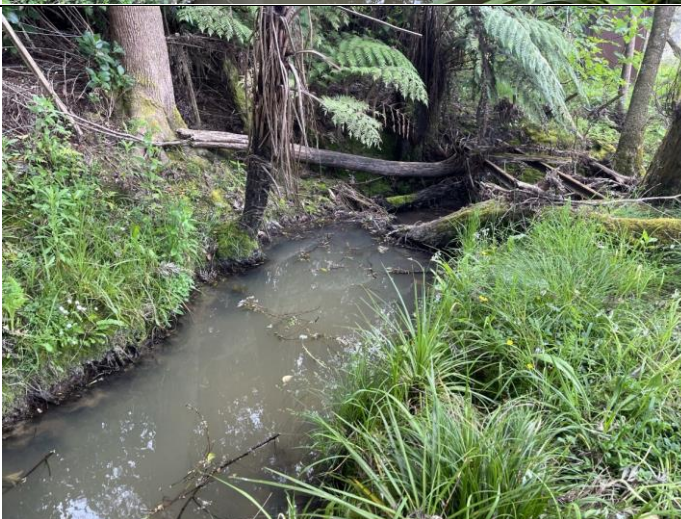
9	Existing feature. Debris/vegetation in stream creating dam like feature.

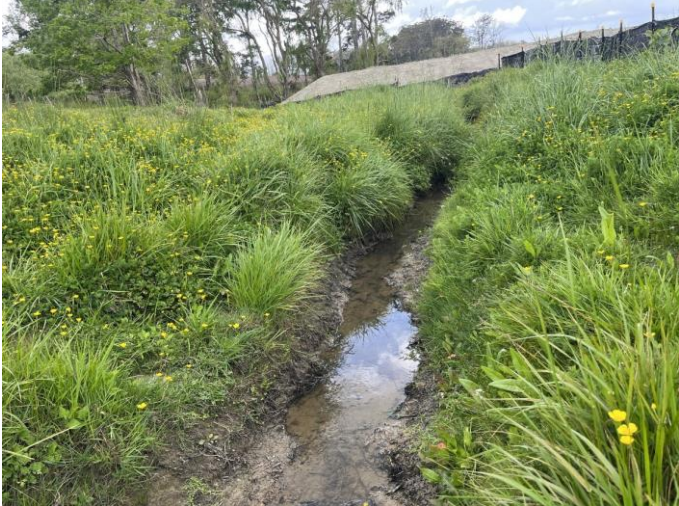
16	130m Cross-section 3 looking downstream.

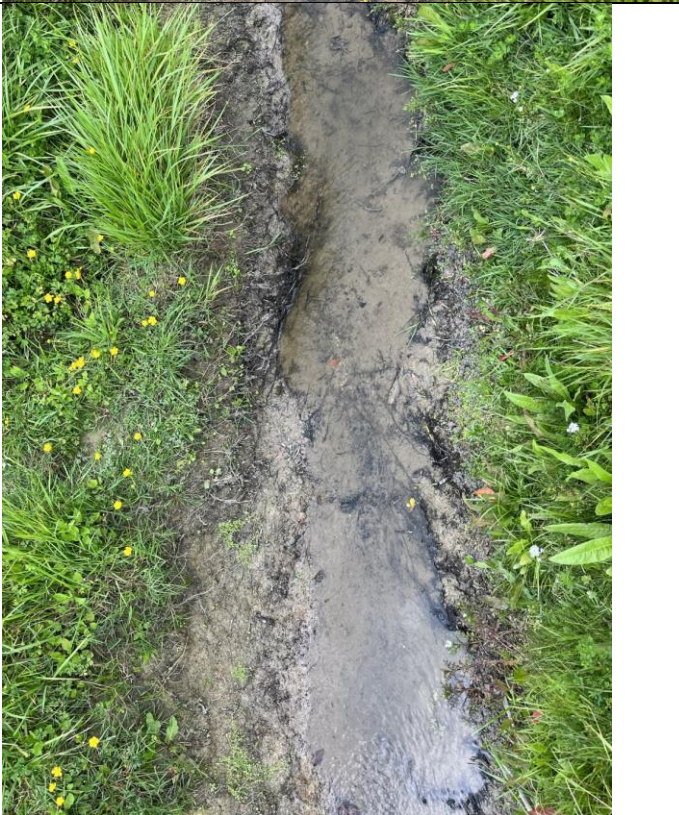
17	130m Cross-section 3 birds eye view.

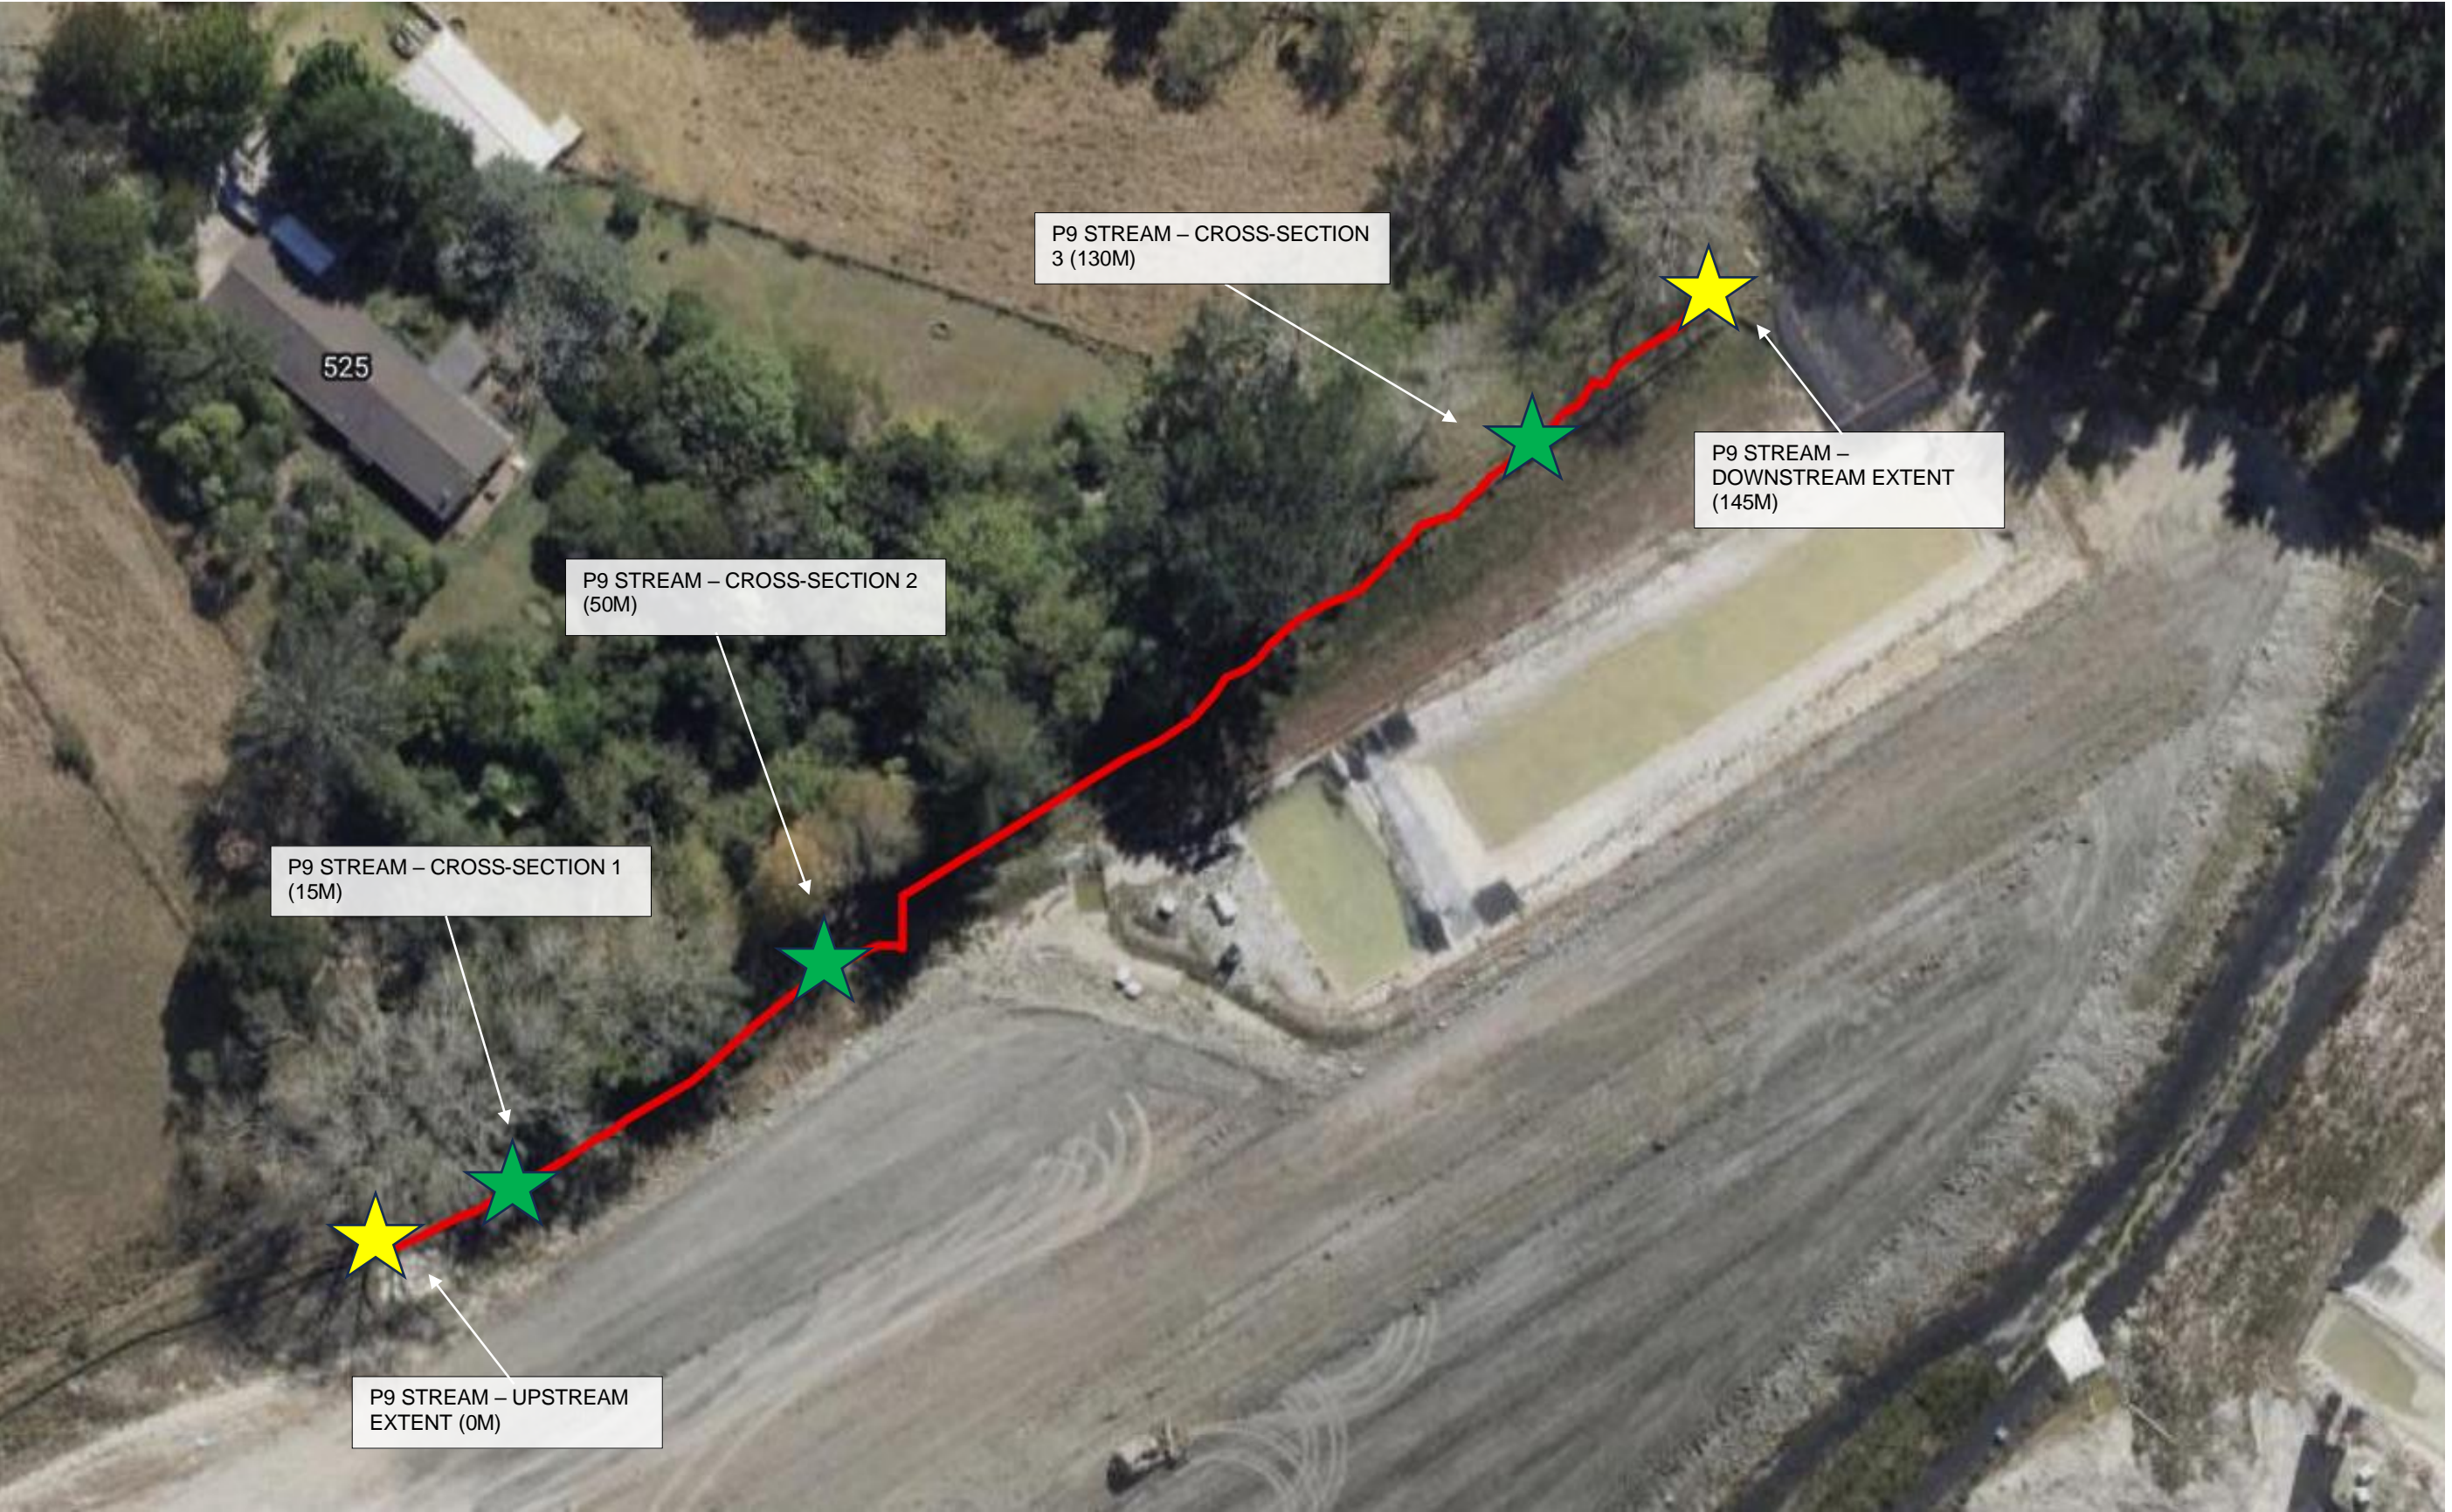
SITE MONITORING PLAN - P9 Baseline Stream Survey

P9 STREAM – CROSS-SECTION 3 (130M)

P9 STREAM – DOWNSTREAM EXTENT (145M)
