## WESTHAVEN RESIDENTIAL LP

## 188 BEAUMONT STREET – DEVELOPMENT

## GEOTECHNICAL ASSESSMENT REPORT FOR FTAA APPLICATION

INITIA REF P-002883 REV C

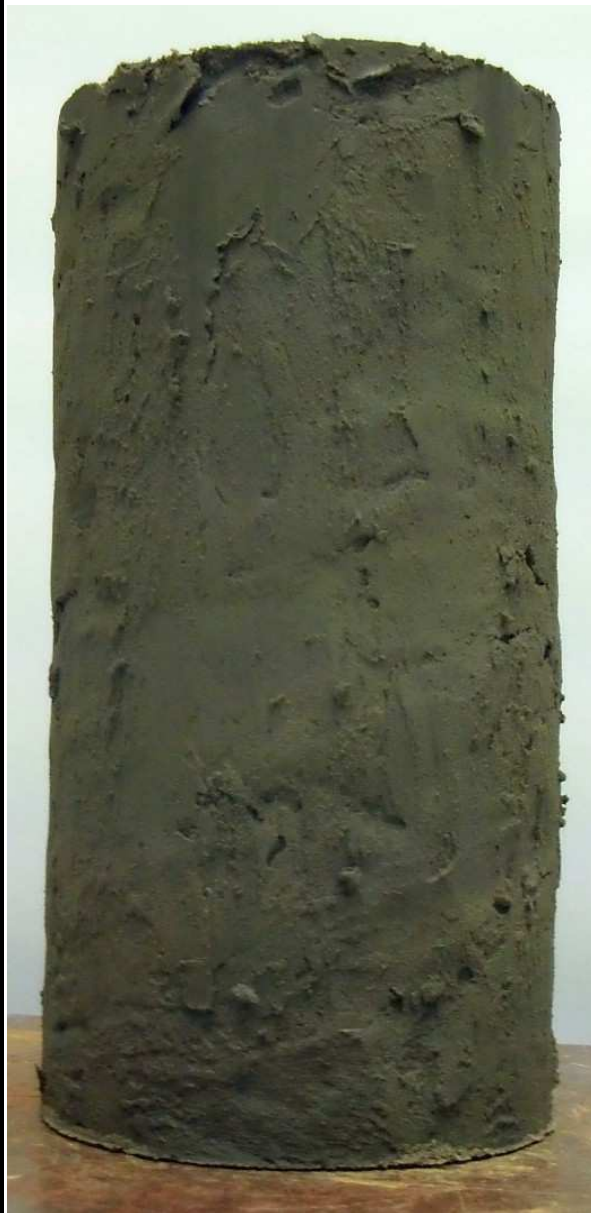
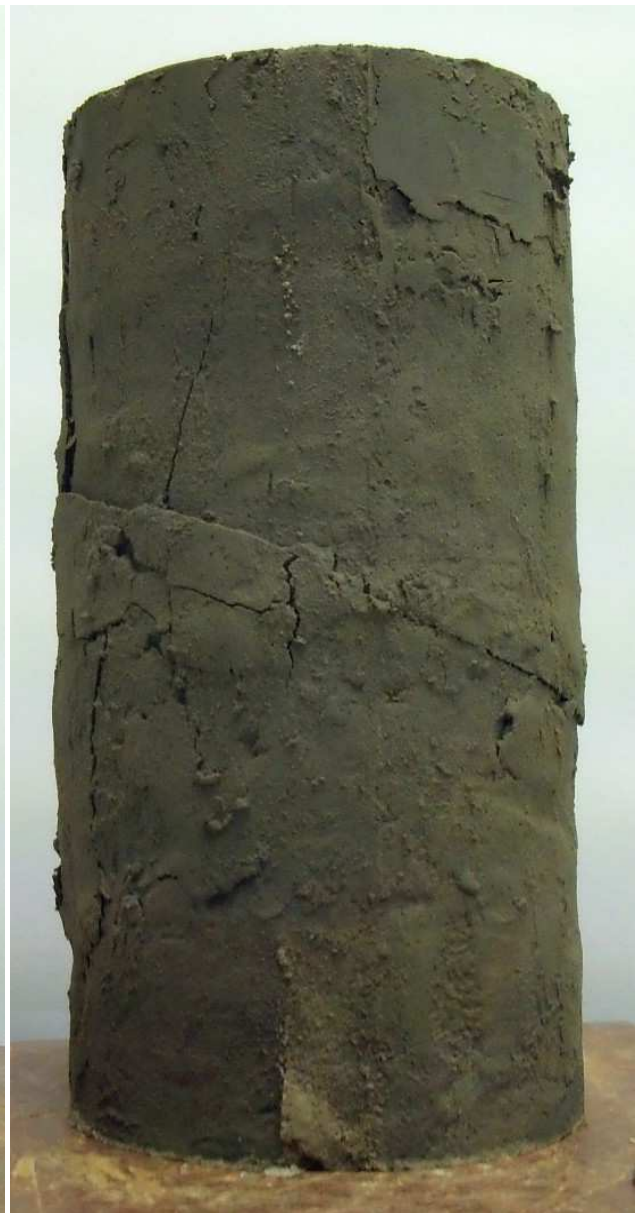
**SAMPLE BEFORE TEST**

**SAMPLE AFTER TEST**

**Unconfined Compressive Strength of Cohesive Soils**

Test Methods: NZS4402: 1986: Test 2.1 / Test 6.3.1

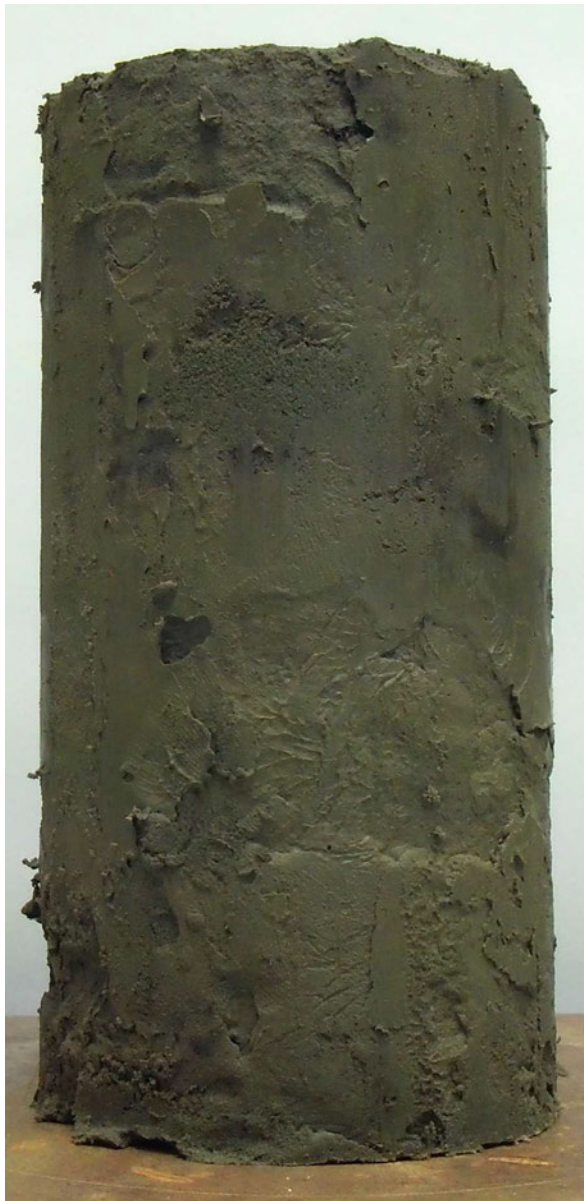
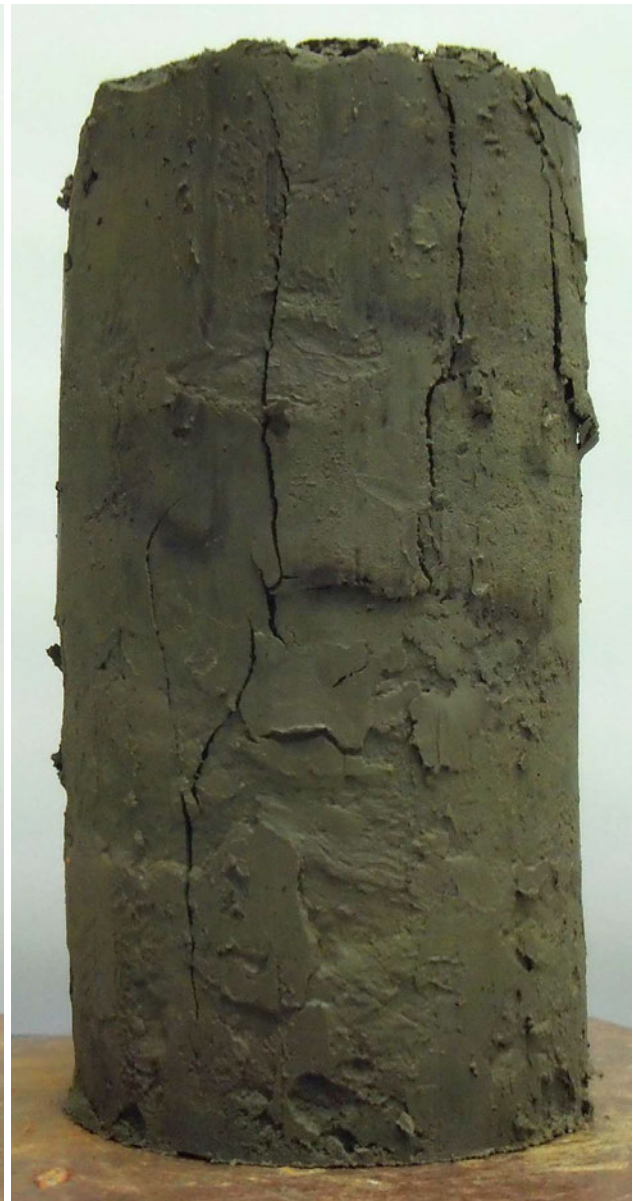
**SAMPLE BEFORE TEST**

**SAMPLE AFTER TEST**
