# NEW ZEALAND WETLAND DELINEATION DATA FORM

Site: Doolans Region: Remarkables Sampling point: WT 23  
 Owner: DOC Date: 15/01/26 Land use: Conservation  
 Landform: Slope Local relief: Flat to concave Land cover: Tussock  
 Is the land drained (circle) YES NO Investigator(s): LSW NM Soil °C: ✓ Slope: 20°  
 GPS (NZTM): 400 Altitude m: 1495 Photo Nos: 7255 (LSW)

**Appendix F: Wildlife Act Application**

The purpose of the Project is to upgrade the existing infrastructure within the Remarkables Ski Area and expand the skiable terrain available through an expansion into the adjacent Doolans Basin. The Doolans Basin will be accessed via a newly established gondola and ski trails. Sections 1.1 and 1.2 of this report provide further detail regarding the project. Section 7 of this report identifies the need for mitigation measures to avoid and minimise the impacts on New Zealand pipit and eastern falcon. The purpose of the proposed conditions is to avoid injury and mortality to native birds.

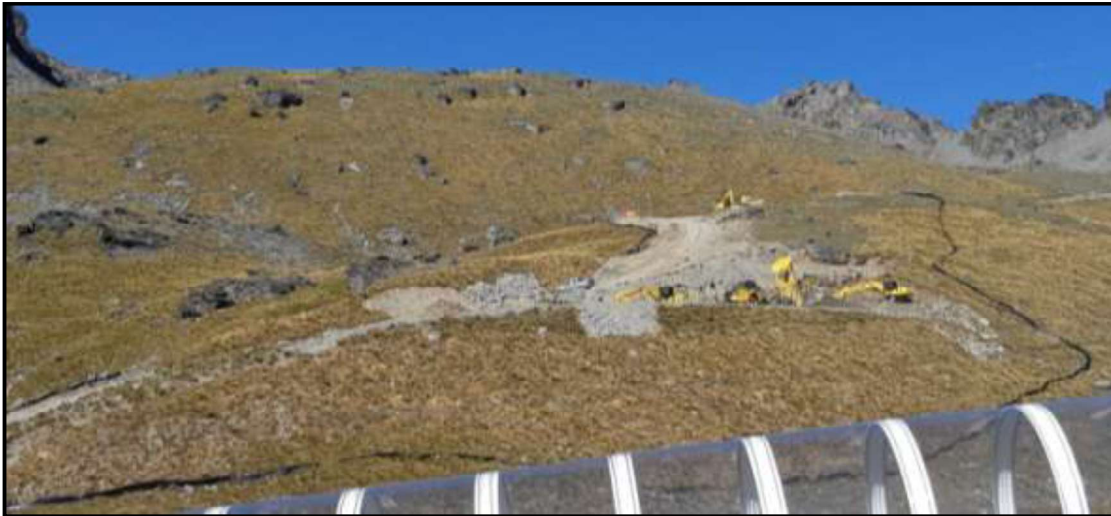
**Figure 71. Sugar Bowl trail 2020 under construction. The area enclosed by the black fence and the track above has been reshaped and revegetated by machines and is hardly distinguishable from the untouched tussock grassland.**

Over the years various methods of restoration have been used with varying success. One of the more successful restoration projects was early on where a spur was removed to form the first car park. A skilful machine operator removed tussocks from the area to be cut and replaced them on the finished slopes behind. The large area re-tussocked was only visible from the undisturbed tussockland if you were aware of the change. This method has been used this year on the new Sugar Bowl trail with a similar result. (Refer Figure 71 below).

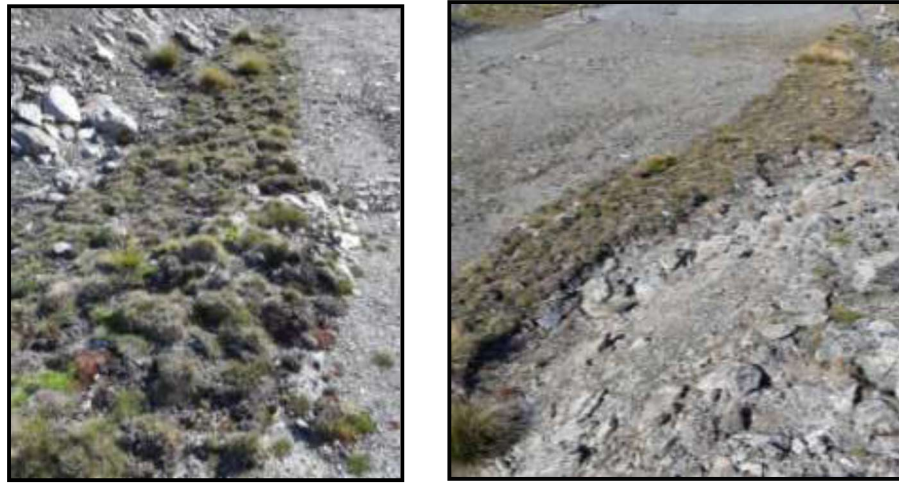
Figures 72 & 73. Two successful experimental transplanted cushionfield communities at 1800 m in the upper Sugar Bowl, approximately 5 years old.

It was considered that replanting cushion plants would not be successful and early attempts with machine placement were not. However an area in the upper Sugar Bowl at about 1800 m that was hand planted shows that cushion plants can be replanted successfully with care. Species present here include *Dracophyllum muscoides*, *Epilobium tasmanicum*, *Raoulia hectorii*, *Raoulia grandiflora*,

*Rytidosperma pumila*, *Poa colensoi*, *Colobanthus buchananii*, *Chionochloa macra*, *Craspedia lanata* and *Agrostis muelleriana*.

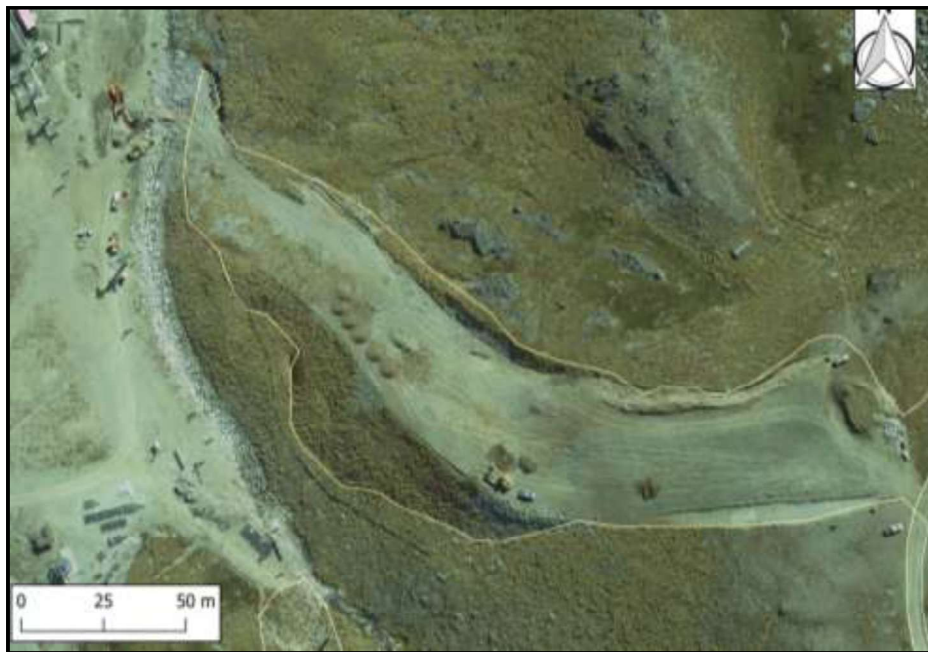
Figure 74. Aerial view of the recent work (refer Figure 71 above) withreworked area outlined in yellow and replanted area the slope below he skin trail. Note piles of saved top soil and repainted tussocks on the trail.

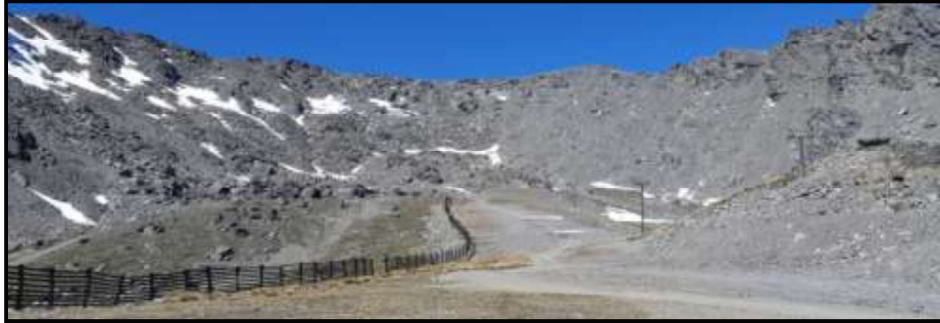
Figure 75. Experimental hand transplanting and hand seeding along the fence, upper Sugar Bowl. View uphill. Several hand planted plots can be seen up the fence line and at the right.

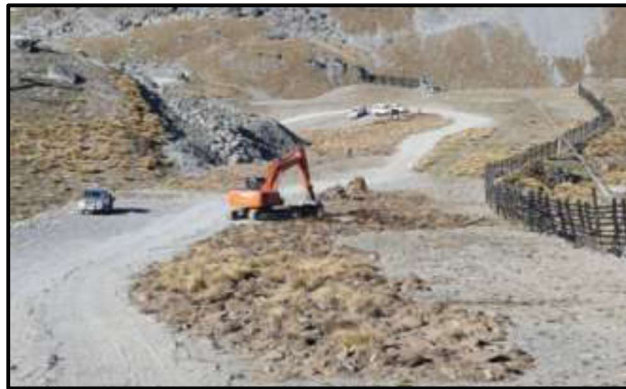
Figure 76. Further rehabilitation taking place in 2020 on the same site as Figure 75 above but the opposite view, here looking down the site. In foreground tussock clumps are being placed by digger and lower on the corner, seen as bare ground in figure 75. Later hand work is carried out to ensure plants are upright and well bedded in.

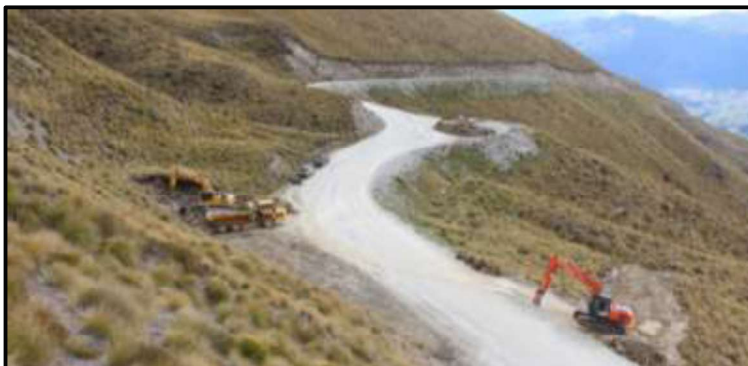
Figure 77.  
Car park 4 development  
2015 before modification.  
Below and above the  
existing road.

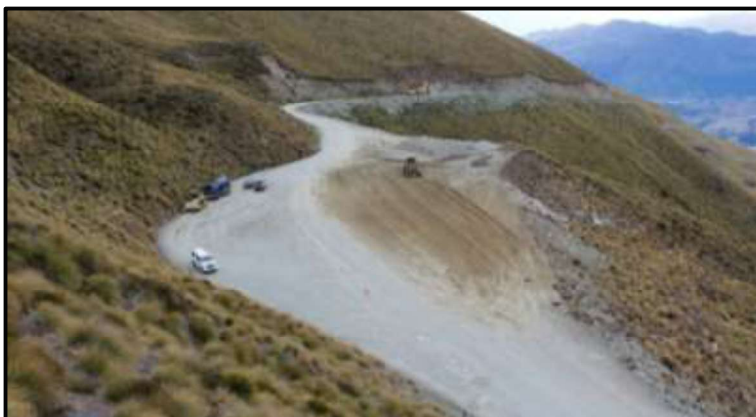
Figure 78.  
Note the rehabilitation below  
the road and beside the parked  
vehicles. Also the far corner  
has been cut and replanted.

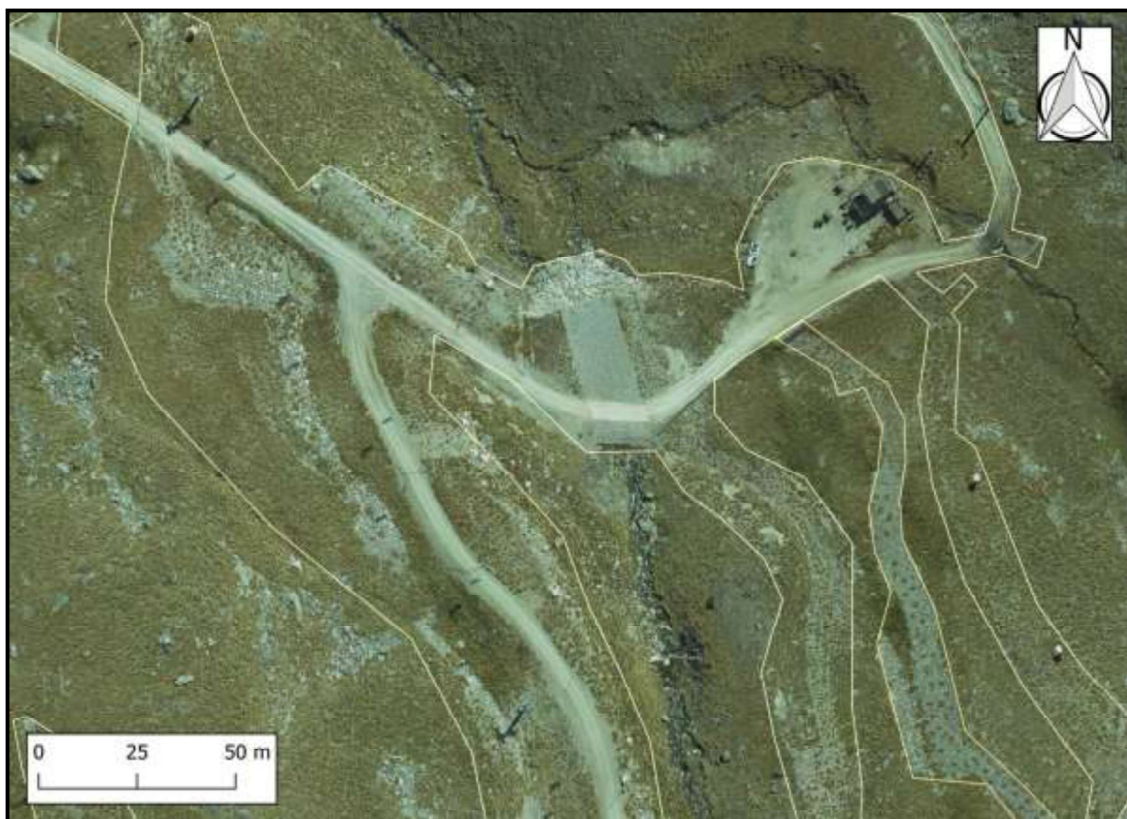
Figure 79. Shows the areas referred to above. Rastus Burn centre, old Sugar Bowl lift top right, Alta road centre bottom. The surveyed areas are to the left of the Alta road junction where spaced tussock shows to the left of the stone drain compared with the denser tussock left of the yellow line. All the area within the yellow line has been re-worked several times since at least 2011. Overall revegetation and its recovery has been good with further improvement expected. The yellow lines enclose re-worked areas with the widely spaced tussocks marking an old 4WD and walking track from time before the Alta road was made.

An area restored tussock area (*Chionochloa macra*) beside the Alta road and above the lower Alta wetland was sampled to compare the species numbers and their relative coverage. The undisturbed grassland was 90% *Chionochloa macra* with litter 5%, *Poa colensoi*, *Raoulia grandiflora*, *Epilobium atriplicifolium*, *Raoulia subsericea*, *Rytidosperma pumila*, *Scleranthus uniflorus*, *Uncinia fuscovaginata* and lichens.

The adjacent replanted area had widely spaced tussock where rock and rubble was about 90% cover. Species present as well as the replaced tussock were *Epilobium tasmanicum*, *Carex wakatipu*, *Epilobium atriplicifolium*, *Raoulia subsericea*, *Rytidosperma pumila*, *Scleranthus uniflorus* and *Polytrichum* sp. This area had been reworked several times and was an example of restoration that was not ideal and where insufficient tussocks had been used but that in time would recover to become similar to the undisturbed areas as had occurred in other similar areas below. On one of these areas below the road the public had formed an unofficial access track to the car park that was causing some erosion by opening up the ground cover.

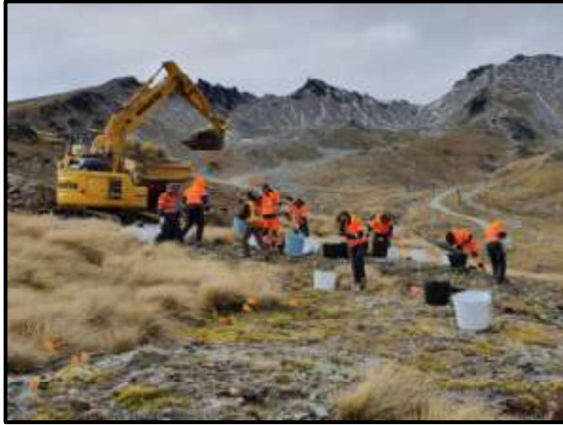
Figure 80.

Where special plant species have been identified such as *Anisotome lanuginosa*, staff are deployed to carefully dig the special plants up and then re-planted once the works have been completed or they are planted close by.

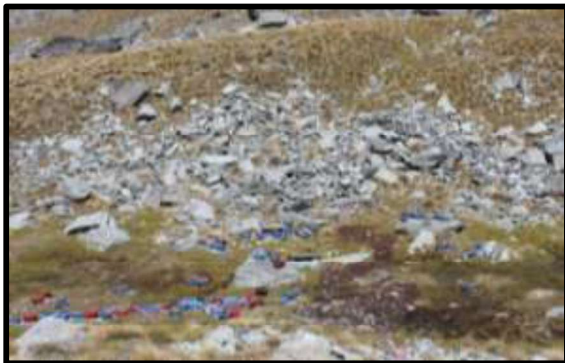
Figure 81. Cut squares of vegetation are carefully Removed in baskets and placed on wet ground Below (red & green baskets).

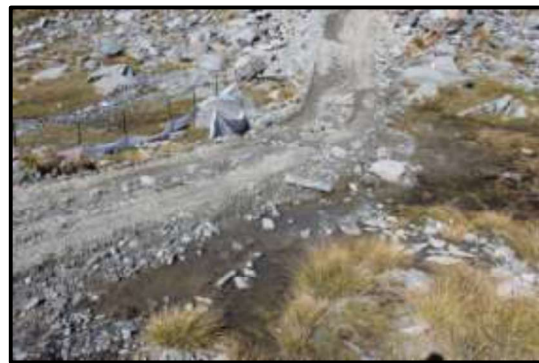
Figure 82. Same area after trench dug, pipeline laid and buried. To orient oneself note large rock upper centre left. Lower centre in Fig. 81.

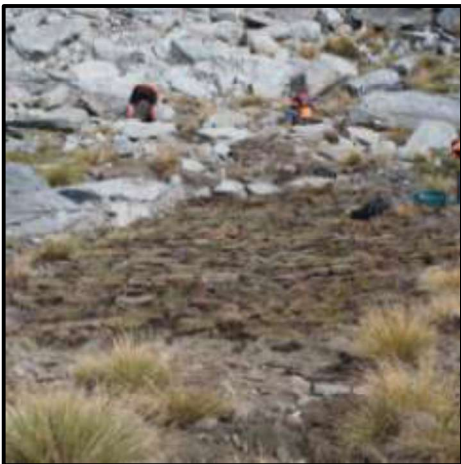
Figure 83. After two months all vegetation that had been removed was relocated and placed like a patchwork quilt, over the reformed ground and packed into place.

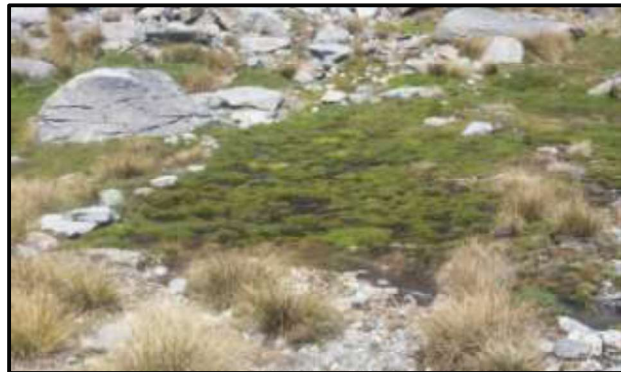
Figure 84. The site February 2019
