**SUBJECT: FOXTON SOLAR FARM WATERWAY CLASSIFICATION ASSESSMENT**

A fast-track resource consent application has been made by Genesis Energy to construct a solar farm near Foxton (APP-2025205573.00). There are a number of watercourses located onsite that the applicant has described as artificial farm drainage canals. I visited the site on 28 April 2026 to undertake a stream classification assessment, with specific regard to differentiating whether these waterbodies are artificial or modified in nature.

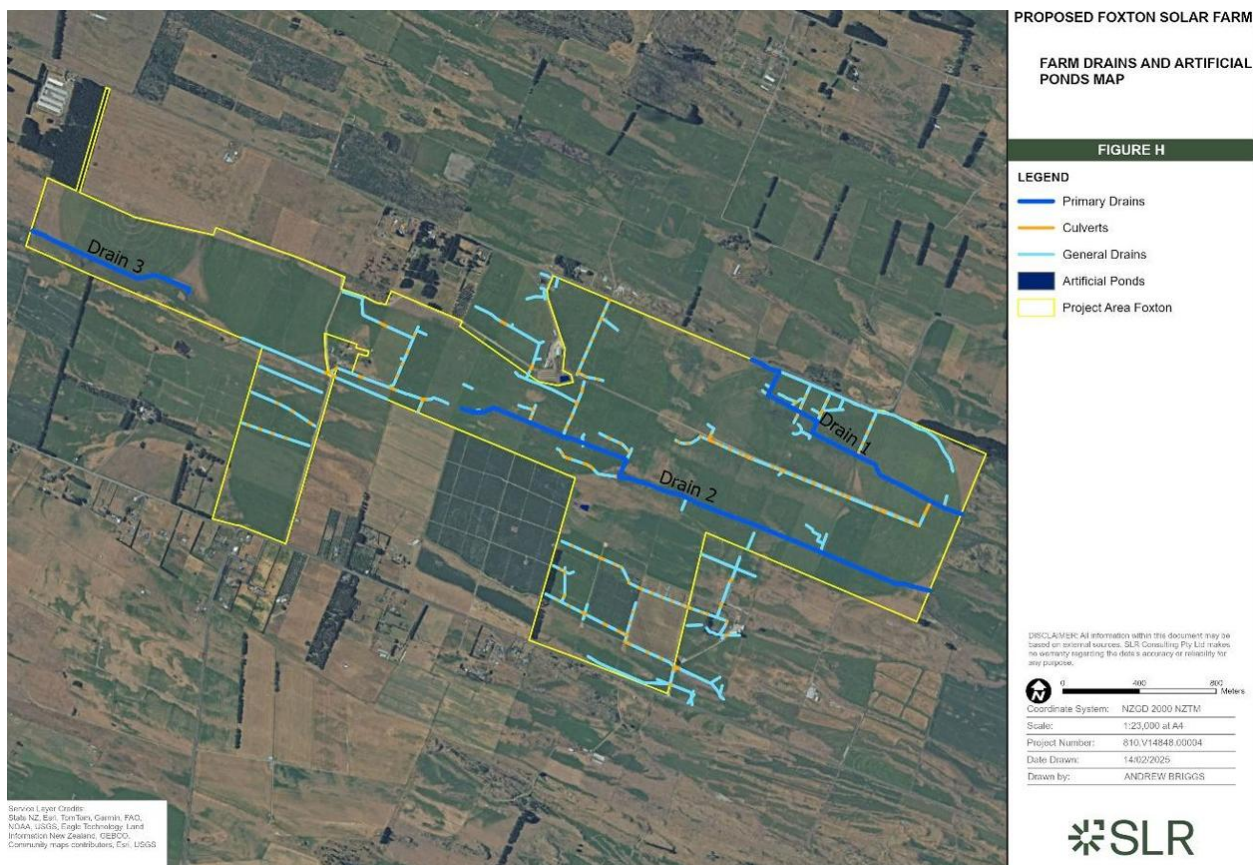
**Figure 1.** The locations of the watercourses onsite. Sourced from Appendix I of the application, the Ecological Impact Assessment

Numerous channels are located across the proposed solar farm site (Figure 1). The three main 'drains' identified by the applicant are assessed in full. The remaining smaller channels observed are grouped together and described collectively.

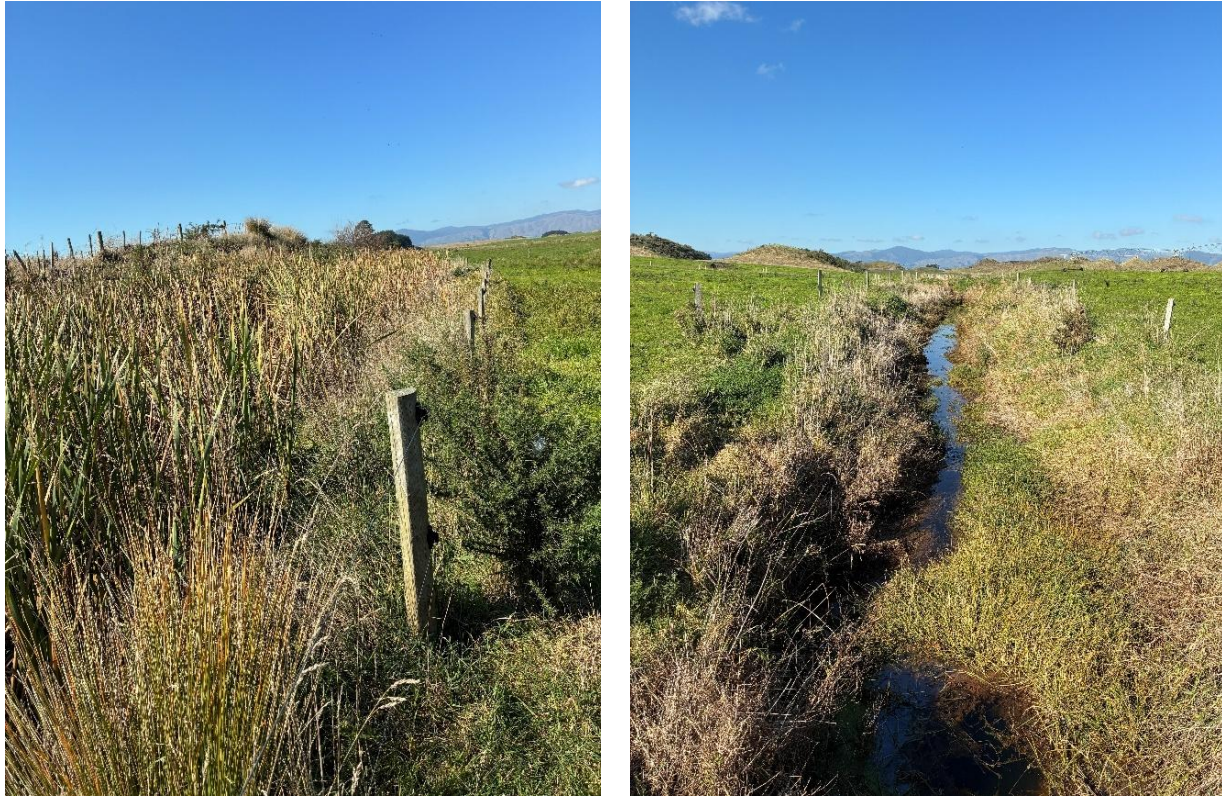
**Figure 2.** Main 'drain' 1 at the upper (left) and lower (right) sites

Main 'drain' 1 was assessed at two locations on the site; an upper reach where the watercourse enters the site, and a downstream location. At the upstream assessment site, the channel exhibited a combination of stream and wetland characteristics, suggesting this system functions as a stream-wetland mosaic. At the downstream location, the channel had a moderate flow and supported aquatic obligate macrophytes, including watercress.

| Classification criteria | Criterion present in the watercourse? (yes/no) |
|---|---|
| Does the waterway convey water from natural sources, such as springs, snow melt, or a natural rainwater catchment? | Yes – a small upstream rainwater catchment is present. A groundwater connection is also likely, with the channel likely at least partially replacing historical wetland extent. |
| Does the watercourse mostly align with, or does it replace, a historical natural river, stream, or wetland? | Yes – this criterion is difficult to assess given limitations in historic knowledge at the site scale. While this channel has been constructed and is unlikely replacing a historic stream of similar size, it likely replaces historic wetland hydrological systems. |
| Is the bed of the watercourse made from natural materials, with evidence of substrate sorting processes? | Lack of evidence – this channel is highly modified, with a straightened form and numerous culvert crossings influencing flow and substrate transport. The streambed is dominated by soft substrates, which do not exhibit substrate sorting processes as clearly as coarser, hard-bottomed streams. |
| Does the watercourse meander? | No – the channel has been mechanically straightened. |
| Does the watercourse host riverine (and/or wetland) ecosystems? | Yes – wetland vegetation (including raupō) was observed at the upstream site, and aquatic macrophytes (including watercress) were present downstream. The watercourse provides suitable habitat for fauna such as tuna and kōura. Freshwater fish and macroinvertebrates are likely to utilise this habitat. |
| <b>Waterway classification status</b> | <b>Natural - modified</b> |

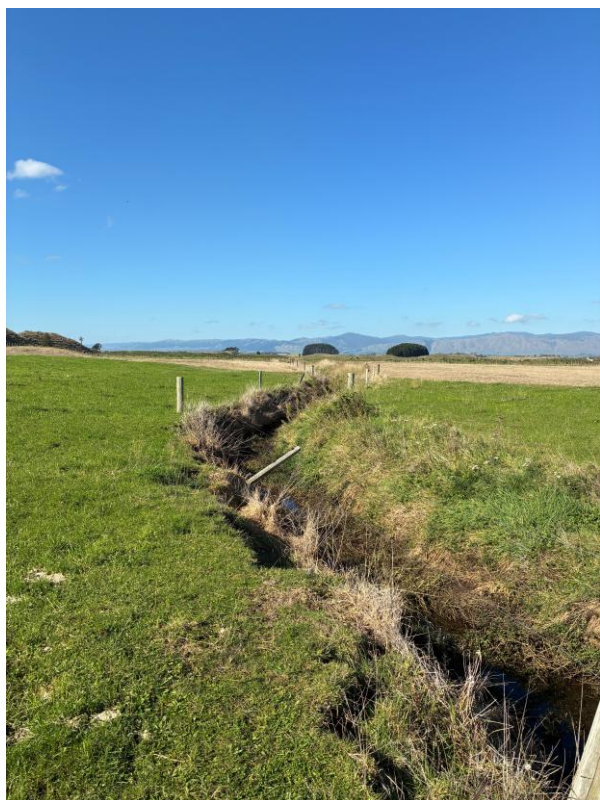
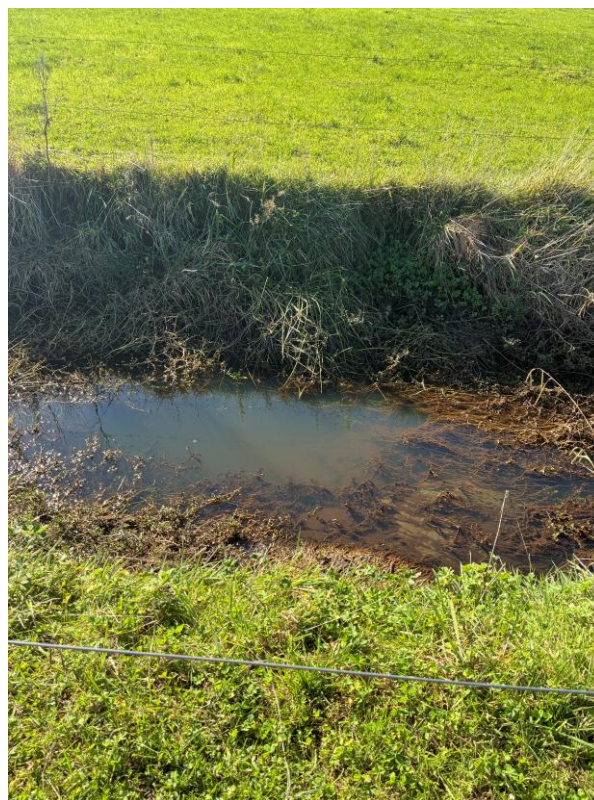
**Figure 3.** Main 'drain' 2 at the assessment reach

Main 'drain' 2 was assessed at a reach within its downstream extent, near the project site boundary. This watercourse had some flow at the time of assessment and supported aquatic obligate macrophytes, including watercress.

| Classification criteria | Criterion present in the watercourse? (yes/no) |
|---|---|
| Does the waterway convey water from natural sources, such as springs, snow melt, or a natural rainwater catchment? | Yes – while only a small upstream rainwater catchment is present, a groundwater connection is also likely. The channel likely at least partially replaces historical wetland extent. |
| Does the watercourse mostly align with, or does it replace, a historical natural river, stream, or wetland? | Yes – this criterion is difficult to assess given limitations in historic knowledge at the site scale. While this channel has been constructed and is unlikely replacing a historic stream of similar size, it likely replaces historic wetland hydrological systems. |

| Is the bed of the watercourse made from natural materials, with evidence of substrate sorting processes? | Lack of evidence – this channel is highly modified, with a straightened form and numerous culvert crossings influencing flow and substrate transport. The streambed is dominated by soft substrates, which do not exhibit substrate sorting processes as clearly as coarser, hard-bottomed streams. |
| Does the watercourse meander? | No – the channel has been mechanically straightened. |
| Does the watercourse host riverine (and/or wetland) ecosystems? | Yes –aquatic macrophytes (including watercress) were observed. The watercourse provides suitable habitat for fauna such as tuna and kōura. Freshwater fish and macroinvertebrates are likely to utilise this habitat. This is corroborated by eDNA monitoring carried out by the applicant within this watercourse. Shortfin tuna, common bully, gambusia, and goldfish were detected, indicating the watercourse provides sustained flow to support freshwater fauna. |
| <b>Waterway classification status</b> | <b>Natural - modified</b> |

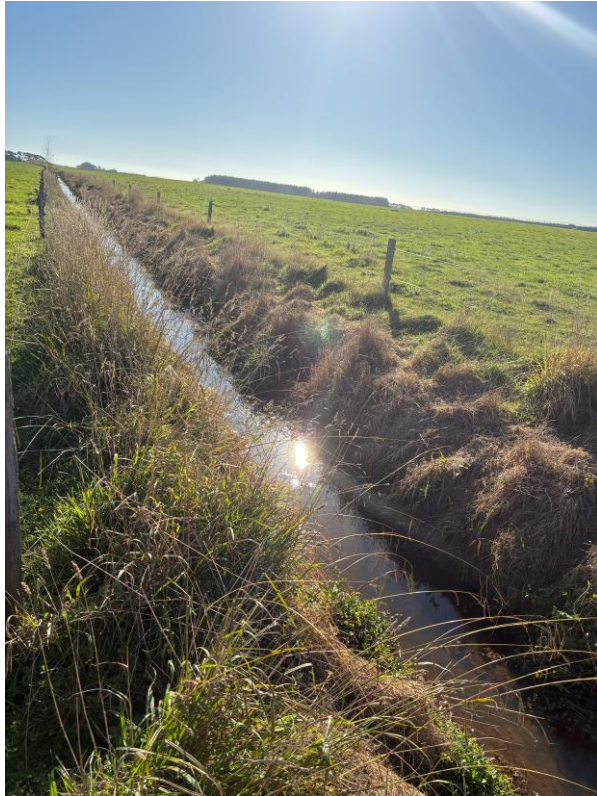
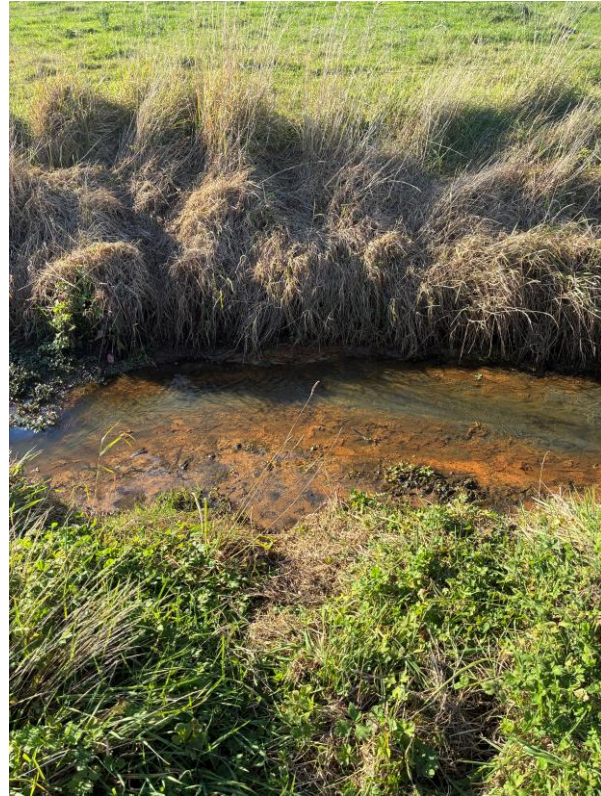
**Figure 4.** Main 'drain' 3 at the assessment reach

Main 'drain' 3 was flowing at the time of the assessment, and supported aquatic obligate macrophytes, including watercress.

| Classification criteria | Criterion present in the watercourse? (yes/no) |
|---|---|
| Does the waterway convey water from natural sources, such as springs, snow melt, or a natural rainwater catchment? | Yes – while only a small upstream rainwater catchment is present, a groundwater connection is also likely. The channel likely at least partially replaces historical wetland extent. |
| Does the watercourse mostly align with, or does it replace, a historical natural river, stream, or wetland? | Yes – this criterion is difficult to assess given limitations in historic knowledge at the site scale. While this channel has been constructed and may not be replacing a historic stream of similar size, it likely replaces historic wetland hydrological systems. |
| Is the bed of the watercourse made from natural materials, with evidence of substrate sorting processes? | Lack of evidence – this channel is highly modified with a straightened form. The streambed is dominated by soft substrates, which do not exhibit substrate sorting processes as clearly as coarser, hard-bottomed streams. |
| Does the watercourse meander? | No – the channel has been mechanically straightened. |
| Does the watercourse host riverine (and/or wetland) ecosystems? | Yes –aquatic macrophytes (including watercress) were observed. The watercourse provides suitable habitat for fauna such as tuna and kōura. Freshwater fish and macroinvertebrates are likely to utilise this habitat. This is corroborated by eDNA monitoring carried out by the applicant within this watercourse. Shortfin tuna, common bully, gambusia, and goldfish were detected, indicating the watercourse provides sustained flow to support freshwater fauna. |
| <b>Waterway classification status</b> | <b>Natural - modified</b> |

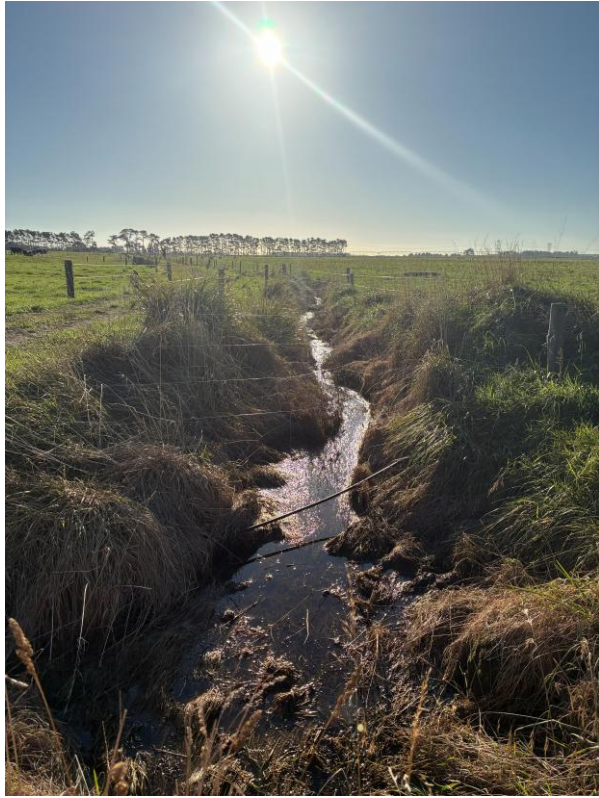
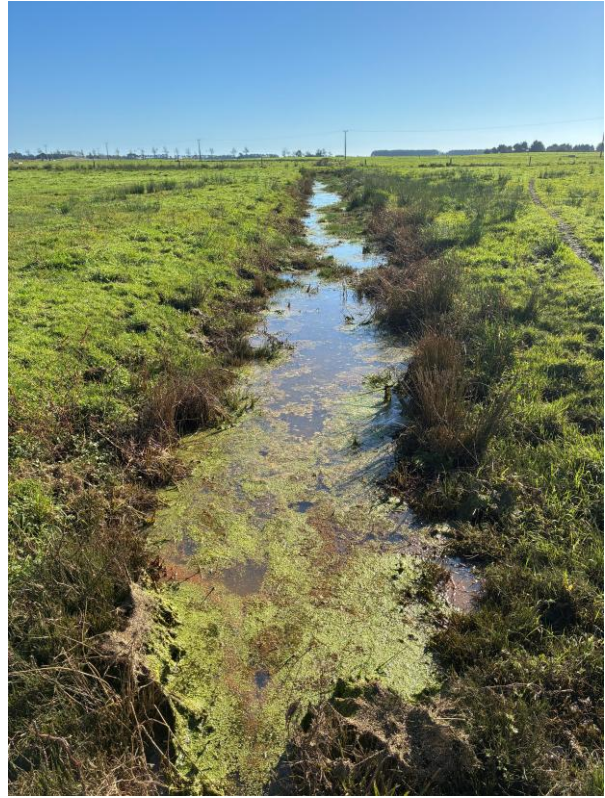
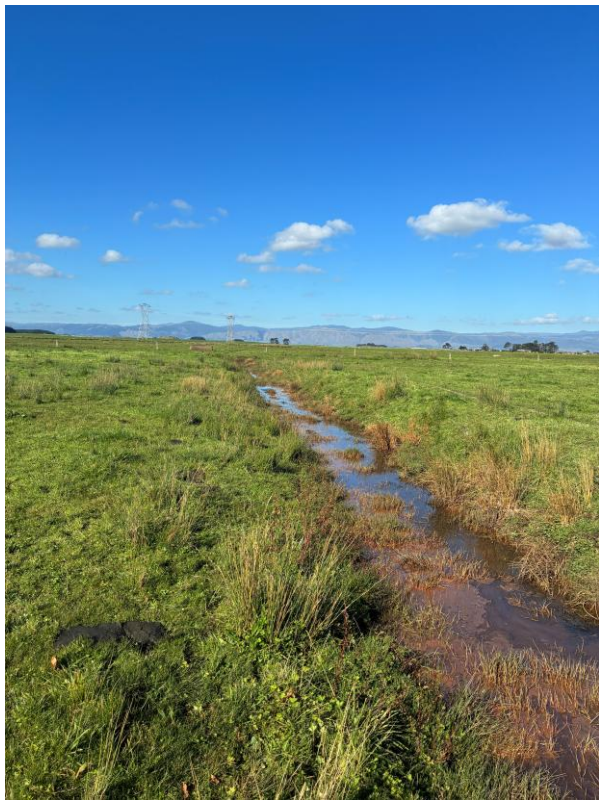
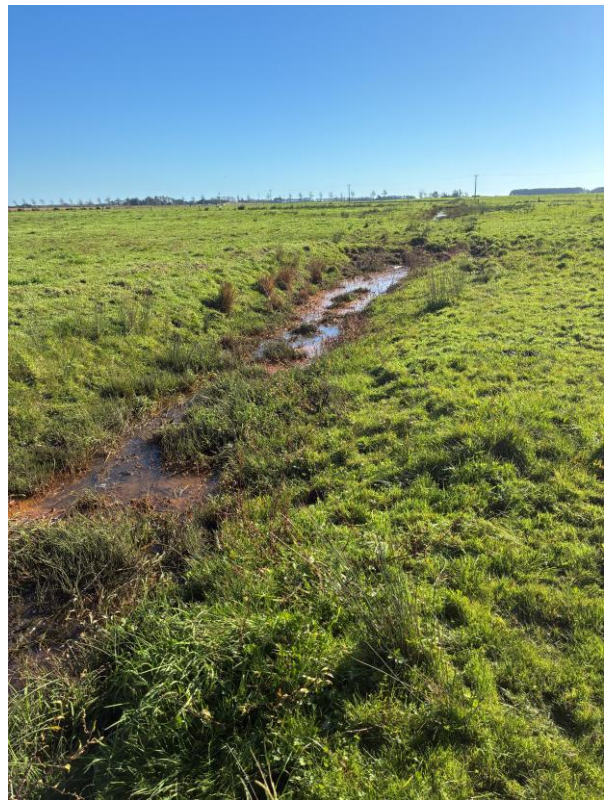
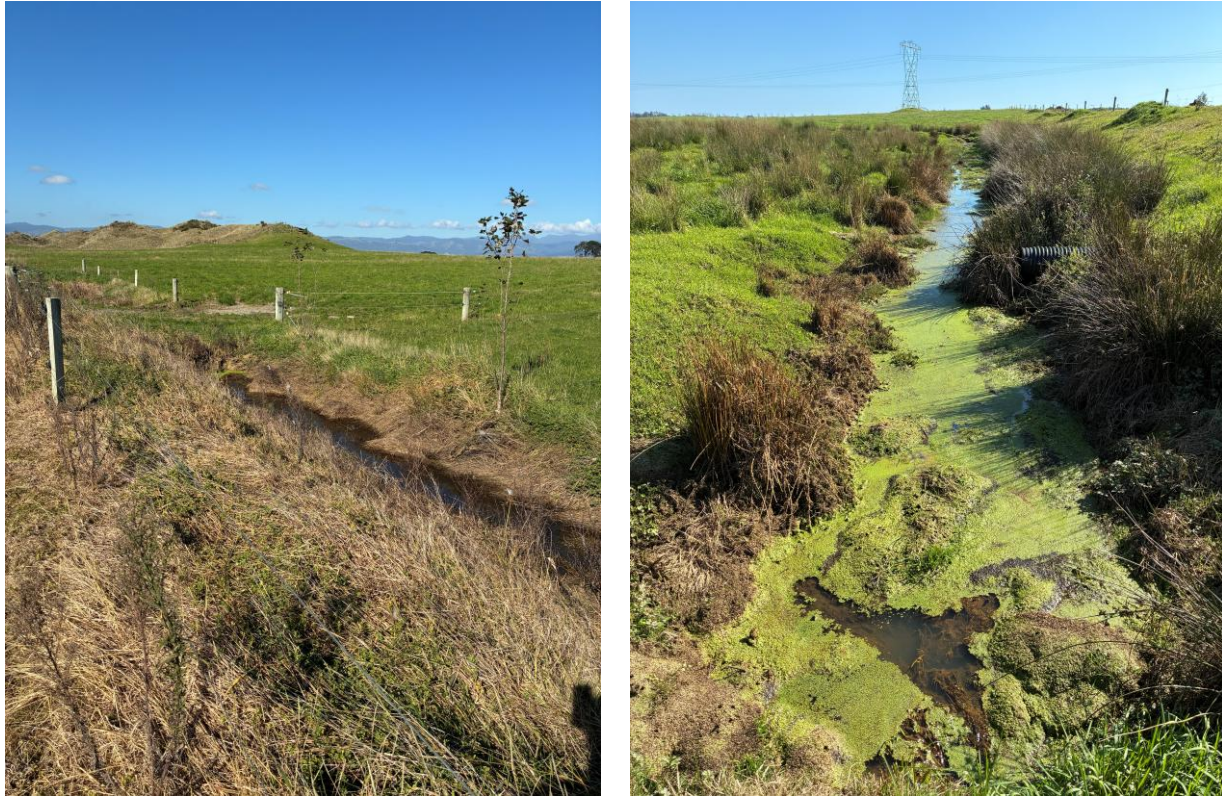
**Figure 5.** Photographs taken of the various smaller channels observed onsite

These watercourses all had straight mechanically formed channels, and similarly to those assessed above, likely convey water that would originally have been part of a wetland hydrological system. This is corroborated by the wetland vegetation observed within and adjacent to many of the channels, and knowledge of potential historical site characteristics.

The channels show some variance in size; several of the larger channels were flowing at the time of assessment and were similar in character to the three primary waterways assessed above. A number of the smaller channels had little flow, with wetland vegetation rooted in the bed.

| Classification criteria | Criterion present in the watercourse? (yes/no) |
|---|---|
| Does the waterway convey water from natural sources, such as springs, snow melt, or a natural rainwater catchment? | Likely – the channels ranged from having small upstream rainwater catchments to effectively no upstream catchment. Groundwater connections are probable given that these channels are likely at least partially replacing historical wetland extent. |
| Does the watercourse mostly align with, or does it replace, a historical natural river, stream, or wetland? | Yes – this criterion is difficult to assess given limitations in historic knowledge at the site scale. While these channels have been constructed and may not be replacing historic streams of similar size, they do likely replace a historic wetland hydrological system. |
| Is the bed of the watercourse made from natural materials, with evidence of substrate sorting processes? | Lack of evidence – the channels are highly modified with a straightened form. The streambeds are dominated by soft substrates, which do not exhibit substrate sorting processes as clearly as coarser, hard-bottomed streams. |
| Does the watercourse meander? | No – the channels have all been mechanically straightened. |
| Does the watercourse host riverine (and/or wetland) ecosystems? | Yes – wetland vegetation was observed within many of the channels, with aquatic macrophytes present in the channels sustaining more flow. Some of the watercourses would provide suitable habitat for fauna such as tuna and kōura. Freshwater fish and macroinvertebrates are likely to utilise these habitats. |
| <b>Waterway classification status</b> | <b>Natural - modified</b> |
