Geotechnical Assessment Report

Waikato Thoroughbred Racing Greenfield Racing Hub

**Referral Application - REV 5
17 April 2026**

23-1883 Waikato Thoroughbred Racing – Greenfield Racing Hub

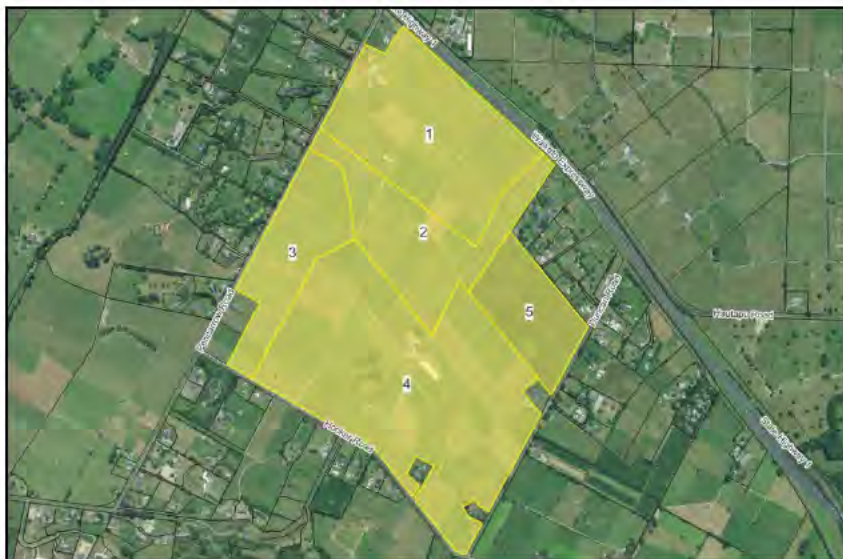
Figure 1: Aerial view of site and surrounding area

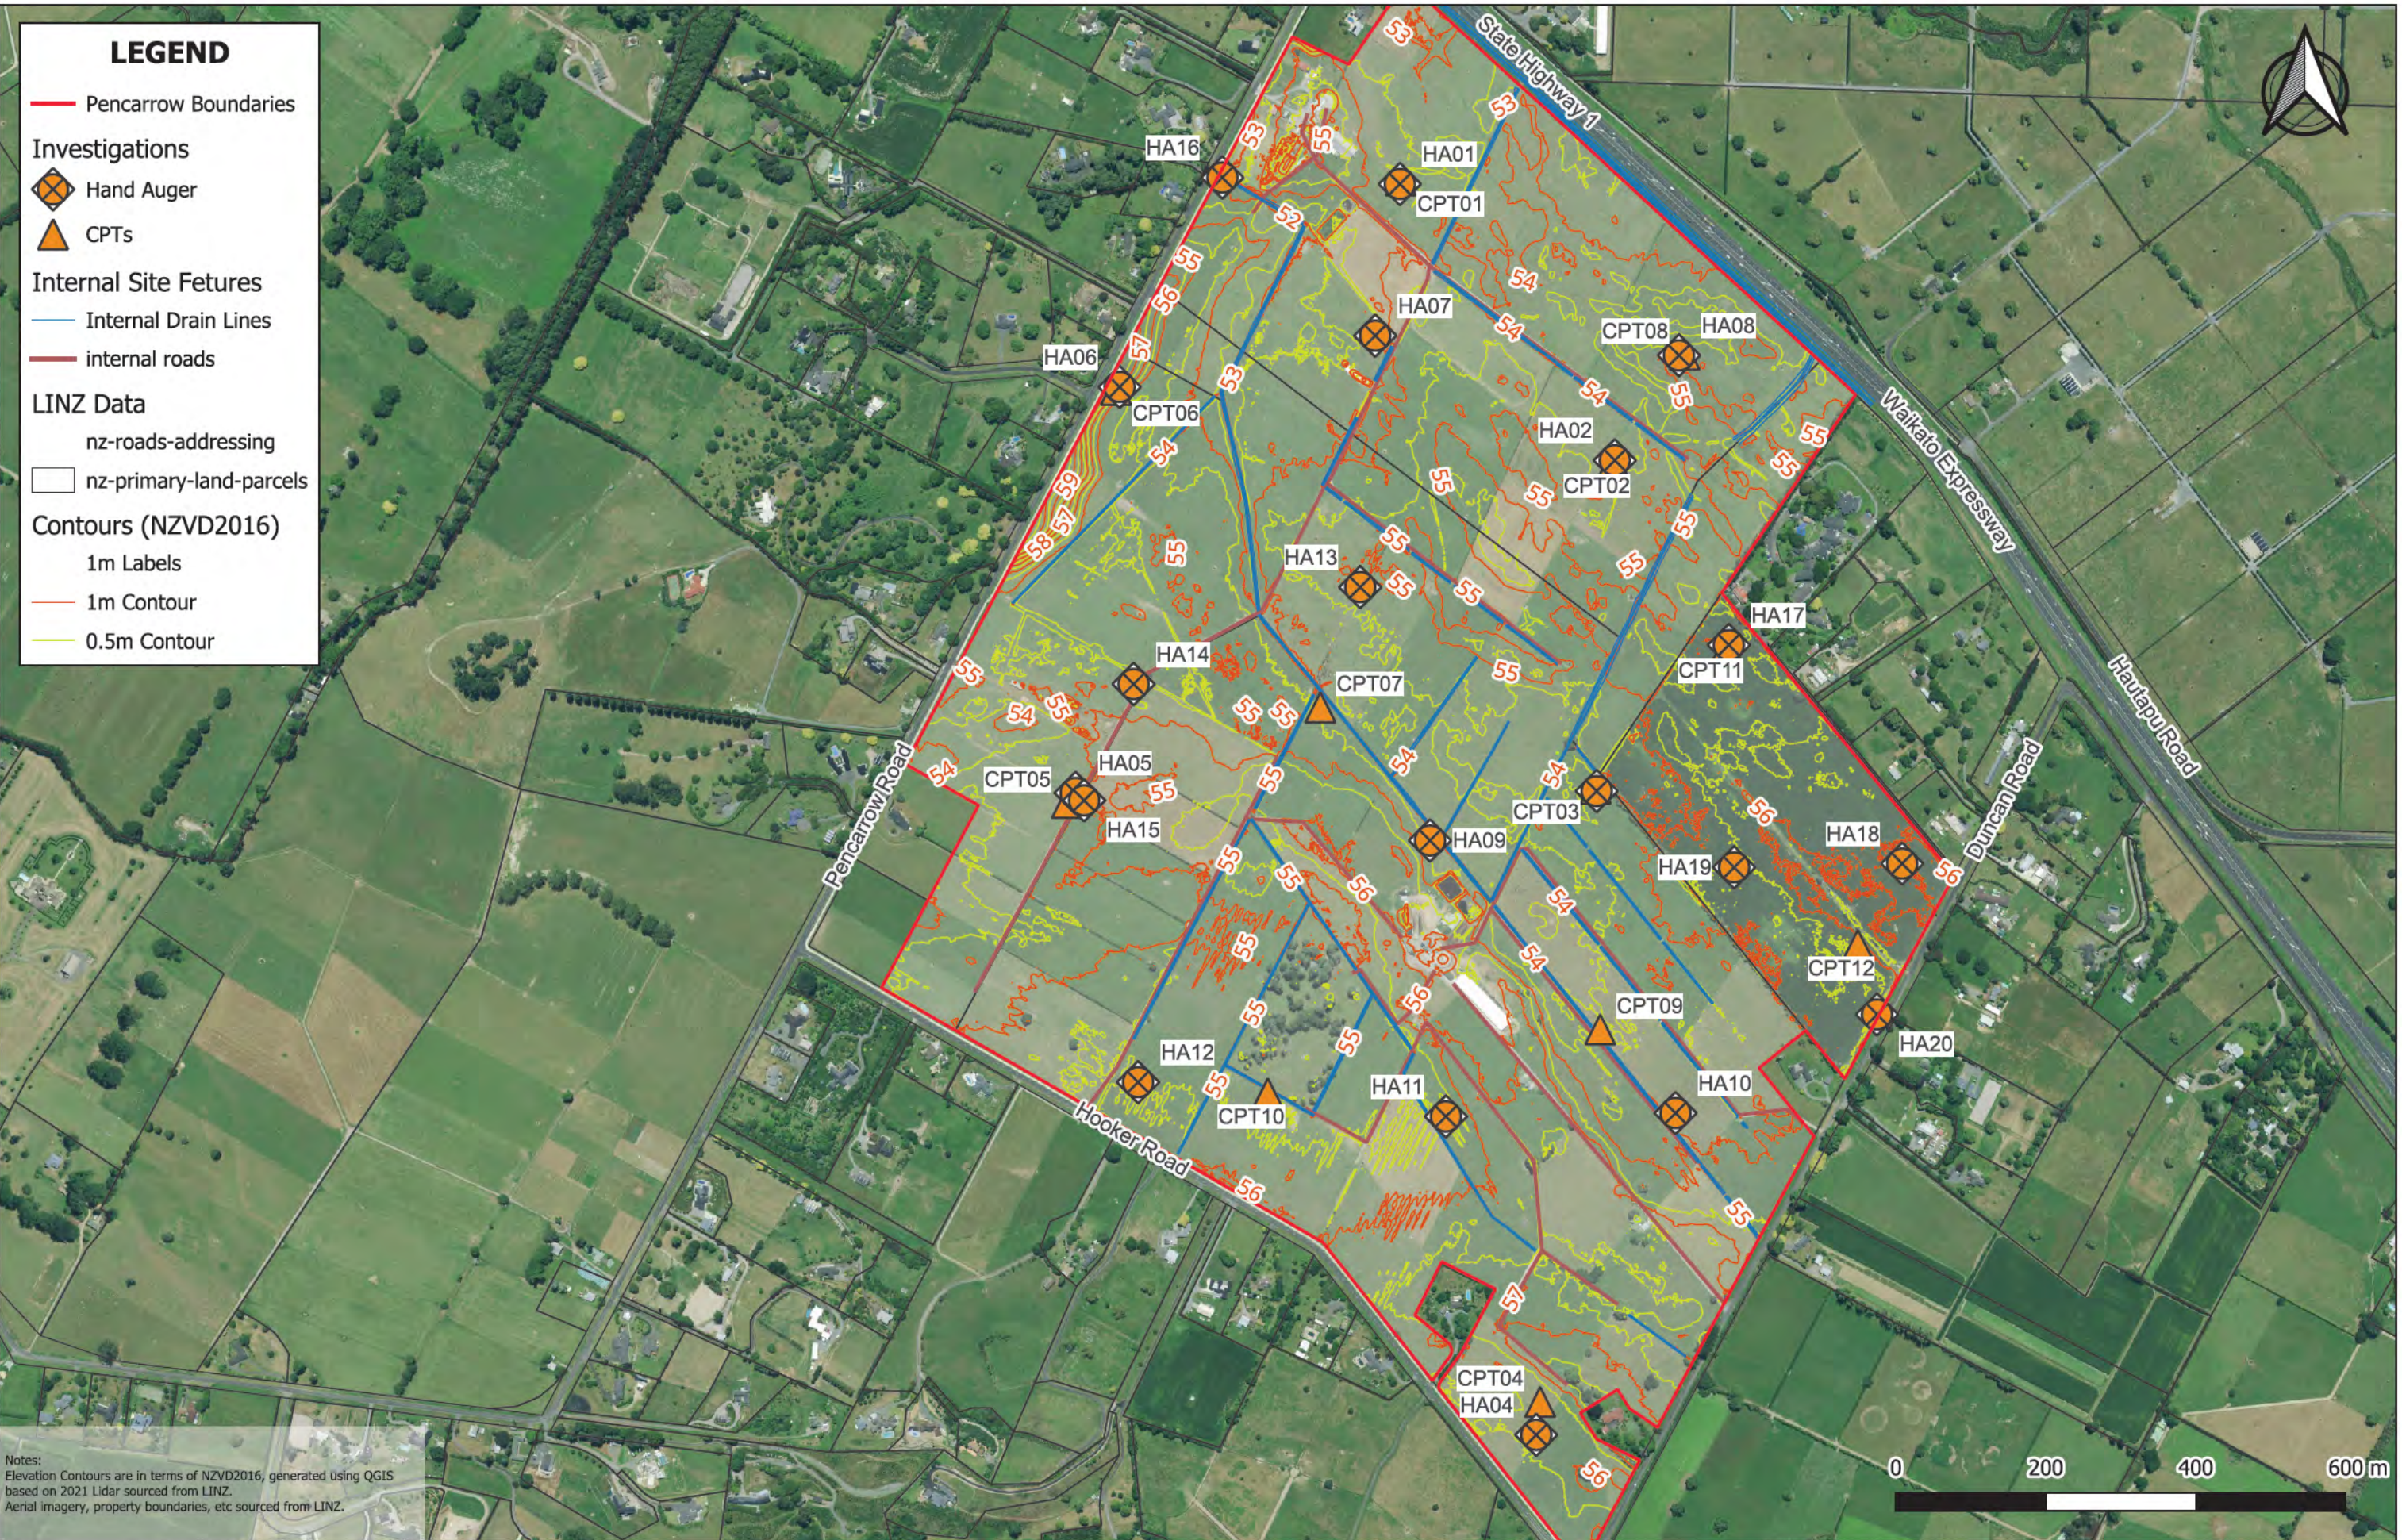
Drawn: BB	SCALE: 1:8000	At: A3
Engineer: BB		
Job Number: 23-1883	Sheet Number: C-01	Revision: 04

Notes:
 Elevation Contours are in terms of NZVD2016, generated using QGIS based on 2021 Lidar sourced from LINZ.
 Aerial imagery, property boundaries, etc sourced from LINZ.

The following investigations were undertaken by BCD to evaluate the subsurface conditions at the site on 10-14/11/2025. Investigation data can be found in Appendix C. CPT data have not been attached and may be made available on request.
