# SOUTHERN LINKS 1: RESIDENTIAL DEVELOPMENT – PRELIMINARY SITE INVESTIGATION

Prepared by Swiftsure Consultants Ltd

30 August 2026

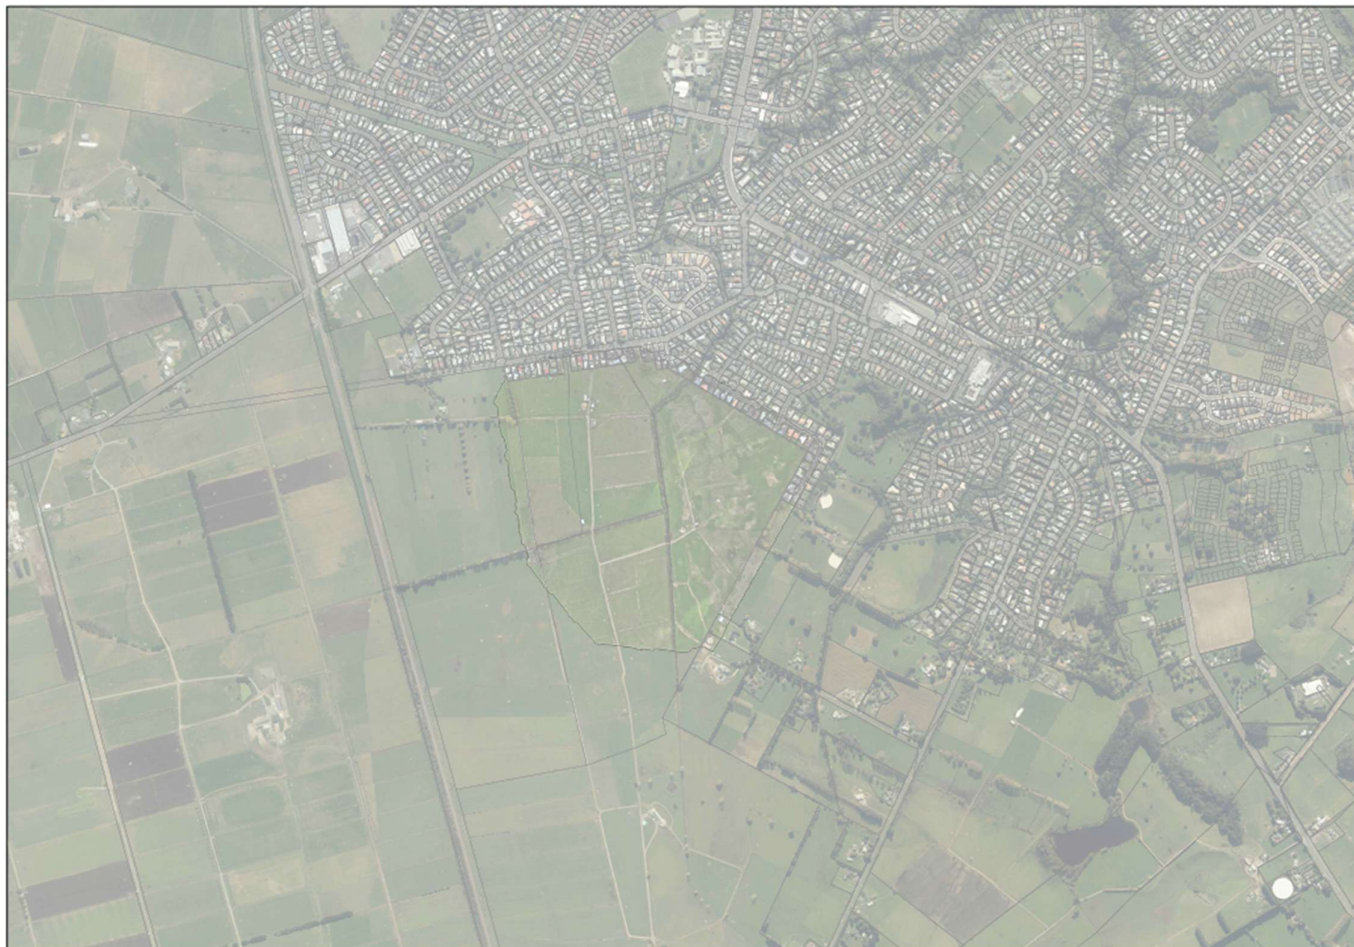
**Figure 2: Aerial images of the SL1 Residential Block**

The site is located at Saxbys Road, Deanwell, Hamilton. The site is approximately 46 hectares in area. The site location is shown in **Figure 1** and an aerial image of the site is shown in **Figure 2**. The area of proposed development is topographically flat across the site with no elevation changes included on the WDC online mapping layer.

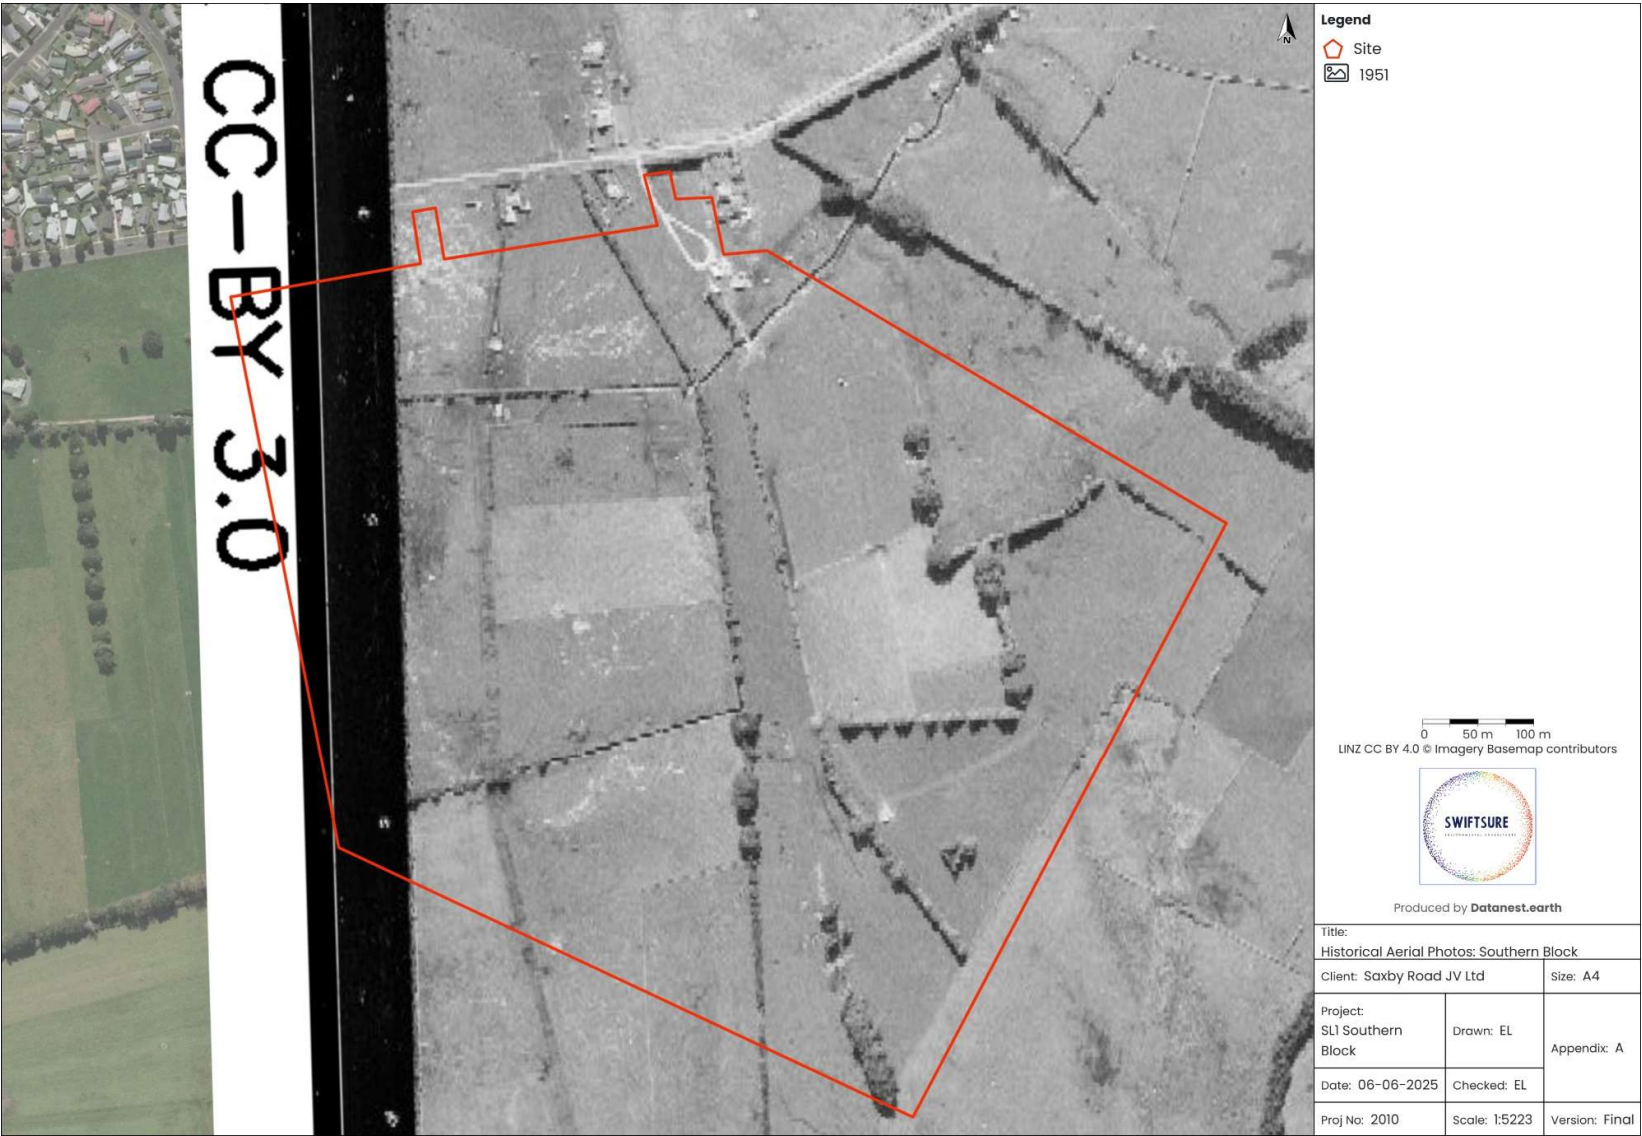
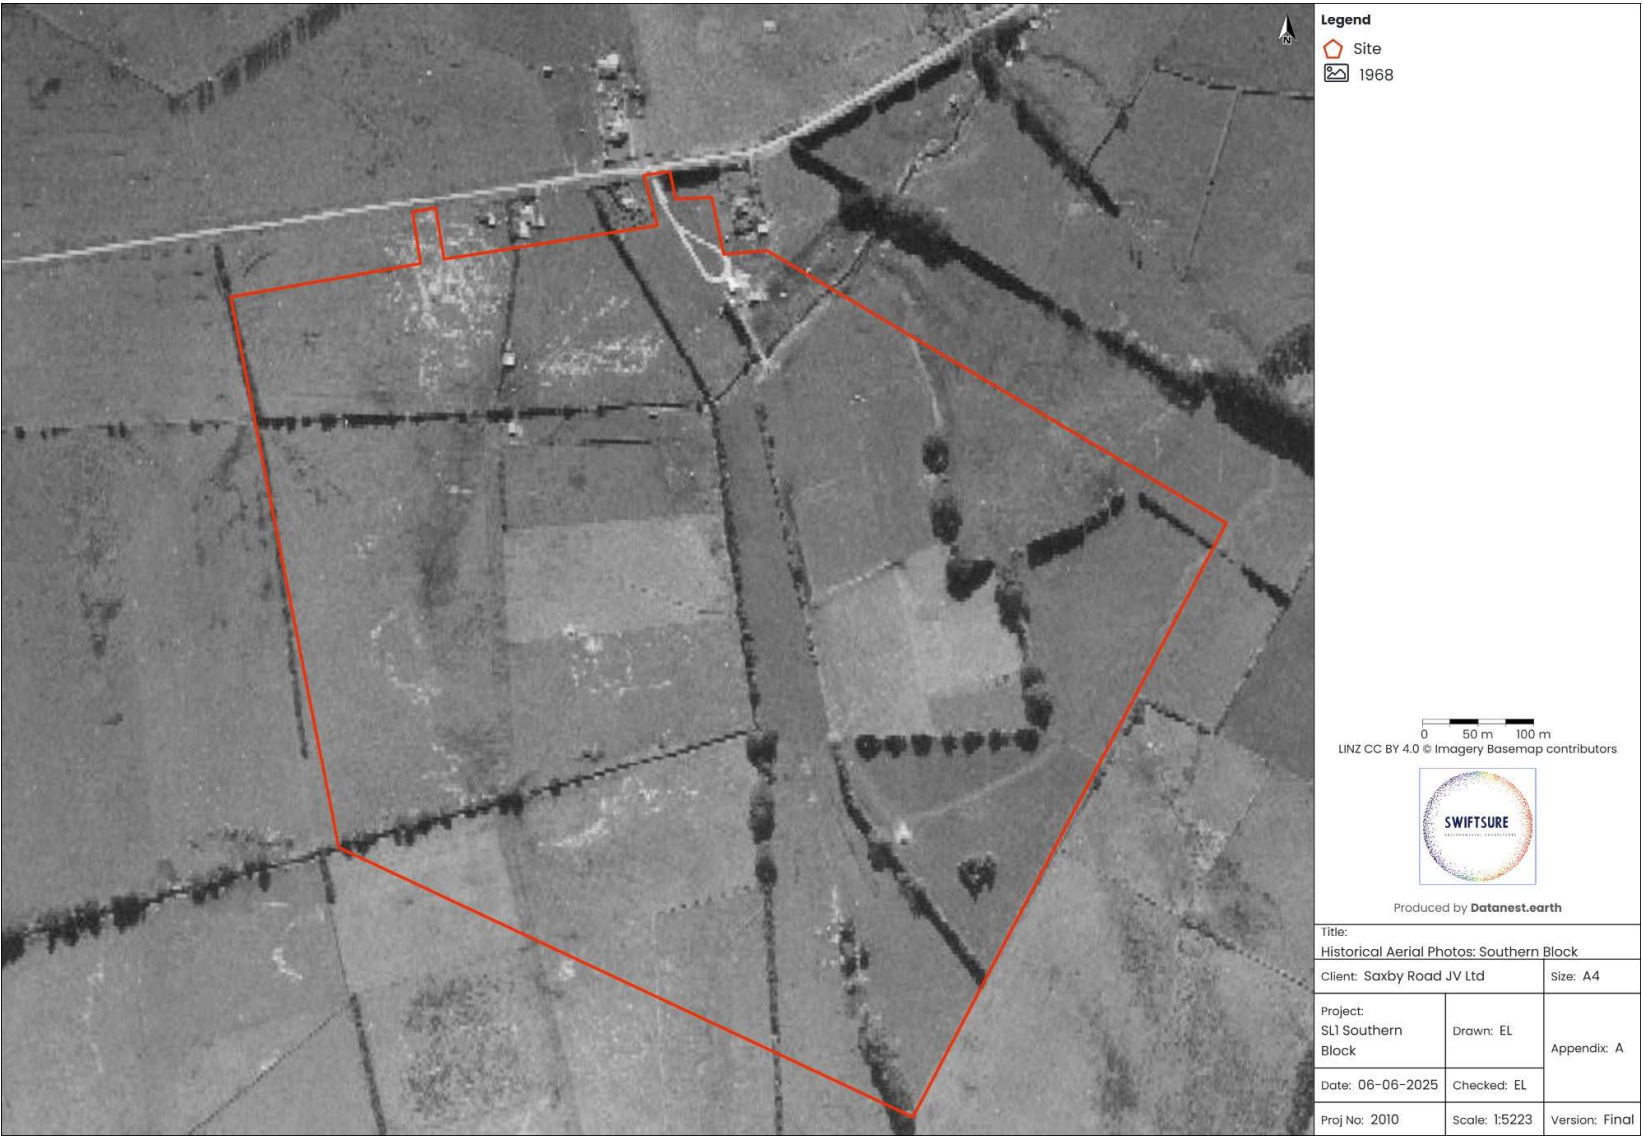
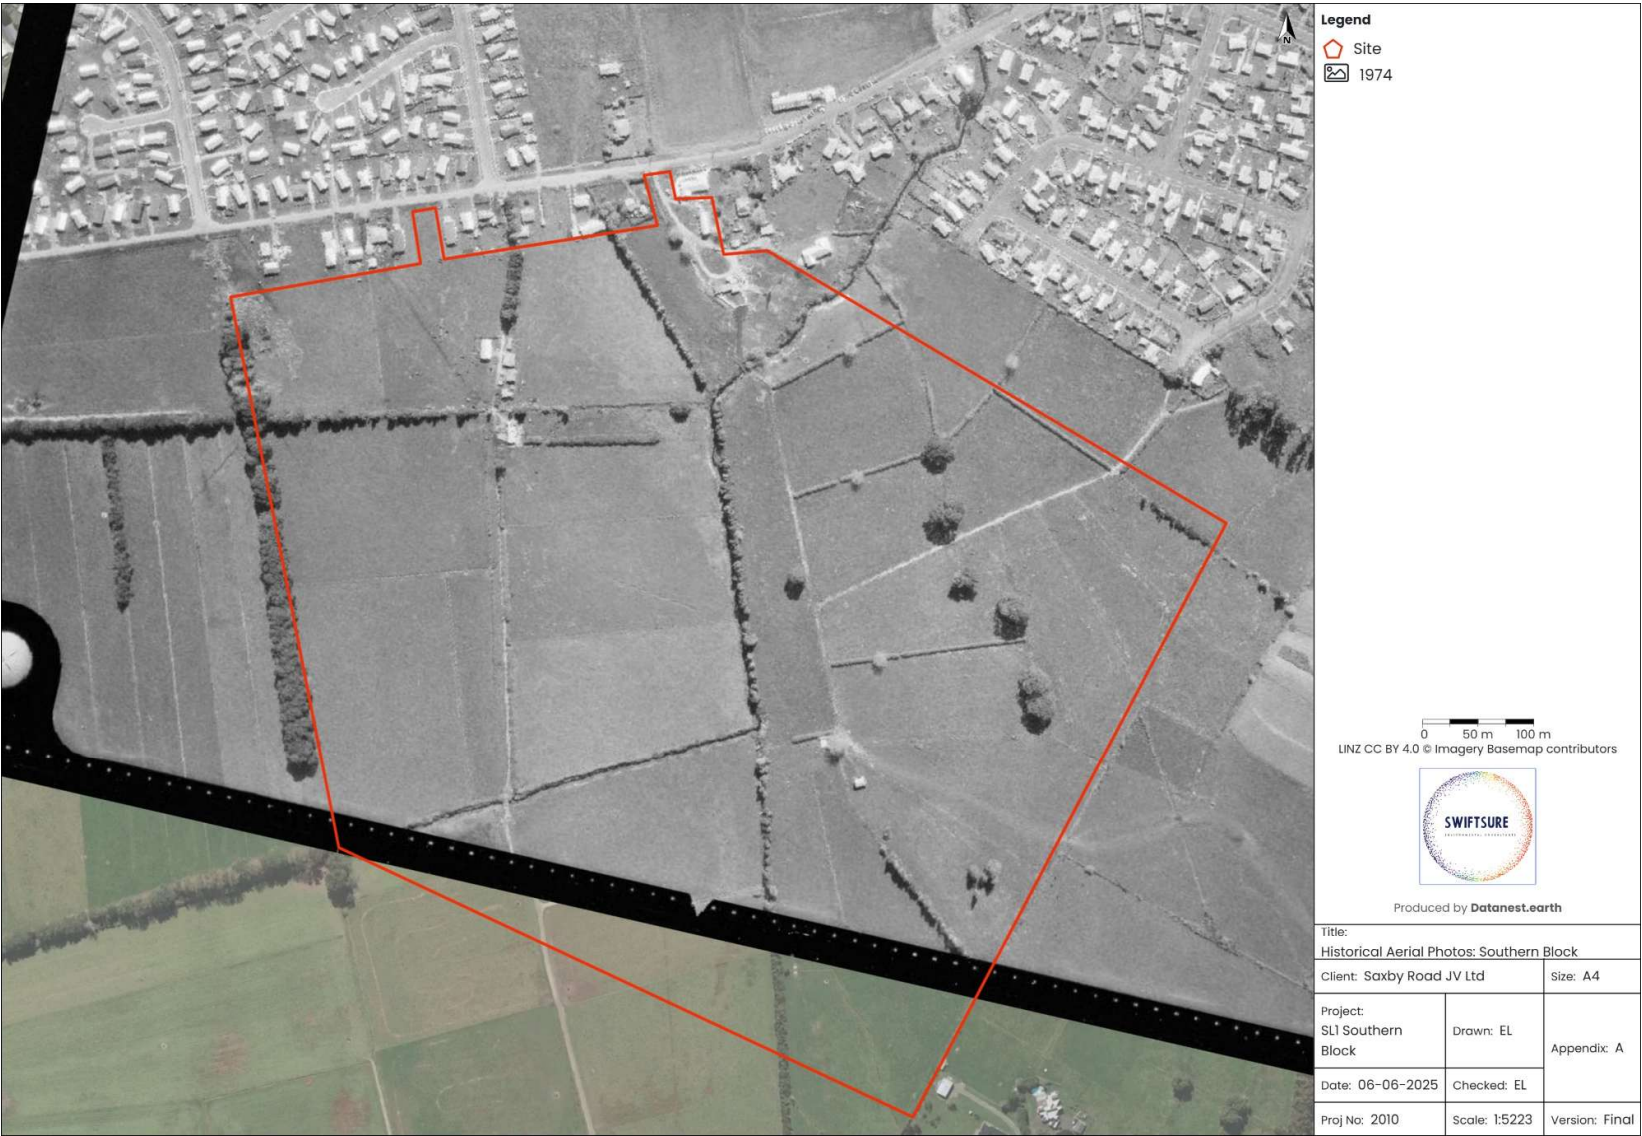
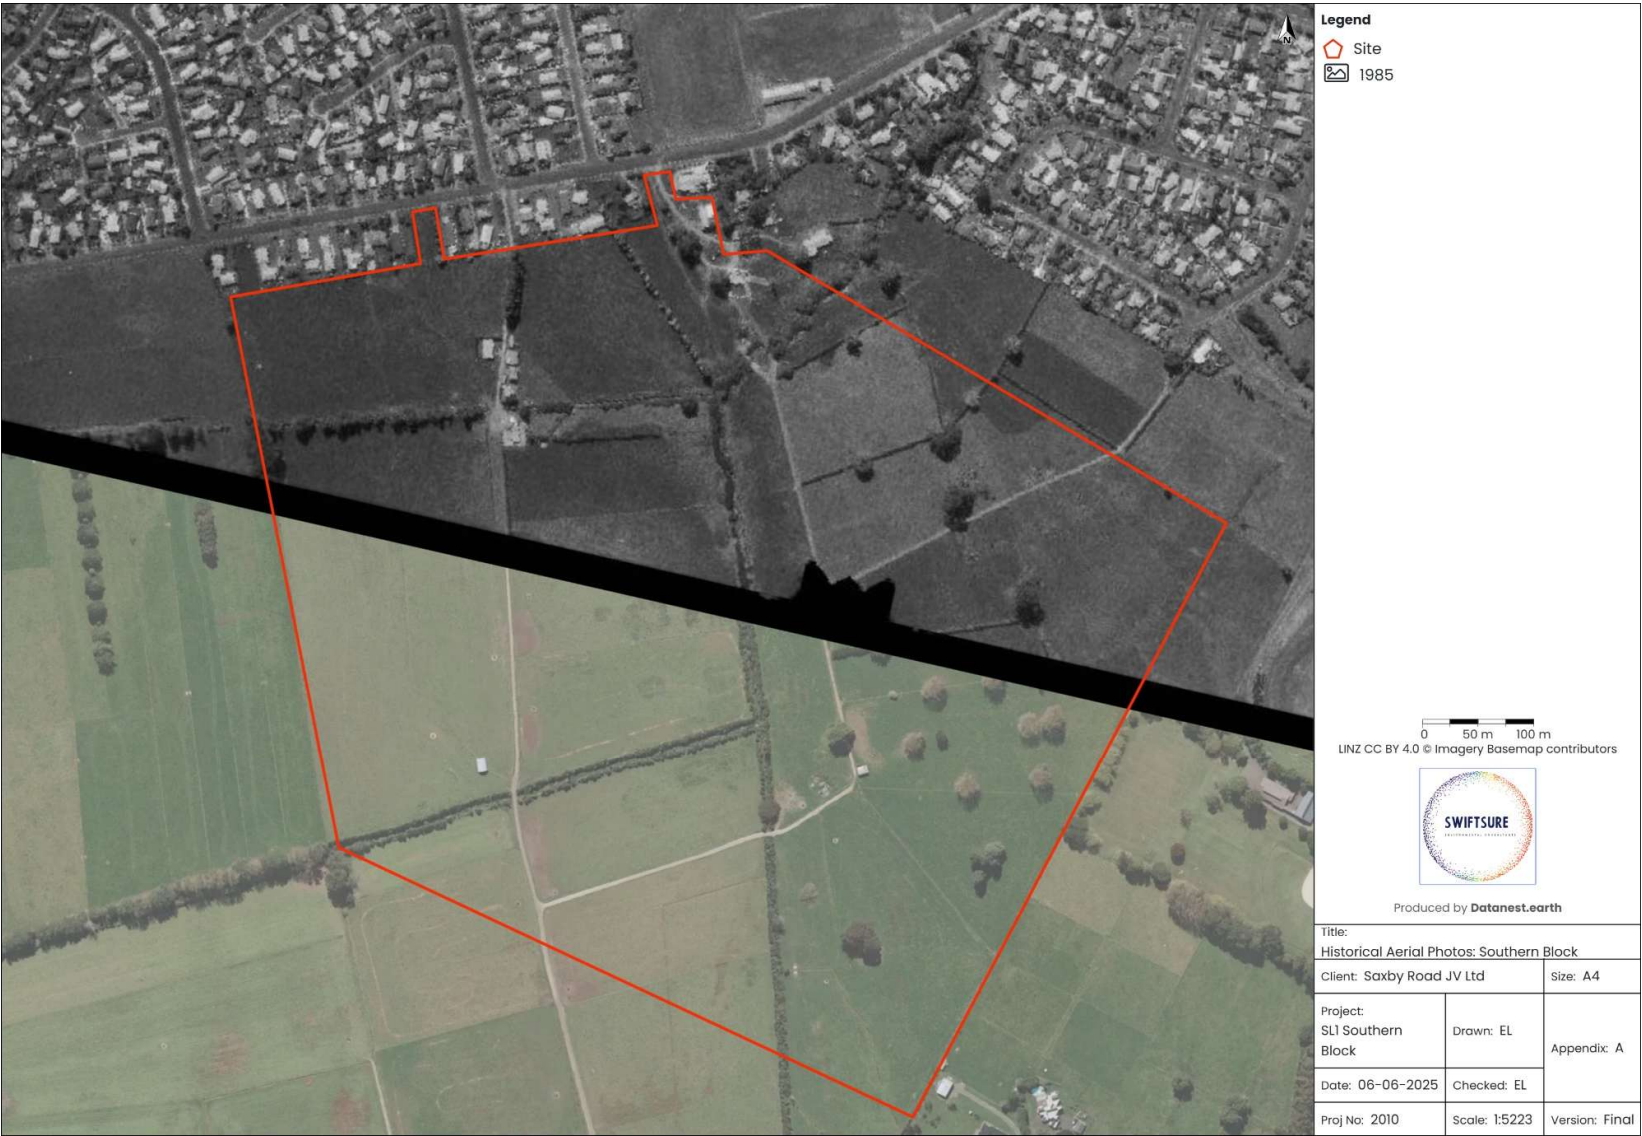
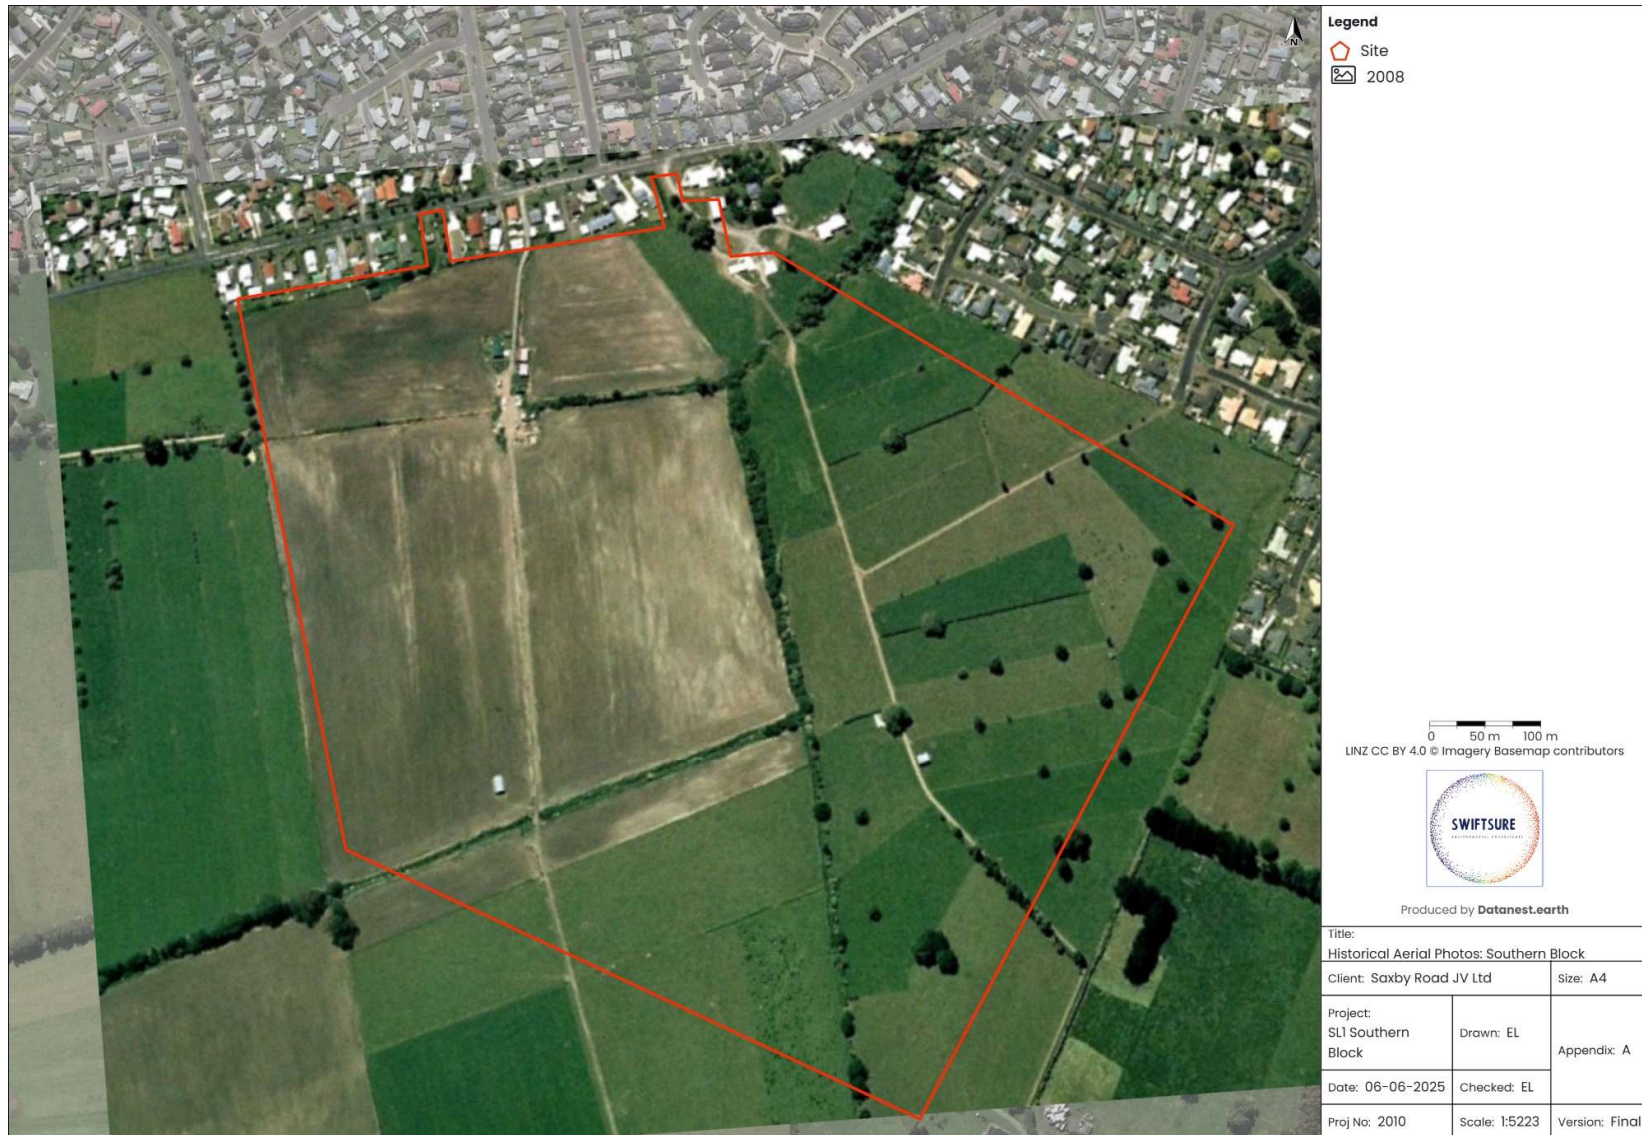
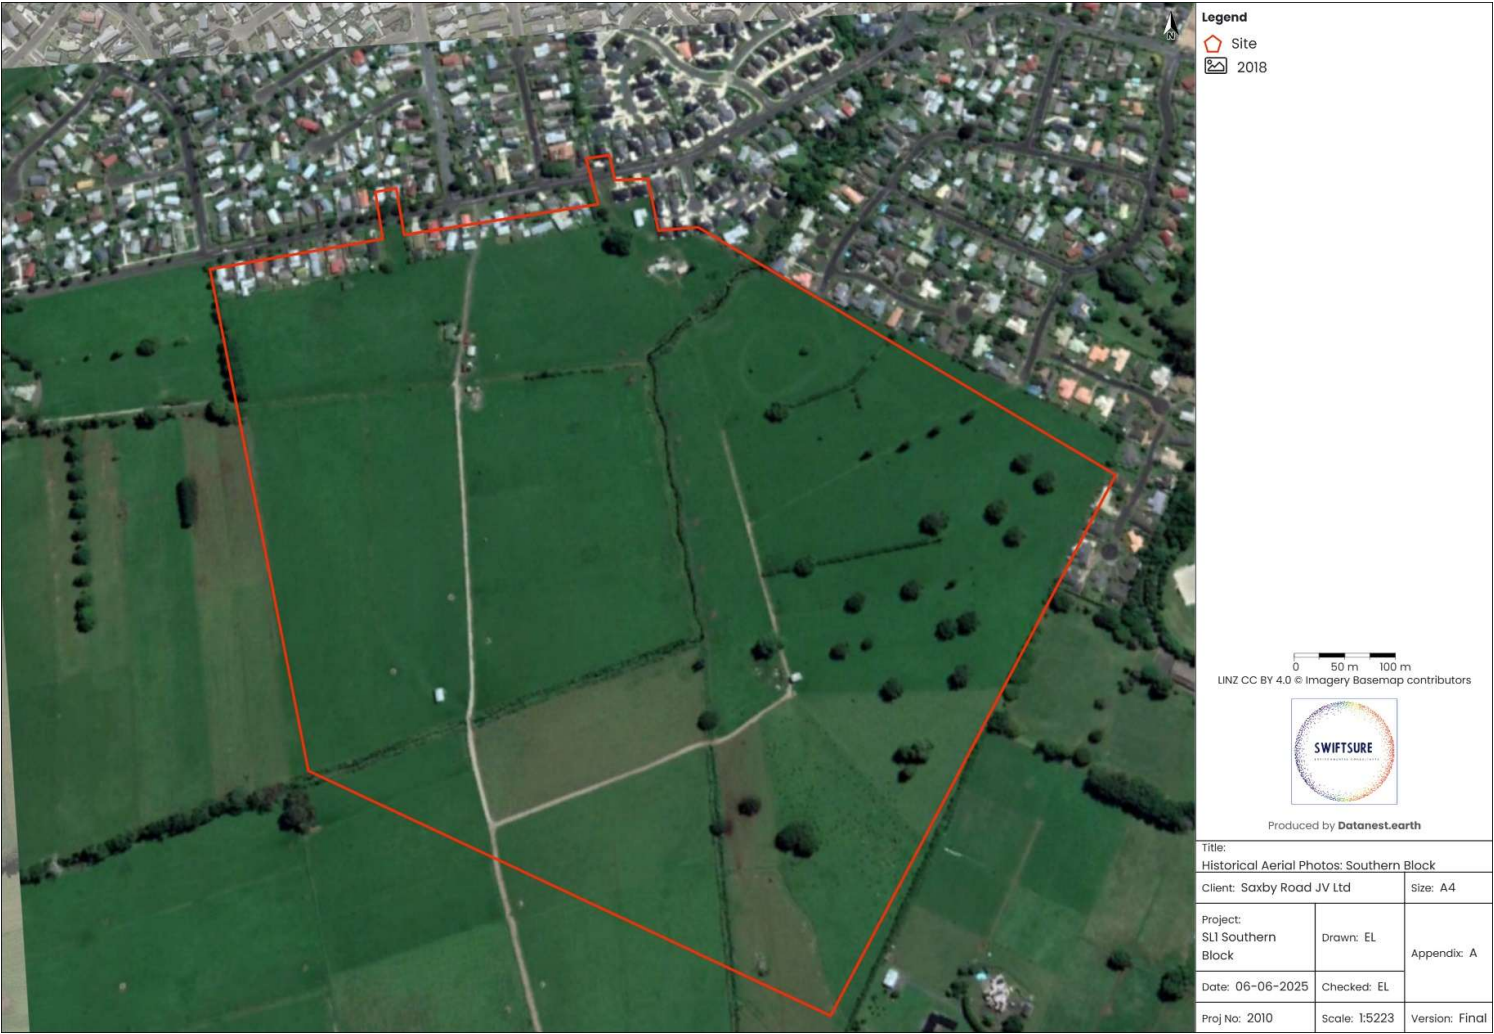
## **APPENDIX A:** Historical Aerial Photographs

| Year | Key Information |
|---|---|
| 1951 | The site is undeveloped pasture/farmland. A turning circle/driveway is evident at the north of the site which exits onto Saxbys Road. The image quality is poor but there looks to be a cluster of dwellings adjacent to the turning driveway. There are also scattered structures located to the north-west of the site and the south of the site. It is unknown what these structures are but are likely farm sheds looking at the size/shape. |
| 1974 | Four structures (possibly three houses and one out building/shed) are present along the accessway from the road (now 47 Saxbys Road). Current day observations correlate with these being residential dwellings. Residential development has begun in the peripheral to the turning circle off Saxbys Road. Earthworks are noted south of the turning circle within the site. Farm races are more evident. |
| 1985 | The image only covers the northern half of the site. The main observations can be made around the dwellings off 47 Saxbys Road. The southern most structure has been extended (which correlates to today's observations of there being a dairy shed). No distinguishable change for the remainder of the area. |
| 2008 | The western half of the site has been recently grazed/wet as pasture is poor. A half round shed is noted towards the north-west of the site. One of the dwellings at 47 Saxbys Road has been removed/demolished. There are now three houses. Various miscellaneous items are stored in the vicinity to the dwellings of 47 Saxbys Road. |

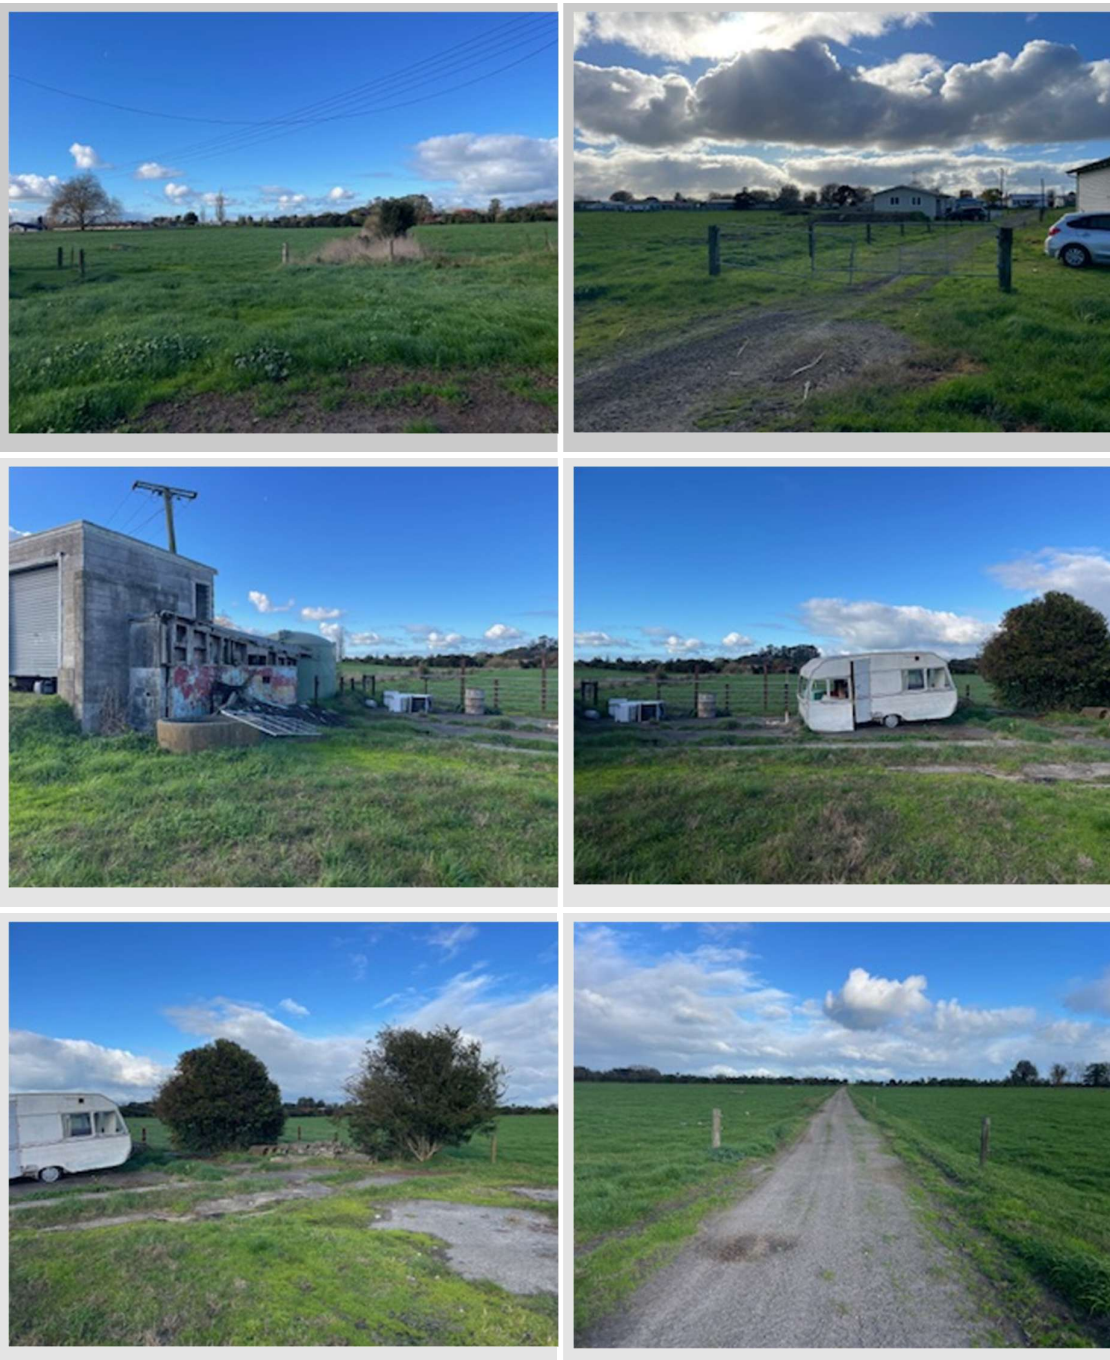
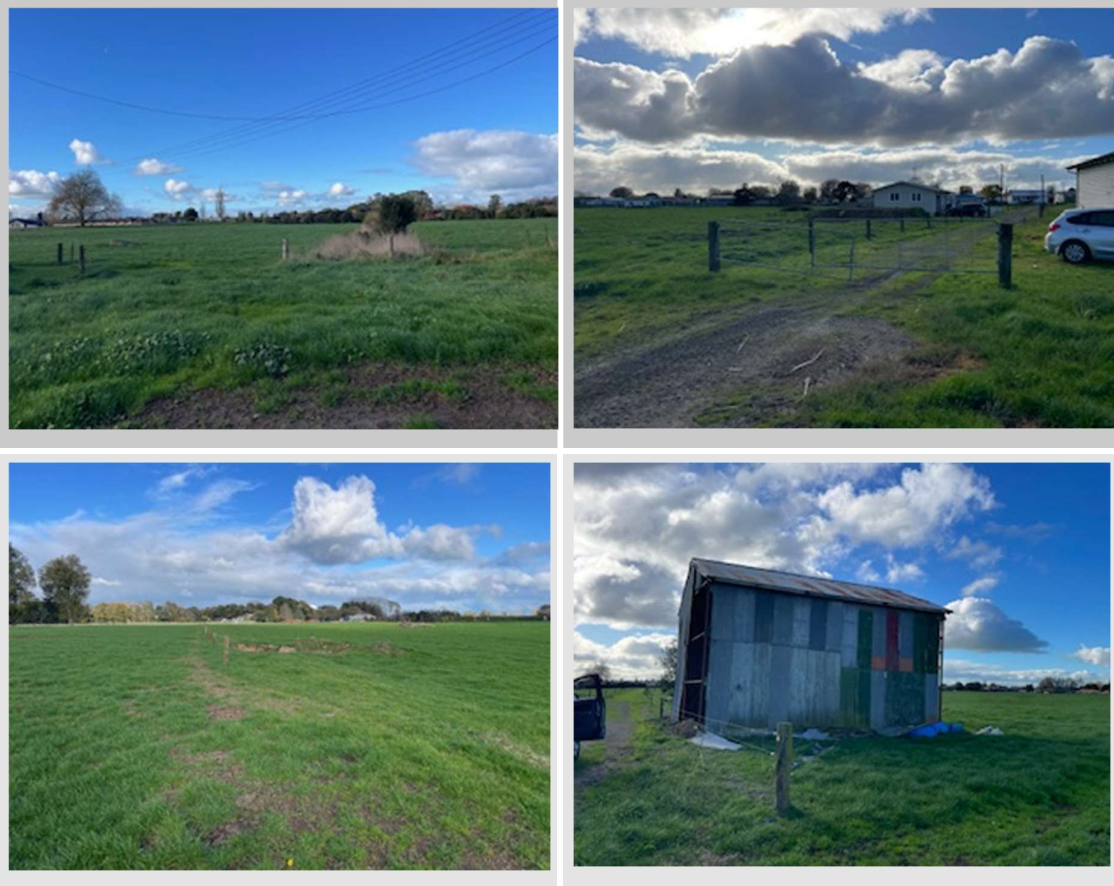
## **APPENDIX B:** Site Photographs

The site is located within a predominantly rural and agricultural setting and is currently in use as a dairy farm. The land comprises mostly pasture and farm races and remains largely undeveloped.

The Mangaotukutuku Stream runs through the centre of the site in a north–south direction. Several farm drains are distributed across the property, feeding into the stream.

In the northern portion of the site, there are three dwellings along with various farm outbuildings supporting the farm's operations. This area also contains the remains of a former milking shed and a disused water tank. The milking shed was constructed of suspected ACMs (asbestos containing material). A range of miscellaneous items are present, including cement pipes, an old caravan, empty drums, electrical appliances, and farm gates.

Additional farm structures are scattered throughout the site, including half-round iron sheds and iron-clad sheds in varying states of disrepair, many of which appear disused or redundant.

A variety of miscellaneous materials—including a disused caravan, household whiteware, a rainwater tank, concrete piping, and gallon drums—are stored in close proximity to a disused milking shed. The shed is assessed to have been constructed with materials suspected of containing asbestos (ACMs) and is currently in a visibly derelict state. Structural degradation of the shed increases the likelihood of ACM weathering, which may have led to the release and subsequent deposition of asbestos fibres into the adjacent soil profile.

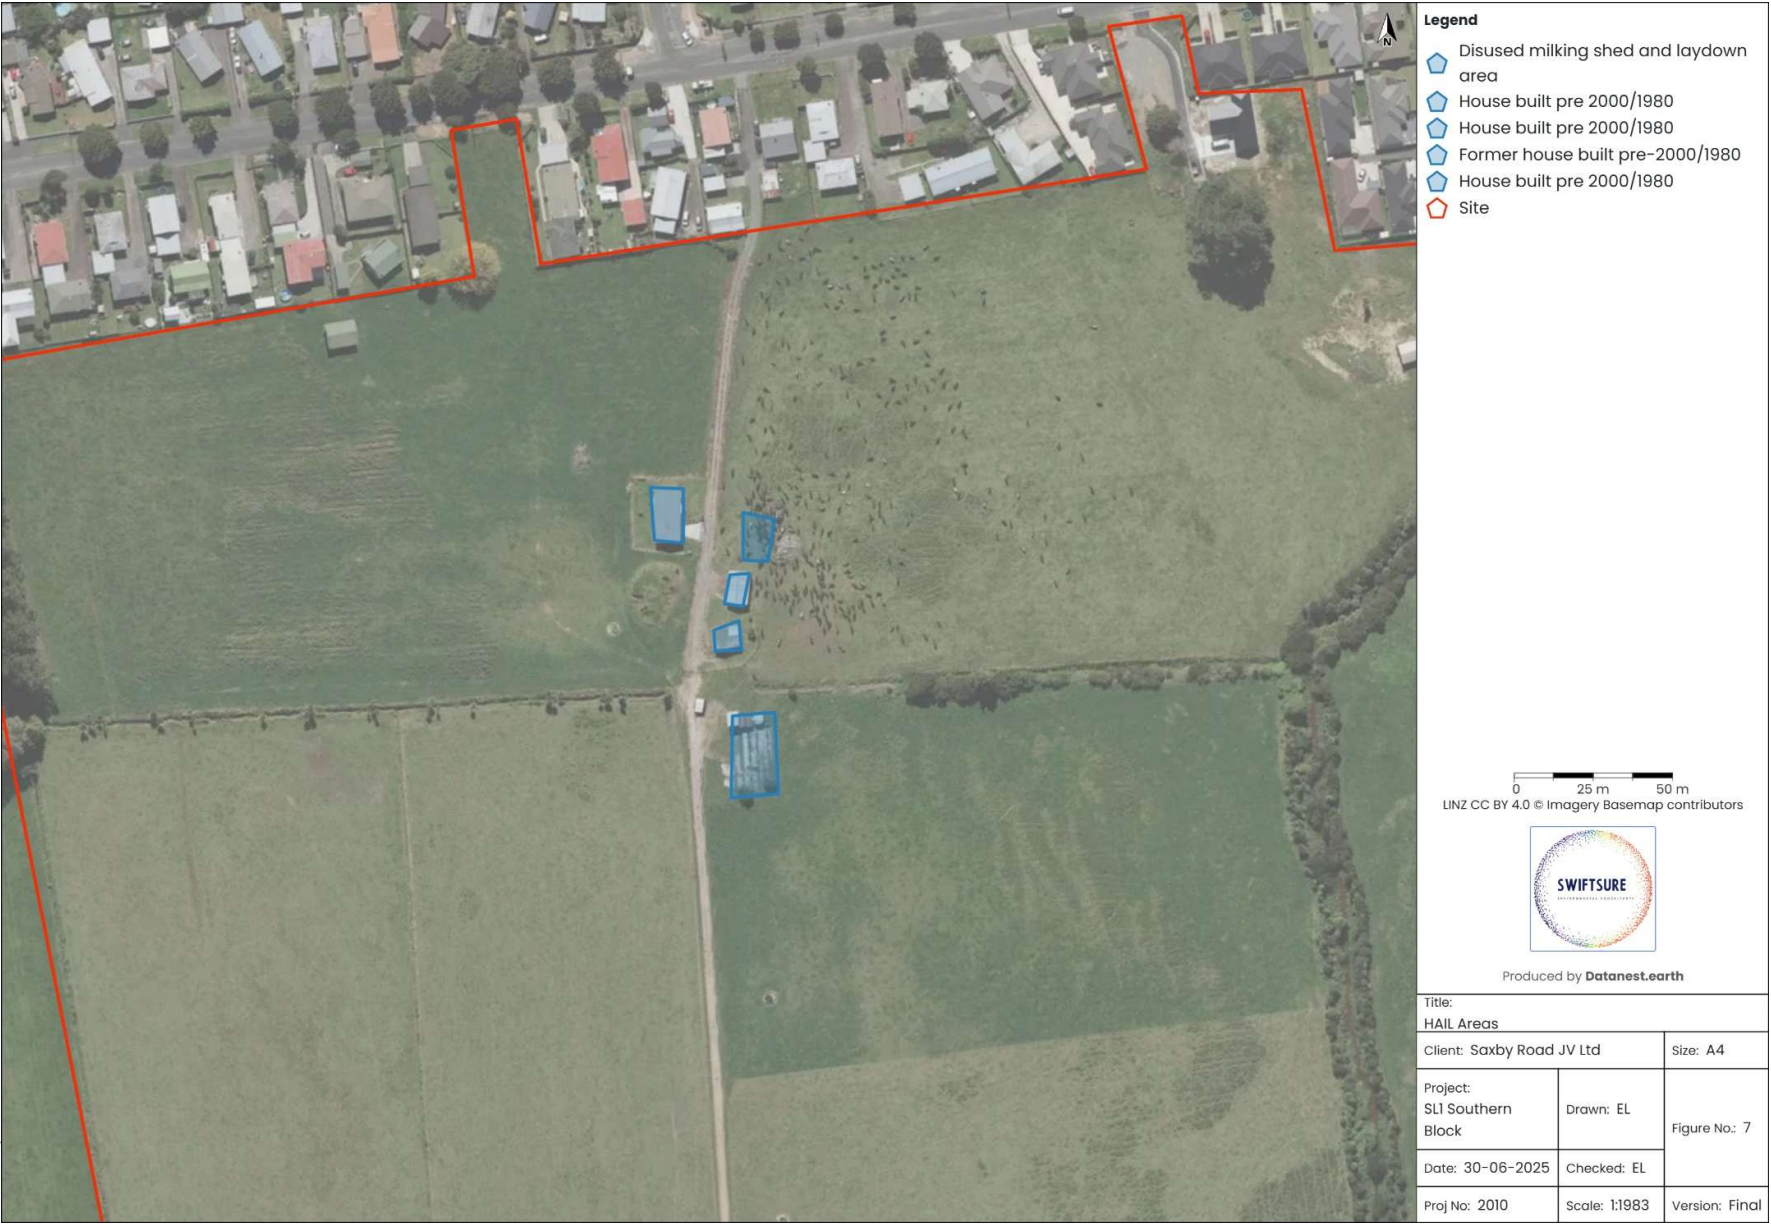
## **APPENDIX C:** HAIL Areas

Based on the information review and limited soil sampling, the conceptual site model is shown in **Table 3**. Included are the HAIL codes considered to apply on a 'more likely than not' basis. **Appendix C** shows the areas of the site where the HAIL code applies.

The following HAIL<sup>6</sup> activities (please refer to **Table 3** and **Appendix C** for further detail) have been identified for this site on a more likely than not basis:

- **E1** - Asbestos products manufacture or disposal including sites with buildings containing asbestos products known to be in a deteriorated condition (current and former structures).
- **I**- any other land that has been subject to the intentional or accidental release of a hazardous substance in sufficient quantity that it could be a risk to human health or the environment.
