Proposed Residential Subdivision

Milldale, Wainui East

# **FAST TRACK APPLICATION: SPECIALIST COMMENTS RESPONSE ADDENDUM**

Fulton Hogan Land Development Limited

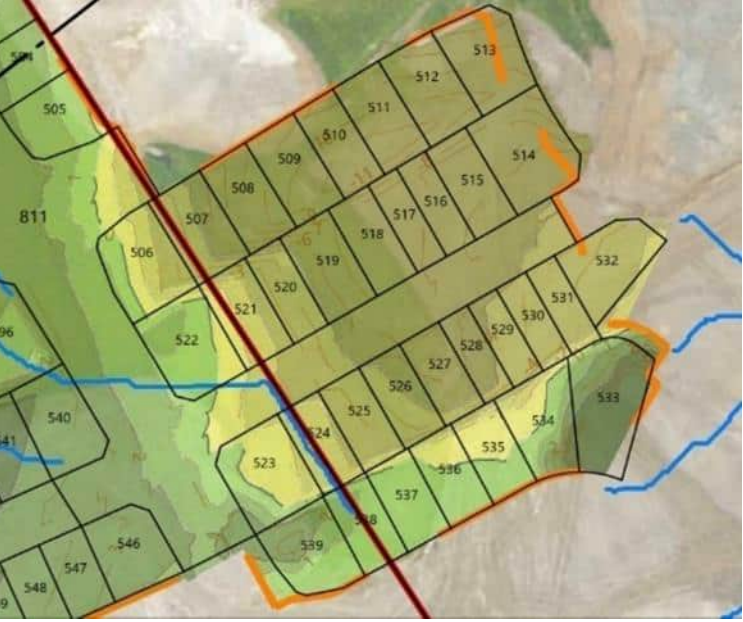
<p>Extract of settlement monitoring plan from Geotech report – notice the difference in contours</p>

Item #	Auckland Council Comments	Final Comment to Auckland Council in Response to Item
20.1	<ul style="list-style-type: none"> <li>• Time to achieve estimated t90 settlement not stated, though this is partially addressed in the settlement memo where it stated previous stages observed time to t90 around 9 months to 1 year. We suggest that this be confirmed to aid in managing and controlling the effects of earthworks causing subsidence/instability onsite and ensure safe building platforms are achieved before 224(c) is issued following objectives and policies under E38 subdivision. We are agreeable that a settlement monitoring plan is required.</li> <li>• Note that the earthworks plan relied upon for the settlement monitoring plan in the Geotechnical Report does not align with the plan supplied by Milldale (drawings : P24-128-00-1202-EW and P24-128-00-1203-EW), a finalised settlement monitoring plan should be submitted.</li> </ul>	<ul style="list-style-type: none"> <li>• The timing between earthworks and civil works and therefore 224c typically exceeds 12 months at Milldale. We note earthworks are typically carried out across numerous stages, in most cases 1-2 years prior to civil works being undertaken. Settlement monitoring plans target critical areas (i.e. soft natural ground and deepest fills), and we generally observe the majority of settlement occurring prior to civil works commencing.  Timeframes are based on previous monitoring observed over the last 7 years of the development – we believe that settlement data provides a much better estimate of timeframes than site investigation estimates (i.e. based on correlations in CPTs etc).</li> <li>• The Settlement Monitoring Plans have been updated and are at <b>Appendix A</b>. (AKL2024-0257 DG21-22, Rev 1, 8/07/2025, shown below).</li> </ul>

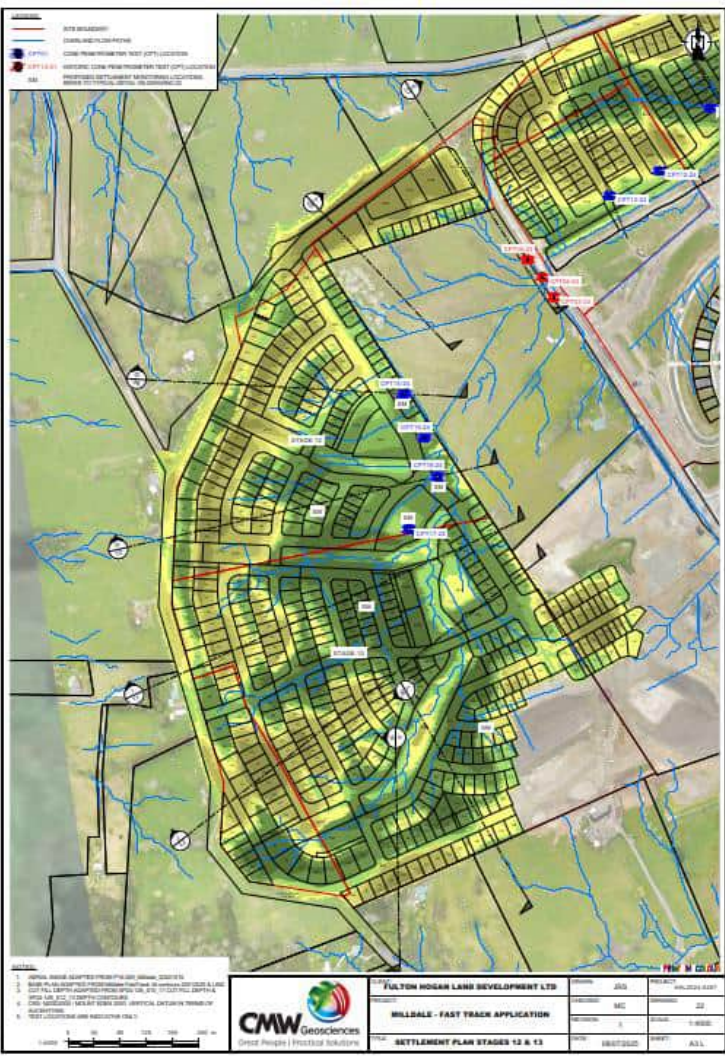
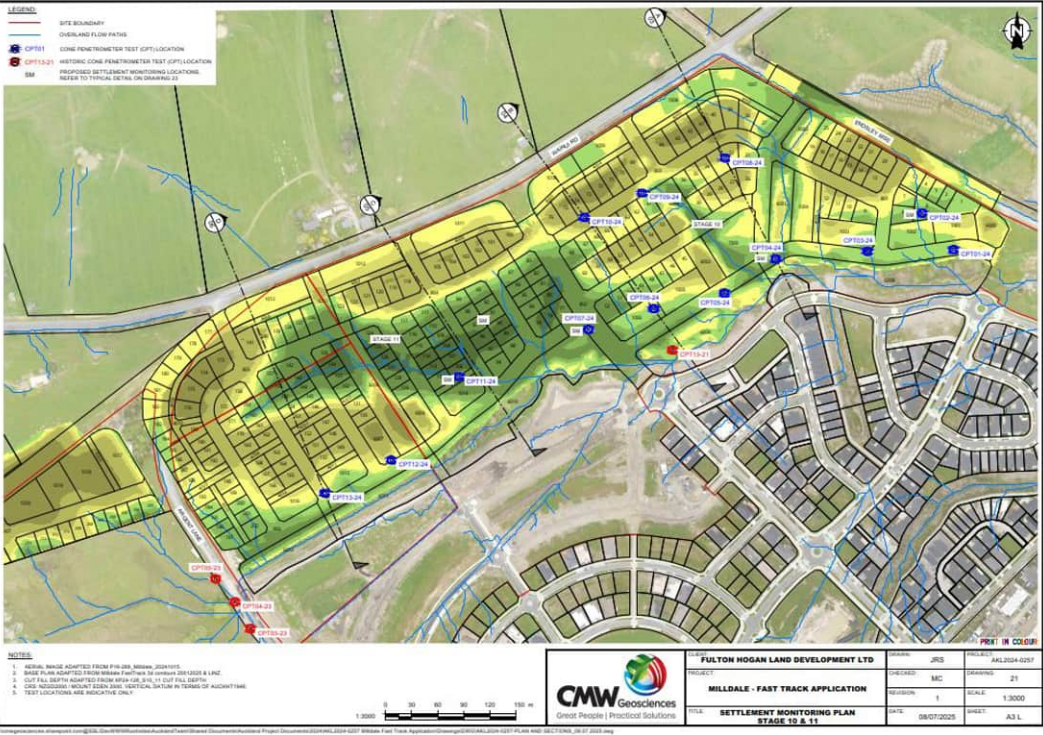
<p>Extract from Engineering drawings showing the cut fill layout (P24-128-00-1203)</p></div>	<div>

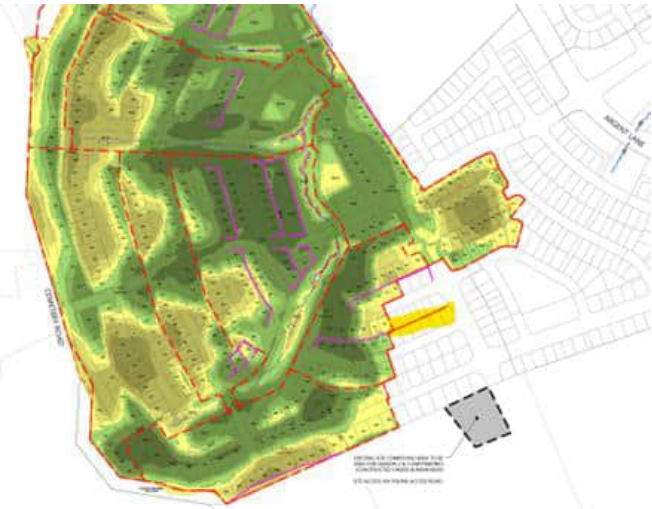
Item #	Auckland Council Comments	Final Comment to Auckland Council in Response to Item
20.3	<p>There are cut works proposed at the boundary of Stage 10-13, in which it does not seem to have commented on how the boundary stability will be achieved, this includes new retaining extending from Stage 13 connects to another retaining wall east of Stage 13 (Wall 22). This is necessary to assess against E12.6.2(2) and E12.8.2(1)(c). We suggest preliminary recommendations or methodologies be provided to manage the effects.</p>

<p>Typically at Milldale, earthworks / retaining walls are constructed beyond stage boundaries where practical to avoid temporary works situations and where construction makes sense. In the event this does not occur, the following typical measures have been used at Milldale to control temporary stability. We typically would note these as part of the building consent design report for walls.</p> <ul style="list-style-type: none"> <li>• Leaving cut retaining wall locations at an appropriate temporary batter angle (typically shallower than 1V:3H)</li> <li>• Overfilling in areas of future fill retaining walls, batters at 1V:3H</li> </ul>

20.19	No recommendations or preliminary construction methodology were provided for the proposed retaining wall.	<p>As in item 20.3 above, typically at Milldale, earthworks / retaining walls are constructed beyond stage boundaries where practical to avoid temporary works situations and where construction makes sense. In the event this does not occur, the following typical measures have been used at Milldale to control temporary stability. We typically would note these as part of the building consent design report for walls.</p> <ul style="list-style-type: none"> <li>• Leaving cut retaining walls at an appropriate temporary batter angle (typically shallower than 1V:3H)</li> <li>• Overfilling in areas of future fill retaining walls, batters at 1V:3H</li> </ul>

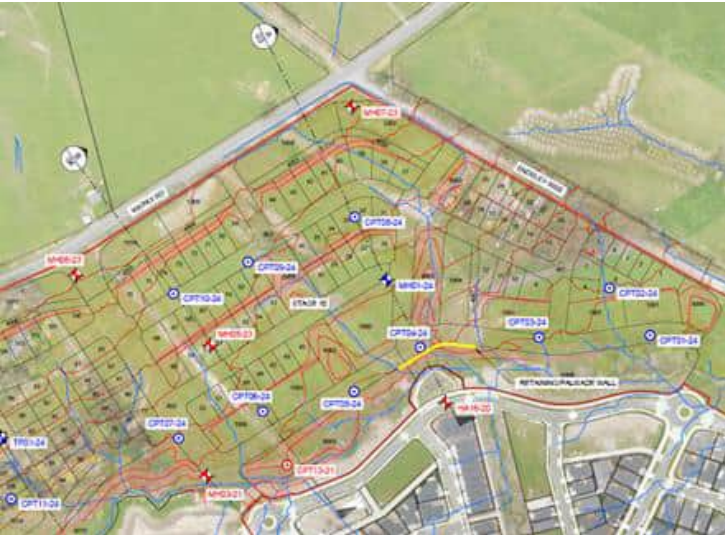
<p>Site plan from geotechnical report</p>	<p>The CMW Remediation Plan, Stage 10 &amp; 11 (DG 17) has been amended (ref. AKL2024-0257 DG17, Rev 1, shown below) so that the retaining wall shown is the same as that indicated on the Woods Retaining Wall Plan.</p> <p>The palisade wall location is based on the location of the retaining wall (culvert headwall) in Woods design, we have just noted that this retaining wall will require deeper piles due to global slope instability issues.</p> <p>Further discussion on this wall is in comment 20.5. The plan is included in <b>Appendix A</b>.</p>

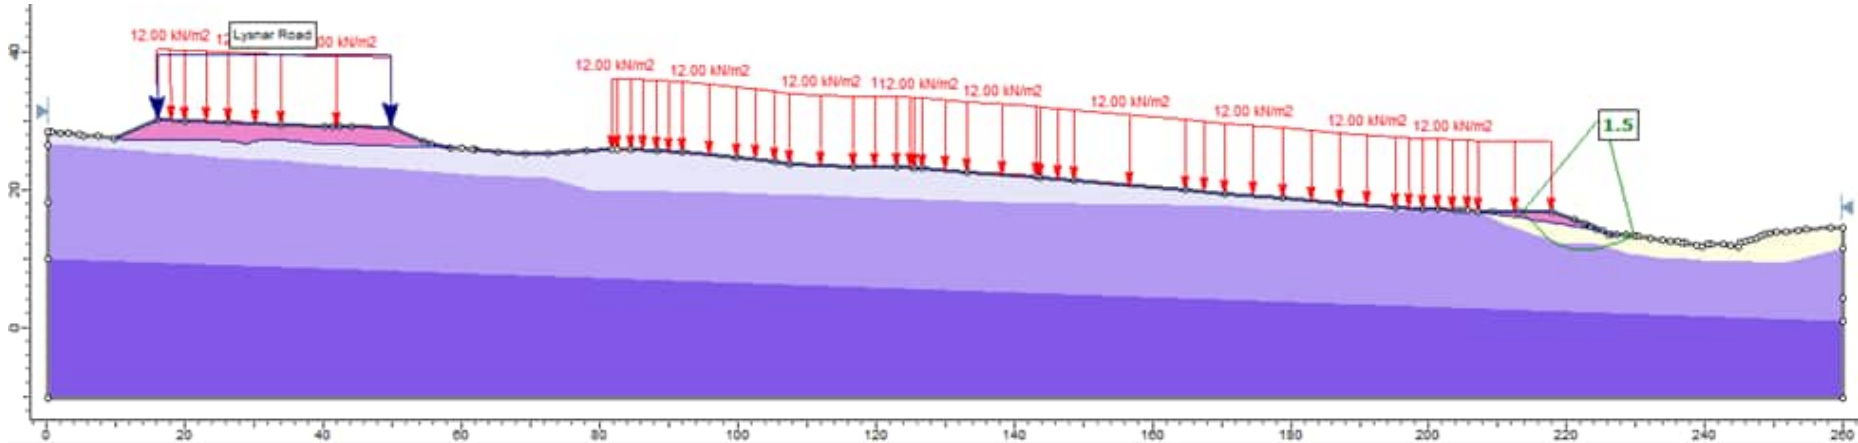
<p>SHEET 1202-EW</p> <p>PROPOSED TEMPORARY TOPSOIL STOCKPILE AREA</p>	<ul style="list-style-type: none"> <li>We have provided additional stability cross sections across the stream near the eastern end of the site to demonstrate approximate extents of the palisade action required beneath the culvert headwall shown on the Woods drawings. (XS M &amp; XS N, locations shown below). Stability analyses of these new sections indicates that palisade action is not required at these locations to achieve the required global stability factors of safety. Further site specific investigation and design will be undertaken to inform the design of the proposed culvert headwall (marked in yellow below), including the extents of the required palisade component. Stability outputs for these sections are below and in <b>Appendix C</b>.</li> </ul> <p><b>Cross Section M: - Proposed Slope, Transient Elevated Groundwater Condition:</b></p>

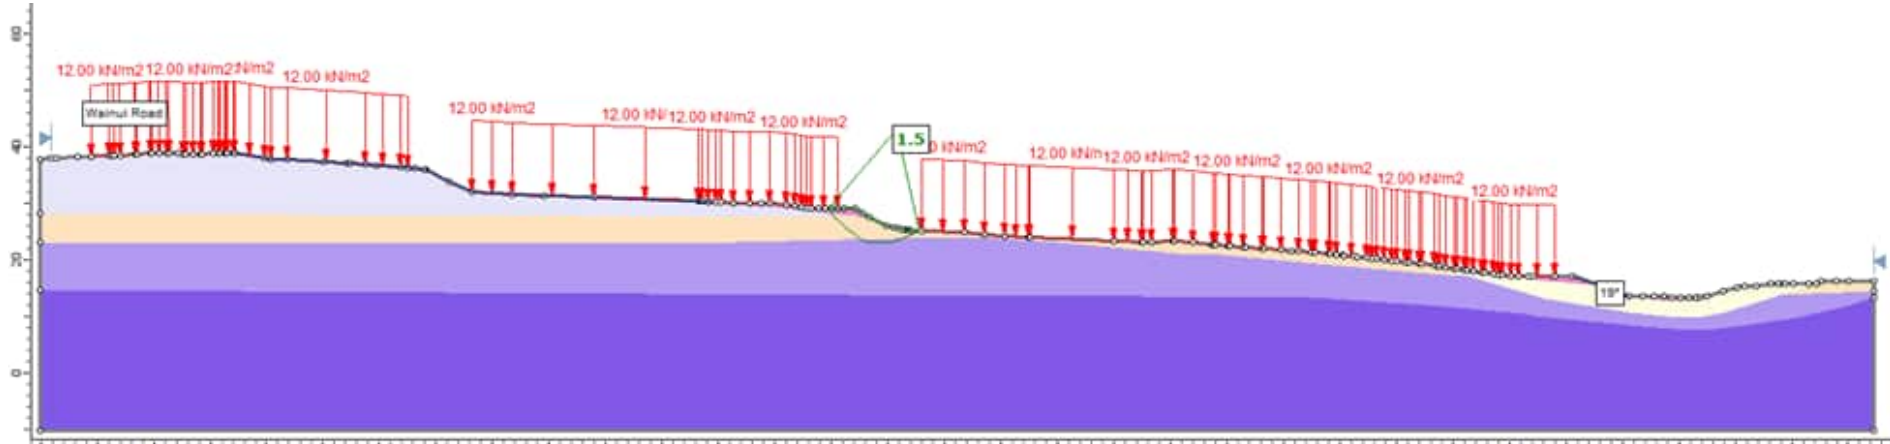
<p><b>Cross Section N: - Proposed Slope, Transient Elevated Groundwater Condition:</b></p>

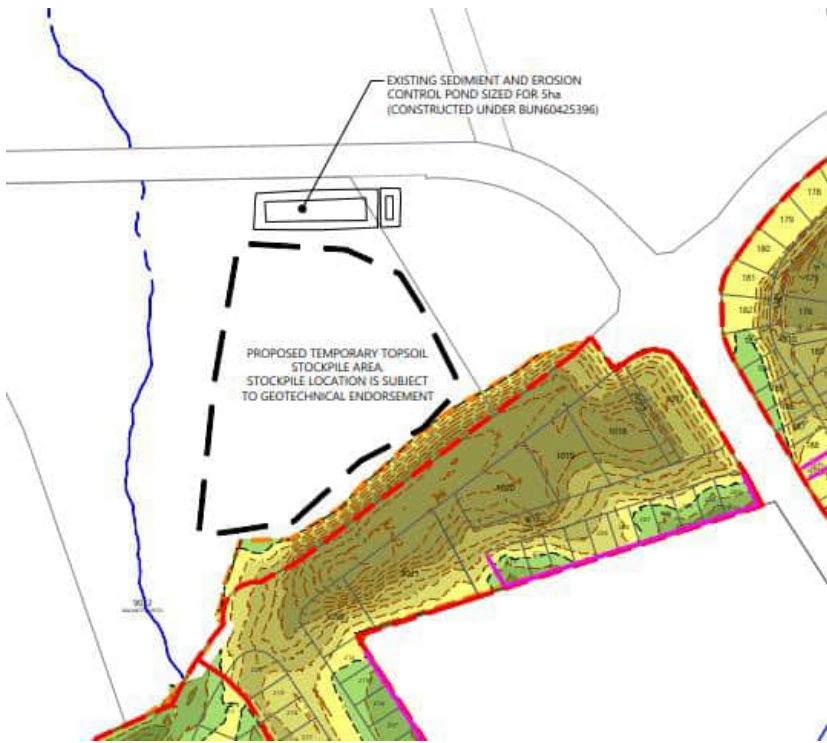
Item #	Auckland Council Comments	Final Comment to Auckland Council in Response to Item
		<ul style="list-style-type: none"> <li>Annotation re topsoil stockpile area being subject to approval by Geotechnical Engineer has been included on plans, as shown below. The updated Woods plan (P24-128-00-1202-EW-CUT FILL PLAN) is at <b>Appendix A</b>.</li> </ul>

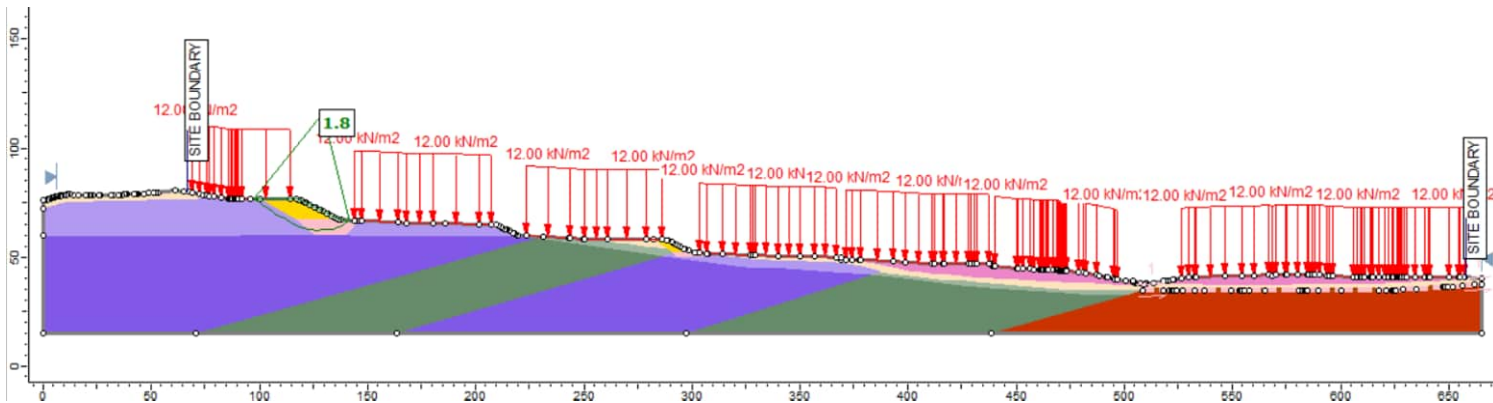
</div> <div><p><b>Cross Section J: - Remediated Slope, Normal Groundwater Condition:</b></p>

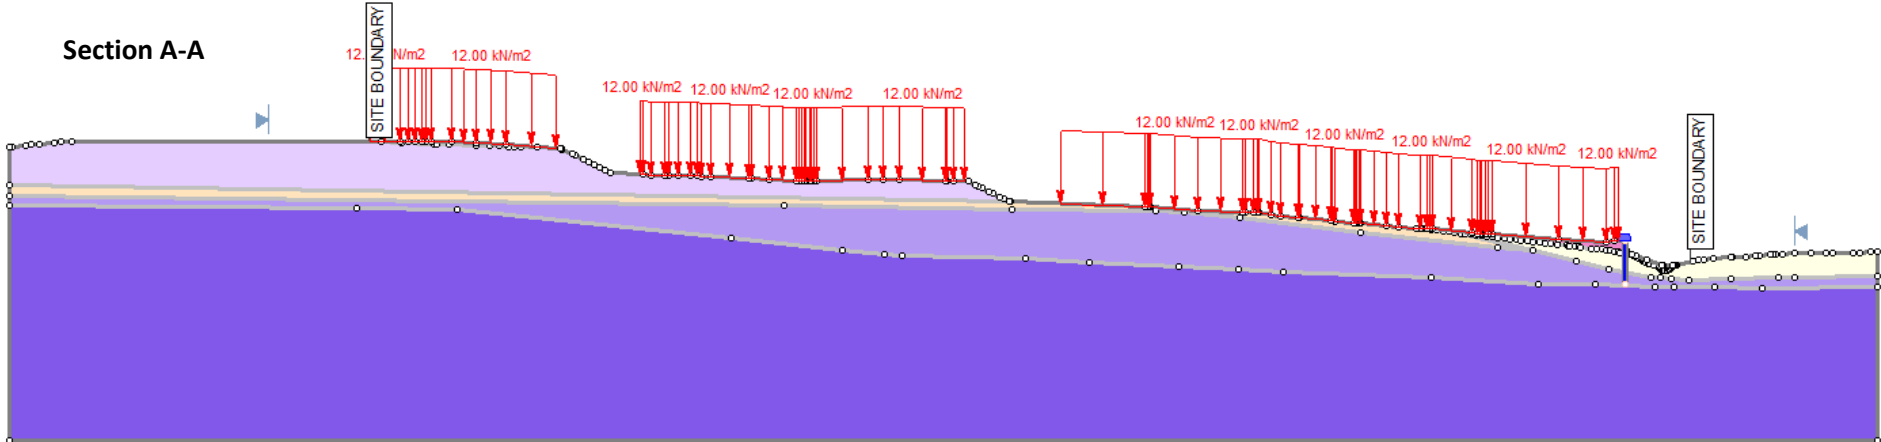
Buttress Fill		18	Mohr-Coulomb	8	28	None	0																																																																																																			
20.11	Appendix F, Figure 3 of the slope stability assessment omits remediation outputs for Section A, which was identified as requiring remediation ‘retaining wall with palisade action’ in Section 5.	<p>Figure 3, Section A-A, Proposed with Remediation model is shown below:</p>

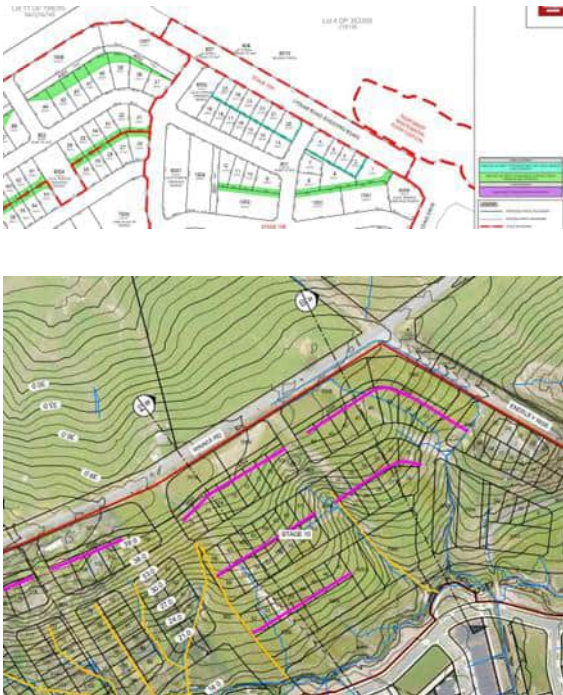
20.14	<div>Reinforced slopes shown in the Milldale plans (e.g., P24-128-00-0013-SU) are not clearly shown in the remedial slope stability analyses e.g., Cross Section A and B etc. Are reinforced slopes still required in these areas or just drainage? We also note that Sections A and B has been excluded from drawing 25 by CMW for reinforced earth batter slopes. This creates inconsistency, may alter the ground profile and development restriction zones.</div> <div>

</div>	<div>Our typical reinforced earth slopes only require geogrids for face creep control, not for global stability so are not shown on stability models. All reinforced engineered fill batter slopes include a drainage blanket as shown in DG 25.</div> <div>Where further remediation is required to address global stability, shear keys (below the toe of the slope) and buttress fills (beyond the minimum 4m fill width required for the geogrid reinforcing) are proposed. Sections A &amp; B do not require this remediation and as such are not listed in the tables provided in DG 25. DG 25 shown below for reference.</div> <div><table><tr><th>KEY</th><th>GRID TYPE</th><th>EMBEDMENT DEPTH L (m)</th><th>VERTICAL SPACING S (m)</th></tr><tr><td> </td><td>PRIMARY</td><td>4.5</td><td>1.5</td></tr><tr><td> </td><td>SECONDARY</td><td>2.5</td><td>0.5</td></tr></table><div><p>PRELIMINARY FILL BUTTRESS WIDTHS (FORMED AT 1V:2H, PARALLEL TO SLOPE FACE)</p><table><tr><th>CROSS SECTION</th><th>WIDTH (m)</th></tr><tr><td>G/G</td><td>28</td></tr><tr><td>H/H</td><td>17</td></tr><tr><td>J/J</td><td>13</td></tr><tr><td>J/J</td><td>20.5</td></tr></table><p>NOTE: FINAL BUTTRESS WIDTHS TO BE DETERMINED ON SITE BY GEOTECHNICAL ENGINEER BY MAPPING EXPOSURE</p></div><div><p>PRELIMINARY SHEAR KEY WIDTH AND DEPTHS</p><table><tr><th>CROSS SECTION</th><th>BASE WIDTH (m)</th><th>DEPTH (m)</th></tr><tr><td>G/G</td><td>18.5</td><td>5</td></tr><tr><td>H/H</td><td>17</td><td>5</td></tr><tr><td>J/J</td><td>10</td><td>6</td></tr><tr><td>J/J</td><td>14</td><td>7</td></tr></table><p>NOTE: FINAL SHEAR KEY DEPTHS TO BE DETERMINED ON SITE BY GEOTECHNICAL ENGINEER, MINIMUM EMBEDMENT INTO NORTHLAND ALLOCHTHON ROCK = 0.5m</p></div><div>

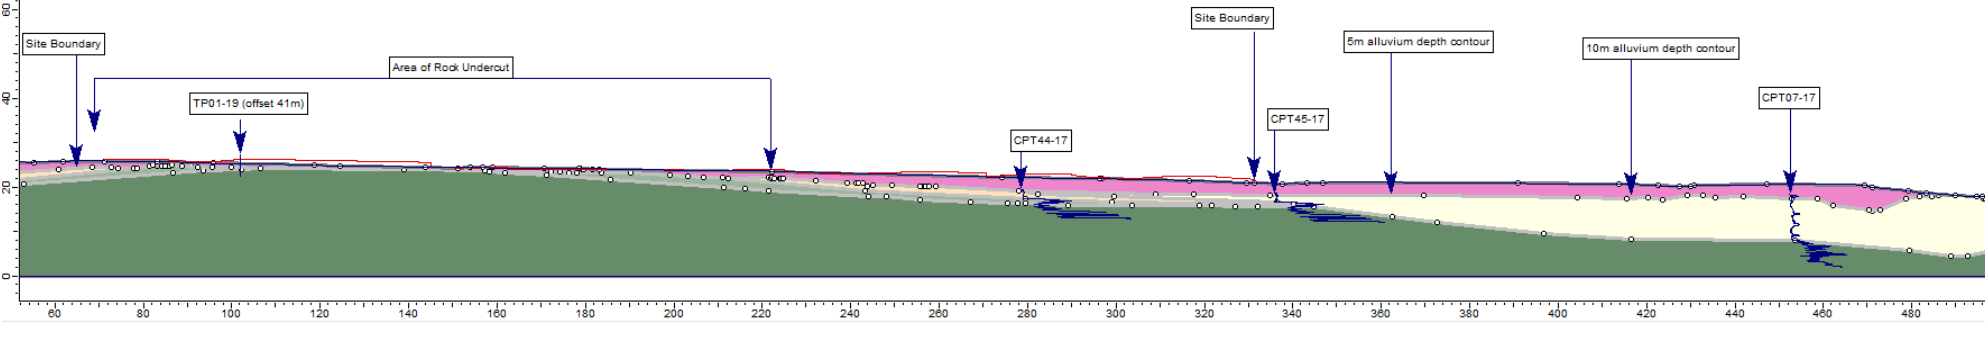
<p>Current (post EW2 and EW3A) ground surface contour, with proposed (Stage 4C, Phase 2) contour in red. Areas of certified engineered filling are shown in pink.</p>

<p>Considering the very gentle to flat gradient shown above, we do not believe that assessment for global instability is required.</p> <p>A network of underfill drains, at a minimum of 50m spacing was installed beneath the fill areas; we expect that groundwater is typically found at the base of these engineered fills, and this has been confirmed as being the case on earlier stages of Milldale that were constructed in the same manner. Underfill drains are shown on the as-built plan above as purple lines.</p>

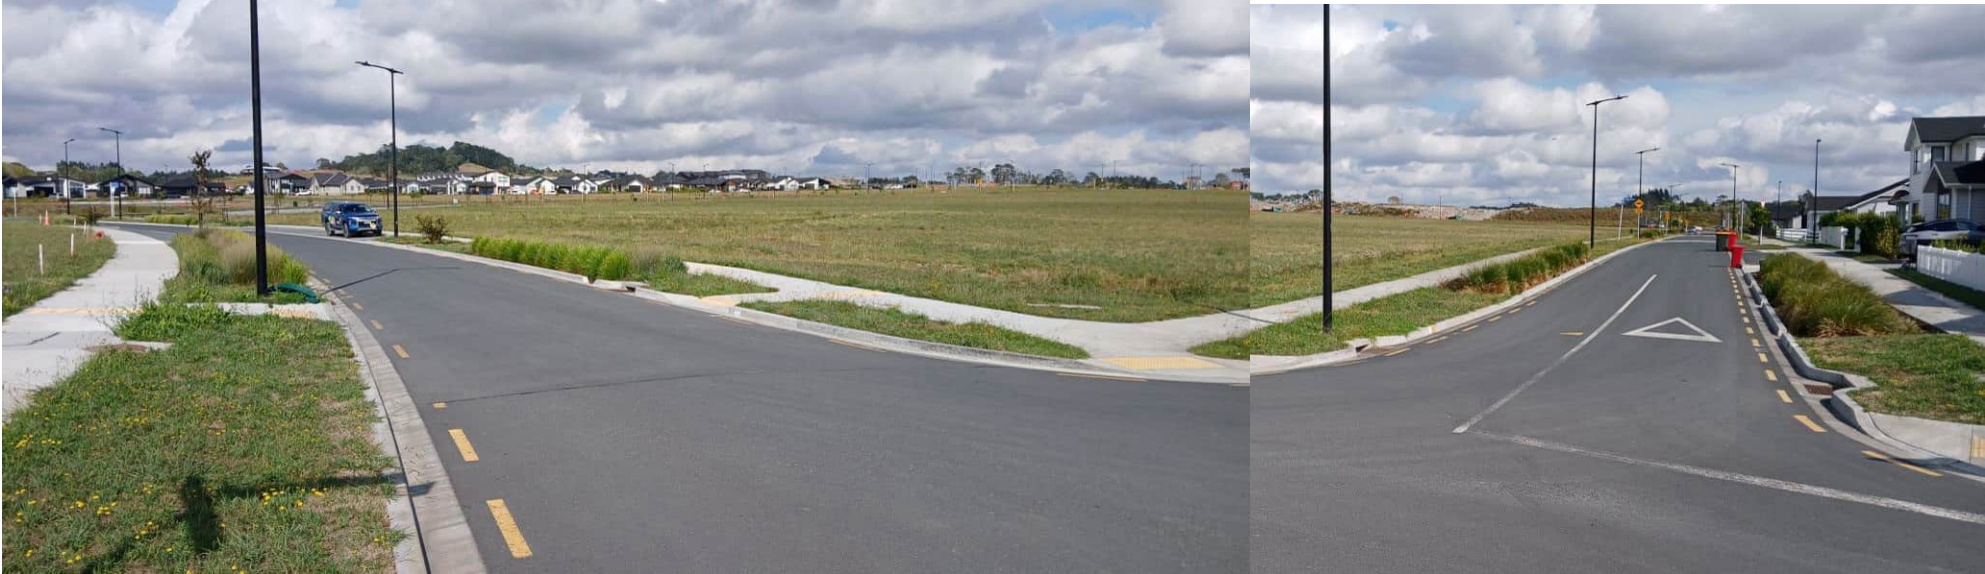
20.18	<p>While it is understood that slope stability analyses were not undertaken on the basis that the site is on a gentle landform, the proposed filling and retaining would result in level difference of up to 2m, where it would be appropriate to conduct slope stability analyses to confirm that global instability is not an issue.</p>	<p>As discussed in Item 20.17 above, we do not believe that global stability analyses are required. Local stability will be assessed during specific design of retaining walls.</p> <p>View west from eastern corner of site:</p>

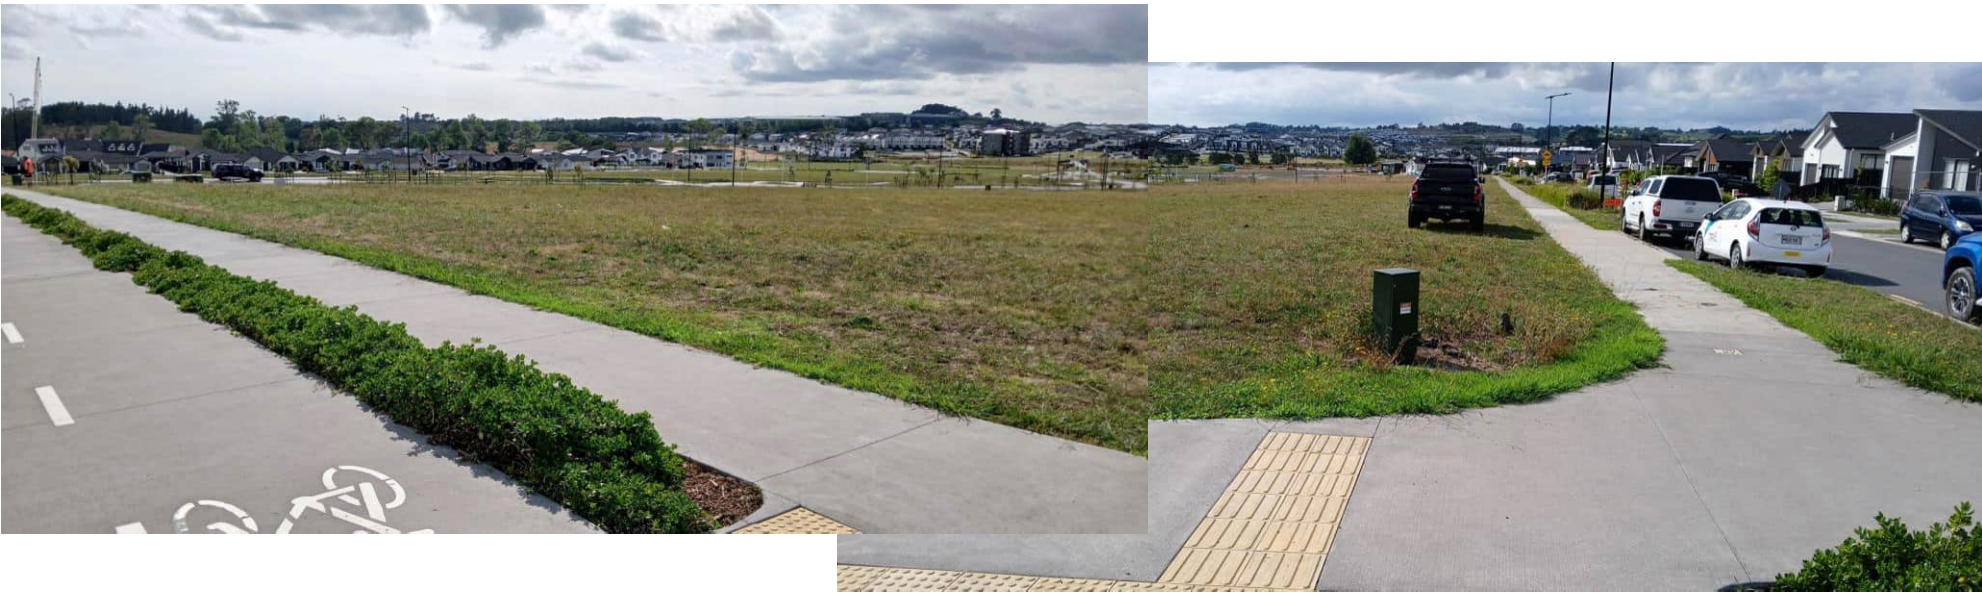
Item #	Auckland Council Comments	Final Comment to Auckland Council in Response to Item
		<p>View east from western corner of site:</p>

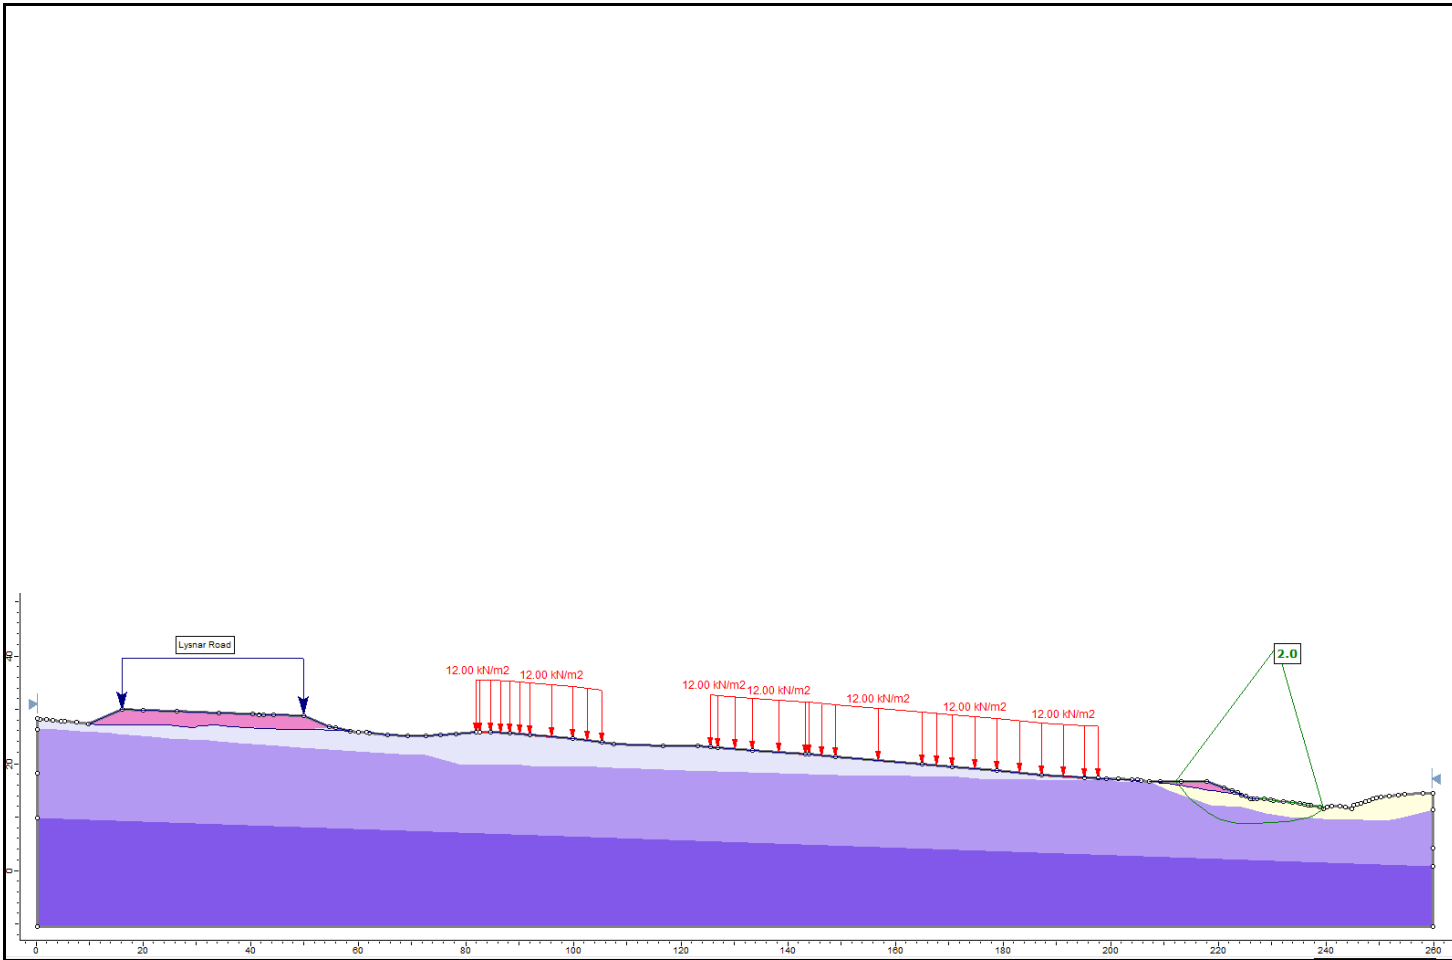
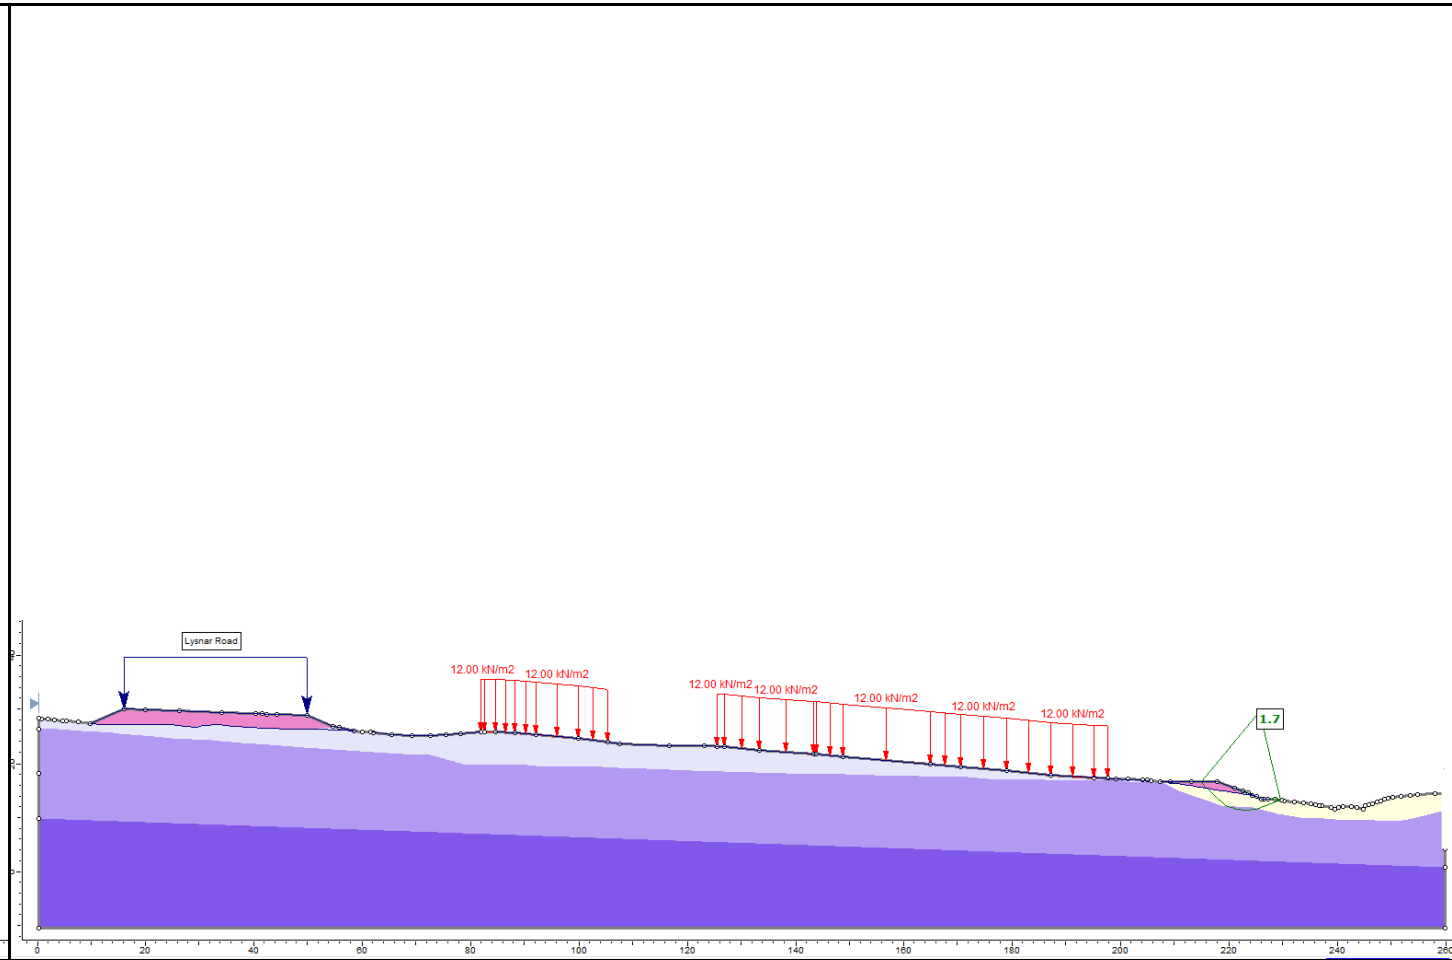
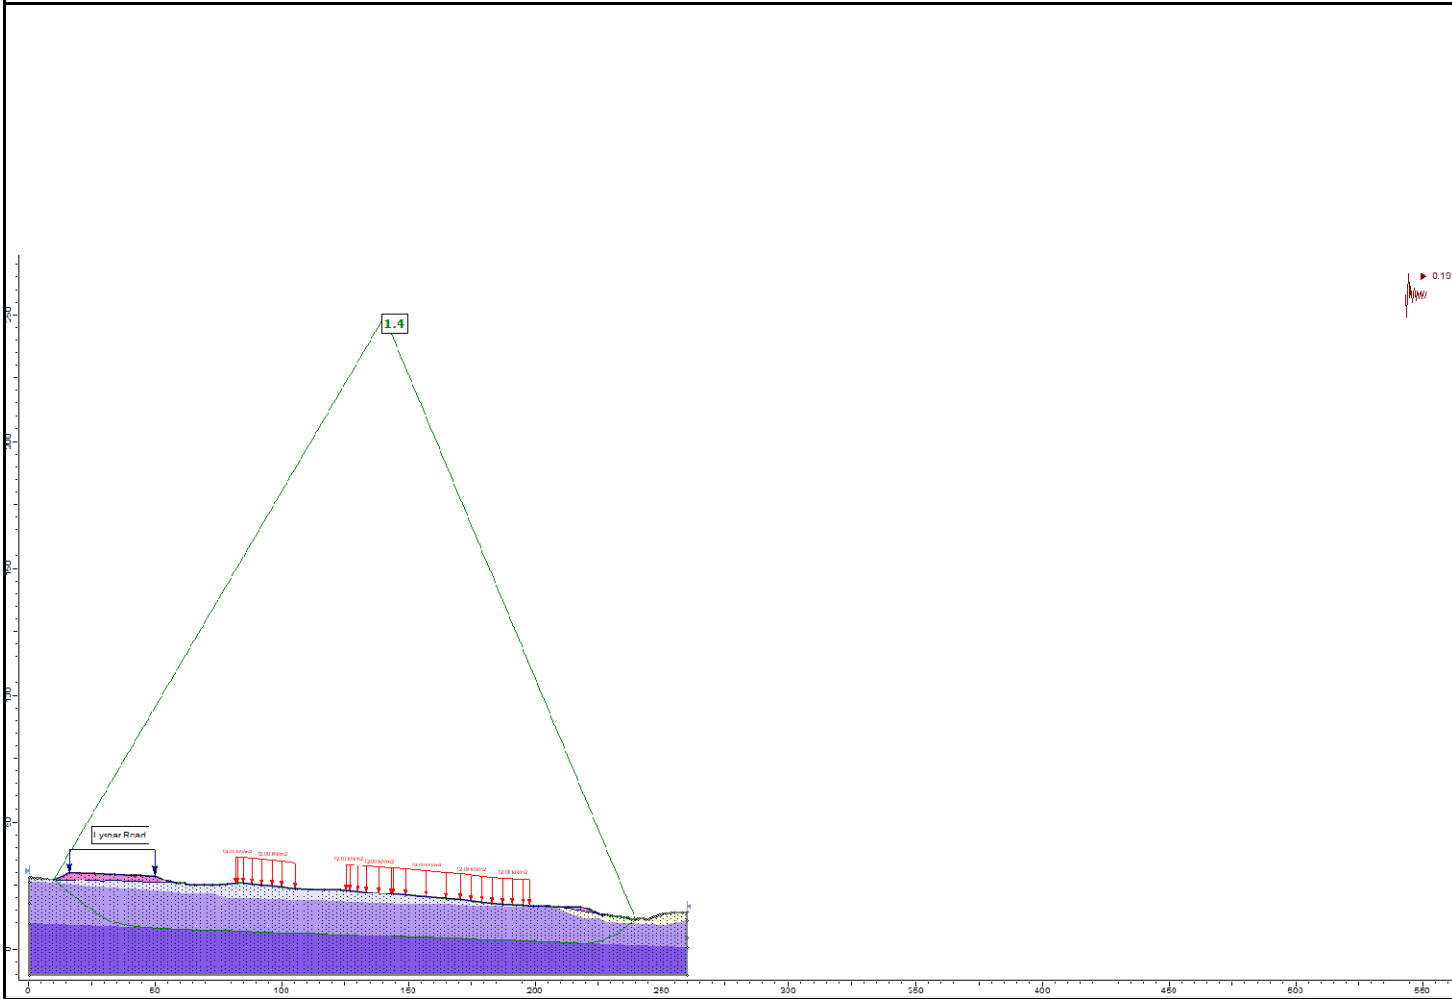
Drawing  
STAB 13

Normal Groundwater Conditions

Transient Groundwater Conditions

Seismic Event
