Awanui Links Development

28 Telephone Road, Puketaha

# PRELIMINARY GEOTECHNICAL DESKTOP REPORT

Job No. HAM2025-0123AB | Version 1

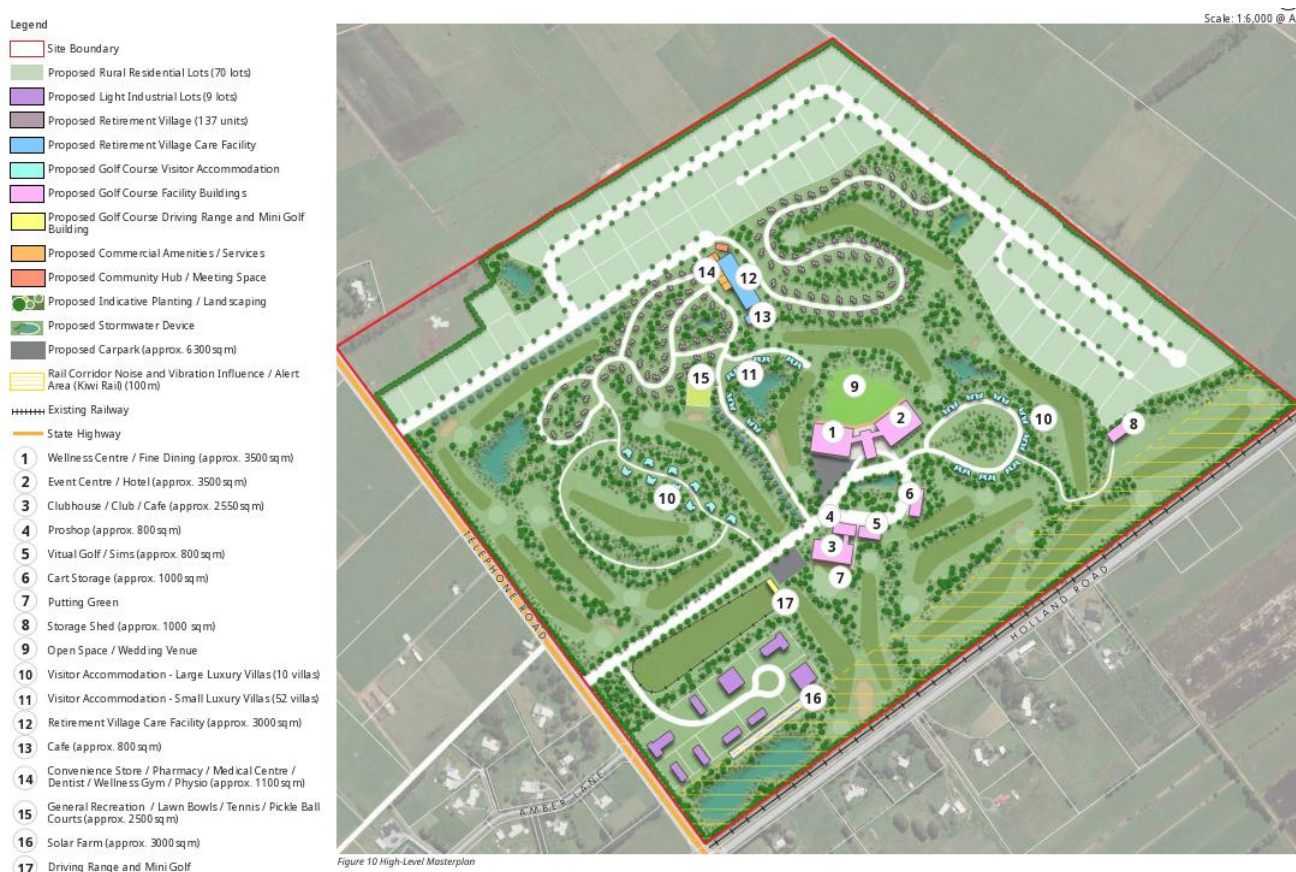
Figure 2: Awanui Links Masterplan (Source: Maven)

The proposed Awanui Links is a mixed-use development as shown in Figure 2. It includes rural residential lots, light industrial lots, a retirement village with a care centre, a solar farm and an 18-hole international golf course with visitor accommodation, an event centre and wellness centre.

Based on the assessment presented in this report, there are no unusual features or geotechnical constraints observed for this site that would prevent a mixed use development as indicated on the Maven masterplan from proceeding.

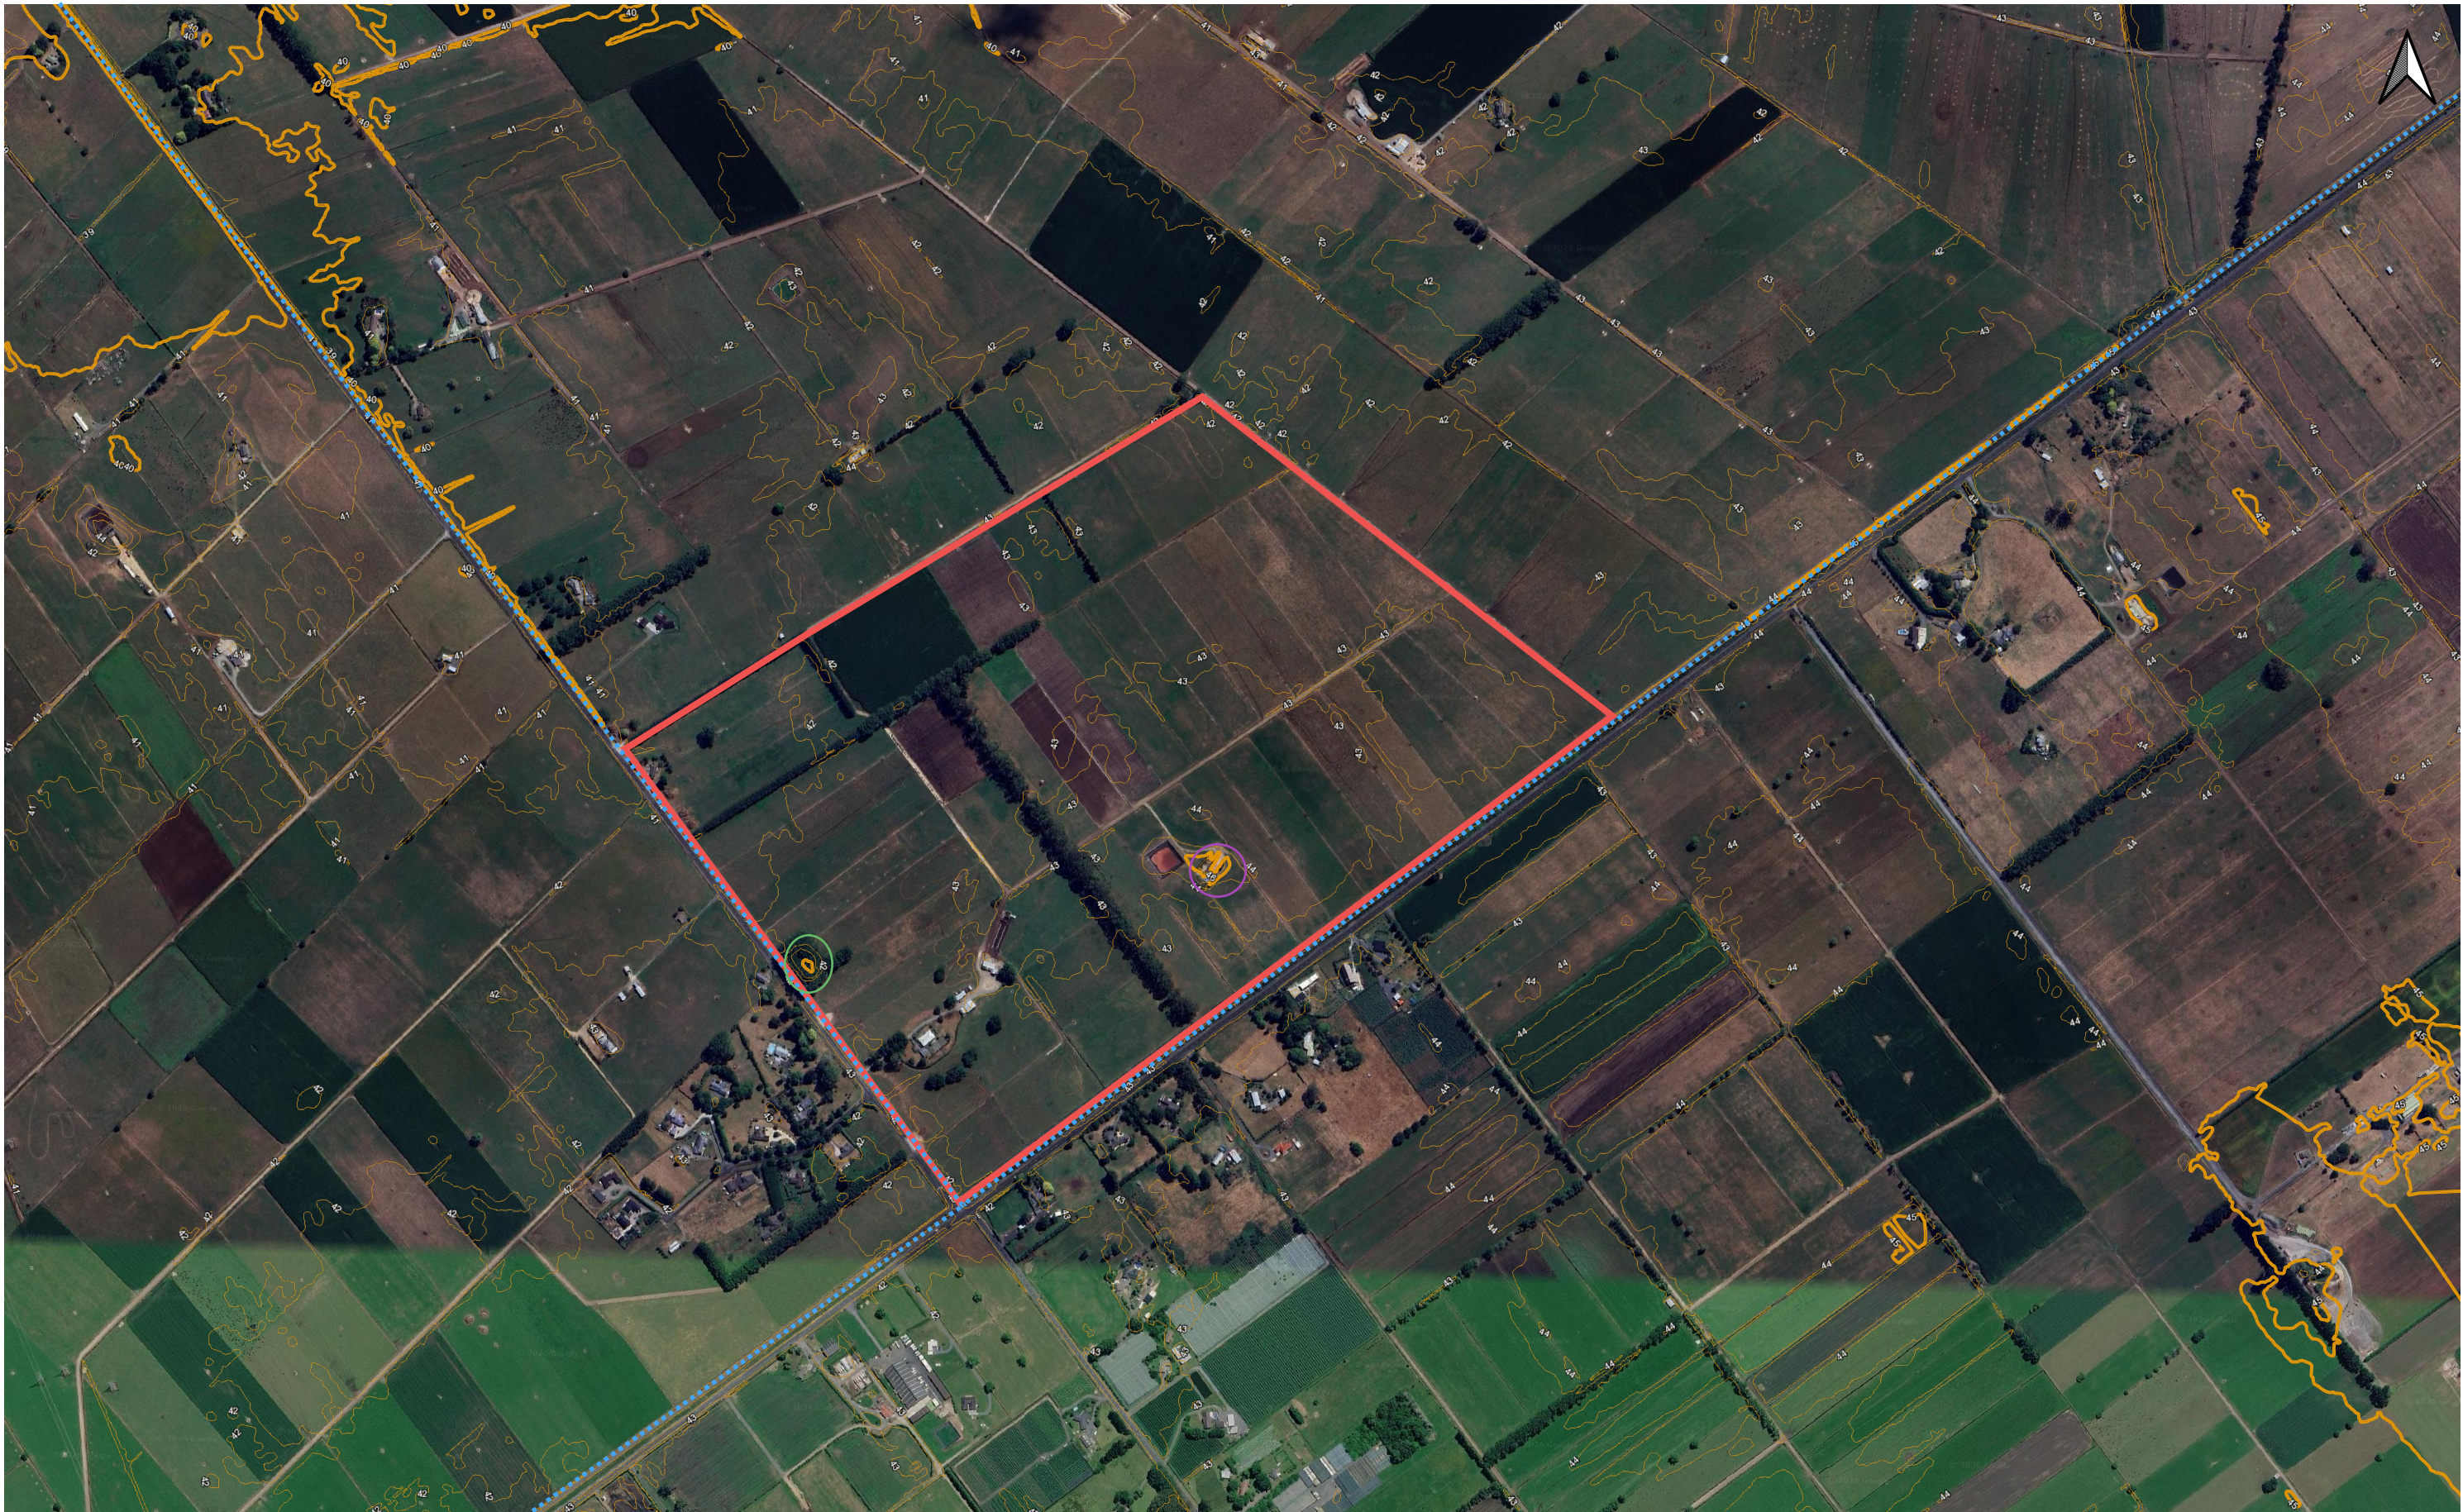
| | TITLE: | EXISITING SITE INVESTIGATION PLAN | DATE: | 2/07/2025 | SHEET: | A3 |

- SITE BOUNDARY
- - - ROADSIDE DRAINS
- DEPRESSION
- HILL

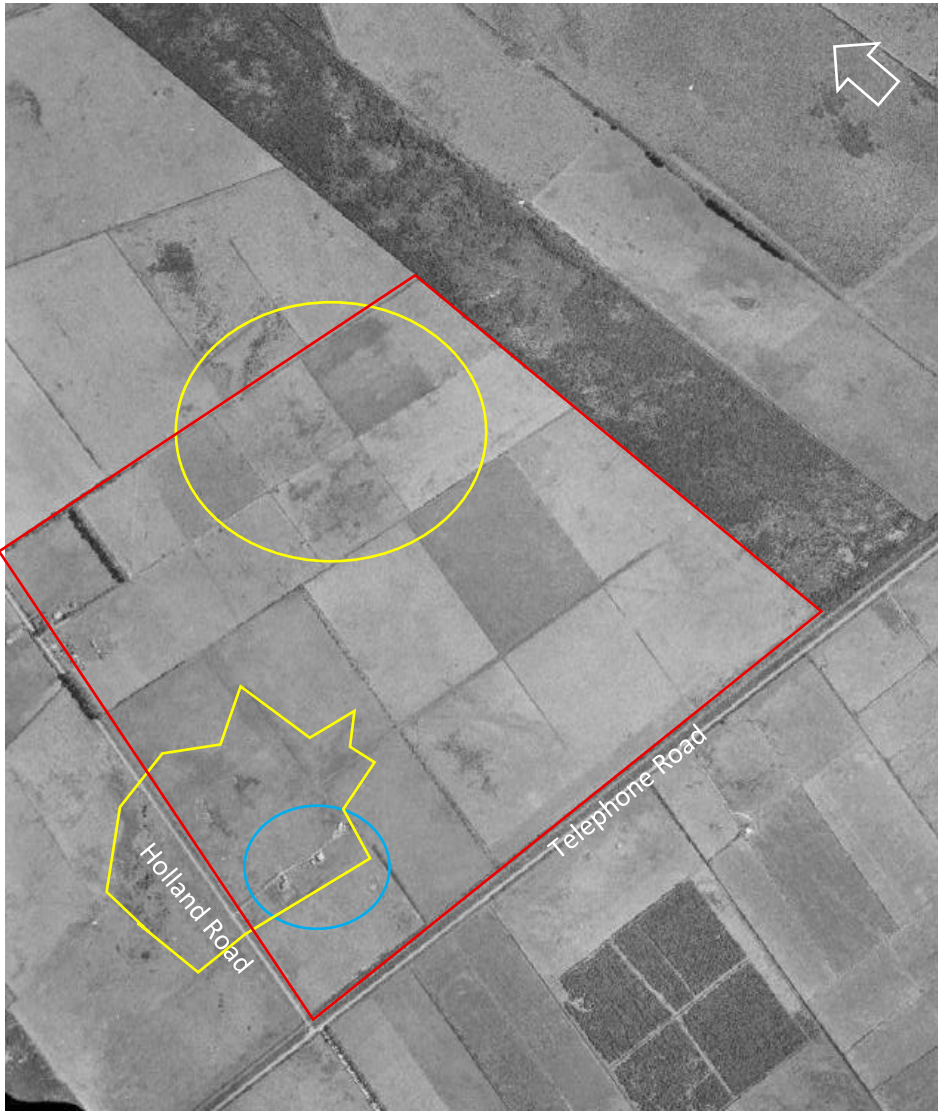
| Date and source | Key Features |
|---|---|
| 1962<br>Retrolens | <ul style="list-style-type: none"> <li>• building structures (circled in blue)</li> <li>• Potentially swampy areas (outlined in yellow)</li> </ul> |

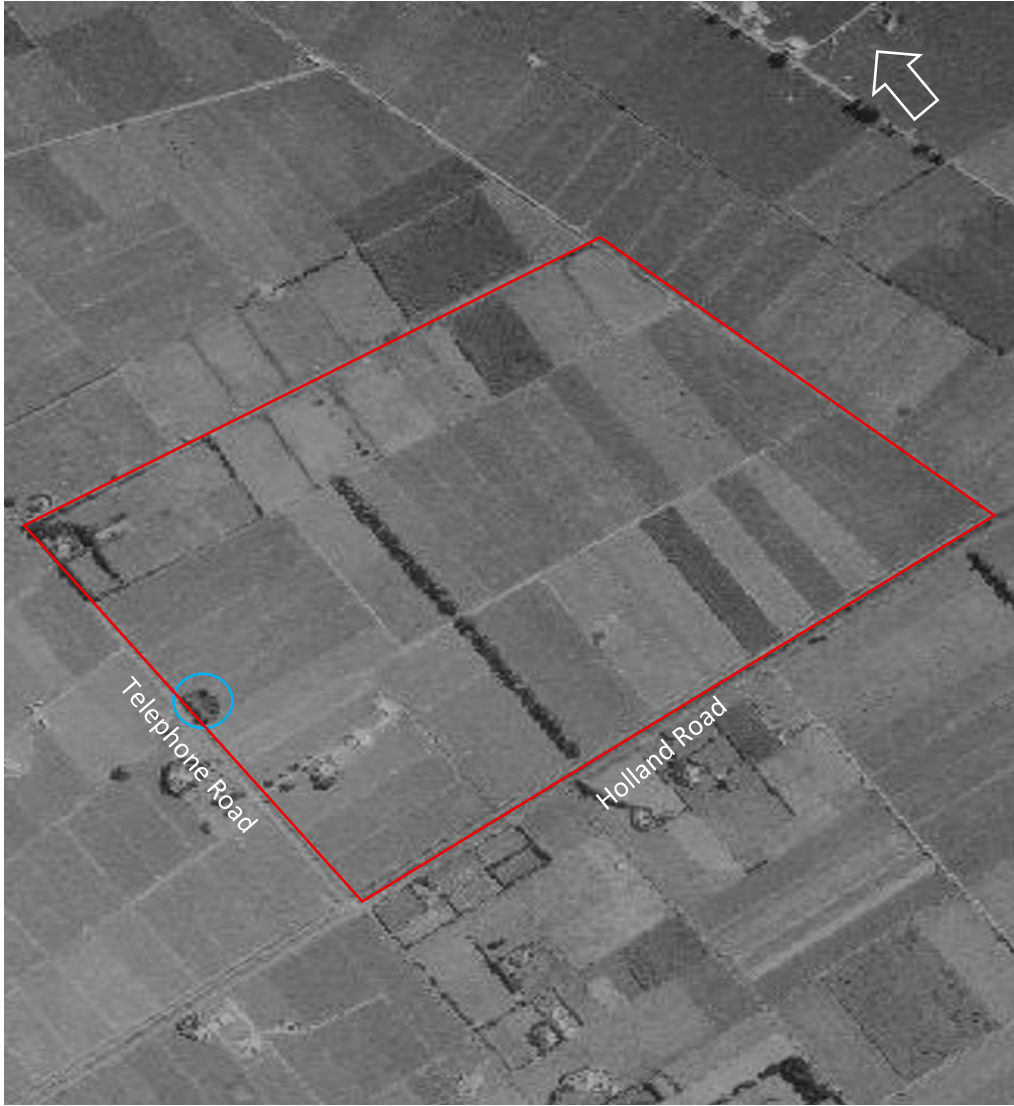
| Date and source | Key Features |
|---|---|
| 1991<br>Retrolens | <div data-bbox="352 394 1370 1496"> </div> <ul style="list-style-type: none"> <li>• Depression next to Telephone road appears (circled in blue)</li> <li>• Additional paddocks have been created. Farm drains could run between them.</li> </ul> |

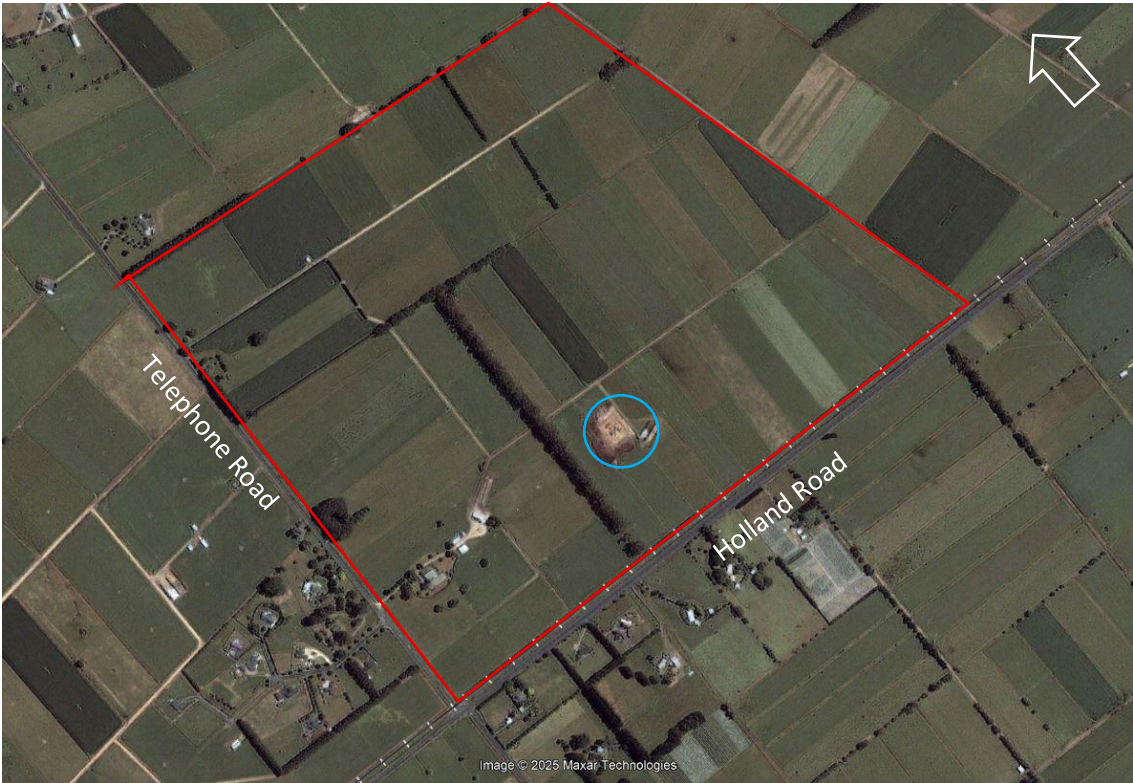
| Date and source | Key Features |
|---|---|
| 2013<br>Google<br>Earth | <p>Image © 2025 Maxar Technologies</p> <ul style="list-style-type: none"> <li>• Effluent pond being constructed next to silage pad (circled in blue).</li> </ul> |
