**Soil Contamination Risk  
Preliminary Site Investigation Report**

**Lot 3 DP 68573 of 101 Sabys Road and 6 Wroots Road,  
Halswell, Christchurch**

March 2026

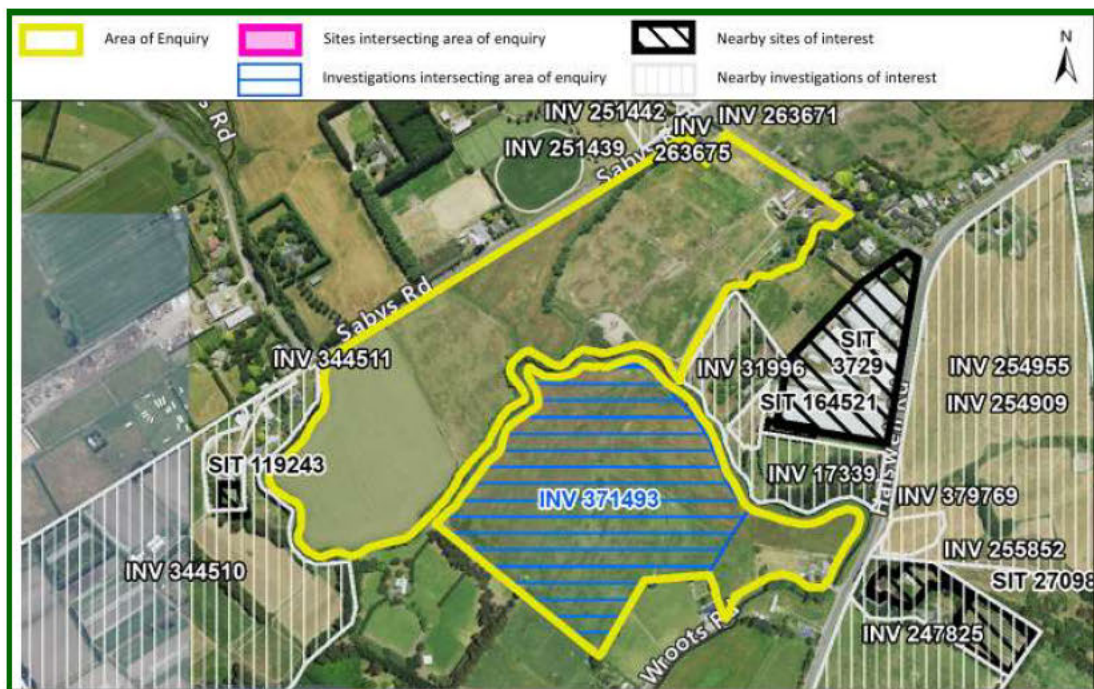
Figure 2 – ECan LLUR plan

Five properties within a 100m radius of the site are listed on the ECan LLUR for potentially contaminating activities. **Figure 2** below shows the listed areas in relation to the site. **Table 2** below outlines the details relating to the five listed properties. Several nearby investigations were also available. The investigations have been reviewed and show no significant risk of migration of contaminants to the site.

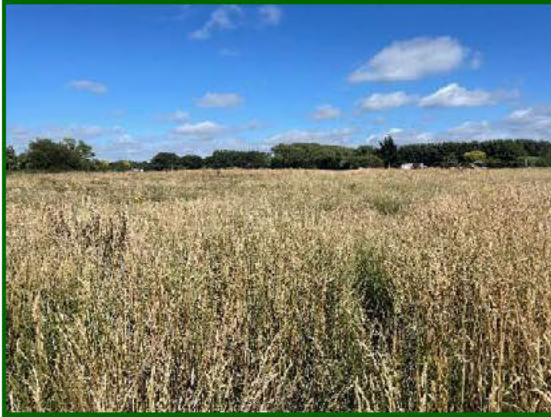
The majority of this area is vacant farmland. The waste disposal area with evidence of previous burning and soil excavations, located in the middle of the paddocks was grassed over with no visible signs of disturbance or evidence of previous burning.

Photo 6 – Soil excavation and waste disposal to land area

Potential waste disposal to land, burning and soil excavations have been undertaken in the middle of 101 Sabys Road since the early 1990's. These activities were not visible during the site inspection due to overgrown grass.

Contaminants of concern associated with burning and disposal of material is dependent on the type of material but could include heavy metals, asbestos and petroleum hydrocarbons.

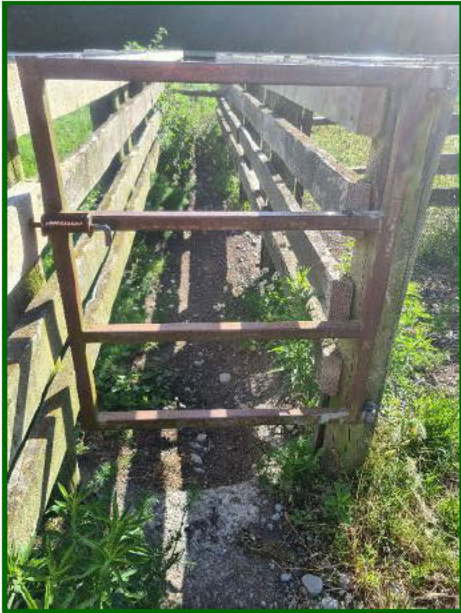
Concrete edging was present within the stockyards indicating the presence of a former livestock dip. XRF screening was undertaken in this location and identified levels of arsenic above the 'residential 10% produce' soil guideline value (SGV). The highest arsenic level recorded was 285mg/kg, compared to the 'residential 10% produce' SGV of 20mg/kg. This is generally consistent with the area containing a former livestock dip.

Photo 12 – Potential former sheep dip structure Photo 13 – Shipping container and grain silos

Historical aerials show a farmyard and stockyards present at 101 Sabys Road from as early as the 1950's. During the site inspection a potential concrete sheep dip structure was noted within the stockyards. XRF screening identified arsenic contamination in the soils which is consistent with the presence of a former livestock dip.

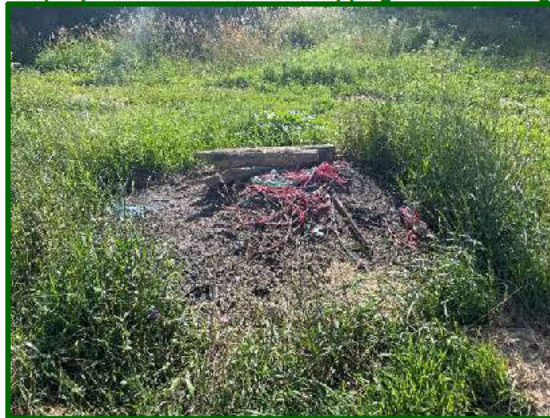
A burn area was also identified to the south of all the farmyard and contained timber, nails and ash. XRF screening showed very high arsenic levels above the 'residential 10% produce' SGV. The arsenic reading was 5902mg/kg.

Photo 14 – Burn area

One burn area was identified during the site inspection at 101 Sabys Road. A potential burn area is also visible on recent aerial photographs at 6 Wroots Road. Storage of scrap and other items was observed within treeline and around the pottery workshop, farmyard and residential dwelling at 6 Wroots Road. Historical aerial photographs show extensive storage has occurred at the site over many years. Pottery kilns are also present in the pottery workshop area.

Contaminants of concern associated with pottery kilns, burn areas and storage of materials is dependent on the type of material burnt/stored but could include heavy metals, asbestos and petroleum hydrocarbons.

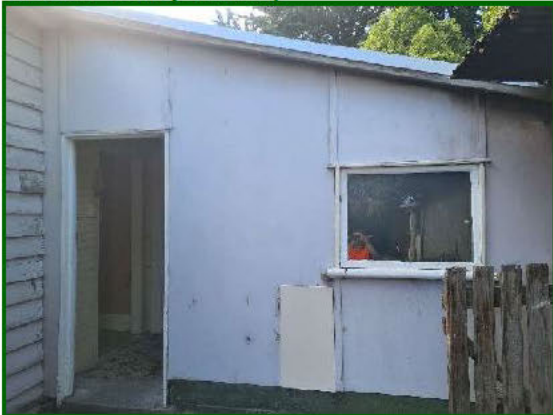
To the south-east of the farmyard is a former residential dwelling with painted weatherboard cladding currently used as a pottery workshop and retail store. An extension is present along the south-west wall of the pottery workshop with potential asbestos containing materials (PACM) and an attached corrugated iron clad shed. There is another detached shed with painted weatherboard cladding. Several pottery kilns are present to the north-west of the pottery house and within the corrugated iron shed. Storage of scrap material is present around the pottery workshop and within the surrounding treelines.

Photo 17 – House extension with PACM cladding

The site has had buildings sited on it since at least 1941, with additions and removals over time. Due to the era of construction of some buildings, there may be a risk of asbestos containing material use. Any natural deterioration or intentional removal may have caused contamination of the surrounding soils.

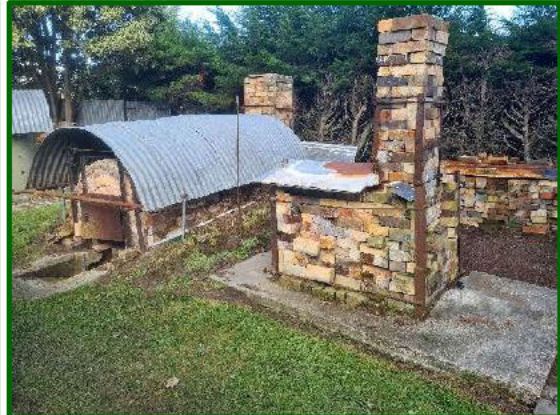
Photo 20 – Pottery kilns

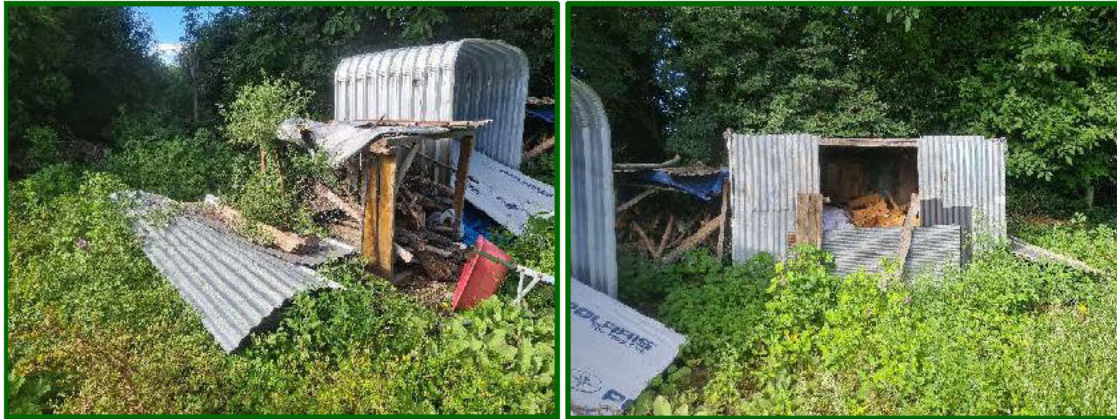
Photo 21 and photo 22 – Scrap material, southern side of pottery workshop

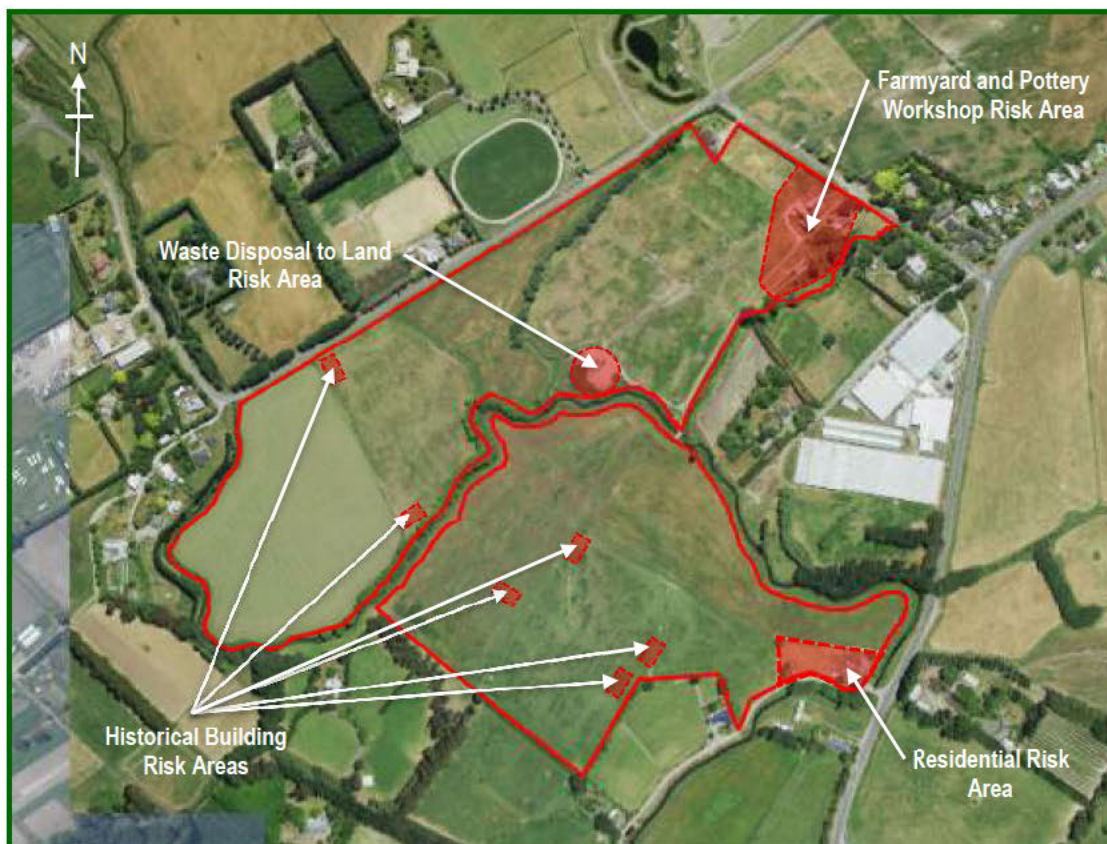
**Figure 3 – Risk Area Plan**

The following conceptual site models indicate potentially complete exposure pathways for the identified risk areas at the site. The risk areas have been grouped together as follows; the farmyard and pottery workshop risk area, the residential risk area, the waste disposal to land risk area and the historical building risk areas. The risk areas are shown on the plan in **Figure 3** below.

- Farmyard and pottery workshop risk area – Potential heavy metal, OCP, petroleum hydrocarbon and/or asbestos contamination around old sheds and buildings, pottery kilns, a potential former sheep dip, storage and burn areas.
- Waste disposal to land risk area - Potential heavy metals, petroleum hydrocarbon and/or asbestos contamination from storage and burning of waste.
- Residential risk area – Potential heavy metal, petroleum hydrocarbons and/or asbestos contamination around old building, storage of items and a potential burn area.
- Historic building risk areas – Potential heavy metal contamination at the location of former buildings.

It is recommended that a Detailed Site Investigation be undertaken on the identified risk areas prior to any development occurring. Beyond the identified risk areas there have been no HAIL activities identified and no further investigations required at this time.

The locations of these risk areas are shown on the plan in **Figure 3** above. These are confirmed or likely HAIL activities and there may be a risk to human health from contaminated soils in these areas. It is recommended that a Detailed Site Investigation be undertaken across all risk areas prior to development of the site.
