# Soil and Resource Report for 174 Brookvale Road, Havelock North.

**Prepared By: Ian Hanmore**

**Prepared For: Vermont Street Partners No. 4 Ltd**

20<sup>th</sup> November 2024

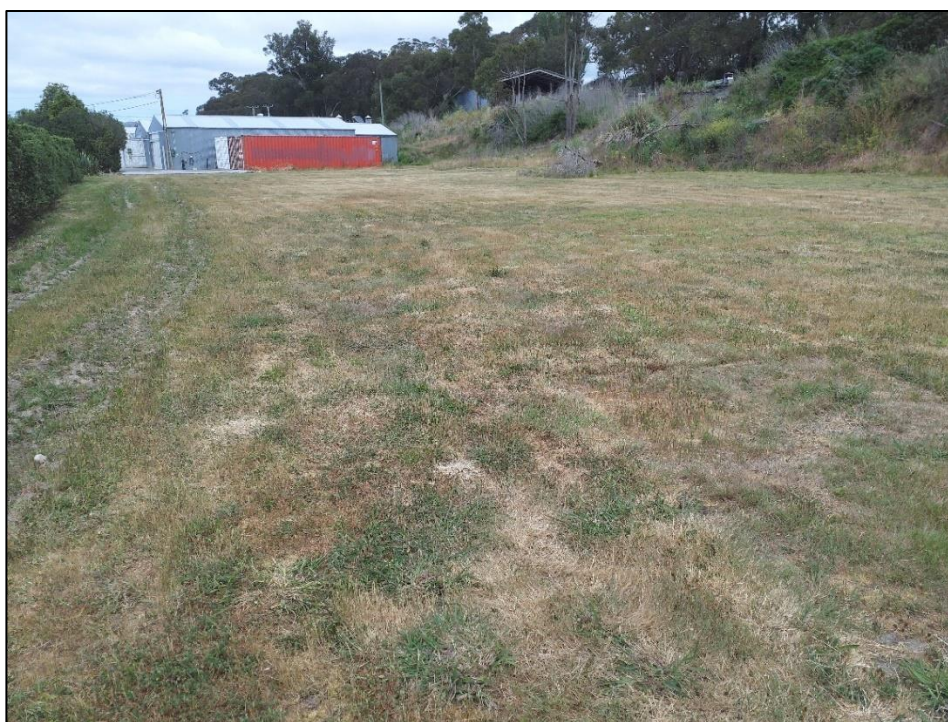
Figure 1. Excavated site with anthropic soil

The area of anthropic soil is located on an excavated area of the site where the slope from the terrace above has been removed to create a flat area. The soil at this site consists of very stony subsoil a number of metres below the surface of the original soil profile. Figure 1 below shows the area including the bank cutting on the right while figure 2 shows the shallow, stony soil surface that exists below the grass cover.

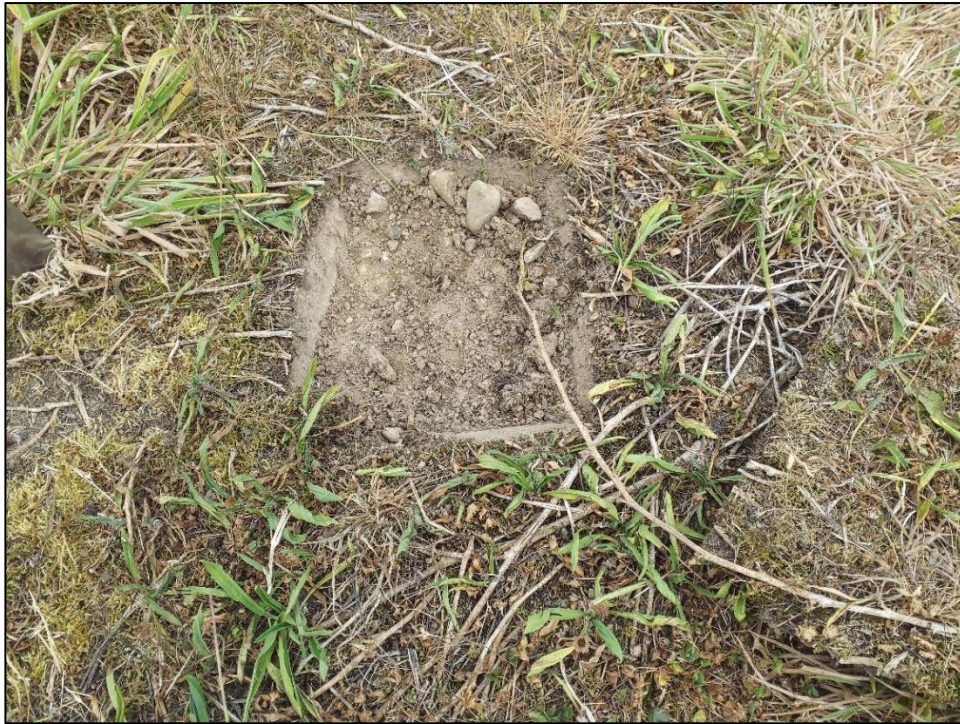
Figure 2. Very shallow soil over gravel at the excavated site.

The soil at this site cannot be dug manually with a spade due to the degree of stoniness and only has a very thin layer of soil material overlaying the stony profile.

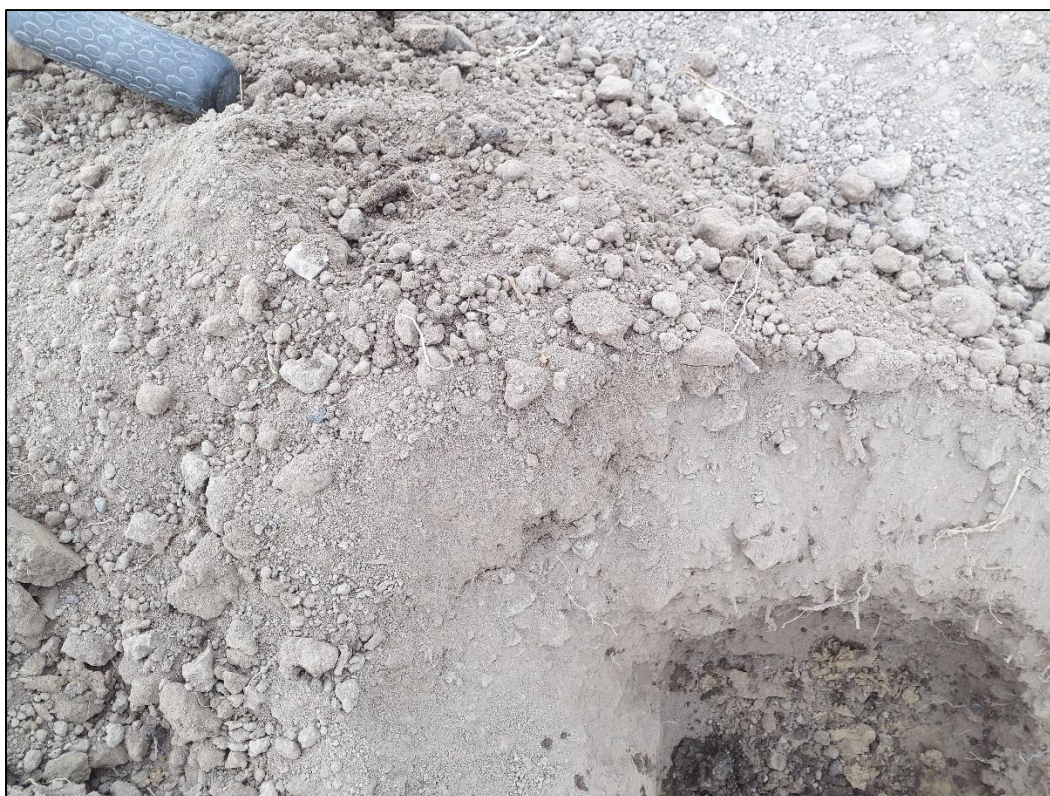
Figure 3. Soil degradation at the site from a loss of structure likely due to over cultivation.

In general, the condition of the soil on Title 2 was found to be slightly to significantly degraded due to compaction and a loss of soil structure. Figure 3 below shows the degraded topsoil of a recently cultivated area of the site with structure almost total lost leaving a powdery texture topsoil containing small, compacted clods of subsoil

- Productive soils at the site have been degraded due to compaction and loss of soil structure and require remedial action to return them to their natural level of productivity.

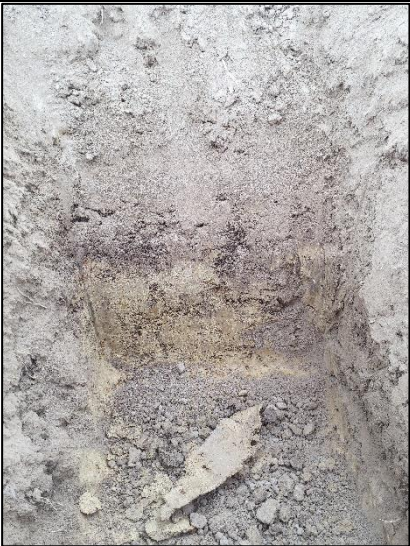
| Soil Profile | Soil Profile Description |
|---|---|
| | <p><b>Soil Name:</b> Hinds_25a.1.</p> <p><b>Soil classification:</b> Mottled fluvial recent soil.</p> <p><b>Parent material:</b> Alluvium</p> <p><b>Soil description:</b></p> <p>0-200 Loss of soil structure and organic matter, becoming powdery with compacted lumps</p> <p>200-400mm: Firm, massive, sticky plastic, light yellowish brown (2.5y6/3) to light brownish grey (2.5y6/2) sandy clay with black (10yr 2/1) iron staining and yellowish red (5yr 5/8) mottling.</p> <p>400mm+ – clay to firm to auger</p> <p><b>Overall drainage:</b> Imperfectly drained</p> |

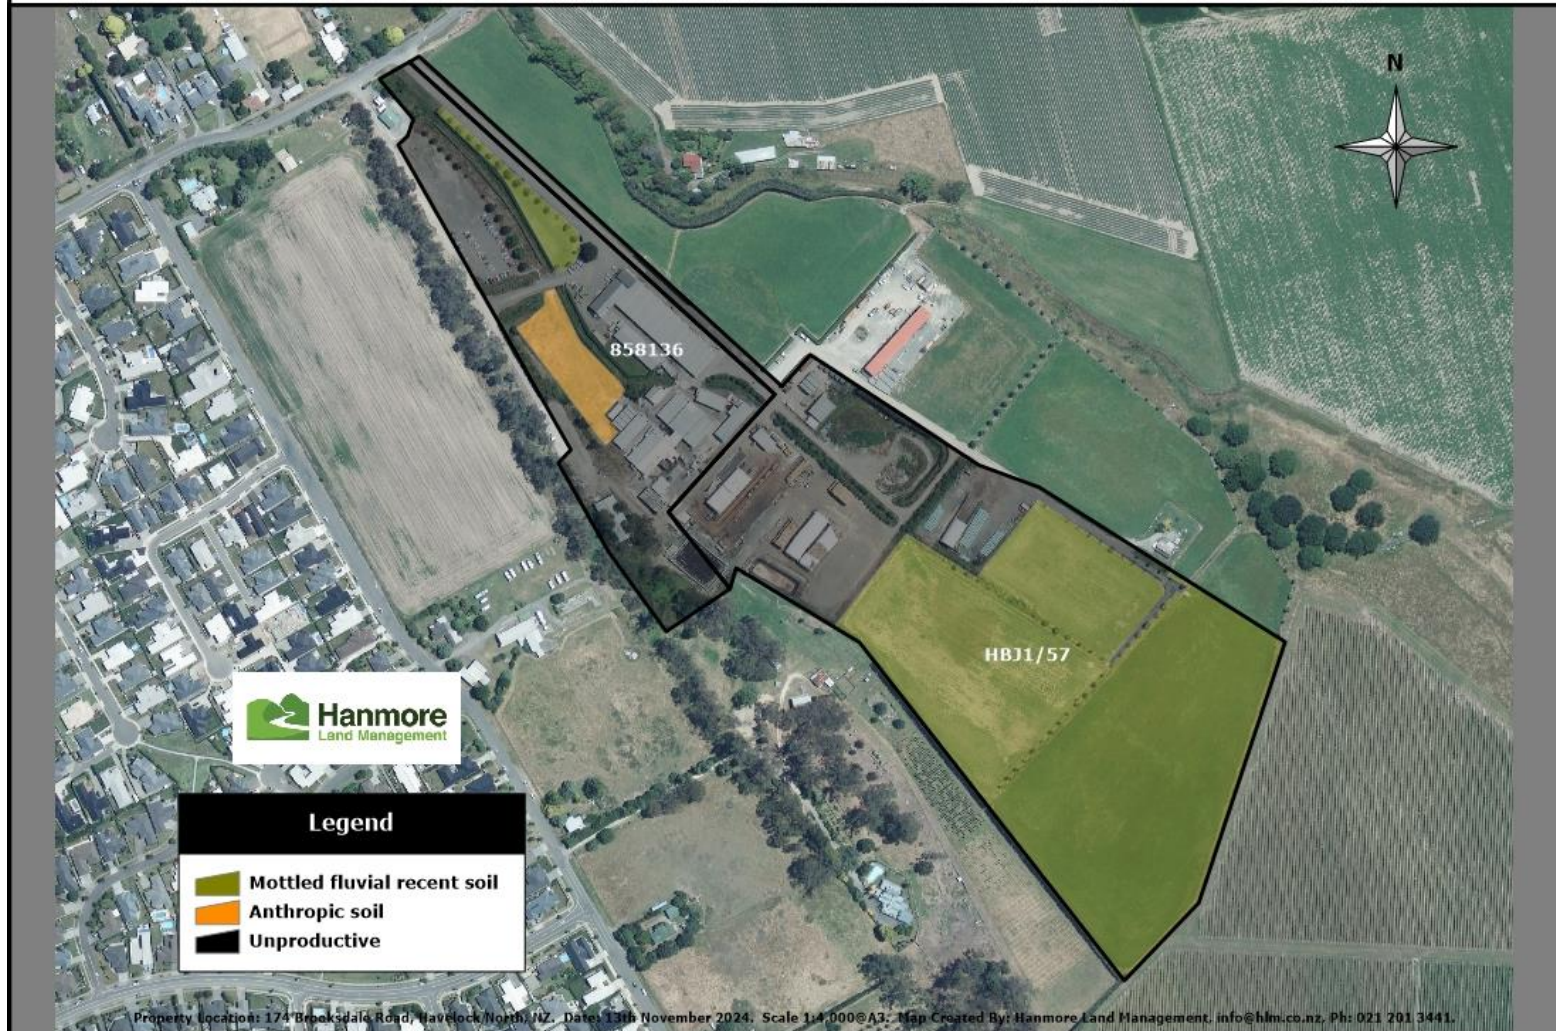
## 174 Brooksdale Road Soil Map

On Title 1 there are only two notable flat grassed areas. These are shown on the soil map in Section 7 of this report as anthropic or manmade soil and mottled fluvial recent soil (recorded as Hinds\_25a.1 in S-map). A third area has not been highlighted as it covers only 400m<sup>2</sup> adjacent to a building and as such a negligible production potential.

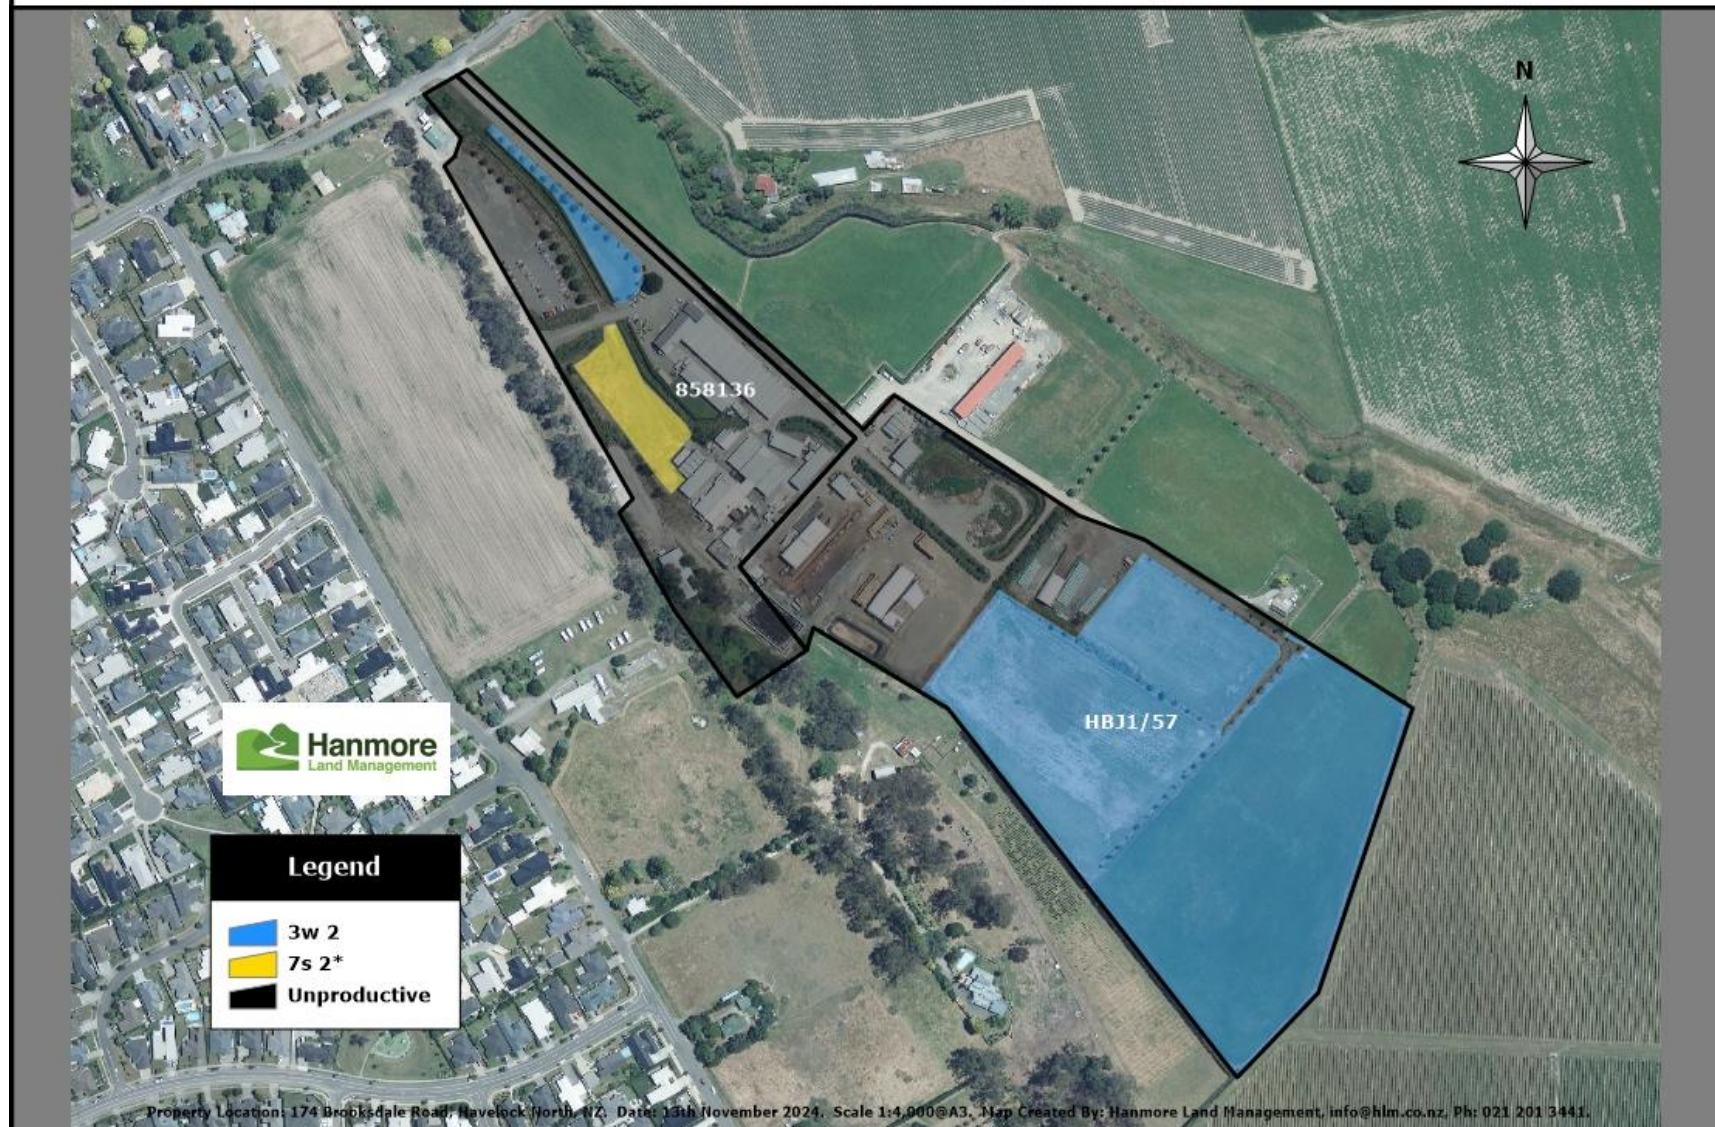
## 174 Brooksdale Road Land Use Capability Classifications

The LUC units mapped on the proposed site are presented in the table below. An LUC map showing the distribution of the mapped units is contained in Section 7.

As can be seen in the soil and LUC maps there is very little in the way of undeveloped ground that has any potential primary productive use on Title 1. The soils on this title have been discussed in Section 3.1 of this report and have highlighted only three flat, undeveloped areas that could be considered to have any production potential. The smallest of these is discounted as it is the size of a small residential lawn – approximately 400m<sup>2</sup>. Of the remaining two areas the largest - 0.35ha, has anthropic or a manmade soil profile due to site levelling. This process

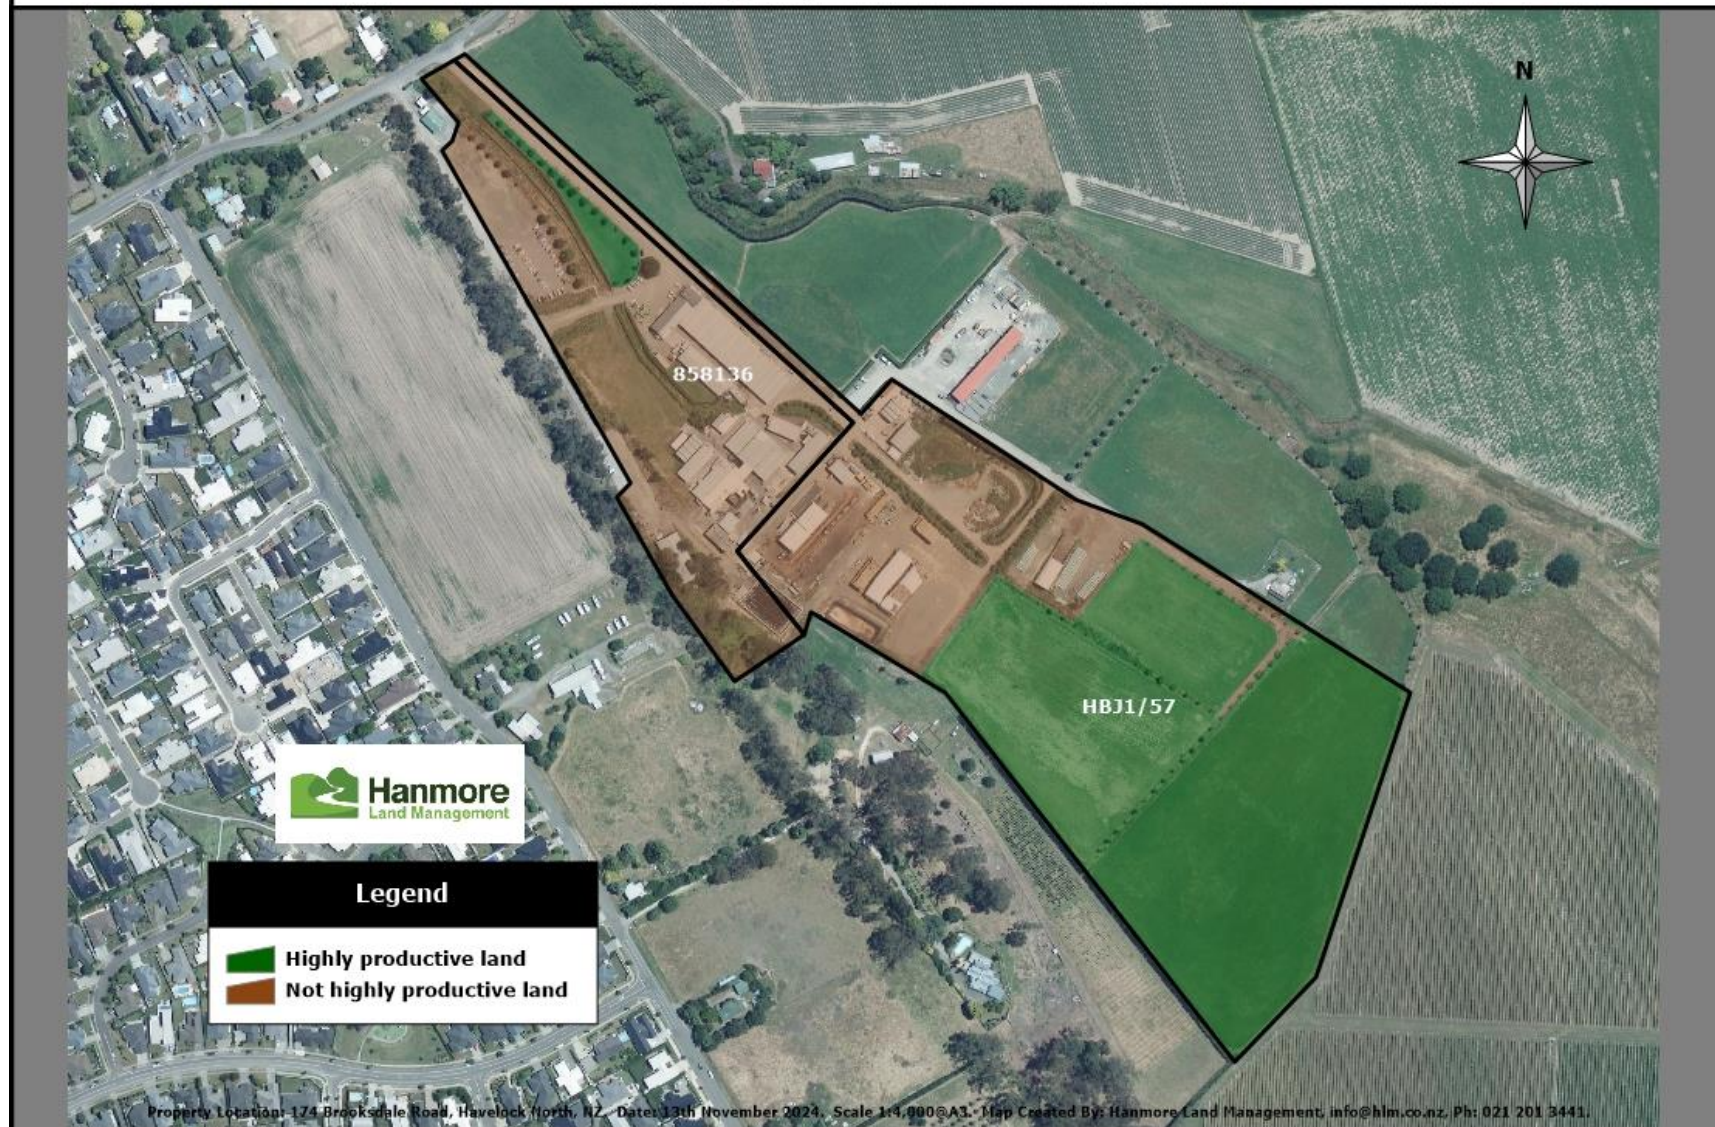
## 174 Brooksdale Road Highly Productive Land Classifications

- The entire site is technically classified as HPL under the NPS-HPL but in reality the majority has been highly modified and developed with buildings and hard surface areas. As such, that area of the site is in no way able to be used for primary production let alone in a highly productive capacity.

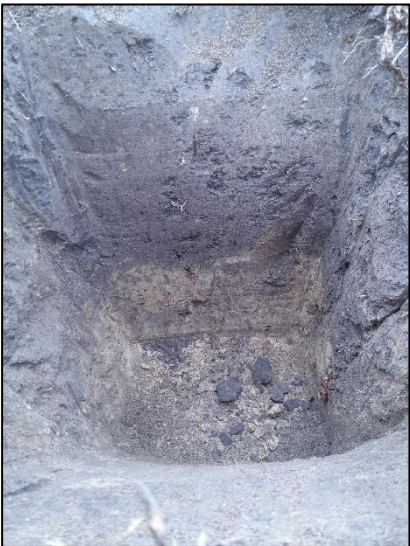
| Soil Profile | Soil Profile Description |
|---|---|
| | <p><b>Soil Name:</b> Hinds_25a.1.</p> <p><b>Soil classification:</b> Mottled fluvial recent soil.</p> <p><b>Parent material:</b> Alluvium</p> <p><b>Soil description:</b></p> <p>0-260mm: Friable, weakly developed, 2-3mm nut, some compaction evident, very dark greyish brown (10yr 3/2), sticky, plastic, silt loam.</p> <p>260-400mm Very firm, massive, breaks to weakly developed 2-3mm nut, light brownish grey (10yr 6/2), sticky, plastic, gravelly clay with dark yellowish brown (5yr 4/6) iron deposits.</p> <p><b>Overall drainage:</b> Imperfectly drained</p> |

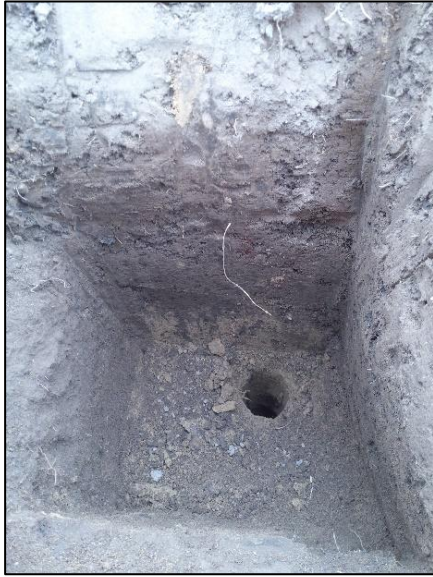
**Soil Name:** Hinds\_25a.1.

**Soil classification:** Mottled fluvial recent soil.

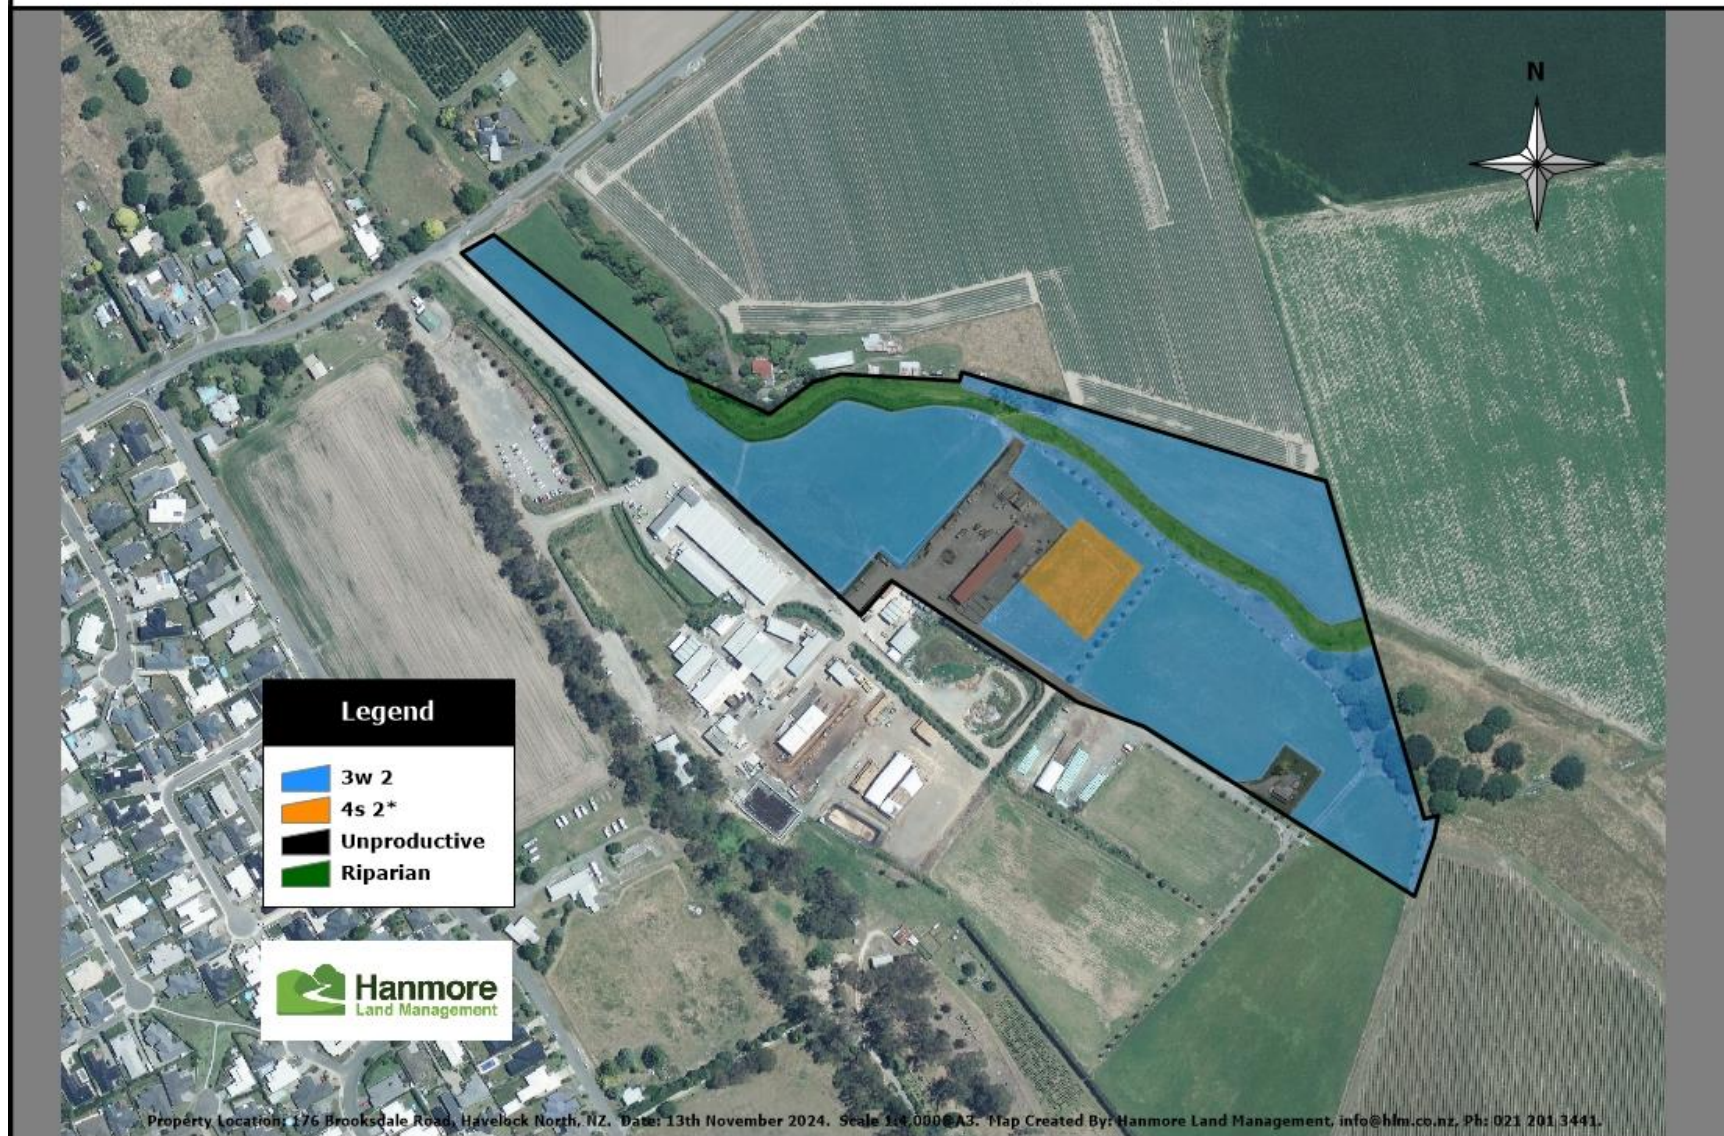
## 176 Brooksdale Road Land Use Capability Classifications

Due to the alteration of the soil profile at the site of the old settling pond this area has been given a 4s 2\* classification reflecting the degradation of the natural soil profile. The remaining area of the site, apart from the riparian zone, retains its 3w 2 classification.

It should be noted that soil degradation due to compaction and loss of soil structure was observed at the site and needs remedial action to return it to its natural level of productivity.

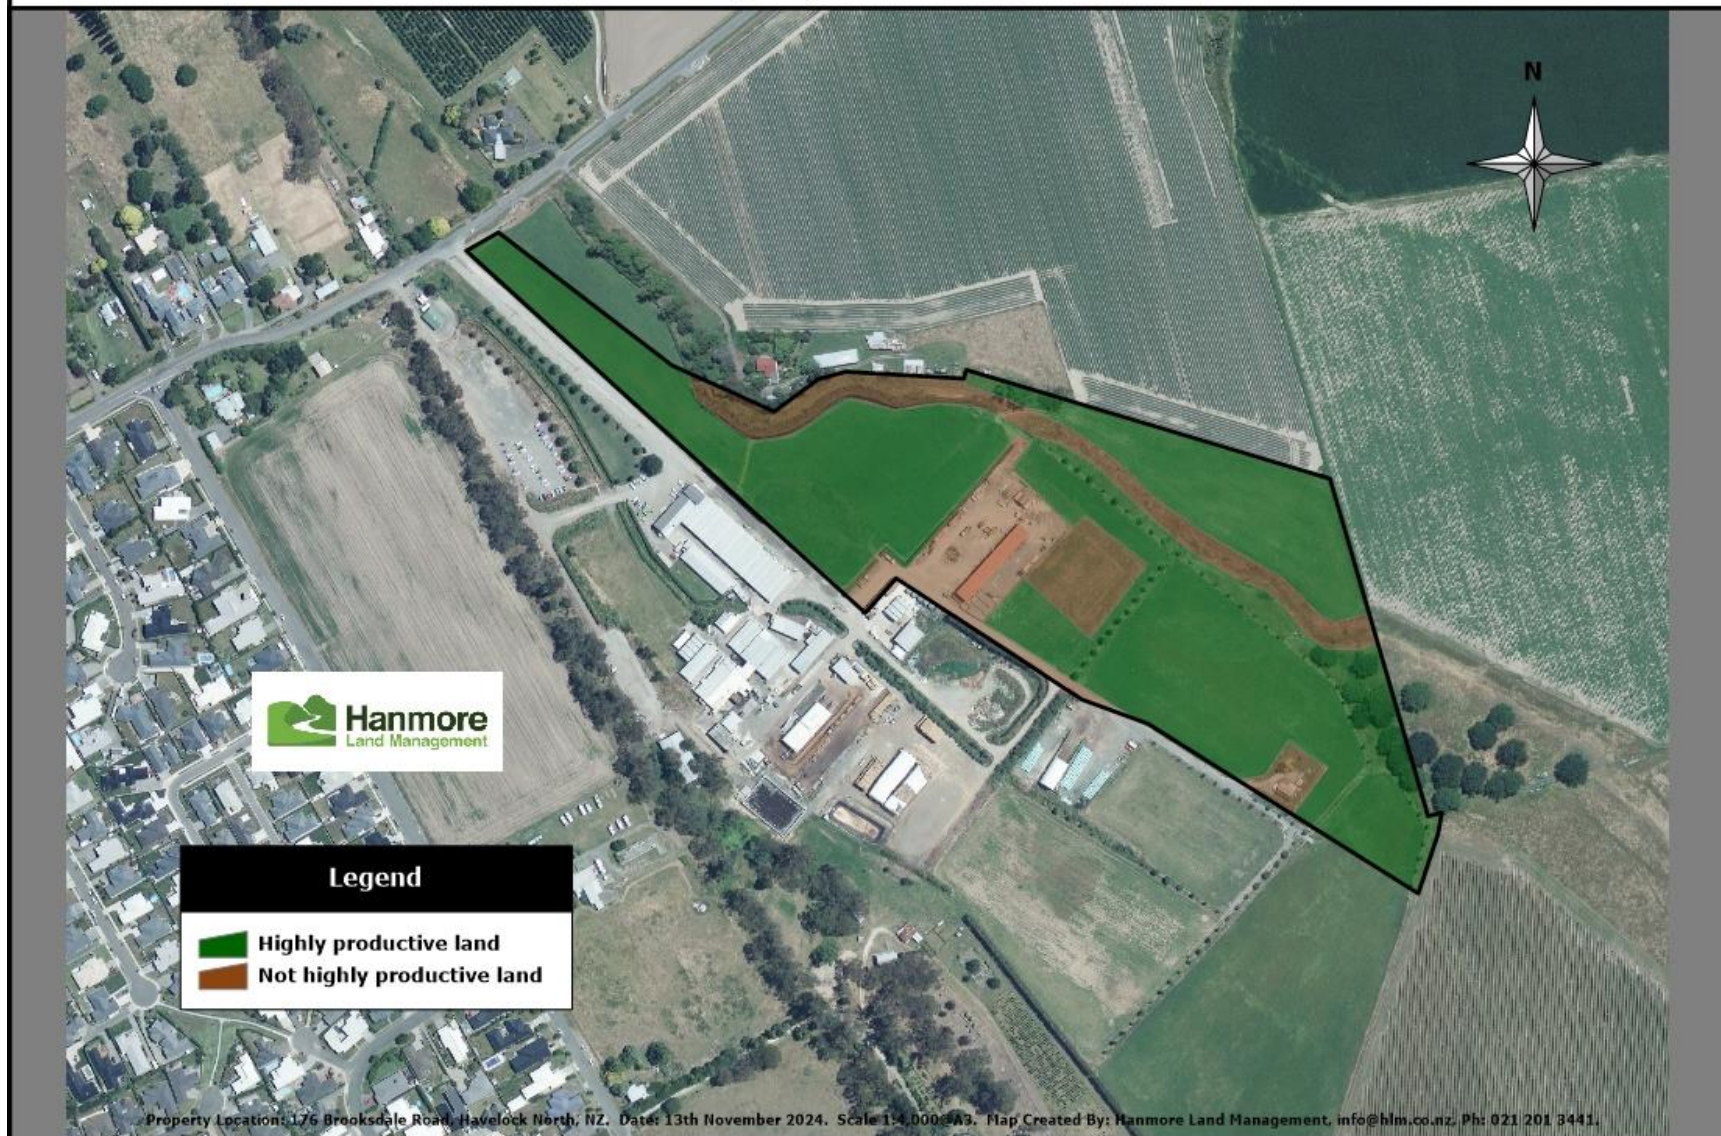
## 176 Brooksdale Road Highly Productive Land Classifications

- The entire site is technically classified as HPL under the NPS-HPL but in reality significant areas of the site have been developed and have no productive potential.
- The site is currently operated in conjunction with 174 Brookvale Road but needs to be considered separately in its productive capacity rather than as one block.
- Impeded soil drainage and stony soil profiles limit the productive potential of the site making it more suited to intensive grazing than cropping.
- Soils at the site have been degraded due to compaction and loss of soil structure and require remedial action to return them to their natural level of productivity.
- The current land use appears to be unsustainable due to the soil profile degradation observed.
- The lack of land use options or site versatility mean this site would not be classified as a highly productive site.
