## **Appendix 2:** Historical Aerial Photo Review

### **Appendix 3:**

Previous Ground Investigation Report Logs

## GEOTECHNICAL INVESTIGATION

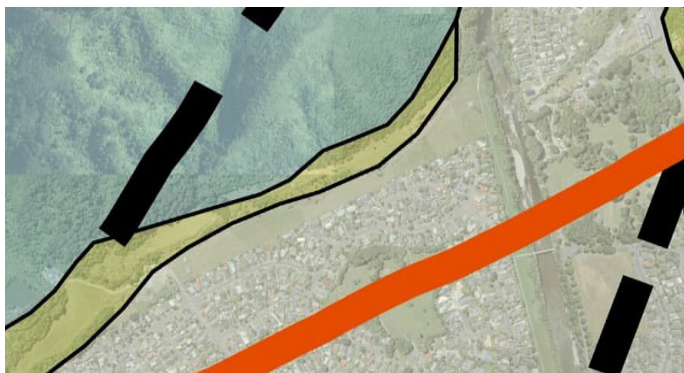
### ANTICIPATED GEOLOGY (GNS MAPS)

Underlying geology of the investigation area has been mapped as Late Pleistocene River Deposits, Rakaia Terrane Sandstone and Mudstone, and Holocene River Deposits

Source: Geology of the site from GNS 1:250000 Geological Map of New Zealand
